Water Quality Implications of Culvert Repair Options: Cementitious and Polyurea Spray-on Liners

Final Report VCTIR 13-R3

FINAL REPORT

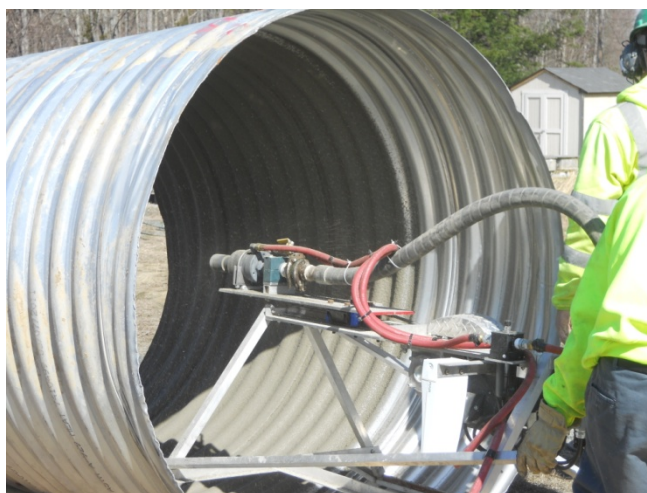
An installation was carried out on a 20-ft section of a 72-in corrugated metal culvert (Figure 2). Large globules of overspray were visible within a few feet of the downwind end of the culvert and were captured on fabric placed outside the inlet and outlet. Small gusts of wind carried airborne particles downwind a minimum of 60 ft. Following application, the product had a soft clay-like texture for the first several hours and had hardened by the following day. Because VDOT had no prior experience using this liner, there were no observations by VDOT staff present at the installation regarding past installations or liner performance.

Figure 2. Installation of Cementitious Spray-on Liner

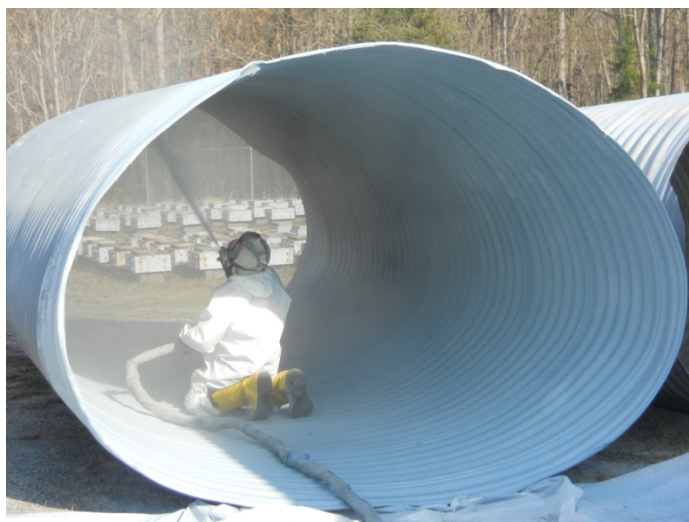
The polyurea spray-on installation was conducted on a 20-ft section of a corrugated metal arch culvert with a cross section of 110 by 79 in (Figure 3). Overspray was evident at both culvert openings, and airborne particles were visible a minimum of 90 ft downwind.

Figure 3. Installation of Spray-on Polyurea Liner

The monitored installation resulted in a smooth liner that was seemingly fully bonded to the host culvert. However, as noted by VDOT staff with prior experience using this liner, polyurea spray-on applications in damaged VDOT culverts have resulted in instances of unsuccessful final products (i.e., separation of the liner from the host culvert and several cracks in the liner) (S. Hite, personal communication; J. Milton, personal communication). Company representatives claim that problems with prior installations were likely a result of the use of the robotic head applicator (which has since been replaced with hand applicators) (T. Meyer, personal communication). However, difficulties with the bond between the liner and the host culvert are typically experienced when water infiltrates during the spraying process (Najafi, 2004). Not only does water infiltration during installation affect the liner performance, but surface water contacting the coating before it is fully cured may also impact water quality.
