# **Corrosion Assessment for the Failed Bridge Deck Closure Pour at Mile Marker 43 on I-81**

Final Report VCTIR 14-R13

The purpose of this research was to investigate the influence of corrosion and shrinkage on the failure mechanism that occurred on an I-81 bridge deck. After 17 years in service, a 3 ft by 3 ft closure pour section punched through. The closure was positioned under the left wheel path of the southbound right lane of the bridge deck. The bridge deck had been replaced in 1992 as part of a bridge rehabilitation project, and the reinforcement was epoxy coated. Four 4.5 ft by 10 ft slab sections, containing the closure, were saw cut from the deck, removed, and transported to the Virginia Tech Structures and Materials Research Laboratory for further evaluation. Also, for comparison, three new slabs were fabricated as part of the assessment program.

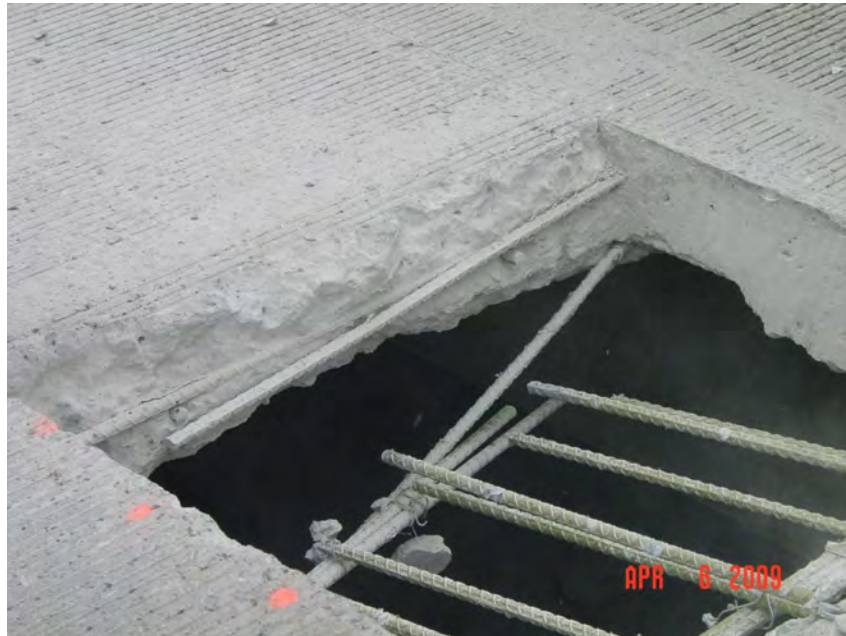
The closure pour was positioned under the left wheel path of the southbound right lane of the bridge deck, so the joint was subject to a very large number of wheel loads. Observations at the bridge site indicated that the joint had opened slightly. In this case, it is possible that the reinforcing bars alone were carrying shear and moment across the joint. The open joint also provides a more direct path for deicing salts to penetrate to the reinforcing bars and induce corrosion. It is therefore likely that both fatigue and corrosion played a role in the failure of the closure.

**Figure 2. Failed Section of Closure Pour**

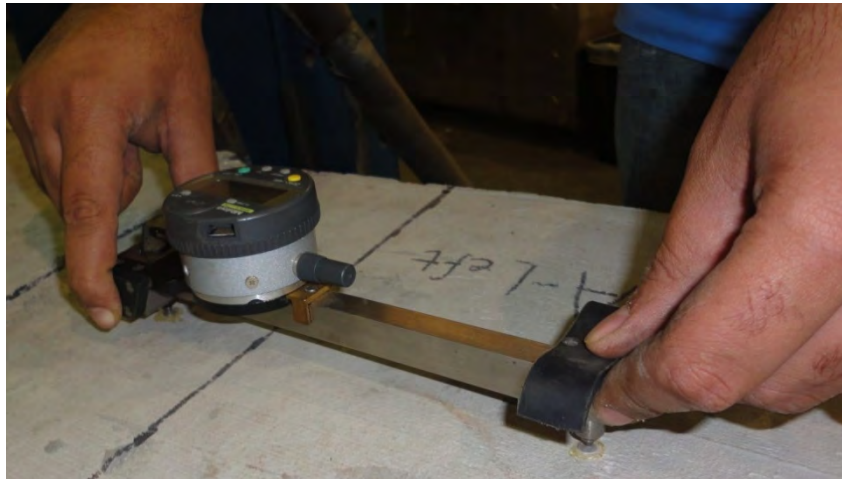
DEMEC points were placed using epoxy on the slab surface. A DEMEC gage was used to measure the length change between the points as shrinkage occurred as shown in Figure 11. Measurements were conducted for a period of 180 days for the deck on each side (first placement), the closure pour that connects each side of the deck (second placement), and across the closure pour joint (between the first and second placement). The time interval between the first and second placement was 30 days. Figure 12 illustrates the location of the DEMEC points.

Figure 11. A DEMEC Gage Measuring DEMEC Points

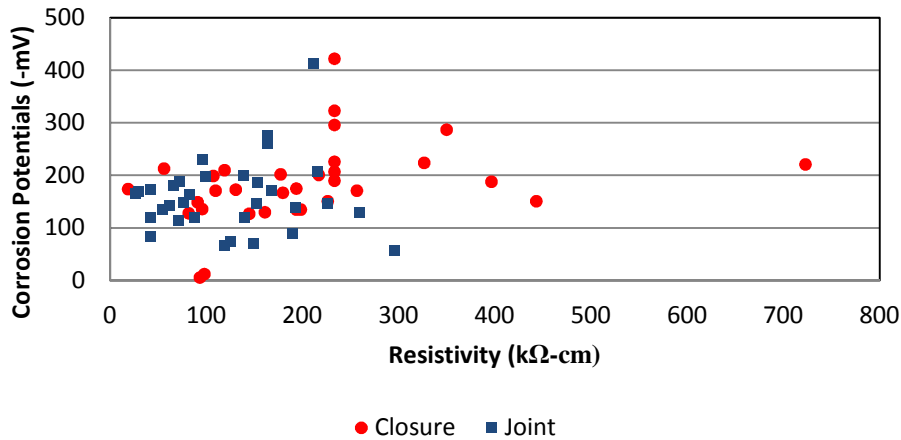
**Figure 14. Corrosion Potentials vs. Resistivity for I-81 Slabs**

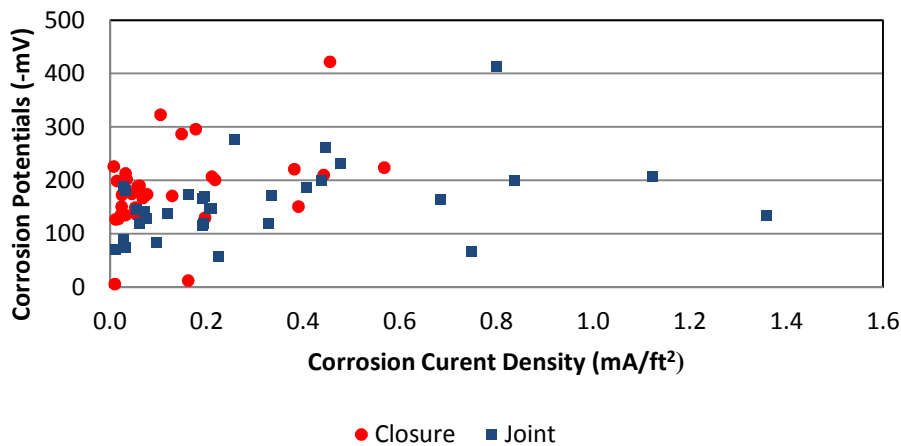
Figure 15 shows a scatter diagram for corrosion potentials versus corrosion current density for I-81 deck slabs. As shown, corrosion current density measurements for the closure joints indicate higher corrosion activity compared to the closure pour measurements. Most of the measurements of the closure pour are less than 0.2mA/ft<sup>2</sup>. The closure joint measurements are highly variable showing low to higher corrosion rates. However, in general the corrosion rates increase with higher negative values of the corrosion potentials for both the closure and joint values, but more so for the joint measurements.

**Figure 15. Corrosion Potentials vs. Corrosion Current Density for I-81 Slabs**

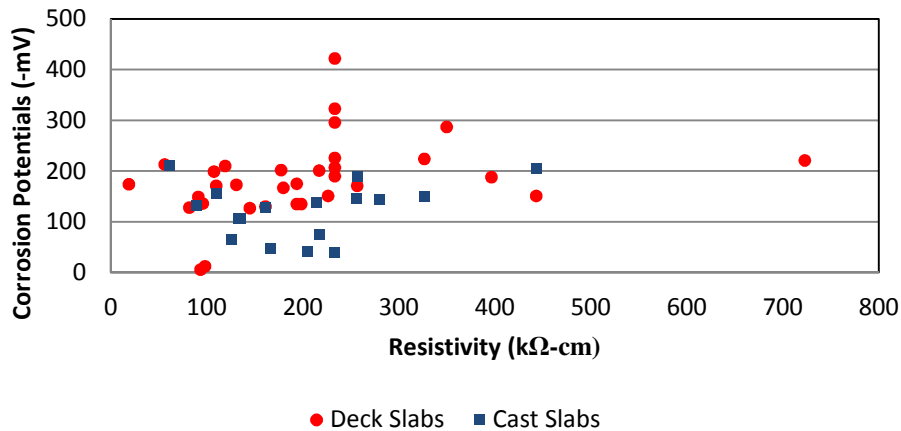
Figure 18 shows a scatter diagram for corrosion potentials versus resistivity for the closure pour of the I-81 slabs versus the lab cast slabs measurements. As observed, the corrosion potentials for the I-81 deck slabs indicate higher corrosion activity compared to the lab cast slab measurements. The lab cast slabs' corrosion potentials are less than -200 mv, which indicates low corrosion activity, while the I-81 deck slabs measurements are indicating higher corrosion activity with corrosion potentials greater than -200 mv. The resistivity measurements for the I-81 deck and lab cast slabs indicate high resistivity with a similar range of measurements.

**Figure 18. Closure Pour Corrosion Potentials vs. Resistivity for Deck vs. Cast Slabs**

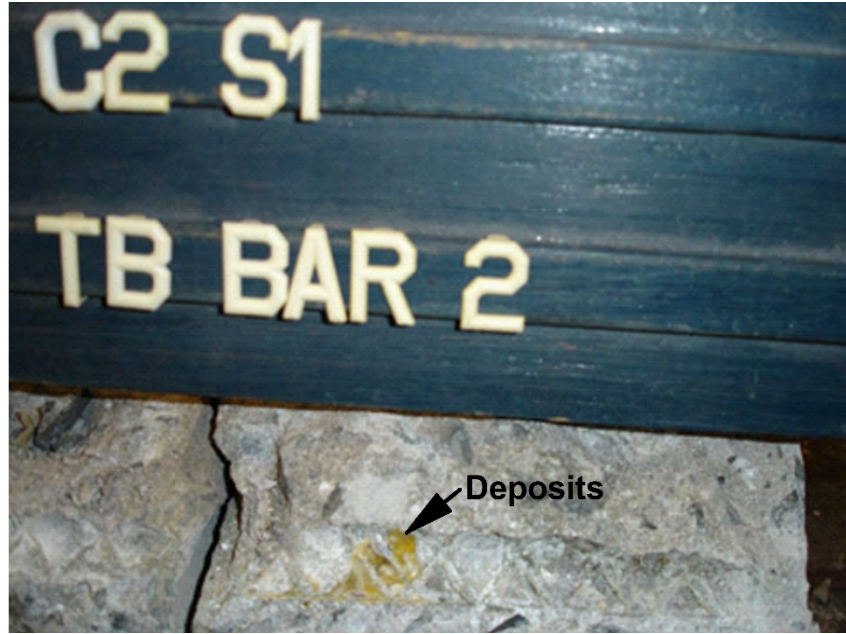
**Figure 25. C2-S1 Top Bar 2 After Removing Bar**

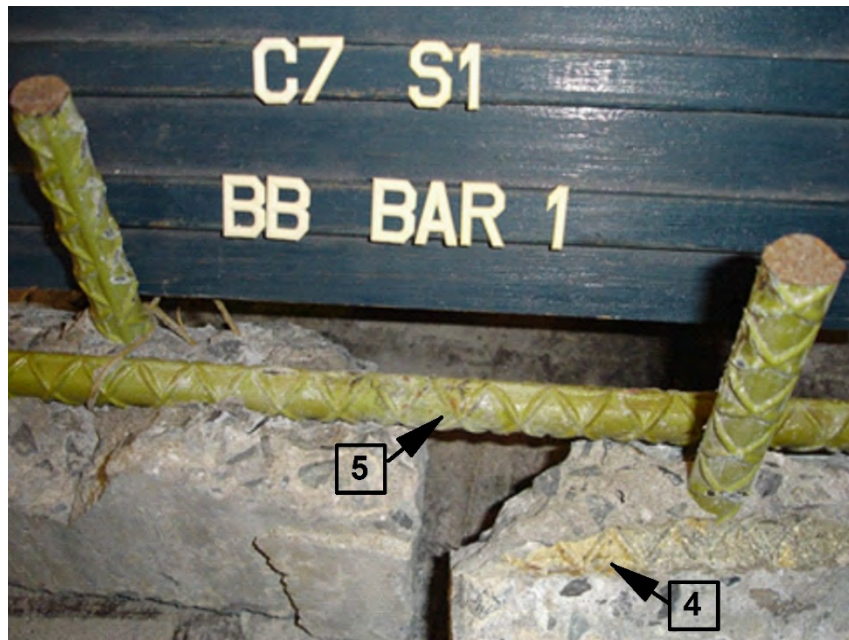
The sample shown in Figure 26 was taken from the bottom of slab three across joint one, as shown in the Appendix. Figure 26 shows some precipitation, arrow 4, at the top of the bar and corrosion, arrow 5, at the bottom of the bar. Samples shown in Figures 27 and 28 were taken from the top of the same slab. Figure 27 shows some white and yellow deposits on the bar at arrow 6, and Figure 28 shows the yellow precipitation in the bar trace at the location of arrow 7.

**Figure 26. C7-S1 Bottom Bar 1**

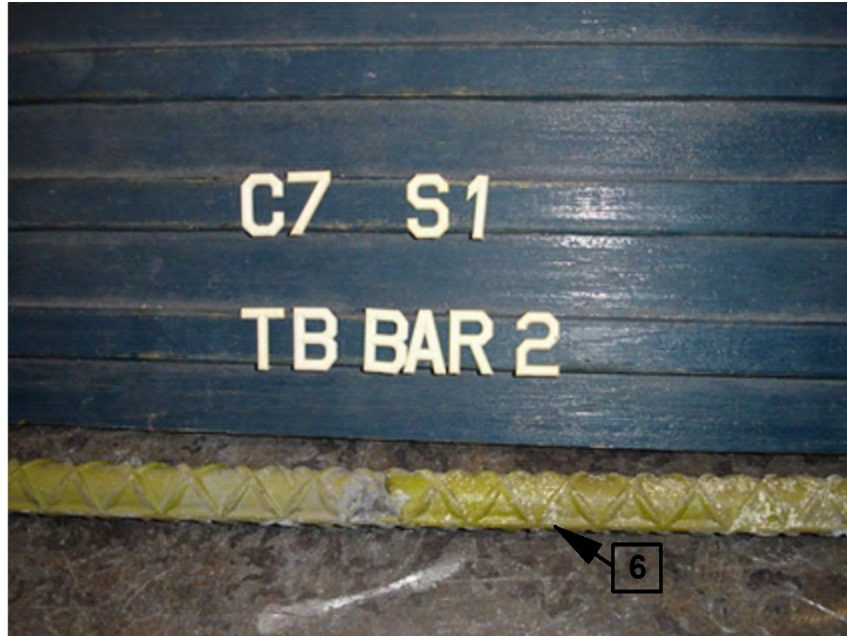
**Figure 27. C7-S1 Top Bar 2 Without Concrete**

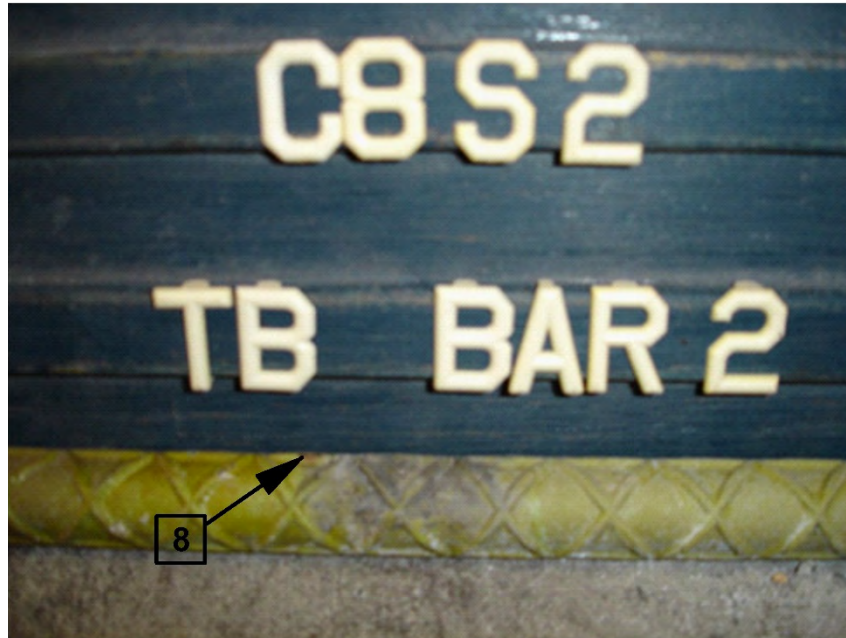
The samples shown in Figures 29 and 30 were taken from the top of slab four across joint two, as shown in the Appendix. Samples shown in Figures 31 and 32 were taken from the bottom of the same slab. Figures 29 and 30 show some deposits, arrow 9, at the top of the bar and corrosion, arrow 8, at the bottom of the bar. Figures 31 and 32 show the bar at the top of the bottom bar with some precipitation, arrow 11, and corrosion, arrow 10, at the joint.

**Figure 29. C8-S2 Top Bar 2 Without Concrete**

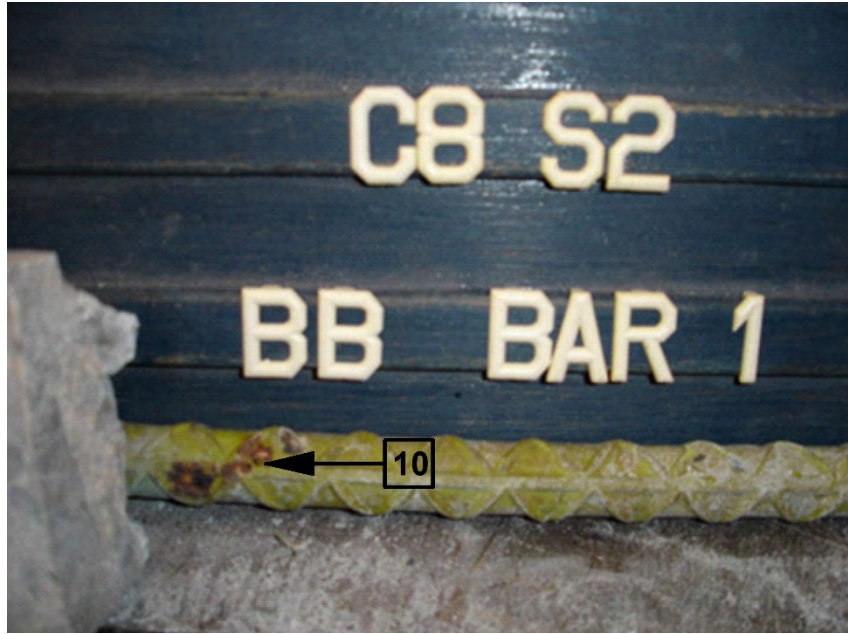
Figure 31. C8-S2 Bottom Bar 1 Without Concrete

For all of the samples taken from different locations from the slabs, deposits and corrosion were observed at the joint and moving along the bar and bar trace in both the closure and the deck concrete. Although corrosion was noticed in some bars, the epoxy coating was difficult to peel off the reinforcing bar. The bars were soaked for two weeks in water to aid the epoxy debondment from the bars to have a closer look at the corrosion under the coating. This had no effect on debonding the epoxy from the bars, although there were some places where the coating was peeled off due to the corrosion on the bar, as shown in Figure 31.

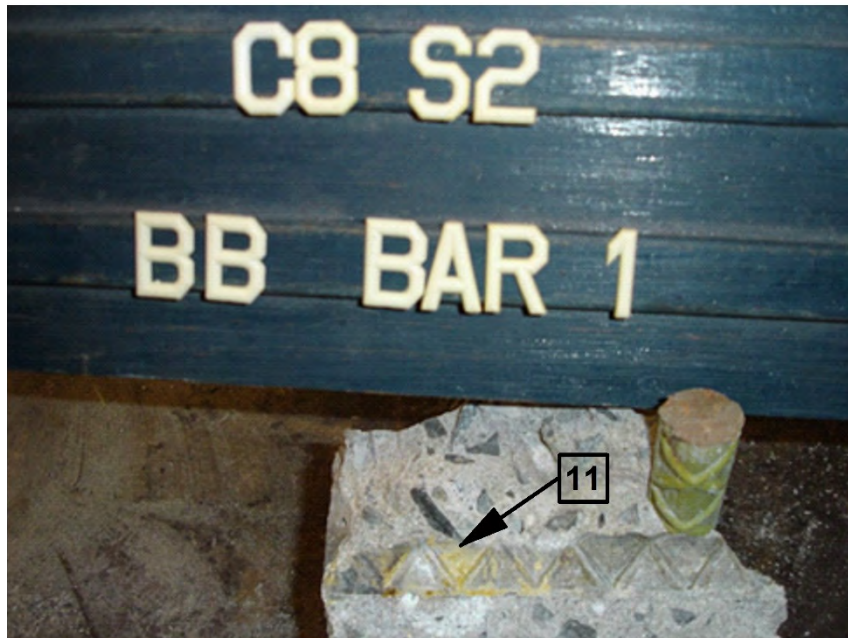
Figure 32. C8-S2 Bottom Bar 1 After Removing Bar

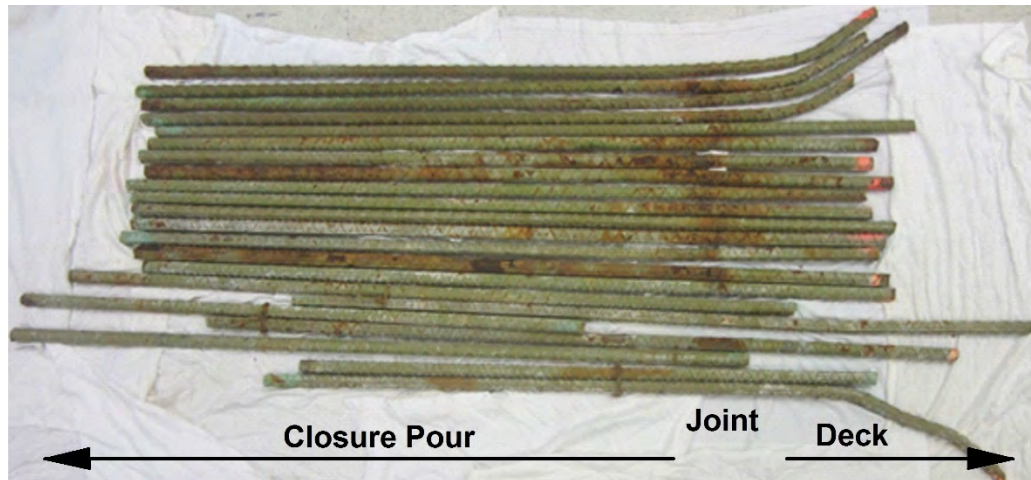
**Figure 33. Corrosion Extent of Extracted ECR Bars**

The higher percent of voids at the ECR-concrete interface would allow water, chloride, and oxygen to penetrate along the ECR-concrete interface some distance and corrode the ECR as shown in Figure 33.

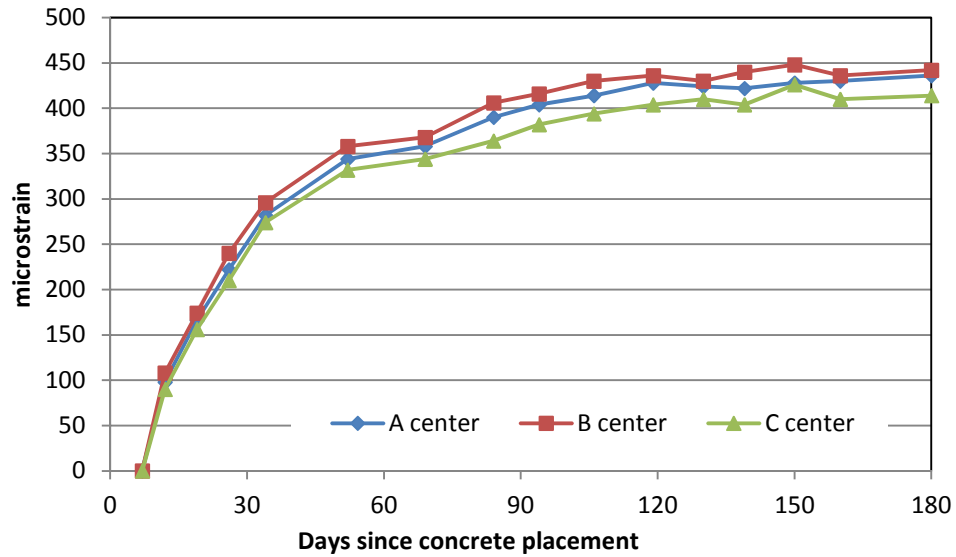
Figure 38 presents the shrinkage of the closure concrete for the three slabs. Each curve is the average of two pairs of DEMEC points. The shrinkage for the closure concrete was slightly higher than the first placement, with shrinkage at 180 days between 410 and 440 microstrain.

**Figure 38. Slab Shrinkage Readings for Second Placement**

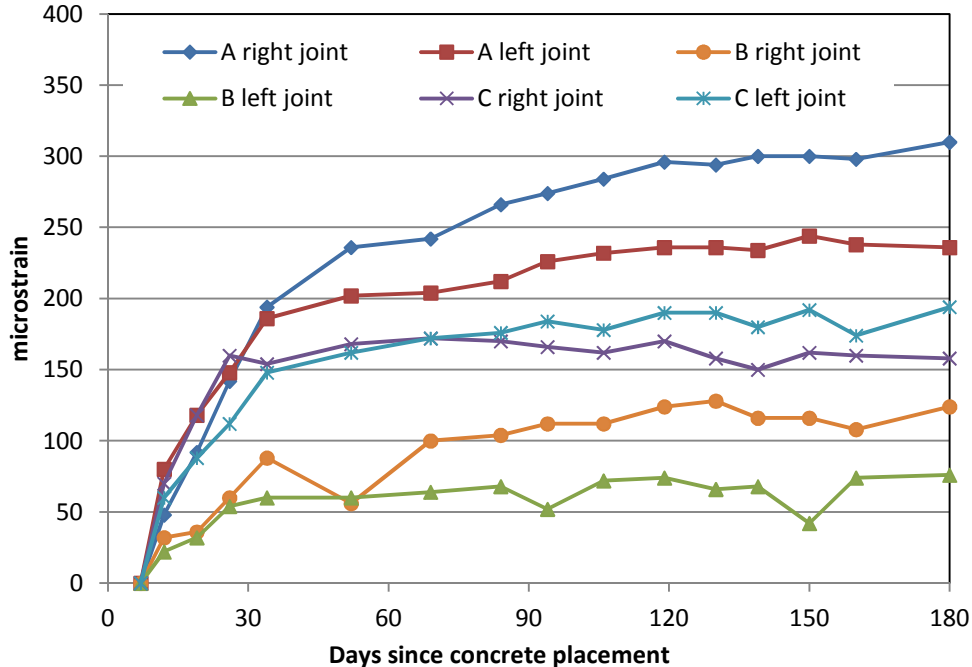
Figure 39 presents the shrinkage measured across the joints of the three slabs. There is considerably more scatter in these readings, most likely due to the opening of the joint. The shrinkage at 180 days varies from 75 to 300 microstrain. This is much less than the shrinkage measured for the monolithic concrete, which is also most likely due to the opening of the joints.

**Figure 39. Shrinkage Readings for Joints Between Deck and Closure**

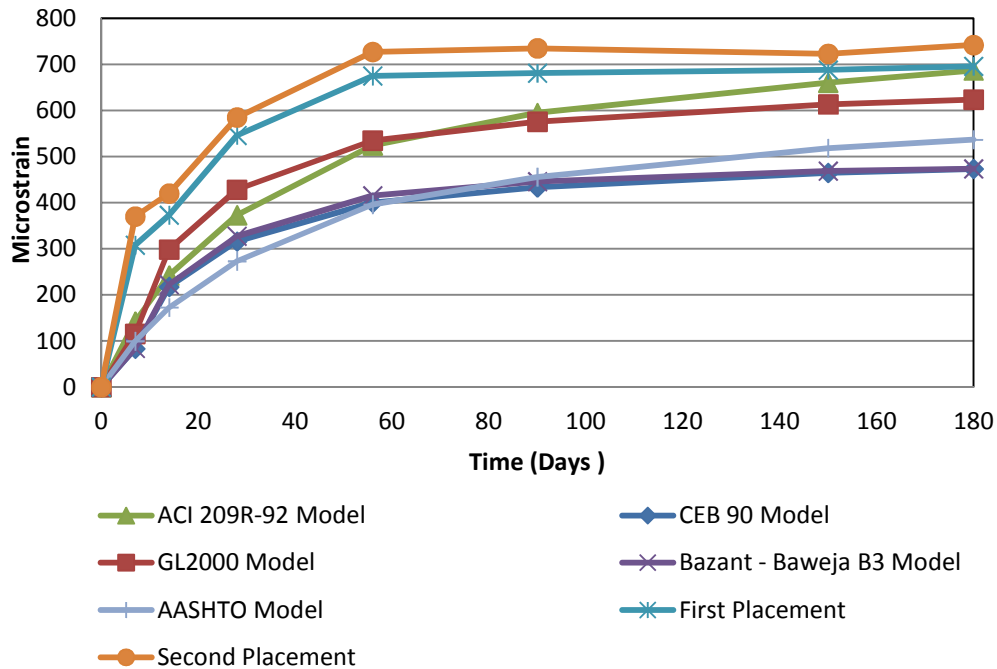
Five models were used to predict the unrestrained shrinkage and compare it with the actual measured results. The average relative humidity in the laboratory varied, from 40% to 92%, throughout the testing period, from December 2010 to June 2011. Figure 40 presents a comparison for the five models for 50% RH. The two models with the best predictions are the ACI 209 model and the GL2000 model. Both models, however, predict a slower rate of shrinkage development than was measured.

**Figure 40. Shrinkage Models Comparison for 50% Relative Humidity Ponding Observations**
