Virginia Center *for* Transportation
**INNOVATION
& RESEARCH**

Investigation of Panel-to-Panel Connections and Block-outs for Full-Depth Precast Concrete Bridge Decks

Final Report VCTIR 15-R5

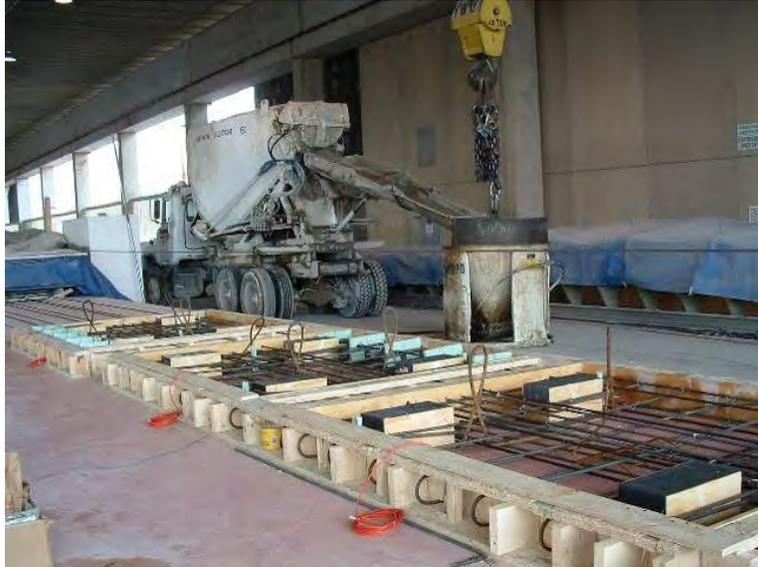
Figure 1. Constructing Precast Panels at a Precast Plant

Full-depth precast concrete bridge decks are one option to help speed up the construction of bridge decks at the bridge site. The deck is cast in segments away from the construction site (Figure 1). This provides good quality control and more flexibility during construction. In addition, there is minimal work done on the job site and large concrete placements are eliminated from the field. Panels may be lifted directly from a truck and placed on the beams. The panels are placed in their final positions and a minor amount of formwork is placed around the haunches and connections. The panels are then connected to the beams and to each other (Figure 2). Using precast deck panels should limit the amount of construction needed on the bridge site and reduce the disruption to the public.

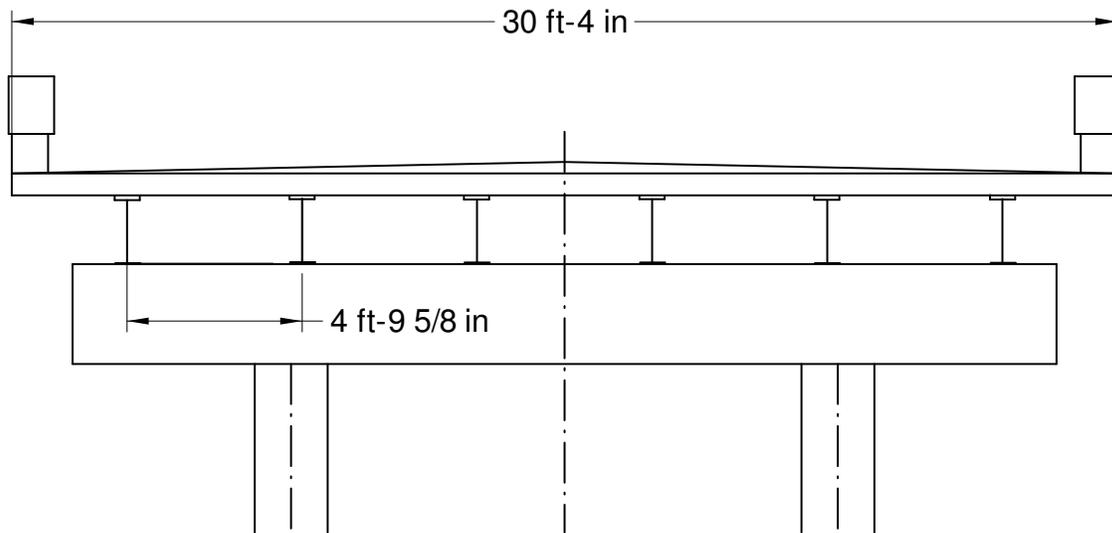
Figure 4. Transverse Section View of the Virginia Bridge

The continuous three-span bridge in southwest Virginia that carries Rte. 65 over Staunton Creek provided the basis for the design of the test setup and panel-to-panel connection specimens (Figures 4 and 5). The selected bridge represented a typical layout for a steel beam bridge in need of a new deck. The bridge is owned and maintained by VDOT. The superstructure layout for the project included W21×83 beams spaced at 4.8 ft, an out-to-out deck width of 30.3 ft, and a composite three-span design (31 ft - 32.5 ft - 31 ft). The bridge has one 12-ft lane in each direction, a 2-ft shoulder on each side, and a Kansas Corral barrier rail.

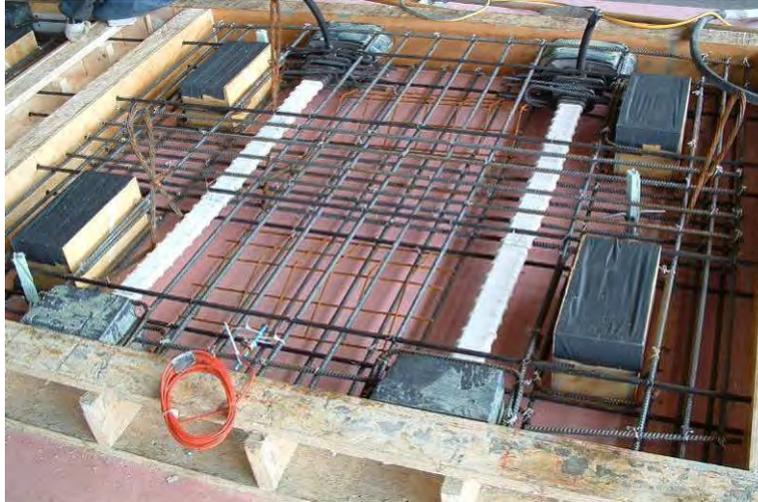
Figure 12. Installing the Vibrating Wire Gauges in the Panel

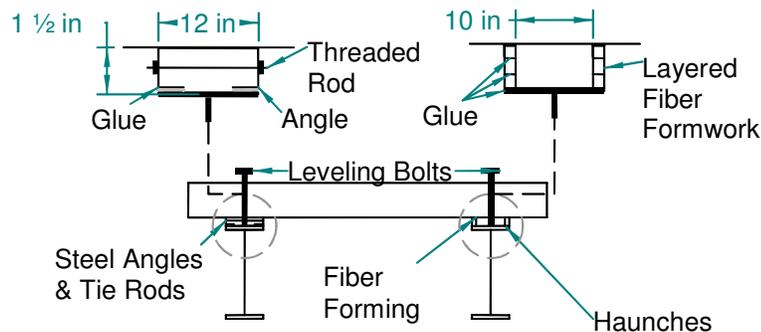
Figure 13. Bridge Haunches

The haunches were formed between the panels and steel beams to keep the grout in place during placement. In the first test setup, two methods were used to form the haunches: fiber forming board and cold formed steel angles (Figure 13). The fiber forming board was made of recycled paper fiber. The board was purchased in 1/2-in-thick sheets, cut to size, and glued together. A 1 1/2-in-thick haunch was used throughout. The boards were then glued to the outer edge of the top flanges of the beams. The second material used was a cold formed steel angle with leg dimensions of 1 1/2 in. A 1/4-in-diameter tie rod was used at approximately 4-ft spacing along the beam to provide transverse support. The bottom leg of the angle was glued to the top flange of the beam to ensure stability during construction. Prior to putting the panels in place, a small strip of weather seal was placed on the top edge of the flange of the angles. Observations were made of the ease of construction and effectiveness at containing the grout. In the last two setups, the fiber forming board was used throughout.

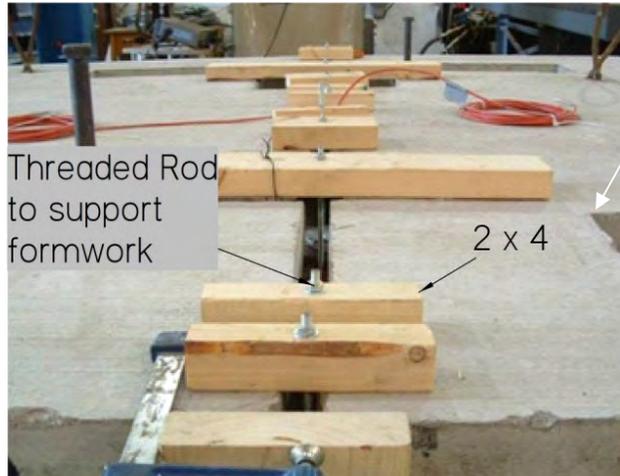
Figure 14. Formwork for the Narrow Transverse Connections

Wooden formwork with threaded tie rods was used for all of the transverse connections (see Figure 14). A liquid adhesive was applied around the connections between the wood and concrete to ensure the grout would not leak. The time and ease of construction were monitored. After the grout cured, the wooden formwork was removed but the tie rods were left in place. In five of the six connections, the tie rods left weak spots that extended through the entire depth of the connections. In the looped reinforcing bar connection, the reinforcing within the connection was used as support for the bottom formwork. This method was devised to prevent protrusions in the top surface of the grout (Figure 15).

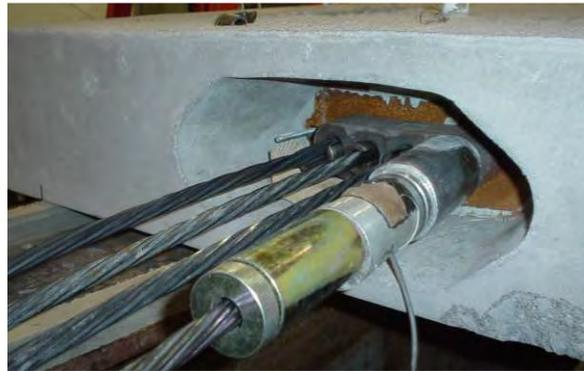
Figure 18. Load Cell on the Dead End of a Strand During Stressing

One load cell was placed on the dead end of one strand in each duct (Figure 18). The load cells ensured that the load in the strands was correct and provided data to back-calculate friction losses. The strand with the load cell was stressed first so that elastic shortening losses from subsequent stressing could be monitored. After post-tensioning, the ducts were grouted as described previously. The additional time and labor needed to add post-tensioned strands were measured.

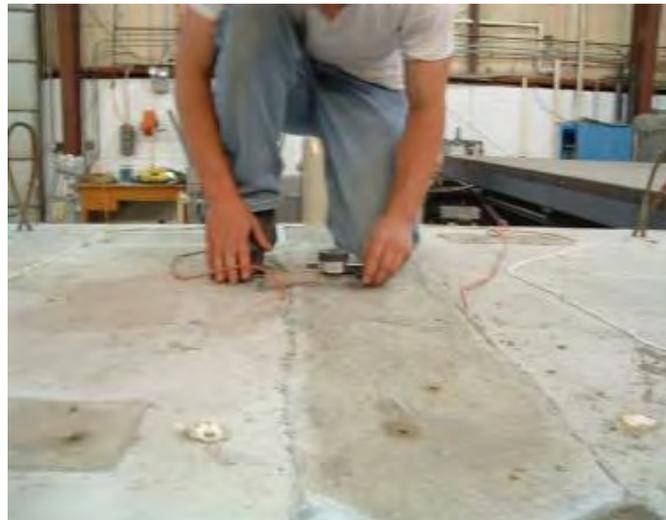
Figure 21. Taking DEMEC Reading

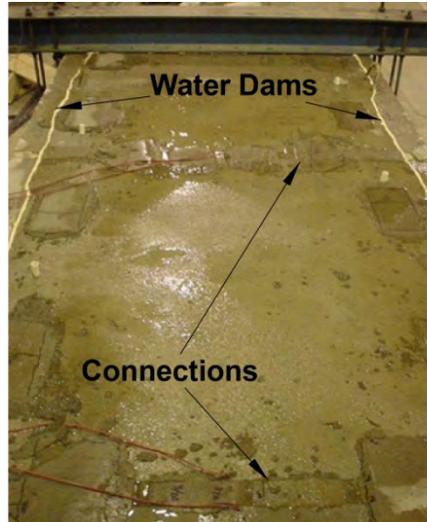
Figure 22. Ponding Test

A ponding test was performed at particular points during the load cycles (Table 2 and Figure 22). A 1-in-high layer of construction adhesive was applied around the edge of the surface of the panels as a dike. Water was then placed on the bridge deck. The ponding test determined when the cracks in the deck were big enough to allow water to flow through the deck over a two-hour time period. No load was applied during these tests, except during the final ponding. After the one-millionth cycle, a ponding test was performed while applying ten service load cycles and then while applying one hundred service load cycles. The bottom and sides of the deck panels were observed for leaks.

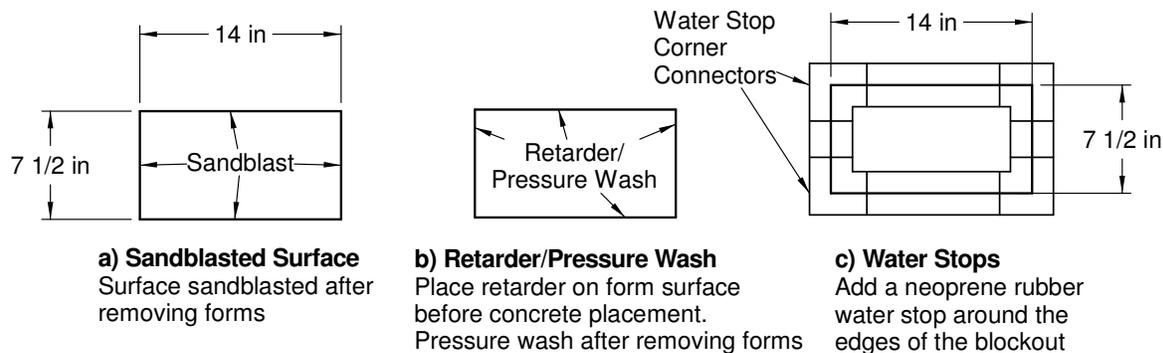
Figure 24. Shear Pocket Construction Notes

Three of the techniques required additional work from the precast manufacturer. The exposed aggregate pockets were treated with a set retarder prior to placing the concrete. When removing the forms, the pockets were sprayed with water to remove the paste. Sand-blasting was performed on two pockets immediately after removing the formwork. It is noted that the sand-blasting took place 49 days before the grout was placed in the shear pocket. The water stops were placed inside the pocket formwork and cast into two shear pockets. The construction diagrams are shown in Figure 24.

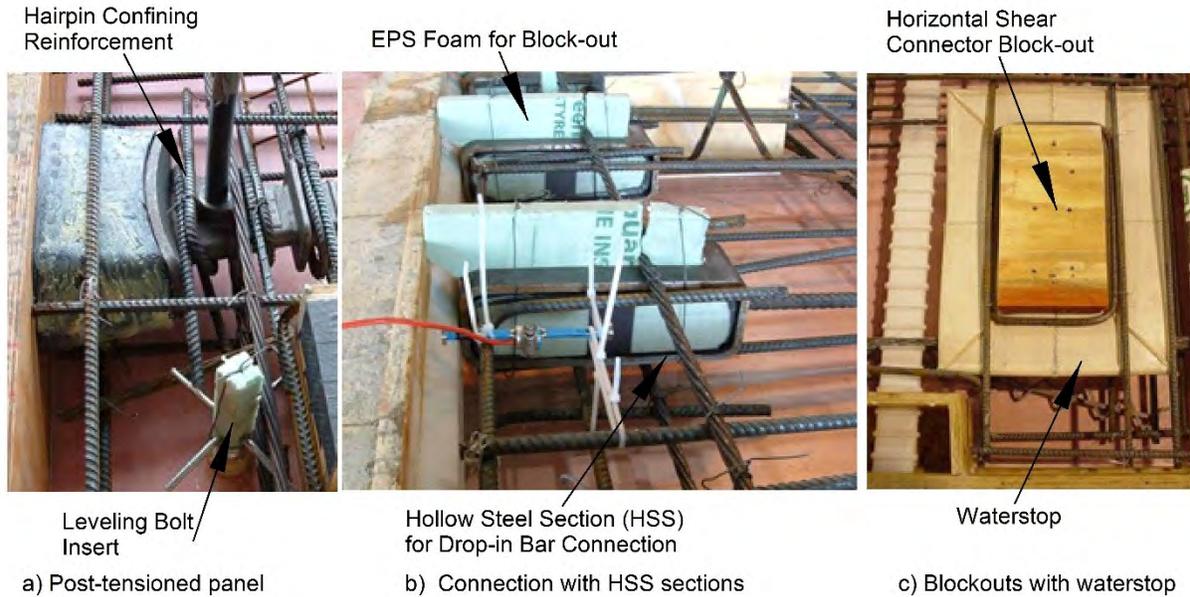
Figure 26. Difficulties Forming Precast Parts

The water stops for the last set of panels were built by the researchers and given to the precast fabricator to install. The precast fabricator had no problems installing the block-outs, but the workers did comment on the complexity and challenge to build a large number of these assemblies. In general, when pieces had to be suspended in the formwork (ductwork, water stops, HSS assembly), the complexity increased and created problems (Figure 26).

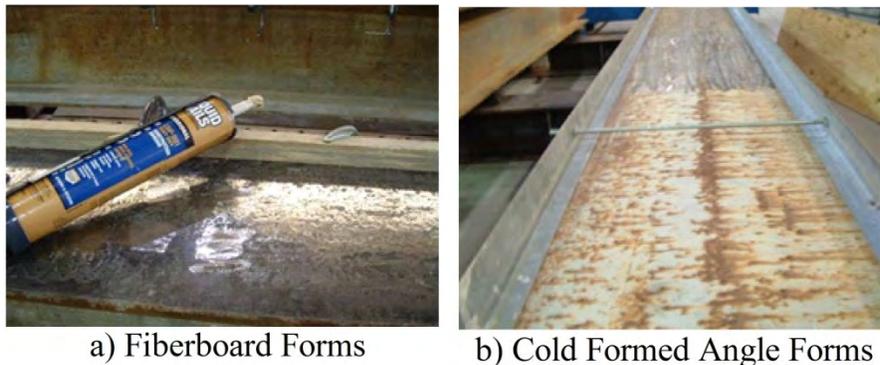
Figure 27. Fiber Formwork and Steel Angle Formwork

Each beam was placed on three support points: the roller in the middle and the temporary support beams on each end. Temporary steel angles were clamped to the flanges of each beam for stability during construction. The top surfaces of the beams were cleaned with a grinder and washed prior to placing the haunch formwork. Two types of haunch formwork were used on the initial setup. The first was a fiber forming board made of recycled paper fiber. The second was the 1.5-in cold formed steel angles tied transversely together with 0.25-in threaded rods. A 1½-in-thick haunch was used throughout (Figure 27).

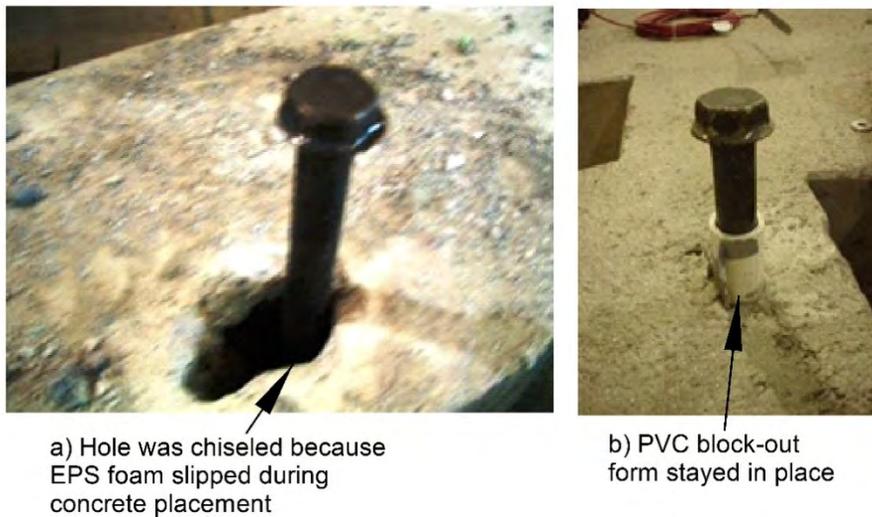
Figure 28. Block-outs Around the Leveling Bolt Assemblies

Upon arrival at the lab, the first problem was observed on the panels. The EPS foam used as block-outs for the HSS sections and the leveling bolts did not work well. In every location, the EPS was extremely difficult to remove and the leveling bolts were not properly positioned. Many of the leveling bolt locations had to be adjusted with a hand held concrete hammer drill (Figure 28). The HSS sections did not have any concrete inside, however the EPS was hard to remove. A chisel and a propane torch were used to remove the EPS (Figure 29). In the future, the leveling bolt assembly should be used with PVC pipe at the block-outs. The HSS sections should be blocked out with a different material that is easier to remove. A possible option would be to tape around the exterior of the assembly.

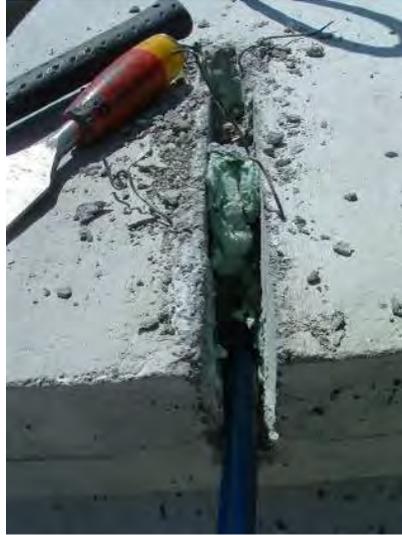
Figure 29. Removing the EPS From the HSS Anchorage Assemblies

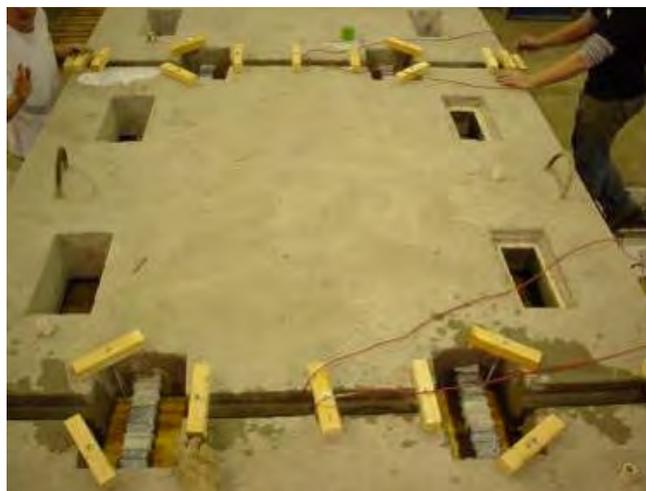
Figure 30. Coupling Post-Tensioning Duct Across Connection

The post-tensioning ducts lined up well and the panels were easy to set into place. A few extra minutes were needed to tape each duct together in the block-out regions. Typically, the duct had to be lined up by hand and then taped, but the process worked effectively (Figure 30).

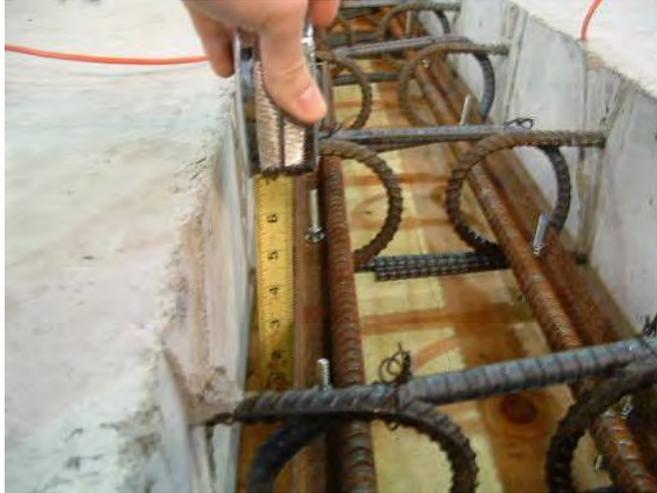
Figure 31. Looped Reinforcing Bar Tied to Bars Extending From Panel

The looped reinforcing bars with the looped connecting bar were easy to place. This connection took a little more time because the bars had to be tied together at a 6-in spacing throughout. However, there was ample space to place the rebar and tie it by hand (Figure 31).

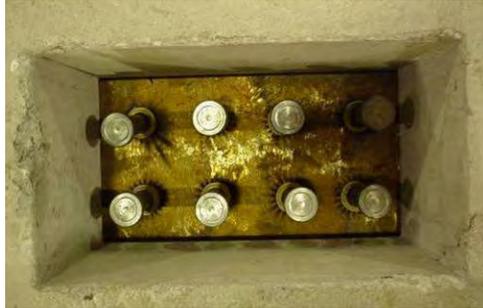
Figure 33. Layout of Shear Studs in a Pocket

Grout was placed in the shear stud pockets after the shear studs were welded in the pockets. The pockets had been designed to be as small as allowed by the design code and only provided a couple of inches of space between the shear studs and the walls of the pocket (Figure 33). The process of welding 96 shear studs took approximately one hour for a single experienced welder. The welder commented that the process was not overly difficult. Cleaning the ferrules out of the pockets was the most difficult part after welding the studs. A hand pick was used to break the ferrules off of the studs and a vacuum was used to remove the pieces.

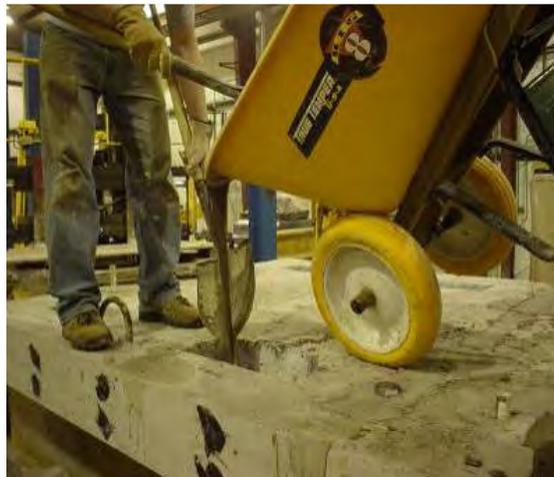
Figure 34. Filling the Shear Pockets and Haunches With Grout

The objective of the last grout placement on the post-tensioned decks was to fill the haunches and shear pockets. This process went very smoothly, mainly due to the experience of the workers. First, the shear studs were welded to the top of the beam through the shear pockets. Like the previous haunch grout placement, grout was placed along each beam line starting at one end. After a pocket was full, the next pocket in line was filled (Figure 34). Grout flowed out of the pockets into the haunch. The flow of the grout was monitored through the shear pockets (see Figure 16). Generally, a vibrator was not required to consolidate the grout; however, for a couple of dry mixes, a pencil vibrator was temporarily used.

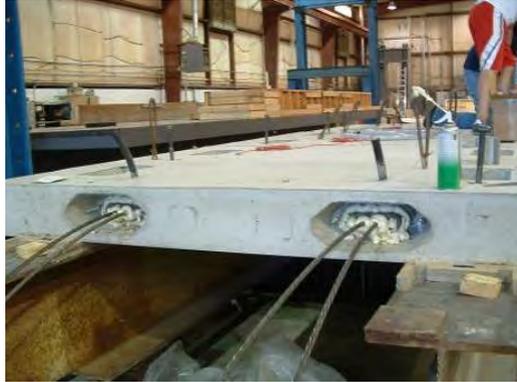
Figure 35. Two Strands per Duct in the 167 psi Post-Tensioned Connection

The last four transverse connections were longitudinally post-tensioned. In the first post-tensioned deck, two strands were used per duct (Figure 35). This amounted to a total of four strands in the 7-ft wide bridge deck, or two per beam line. The second post-tensioned deck was the same width, but four strands were placed in each duct (Figure 36). Oversized (super) ½-in strands were used throughout. Threading the strands through the ducts was very easy and only took one person a few minutes per strand.

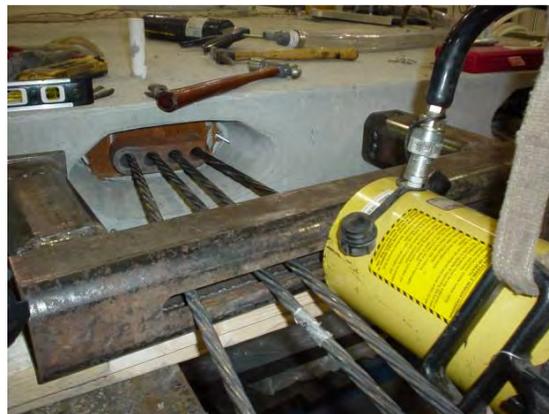
Figure 37. Stressing Assembly

The steel strands were stressed by placing an actuator against a stressing chair. The stressing chair was placed around the anchor assembly and against the end of the panels. The anchor assembly was then accessible for aligning and anchoring the strands (Figure 37). The assembly was easy to use, especially after gaining experience. Two people were needed: one to hold the assembly in place and another to apply the load and monitor the gauges. The hardest part was properly seating the chucks in the anchor. A hammer was used to drive the chucks into the anchor as far as possible to reduce seating losses. Stressing sequence alternated between strands in each duct.

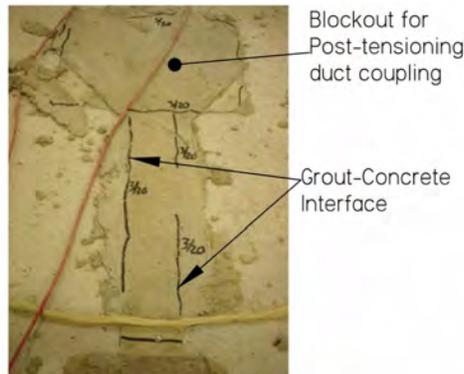
Figure 39. Shrinkage Cracks on Top of Deck in the 340 psi Post-Tensioned Connections

Shrinkage cracking was a problem in the panel-to-panel connection in these tests. The connections that cracked the most were the ones that were monitored the longest. The lack or presence of post-tensioning stress in the deck did not alleviate the problem. The connection with the highest compressive stress sat the longest and cracked the most.

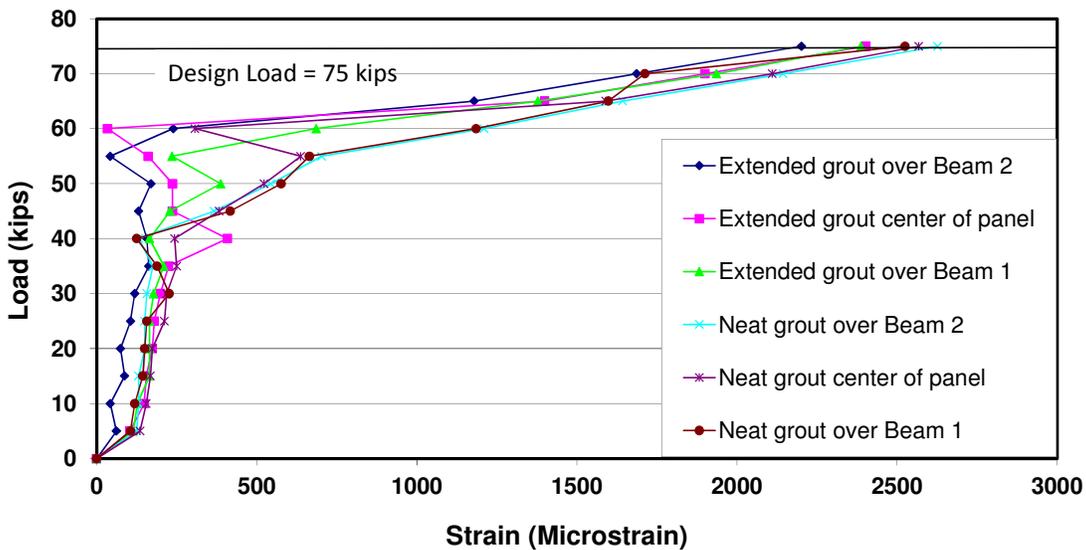
Figure 43. Load Versus Deck Surface Strain From DEMEC Points – Post-Tensioned Connections - 167 psi Stress – One Service Load Cycle

The four post-tensioned connections cracked at different loads and points in the cyclical loading. The initial cracks in the neat and extended grout connections with 167-psi level of stress occurred during the first static load (Figure 43). The neat grout connection cracked at 40 kips, whereas the extended grout cracked at 55 kips. In both connections, one transverse crack appeared on one side, at the grout-to-concrete interface, across the full width of the panels.

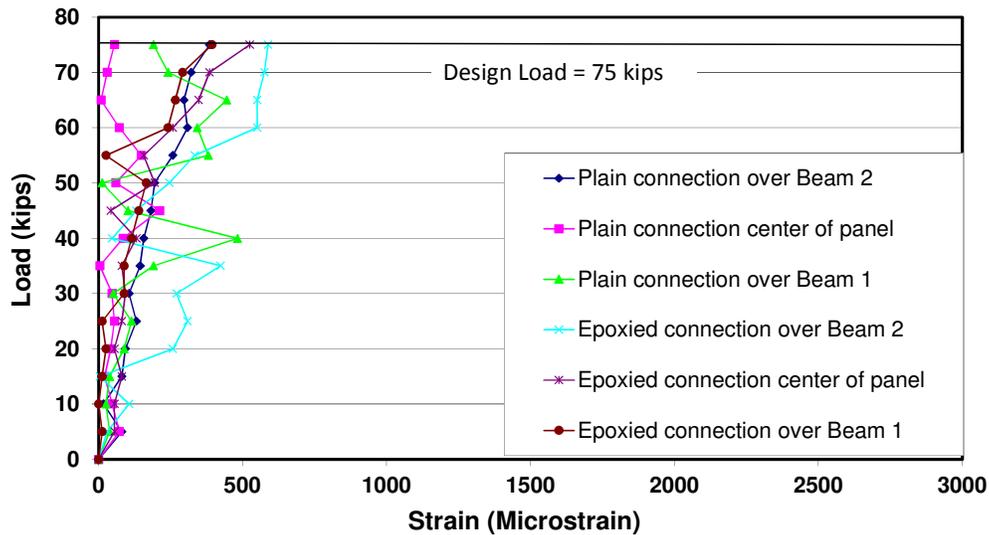
Figure 44. Load Versus Deck Surface Strain From DEMEC Points – Post-Tensioned Connections -340 psi Stress – One Service Load Cycle

In the post-tensioned connections with prestress level of 340 psi, the connections did not experience large cracking. While no cracking was predicted, small shrinkage cracks occurred at the concrete-to-grout interface in the connections prior to service loading. The first crack due to service loads was seen at 5000 cycles for both connections; however, the DEMEC measurements on top of the deck were not conclusive (Figure 44). Figure 45 shows the load versus strain at 100,000 cycles with a slight nonlinearity. This nonlinearity in the graph never grew during the cyclical tests. The connection with the higher level of prestress did not exhibit large strains during any of the loadings as were seen in the previous four connections. Maximum surface strains in this connection peaked at about $800\mu\epsilon$, which is almost one-fourth the size of the maximum values in the other two post-tensioned connections. The cracks that did appear were extensions of the shrinkage cracks at the grout-to-concrete interface.

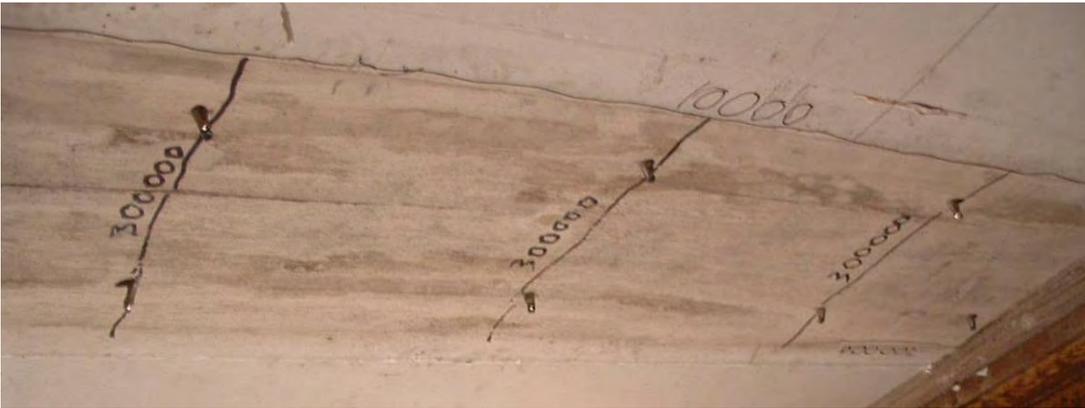
Figure 47. Longitudinal Cracking on the Bottom of the Looped Bar Connection

The looped bar connection had minor cracking throughout the connection. The cracking at the initial loading on both sides of the connection was not visible but did exist according to the strain measurements. Cracks became visible across the top of the connection on both sides of the grout-to-concrete interface around 20,000 cycles. There were no cracks visible on the bottom of the connection until 300,000 cycles. By 600,000 cycles there were cracks on the top and bottom surfaces of both sides of the connection. The cracks slowly became more visible along the entire connection. Additional cracking did occur longitudinally at 300,000 cycles along the connection where the tie rods were left in the grout (Figure 47). Otherwise, the cracks concentrated at the material interface. By the end of the cycles there was complete cracking along both interfaces.

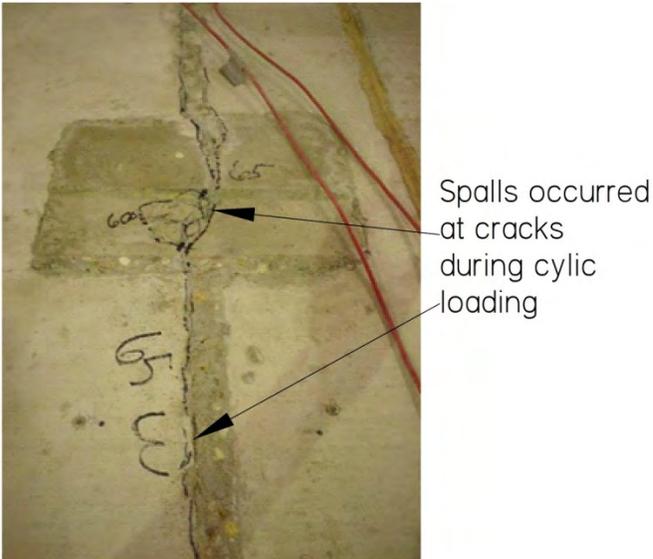
Figure 48. Spalling Along the Post-Tensioned Pea Gravel–Extended Grout Connection

The 167-psi neat grout connection had one full-width crack on the exterior side of the connection and an additional crack along one half of the interior side of the connection. This crack on the interior extended to two-thirds of the grout-to-concrete interface before 200,000 cycles. The cracking extended to the bottom of the panels on the interior side of the connection. Cracking also appeared around the post-tensioning duct coupling block-out corners throughout the tests. More cracking appeared with the neat grout connection than with the pea gravel–extended grout connection.

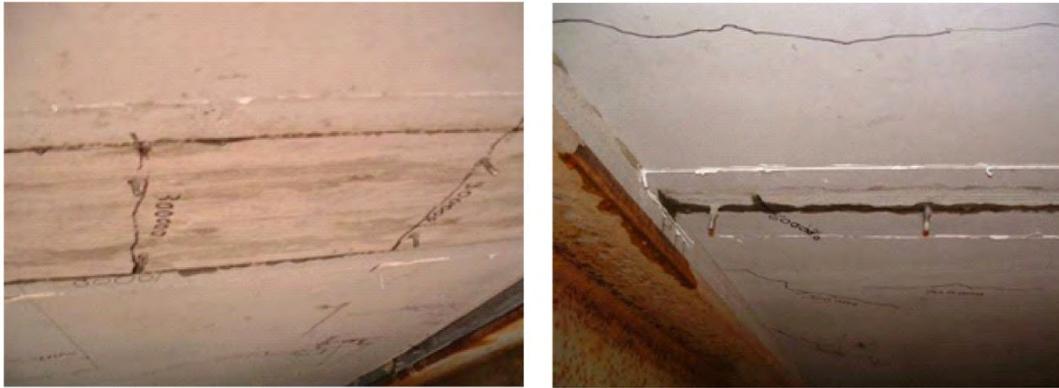
a) Looped Bar Connection

b) Drop-in Bar Connection

At the end of the test, the looped bar connections did not leak and the drop-in bar connections leaked profusely. After the final static ponding test was performed, the test was repeated with 10 load cycles and with 100 load cycles applied during ponding. The cycles consisted of applying the equivalent of HS-20 service load at 1 Hz. While under the cyclic load and ponding, the drop-in bar connection leaked profusely. Water continuously flowed through the cracks in the middle of the connection. Approximately 25% of the looped bar connection began to leak under the 10-cycle load. By the end of 100 cycles under ponding, about 75% of the looped bar connection showed signs of leaks (Figure 51). Most of the water beaded up along the crack between the grout and concrete but did not drip to the ground.

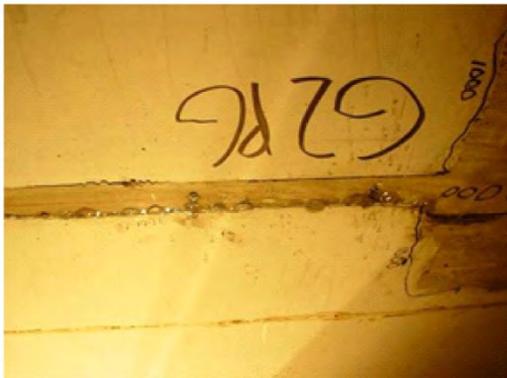
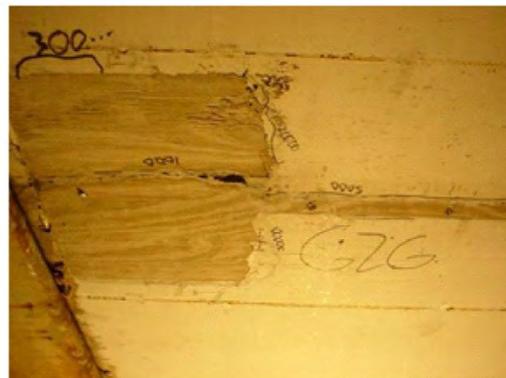
a) Pea Gravel Extended Grout

b) Neat Grout

Figure 52. Final Leaking - Post-Tensioned Connections With 167-psi Prestress

The first post-tensioned specimen had two connections with 167 psi of initial compressive prestress: One connection with neat grout and one with a pea gravel–extended grout. Neither connection leaked until the static test after one million cycles. During this test, the pea gravel connection had three small leaks between the grout and panels that were 1 to 2 in long (Table 14). There was no significant change in the pea gravel connection until ponding with 100 cycles of service load. At the conclusion of the 100 cycles, approximately two-thirds of the connection leaked (Figure 52). Water beaded up on the cracks between the grout and panels but very little water leaked to the ground.

Stage of Loading	Post-Tensioned (PT) Connections			
	Pea Gravel-Extended Grout (167 psi)	Neat Grout (167 psi)	Neat Grout (340 psi)	Neat Grout with Epoxy Faces (340 psi)
500,000 Cycles	No Leaks	No Leaks	No Leaks	No Leaks
1,000,000 Cycles	3 Leaks – 1 to 2 in long	1 Leak – PT Pocket 1 in long	No Leaks	No Leaks
10 Cycles with Water	3 Leaks – 1 to 2 in long	1 Leak – PT Pocket 1 in long	No Leaks	No Leaks
100 Cycles with Water	~66% of Interface Leaked	~20% of Interface Leaked	No Leaks	No Leaks
