Use of Electrochemical Chloride Extraction and Associated Repairs to Extend the Beneficial Life of Reinforced Concrete Substructures

Final Report VTRC 16-R16

**USE OF ELECTROCHEMICAL CHLORIDE EXTRACTION AND ASSOCIATED
REPAIRS TO EXTEND THE BENEFICIAL LIFE OF REINFORCED CONCRETE
SUBSTRUCTURES**

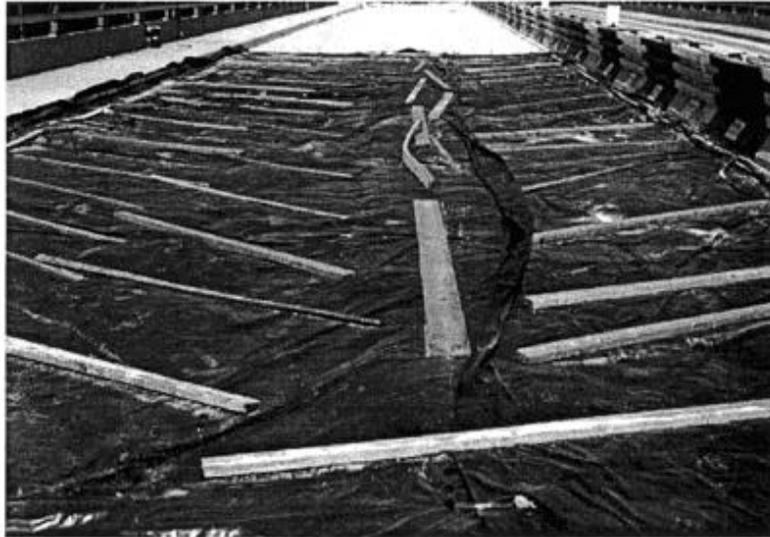
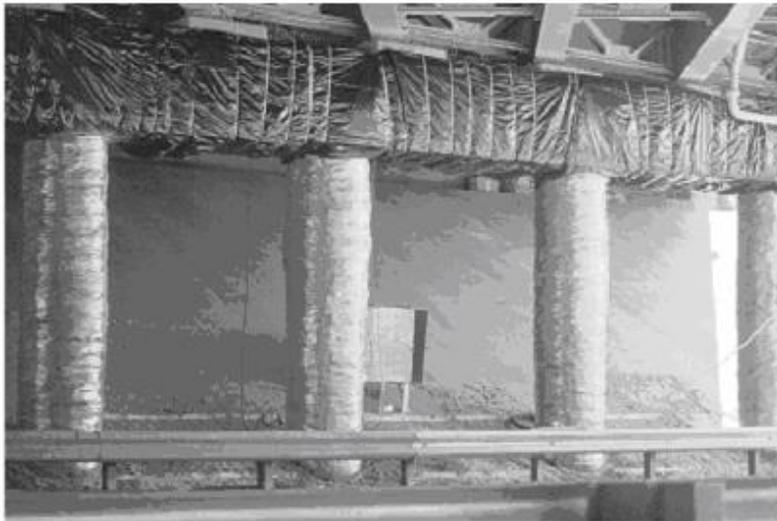
Figure 2. Chloride Removal. (a) 34th Street Bridge Deck (from Clemeña and Jackson, 1996b). (b) 5th Street Extended Bridge Piers (from Clemeña and Jackson, 2000).

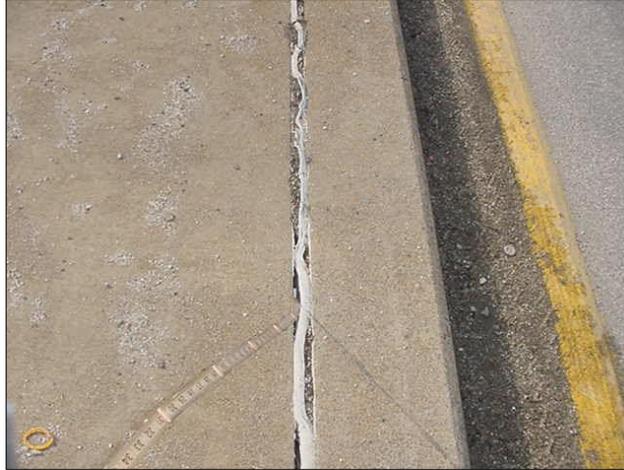
The 2006 report noted the following: “Heavy build up of dirt in armor joint on top. Crack in armor joint adjacent to top of sidewalk 6” in length. Pour seal in median is snagging with random areas of deterioration thru-out” (VDOT, unpublished data, 2006). An example of the observed condition is shown in Figure 7.

Figure 7. Photograph From VDOT Inspection Report. The report stated: "Note heavy deterioration of joint seal & spalling along the edges of longitudinal joint in median" (VDOT, unpublished data, 2006).

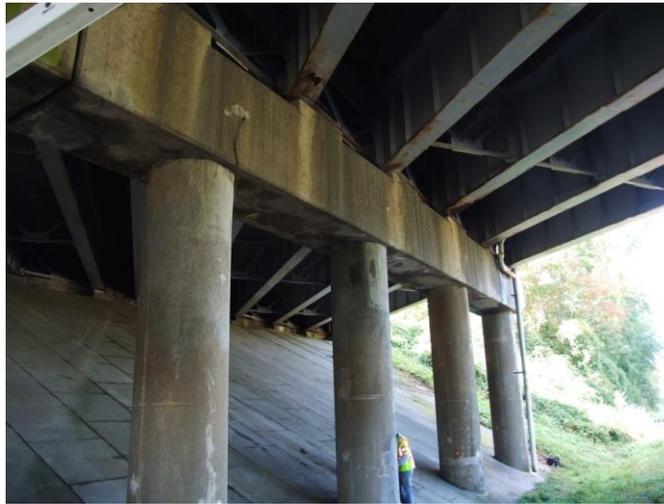
Figure 10. Portion of Pier 1 Under 5th Street Extended Bridge That Was ECE Treated and Silane Sealed. ECE = electrochemical chloride extraction.

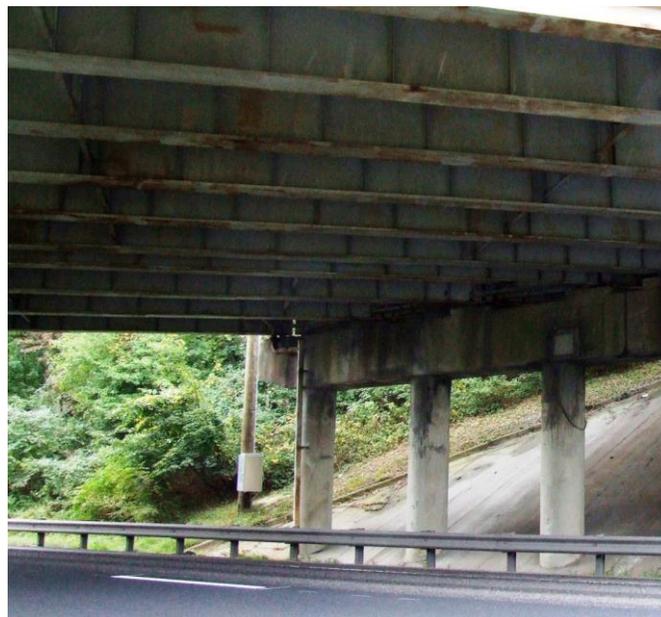
Figure 11. Untreated Side of Pier 1 Under 5th Street Extended Bridge

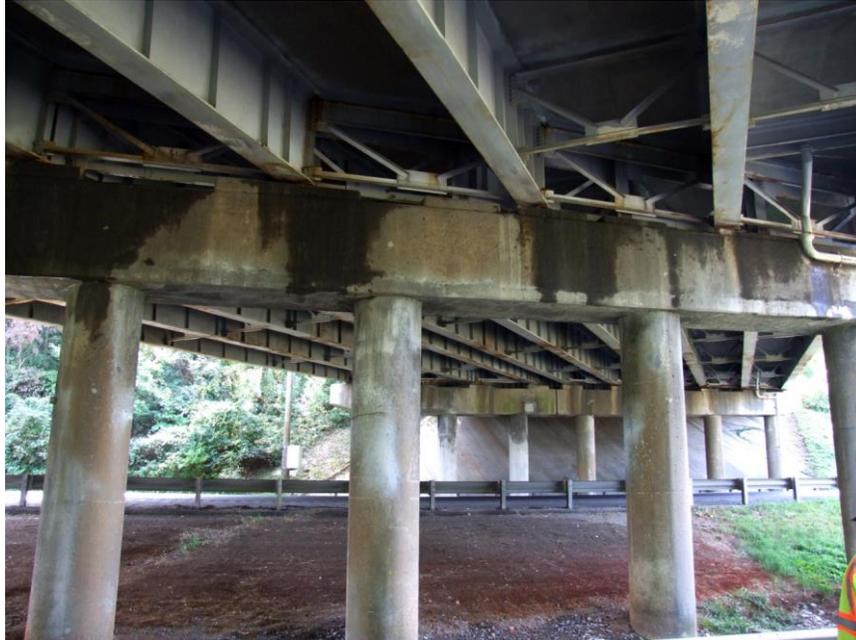
Figure 12. Pier 2 Under 5th Street Extended Bridge Showing Moisture Attributable to Leaking Joint Above Treated Cap and Columns

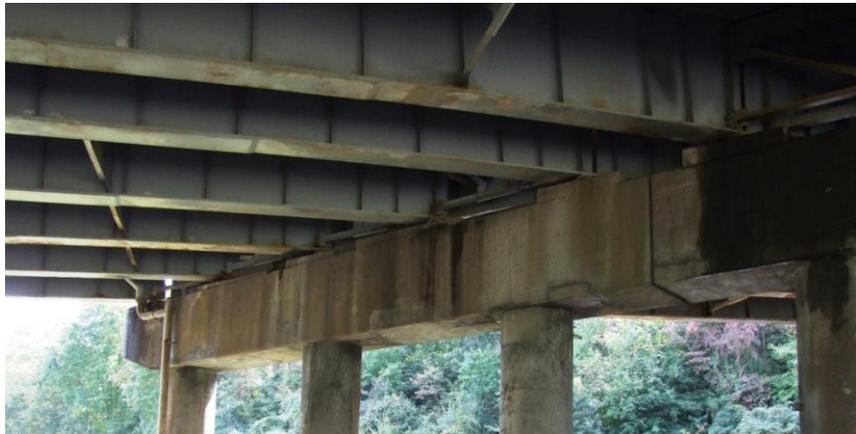
Figure 13. Pier 2 Under 5th Street Extended Bridge That Shows Some Moisture on Untreated Cap Also Exhibiting Some Delaminations That Have Been Repaired

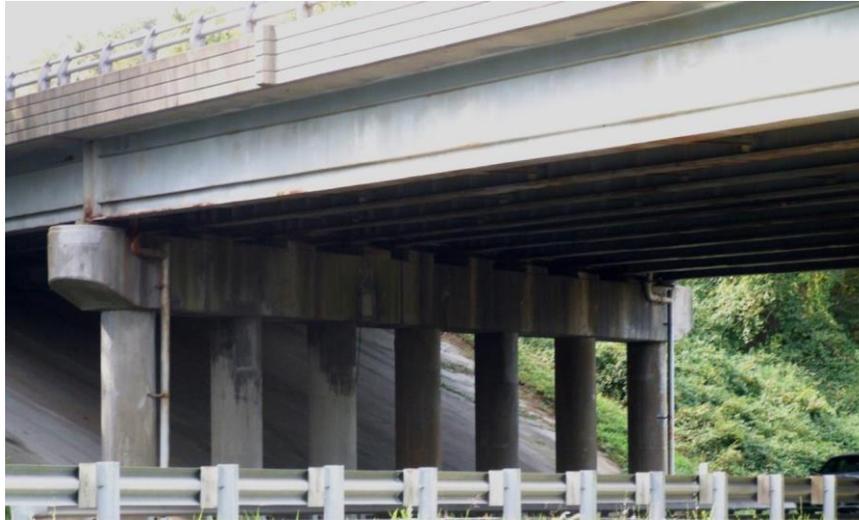
Figure 14. Pier 3 Columns Under 5th Street Extended Bridge: Left 3 columns treated with ECE and sealed; 4 right columns served as control (untreated and not sealed). ECE = electrochemical chloride extraction.

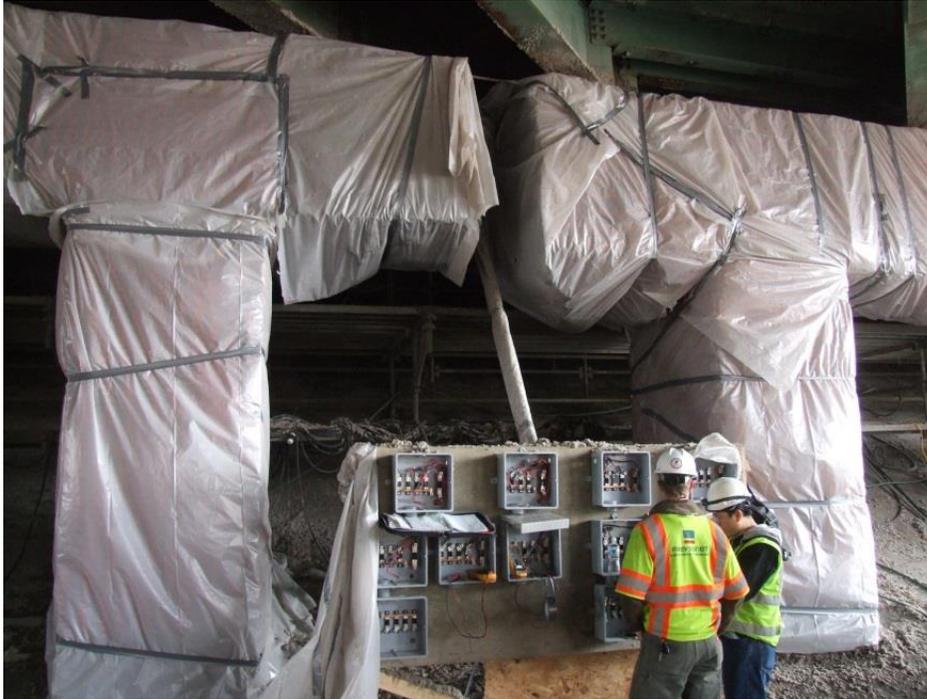
Figure 21. ECE on I-95 Bridge Piers. To ensure better control and an even current distribution during ECE treatment, the electrical systems are divided into smaller areas (sub-zones) on each substructure element. These sub-zones are being monitored during treatment and electric measurements recorded by a qualified technician. ECE = electrochemical chloride extraction.

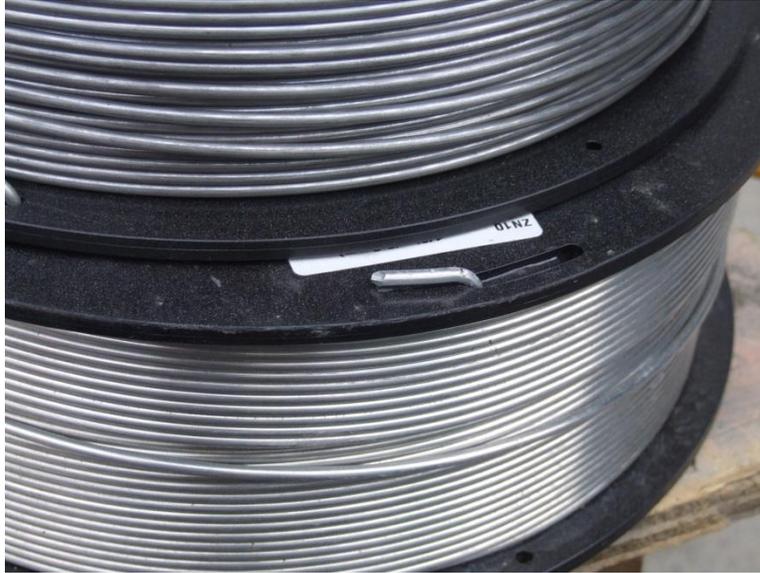
Figure 27. Al-Zn-In Anode Wire on Spool. This wire will be fed through a specially designed gun that will result in the molten metal striking and adhering to the surface being coated.

After ECE was completed, the Al-Zn-In anode wire (Figure 27) was applied to the concrete surface using the arc spray process (Figure 28), which converts the wire to a tightly adherent metallic coating on the concrete surface (Figure 29). This metallic coating on the surface of the concrete will be slowly consumed, intentionally, as it keeps the underlying steel from corroding. Since the anode is on the outside of the concrete, one benefit of this type of CP system is that if additional Al-Zn-In anode material is needed in the future to replace the consumed anode material, the arc spray process can be used again to add more anode material to the concrete surface.

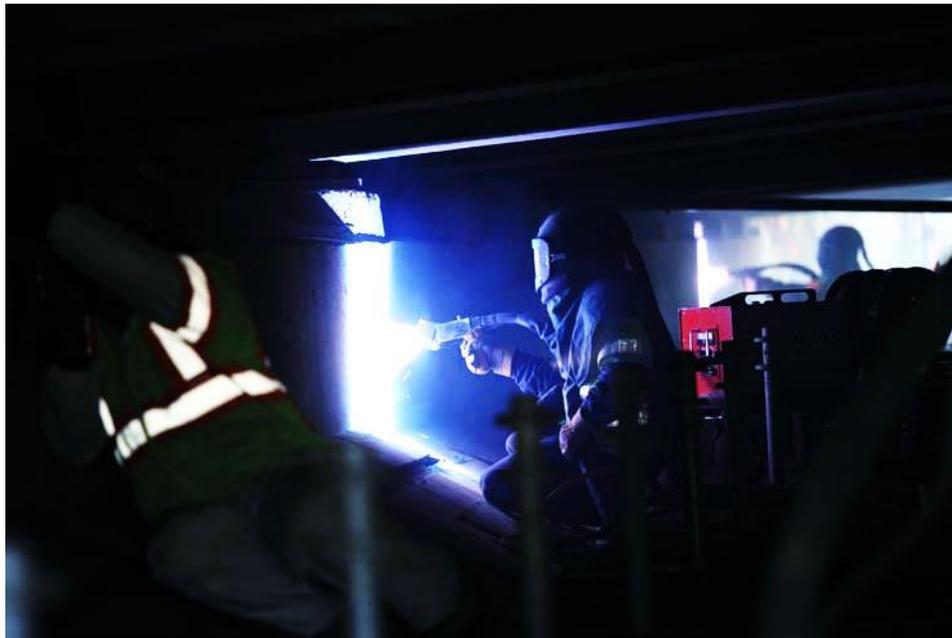
Figure 28. Photograph Taken in December 2011 Showing Arc Spraying of I-95 Bridge Abutment Along Hermitage Road. Molten Al-Zn-In is being applied to the surface of a reinforced concrete element by the arc spray process. Photograph courtesy of VDOT Public Affairs.

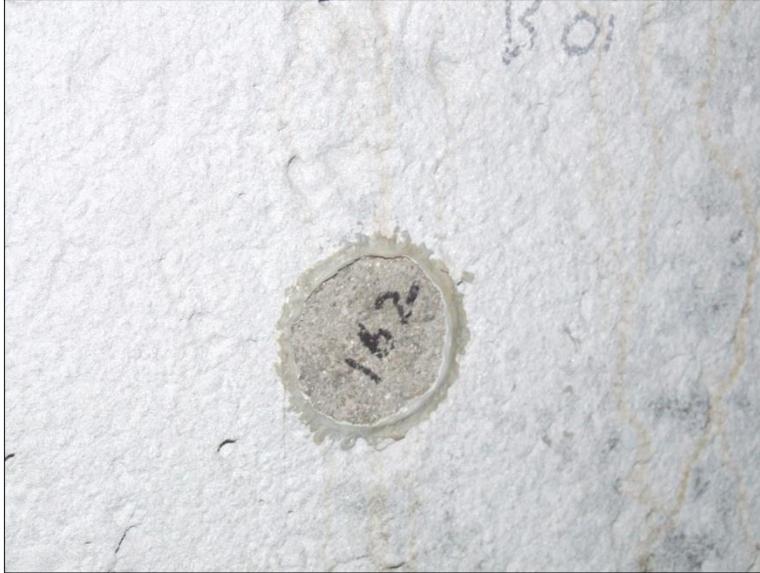
Figure 29. Metallized Reinforced Concrete Surface of I-95 Bridge Substructure Where Test Dolly Was Removed. The removal of the dolly was part of an adhesion test to evaluate the bond between the metallized layer and the concrete substrate.

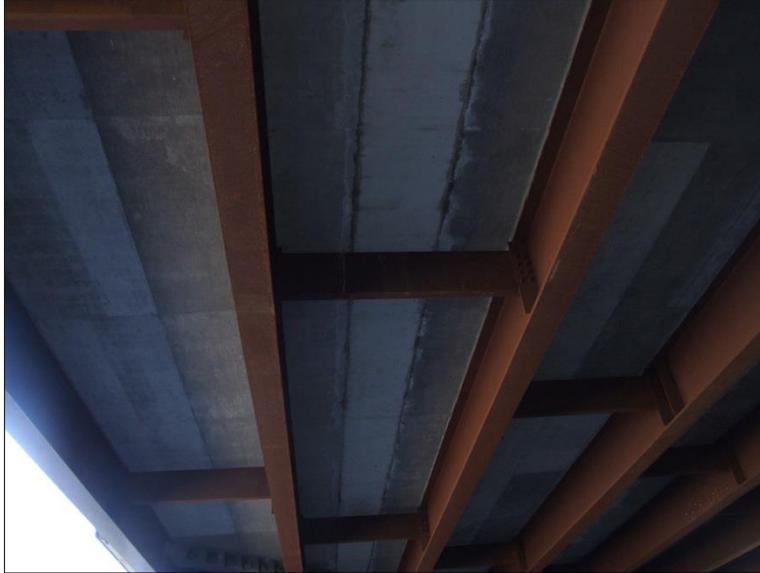
Figure 30. Underside of I-95 Bridge Over Hermitage Road Showing Beams, Diaphragms, and Joints After Superstructure Replacement Was Completed

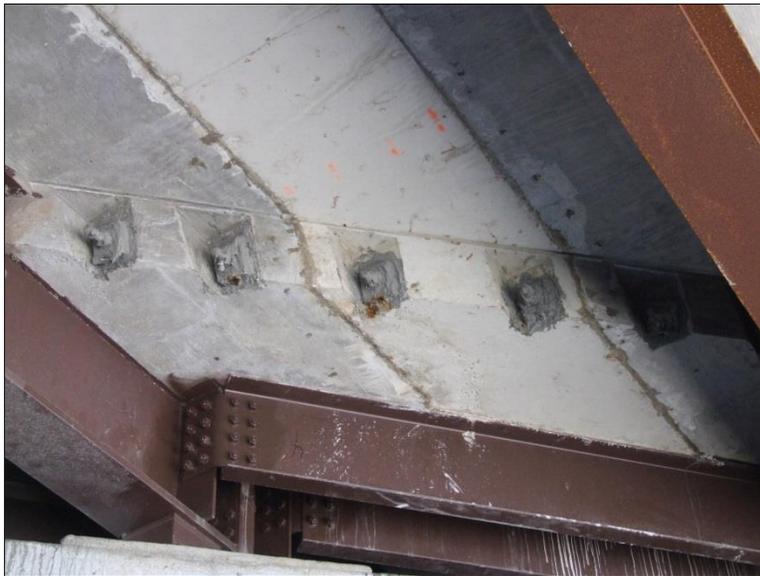
Figure 31. Underside of I-95 Bridge Over Hermitage Road Showing Post-Tensioning Termination Points After Superstructure Replacement Was Completed. No leaking joints were observed.

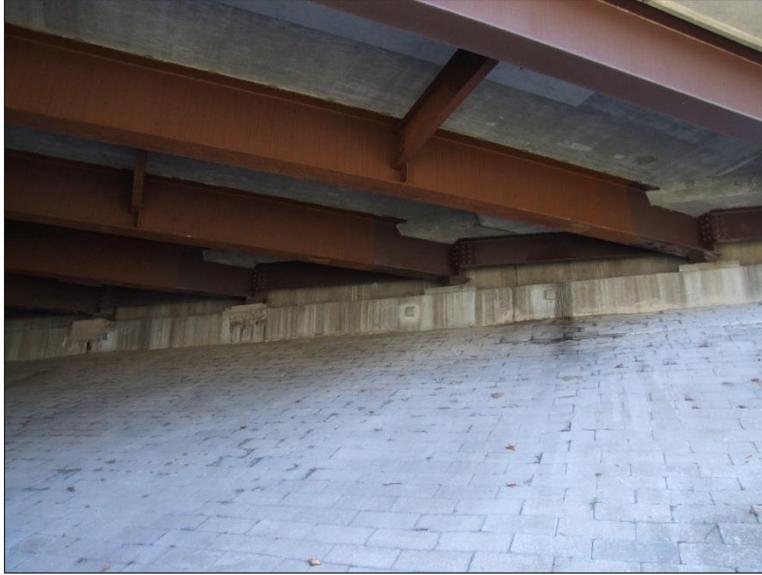
Figure 32. Abutment Under I-95 Bridge Over Hermitage Road After Superstructure Replacement Completed

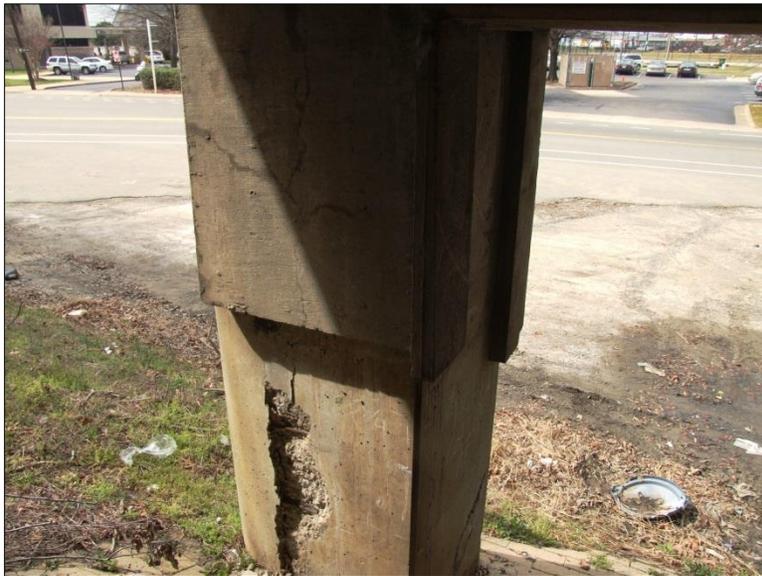
Figure 33. Corrosion Damage Resulting in Spalling of Column Supporting I-95 Bridge Over Hermitage Road Before Repair

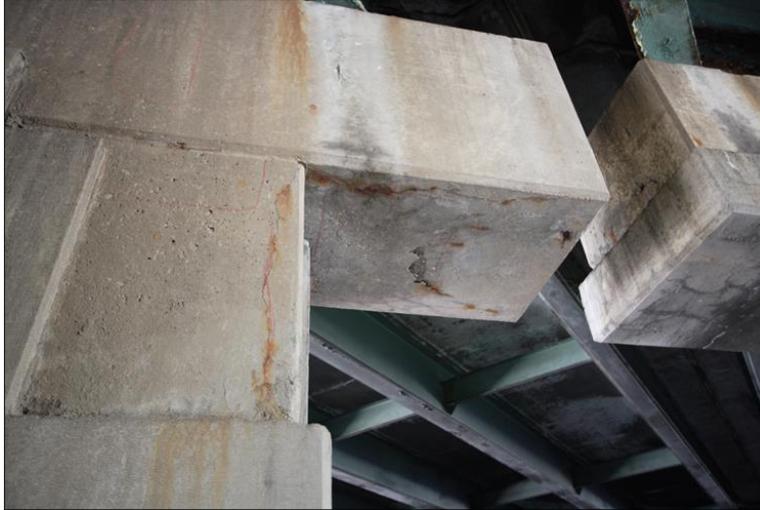
Figure 34. Rust Stains From Water Dripping Onto Caps and Corrosion Damage on Underside of Cap Supporting I-95 Bridge Over Hermitage Road Before Repair. Tight cracks can also be seen on the underside of the cap on the right. Photograph courtesy of VDOT Public Affairs.

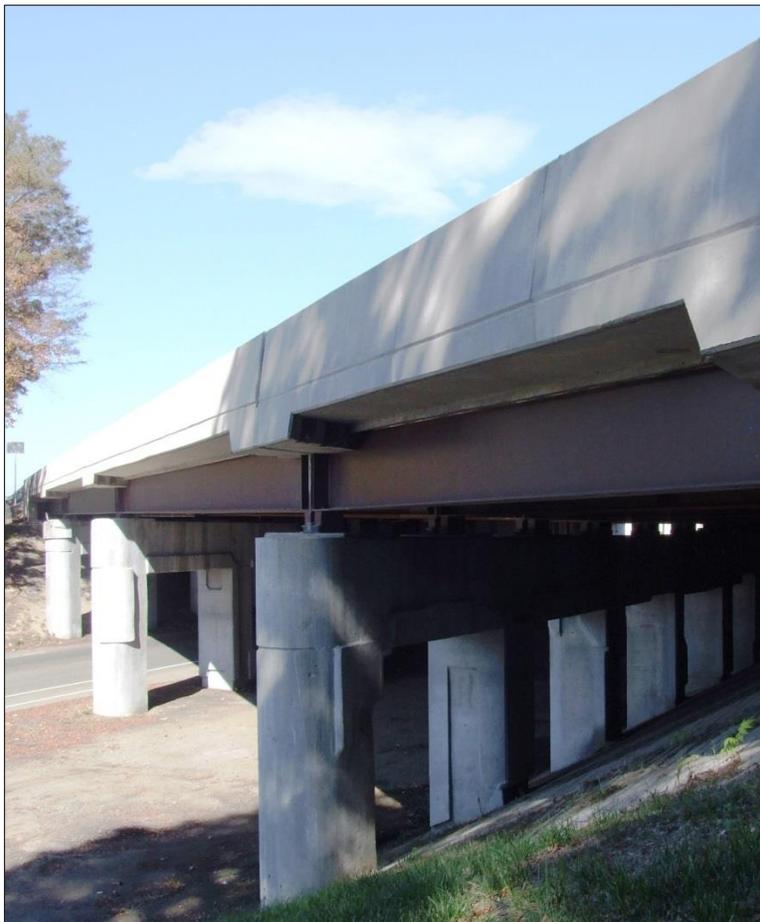
Figure 35. I-95 Bridge Over Hermitage Road After Repairs Completed

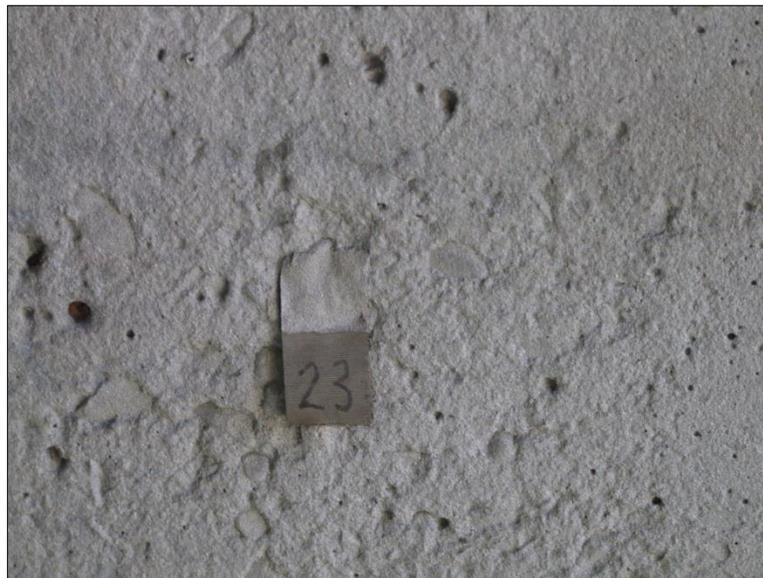
Figure 36. I-95 Bridge Over Hermitage Road Concrete Surface Substructure Element After Application of Al-Zn-In Coating for GACP. GACP = galvanic anode cathodic protection.

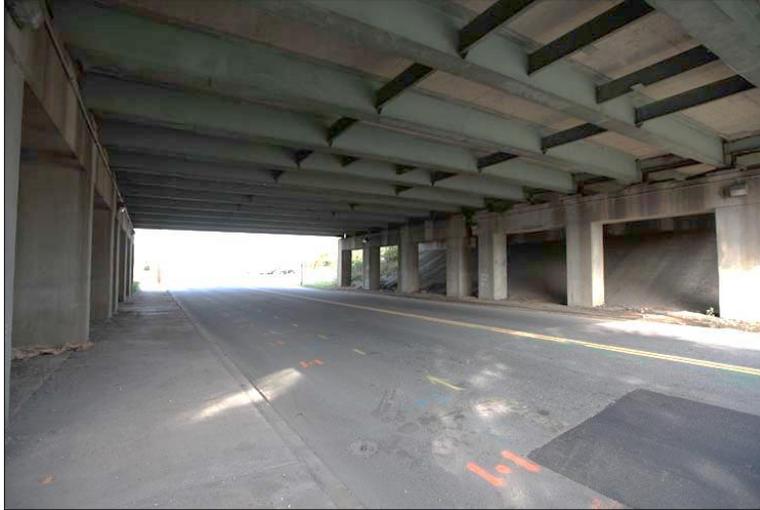
Figure 38. Underside of I-95 Bridge Over Overbrook Road Before Superstructure Replacement and Corrosion Mitigation Work Began. Photograph courtesy of VDOT Public Affairs.

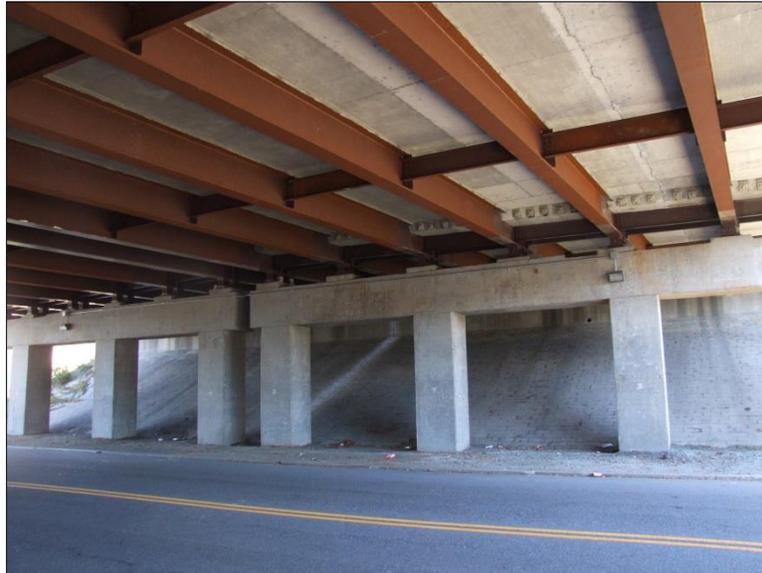
Figure 43. I-95 Bridge Over Overbrook Road Showing Underside After Completion of Project

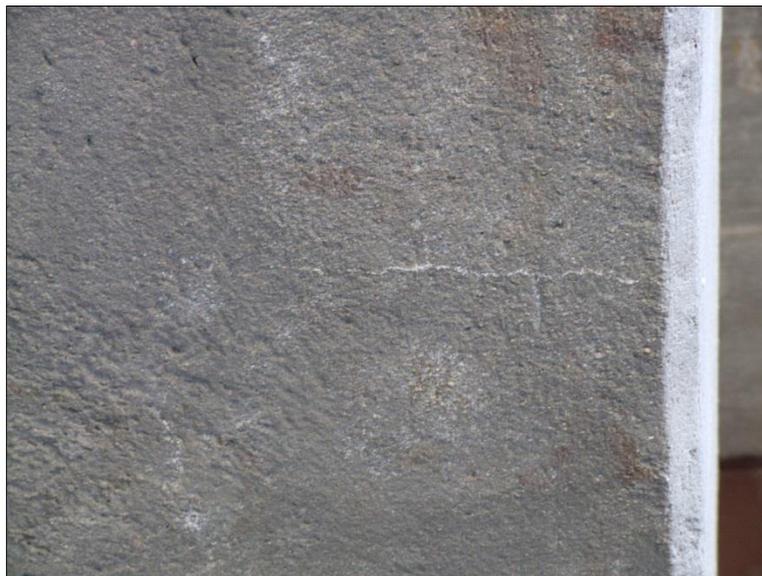
Figure 44. I-95 Bridge Over Overbrook Road Showing Mineral Deposit on Column After ECE. ECE = electrochemical chloride extraction.

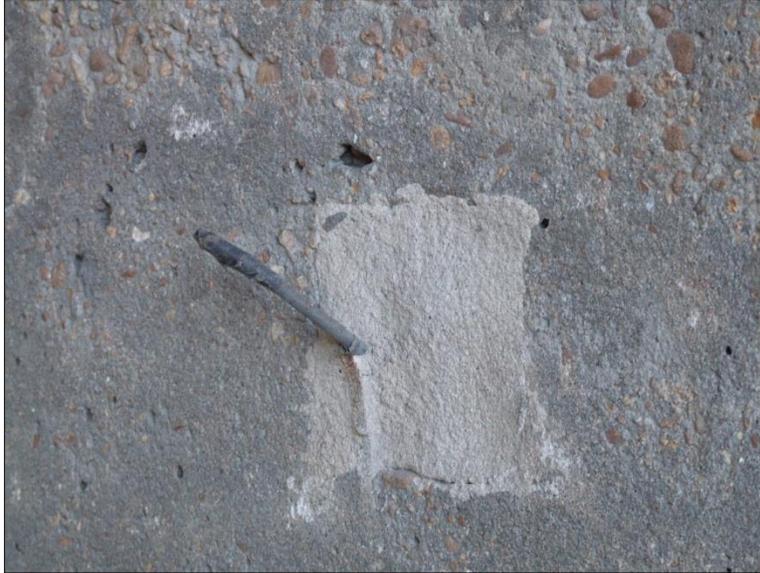
Figure 45. I-95 Bridge Over Overbrook Road Showing Connection Protruding After Completion of ECE Corrosion Mitigation Work. ECE = electrochemical chloride extraction.
