# Development of Improved Connection Details for Adjacent Prestressed Member Bridges

Final Report VTRC 17-R20

**DEVELOPMENT OF IMPROVED CONNECTION DETAILS  
FOR ADJACENT PRESTRESSED MEMBER BRIDGES**

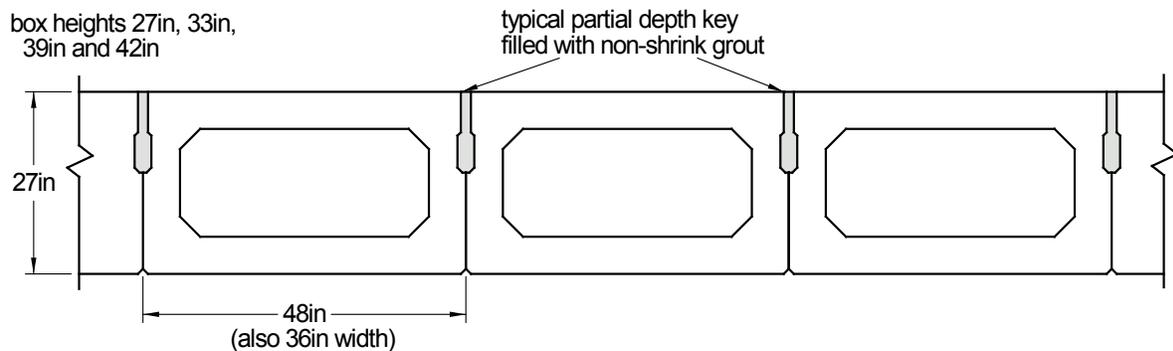
**Figure 1. Typical Adjacent Box Beam Bridge Cross Section**

Adjacent prestressed member bridges are comprised of rectangular beams with rectangular or circular voids. Like other adjacent member bridges, the beams are placed, touching, next to each other with a partial depth shear key continuously running longitudinally between the beams and transverse ties placed intermittently. Generally, there are two types of adjacent prestressed member bridges: ones with adjacent box beams and ones with adjacent voided slabs. Example cross sections are shown in Figure 1 and Figure 2, respectively. The partial depth shear key is generally filled with a high-strength, low-shrinkage grout as shown in Figures 1 and 2. Ties are generally placed at even intervals up to 20 ft apart. The ties are used to snug the adjacent members together before placing the grout in the key.

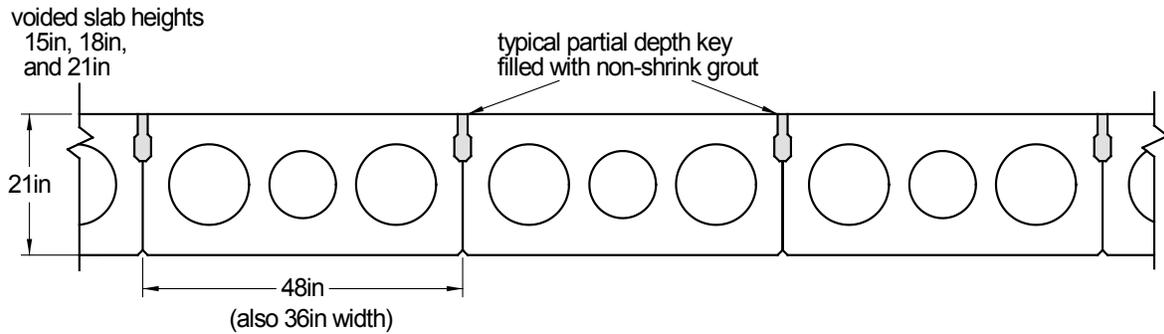
**Figure 2. Typical Voided Slabs Bridge Cross Section**

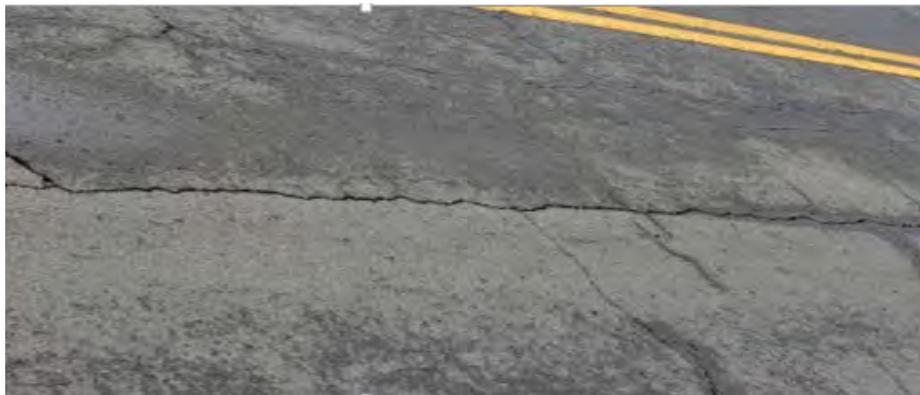
**Figure 3. Longitudinal Reflective Cracking in Asphalt Overlay**

The primary purpose of the shear key is to distribute vehicle loads transversely to adjacent beams. This allows for adjacent beams to share load and provides for a stiffer, stronger bridge system. The key also provides a seal between the beams to prevent water from leaking between adjacent beams. Many adjacent member bridges show reflective cracking in the roadway surface as shown in Figure 3. Reflective cracking is typically attributed to failure of the bond between the grout in the shear key and the precast beam, which is why the reflective cracking in Figure 3 runs longitudinally along the bridge.

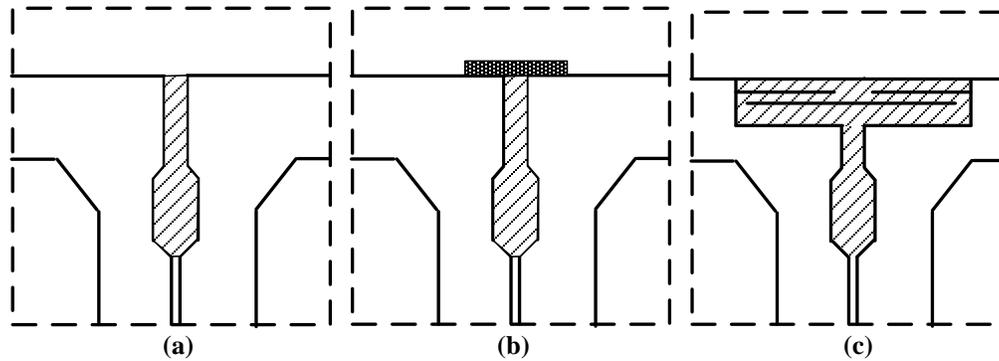
**Figure 4. Connection Details Tested on Bridge Sub-Assemblages: (a) Detail 1 - Existing Partial Depth Detail; (b) Detail 2 - Existing Partial Depth Detail with Kevlar; (c) Detail 3 - Spliced Reinforcing Detail**

The three evaluated types of connections are shown in Figure 4. The spacing of the splices used in the connection detail was determined through additional finite element analysis (FEA). The FEA will be discussed in a later section.

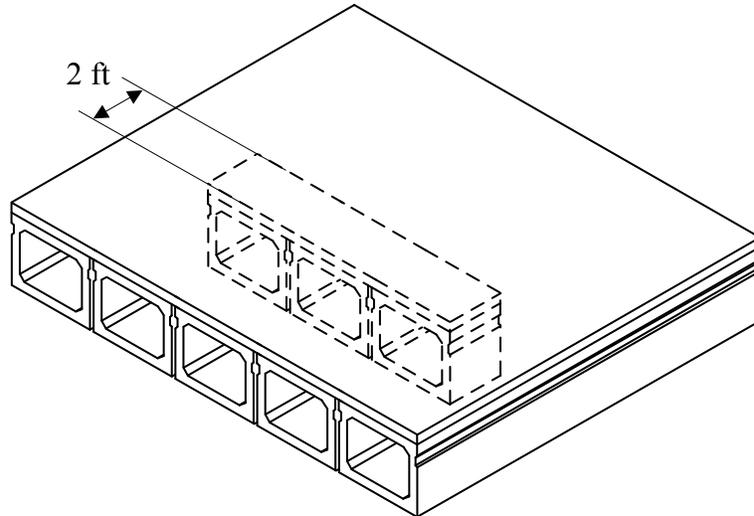
**Figure 5. Test Sub-Assembly Extracted From a Full Bridge**

The sub-assemblage specimen represents a 2-ft-long interior, mid-span section from a typical adjacent precast member bridge, as shown in Figure 5. The three-dimensional behavior of the bridge was simulated in a specimen that predominantly experienced two-dimensional behavior. In a typical bridge, the load sharing between girders induces flexural and shear stresses in the transverse direction across the bridge span. The effect of longitudinal flexure and shear on transverse load sharing is negligible. The purpose of these tests is to ensure that the keys demonstrate adequate transverse load transfer between adjacent girders to justify use of existing AASHTO distribution factors; hence longitudinal effects were neglected.

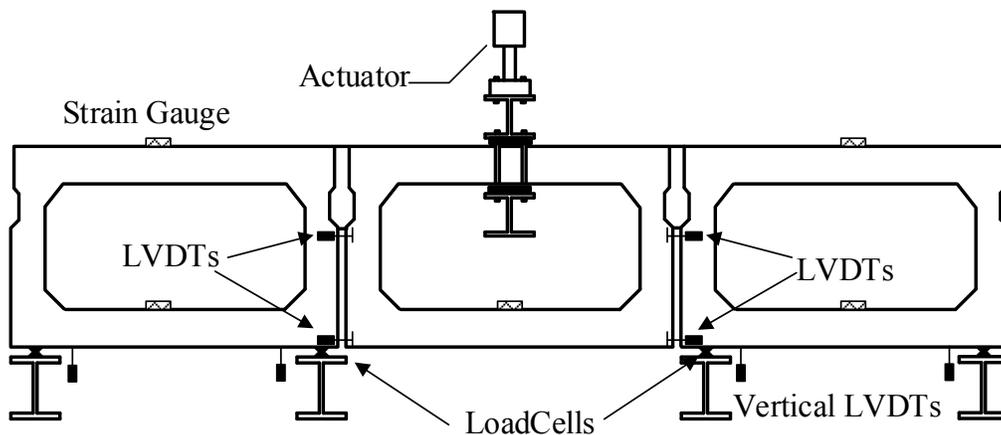
**Figure 6. Schematic View of Sub-Assembly Instrumentation (LVDT = Linear Variable Differential Transformer)**

Although the effect of longitudinal stresses was ignored, the three-dimensional behavior of the bridge itself was not ignored in terms of girder stiffness. The specimen sub-assembly sections were supported on small steel beams. The steel beams acted as flexible supports underneath the sub-assembly girder sections. Essentially, the steel beams simulated the flexural stiffness of the portion of the bridge missing from the sub-assemblages. FEA models of a test bridge and the sub-assemblages were created and the behaviors of the two were compared to ensure that the states of stress in the joints and the relative displacements between girder sections of the sub-assemblages were similar to those observed in typical adjacent member bridges. A cross section of the sub-assembly test set-up for an adjacent box girder bridge is shown in Figure 6. The test set-up for a voided slab bridge is identical except for the different girder type. Instrumentation was used to measure applied load, vertical deflection, joint opening, and concrete surface strain.

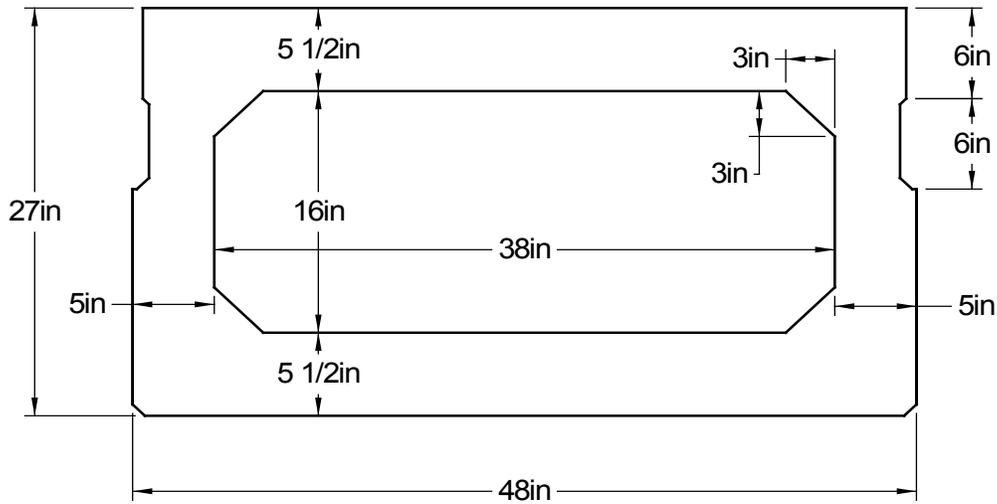
**Figure 7. Dimensioned AASHTO BI-48 Adjacent Box Beam**

VDOT uses a number of different reinforced concrete adjacent box beams that vary in depth, width, and in the number of voids. One commonly used cross section is the BI-48, which was tested for this research project. The BI-48 is a PCI/AASHTO standard shape that is essentially the same as the VDOT 48-in wide by 27-in deep box section. A dimensioned schematic of the BI-48 beam is provided in Figure 7. This beam has one rectangular void. The beam has an overall depth of 27 in and is 48 in wide. The beam's shear key is a 12-in deep partial depth key, and the exact dimensions are provided in Figure 9.

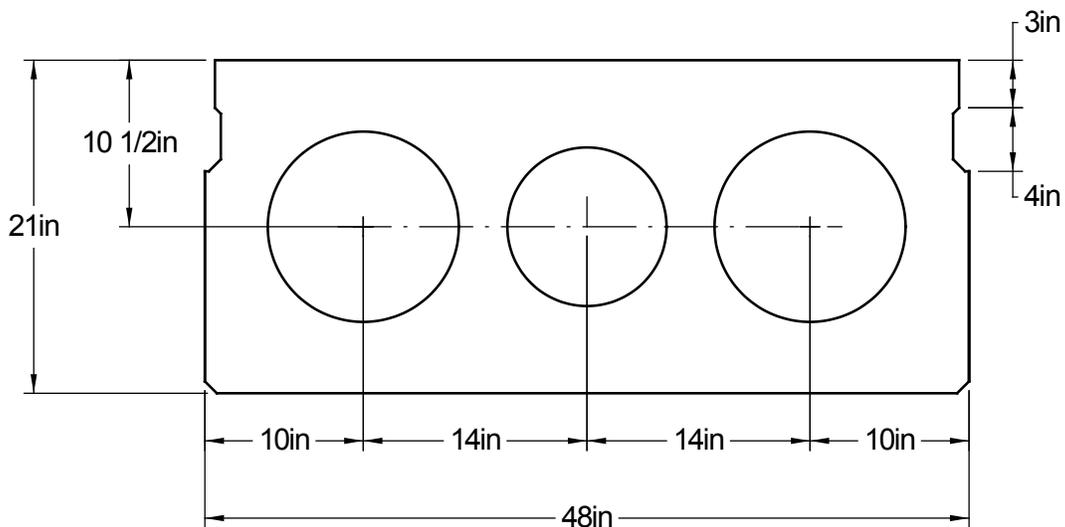
**Figure 8. Dimensioned AASHTO Voided Slab Type SIV-48**

VDOT uses a number of different reinforced concrete voided slab beams that vary in depth, width, and in the number of voids. One of VDOT's more typical sections, based on AASHTO's Voided Slab Type SIV-48, was tested for this research project. A dimensioned schematic of the type SIV-48 slab is provided in Figure 8. This voided slab has three circular voids with the outer two voids being 12 in in diameter and the center void is 10 in in diameter. The beam has an overall depth of 21 in and is 48 in wide. The beam's shear key is a 7-in deep partial depth key, and the exact dimensions are provided in Figure 9.

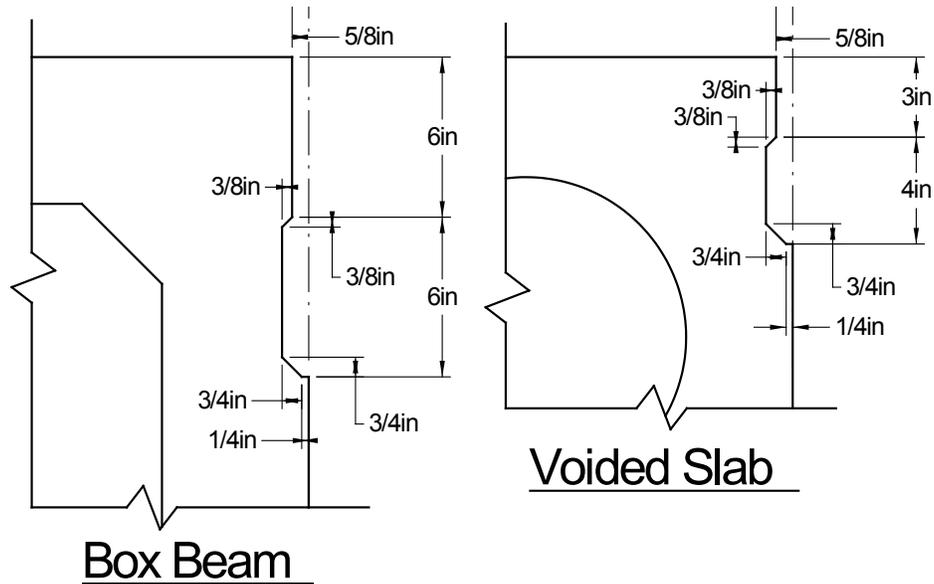
Figure 9. Detailed Shear Key Dimensions for Box Beam and Voided Slab

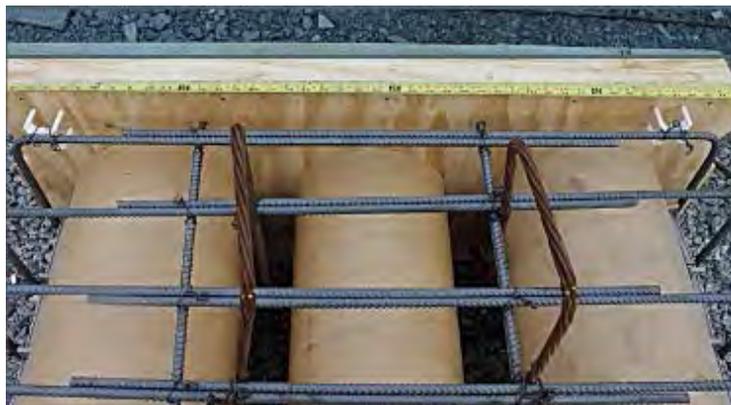
Figure 10. Voided Slab Formwork and Reinforcement Cage

Ross Prestressed Concrete, Inc., fabricated the adjacent member sections at their prestressing plant located near Bristol, Tennessee. Internal voids were formed with either expanded polystyrene foam (for adjacent box beams) or wax-coated cardboard cylinders (for voided slabs). Each 2-ft section was formed between two pieces of plywood with threaded rods running through the voids to hold the plywood in-place. Figure 10 shows typical formwork with the tied reinforcement cage for a voided slab section. Any other blockouts were formed with expanded polystyrene that was wrapped with duct tape in order to prevent the polystyrene from absorbing water that was needed to hydrate the concrete. The forms were aligned in the prestressing beds as seen in Figure 11.

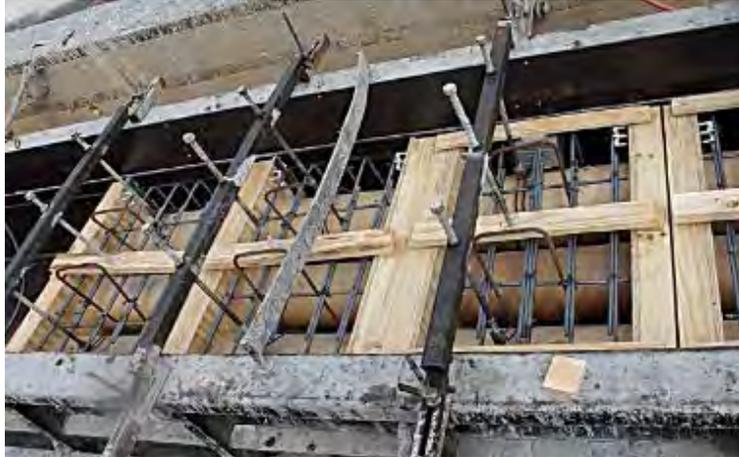
**Figure 11. Voided Slab Forms Sitting in Prestressing Beds**

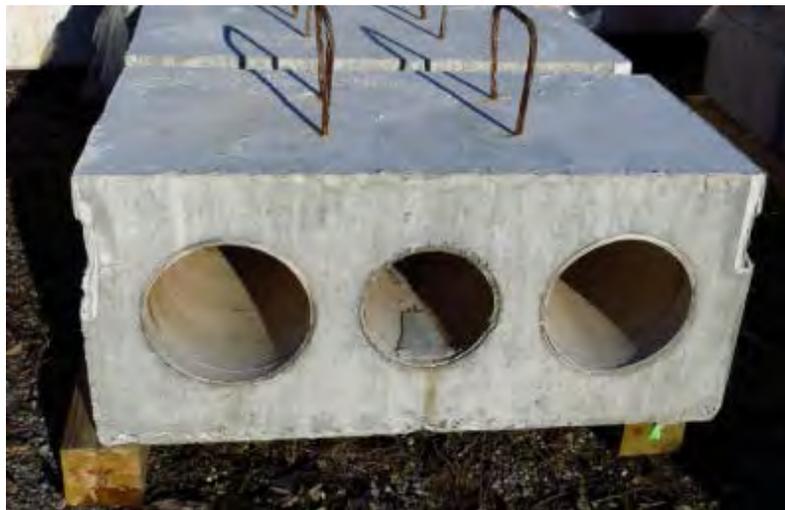
**Figure 12. Finished Voided Slab Specimen**

The concrete was batched and mixed onsite and then brought to the casting location in a standard mixing truck. The concrete was delivered in three batches to cast all of the voided slab and box beam specimens. The slump and air content were checked prior to placement of each batch. Twenty-four test cylinders (4 in by 8 in) were cast for each batch for future material property testing. The material properties to be determined were compressive strength, tensile strength and modulus of elasticity. After the forms were filled with concrete and consolidated properly, the tops of the beams that were to receive a concrete topping were given a roughened rake finish; otherwise the tops of the beams that were not to receive a concrete topping were given a float finish. After the concrete was placed and finished, the beams were covered with wet burlap and steam cured. When the concrete reached a strength of 3,500 psi, the formwork was removed. The specimens were then shipped to the Thomas M. Murray Structures Laboratory at Virginia Tech. Figure 12 shows a finished voided slab specimen.

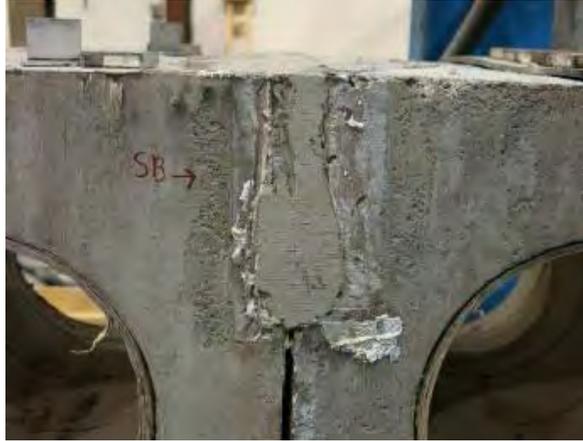
**Figure 13. Hardened Shear Key From First Specimen Tested**

This detail is the standard VDOT adjacent member connection and was tested in order to assess the strength and behavior of the current detail. This connection used a 12-in deep shear key in adjacent box beam specimens (Figure 7) and a 7-in-deep shear key in voided slab specimens, which is shown in Figure 13. Prior to placing the joint, the keyways were sandblasted and kept moist at saturated surface-dry conditions in order to enhance the bond. This is standard VDOT practice and was carried out prior to each connection placement. The shear key was filled with a high-strength, non-shrinkage grout, which according to VDOT's *Road and Bridge Specifications* (VDOT, 2007) must conform to the requirements of ASTM C 1107, Standard Specification for Packaged Dry, Hydraulic-Cement Grout (Nonshrink) (ASTM, 2013), and has to develop a 7-day compressive strength of at least 4,000 psi. Quikrete's Non-shrink Precision Grout complies with ASTM standards (ASTM, 2013) and was used as the grout material. Cube samples of grout were pre-batched to make sure that the grout achieved a 7-day compressive strength of 4,000 psi. The sample cubes reached strengths in excess of 9,000 psi at 7 days, which confirmed the grout developed acceptable compressive strength. Figure 13 is a cross-section photograph of a completed connection detail.

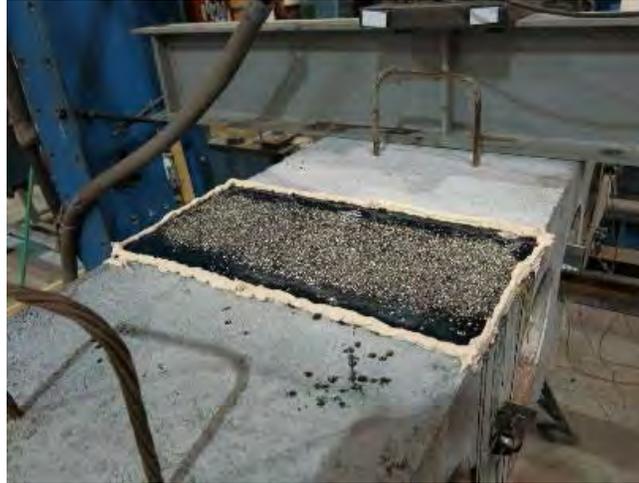
**Figure 14. Photograph of Kevlar-Epoxy Joint With Coarse Sand**

The Kevlar used is a product made by Fortec Stabilization called Fortec 5680-BD Kevlar. According to Fortec, the mesh is a bi-directional, highly durable material composed of dense Kevlar yarns. The ultimate tensile strength listed by Fortec is 100 ksi. The epoxy is a two-component mixture also developed by Fortec and called E-bond 256. The epoxy has a rapid set time and rapid strength development. When cured, the system has very low permeability. In order to construct this connection, the shear key was first grouted and then cured for at least 24 hours. Prior to placement of the Kevlar, the area surrounding the top of the shear key was sandblasted to enhance the bond with the epoxy. The next step was to mix the epoxy by placing a one-to-one ratio of the resin component and the hardener component into a clean container and mixing for at least 3 minutes using a low-speed drill with a mixing paddle. After thorough mixing of the epoxy, a layer, roughly as wide as the Kevlar mesh, was placed along the joint. The Kevlar mesh was then firmly pressed into the epoxy with a paint roller brush until the epoxy oozed through the Kevlar. Coarse sand was then sprinkled on top of the Kevlar and epoxy. After the first layer of epoxy cured, a second layer was placed on top and then more coarse sand was sprinkled on top of that layer. The curing time for each layer was roughly 2 hours. Figure 14 is a photograph of the completed Kevlar reinforced joint.

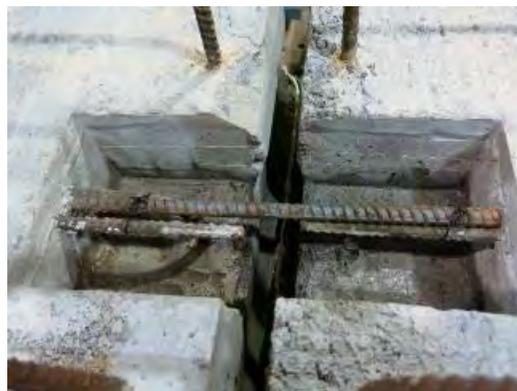
**Figure 15. Blockout With Tied in Lap Splice Bar Before UHPC Placement**

For the new connection detail with UHPC, 6-in long, 6-in wide by 4-in deep blockouts were formed in the middle of the specimens at the top of the shear key at the casting yard. Each breakout exposed one shear stirrup, and each stirrup was lined up with a shear stirrup in the breakout of the adjacent member. The stirrups were connected across the joint by an 11-in long No. 4 Grade 60 reinforcing bar using at least a 5-in lap splice. In related research (Halbe, 2014) it has been shown that No. 4 reinforcing bars can be fully developed in UHPC and VHPC with a 5-in lap splice length. Figure 15 is a photograph of two adjacent blockouts with the tied stirrup splice reinforcing bar. The breakout connection is proposed because it is suited to handle the transverse tension stresses that occur across the joint. This connection should result in a composite connection between the adjacent beams and should reduce the likelihood of cracking of the shear key. The sub-assembly represents a 2-ft section of a bridge, because the initial analysis indicated that a spacing for full-scale implementation of 2 ft on center is adequate to keep service stresses low. Additional research should be done to test further the efficiency of this spacing.

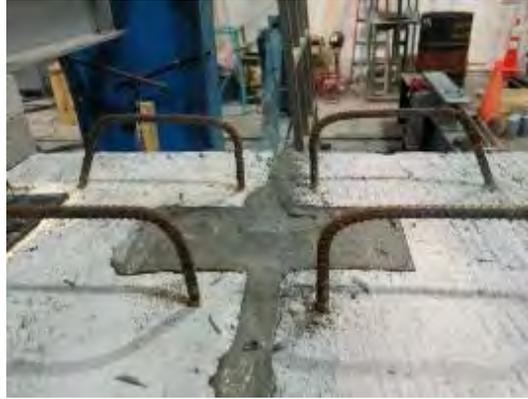
**Figure 16. Photograph of Cured UHPC Joint**

The mixing procedure was a simple process that was provided by Lafarge. The mix quantities used to place the joint and the required material testing specimens can be found in Table 2. After the proper amounts of materials were weighed out, the premix was placed in a pan mixer and was mixed dry for 2 minutes. The water and high-range water reducer were combined and then slowly added to the pan mixer over the course of 2 minutes. The mixing continued until the UHPC turned into a smooth paste with no remaining lumps or clumps. Then the steel fibers were slowly added to the pan. Mixing continued until the steel fibers were well dispersed, usually 1 to 2 minutes. After the mixing, the UHPC was placed in the joint. Since Ductal is self-consolidating, it can be poured into the joint without the need for any consolidation. The Ductal was allowed to cure, covered with a plastic sheet, but with no additional moisture, for at least 7 days before testing began. Figure 16 shows a Ductal filled joint.

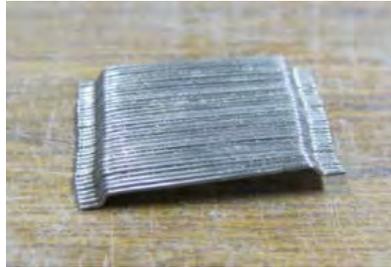
**Figure 17. Photograph Showing the Dramix Fibers, Which Come Glued Together**

continued until the fibers broke apart and dispersed evenly throughout the mixture. When the mixing was complete, the VHPC was placed in the joint. Like the Ductal mixture, the VHPC had a flowable consistency that allowed it to be placed into the joint without the need for consolidation.

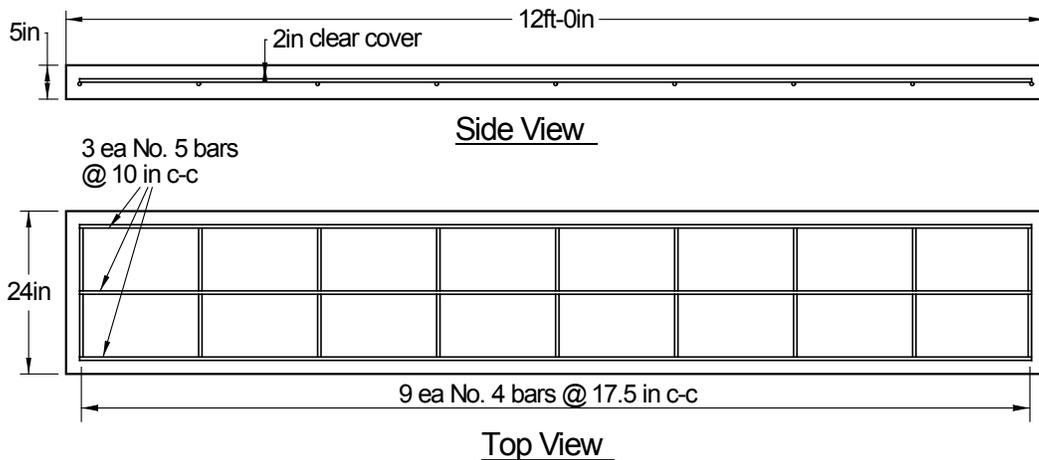
**Figure 18. Topping Reinforcement Mat Detail**

The connections with a topping were identical to the two connections previously described, with the exception that a 5-in concrete topping was added to the specimen. VDOT specifies that adjacent member bridges can have an asphalt topping, a 5-in thick concrete topping with two layers of reinforcing steel, or a 7.5-in concrete topping with four layers of reinforcing steel, depending on the average daily traffic (ADT) and the average daily truck traffic (ADTT) of the route that the bridge will carry. For relatively high traffic volumes (ADT > 4,000 and ADTT > 200), VDOT requires the 7.5-in topping. Bridges with relatively low traffic volumes (ADT < 4,000 and ADTT < 100) require only an asphalt overlay. For bridges with ADTT between 200 and 100, a 5-in topping is required by VDOT. It was not feasible to test both the 7.5-in and 5-in topping. The 5-in topping was chosen because voided slab bridges are usually only selected on bridges that receive a lower traffic volume because of the deterioration of the joint previously described. Figure 18 shows the reinforcement mat detail that was used for the topping. Seventy-two hours after the joint was placed with its respective UHPC or VHPC, the formwork for the joint was removed. Then the reinforcement mat was laid into place and the topping formwork built around it. A VDOT Class A4 (4,000-psi 28-day compressive strength) concrete, supplied by a local ready-mix plant, was used in the toppings. Once at the lab, the concrete's slump was tested to make sure it was of the correct consistency. The concrete was then placed on the specimen and consolidated using a pencil vibrator. After the concrete had cured under wet burlap and plastic for 48 hours, the formwork for the topping was removed. Figure 19 shows the sub-assembly with the topping in place.

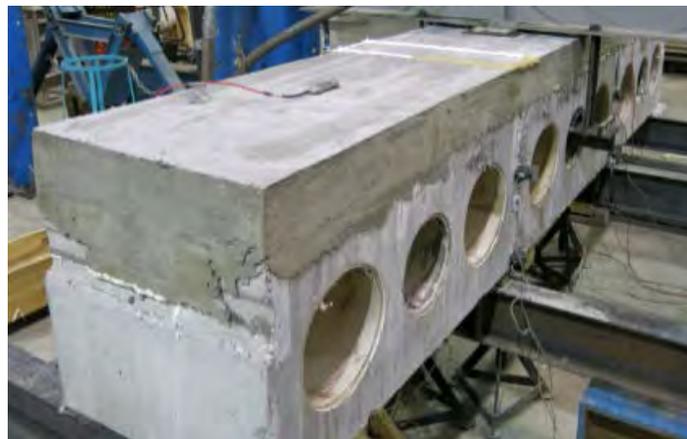
**Figure 19. Concrete Topping on Sub-Assemblage**

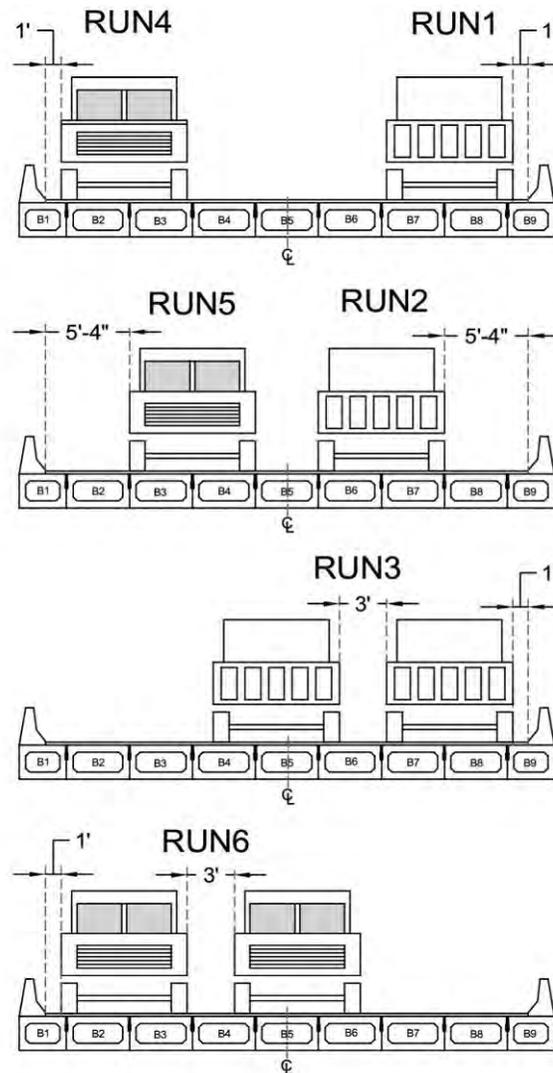
**Figure 20. Transverse Truck Locations**

FEA of one span of the Aden Rd. Bridge was conducted following a live load test of the same span. The purpose of the comparison was to validate the accuracy of the FEA model of the Aden Rd. Bridge as well as concepts used in modeling of the Aden Rd. Bridge. This validation was needed to confirm that the modeling concepts could be used in the sub-assemblage modeling. The Aden Rd. Bridge was replaced after the live load test because of significant damage to many of the beams from corrosion caused by leaking joints; therefore, the comparisons and conclusions made are mainly concerned with the general behavior of the bridge. The analysis performed was linear-elastic and was used to approximate the magnitude and distribution of stresses in the bridge induced by either one or two side-by-side VDOT three-axle dump trucks loaded to approximately 25 tons each. The transverse locations of the trucks in the FEA were identical to those used in a live load test of the Aden Rd. Bridge, as shown in Figure 20. During the live load test of one span of the Aden Rd. Bridge, vertical deflections and surface strains of the adjacent box beams were continuously recorded during passage of the truck or trucks over the bridge. To improve accuracy of results during the live load tests, passes along each transverse truck location were repeated a minimum of three times, which together comprise a "Run."

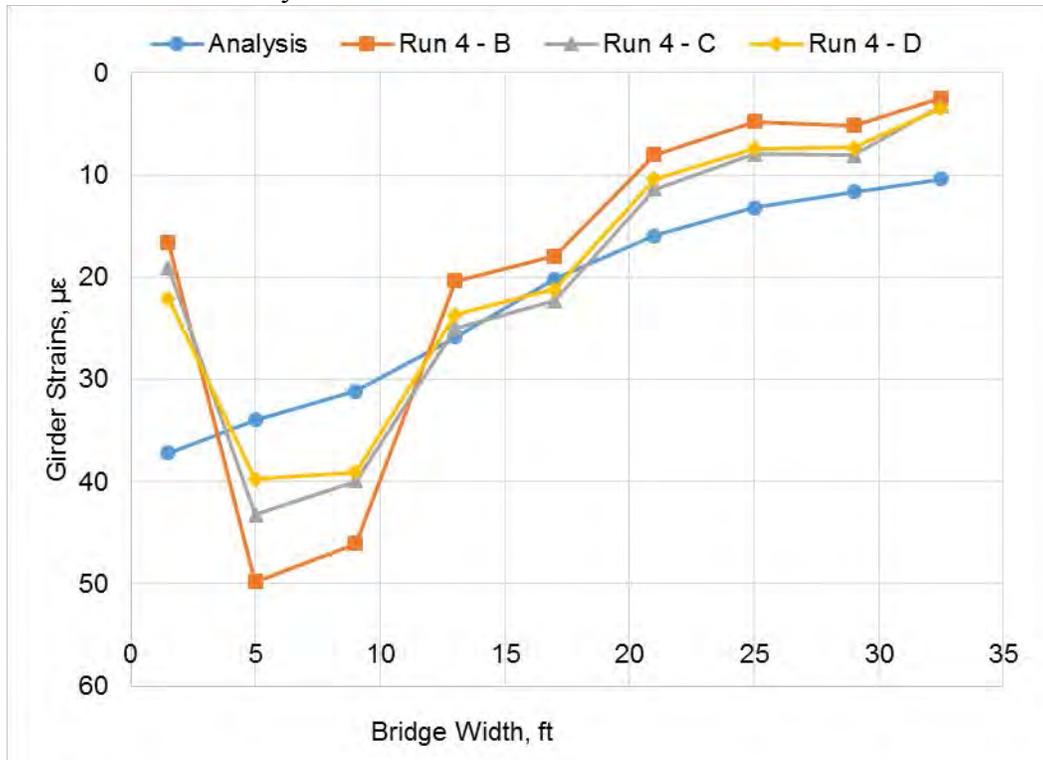
Figure 21. Analysis and Live Load Test Results Comparison

Figure 21 contains a comparison of results from transverse truck Run 4. Shown in the figure are mid-span concrete surface strains from the three repeated live load tests (Run 4 - B, C, and D) and the results from the FEA model. The concrete surface strains were obtained on the bottom of each girder at mid-span. These results are very similar to comparisons made from other transverse truck locations. The most severely damaged shear keys were between girders 1

and 2 and between girders 2 and 3. This damage was not included in the FEA model because of the difficulty in capturing the effects. The model and live load test results show similar behavior away from the severely damaged areas; however, in the area where the shear keys were showing significant signs of deterioration such as leaking and spalling, the two are quite different. The live load results in these areas are indicative of a significant loss of transverse load distribution, which would occur if the shear keys had failed. The FEA results show a best-case transverse load distribution that results from intact and properly functioning shear keys. In general, there is satisfactory agreement between the model and live load tests results to continue using the full bridge model for further analyses.

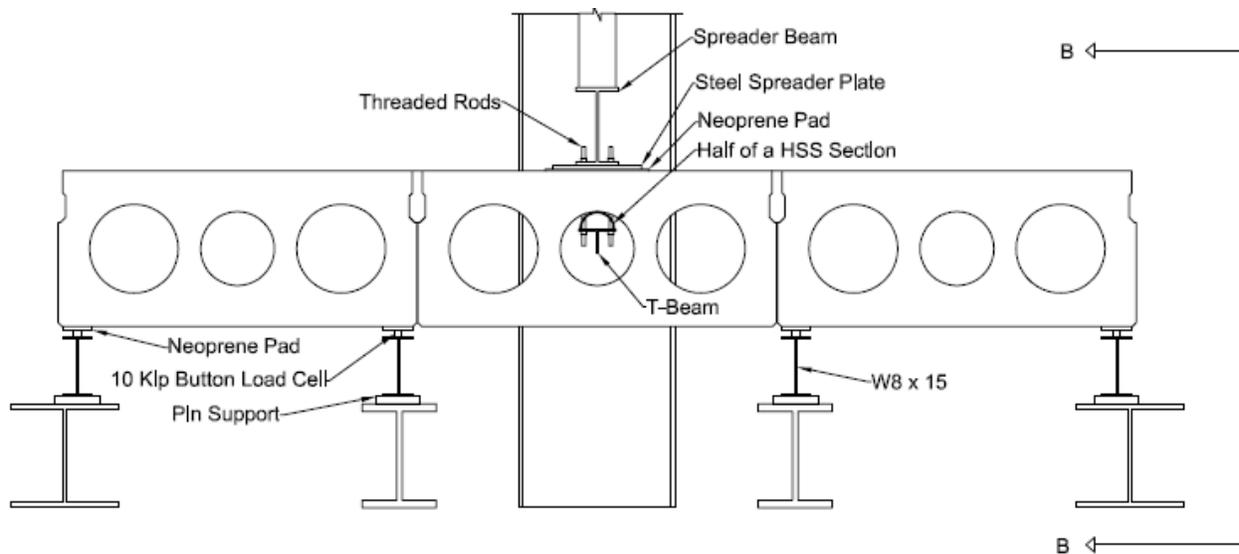
**Figure 23. Front View of Test Setup. HSS = Hollow Structural Section.**

The 12 sub-assemblages that were fabricated and tested were designed to replicate the transverse bending found in mid-span sections of typical adjacent box beam and voided slab bridges. The specimens were subjected to static and cyclic loads in order to evaluate the relative performance of the new, proposed shear key concepts. Boundary conditions used in the tests mimicked those found in the sub-assemblage models. The loading frame consisted of two columns that were bolted to the reaction floor, and were spaced 8 ft apart. Connecting the columns, 10 ft above the reaction floor, were two cross beams that were bolted to both columns. The servo-controlled hydraulic actuator used to load the specimen was bolted to the center of the cross beams, and was positioned vertically so as to load the sub-assemblages in the center. The actuator system was capable of applying both static and cyclic loads under either load or displacement control. Figure 23 is a front view of the test setup.

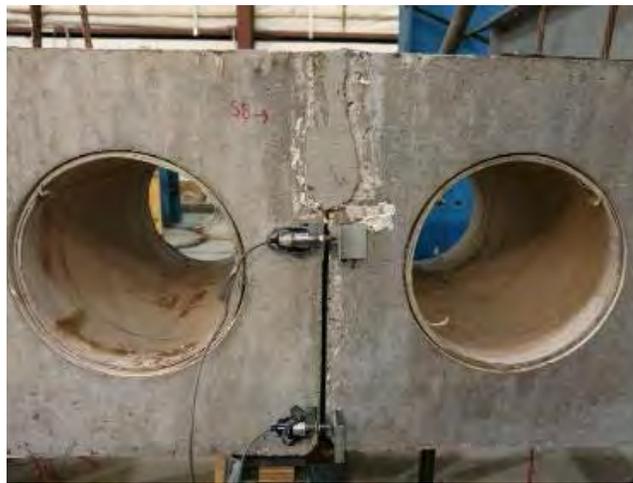
**Figure 24. Photograph Showing Instrumented Joint**

Joint opening during testing was measured using Linear Variable Differential Transducers (LVDTs) in two locations at each joint face: at the bottom of the shear key and at the bottom of the adjacent beam sections as shown in Figure 24. The LVDT at the bottom of the shear key was important because a sudden change in deflections here would imply cracking in the shear key. There were eight of these horizontally placed LVDTs in total, since there were two at each joint face with two faces per joint.

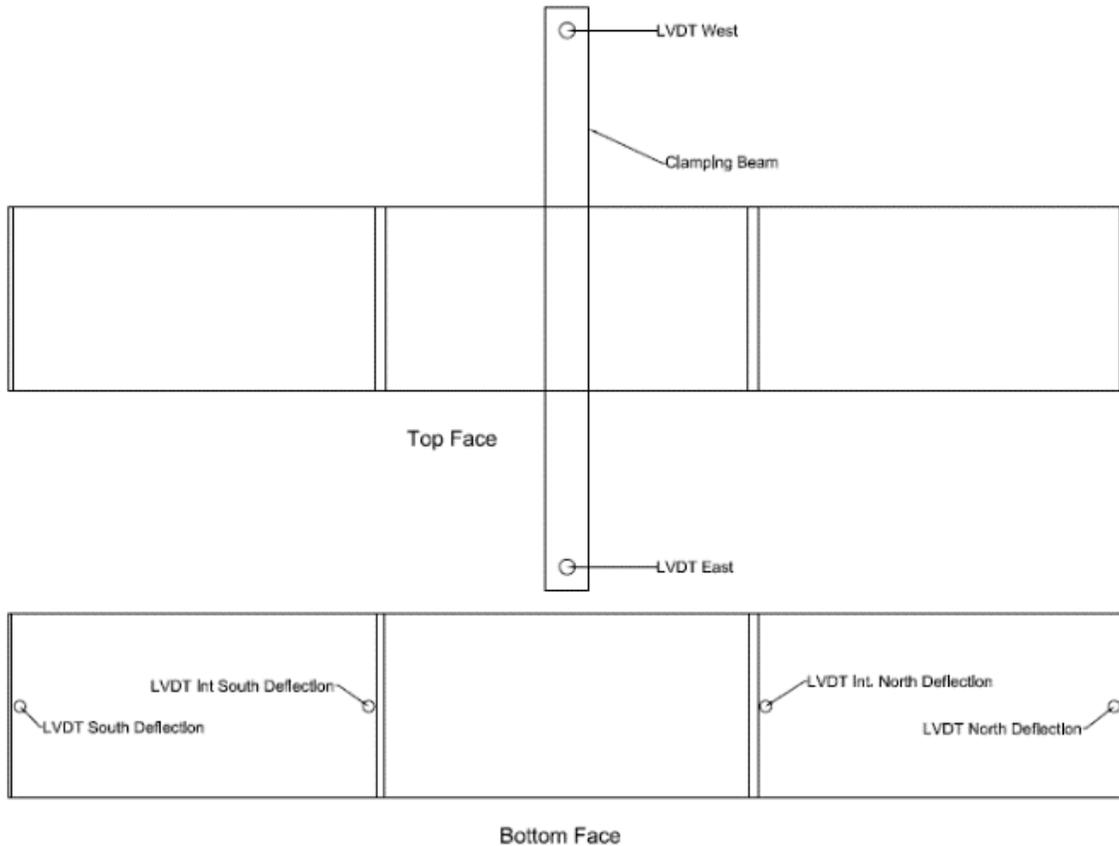
**Figure 25. Sketch Showing Location of Vertical LVDTs**

Aside from the horizontally placed LVDTs, there were also six LVDTs used to measure vertical movements. Figure 25 is a sketch showing the location of the six LVDTs used to measure vertical deflection. Two of these vertical LVDTs (labeled LVDT East and West) were placed on both ends of the spreader beam, which was attached to the actuator. These LVDTs served two purposes. First, these vertical LVDTs measured the deflection that the actuator directly imposed on the specimen. The second purpose was to make sure the spreader beam remained level during testing. The other four vertical LVDTs (labeled LVDT South, LVDT Interior South, LVDT North, and LVDT Interior North) were placed under the two exterior voided slab specimens to measure vertical deflection of the specimen. These LVDTs were placed next to both of the supporting wide flange sections and longitudinally in the middle of the specimens.

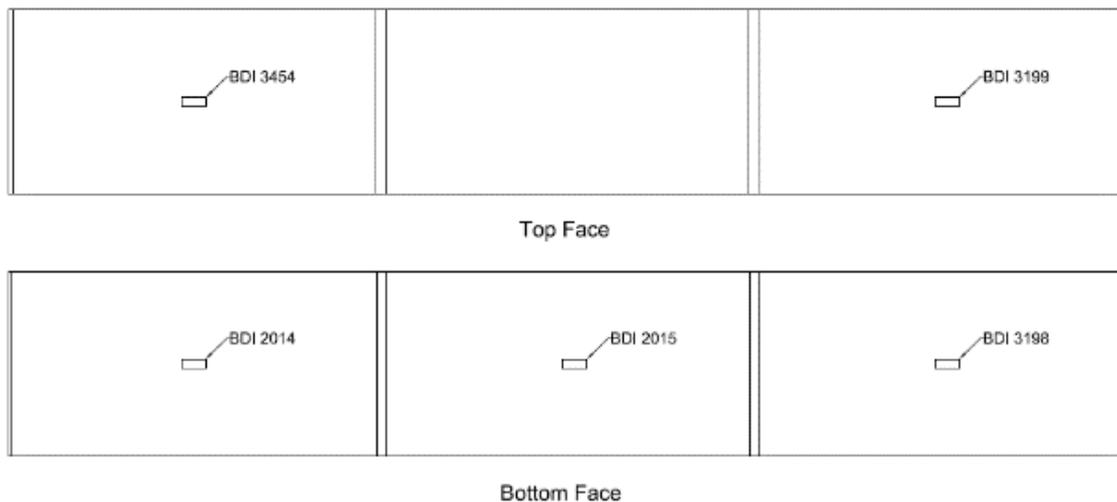
**Figure 26. Sketch Showing Location of BDI Gauges**

strain transducer locations on a test specimen. Two of the BDI strain transducers (labeled BDI 3454 and BDI 3199) were centered on the top of the exterior voided slab sections. The other three BDI strain gauges (labeled BDI 2014, BDI 2015, and BDI 3196) were centered on the underside of the each of the voided slab sections. These gauges were used to compare expected and actual sub-assembly behavior during testing. The LVDT and load cell built into the actuator were also wired into the data acquisition system.

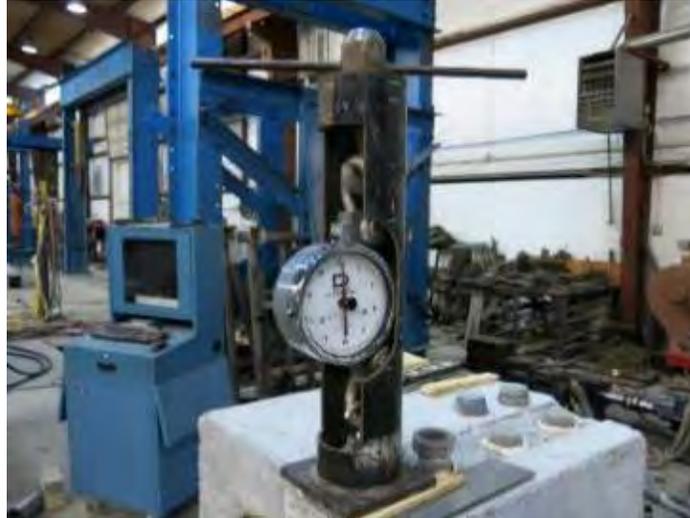
**Figure 27. Photograph of Pull-Off Test Setup**

In addition to material testing of the sub-assembly constituents, pull-off tests were performed with the joint material and the adjacent box beam and voided slab concrete. This was done in order to determine the bond strength of the joint material to the adjacent member concrete. A pull-off test procedure similar to that used for bridge deck overlays was employed. The tests were performed by casting small cylindrical forms (2-in diameter and 1-in high) directly against the shear key of both the adjacent box beam and voided slab sections. These surfaces were also sandblasted and kept moist prior to placement. In order to perform these tests, a metal cap was epoxied to the concrete pull-off specimens. An insert with a hook on the end was threaded into this metal cap. A tension load cell was hooked onto the insert and then pulled from the other end via a screw jack device. Figure 27 is a photograph of the setup. These pull-off tests were run on the first day of testing and on the final day of testing. Table 4 summarizes the material testing performed for each specimen.

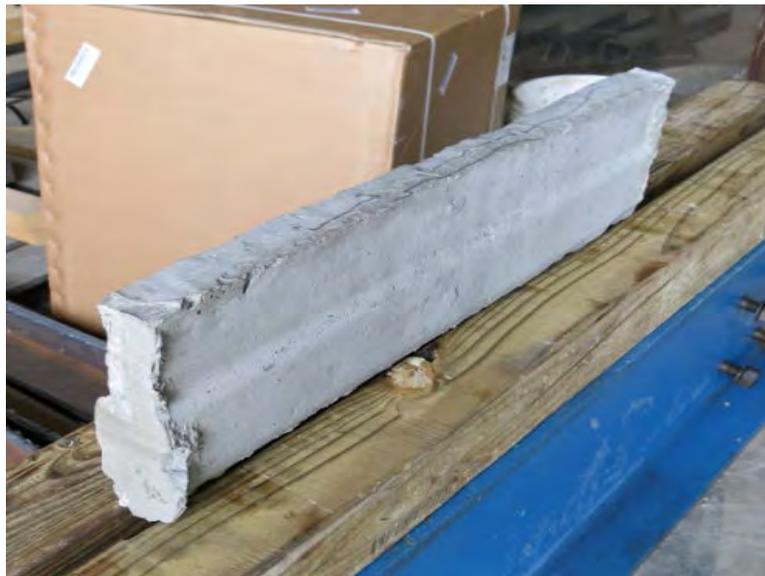
**Figure 28. Intact Shear Key After Failure of Bonded Connection**

Bond strength is an important property for a joint filler material. Table 6 shows that grout has relatively low bond strength, while both the UHPC and VHPC have high bond strength. Some UHPC and VHPC pull-off specimens failed in the substrate concrete, not at the UHPC or VHPC-substrate interface. This shows that the bond strengths were higher than the tensile strength of the substrate concrete. Consistent with the pull-off test results, the specimens with grouted connections developed full-length cracks in the shear key at relatively low loads, while the UHPC and VHPC connections took much higher loads before developing cracks. The low bond strength of the grout to the precast concrete resulted in debonding of the entire shear key, which could be removed, leaving no grout pieces bonded to the concrete. Figure 28 shows a post-cracking grouted shear key, which remained intact after fully debonding from the precast concrete.

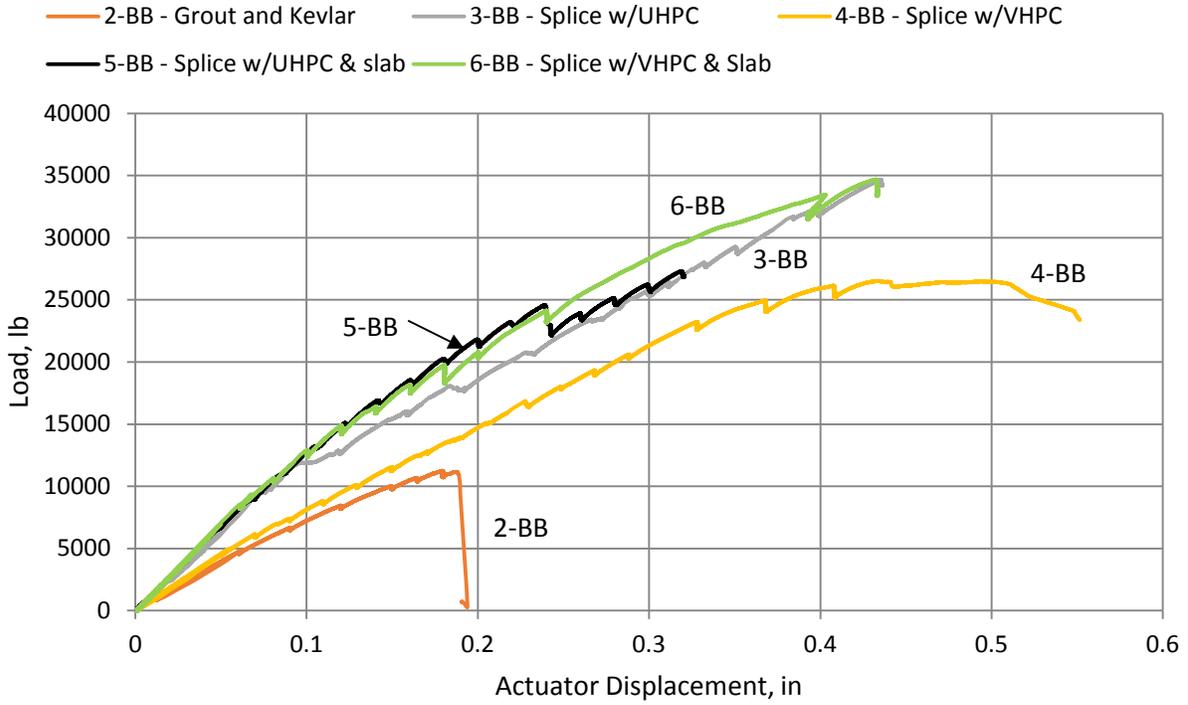
Figure 31. Load vs. Displacement Plots for Adjacent Box Beam Specimens Final Static Tests

Figures 31 and 32 show the final static test results for adjacent box beam specimens and voided slab specimens, respectively. At the conclusion of cyclic testing, it was intended to load each specimen to failure. However, this was not possible for all specimens. The two specimens with grouted shear keys failed before or during cyclic testing. Six of the other ten specimens could not be loaded to failure because their resistance exceeded the capacity of the test fixture. These were specimens 3-BB, 5-BB, 6-BB, 4-VS, 5-VS, and 6-VS. However, all six of these specimens resisted loads well in excess of design service load.

The design service load used during cyclic testing corresponded to an actuator displacement of 0.03 in, and simulated the displacement caused by an AASHTO design truck on the full model of the bridge. Specimens 2-BB to 6-BB and 2-VS to 6-VS greatly exceeded this level of deflection before failure or termination of the test. Specimens 2-BB and 2-VS (which contained grout with Kevlar strip above) had significantly poorer performance during the final static tests as compared to the specimen containing UHPC or VHPC; however, each of these specimens exceeded service load by a factor of approximately 4.

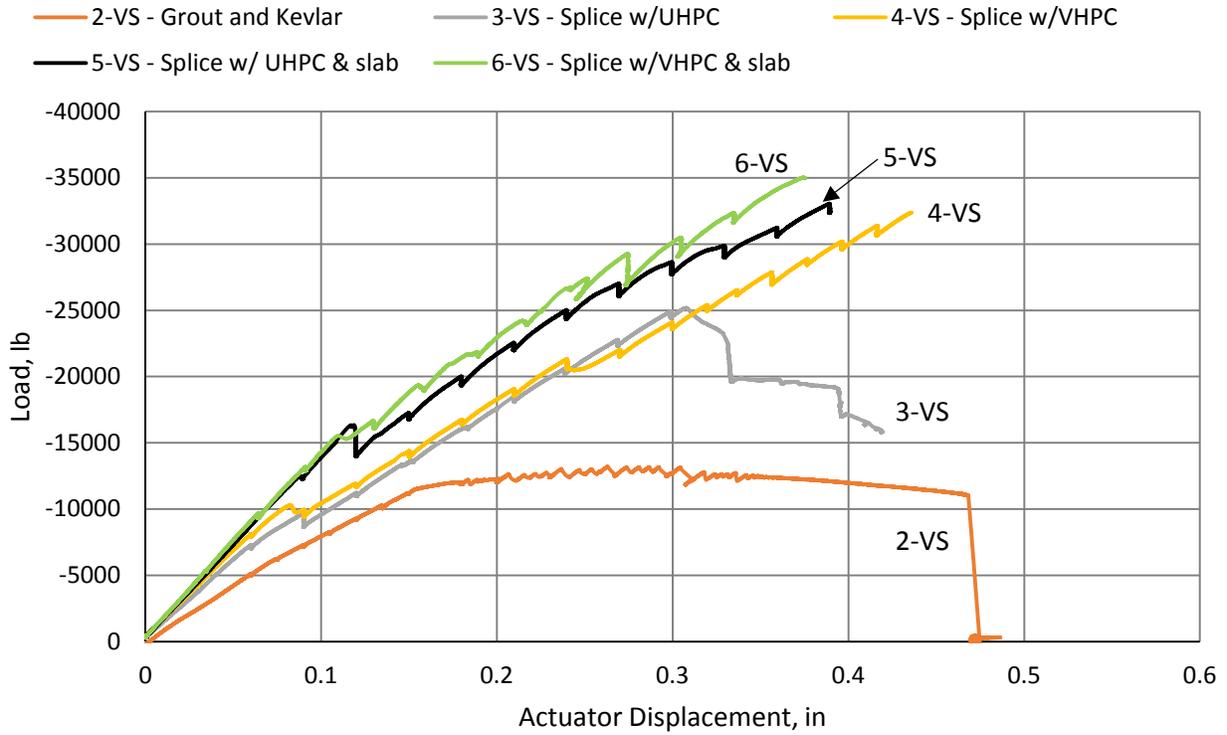
Figure 32. Load vs. Displacement Plots for Voided Slab Specimens Final Static Tests

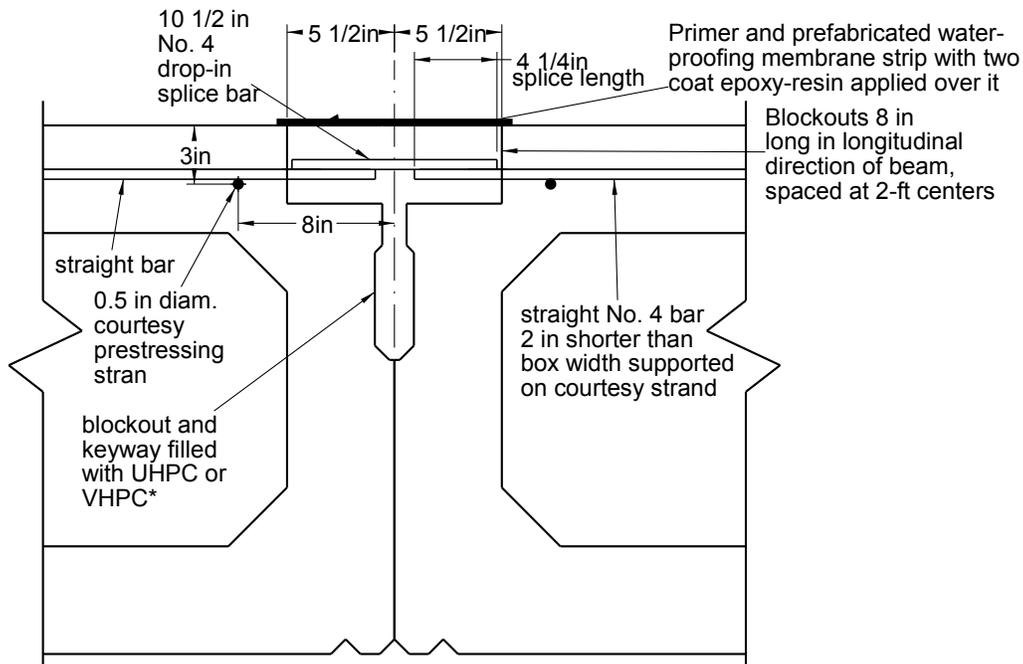
Figure A1. Longitudinal Shear Key and Blockout Detail-Section at Blockout  
(shown for 27-in deep prestressed box beam)

- The filler material shall be UHPC or VHPC, placed in one continuous operation without interruption for the entire length of each shear key in each span. A sample special provision for the UHPC or VHPC is provided on the following pages.

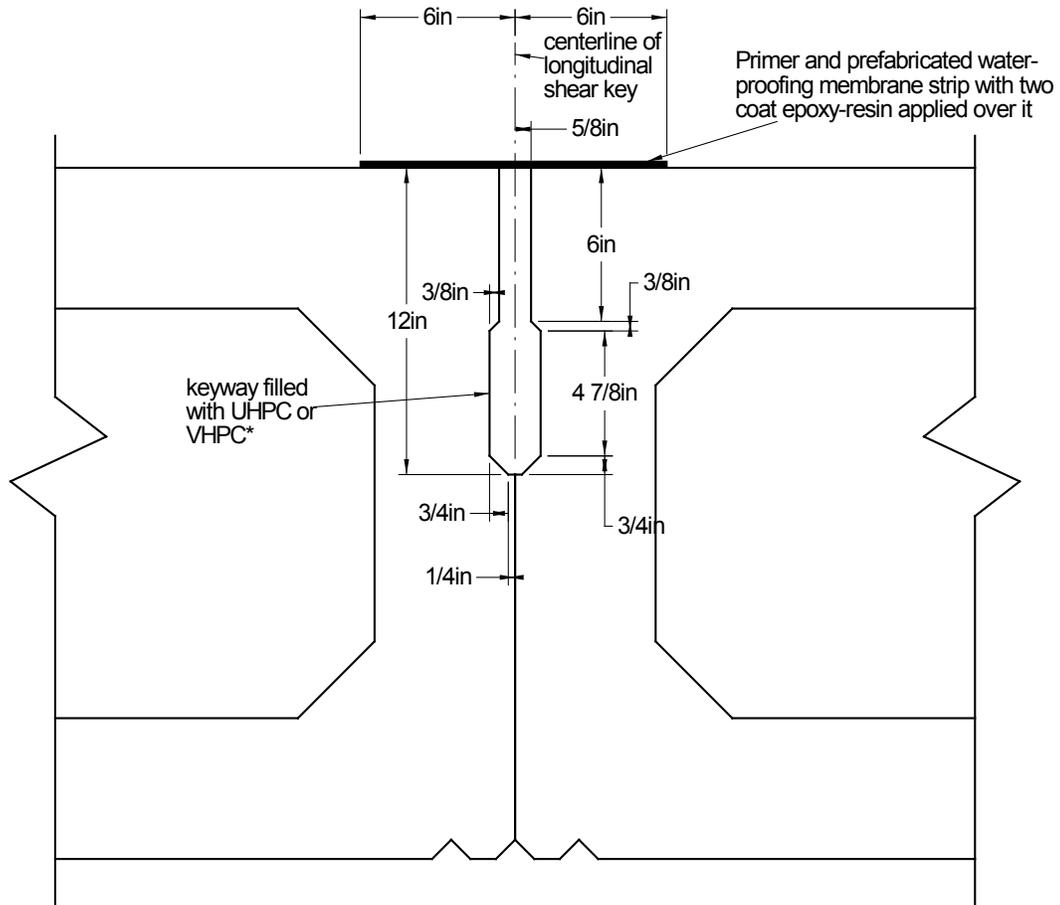
**Figure A2. Longitudinal Shear Key and Blockout Detail—Section Between Blockouts**
