# Development of Improved Connection Details for Adjacent Prestressed Member Bridges

Final Report VTRC 17-R20

**DEVELOPMENT OF IMPROVED CONNECTION DETAILS  
FOR ADJACENT PRESTRESSED MEMBER BRIDGES**

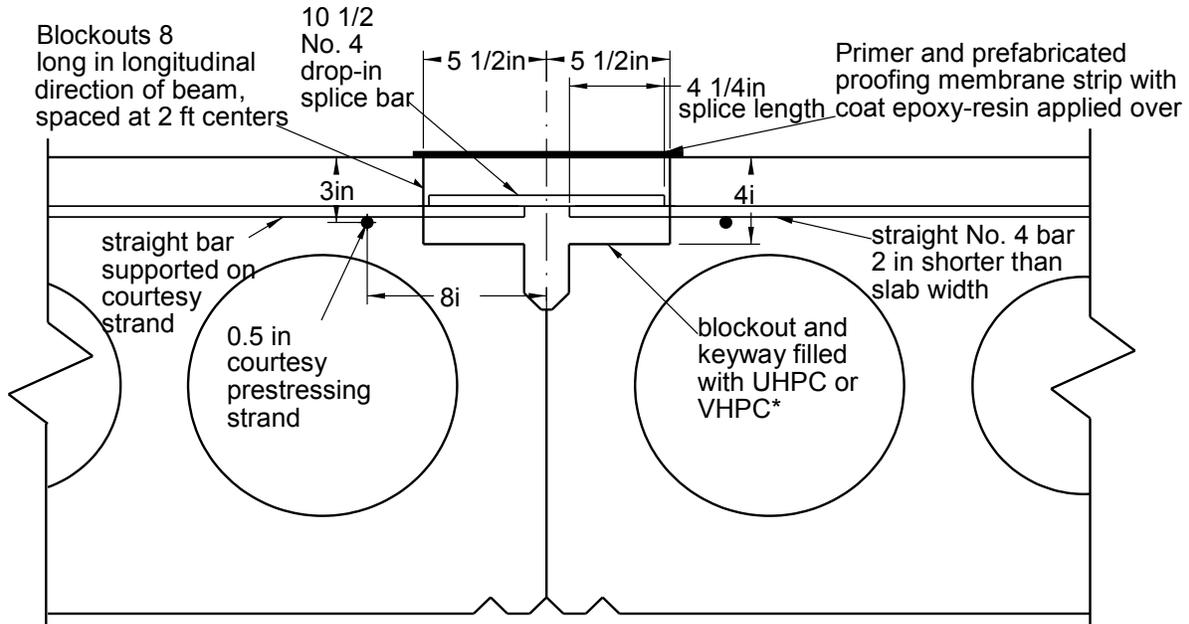
**Figure A3. Longitudinal Shear Key and Blockout Detail—Section at Blockout  
(shown for 21-in deep prestressed voided slab)**

- The filler material shall be UHPC or VHPC, placed in one continuous operation without interruption for the entire length of each shear key in each span. A sample special provision for the UHPC or VHPC is provided on the following pages.

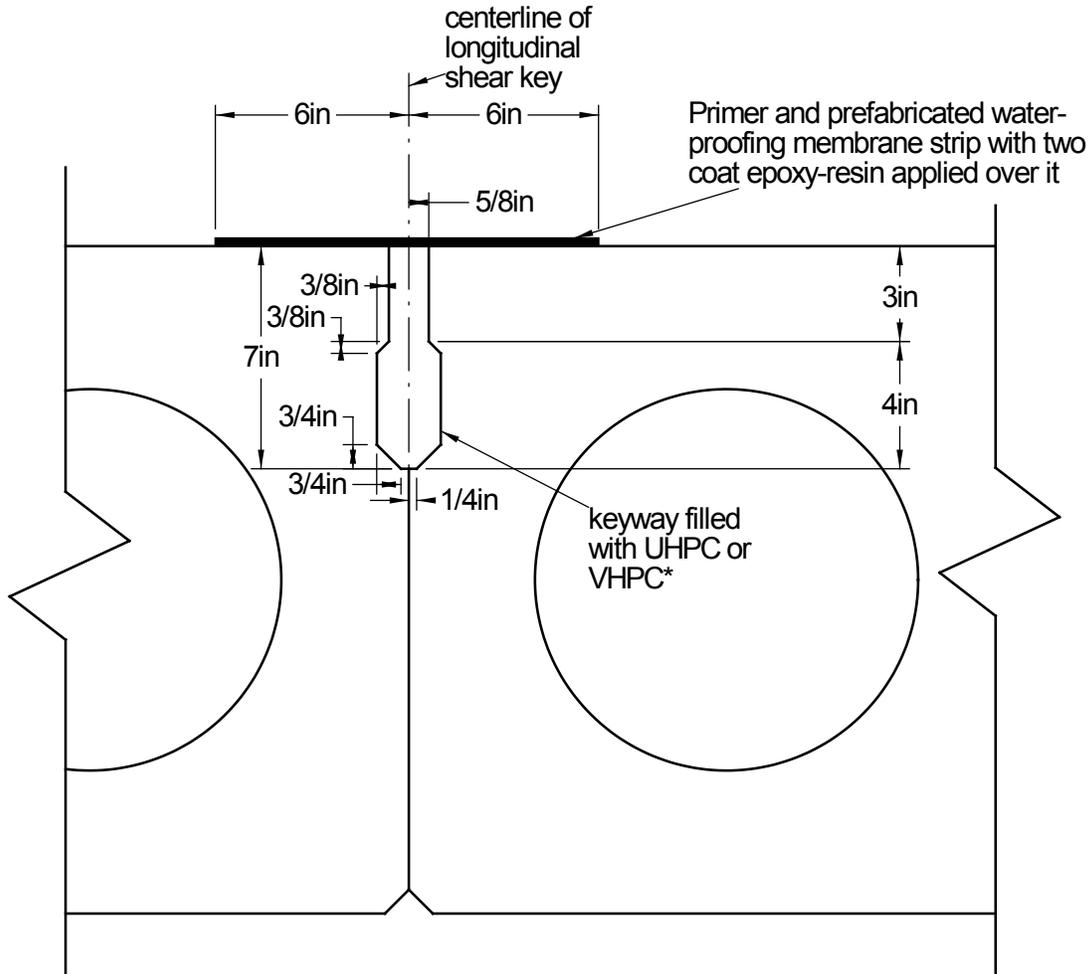
**Figure A4. Longitudinal Shear Key and Blockout Detail—Section Between Blockouts**

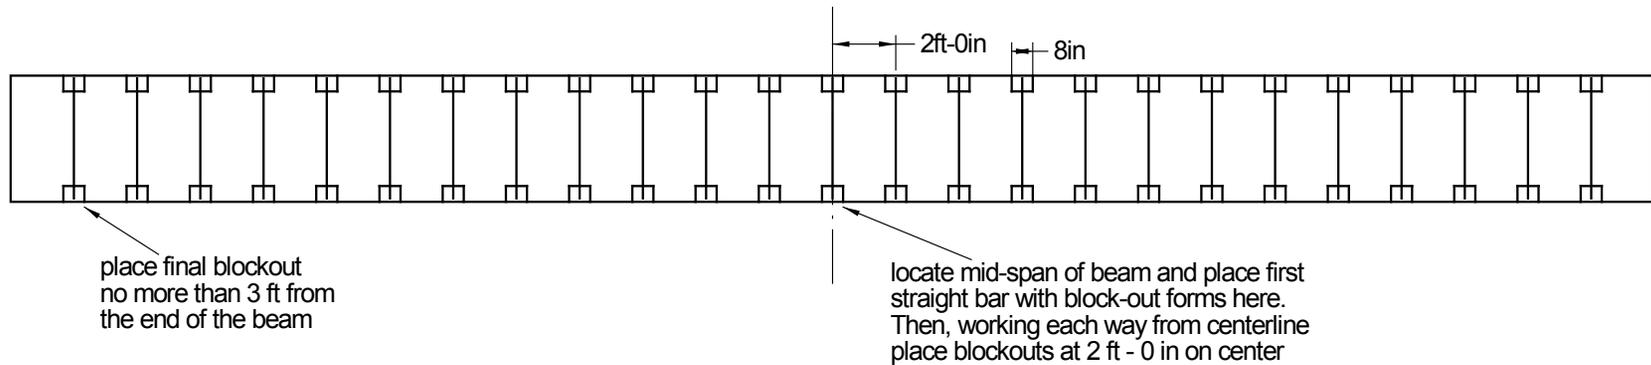
**Figure A5. Plan View of Squared-Ended Box Beam**

- For bridges with no skew, the blockout pockets and No. 4 straight bars shall be laid out as shown in Figure A5. A blockout pocket and bar shall be located at the mid-span of the beam, and then the remaining blockouts shall be spaced at 2-ft centers in either direction from mid-span. The final blockout pocket shall be no further than 3 ft from the end of the beam, but shall not be placed within the end diaphragm of the beam.

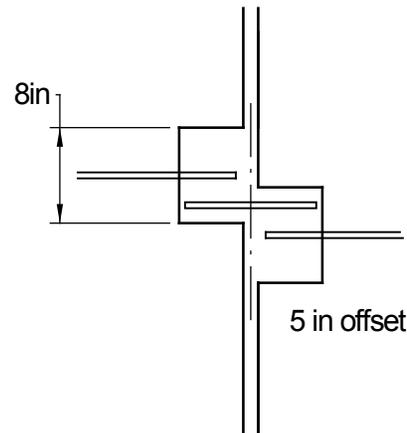
**Figure A6. Schematic Showing 8-in Blockout Can Accommodate Up to a 5-in Misalignment of the Blockouts on Either Side of the Joint**
