# In-Service Performance Evaluation and Monitoring of a Hybrid Composite Beam Bridge System

Final Report VTRC 18-R5

**IN-SERVICE PERFORMANCE EVALUATION AND MONITORING OF A HYBRID  
COMPOSITE BEAM BRIDGE SYSTEM**

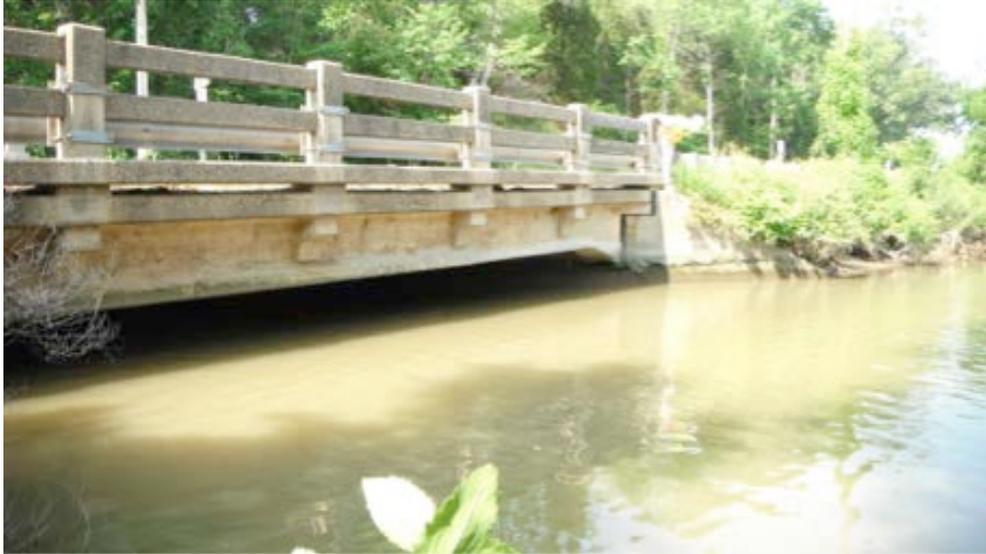
**Figure 1. Original Bridge Crossing Tide Mill Stream Along Route 205**

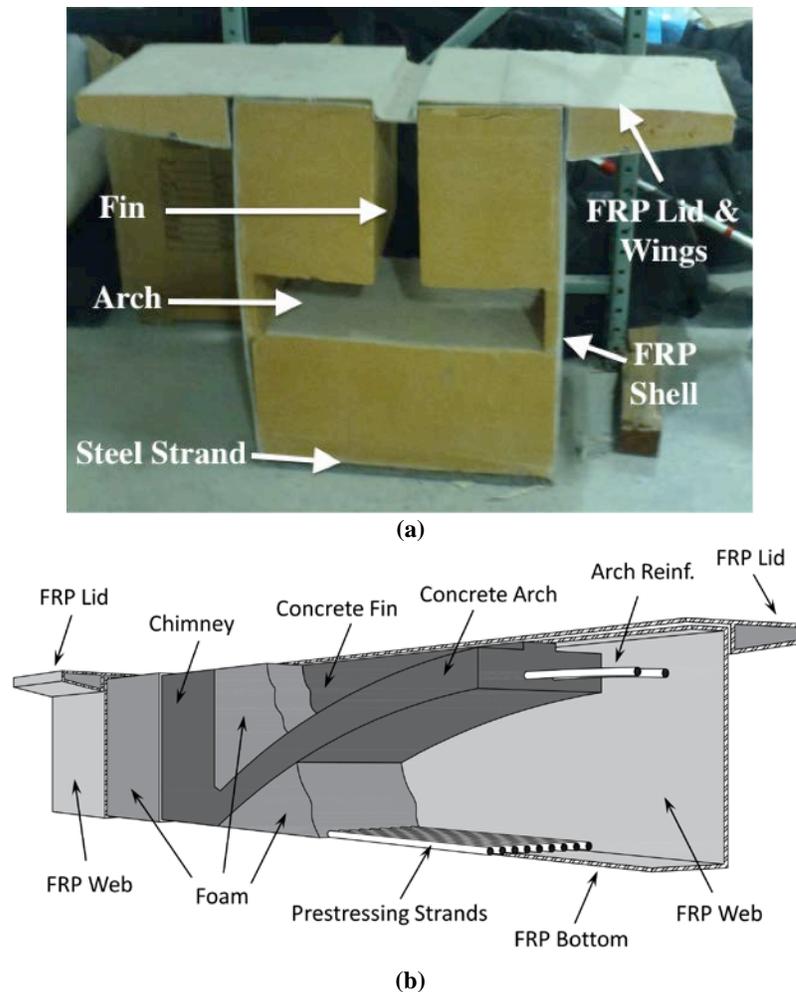
**Figure 2. Hybrid Composite Beam (a) Cross-Section and (b) Isometric System**

As highlighted in the previous section, the HCB system at its core can be described simplistically as a tied concrete arch encased in an FRP shell. A single beam consists of a parabolic concrete arch tied in the tension zone by steel, carbon fiber, or glass fiber prestressing strand. Under bending, the beam distributes loads from the top of the beam through axial compression of the arch down to the supports, where the tension strands restrain the supports. The entire arch system is contained within a glass FRP box shell that protects the main load carrying components and contributes additional shear resistance. Figure 2 provides a visual representation of the orientation of each of the aforementioned components.

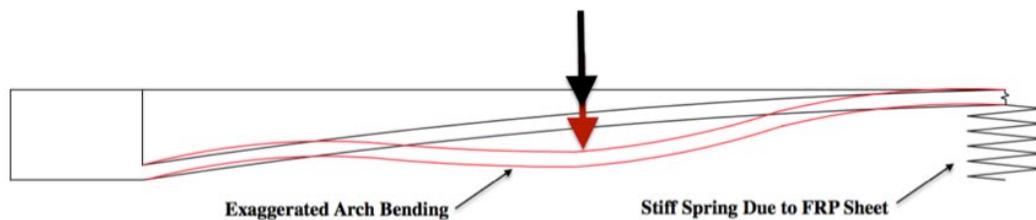
**Figure 3. Thin Arch Local Bending Hypothesis (Adapted from Ahsan, 2012)**

It was determined that the concrete arch does not act compositely with the rest of the HCB system. Ahsan (2012) hypothesized the existence of a local bending phenomenon of this thin arch that is accentuated at the unsupported quarter-spans. The tension strains registered in the bottom of the arch are not compatible, but quite exaggerated compared to the strains read from the external FRP strain gauges, indicating the existence of this phenomenon. Further, there exists a discrepancy between the upper and lower strain readings in the arch also indicating flexure within the arch. Figure 3 shows an adaptation of the phenomenon described by Ahsan.

In this theory, the mid-span of the arch is treated as being supported by a stiff spring, as an 8 ft FRP sheet connects the two FRP webs directly beneath the arch conduit. From a practical perspective, the purpose of this sheet was to provide a rigid surface to protect the foam formwork from the force of the concrete placed at this location, and preserve the shape of the arch. Following this theory, it is easy to see how flexure could be induced throughout the length of the arch, but especially at the unsupported quarter points. Some of the theories proposed by Ahsan (2012) include:

Rather than cracking in the arch, Ahsan (2012) hypothesized that there exists a local bending phenomenon within the concrete arch. As illustrated in Figure 3, it can be rationalized that the arch would be able to experience bending, especially at higher levels of overall HCB curvature where the arch begins to flatten out. Ahsan also proposed that this effect is dampened at mid-span due to the 8 ft sheet of FRP that serves as the bottom formwork for the arch, which also likely provides stiffening to the arch. This FRP sheet that forms an enclosure for the arch at this location also connects to either FRP web and thus enforces greater congruence with the FRP curvature and overall HCB response at mid-span. The data collected in this experimental program aligned with the hypothesis, as the quarter-span arch gauges of Beams 5 and 7

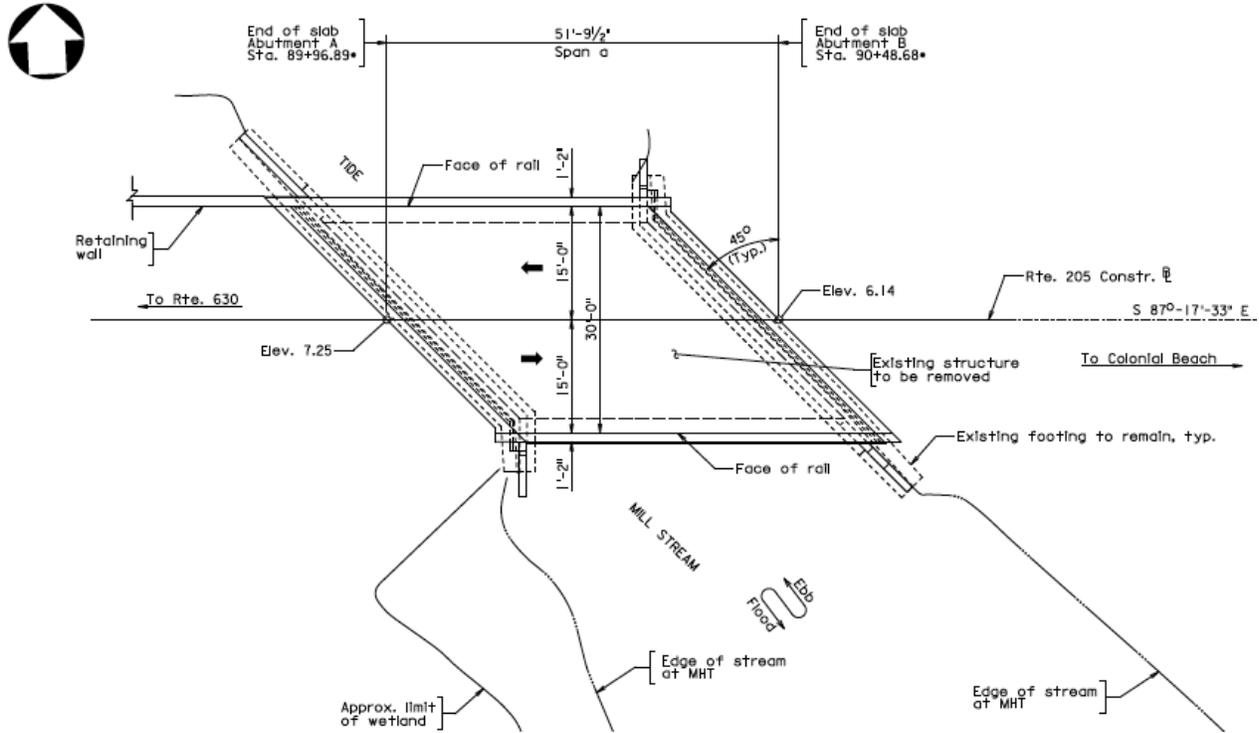
**Figure 4. Tides Mill Stream Site – Plan View**

The live load testing program focused on the newly constructed HCB bridge on Route 205 over Tides Mill Stream in Colonial Beach (Figure 4). Beam fabrication took place in a series

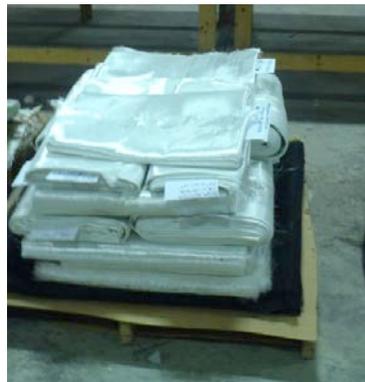
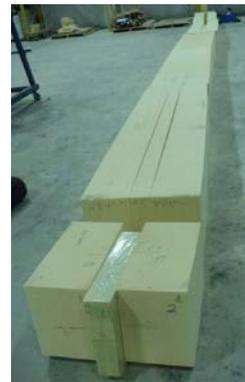
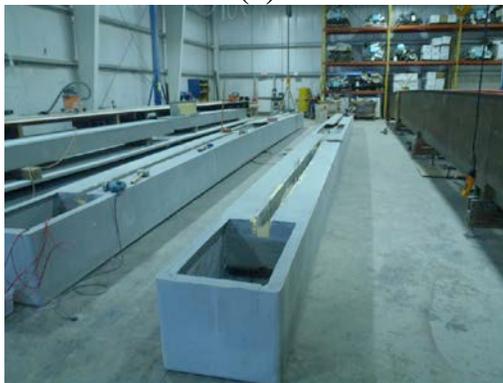
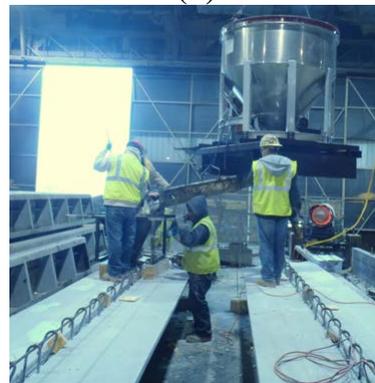
**Figure 5. HCB Fabrication Process: (a) Glass Fiber Fabric, (b) Foam Inserts, (c) Completed HCB Box, and (d) Placement of SCC Within HCB Arch**

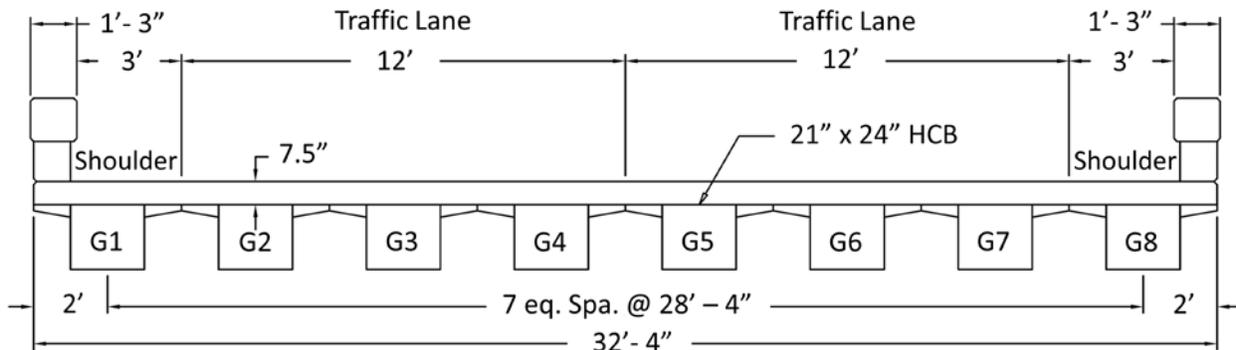
Figure 6. Tides Mill Stream – HCB Bridge Cross-Section

The previous concrete girders and deck were replaced with eight HCBs spanning 44 ft over a small creek and supporting a 7.5 in deep conventionally reinforced, cast-in-place concrete deck, while maintaining the existing substructure. Each HCB girder was 21 in deep by 24 in wide and contained inclined shear connectors that enforced composite action between the HCB and the concrete deck. The girders were spaced at approximately 4 ft center-to-center, yielding a 32 ft 4 in transverse width that allowed for two lanes of traffic with 3 ft shoulders (Figure 6). The girders were skewed at 45° and supported by two parallel abutments, and the ends were encased in integral abutment backwalls, resulting in semi-integral abutments. The girders crossed the waterway with a very low clearance of approximately 6 ft at low tide, making access for instrumentation a challenge. The stream feeds to the Potomac River, which flows to the North of the bridge site.

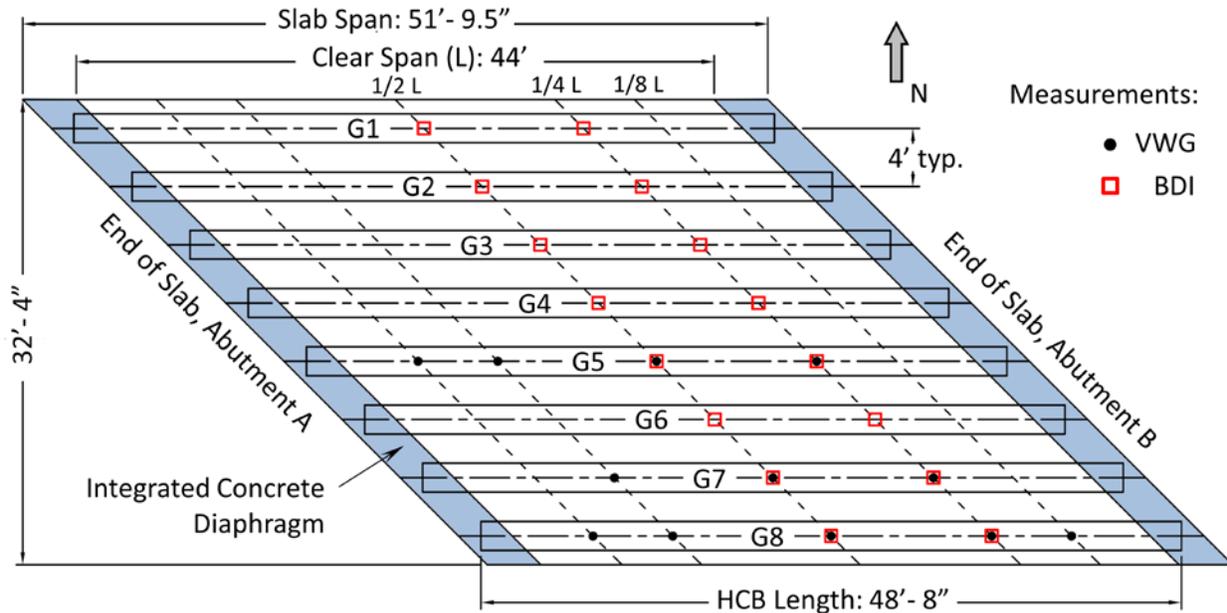
**Figure 7. Bridge Nomenclature With Instrumentation Overview (Plan View)**

The focus of this investigation was the initial in-service performance assessment of this particular HCB bridge; however, the instrumentation program that was implemented was chosen to serve two purposes: (1) to yield measured responses during load testing, and (2) to provide long-term monitoring capabilities for the HCB bridge system. To keep the instrumentation systems organized, a nomenclature for the girders was established (Figure 7) where the northernmost girder was labelled number 1 (alternatively girder A per VDOT Plans), and the numbers progressed sequentially to the eighth and southernmost girder, labelled girder 8 (alternatively girder H per VDOT Plans).

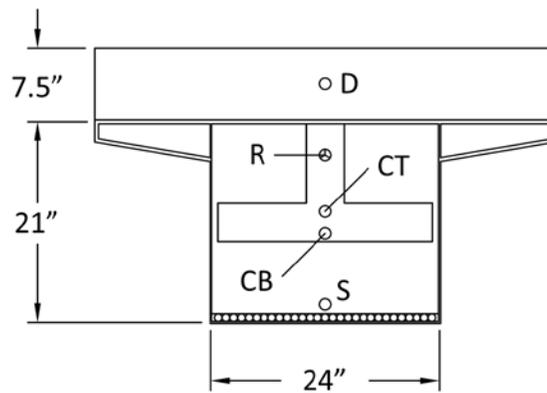
**Figure 8. General Vibrating Wire Gauge Locations Through the Depth**

Along the length of the three selected beams, gauges were installed at mid-span to yield the maximum flexural responses of these select girders, and at both the quarter-span locations to capture the effect of the skew. Additional gauges were installed at select eighth-span points in a 60° rosette configuration on these three girders to measure shear response.

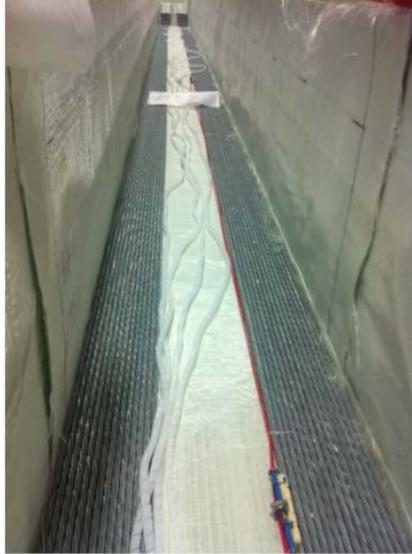
**Figure 9. Internal VWG Placement at Tension Level**

During the first phase of fabrication of the HCBs, the fabrication of the FRP box shell, a VWG was installed at each of the nine proposed mid-span and quarter-span locations at the level of the steel strand. This involved tying the VWG parallel to a tension steel strand as close to the middle of the girder as possible during the layup of the fiberglass sheets and high-strength steel strand (Figure 9). Just as concrete transfers strain to a VWG through the movement of concrete perpendicular to the end discs, it was theorized that when cured, the resin would offer the same transfer of strain to the gauge and an accurate reading would be provided for the particular cross-sectional depth.

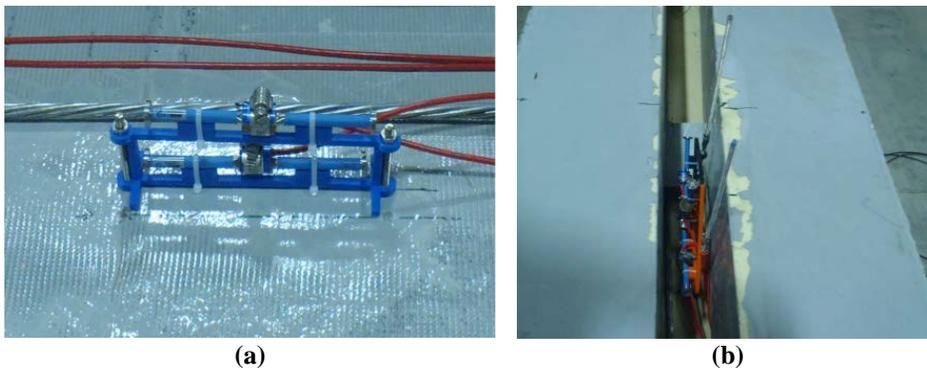
**Figure 10, Stacked Strain Gauge Configuration: (a) Concrete Arch VWG Frame at Mid-span and (b) Additional Rosette Configuration at Eighth-span**

After infusion of the FRP shell, the remainder of the VWGs internal to the HCB itself were installed. A series of non-corroding, acrylonitrile butadiene styrene, 3D-printed frames were designed to hold the VWGs in place at the desired location within the voided conduits that would later be filled with SCC. Again, nine frames were placed at the proposed mid-span and quarter-span locations with two VWGs stacked 2 in apart. Each frame was then inserted through the void for the concrete fin (Figure 10a) down to the level of the arch void and inserted into the existing foam formwork such that the VWGs were aligned longitudinally and horizontally with the beam, not parallel to the slope of the arch. Note that the exact cross-sectional depth of these gauges differed by location due to the varying profile of the parabolic arch. At the three designated eighth point locations, a frame identical to the one devised for the other arch locations was used in conjunction with an additional frame on top of the first. This added frame held three VWGs arranged in a 60° rosette. The rosette was designed to measure the shear in the fin near the point of maximum shear and where the fin is deepest. The two frames were linked by two stainless steel threaded rods that enabled the whole assembly to be lowered into the deeper eighth-span locations (Figure 10b).

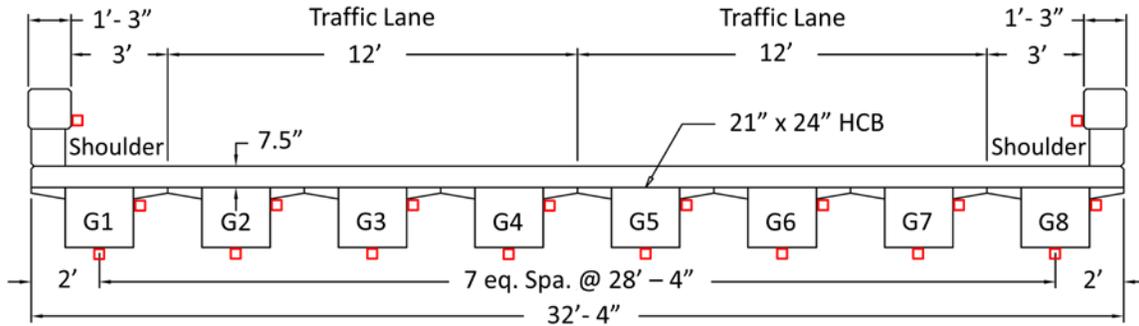
**Figure 12. Tides Mill Stream Bridge Cross-Section With Midspan External Strain Gauge Configuration**

The second data acquisition system was deployed on the day of testing only and used a rapidly deployable wireless field-testing setup by Bridge Diagnostics Inc. (BDI), which primarily used externally mounted strain gauges. The external BDI strain gauges were placed in conjunction with the internal VWGs in order to mirror the strain locations and provide a comparison between the internal strains and the strains experienced by the external FRP shell (Figure 7 and Figure 12). These external gauges were mounted on the bottom flange of each girder at mid-span and the East quarter-span to capture distribution behavior laterally across the eight girders. Additional gauges were mounted on the web of the girders at these locations as close to the arch position as possible, though the depth of the wings made this somewhat challenging at mid-span. These web gauges were used to create an external strain profile that could be aligned with the internal strain profiles and contribute to the evaluation of the load sharing behavior of the individual HCB elements. Last, two additional external BDI strain gauges were placed on the parapet at mid-span such that any strains registered could give an indication of the level of stiffening provided by the barriers to the bridge system. A BDI string potentiometer was also used to measure deflection for the northern exterior girder; however, the anchorage system for the string pot was insufficient to maintain the required tension and was therefore not included in this report.

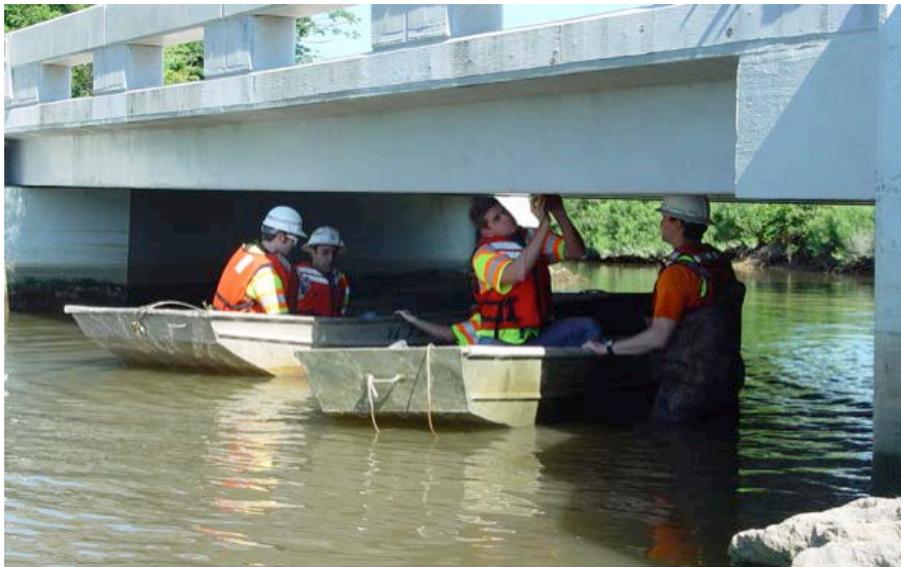
**Figure 13. Instrumenting Bridge Underside**

The instrumentation was performed over two days, August 5 and 6, 2013. The first day consisted mostly of setup and preparatory work and the second day included final preparation and carrying out the load test runs. It was a function of the bridge site that the clearance of the waterway was already shallow, but the clearance between the bridge and stream also fluctuated with the rising tides. This was a concern that had to be factored into the schedule of the load test, and dictated when certain tasks could be performed underneath. This factor determined the need to carry out the load test over two days. The depth of the waterway varied, and as such, a combination of small jon boats and researchers in waders was used for access to attach the sensors beneath the bridge (Figure 13).

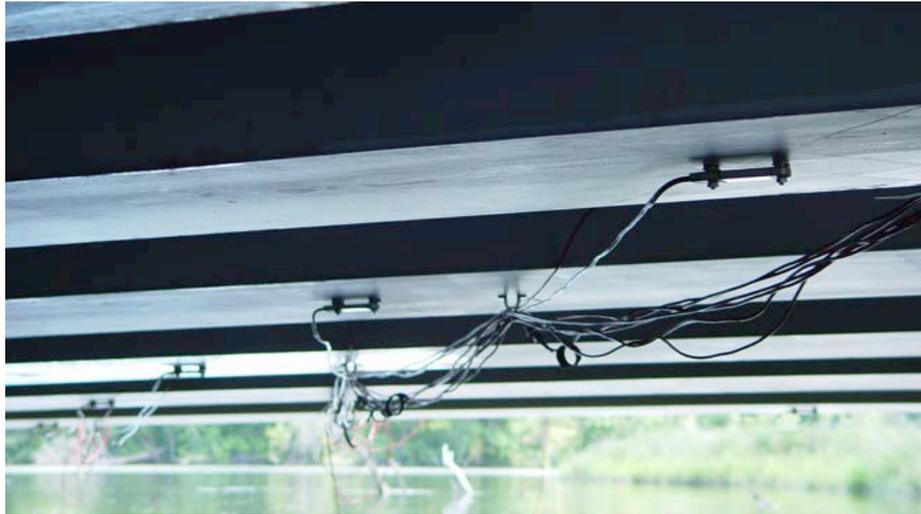
**Figure 14. Bottom Flange External Strain Gauge Placement**

On the morning of August 5, two teams worked to accomplish multiple tasks. One team was responsible for affixing the BDI strain gauges to the underside of the bridge using a very rapid-set epoxy. The bottom flange gauges were aligned and centered on the flange (Figure 14), while the additional longitudinal gauges were adhered 1.5 in beneath the wing edge on the south-facing web. The underside installation and began marking mid and quarter-span locations with measurements taken from the clear span distance, and a chalk line was dropped across all eight

girders, along the skew to mark these locations on each beam. To keep the sensor lead wires organized and dry, conduit clamps were glued along the girders and the lead wires were sequentially zip-tied to the clamps, channeling the groupings out the South end of the bridge where they were bundled and bagged to keep moisture out overnight. These bundles were then hung on conduit clamps on the first interior web, or rested on the abutment face to remain out of sight.

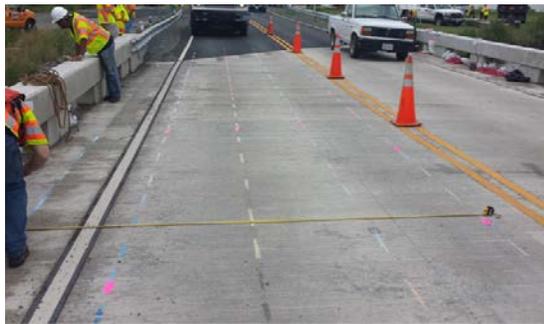
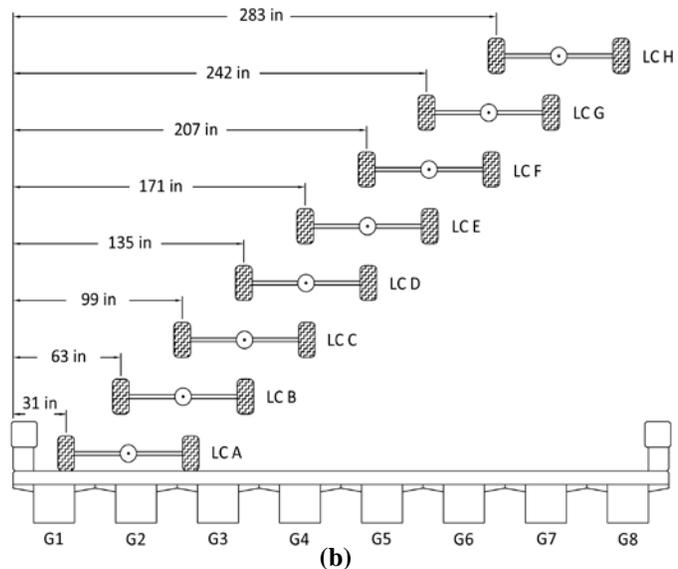
**Figure 15. Wheel Path (a) Markings and (b) Configuration**

The second team was responsible for marking the pre-determined wheel paths or load cases (Figure 15) and organizing the BDI wireless nodes as input channels (Figure 16). It was important to place specifically labeled gauges at the predetermined locations for data analysis; however, the BDI system does not require one to plug in the gauges in any particular order.

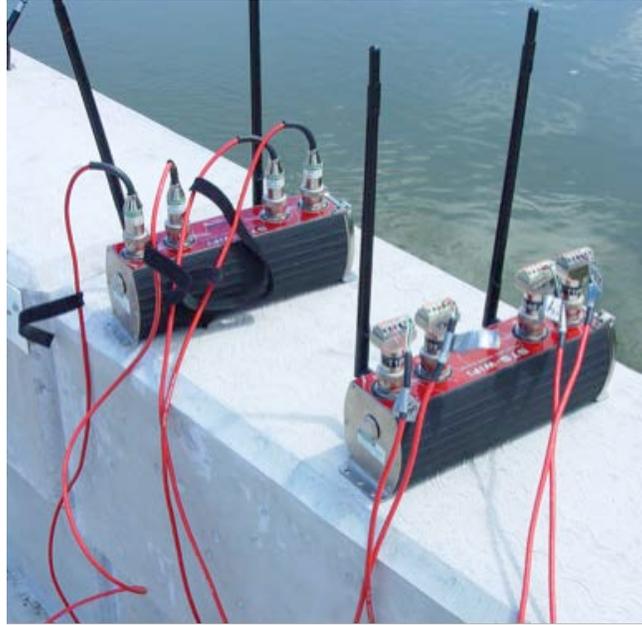
**Figure 16. Wireless BDI Node with Intelliducer Plugs**

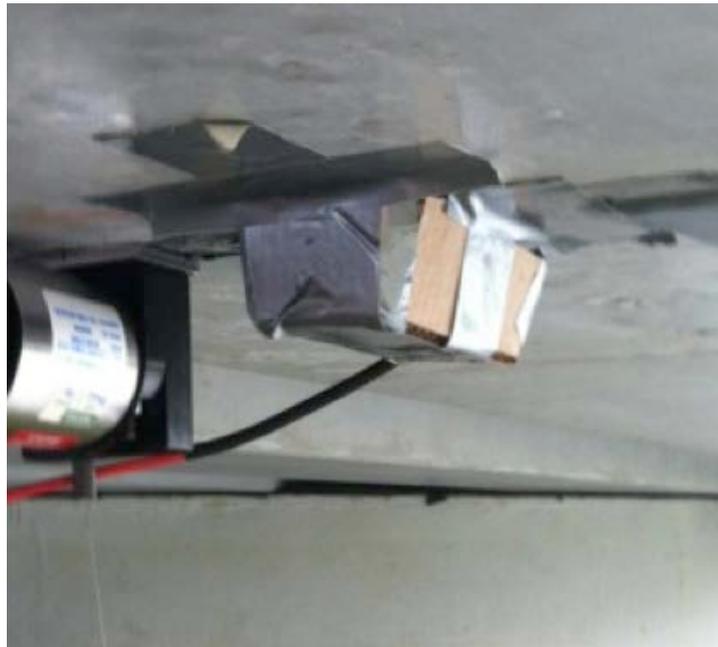
**Figure 17. Cardboard Shield (“Igloo”)**

On the morning of the load test, the BDI wire leads were retrieved from under the bridge and connected to the wireless BDI nodes, which were in turn connected to the wireless base station, which communicated wirelessly with the computer controlling the system. In addition, pre-made cardboard shields or “igloos” (Figure 17) were mounted to protect the externally mounted strain gauges from wind, as other researchers have noted that BDI strain gauges tended to have a sensitivity to wind currents.

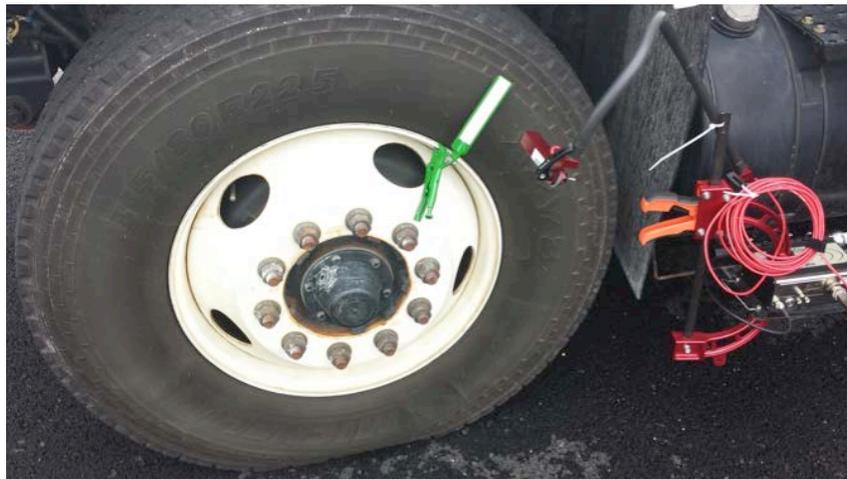
Figure 18. BDI Autoclicker Setup

In addition to the instrumentation on the bridge, a BDI product called an *Autoclicker* was attached to the wheel well of the load test truck to track the time and longitudinal position of the truck as it crossed the bridge (Figure 18). Prior to testing with a particular vehicle, the research team measured the distance traveled during one complete revolution of the front wheels, or one “click” of the *Autoclicker*. A vice grip with a reflective paddle was attached to the wheel rim and a lens on a flexible arm was positioned over the paddle such that each time the wheel made a complete rotation, the *Autoclicker* would recognize the paddle and provide a “click” or instantaneous, time-stamped unit value. Using the geometry of the truck, the relative progress for each of the axles is illustrated versus the number of clicks in Figure 19. Each time the truck pulled up to the start of the bridge deck, the reflective clicker tab would manually be reset to the “zero” position on the wheel, where the *Autoclicker* would clock a click near the start of the truck motion.

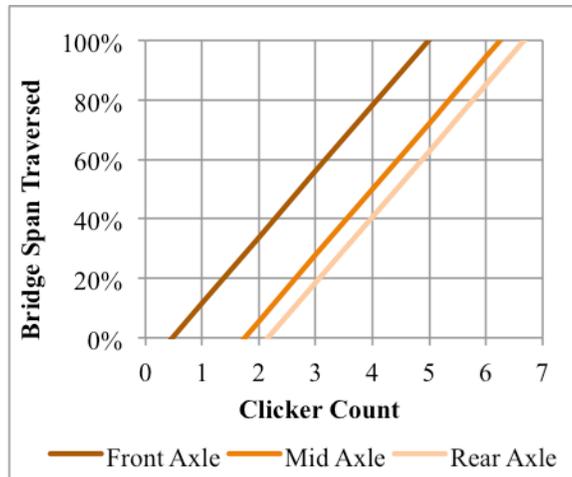
Figure 19. Autoclicker Position Encoder

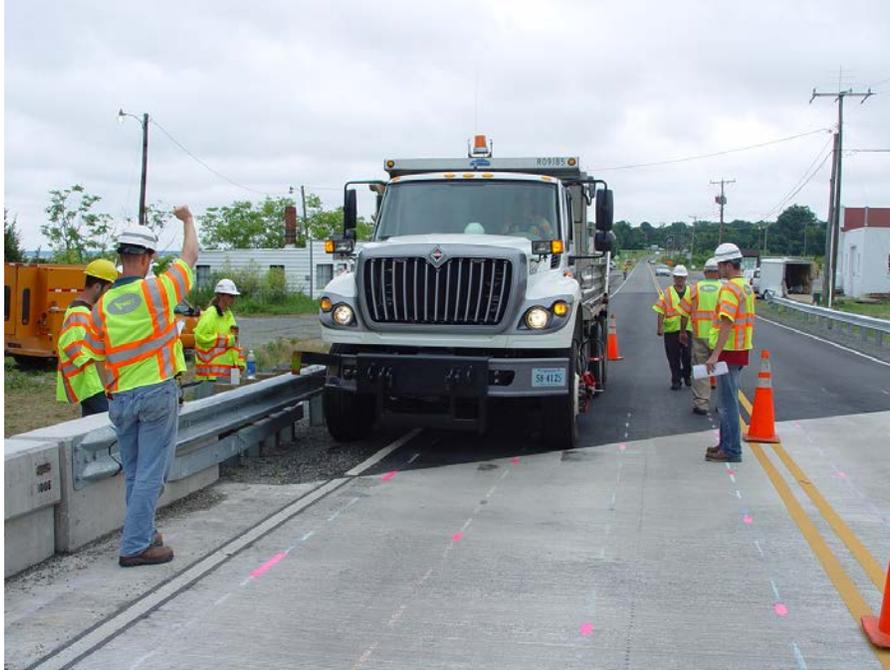
**Figure 20. Static Load Testing with Truck Guided Along Wheel Path A**

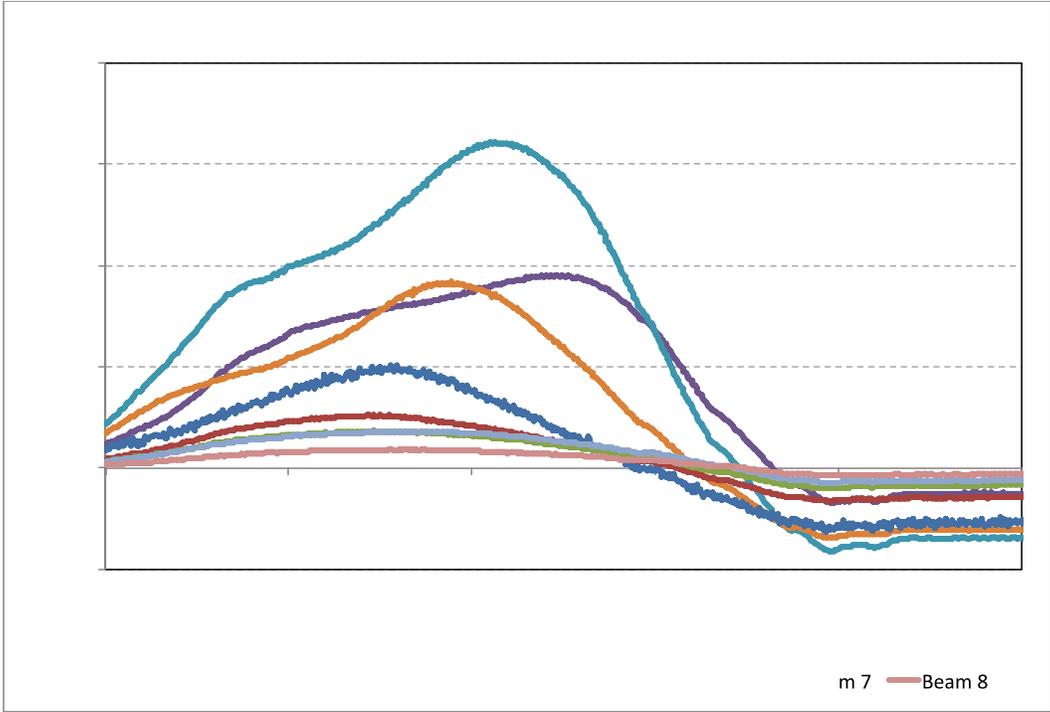
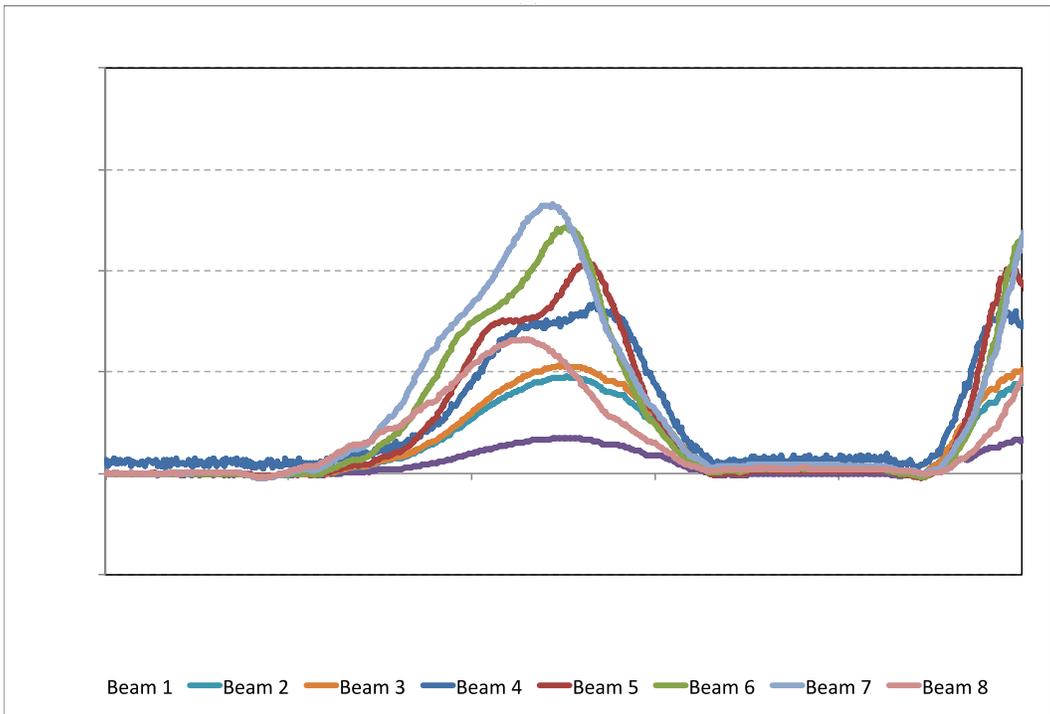
Figure 21. Time Series Strain Data (All Beams) – Static Loading (a) Load Case A1 and (b) Load Case F1

As previously highlighted, the most heavily loaded girders experience the greatest bottom flange strain and internal strain, while girders further away experience less. An interesting phenomenon observed through these strain profiles is the contribution provided by the parapet

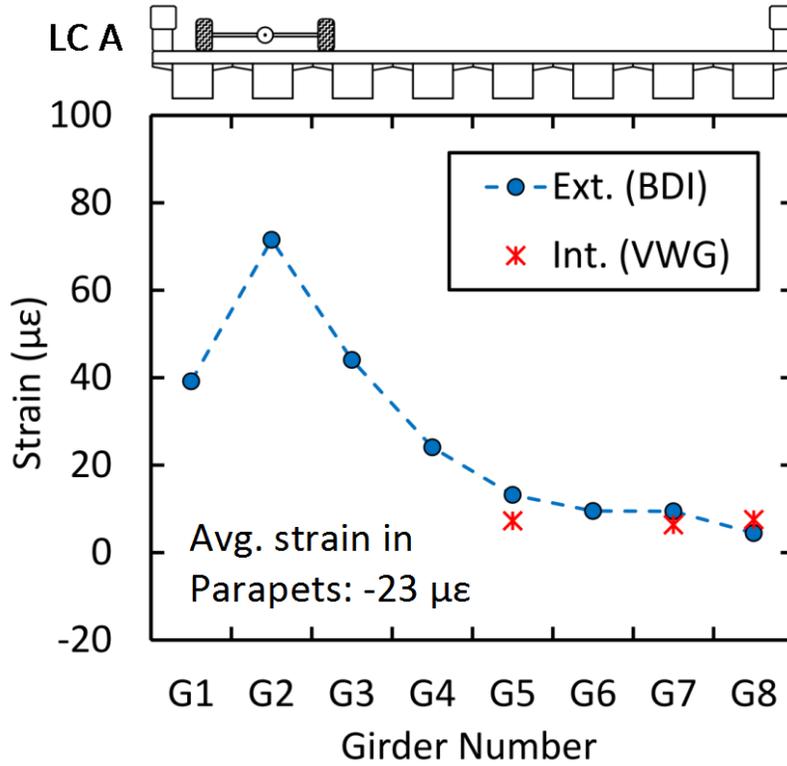
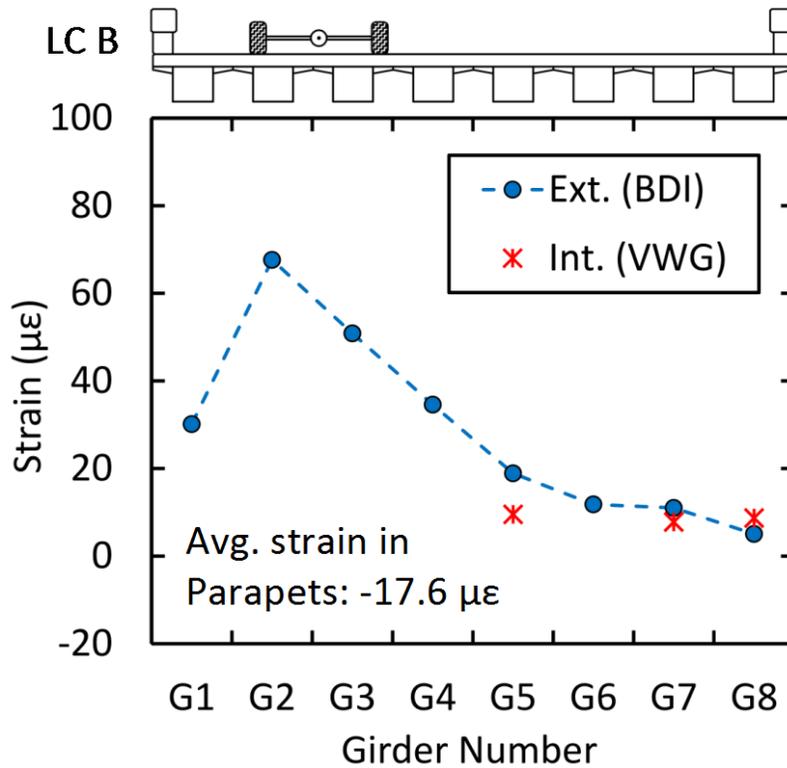
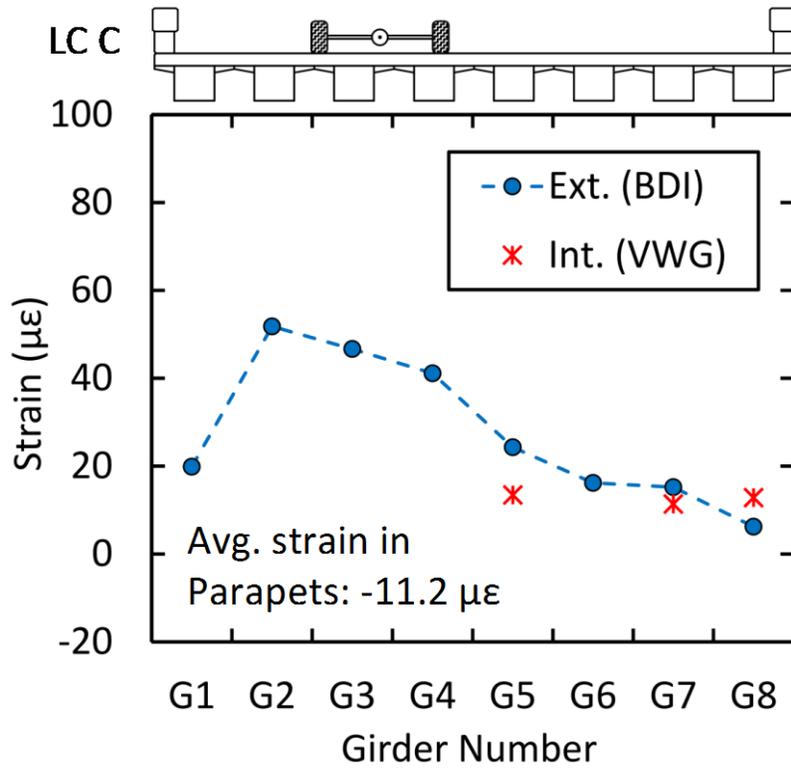
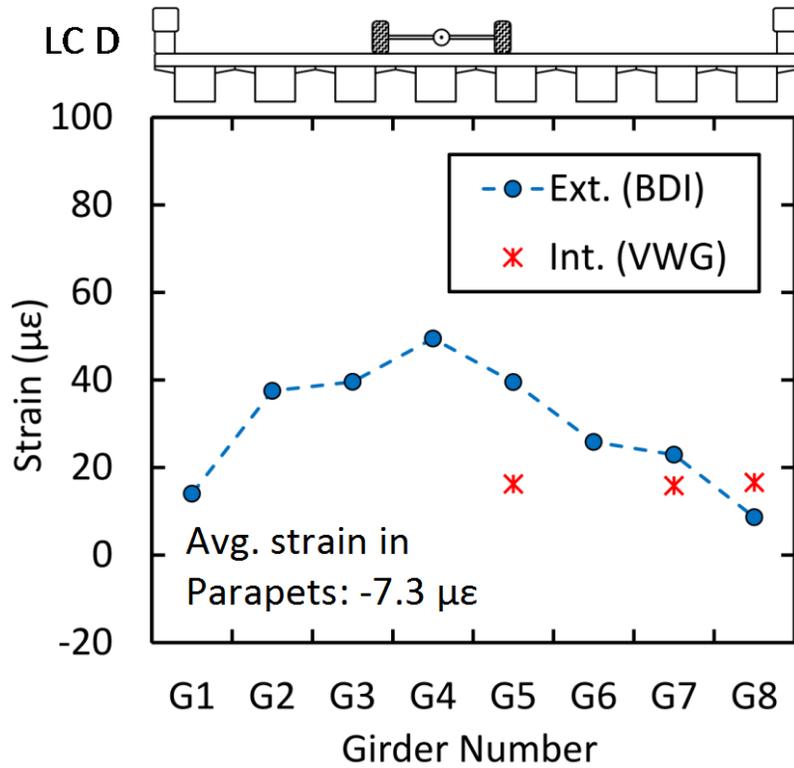
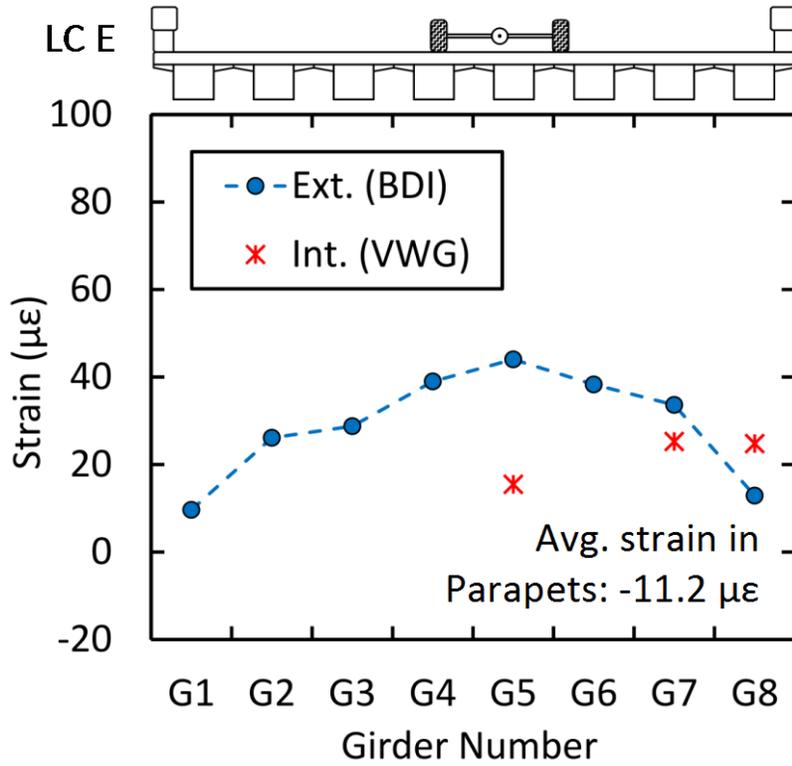
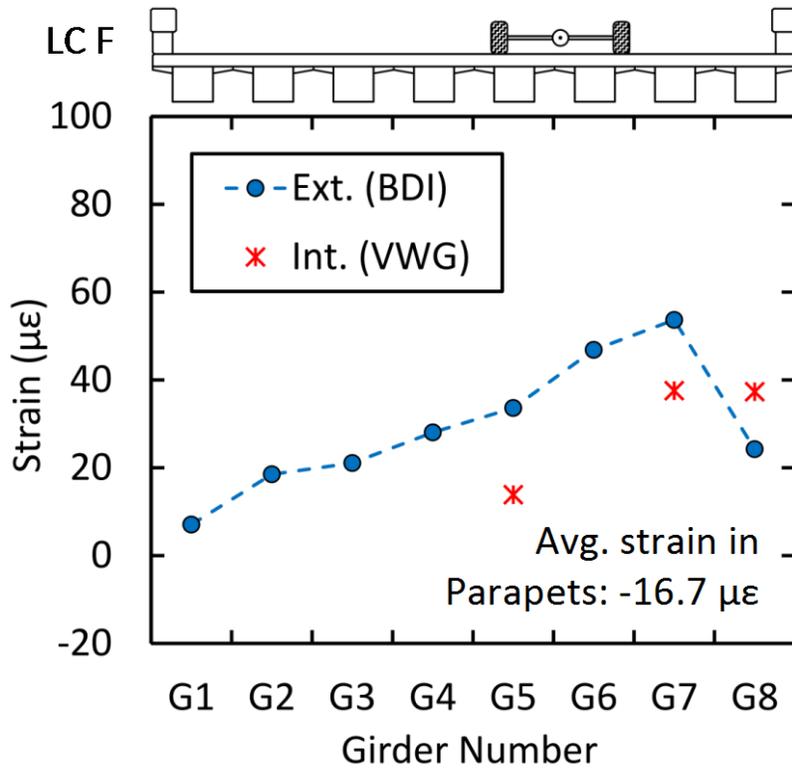
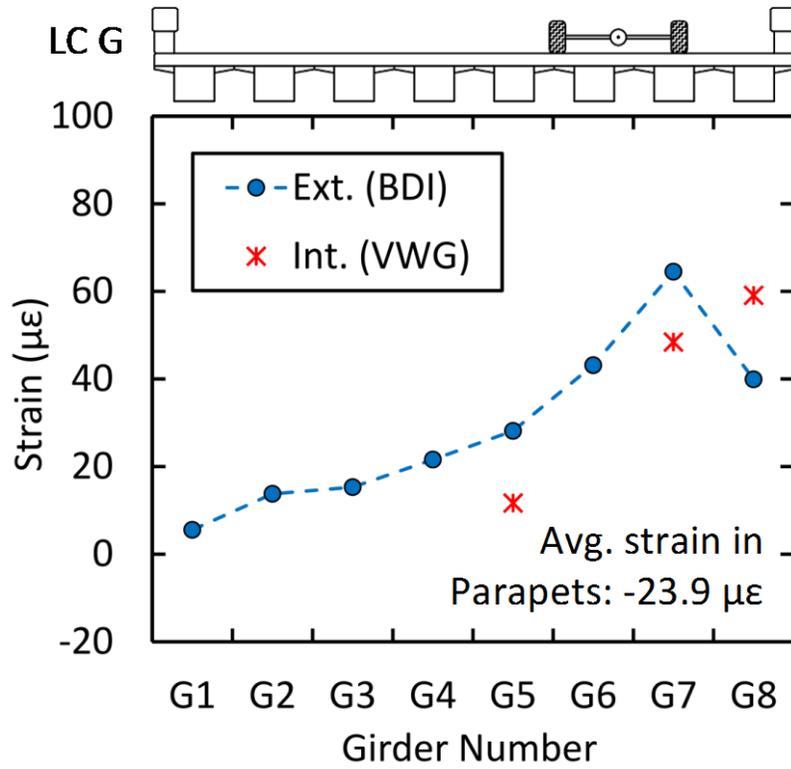
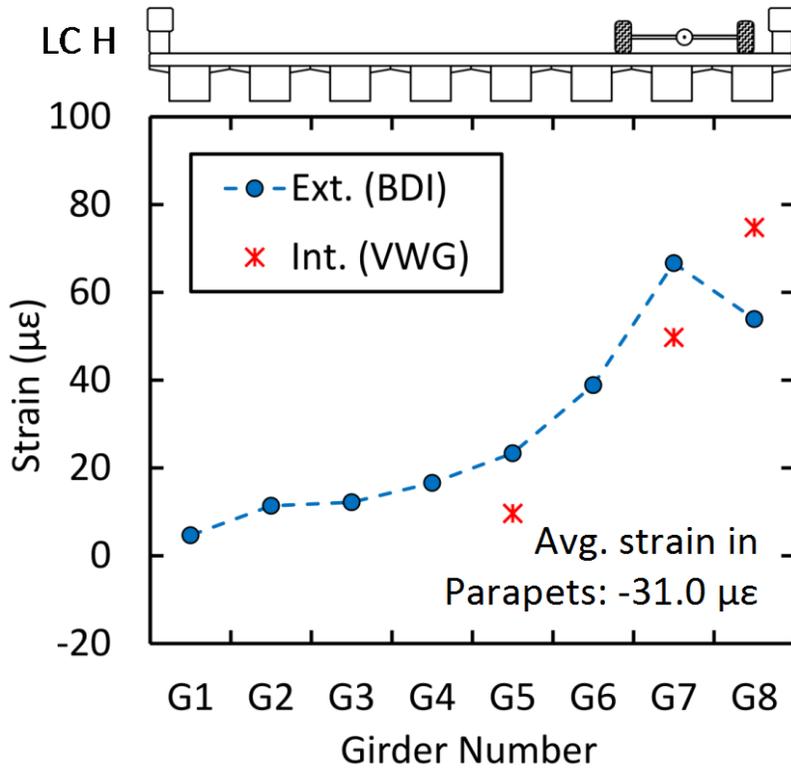
Figure 22. Tensile Zone Strain Across Cross-section (LC A)

Figure 23. Tensile Zone Strain Across Cross-section (LC B)

Figure 24. Tensile Zone Strain Across Cross-section (LC C)

Figure 25. Tensile Zone Strain Across Cross-section (LC D)

Figure 26. Tensile Zone Strain Across Cross-section (LC E)

Figure 27. Tensile Zone Strain Across Cross-section (LC F)

Figure 28. Tensile Zone Strain Across Cross-section (LC G)

Figure 29. Tensile Zone Strain Across Cross-section (LC H)

wall, which carry a fraction of the load, as evidenced by the decrease in strain in the exterior beams. In the Virginia Tech study, Ahsan (2012) observed a similar distribution response for the interior girder, but the exterior stiffening effects were not present due to the lack of parapets in those tests. It should also be noted that this phenomenon was not observed in the internal VWGs, likely due to the non-composite behavior between the internal and external beam components.

When comparing the strains observed on the exterior (BDI) with those measured internally (VWG), the VWG strains do not consistently match the same trend for lateral load distribution. The internal strain readings are consistently lower than the external FRP strains, with the exception of the fascia girder number 8. The cause of this non-correspondence is unknown, but may be attributed to the non-composite behavior of the HCB components, as discussed in the next section on element load sharing behavior. This non-composite behavior theory is also reinforced by an observation of the strains near the exterior of the bridge near the parapet walls where there is a lower stiffening effect on the internal tension strands than the FRP shell.

For the load-testing program, the controlling distribution factor for the interior girder resulted from Load Case A, while the controlling value for the exterior girder occurred for Load Case H. This exterior girder response highlighted the effect of the skewed configuration on the lateral load distribution behavior of the system. Despite the almost symmetric loading conditions (A compared to H) and symmetric cross section of the bridge, the skew caused the exterior girder to behave differently on opposite sides of the bridge, with lower exterior distribution factors measured for Load Case A. The interior distribution factors from the field test were slightly lower than the results from the study by Ahsan (2012), indicating a more uniform load sharing phenomenon than was found in the full-scale laboratory testing. This is not surprising considering the Tides Mill Stream Bridge had more beams amongst which to distribute the load. Furthermore, the measured exterior distribution factors were lower than the laboratory values, most likely due to the absence of the parapet walls in the preliminary study.

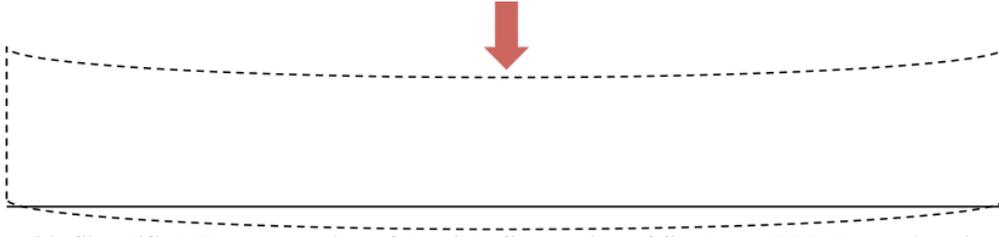
**Figure 30. Simplified Representation of Possible Separation of Steel and FRP Under Applied Load**

In contrast, the quarter-span location did not mimic the distribution responses at midspan. The quarter-span location exhibited some degree of counter-flexure, which was likely the result of a combination of plate action of the bridge system, skew, and boundary conditions. These results are not presented herein, but can be found in Civitillo (2014). However, the internal VWGs at the quarter spans did track the external strains much more closely than at the mid-span locations. While the internal strains still tended to be slightly lower than the external values, the discrepancy between the two gauges was seldom more than a few microstrain, suggesting that there was not as much slippage between the internal steel and external FRP shell. The reason for the difference in behavior at the two span locations is also unknown, as the load carrying elements were self-contained within the shell and not readily available for inspection. However, one possible theory is that the tension steel pulled away from the FRP shell at midspan because of the lack of support provided by the foam. In other words, as curvature developed in the beam during flexure, the tension steel may have pulled away from the FRP shell and remained as linear as possible in tension, while the curvature of the bottom flange of the FRP was enforced by the stiffness of the side webs tying into the remainder of the system and the curvature of the deck. A simplified diagram depicts this phenomenon in Figure 30; the dashed line represents the deflected beam shape. The solid line represents the tensile steel that may not follow the curvature of the beam due to lack of restraint. While the steel is embedded in the FRP, it is not restrained above by anything but a single layer of FRP and foam. A single extreme loading event may be enough to separate the steel from the FRP, and each subsequent loading would

exhibit this effect. Such a phenomenon would surely be accentuated at mid-span, where curvature of a traditional beam is maximized.
