# In-Service Performance Evaluation and Monitoring of a Hybrid Composite Beam Bridge System

Final Report VTRC 18-R5

**IN-SERVICE PERFORMANCE EVALUATION AND MONITORING OF A HYBRID  
COMPOSITE BEAM BRIDGE SYSTEM**

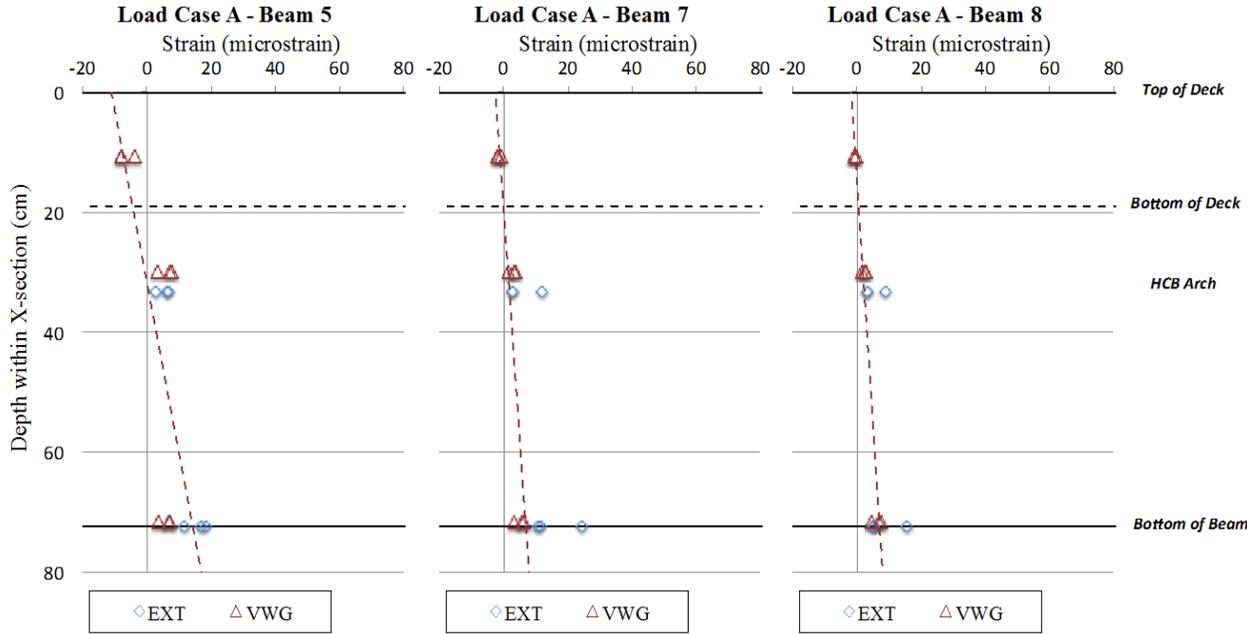
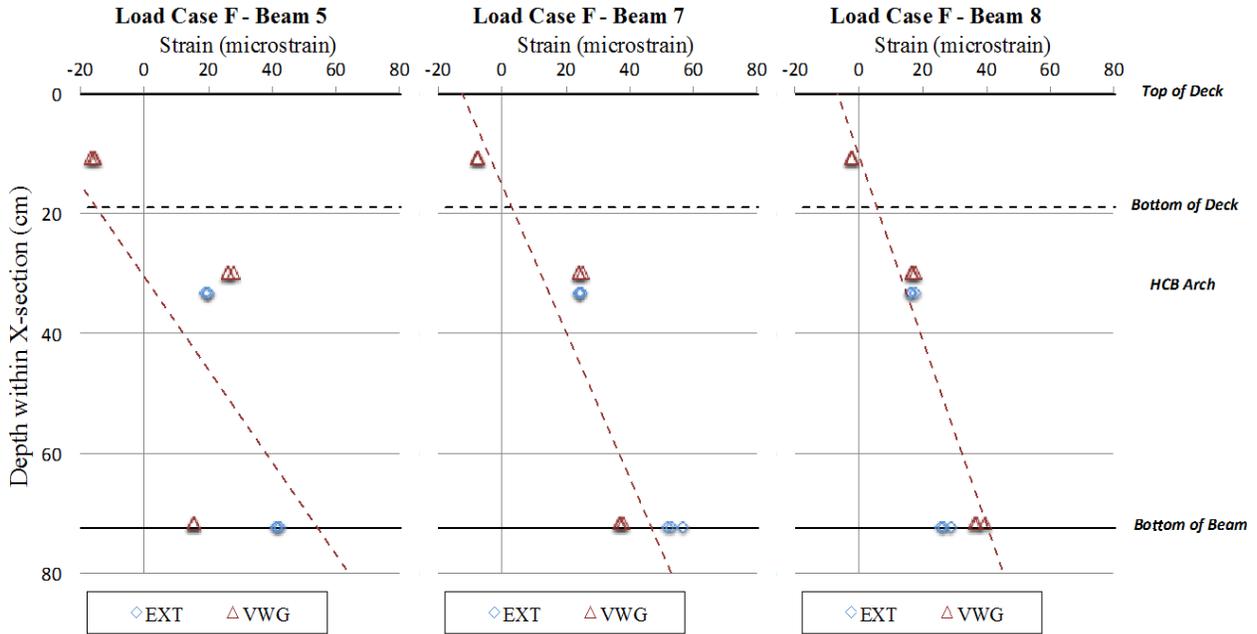
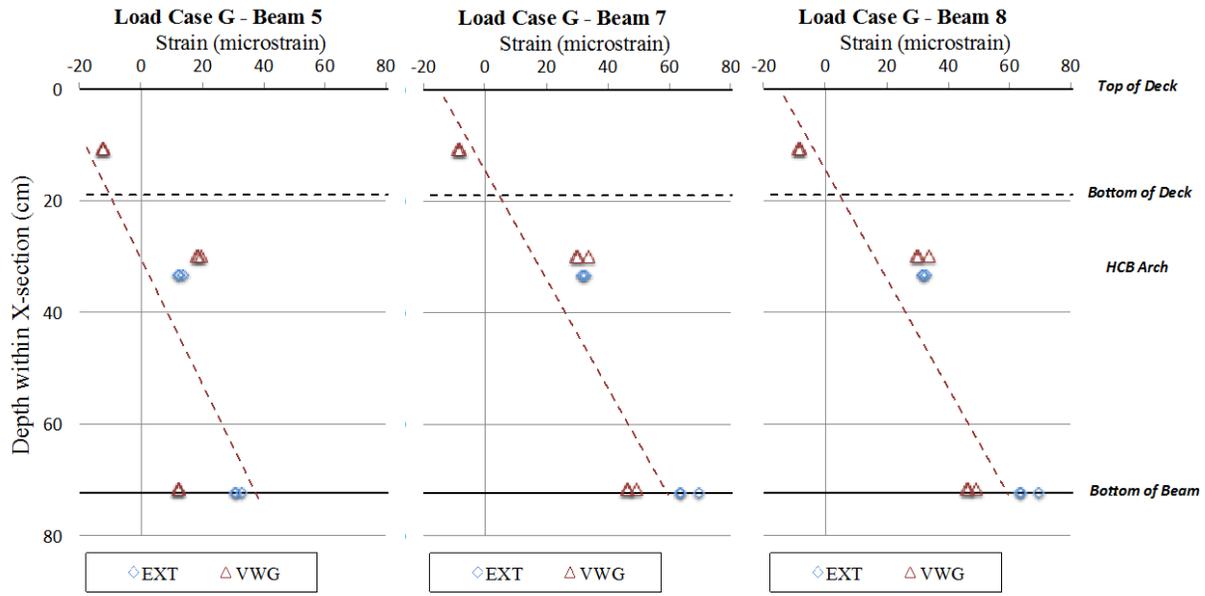
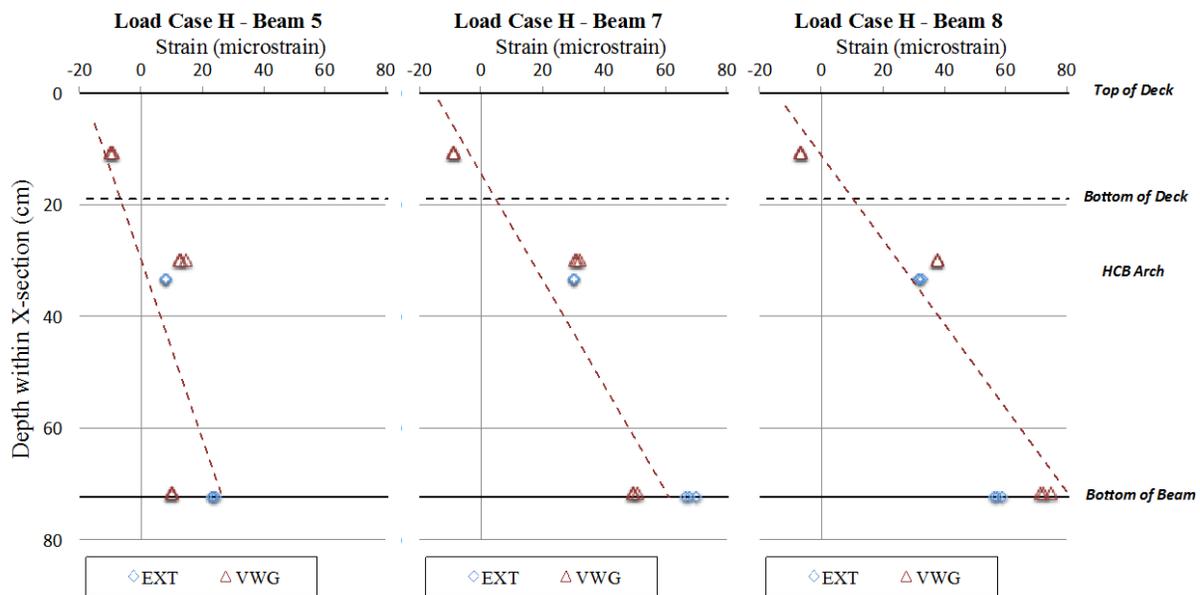
Figure 31. Mid-span Strain Profiles Load Case A

Figure 32. Mid-span Strain Profiles Load Case F

Figure 33. Mid-span Strain Profiles Load Case G

Figure 34. Mid-span Strain Profiles Load Case H

Figure 31 through Figure 34 illustrate the midspan strain profiles through the depth of the cross-section for beams 5, 7, and 8 subjected to Load Cases A, F, G, and H. Load Case A is presented merely for illustrative purposes, while Load Cases F, G, and H were selected because the load truck was in close proximity to the three girders that maintained both internal and external instrumentation through the depth of the beams, and thus yielded the most relevant results pertaining to the composite behavior of the HCB. The transition from positive strain at the tension steel to negative strain within the deck defined the location of the neutral axis, i.e. zero strain. The occurrence of the neutral axis varied for each of the load cases and it was difficult to define a consistent neutral axis location because the profile through the depth was not linear as might be expected for the design assumption of full composite action. As an example, the tensile strains in the arch section of Girder 5 exceeded those in the tensile strand level. At first it was surmised that the higher concentrations of strain were due to service load tensile cracking in the unreinforced arch concrete, solely intended for support during construction (Van Nosedall et al., 2013). However, after evaluation of the quarter-span strain profiles (Figure 35 through Figure 38), it appears that the two steel strands resting along the bottom of the arch profile, which were used to anchor the stirrups, may be carry significant levels of tension, despite their absence in design calculations. The VWG arch strains seen in the quarter-span plots (Figure 27) are in tension, well beyond the cracking strain of the arch concrete, yet the arch continues to carry the strain. Another potential source of this discrepancy in the neutral axis location is the occurrence of slip between the concrete deck and the HCBs; however, this phenomenon could not be discerned from the available data.

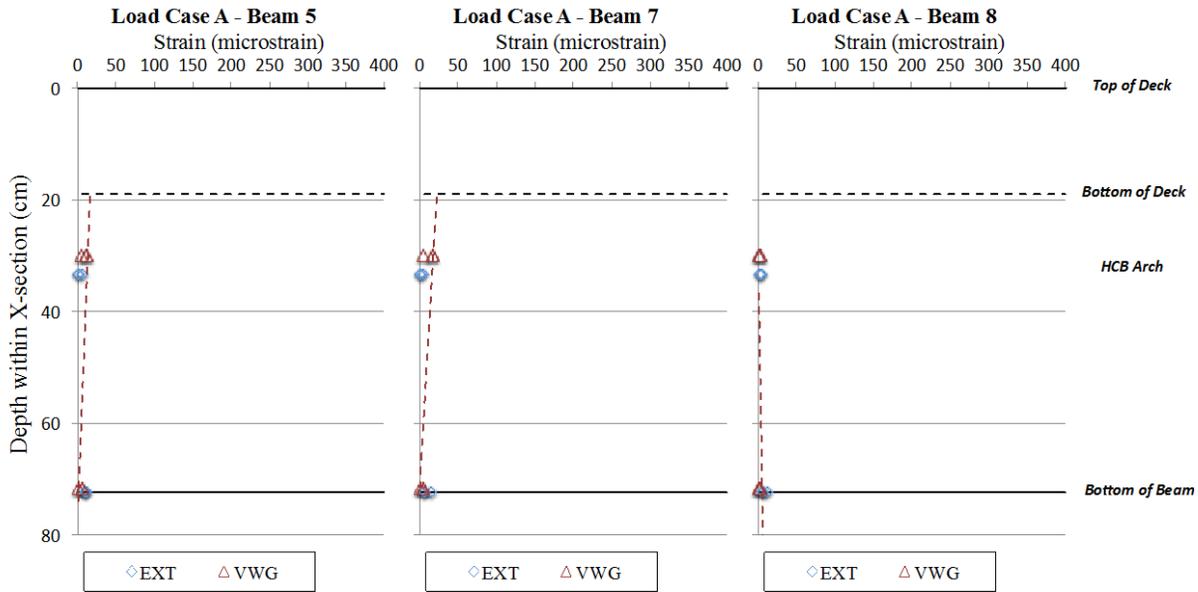
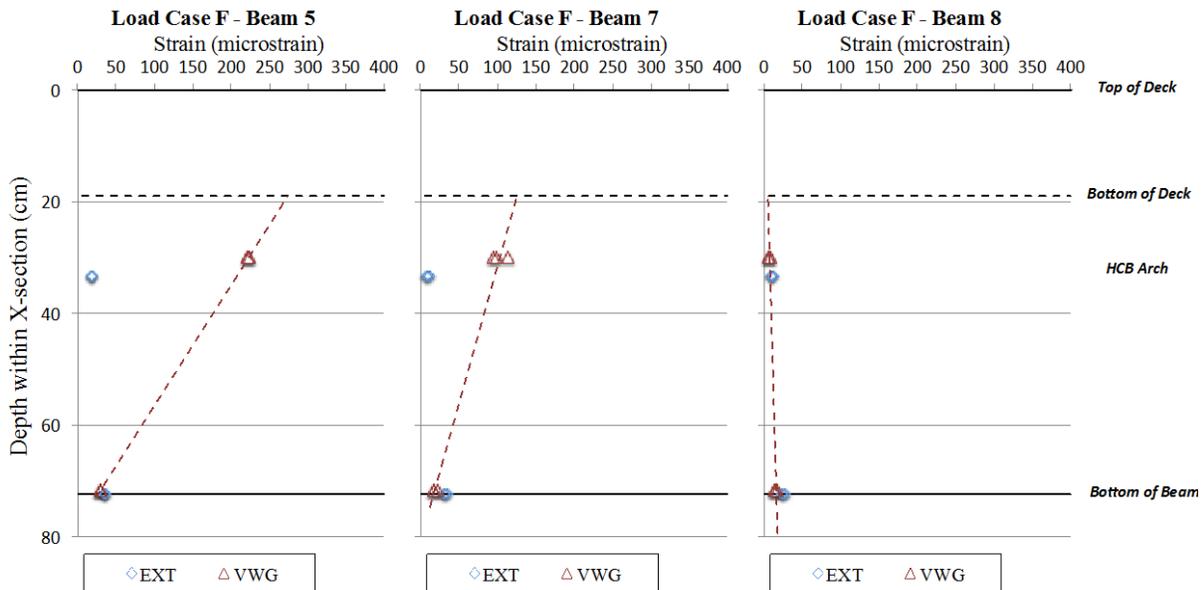
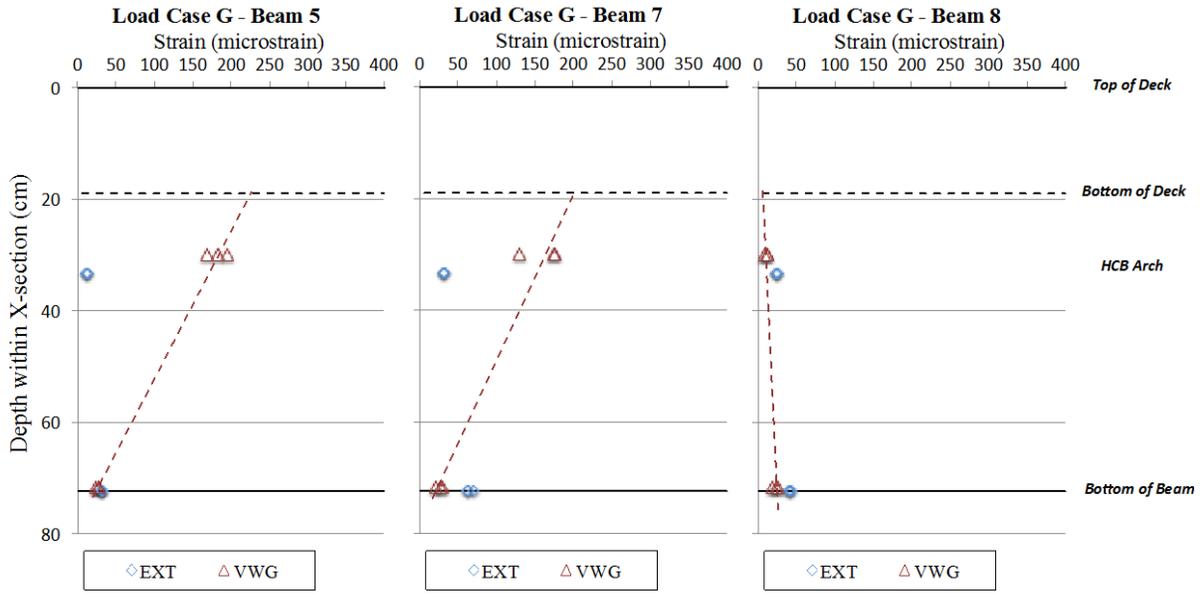
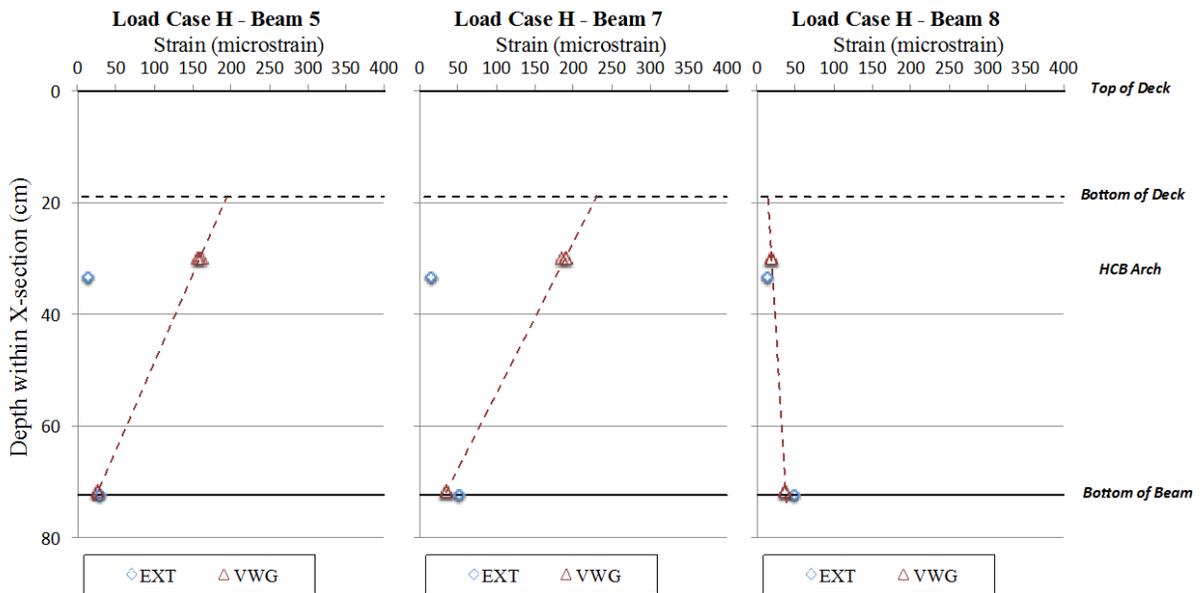
Figure 35. Quarter-span Strain Profiles Load Case A

Figure 36. Quarter-span Strain Profiles Load Case F

Figure 37. Quarter-span Strain Profiles Load Case G

Figure 38. Quarter-span Strain Profiles Load Case H

Rather than cracking in the arch, Ahsan (2012) hypothesized that there exists a local bending phenomenon within the concrete arch. As illustrated in Figure 3, it can be rationalized that the arch would be able to experience bending, especially at higher levels of overall HCB curvature where the arch begins to flatten out. Ahsan also proposed that this effect is dampened at mid-span due to the 8 ft sheet of FRP that serves as the bottom formwork for the arch, which also likely provides stiffening to the arch. This FRP sheet that forms an enclosure for the arch at this location also connects to either FRP web and thus enforces greater congruence with the FRP curvature and overall HCB response at mid-span. The data collected in this experimental program aligned with the hypothesis, as the quarter-span arch gauges of Beams 5 and 7

experienced uncharacteristically high levels of tensile strain, often greater than the maximum tensile strain in the bottom flange of mid-span girders. Beam 8 did not exhibit such an accentuated trend, but this was likely caused by the stiffening effect of the parapet in combination with the additional steel (nearly double that in the interior girders) added to the tension zone of the exterior girders. These exterior beams were likely stiff enough to minimize beam curvature, and the local bending effects in the arch were therefore not as evident.

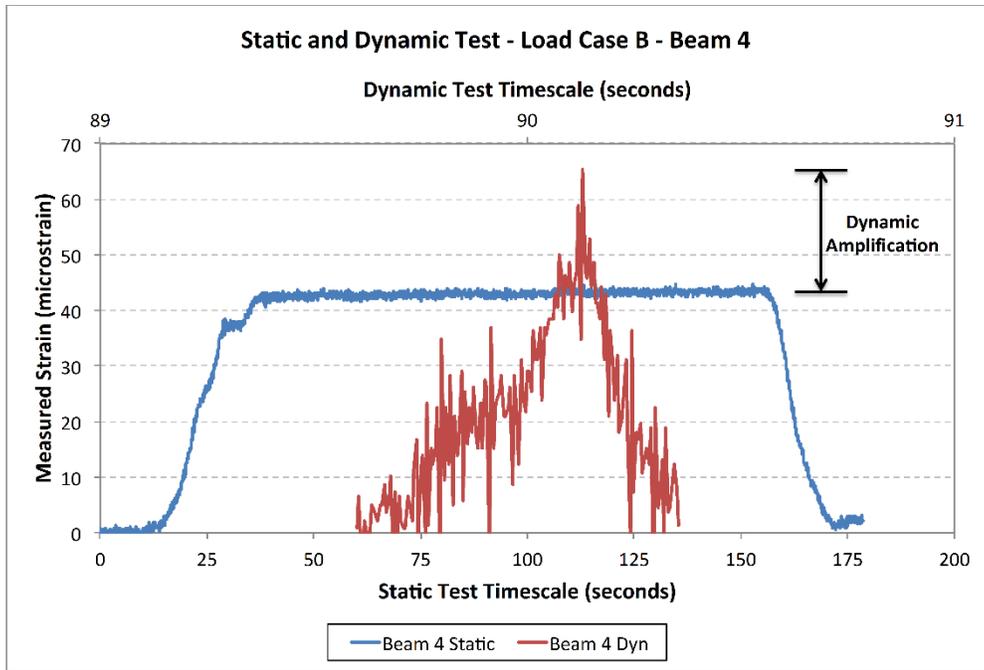
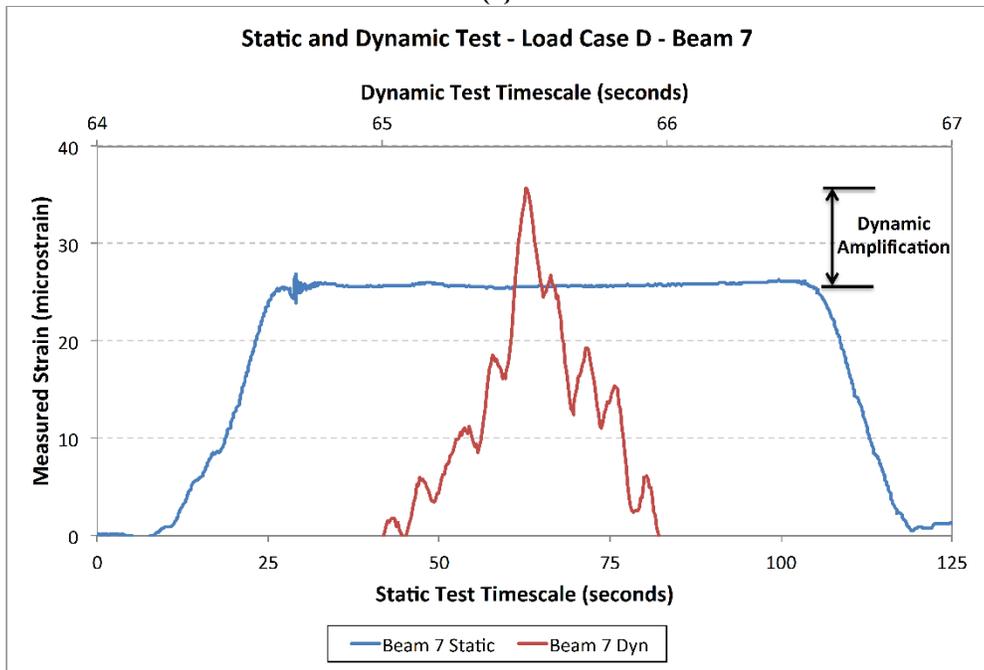
Figure 39. Maximum Dynamic Amplification Response (a) Load Case B and (b) Load Case D

The controlling or maximum dynamic amplification response for each of the two load truck positions tested under dynamic conditions is presented in Table 4 along with the design values from the AASHTO LRFD and Standard Specification (AASHTO, 2002; AASHTO, 2012). These measured values represent the amplification observed in the most heavily loaded girders for the respective load cases. The table shows that the average dynamic amplification was comparable to those prescribed by AASHTO, but there is the potential for larger amplification as demonstrated by the maximum responses observed in the most heavily loaded girders, as much as 46% compared to the AASHTO LRFD value of 33%. In the maximum dynamic amplification cases shown, the maximum response registered in Beam 4 for Load Case B was 46%, while a response of 33% was registered in Beam 7 for load case D.

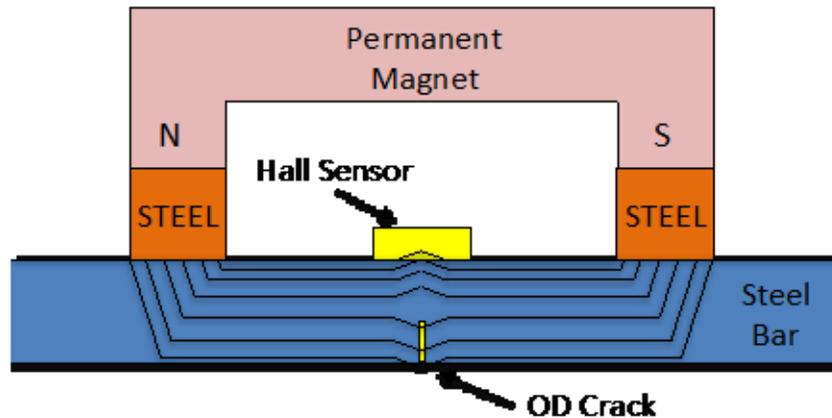
Figure 40. Magnetic Flux Leakage Theory. Adapted from Civitillo (2014).

Magnetic flux leakage (MFL) provides a quantitative analysis of potential discontinuities of steel, that is, any reductions in cross-section or breaks in individual wires in a given strand. The benefit of this method is the ability of a magnetic field to penetrate materials that are not ferromagnetic, such as concrete or FRP. Magnetic flux leakage inspection involves saturating the ferromagnetic material, in this case high-strength steel, with a magnetic field that would flow longitudinally along a steel component that exhibits no defects or flaws. The theory behind the method is that any defects, be they cracks or loss of section due to corrosion, will cause a disturbance in the magnetic field, requiring that the magnetic flux detour around the defect. If the flaw is significant enough, the magnetic field will protrude beyond the boundaries of the steel, and in this case, even the FRP coating. Hall sensors are able to detect and quantify these deviations in the magnetic field (Figure 40). The method is able to detect very minute surface discontinuities that may be quantified in volume and depth. MFL has been used in a variety of applications and has been standardized.
