# Evaluation of Repair Techniques for Impact-Damaged Prestressed Beams

Final Report VTRC 18-R8

**EVALUATION OF REPAIR TECHNIQUES FOR IMPACT-DAMAGED  
PRESTRESSED BEAMS**

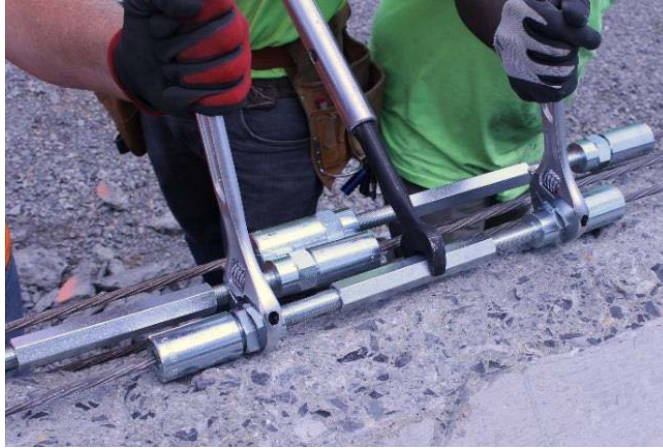
**Figure 1. Installation of Splice Chucks**

Commercially available strand splice systems utilize a reverse thread coupler connected to threaded anchors on each end. Figure 1 shows Grabb-it Splice Chucks used in this study. A prestress force in the strand is introduced by turning the coupler, which moves the anchors

toward each other. These splices re-tension the strand to 60-80% of the ultimate tensile strength of the undamaged strand. It is recommended to re-tension the strands to a value close to the long-term effective prestress of undamaged strands (Harries et al., 2012). Research has shown that splices restore 85-96% of the original tensile strength of the strand (Zobel et al., 1997).

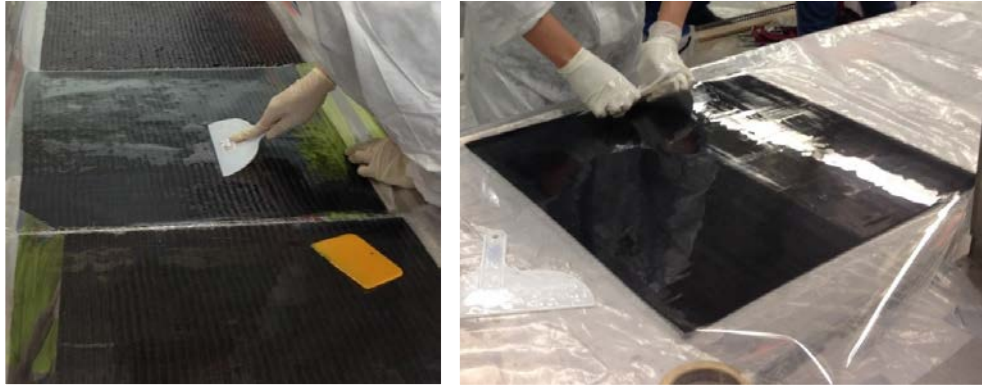
**Figure 7. FRP Panel Fabrication**

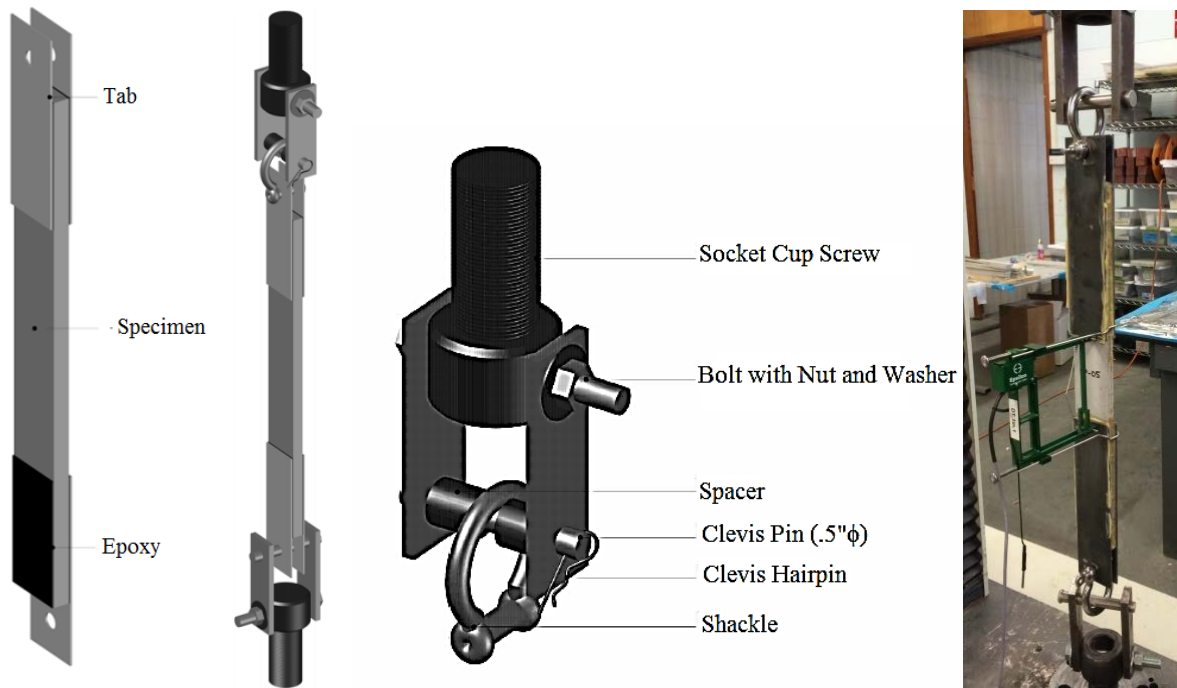
**Figure 10. Specimen Test Setup With Clevis Grips and Extensometer**

All specimens were conditioned prior testing under laboratory ambient conditions at room temperature  $73 \pm 6^\circ\text{F}$  and  $60 \pm 5\%$  relative humidity, for at least 28 days. Uniaxial tension load was applied to the tensile coupons. Testing was performed using a screw-driven Instron Universal Test Frame with a maximum capacity of 30 kips. Axial deformation was measured using a clip-on extensometer with a 4-in gauge length, placed mid-length of the specimen. The gripping mechanism was a clevis-type connection on one end and a double-clevis connection on the other end (see Figure 10).

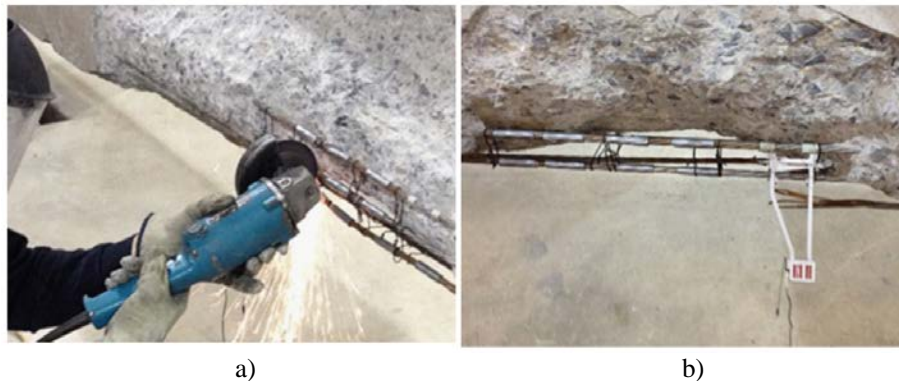
**Figure 11. a) Electric Grinder Cutting a Strand and b) Extensometer to Measure Length Change**

Tests were conducted to determine the effective prestress of the strands in Beam D. Eight strands needed to be severed as part of the damage process. Six of these strands were monitored during cutting to evaluate effective prestress. The strands were cut with an electric grinder with a steel-cutting blade, as shown in Figure 11a, and an extensometer was used to measure the change in length of the strand when cut, as shown in Figure 11b. Wire ties were utilized to reduce vibration and help to keep the strand in place as it was being cut, and duct tape was placed near the location of the saw cut to prevent unraveling of the strand.

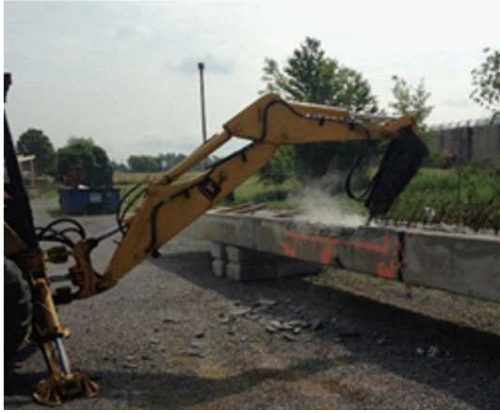
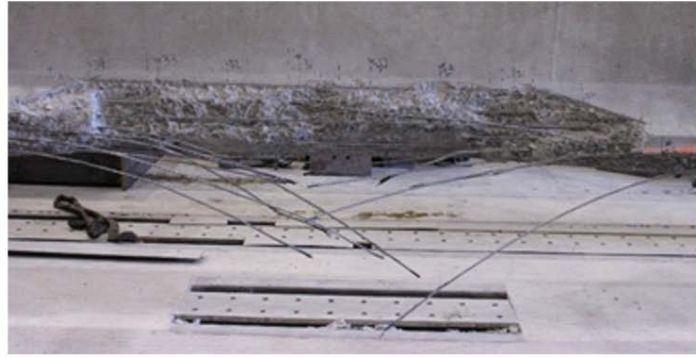
**Figure 14. a) Damaging Beam B with Hydraulic Hammer and b) Damage Location of Beam B Before Repair**

Beam B was a 60-ft-long beam that was damaged at the midspan and repaired using the strand splice method. The applied damage consisted of removing 8 ft of concrete, approximately 4 ft on either side of midspan, and severing eight prestressing strands. The damage location is shown in Figure 12, and a cross section view showing the severed strands is shown in Figure 13. The length of the damage area was chosen to be 8 ft, based on the average width of a semi-trailer (YRC Worldwide, 2015). To damage the girder, it was set on its side and struck with a hydraulic hammer attached to a backhoe, as shown in Figure 14a. After the rough damage was inflicted by the jack hammer, the edges of the repair area were saw cut to a depth of at least 1.0 in to create a defined edge to the repair area. Additional concrete was chipped out from around exposed strands to allow for placement of the splice chucks and to create space for the repair mortar to flow around the strands (see Figure 14b).

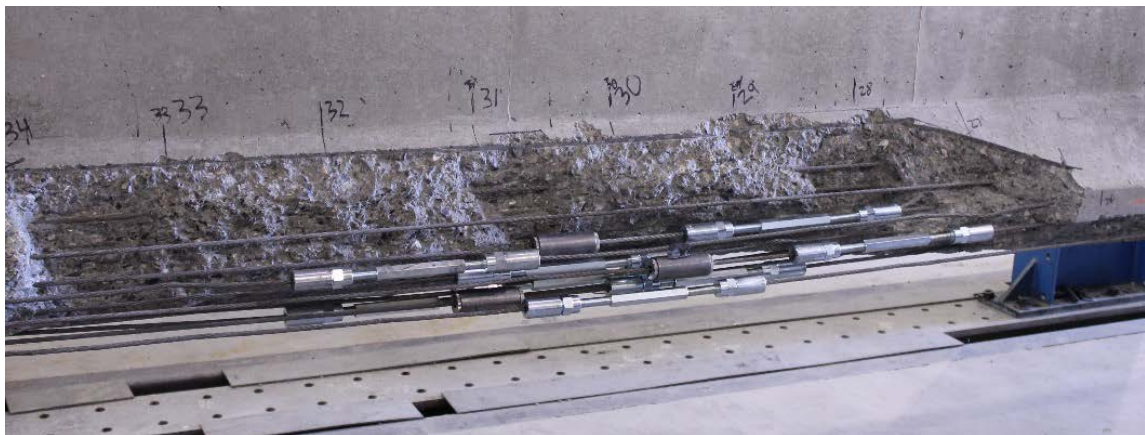
**Figure 15. Completed Installation of Strand Splices**

Repair was performed by Structural Technologies. Strands were spliced and splices were tightened with a torque wrench to 80% of minimum ultimate tensile strength of the strand, based on information provided by the splice manufacturer (Prestress Supply Incorporated, 2010) (see Table 4). After the splices were installed and tightened, the damaged concrete was repaired using a high-strength, quick-cure mortar. Detailed repair procedures can be found in Jones (2015). The repair was performed in two days by three Structural Technologies workers. Figure 15, Figure 16, and Figure 17 show the progress of the repair, including installation of the strand splice, formwork for the concrete placement, and the beam after removal of the formwork.

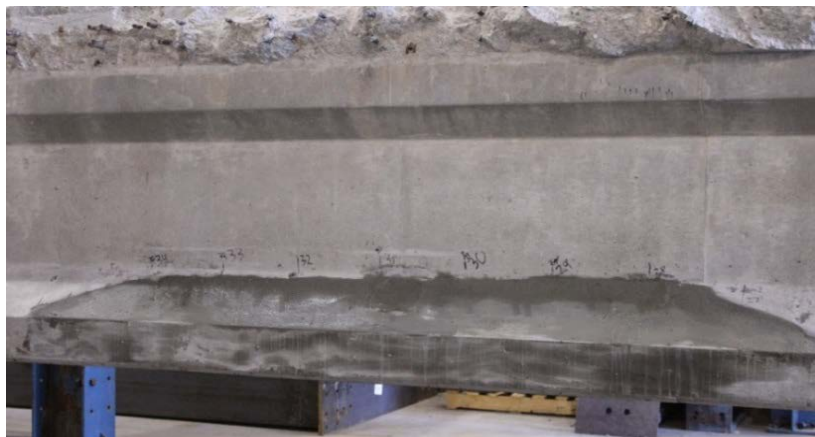
**Figure 17. Completed Repair After Form Removal**

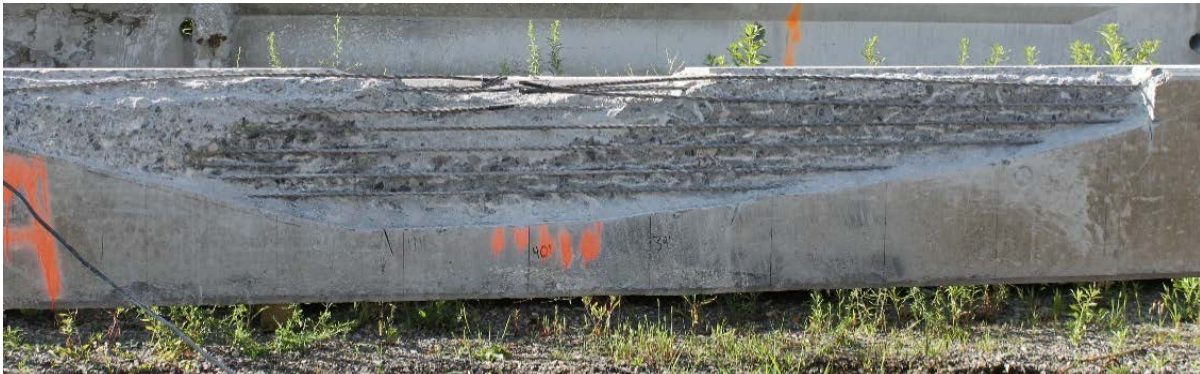
**Figure 20. Damage Location for Test 4 Before Repair**

splice repair on Beam B, was performed in two days by three Structural Technologies workers. Figure 20 and Figure 21 show the progress of the repair, including the prepared repair area, installation of the strand splices and repair area after removal of formwork.

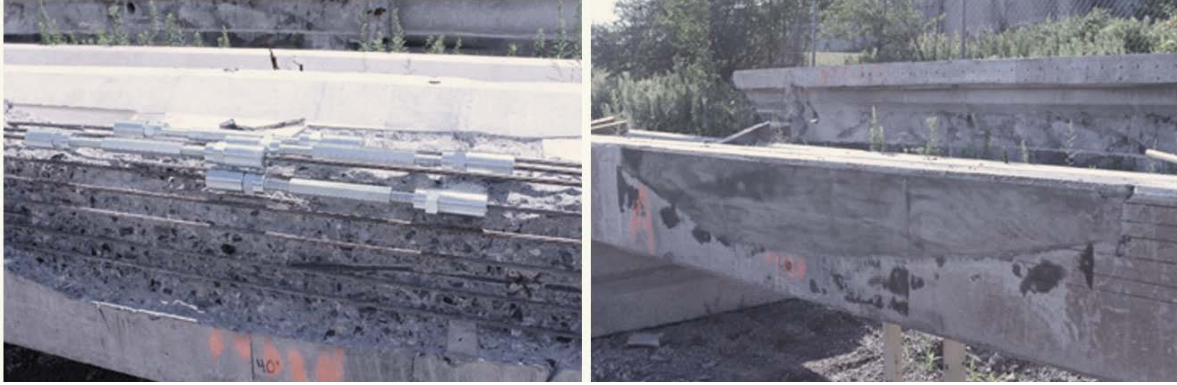
**Figure 21. Completed Installation of the Strand Splices and Beam after Form Removal**

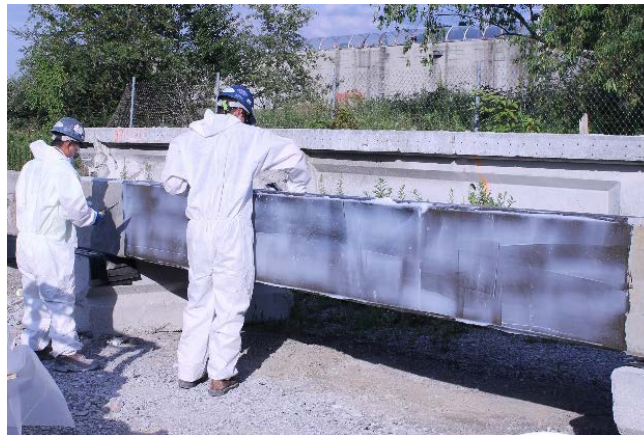
**Figure 22. Spreading Putty Over Area of Beam to Be Repaired**

hammer tap test (sounding) was conducted to make sure that there was sufficient bond between the repair mortar and the original beam concrete. Next, the surface was prepared for the FRP. This included making sure there were not any raised sections or inconsistencies from the formwork. In addition, corners where the fabric was going to be applied were rounded to a minimum of a 0.5-in radius. This was to ensure that there were not any locations that could result in voids, damage, or increased stress in the fabric. Because the FRP system is a contact-critical system, a grinder was then used to roughen the surface of the concrete to the aggregate level. After the surface was prepared, the resin was mixed and applied to the substrate surface as a primer. After the primer was applied to the beam, a resin putty mixture was applied to fill in any voids on the surface of the girder and create as smooth a surface as possible to which the fabric would bond (see Figure 22).

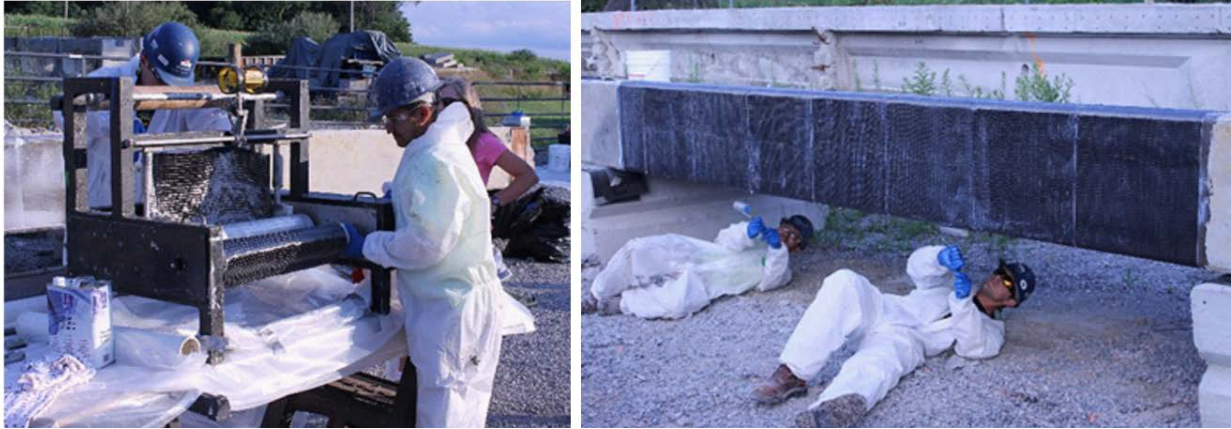
**Figure 23. FRP Saturation Process and Rolling of FRP Fabric to Ensure Bond to Concrete**

After the first layer of fabric was installed, an additional layer of putty was spread across the sheet and the second layer of fabric was saturated, pressed, and rolled onto the bottom of the beam. This resulted in the primary longitudinal fabric being two layers of C400 FRP, each 16 ft long. A third layer of putty was applied and FRP sheets were saturated and installed in the

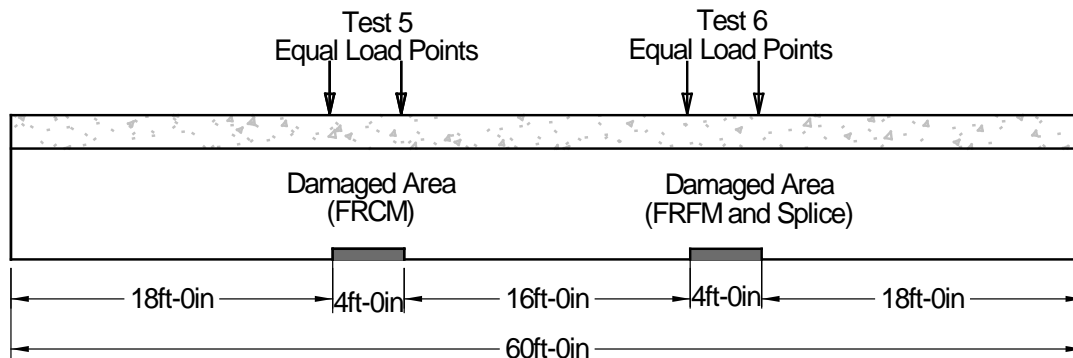
**Figure 24. Beam D Damage Locations**

Beam D, a 60-ft-long girder, was damaged for approximately 4 ft of length at the one-third and two-thirds points along the length of the girder. Four of the 48 prestressed strands in the bottom flange of the girder were severed at each of the two damage locations, identical to those in Beam C (see Figure 19). Figure 24 shows the damage locations along the length of the beam. The damage was inflicted in the same way as for the previous beam. Before repairs, at least 1 in of concrete was chipped throughout the repair surface to create a clean edge to the repair (see Figure 25). At one location, strand splice chucks were used to reconnect the severed strands. At the other location, the severed strands were held in position by reconnecting them with a short length of No. 4 reinforcing bar. Both locations were then repaired with FRCM.

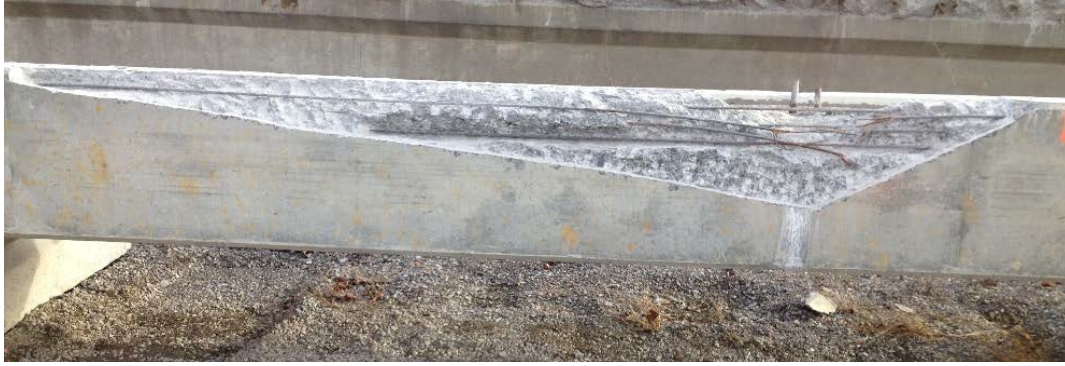
**Figure 25. Beam D After Chipping and Saw Cutting**

The repairs on Beam D were also performed by Structural Technologies. The repair at both of the damage locations was done using a repair mortar, a mesh and a matrix mortar. After the concrete patch was placed and allowed to cure in the same fashion as the other repairs, the FRCM was installed. The concrete patch repair, in addition to the strand splice and patch repair in Test 6, was performed in two days by two Structural Technologies workers. Surface preparation is extremely important, and several hours were spent grinding the concrete substrate.

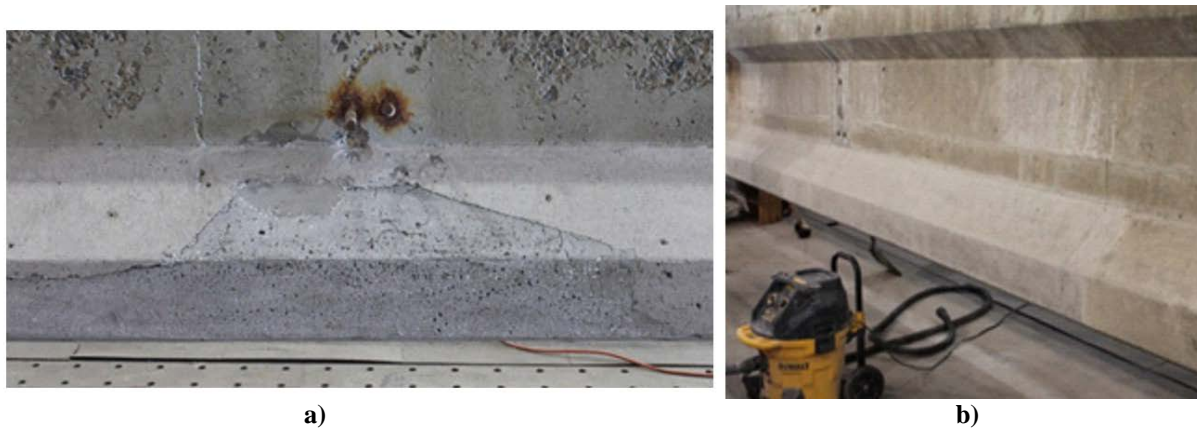
**Figure 26. Repair Location a) After Formwork Removal and b) After FRCM Surface Preparation**

Figure 26a shows the surface after the formwork was removed at one of the locations, and Figure 26b shows the surface after the grinding operation.

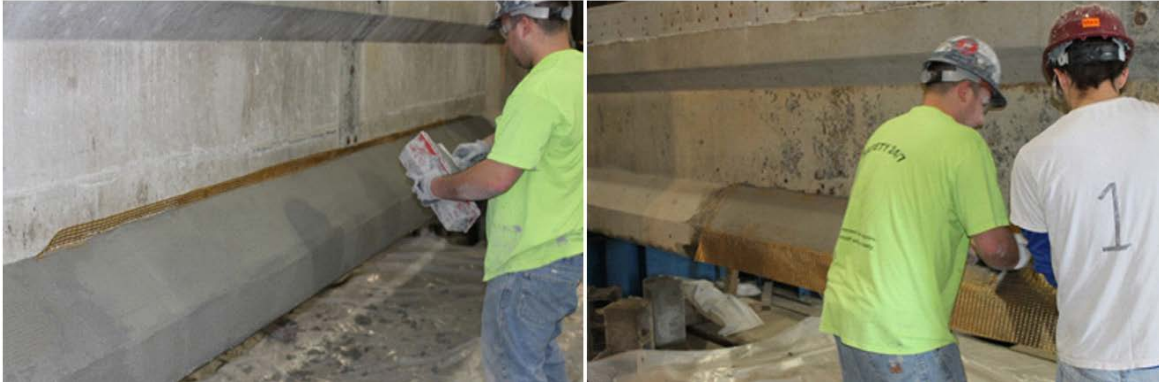
**Figure 27. Trowling Mortar Over a Layer of Mesh and Pressing Mesh Into Layer of Mortar**

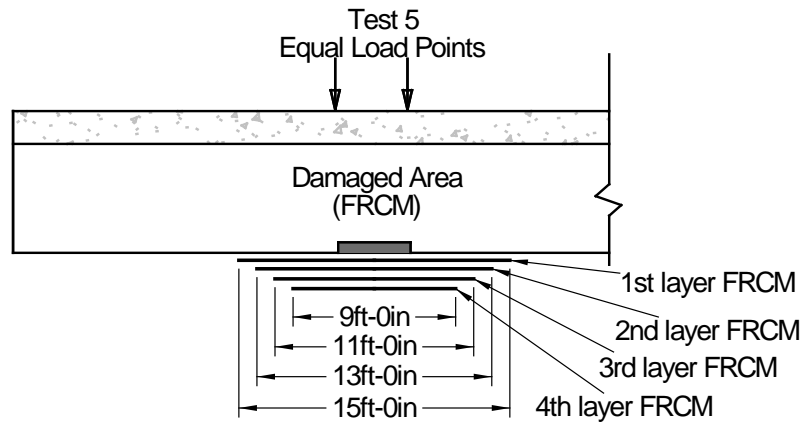
**Figure 28. FRCM Repair Sequence at Both Damage Locations on Beam D**

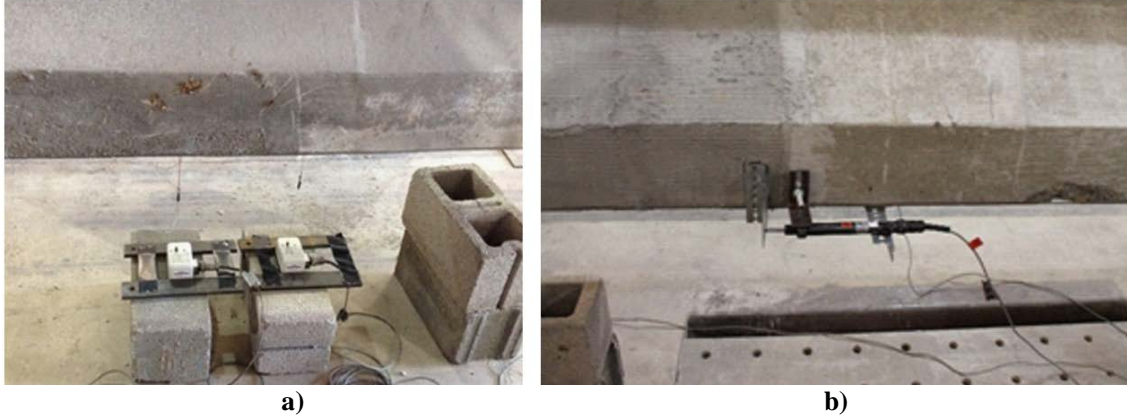
**Figure 29. Measurement of a) Displacement Using Wire Potentiometers Below Load Point, b) Slip Between Beam and FRCM Repair Material Using LVDT**

<b>Instrument</b>	<b>Measurement</b>	<b>Calibration Precision</b>	<b>Figure</b>
Wire Potentiometers	beam vertical and horizontal deflection	0.001 in	29 and 30
Linear variable differential transformer (LVDT)	Slip between repair material and beam concrete and longitudinal deformation of beam	0.001 in	29 and 31
Mini linear variable differential transformer (MLVDT)	Longitudinal deformation near bottom of beam	0.001 in	30
500 kip load cell	Load applied by hydraulic actuator	200 lb	30
Bridge Diagnostic Inc. (BDI) strain transducers	Longitudinal strain through depth of beam below point of applied load	1 $\mu\epsilon$	31

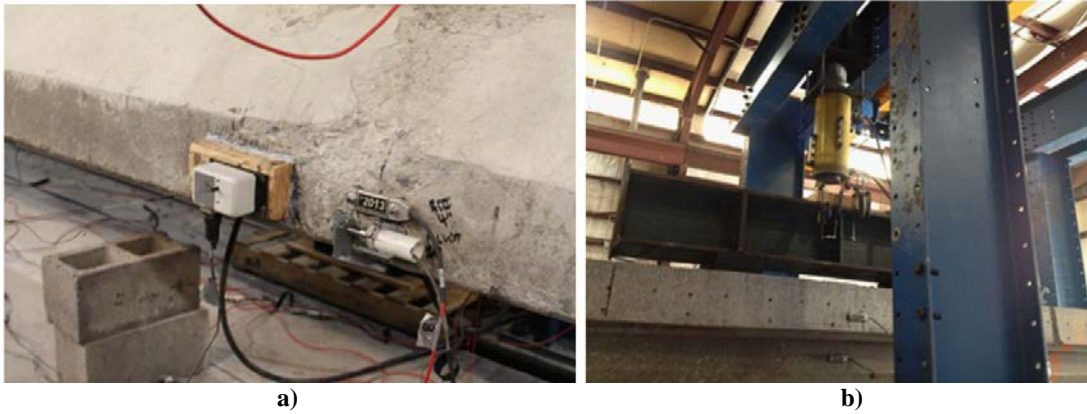
**Figure 30. a) MLVDT, Strain Transducer, and Potentiometer, b) Load Cell, Actuator, Spreader Beam, and Rubber Bearing Pads**

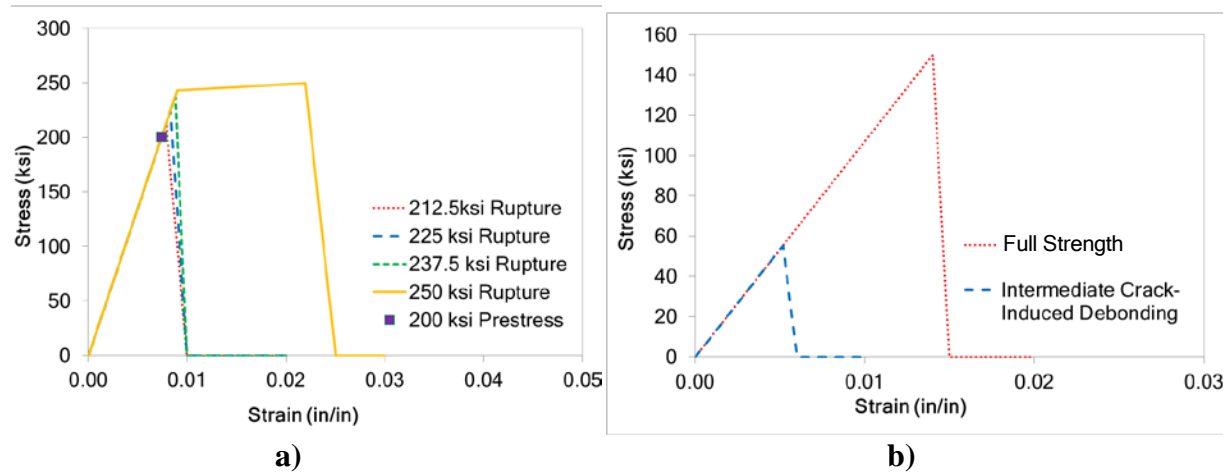
**Figure 44. Uniaxial Material Laws for Retrofit Materials: a) Spliced Strand Stress-Strain Curves Corresponding to Different Levels of Splice Failure and b) FRP Overlay Stress-Strain Curves Corresponding to Full Fiber Strength and to Debonding**

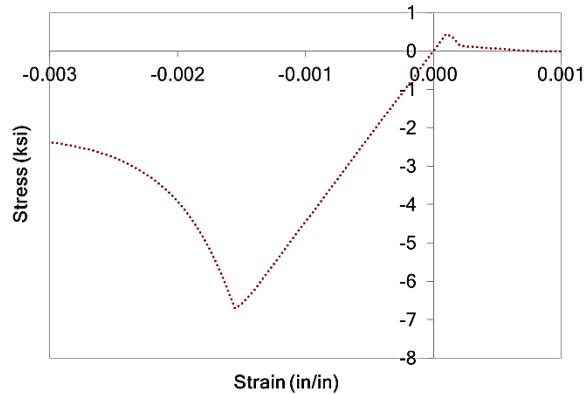
**Figure 47. Concrete Material Uniaxial Stress-Strain for Continuum-Based FE Models**

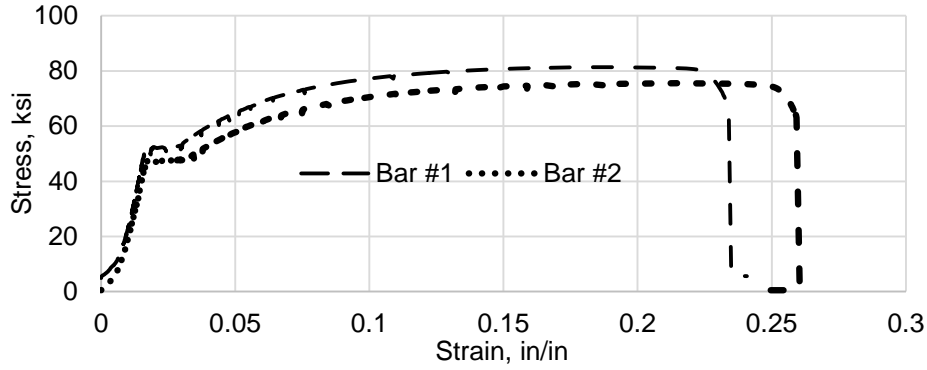
Figure 48. Reinforcing Bar Stress-Strain Relationship

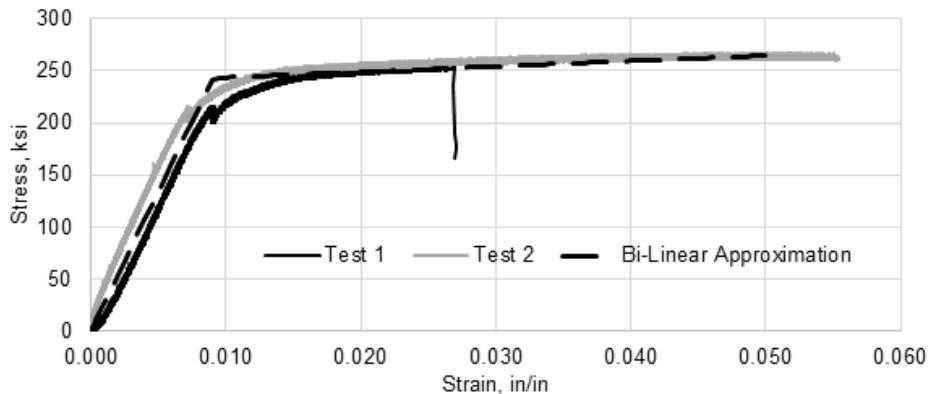
Figure 49. Prestress Steel Stress-Strain Relationship (Gangi, 2015)

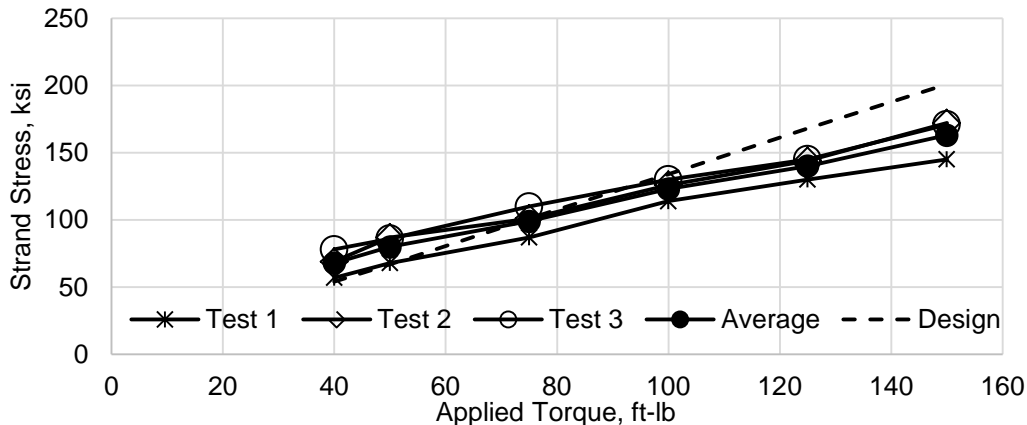
**Figure 51. Strand Splice Torque-Tension Relationship**

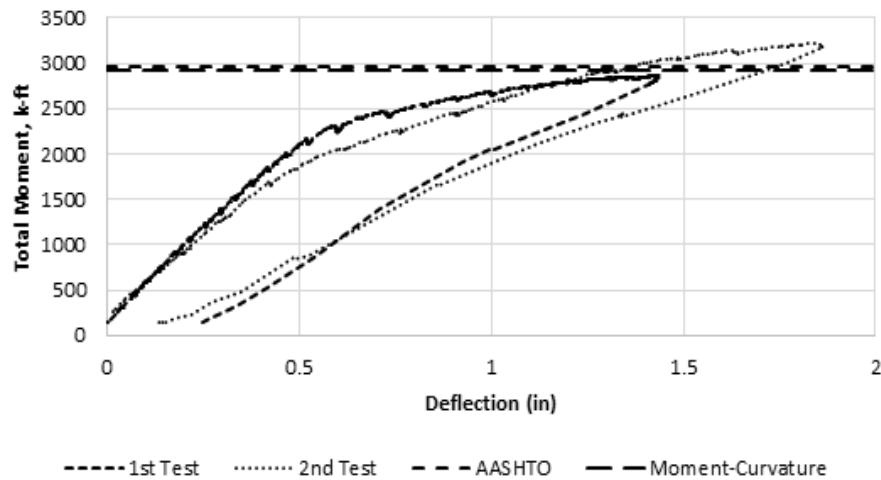
Figure 52. Test 1 Moment Versus Deflection Behavior

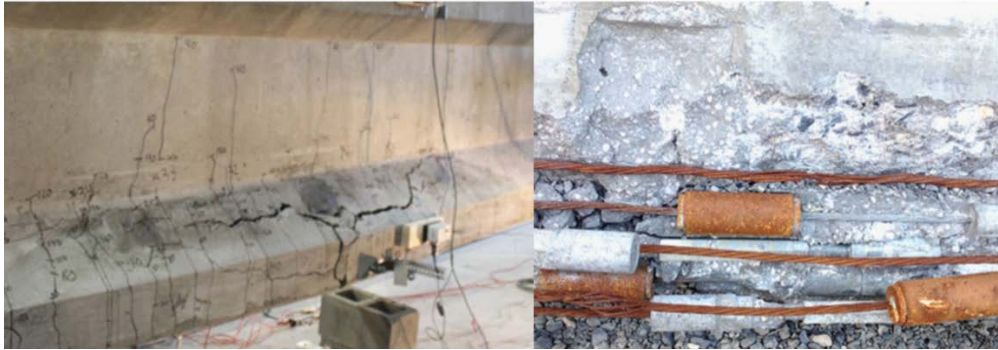
Figure 53. Flexural Cracks in Patch Concrete at Failure (left) and Failed Splices and Strands (right)

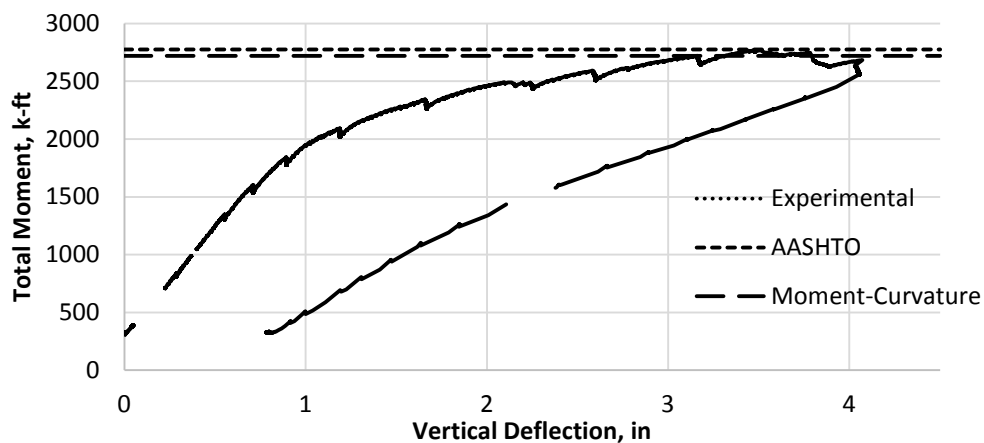
Figure 54. Test 2 Moment Versus Deflection Behavior

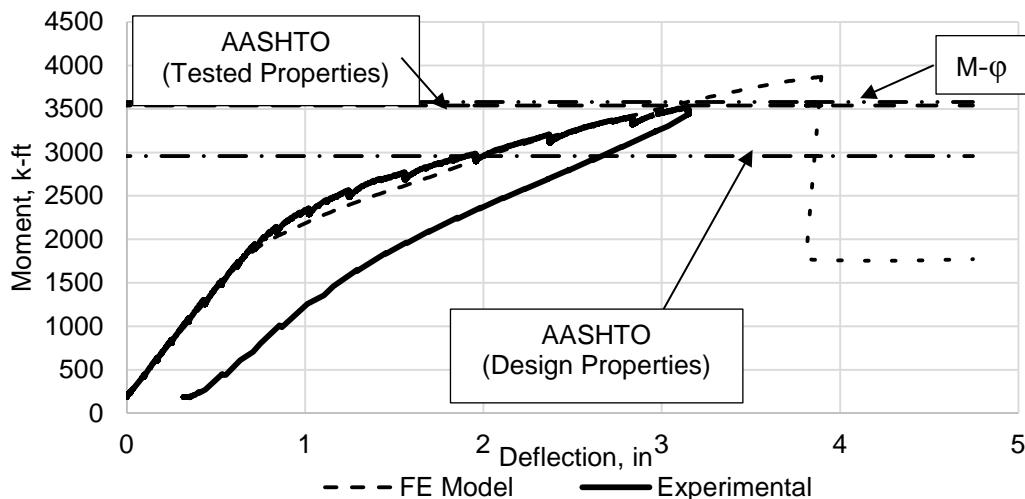
**Figure 55. Test 3 Moment Deflection Behavior (M-φ = moment-curvature)**

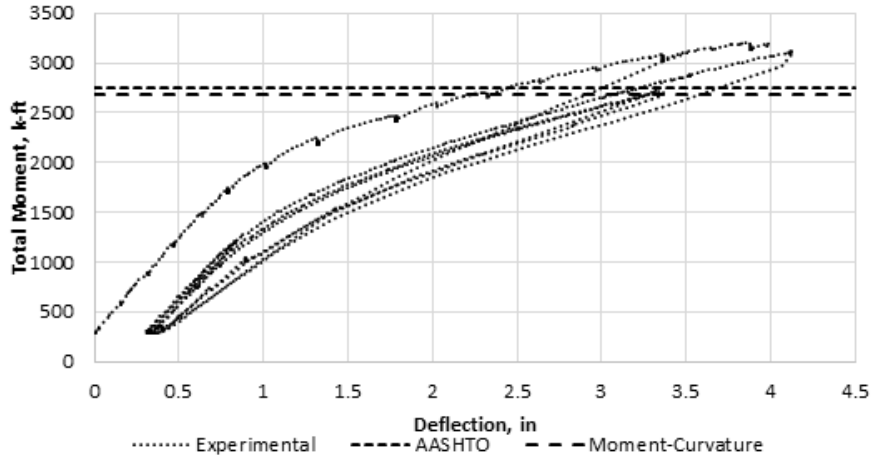
Figure 57. Test 4, Iteration 1 Moment Deflection Behavior

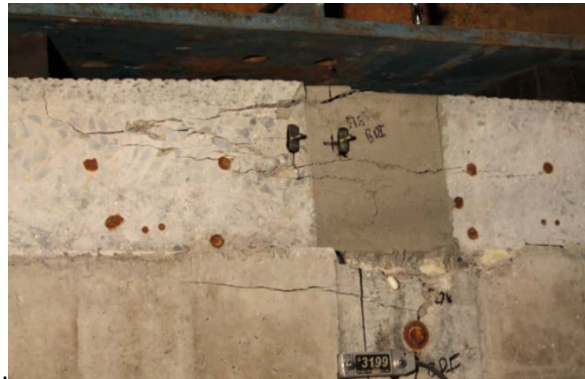
**Figure 60. Compression Failure in the Composite Deck**

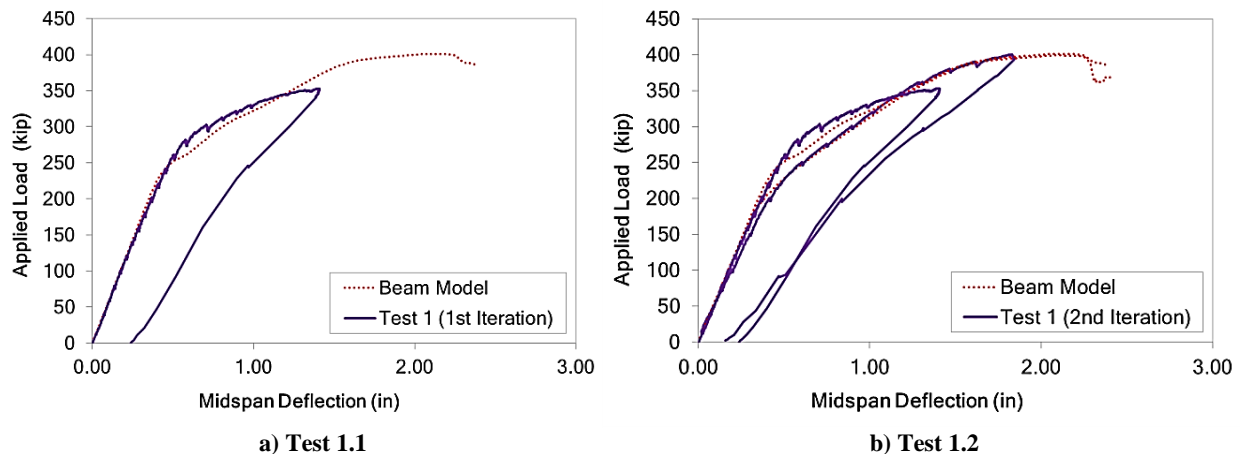
Figure 62. Comparison of Experimental and Analytical Load-Deflection Curves for Test 1

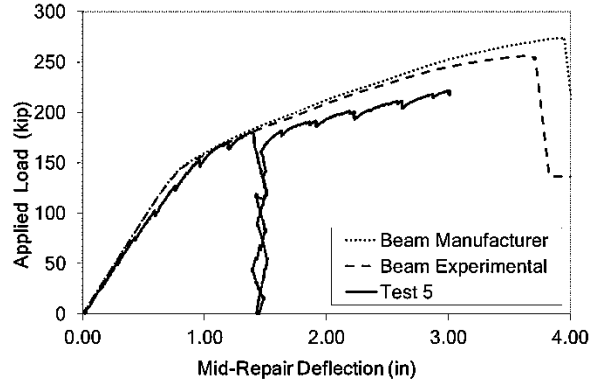
**Figure 65. Load-Deflection Response of Test 5 Versus Nonlinear Beam Models**

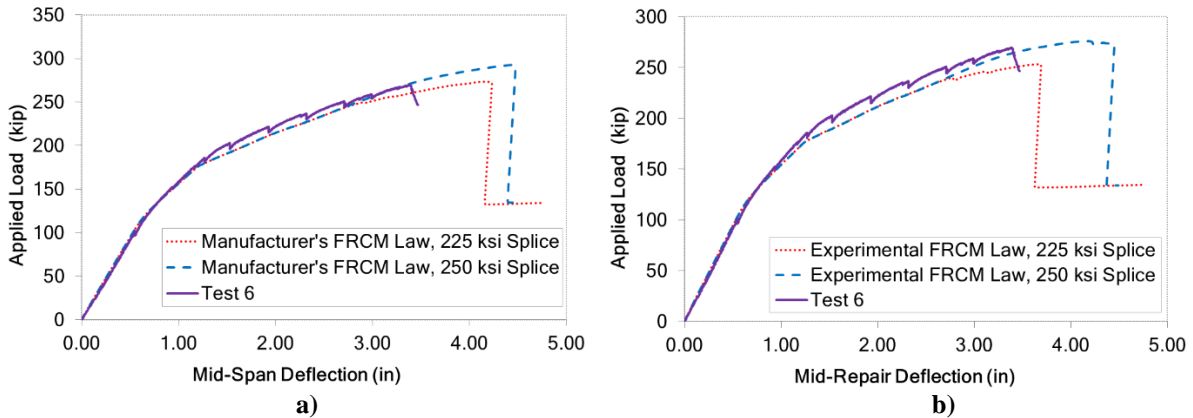
**Figure 66. Comparison of Experimental and Analytical Load-Deflection Curves for Test 6: a) FRCM Model Based on Manufacturer’s Data (Man.), b) FRCM Model Based on Experimental Material Test Data (Exp.)**

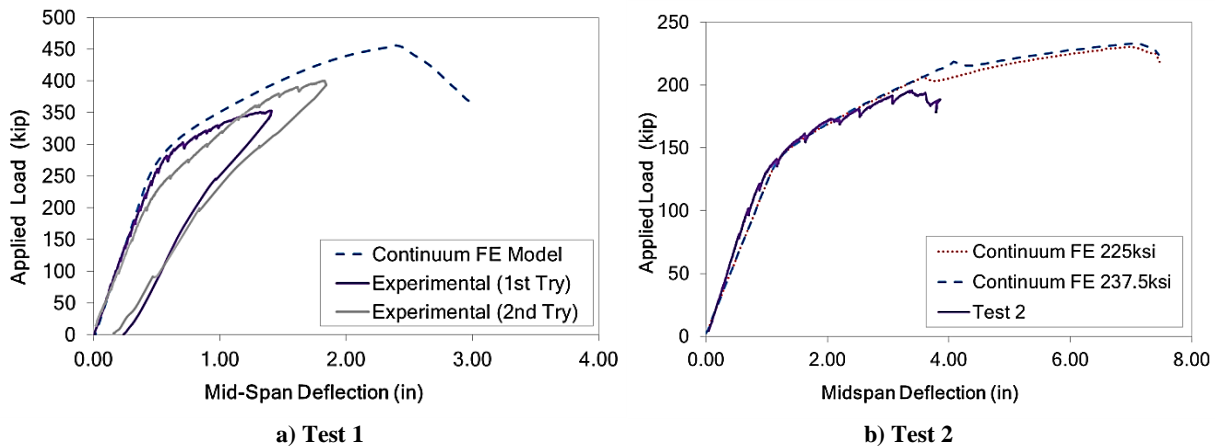
**Figure 67. Comparison of Experimental and Analytical Load-Deflection Curves for Tests 1 and 2**

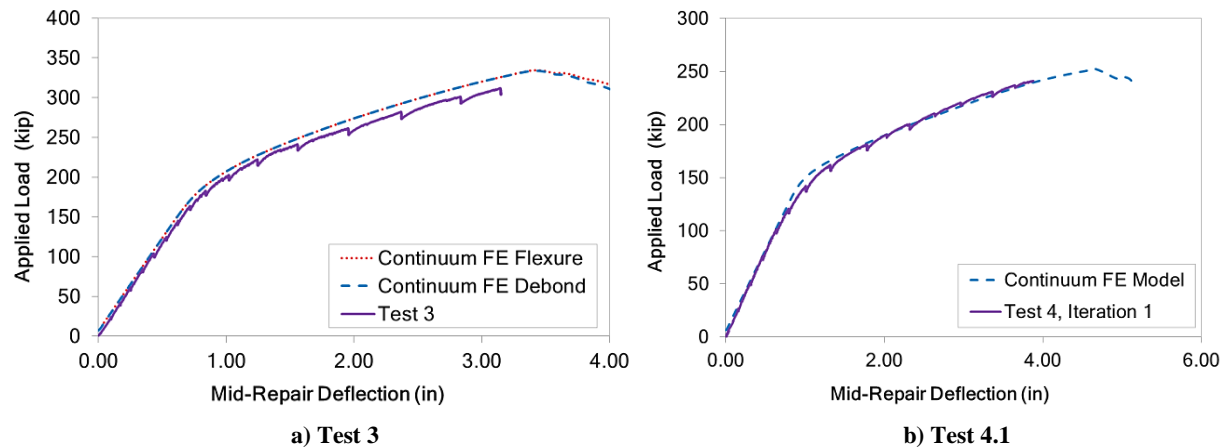
**Figure 68. Comparison of Experimental and Analytical Load-Deflection Curves for Tests 3 and 4.1**

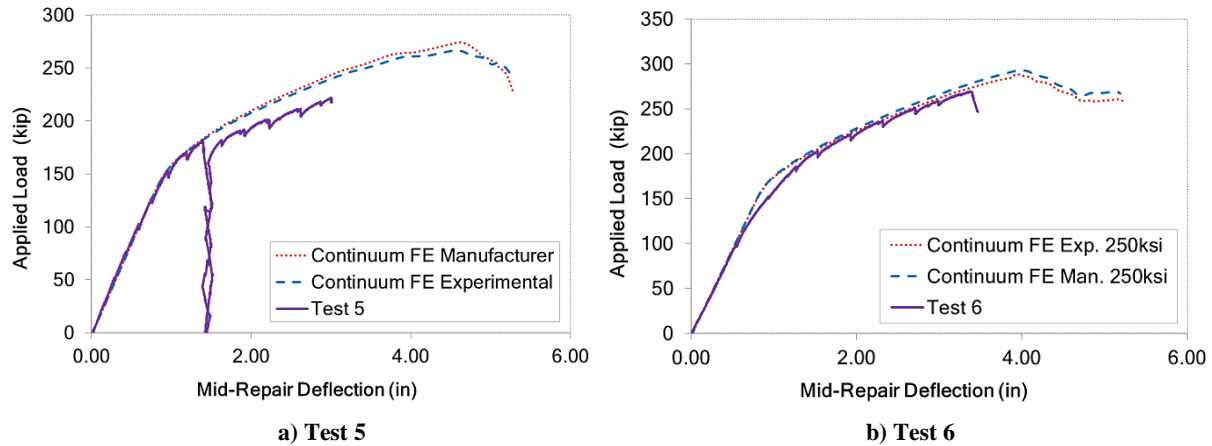
**Figure 69. Experimentally and Analytically Obtained Load-Deflection Curves for Tests 5 and 6**

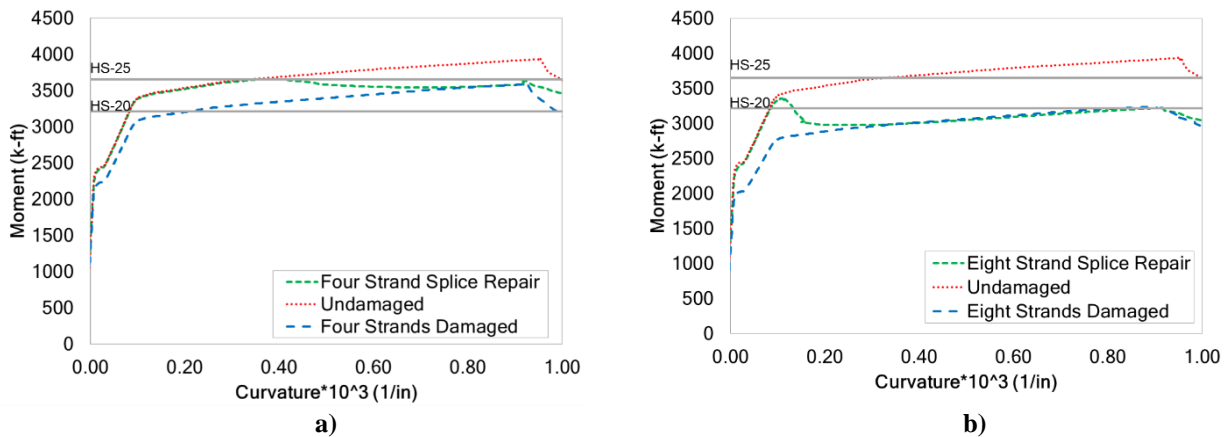
**Figure 74. Moment-Curvature Response of Prototype Girder Investigating the Effect of Strand Splice Repair: a) Splice Repair on 4 Strands and b) Splice Repair on 8 Strands**

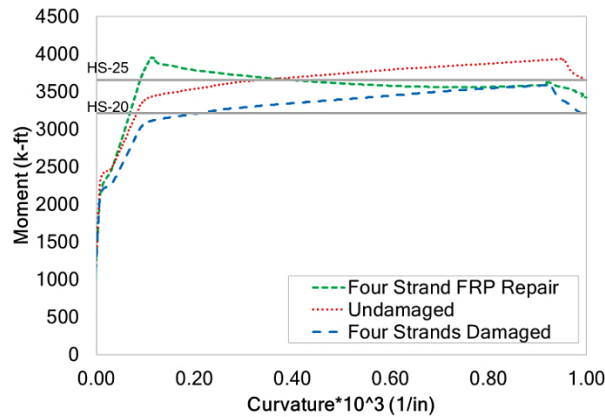
**Figure 75. Moment-Curvature Response of Prototype Girder Investigating the Effect of an FRP Overlay on a Girder With 4 Strands Damaged**

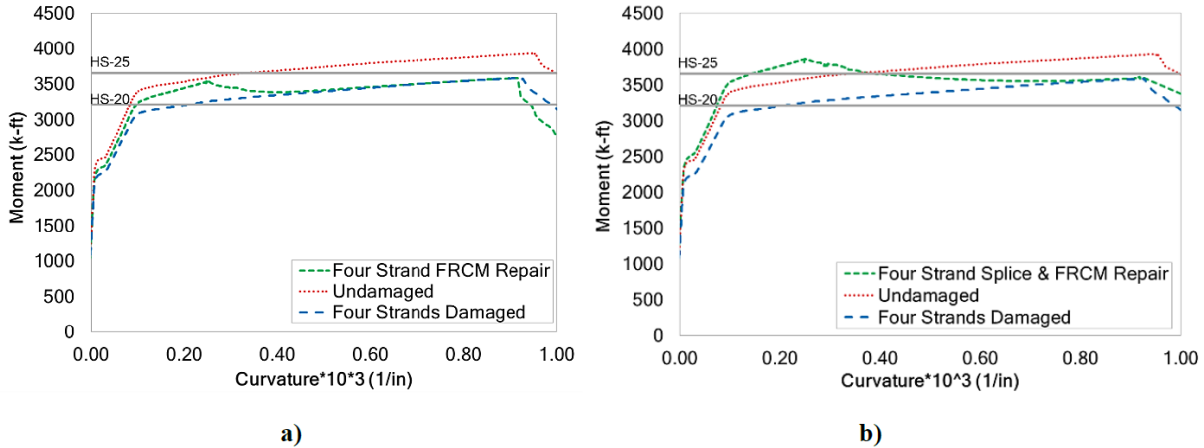
**Figure 76. Moment-Curvature Response of Prototype Girder Investigating the Effect of a Repair Using FRCM Overlays: a) FRCM Overlay and 4 Strands Damaged and b) FRCM Overlay and Splice Repair on 4 Strands**
