# Effectiveness of Innovative Pavement Markings in Facilitating Safe Bicycle Travel

Final Report VTRC 19-R17

**EFFECTIVENESS OF INNOVATIVE PAVEMENT MARKINGS IN FACILITATING  
SAFE BICYCLE TRAVEL**

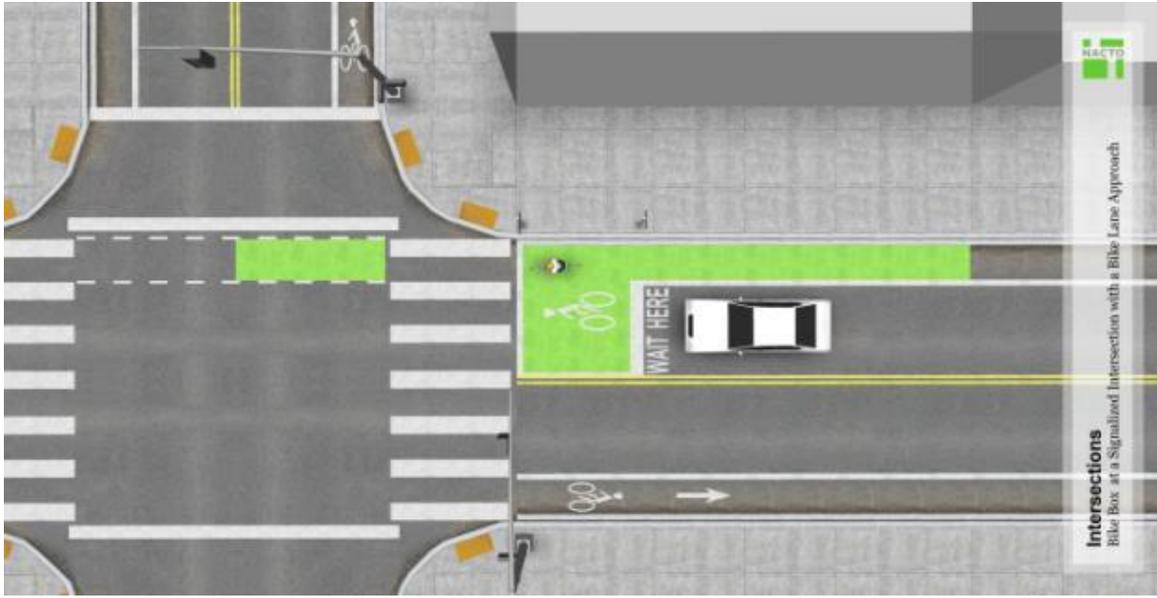
**Figure 1. Illustration of a Typical Bike Box. Image from *Urban Bikeway Design Guide, Second Edition*, by NACTO. Copyright © 2014 National Association of City Transportation Officials. Reproduced by permission of Island Press, Washington, D.C.**

Bike boxes in the United States typically span the bike lane and the adjacent general purpose lane (Hunter, 2000); may be tinted, usually green (Dill et al., 2011); and are usually fed by an ingress bike lane (Figure 1). Stated purposes of bike boxes include relieving bicyclists from breathing motor vehicle exhaust, making bicyclists more visible to motorists at the beginning of the green phrase, and allowing bicyclists to position themselves for turns and merges (Dill et al., 2011; Hamer, 1981).

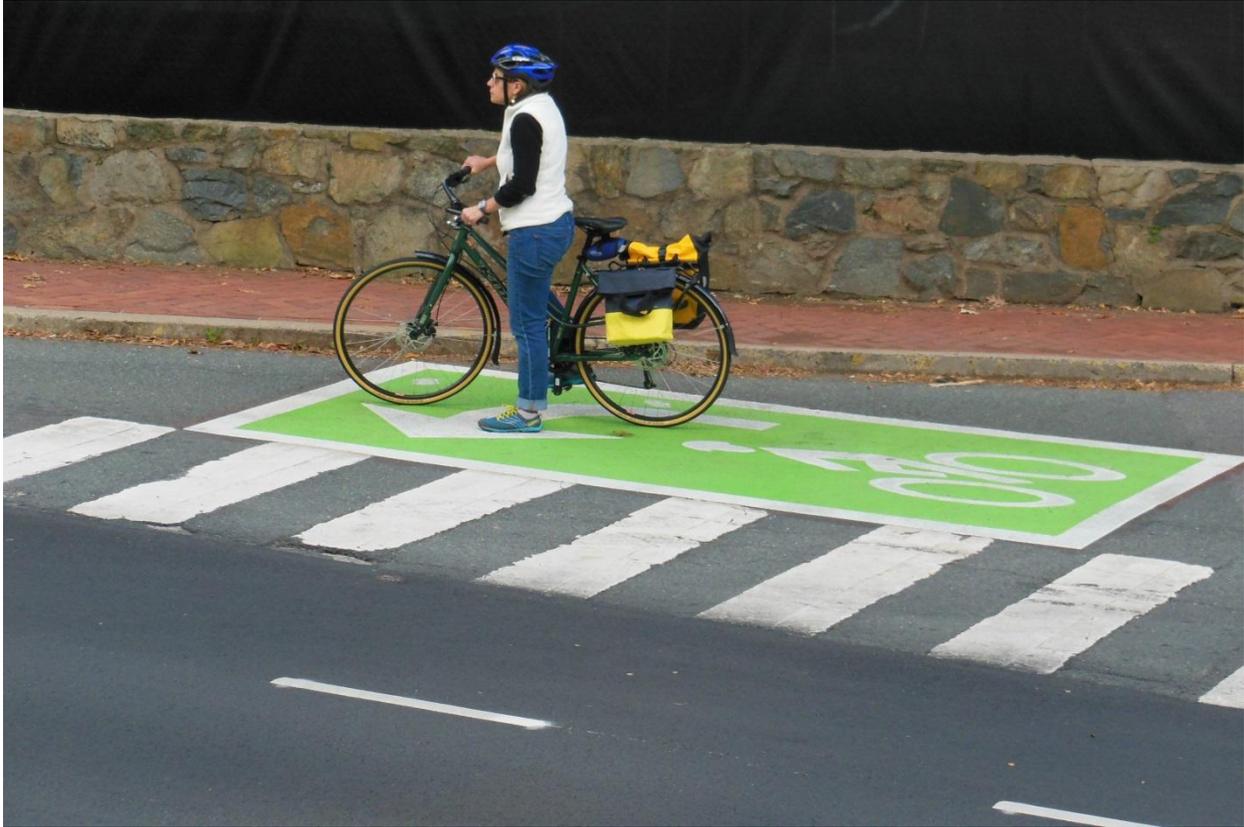
**Figure 2. Photograph of a Bicyclist in a Two-Stage Left-Turn Box**

In a two-stage bicycle left turn, the bicyclist proceeds straight ahead to the right of through automobiles from the same approach (Stage 1) and then stops and waits for the green interval for the cross street, completing the turn by proceeding along the cross street (Stage 2) (Chen and Shao, 2014). The National Association of City Transportation Officials listed several benefits of two-stage turn boxes (Figure 2), including improving bicyclists’ ability to make left turns safely and comfortably, providing a formal queuing space, and reducing turning conflicts between bicyclists and motor vehicles (National Association of City Transportation Officials, 2014). Other terms for similar design treatments include “left-turn waiting areas” (China) (Liang et al., 2015) and “cyclist refuges” (Hamer, 1981).

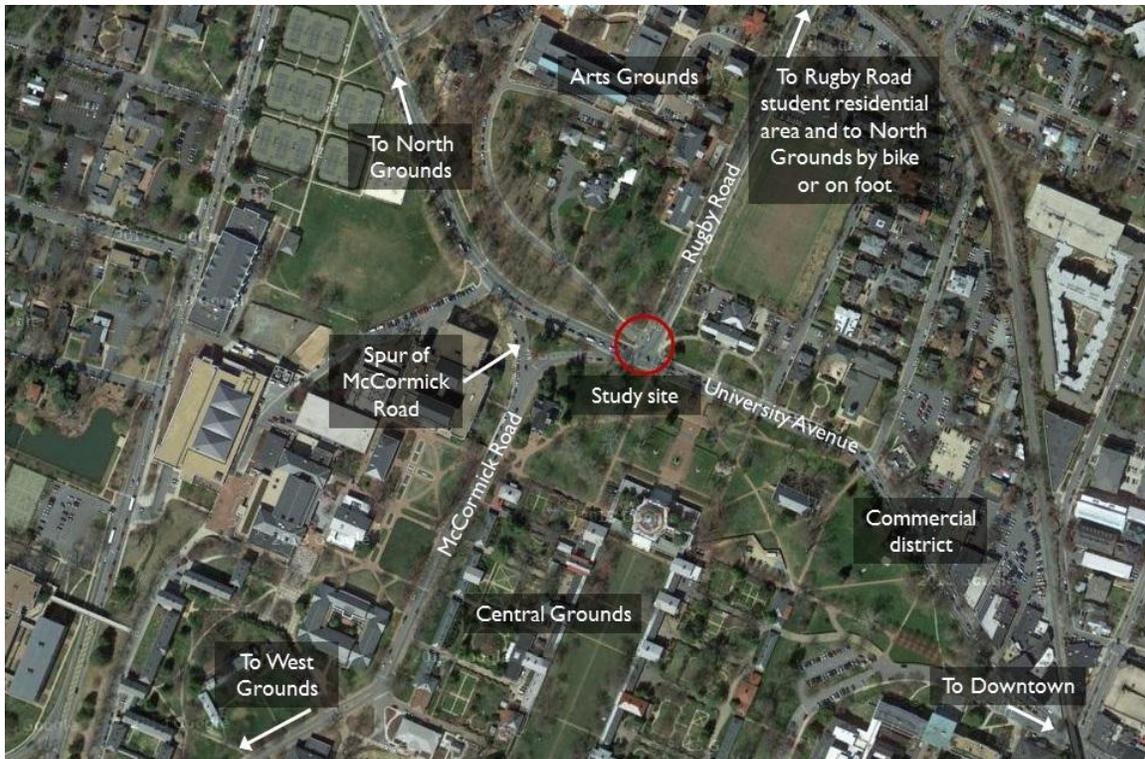
The study intersection of University Avenue and Rugby Road (Figure 3) is an important vehicular entrance to the University of Virginia, which is a major generator of bicycle trips. Rugby Road leads to student residential areas and additional academic buildings and has bike lanes north of the intersection; when used together with an off-street path and bicycle/pedestrian bridge (not shown in Figure 3), Rugby Road provides a key bicycle and pedestrian connection from the university’s central grounds to the north grounds area.

**Figure 3. Experiment Site and Surrounding Areas.** Google Maps imagery © 2013 Commonwealth of Virginia, DigitalGlobe, USDA Farm Service Agency.

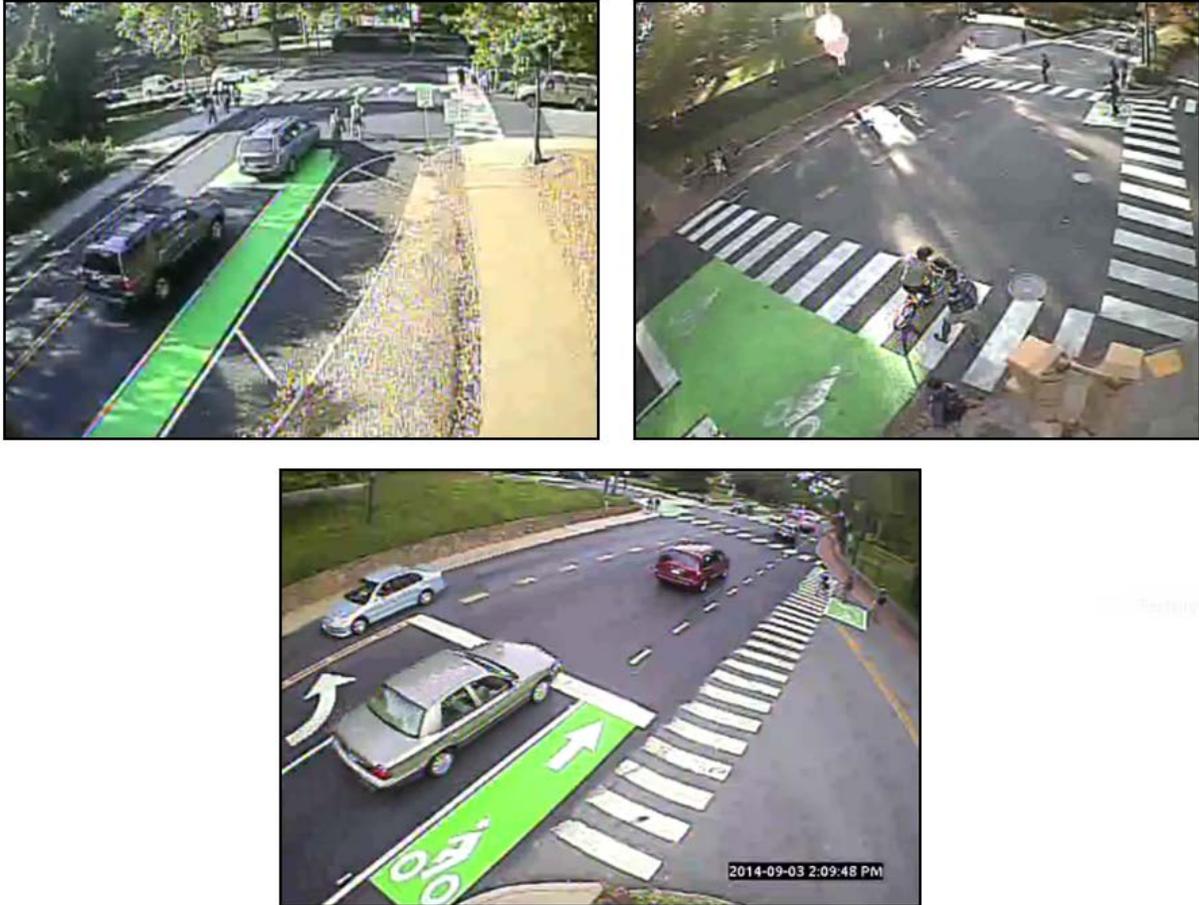
**Figure 6. Camera Views Obtained**

Processing by Miovision—which used computer recognition to classify moving objects by length as pedestrians, bicycles, cars, small trucks, and heavy trucks—provided traffic counts, but in order to classify all bicycle-related traffic interactions at the intersection, reviewers needed to watch the footage of all three cameras for the same recorded period.

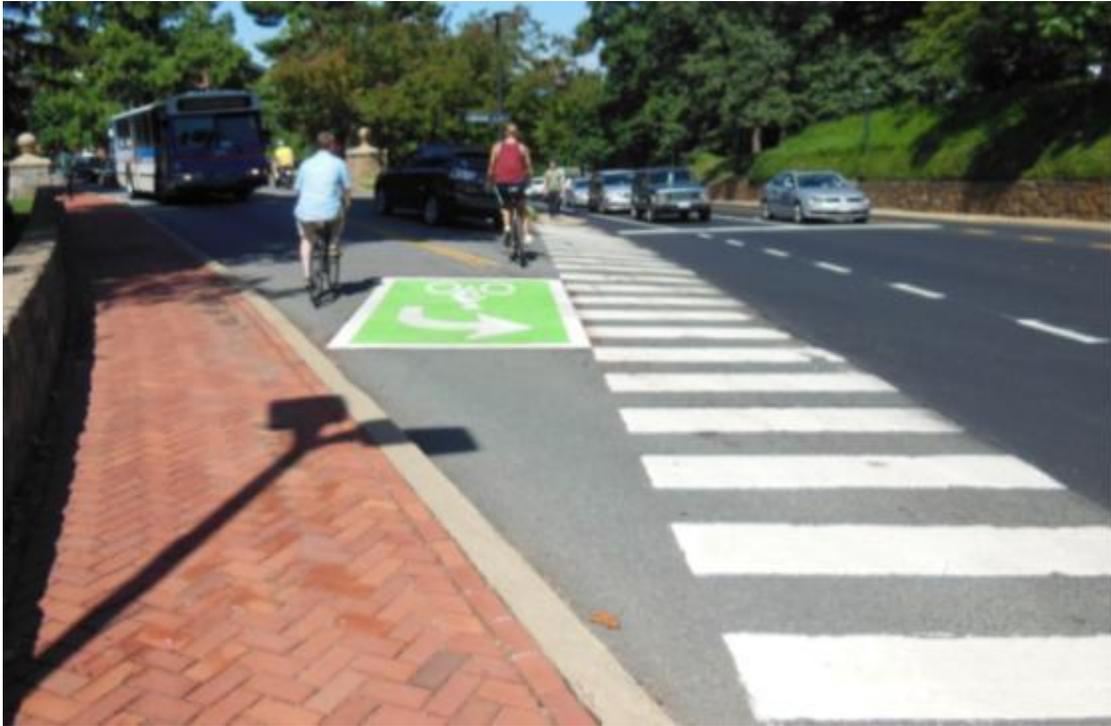
**Figure 7. The Two-Stage Turn Box for Eastbound University Avenue. This was installed south of the crosswalk rather than adjacent to its ingress bike lane.**

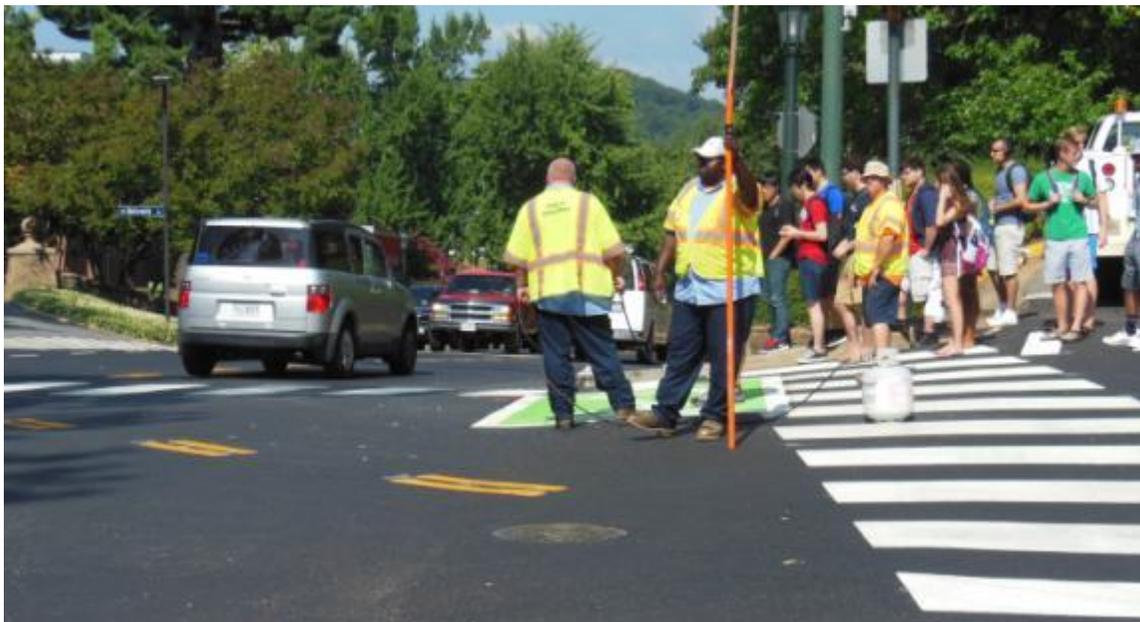
**Figure 8. The Two-Stage Turn Box for Westbound University Avenue. This was installed by narrowing / slightly overlapping a crosswalk.**

Designs included narrowing of the throat of Carr’s Hill Road via a curb extension. This was deferred because of issues with stormwater structures and a historic stone wall. This in turn led to an error or field adjustment when crews placed the crosswalk across Rugby Road farther south than designed, which in turn reduced the amount of space available for the adjacent bicycle turn box. The box was ultimately placed as intended in the design but required narrowing/overlapping the crosswalk slightly (Figure 8).

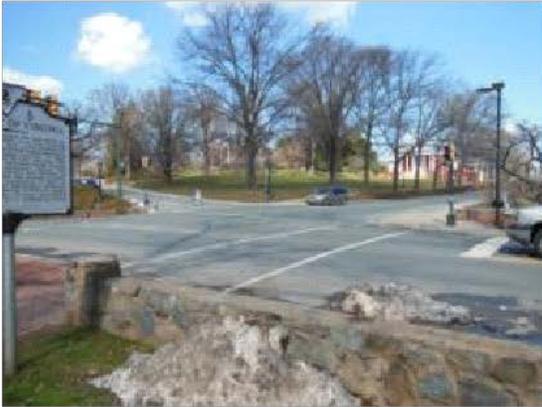
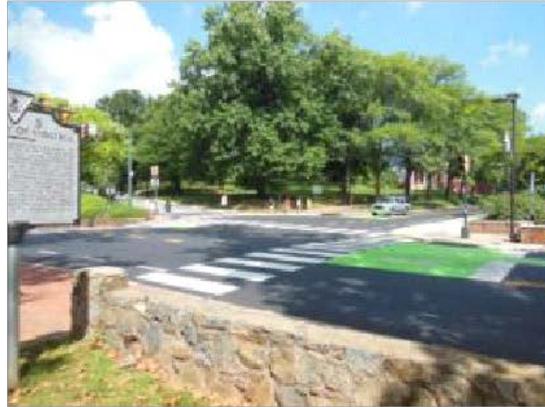
**Figure 9. Before-After Comparisons of Intersection Pavement Markings**

**Looking northwest; westbound University Avenue bike box is in foreground.**

Figures 9 and 10 show various before-after comparisons of the intersection.

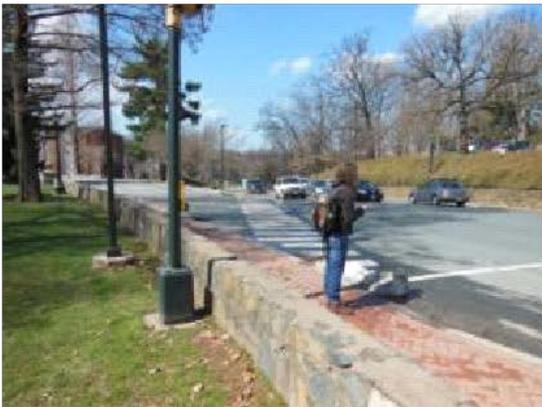
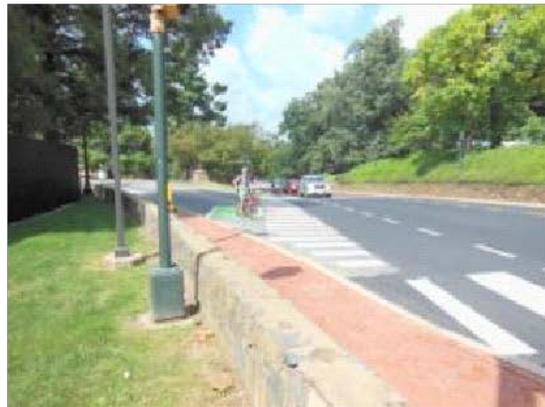
**Looking west; eastbound University Avenue turn box is in foreground.**

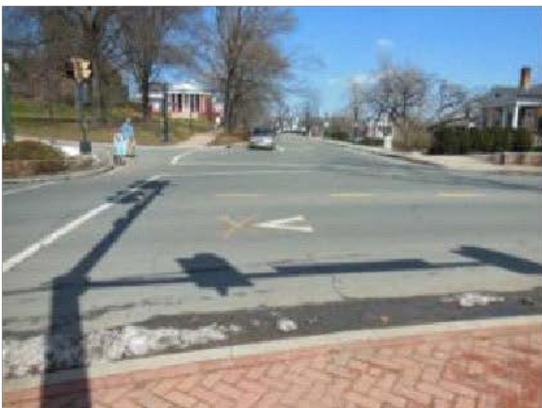
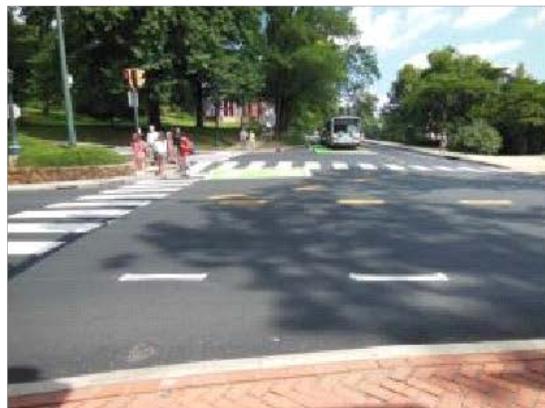
**Looking north; westbound University Avenue turn box and Rugby Road bike box are visible.**

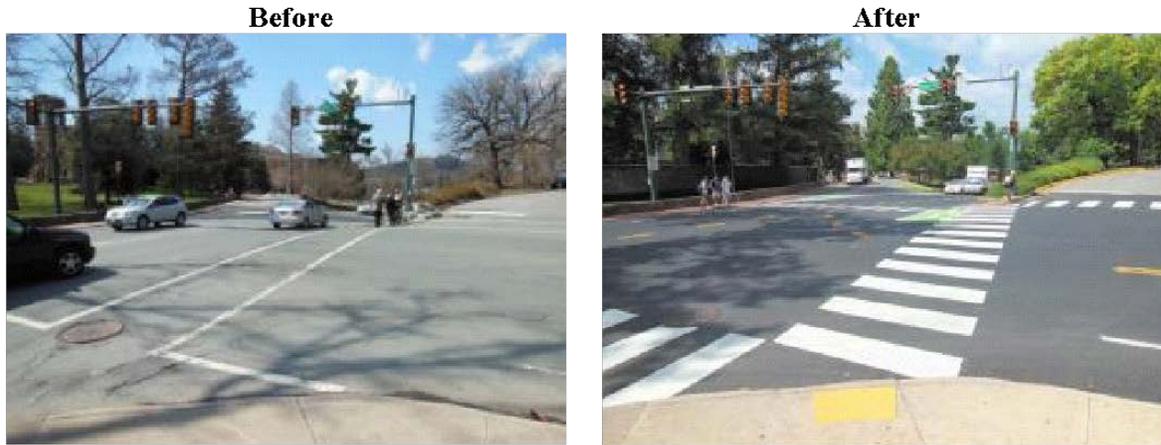
Figure 10. Before-After Comparisons of Intersection Pavement Markings

Looking southwest; westbound University Avenue turn box is visible.

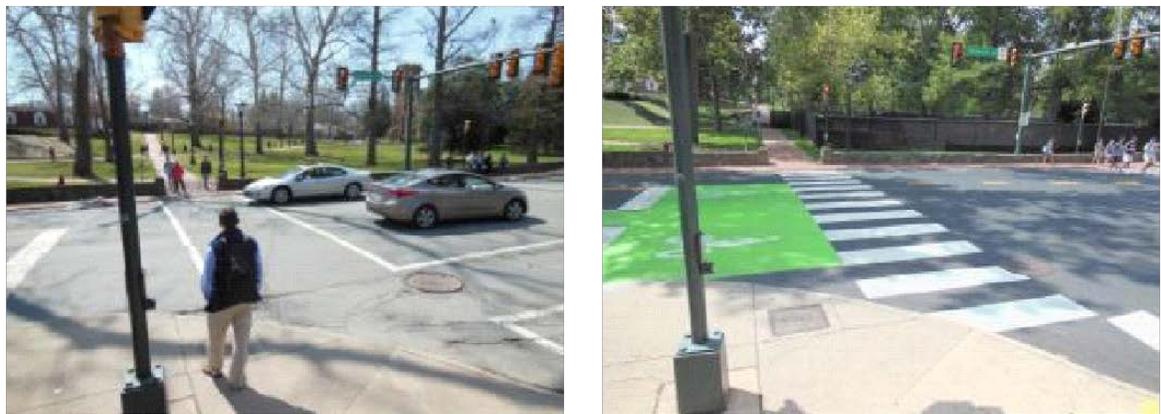
Looking south; westbound University Avenue bike box is in foreground.
