# Assessment of Composite Pavement in Virginia: A Trial Section on US 60

Final Report VTRC 21-R3

**ASSESSMENT OF COMPOSITE PAVEMENT IN VIRGINIA:  
A TRIAL SECTION ON US 60**

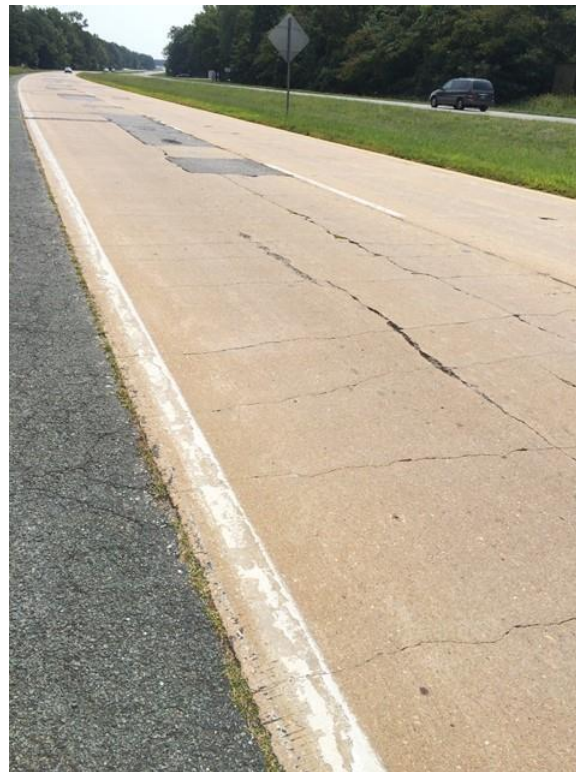
**Figure 3. Surface Distresses on US 60W in September 2015**

In 2016, the existing 37-year-old CRCP pavement was in very poor condition before this rehabilitation. There were many punchouts and transverse and longitudinal cracks, as shown in

Figure 3. VDOT's PMS annually rates each section of highway through an automated digital video logging. Pavement condition ratings from zero (0) to 100 are calculated using a deduct value system for each type of distress based on these video images. A higher rating number represents better pavement condition. In 2015, this section had a Concrete Distress Rating (CDR) of 31 and a Concrete Punch Rating (CPR) of 42, both indicating a very poor condition requiring a significant rehabilitation and/or reconstruction.

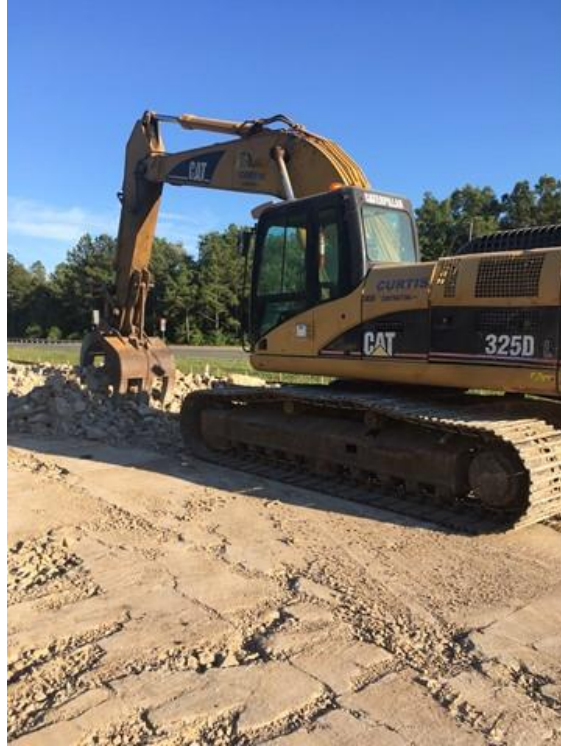
**Figure 4. Crushed Concrete Being Removed**

The existing concrete pavement was removed by crushing the concrete in place using a guillotine breaker and loading the broken pieces on a haul truck using a backhoe as shown in Figure 4. The expectation was to use saw cutting and lift big pieces for removal so the underlying layer would not be damaged.

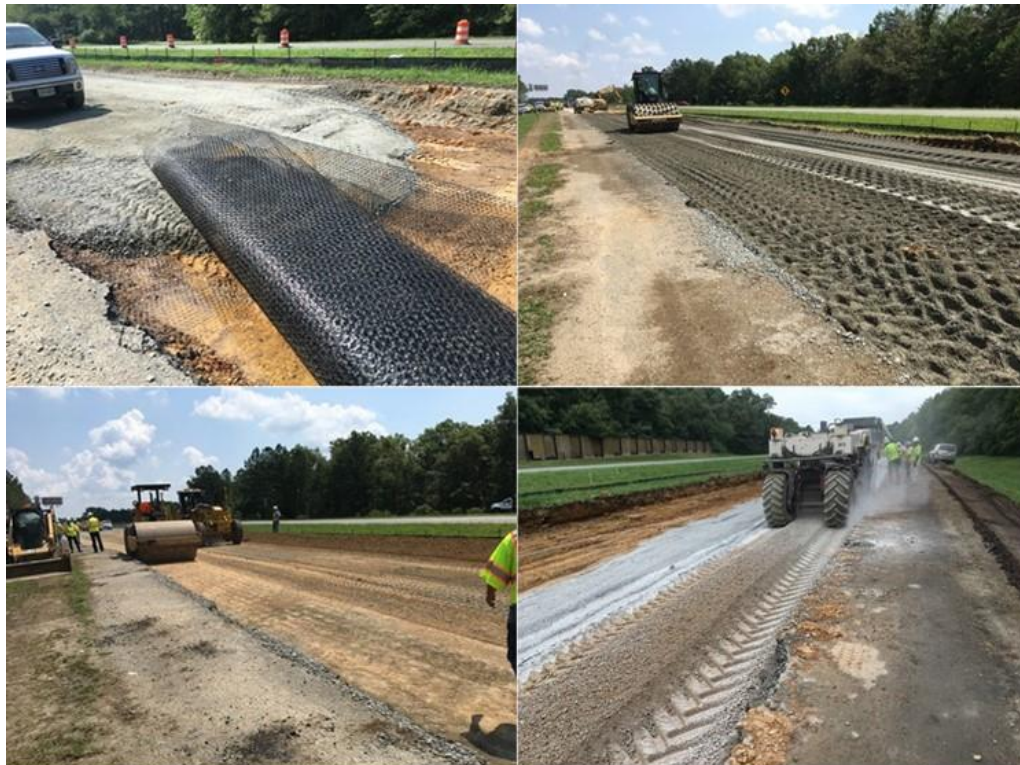
**Figure 6. Base Removal, Replacement, and Stabilization**

In most areas, 15 in of materials (broken CTA base and soft subgrade) was removed except for a few hundred feet in the middle. The base was removed, replaced, and/or stabilized in the following different ways; some of the steps are shown in Figure 6:

1. Remove and replace 15 in of the existing base (broken CTA) and subgrade with 21A aggregate over geogrid. Treat (with cement) the top 12 in with a full-depth reclaimer.
2. Remove 15 in of the existing base (broken CTA) and subgrade, lime stabilize the underlying soft subgrade, and fill with compacted 21A aggregate.
3. Conduct full-depth reclamation of the existing base (broken CTA) and subgrade in place for 12 in using CalCement.

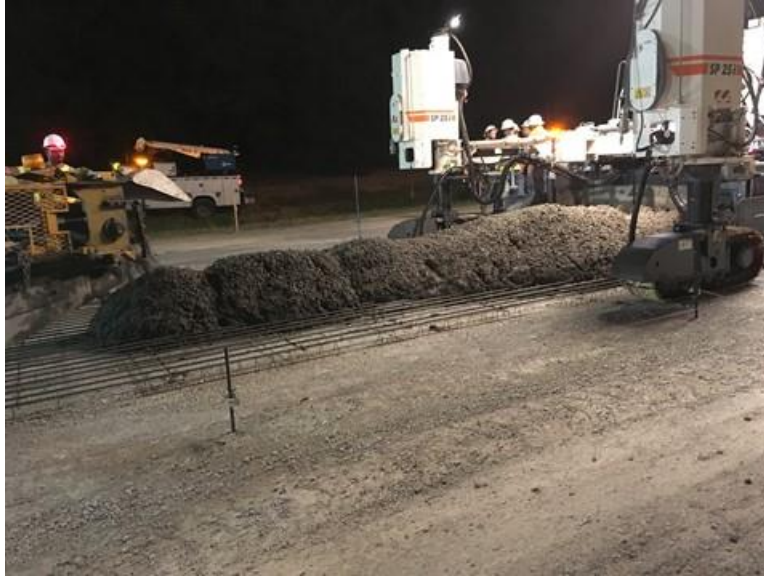
**Figure 8. Paving Right Lane With a Slipform Paver**

Concrete was hauled for approximately 30 minutes in a dump truck and delivered on grade with a belt. A Wirtgen SP25i slipform paver, as shown in Figure 8, was used to pave one lane (12 ft wide) at a time. The placement rate was 1,000 to 1,500 lane-feet per night except for the first night of paving, September 7, when the rate was 200 lane-feet. The construction took place for several nights in 2017; the right lane was constructed on September 7, 10, 11, 13, 14, and 15; the left lane was constructed on September 21, 22, 24, and 25. There were three to five construction cold joints in each lane; a typical joint is shown in Figure 9. Although the VDOT standard calls for doubling the reinforcement at such joints, it was not done for this project because there are some indications in the literature that increased reinforcement may cause congestion and hinder consolidation. Table 7 shows the approximate location of these cold joints.

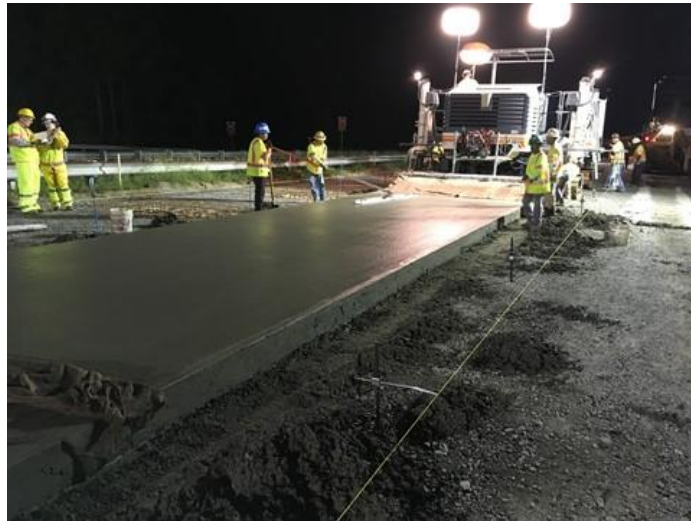
**Figure 10. Burlap Drag for Surface Texturing**

Surface texturing was provided by dragging burlap behind the paver, as shown in Figure 10. A waxed-based curing compound (Dayton Superior White Cure) was sprayed at a rate of 100 to 150 ft<sup>2</sup> per gallon to prevent any moisture loss.

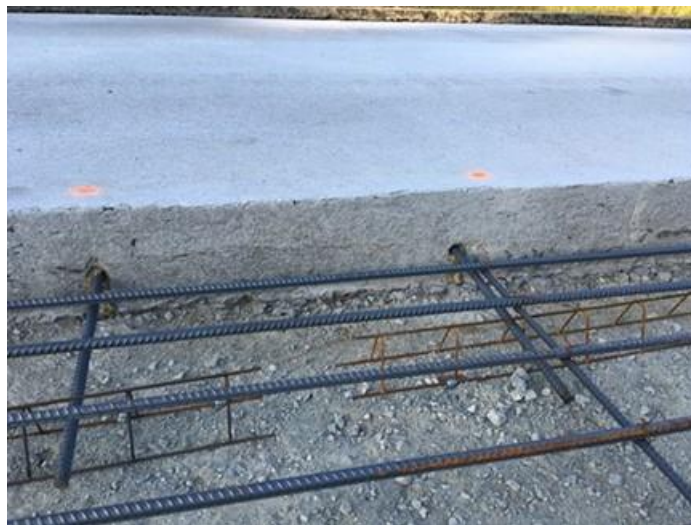
**Figure 11. Drilled and Epoxied Tie Bars to Right Lane**

Since one lane at a time was paved to accommodate construction access, tie bars were installed after the right lane was completed. Holes were drilled and the ties bars were secured with epoxy, as shown in Figure 11. The tie bars were No. 4 at 36-in centers as required in the VDOT standard.

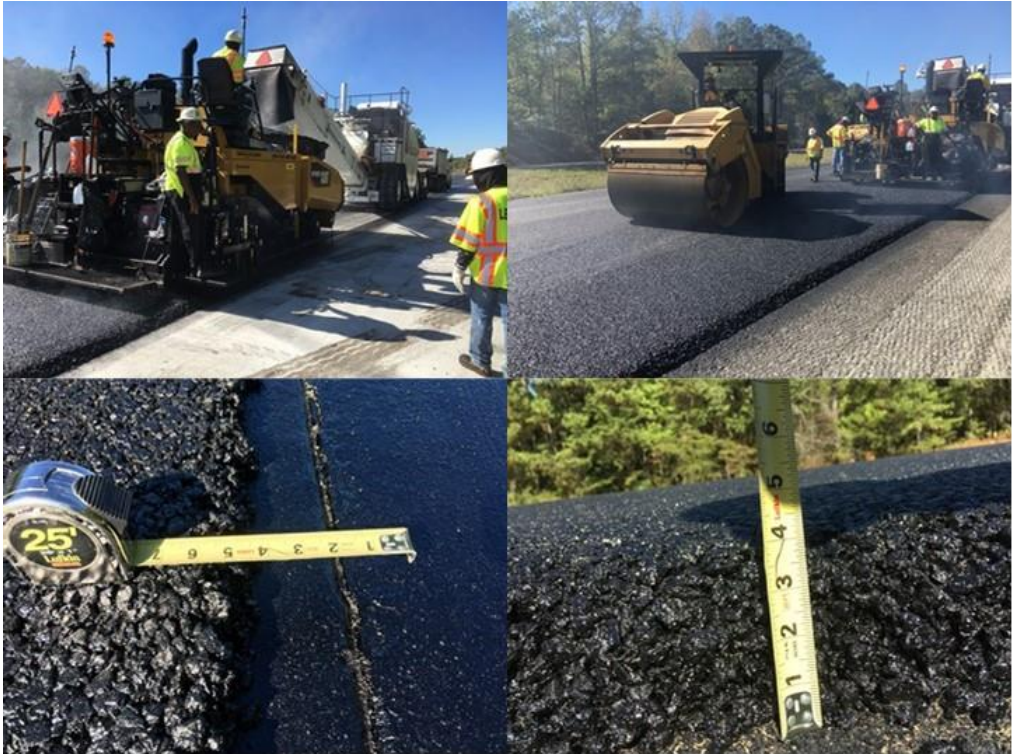
**Figure 13. SMA Overlay Operation. SMA= stone matrix asphalt.**

All sections of CRCP were overlaid, as shown in Figure 13, 2 weeks after the last concrete placement with 2 in of SMA. Unlike with the concrete placement, the left lane was overlaid first, on October 13, 2017, and the right lane was overlaid on October 18, 2017. The VDOT standard construction practice for the SMA mixture was followed.

In order to ensure a good bond between the concrete surface and the SMA, a tack coat was applied, but no cleaning of the curing compound from the concrete surface was done. It is important to note that the concrete surface was textured using a burlap drag. No localized shoving or cracking of SMA was observed, indicating no apparent bonding problem after 2 years of traffic. The lane joint in SMA was offset about 3 in from the concrete lane joint. Although most SMA was 2 in, a small portion on the right edge toward the east end was 4 in to correct the superelevation.

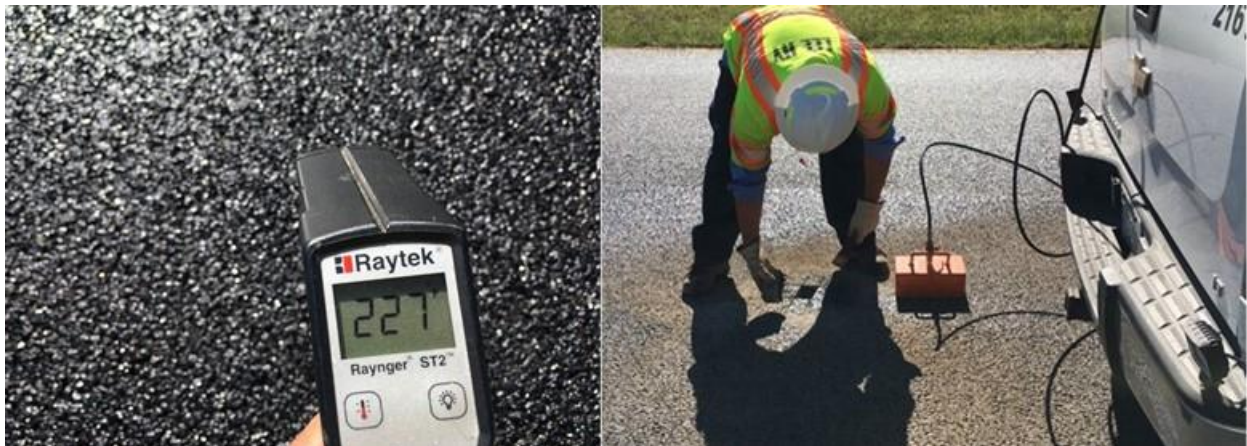
Figure 14. Checking SMA Laydown Temperature and Plug Extraction for Density Testing. SMA = stone matrix asphalt.

As part of VDOT's regular QA operation for SMA, the laydown temperature was verified and a plug was extracted for density testing, as shown in Figure 14.

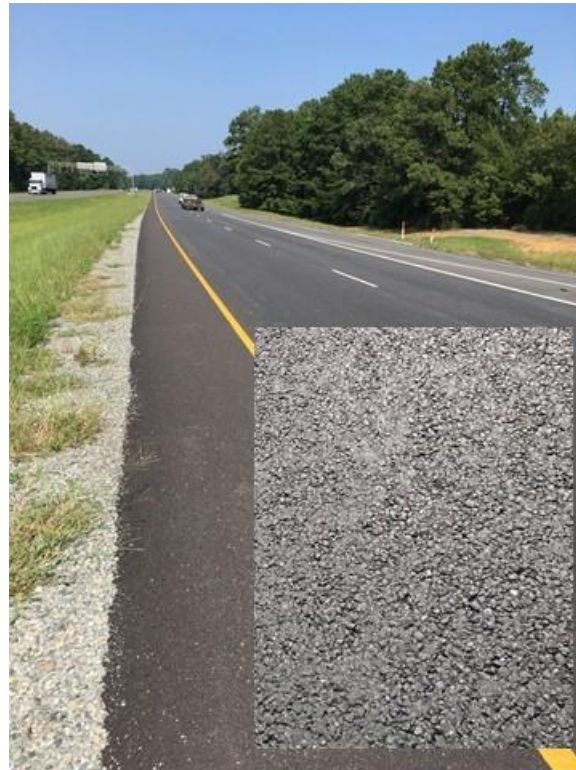
**Figure 20. Composite Pavement SMA Surface Condition After 2 Years of Traffic. SMA = stone matrix asphalt.**

Pavement conditions were visually observed a few days after construction and 2 years after opening to traffic. There were no visible distresses on the surface, as shown in Figure 20. VDOT's PMS also rated this section of pavement in 2019 after 2 years of service. The average

Critical Condition Index (CCI) and rutting from the 2019 PMS data were 98 and 0.12 in, respectively. The average IRI was 65 in/mi compared to 57 in/mi right after construction. Therefore, the composite pavement on US 60W is performing satisfactorily as judged by visual appearance.

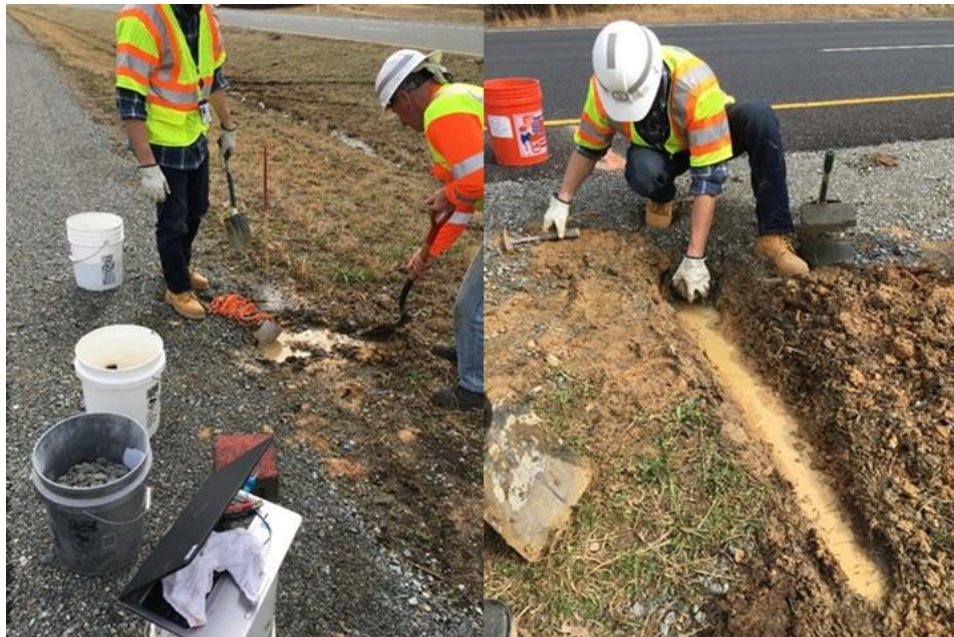
**Figure 24. Standing Water at the Edge of the Pavement in February 2018**

Although a pavement edge drain (VDOT UD-7) was recommended for this project, it was omitted during construction because of a constructability issue in the field. During a site visit to collect temperature data in February 2018, a significant amount of water was found at the edge of the pavement inside the data collection box and tubes, as shown in Figure 24. In a subsequent visit in May 2018, these locations were dry.
