Methods for Evaluation of the Remaining Shear Capacity in Steel Bridge Beams With Section Losses Attributable to Corrosion Damage

Final Report VTRC 22-R4

FINAL REPORT

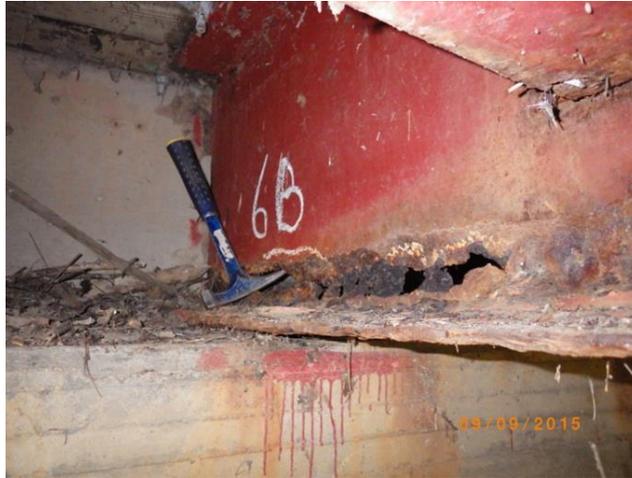
Figure 1. Example of Extensive Beam End Corrosion Damage

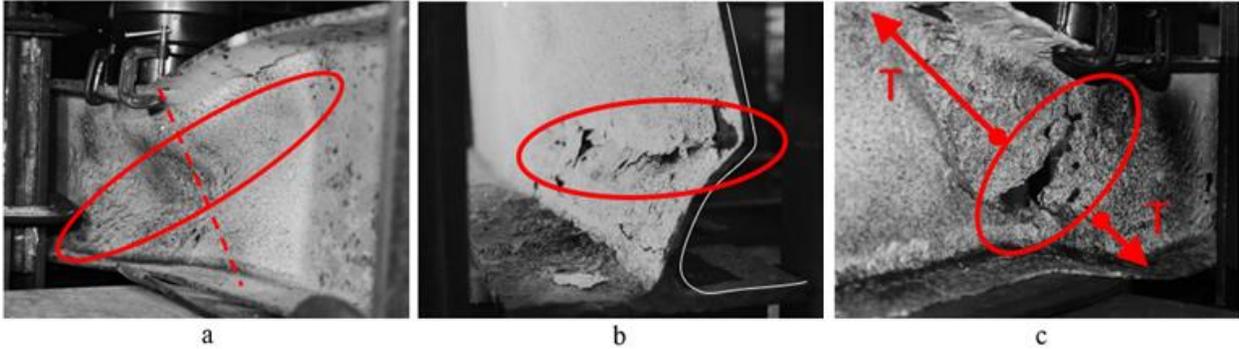
Typical images of the three shear failure types related to this study are shown in Figure 3. Figure 3a shows a web buckling failure occurring within the diagonal red oval perpendicular to the dashed red line between the applied load and the support. This example occurred because of web section losses thinning the web at mid-height between the applied load and the support. Figure 3b shows an example of a web crippling failure that occurred at 3 in above the bottom flange at the bearing for a slender W-shape beam. Some failures more closely resemble continuous plastic web deformation along the length of the web and starting at the beam end, as opposed to true web crippling failures, which would develop above the bearing because of high concentrations of compressive force. Although it is worth noting that these failures did not meet the traditional definition of web crippling, they are referred to as web crippling failures because

of their similarity in location and for the simplicity of categorization. Figure 3c shows an example of web cracking, where cracks formed between adjacent web holes along the height of the beam. This crack formed because of the formation of diagonal shear stress bands perpendicular to the loads creating tension forces, shown as red arrows, which pulled the web apart in the red oval.

Figure 3. Photographs of Shear Failure Types: (a) web buckling; (b) web crippling; (c) web cracking.

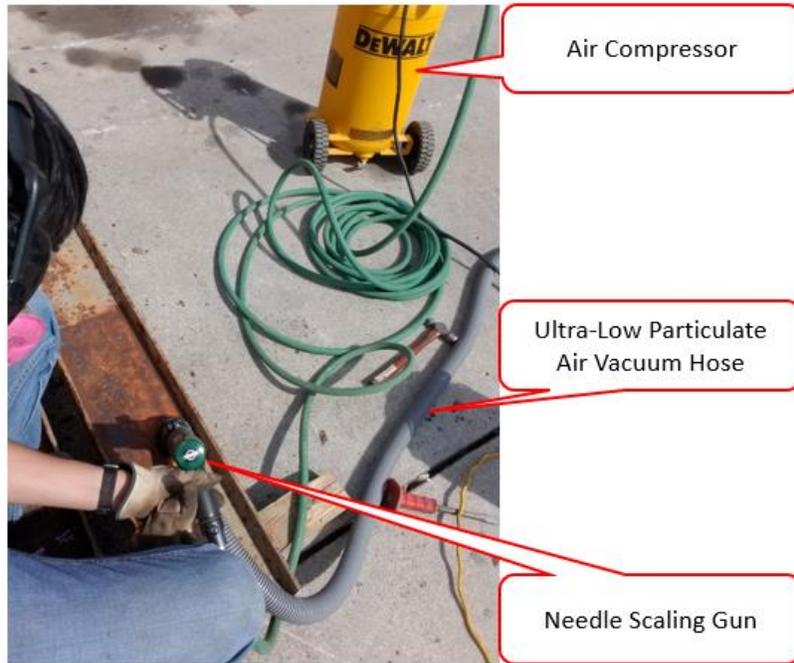
The needle scaling tool uses multiple fine metal needles to abrade the beam's surface to remove layers of paint and oxidized metal from the base metal and capture the particulate using suction from a vacuum. This method was the most effective surface preparation available because of the speed of removal, the enclosed nature of the removal process, and its ability to clean uneven surfaces, which was necessary for the corroded metal of the specimen webs. Further, the process could be used with a gasoline generator and transported to the lot where the beams were stored. This portability was necessary because of limitations on available space at the structures laboratory, as paint removal could be conducted at various locations without the need to allocate a specific area around the laboratory building. An example of this configuration is shown in Figure 4. The needle gun is shown connected to the laboratory's compressor by the

Figure 4. Pneumatic Needle Scaler Configuration

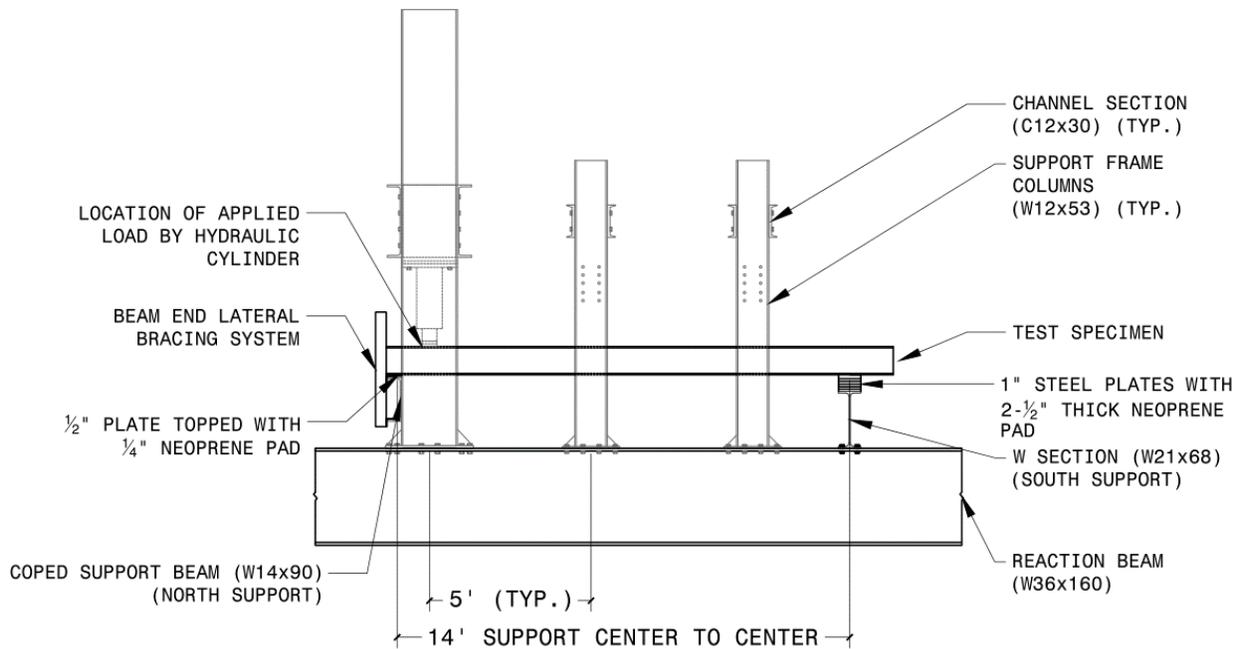
The test setup consisted of a three-point beam loading test with a single applied load near the support to determine the shear capacity. The tests were carried out on a self-reacting steel load frame, resting on two W36x160 reaction beams. Test specimens were supported by a 6-in neoprene rubber bearing pad on top of a W21x68 beam at each end. The neoprene pads were used to replicate the in-field conditions of the specimens better and were chosen in favor of roller bearings because of the minimal translational displacement resulting from the near bearing loading point. The load frame was made up of two W12x53 columns connected by two coped W18x86 crosshead beams, which supported a 200-ton hydraulic cylinder used for loading. This cylinder was connected to a 10,000-psi pump with hoses equipped with ball-type quick couplings and a hydraulic tee adapter connected in series to allow for pressure readings taken using a pressure transducer. Figures 5 and 6 show diagrams of the load frame configuration from the front and side view.

Figure 5. Elevation View of Full-Scale Beam Testing Configuration

The coped support beam shown in Figure 5 was moved to sit on the top flange of the reaction beams during the W16x45 and W21x62 load tests so that the load could be positioned farther from the bearing. As a result, the 1-in steel plates on the south support were moved to the north support to level the test specimen. In addition, lateral supports were added to brace the beams at 5-ft intervals from the loading point and at the beam end to prevent lateral torsional buckling and ensure that the beam would fail in shear. The beam end lateral bracing system first shown in Figure 6 was composed of a system of welded angles clamped to the loading frame

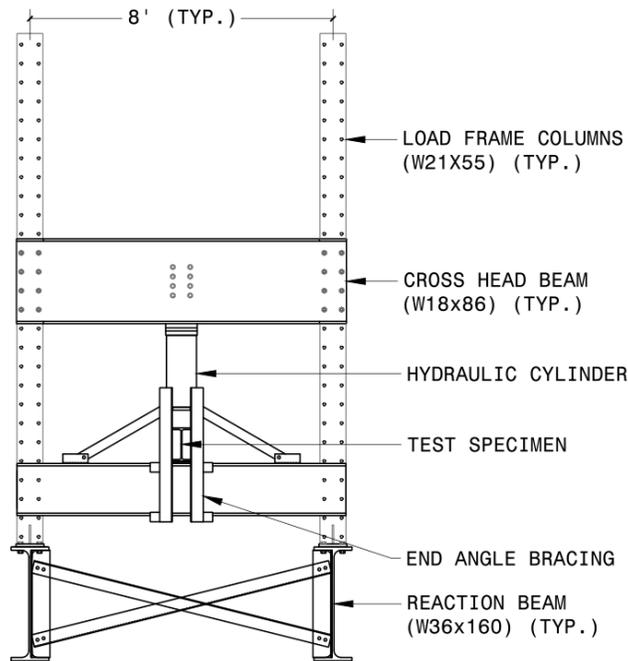
Figure 6. Transverse Elevation View of Full-Scale Beam Testing Configuration

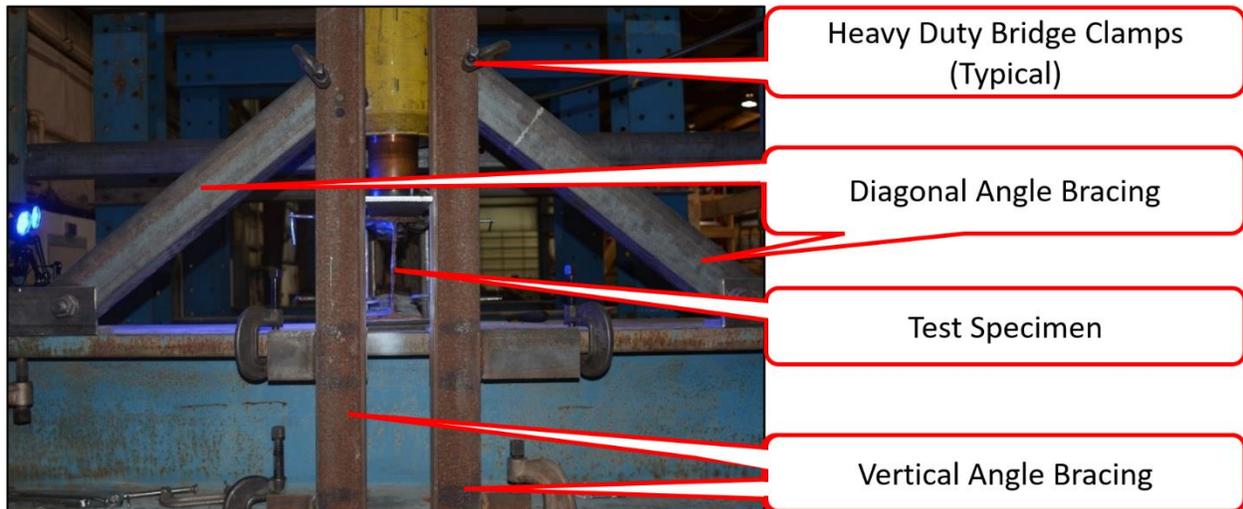
using heavy-duty bridge clamps. The beam end bracing is shown in Figure 7. This configuration was easily reassembled between beam tests and adjusted to various beam widths while providing enough stability to prevent beam torsion at the bearing during testing.

Figure 7. Beam End Bracing Configuration

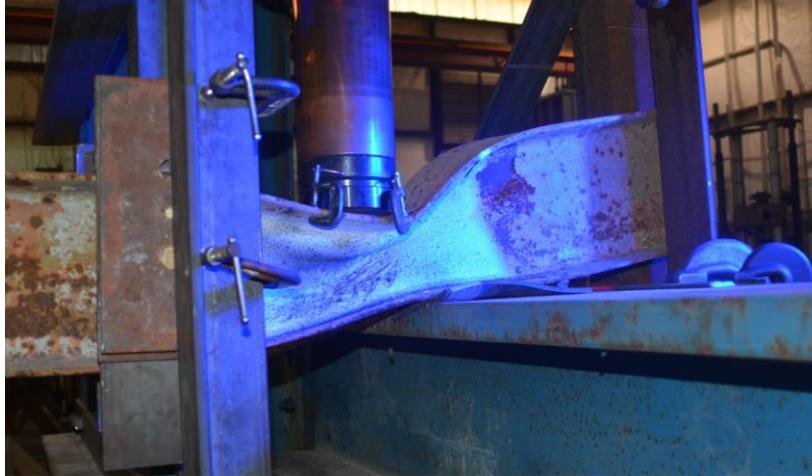
Figure 8. Example of Beam Lifting at End Because of Applied Loads

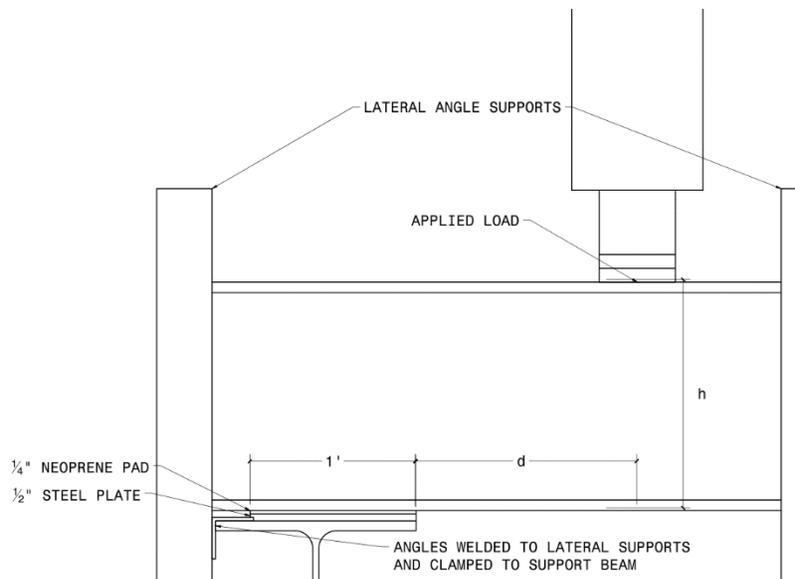
Figure 9. North Support View of Full-Scale Beam Testing Configuration

Test Set	Distance Between Load and Support, Distance d in Figure 9 (in)
S8x18.4	4
W10x26	4
W16x45	16
W21x62	21

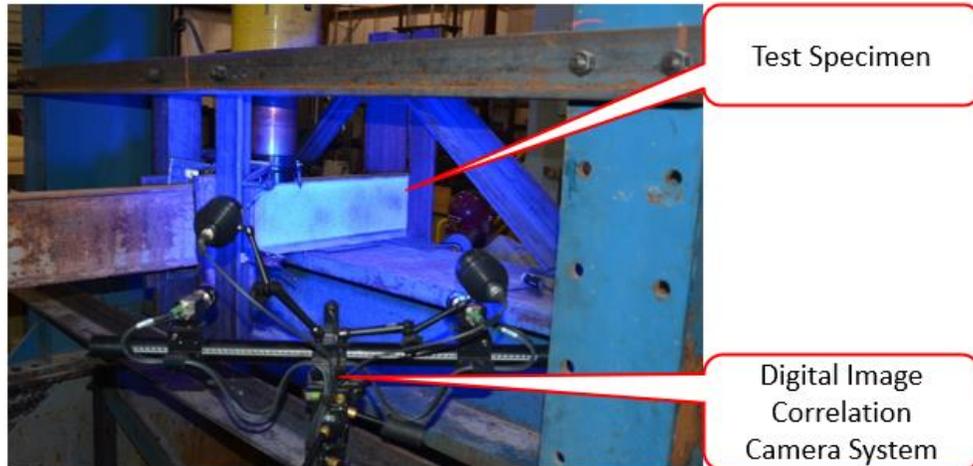
Comprehensive strain fields of the beam webs were captured using the DIC system. This system replaced the need to use strain gauges by instead making use of an applied stochastic pattern. This pattern's application was a simple process. A primary coat of white spray paint was applied to the beam web to create a uniform base layer. The white paint was allowed to dry before a randomized series of black dots were painted overtop by applying a small amount of pressure to the nozzle of a black spray paint can. Figure 10 is an example of the system in use. The camera system projects a bright blue polarized LED light on the stochastic pattern, which was photographed throughout the loading process using a stereoscopic camera arrangement to identify displacements of individual points on the face of the webs.

Figure 10. Digital Image Correlation Camera Scanning a Beam

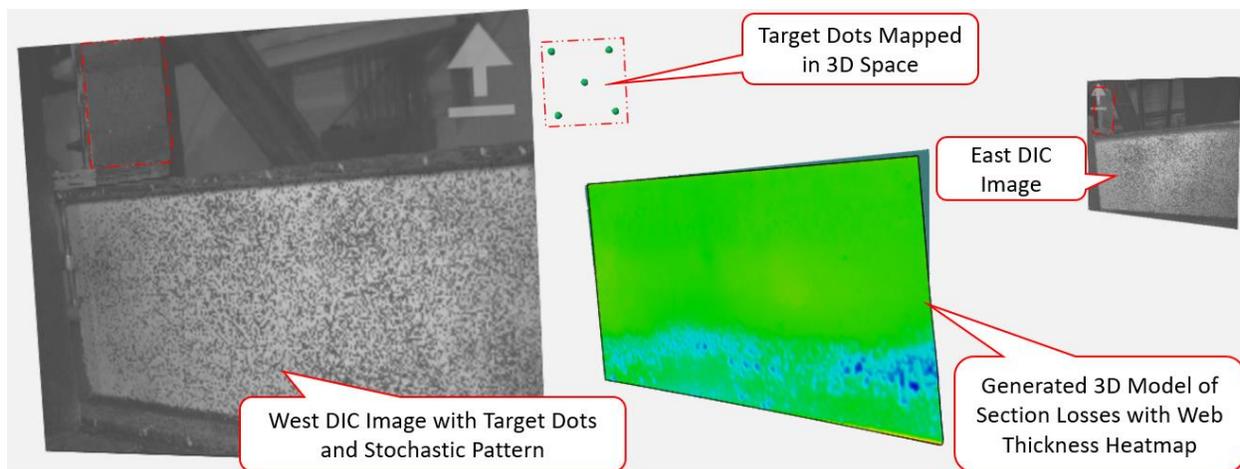
The second method used a wooden board marked with five target dots and clamped to the top flange such that the DIC cameras could see the targets from either side of the beam. Thus, by matching the five marker points using the DIC software, a single web mesh could be generated with relative ease and more certainty of the accuracy of measurements made. Figure 11 illustrates the process by which DIC images were taken of the east and west faces of the beam end. The target dot boards marked with red dashed lines were matched in 3D space to align the surface models in the center of the figure shown as bright green rectangles.

Figure 11. DIC Profile Scanning Using Target Dots. DIC = digital image correlation.

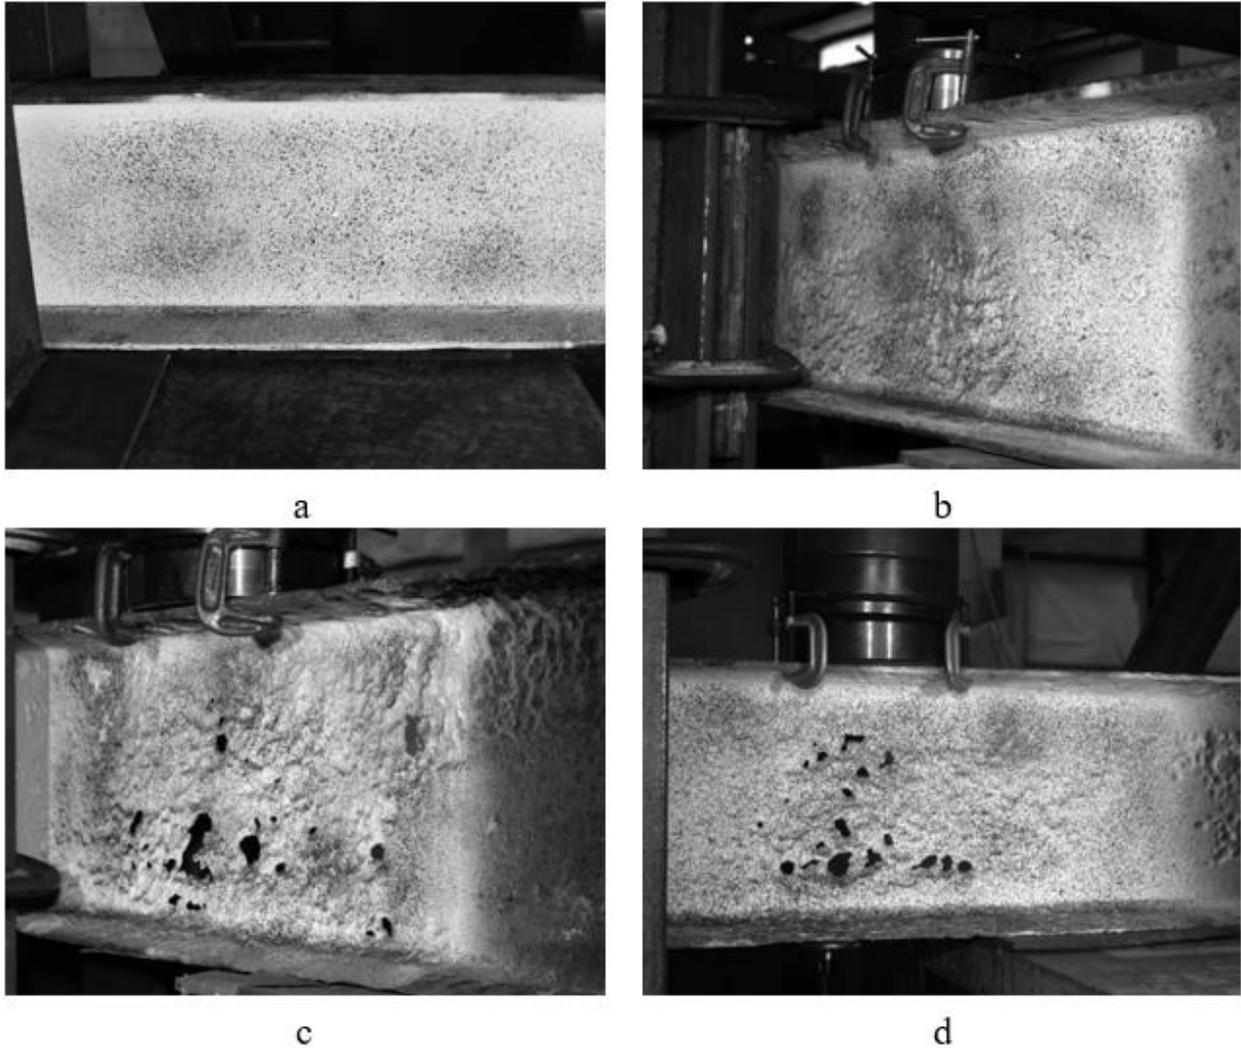
Specimen 2-S8-ML featured significantly more section loss than Specimen 1-S8-L. The decision to use this beam as the medium-low-damage specimen was driven by the presence of significant section losses without any through-web holes. As the study progressed, it became clear that the corrosion on Specimens 2-S8-ML, 3-S8-MH, and 4-S8-H was unlike most patterns characteristic of deck joint failure. The deterioration of a joint failure would follow the path of water runoff along the height of the beam end and near the bottom flange where water typically pools.

Figure 12. Photographs of S8x18.4 Beam End Specimens With Stochastic Patterns Showing Corrosion Damage: (a) 1-S8-L; (b) 2-S8-ML; (c) 3-S8-MH; (d) 4-S8-H.

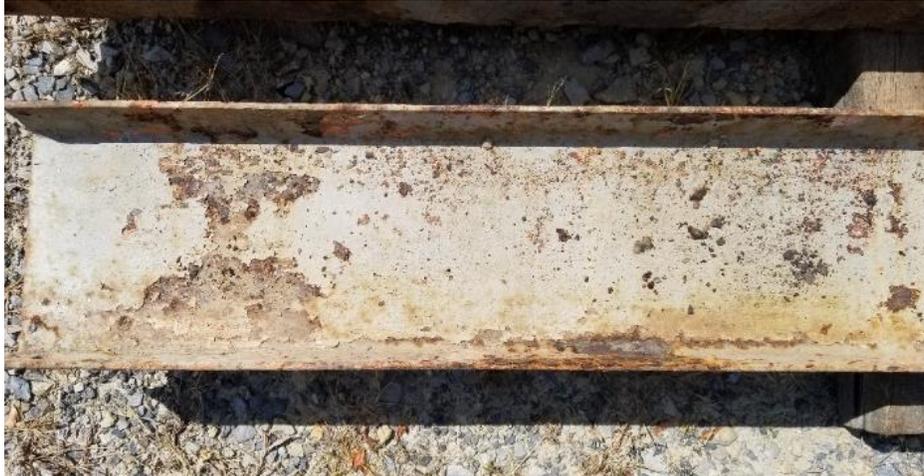
Figure 13. Image of Specimen 1-S8-L After Arrival at Laboratory

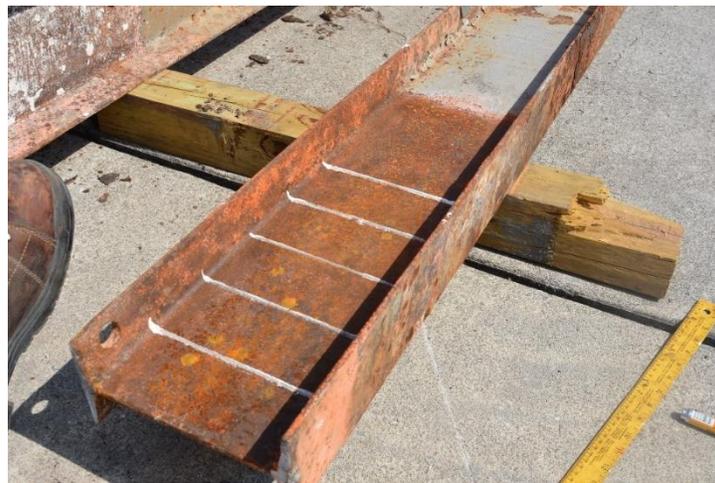
Figure 14. Specimen 1-S8-L Stripped of Paint

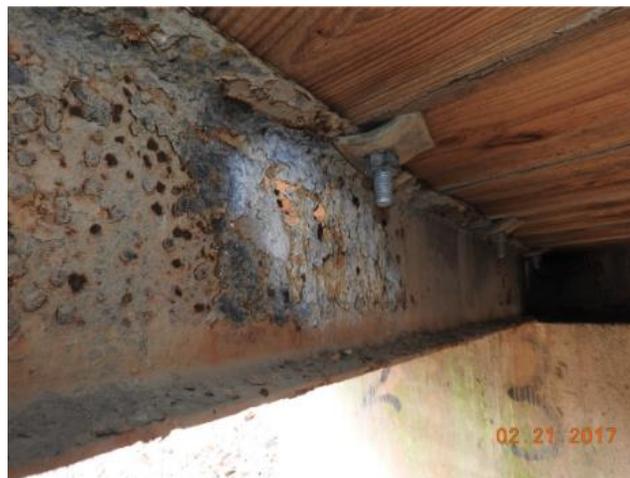
Figure 15. Example of Steel Beam Timber Deck Web Corrosion

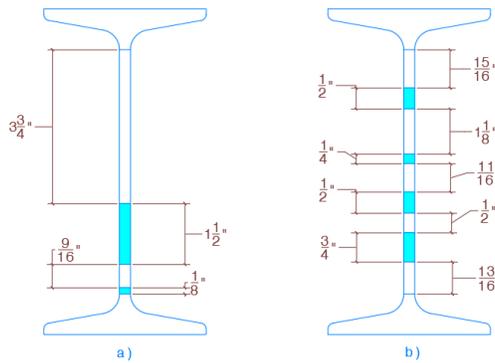
In Figure 16, a comparative drawing of the cross sections illustrates the dimensions of these holes without the surrounding section losses. The ratio of hole to total web cross-sectional area between the flanges results in a 27% section loss for Specimen 3-S8-MH and a 33% section loss for Section 4-S8-H. When the specimen matrix was created, this simplified cross section was used as the rationale for assigning the condition rankings.

Figure 16. Comparison of Worst Cross Sections: (a) 3-S8-MH; (b) 4-S8-H.

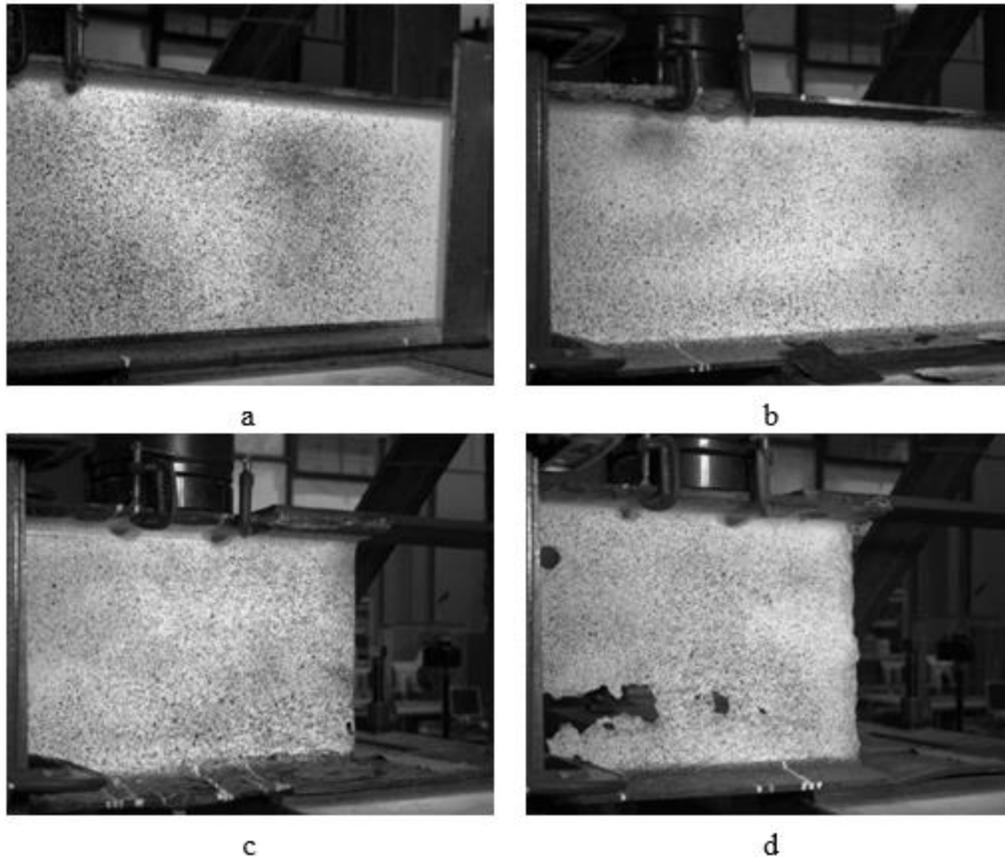
The W10x26 beams selected did show significant corrosion; however, severe damage was found on only one beam in the set. Portions of this beam served as both the medium-high and high-damage specimen to provide the necessary range of damage for the test matrix. First, Specimen 7-W10-MH was loaded 1 ft from the beam's end. However, adjustments had to be made since the last 4 in of the span did not fully extend to the bracing to the north of the support to prevent lateral torsional buckling. A 2-ft steel plate was welded to the last 6 in along the top flange, shown at the top of Figure 17c. This plate extended across the north support to the two angle braces in place of additional beam length.

Figure 17. Photographs of W10x26 Beam End Specimens With Stochastic Patterns Showing Corrosion Damage: (a) 5-W10-L; (b) 6-W10-ML; (c) 7-W10-MH; (d) 8-W10-H.

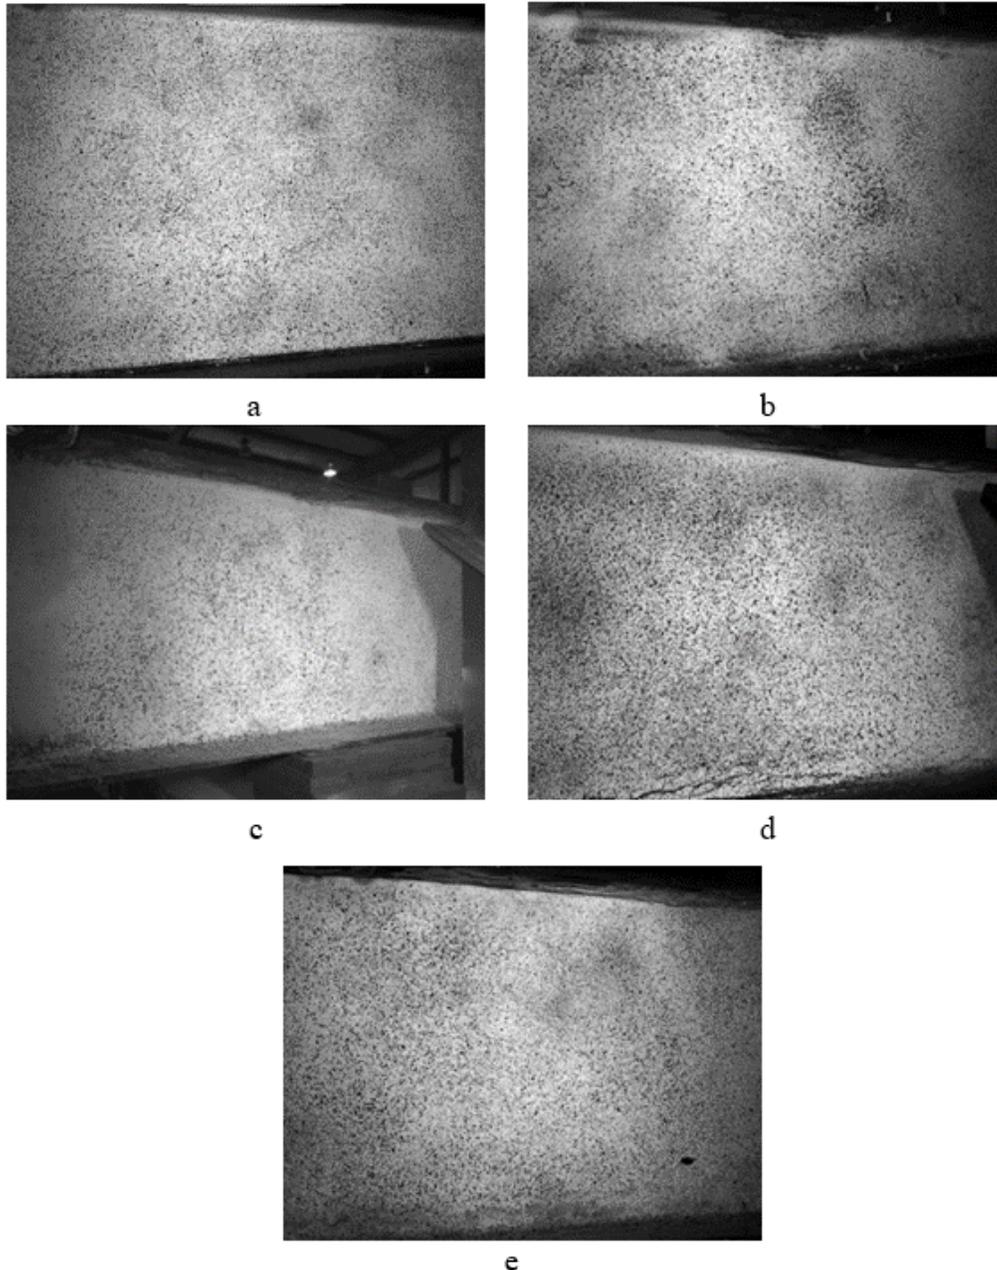
The third set of beams comprised W16x45 beams that came from a completed bridge replacement. Concerns with the bridge's remaining capacity because of corrosion made this decommissioned bridge an appropriate candidate for testing. Six beams with varying levels of damage were transported by a contractor to the structures laboratory at Virginia Tech in February 2020. The low-damage specimen was selected from among the beams with minimal visible corrosion and intact coatings. Figure 18 shows images of all of the W16x45 corroded beam ends with applied stochastic patterns.

Figure 18. Photographs of W16x24 Beam End Specimens With Stochastic Patterns Showing Corrosion Damage: (a) 13-W16-L(A); (b) 9-W16-L; (c) 10-W16-ML; (d) 11-W16-MH; (e) 12-W16-H.

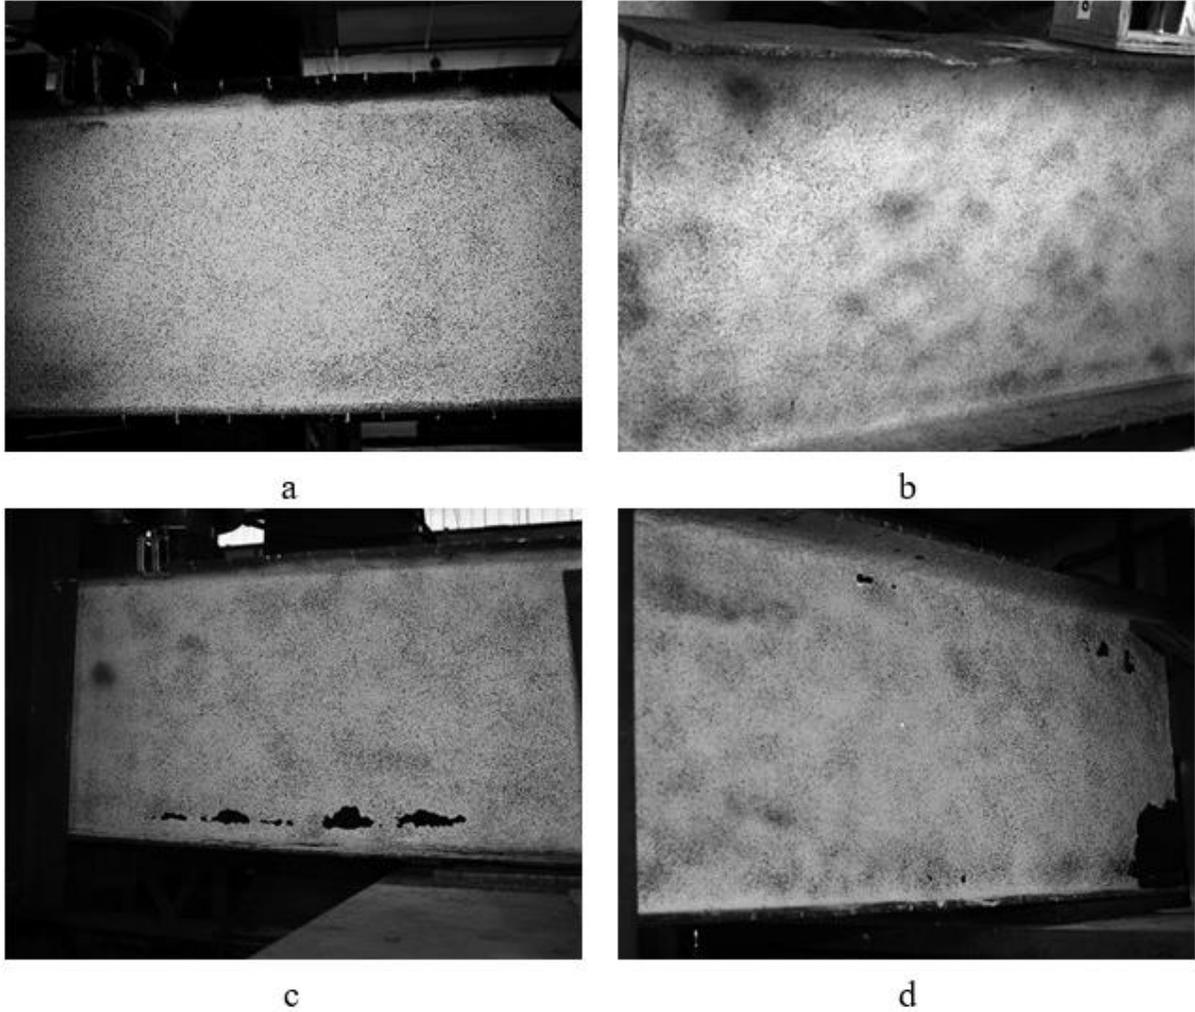
Figure 19. Photographs of W21x62 Beam End Specimens With Stochastic Patterns Showing Corrosion Damage: (a) 14-W21-L; (b) 15-W21-ML; (c) 16-W21-MH; (d) 17-W21-H.

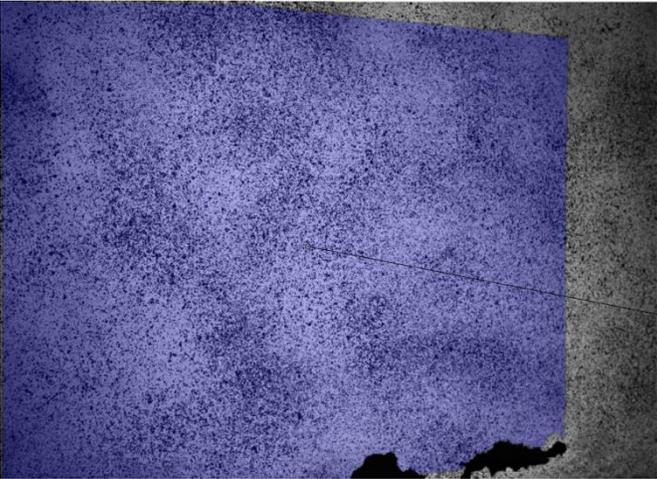
Figure 20. Specimen 16-W21-MH Camera View and DIC Displacement Field. DIC = digital image correlation.

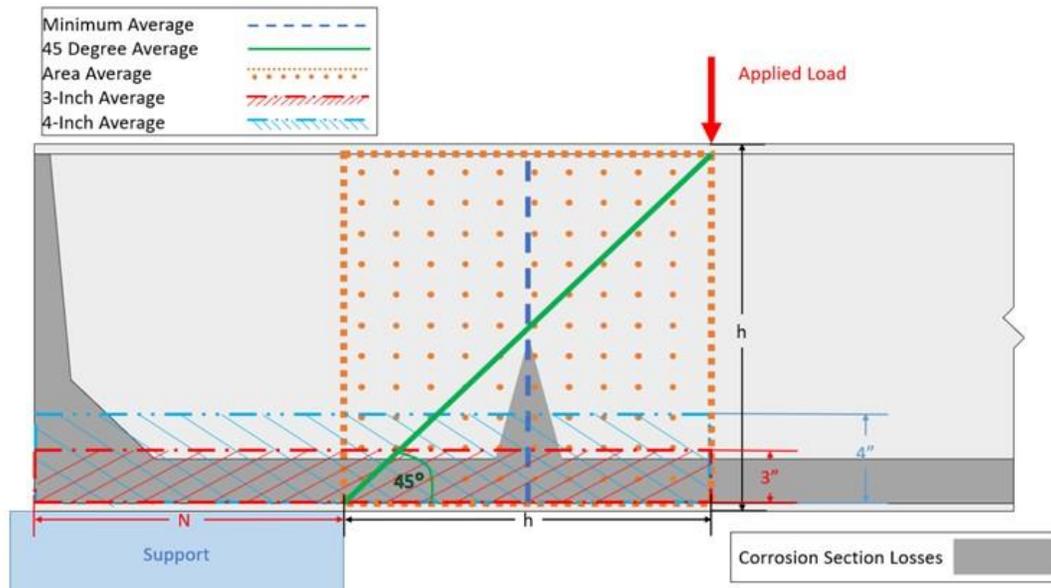
Figure 21. Methods for Calculating Average Web Thickness

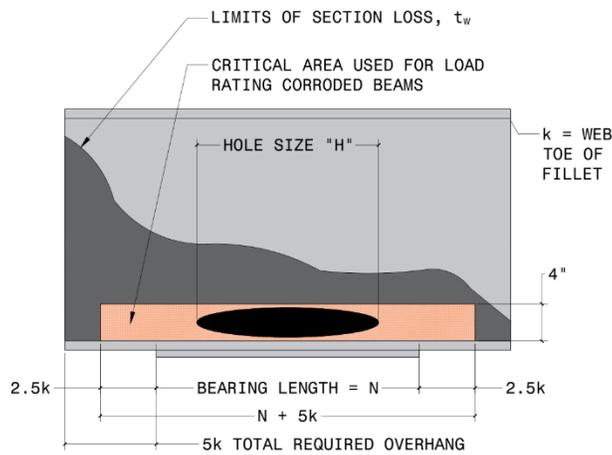
Figure 23. End of Beam Elevation Describing the Deteriorated Beam End

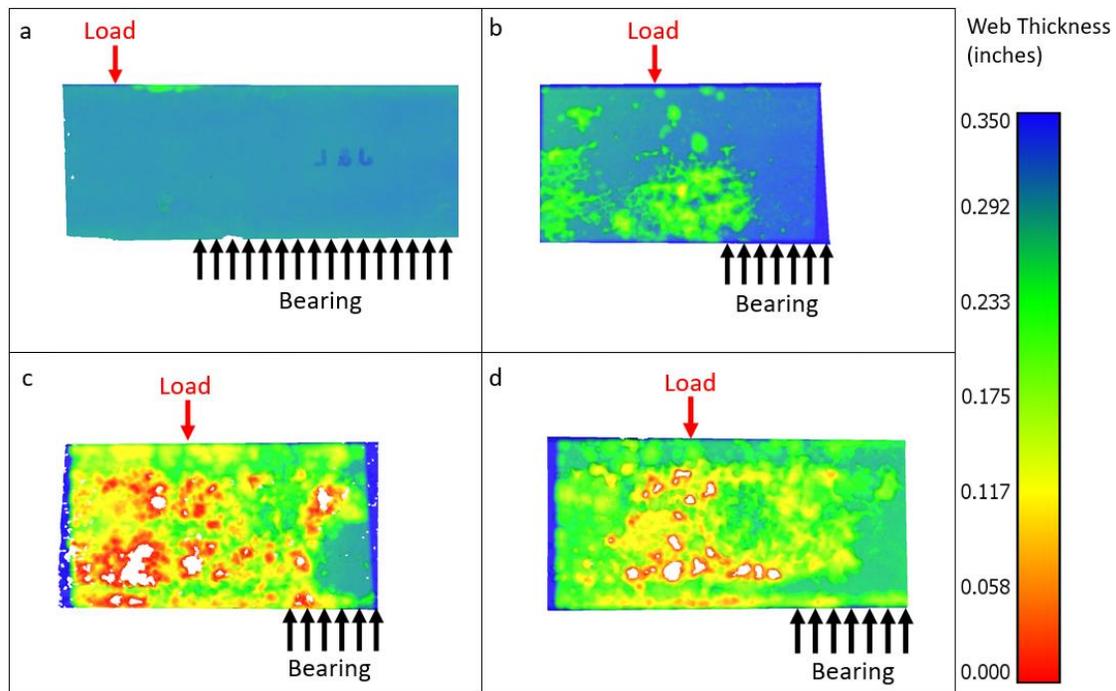
Because of Specimen 1-S8-L being the low-damage beam, there is nothing of note about the surface profile outside of the fact that few noticeable section losses were present. In Figure 24a, small amounts of section loss can be seen toward the top of the web in green. However, the depth of these deformities is approximately 0.06 in or slightly less than 1/16 in. For the purpose of this study, Specimen 1-S8-L can be compared to a new beam as these losses equate to a highly localized 2% thickness loss. This type of damage is insignificant by the measure of any of the studies mentioned in the literature review. The multiple holes present on the figure's left and right are due to the DIC camera failing to recognize points on the painted stochastic pattern.

Figure 24. Heat Maps Showing Web Thickness of S8x18.4 Beam End Specimens: (a) 1-S8-L; (b) 2-S8-ML; (c) 3-S8-MH; (d) 4-S8-H.

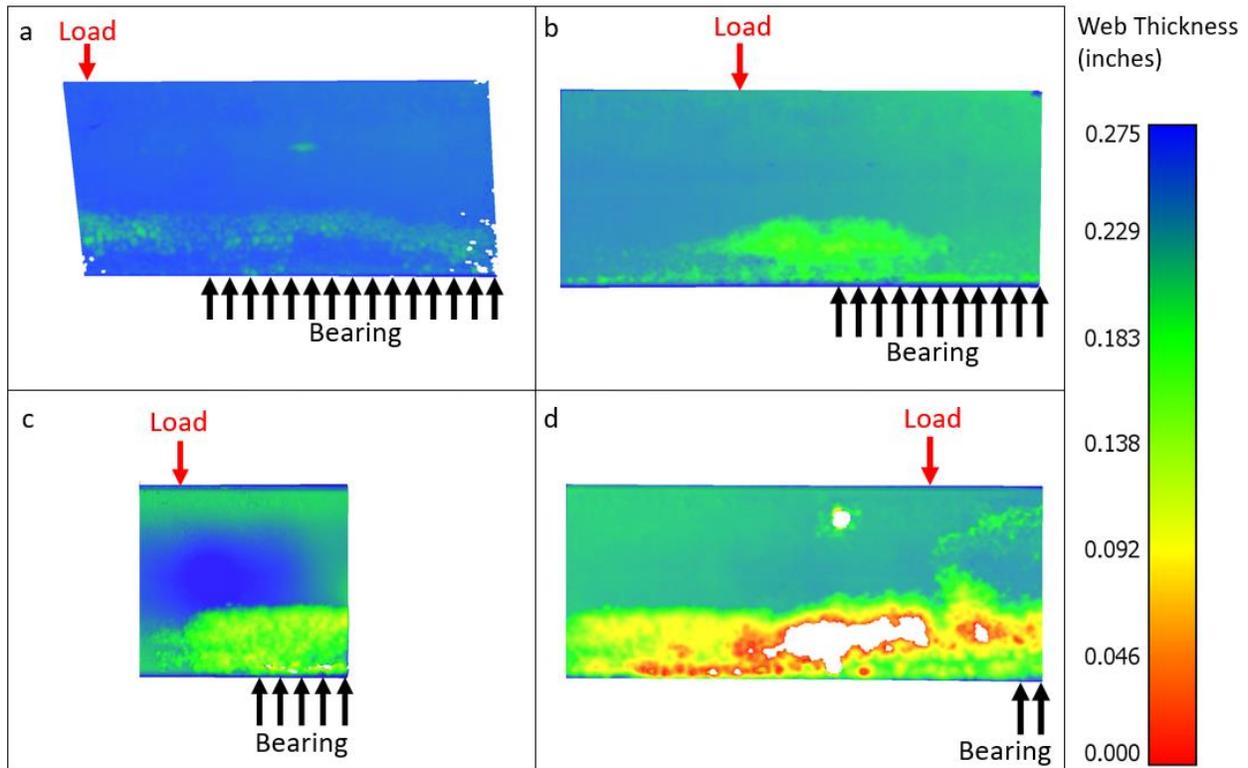
The uniform corrosion in Specimen 5-W10-L amounted to approximately 0.03 in of thickness loss, which was the least of any of the W10x45 shapes tested. The deepest section losses appear as green on the heat map in Figure 25a; however, they still represent only about 0.05 in of loss.

Figure 25. Heat Maps Showing Web Thickness of W10x26 Beam End Specimens: (a) 5-W10-L; (b) 6-W10-ML; (c) 7-W10-MH; (d) 8-W10-H.

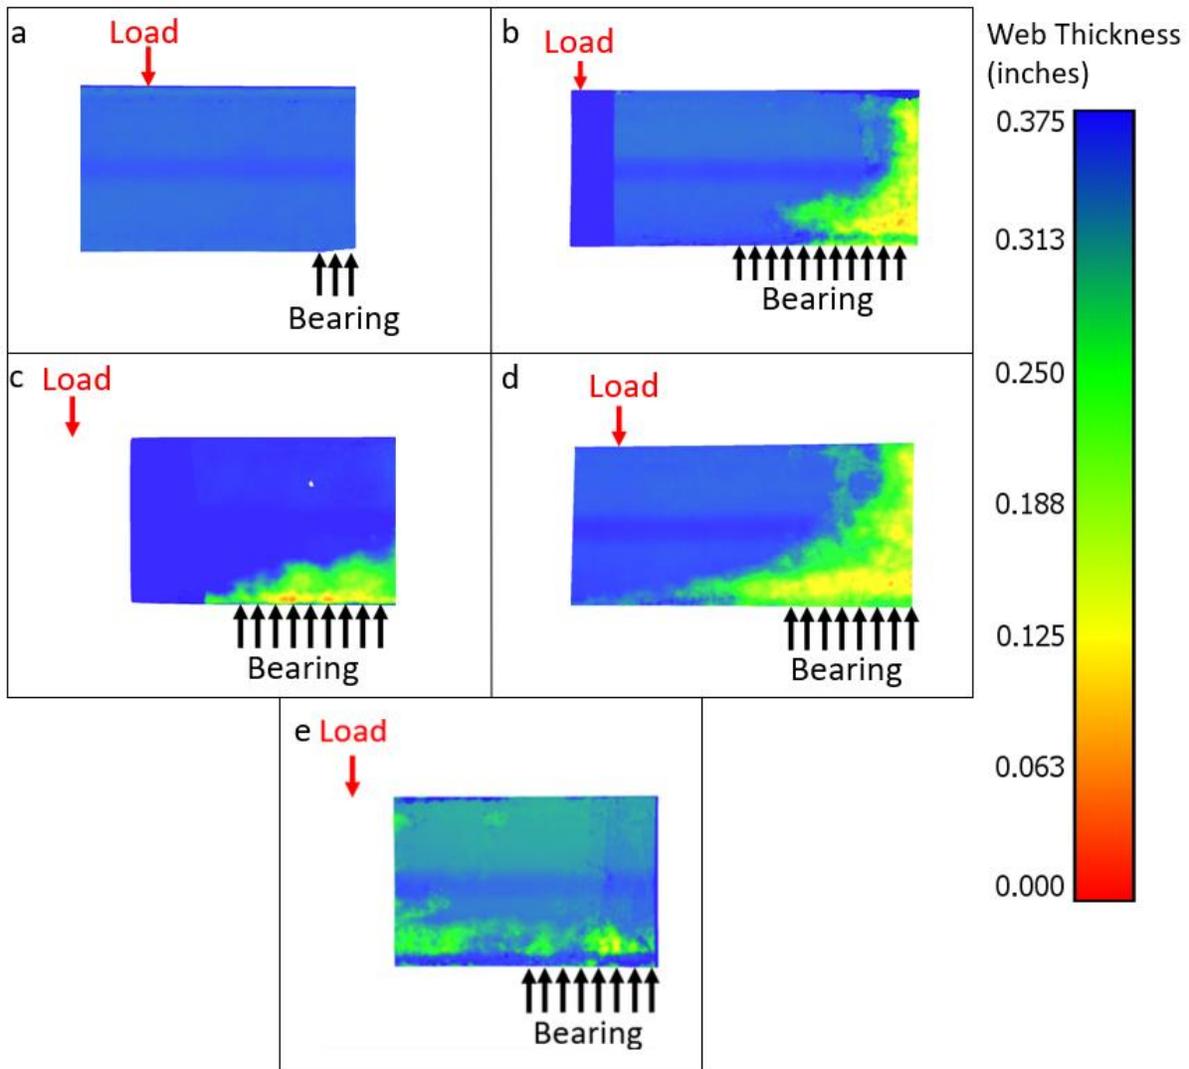
Specimen 10-W16-ML was selected as the medium-low-damage beam because of web section losses near the bottom flange across its length, which is characteristic of corrosion patterns caused by water pooling. Damage to the W16x45 beams was relatively consistent with this lower web loss pattern, and the order of severity was selected based on the presence of localized damage. Upon visual inspection, Specimen 10-W16-ML showed relatively low amounts of section losses on both sides of the web, ranging from 0.04 to 0.2 in of total web thickness loss, as shown in Figure 26c. It should be noted that the web scans for Specimen 10-W16-ML do not continue to the applied load location because of the range of the DIC camera. The red arrow representing the load is placed approximately where the point load was applied during testing to the left of the scan.

Figure 26. Heat Maps Showing Web Thickness of W16x45 Beam End Specimens: (a) 13-W16-L(A); (b) 9-W16-L; (c) 10-W16-ML; (d) M1-W16-MH; (e) 12-W16-H.

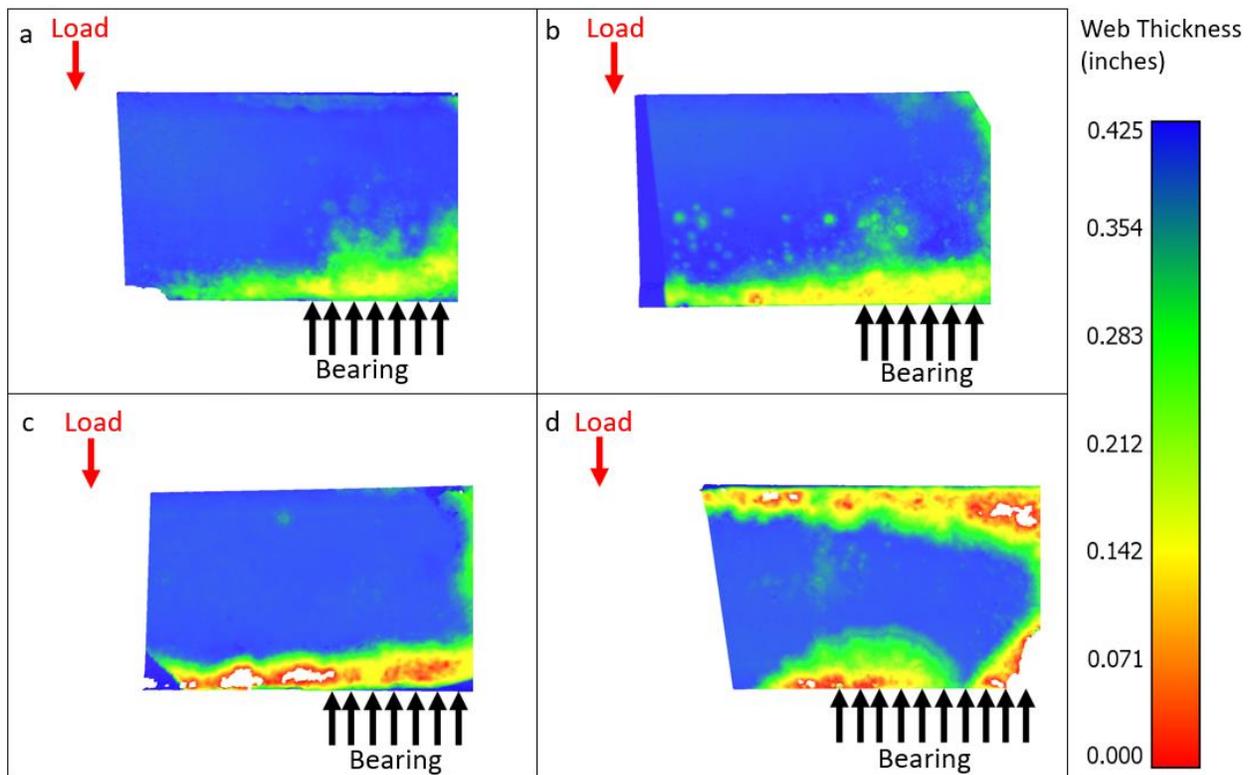
Figure 27 shows the web thickness heat maps of the W21x62 beams. Despite being the low-damage specimen, Specimen 14-W21-L still showed a fair amount of section losses throughout its length. This was due to the history of the W21x62 bridge beams, as they were sourced from a storage yard and were sitting outdoors for several years before delivery to the Virginia Tech structures laboratory. All of the W21x62 beams had some section loss, but Specimen 14-W21-L had the least amount of damage. The heat map in Figure 27a shows the extent of this section loss, ranging from 0.1 to 0.25 in of total thickness reduction.

Figure 27. Heat Maps Showing Web Thickness of W21x62 Beam End Specimens: (a) 14-W21-L; (b) 15-W21-ML; (c) 16-W21-MH; (d) 17-W21-H.

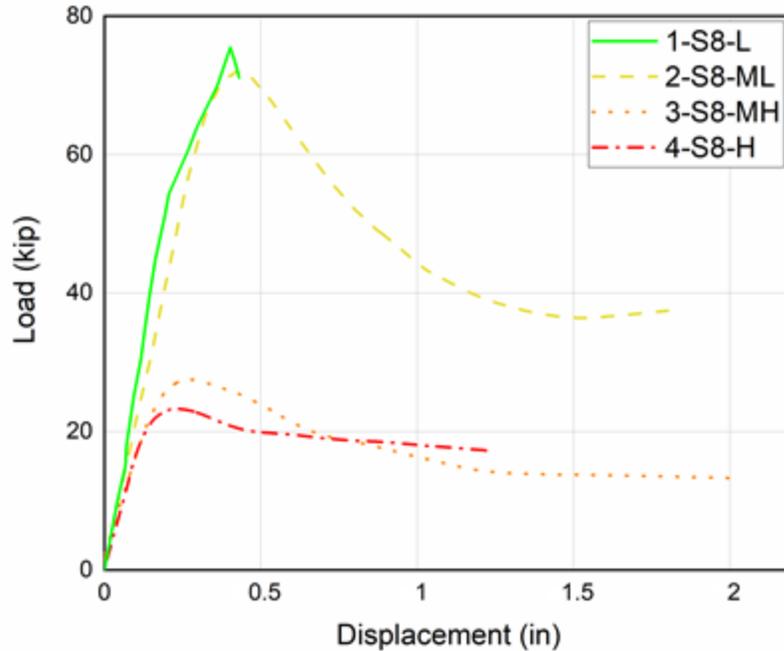
The load curves for the first set of S8x18.4 beams were as expected; however, it should be noted that the data gathered for Specimen 1-S8-L were more linear than for the others (Figure 28). The first test was performed with the string potentiometer placed away from the applied load because of restrictions on available space. Because comparing data gathered in this alternate position to those of the other S8x18.4 beam tests would be inappropriate, the displacements for Specimen 1-S8-L were instead determined using DIC measurements. For this specific case, displacement measurements were averaged from five sampled points placed along the bottom flange fillet. These locations were selected to reduce the influence of vertical displacement because of web deformation.

Figure 28. Load vs. Displacement Data for S8x18.4 Beams

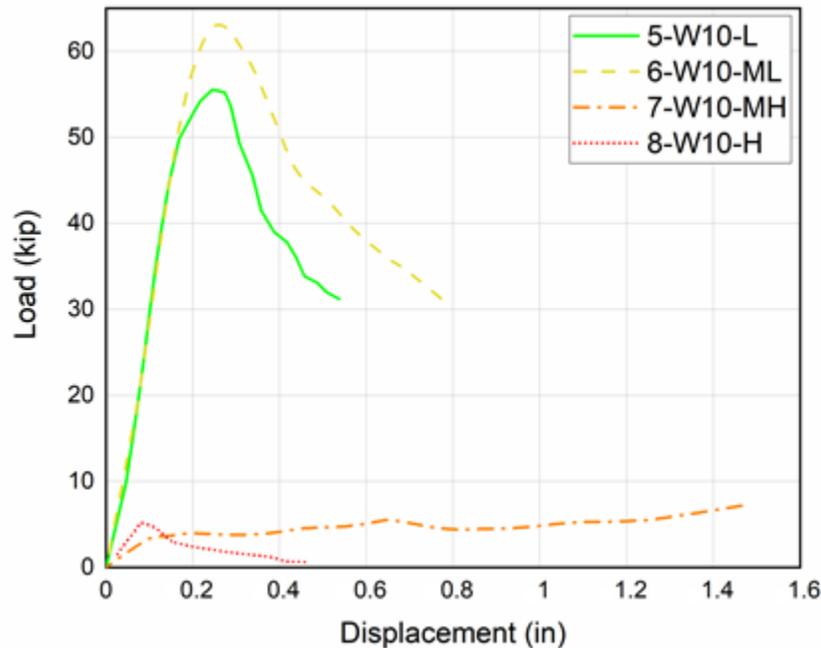
The separation between the low- and medium-low-damage specimens and the two higher-damage beams was much greater than for the first beam set. Although the two high-damage W10x26 beams had holes like the S8x18.4 beams, the main distinguishing factor was the reduced web surface to resist cracking. After a crack propagated across the full length of the engaged shear area, the webs failed. Discussion of the strain fields later in the report discusses this behavior regarding Specimens 7-W10-MH and 8-W10-H.

Figure 29. Load vs. Displacement Data for W10x26 Beams

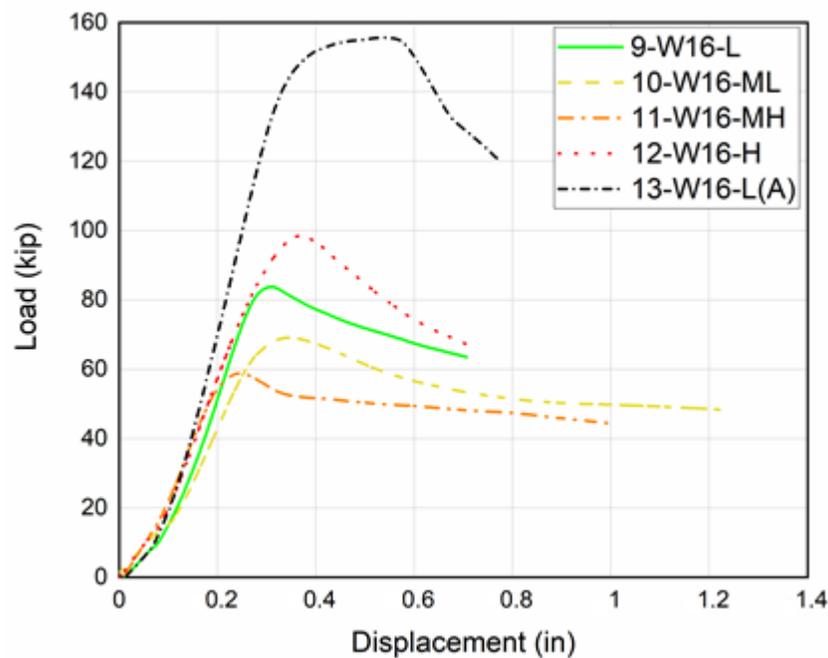
Figure 30. Load vs. Displacement Data for W16x45 Beams

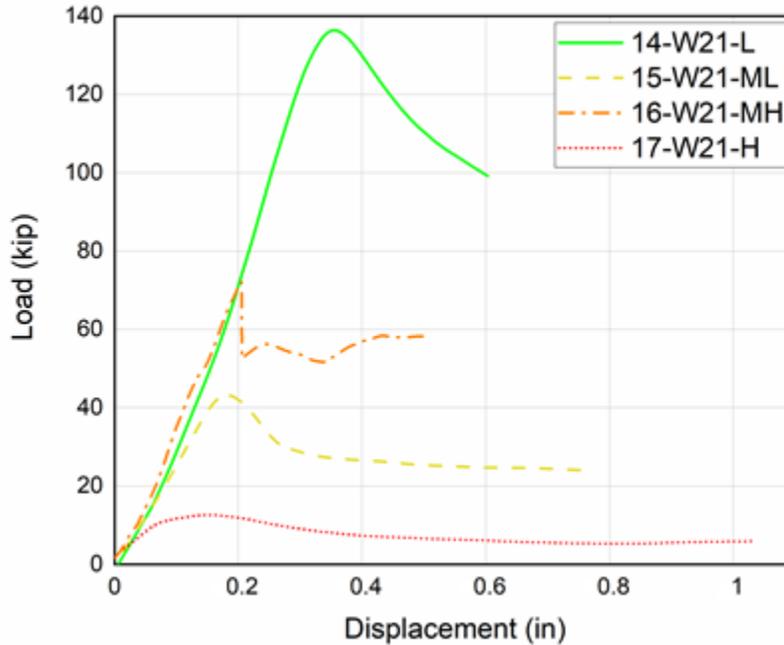
The load versus displacement curves for the W21x62 beams once again followed a similar pre-failure linear relationship between load and displacement, seen in Figure 31. The maximum load, compared to the AASHTO and AISC beam shear capacities using the minimum average web thickness taken between the beam end and the applied load, is shown in Table 15.

Figure 31. Load vs. Displacement Data for W21x62 Beams

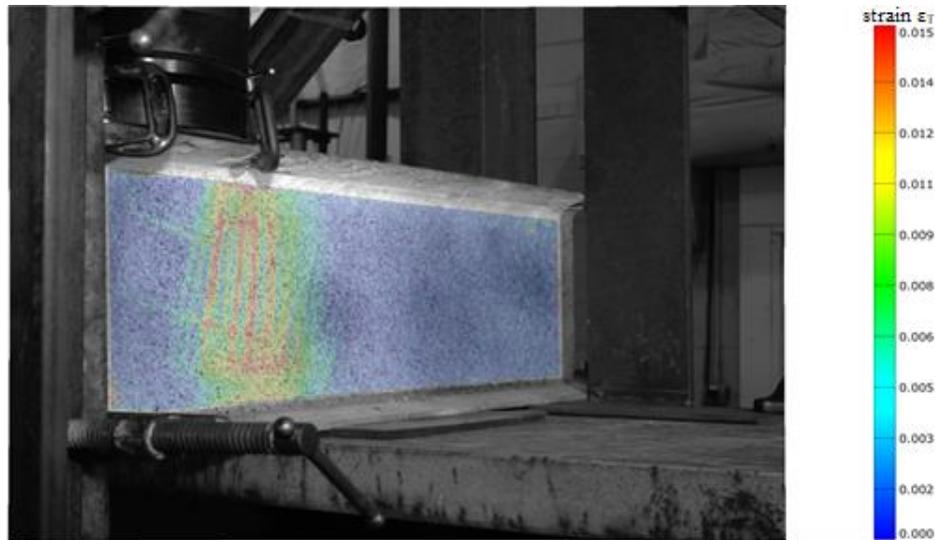
Figure 32. True Major Strain Field of Specimen 1-S8-L at 55 kips of Loading
