Methods for Evaluation of the Remaining Shear Capacity in Steel Bridge Beams With Section Losses Attributable to Corrosion Damage

Final Report VTRC 22-R4

FINAL REPORT

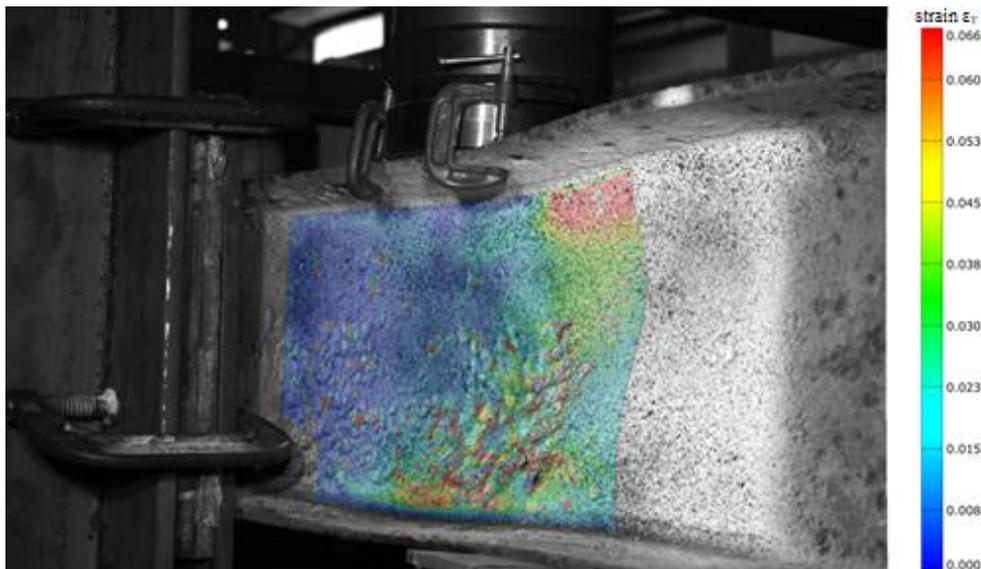
Figure 33. True Major Strain Field of Specimen 2-S8-ML at 0.7 in of Vertical Displacement After Failure

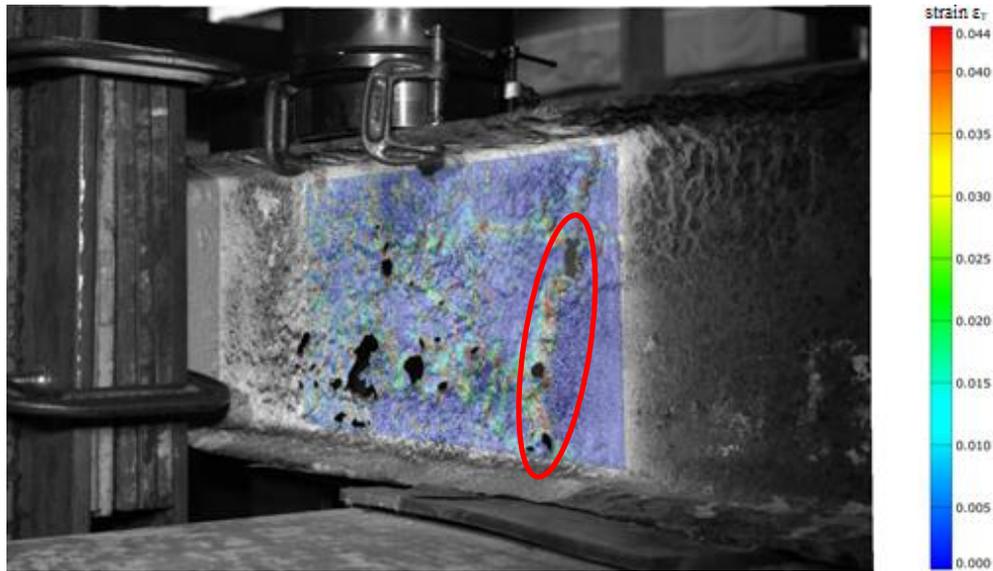
Figure 34. True Major Strain Field of Specimen 3-S8-MH at 20 kips of Loading Before Failure

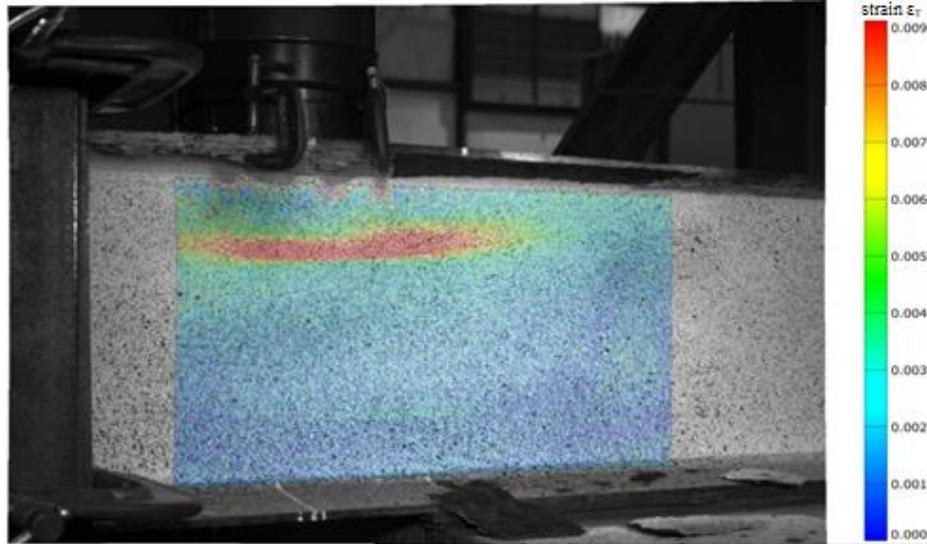
Figure 35. True Major Strain Field of Specimen 6-W10-ML at 49.9 kips of Loading Before Failure

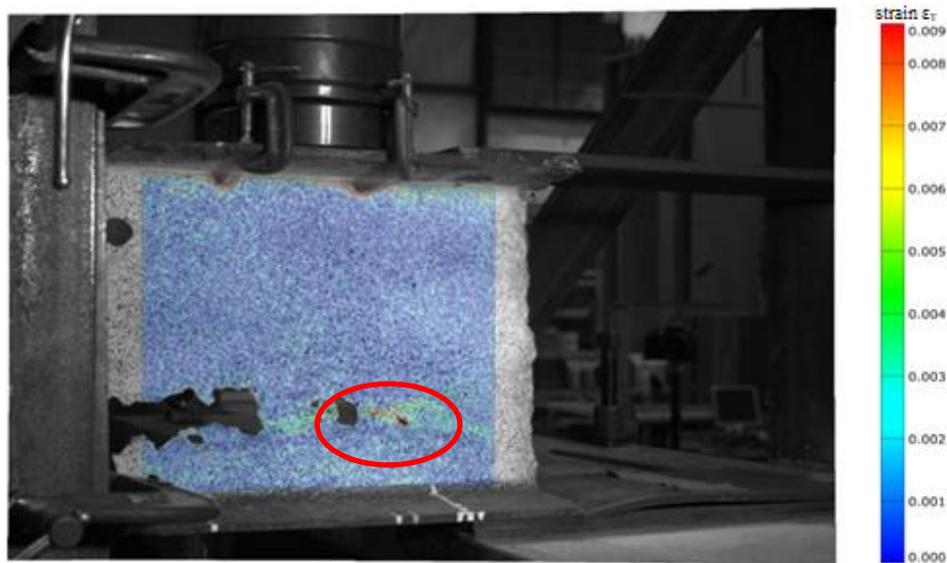
Figure 36. True Major Strain Field of Specimen 8-W10-H at 5 kips of Loading Before Maximum Loading

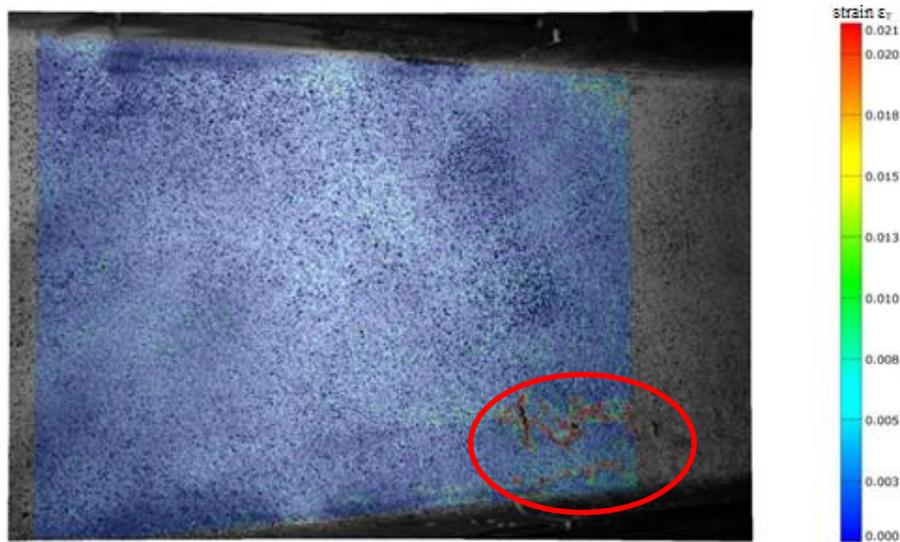
Figure 37. True Major Strain Field of Specimen 9-W16-L at 77 kips of Loading Before Failure

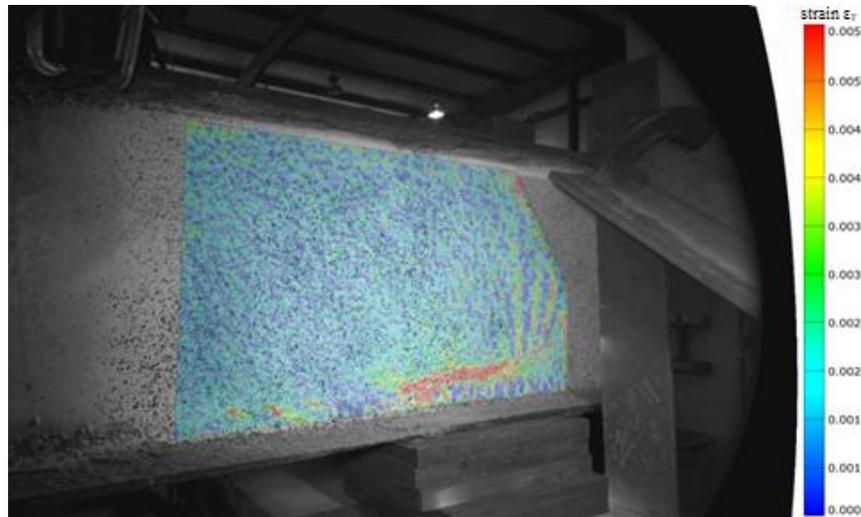
Figure 38. True Major Strain Field of Specimen 10-W16-ML at 67 kips of Loading Before Failure

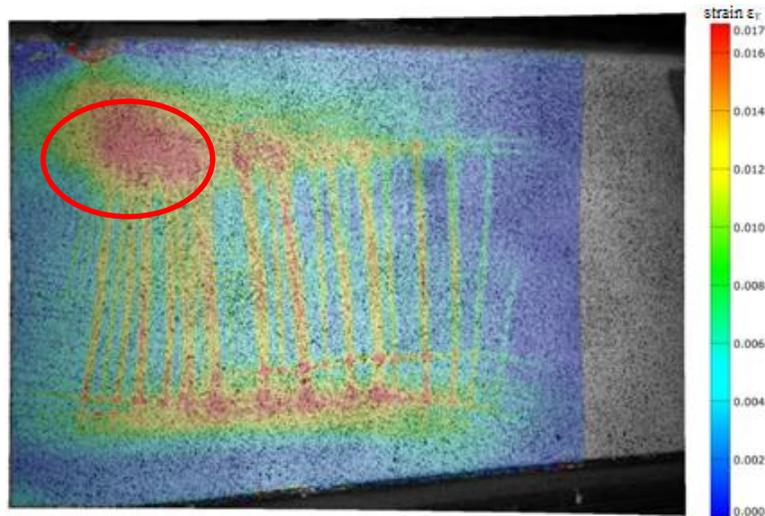
Figure 39. True Major Strain Field of Specimen 13-W16-L(A) at 145 kips of Loading Before Failure

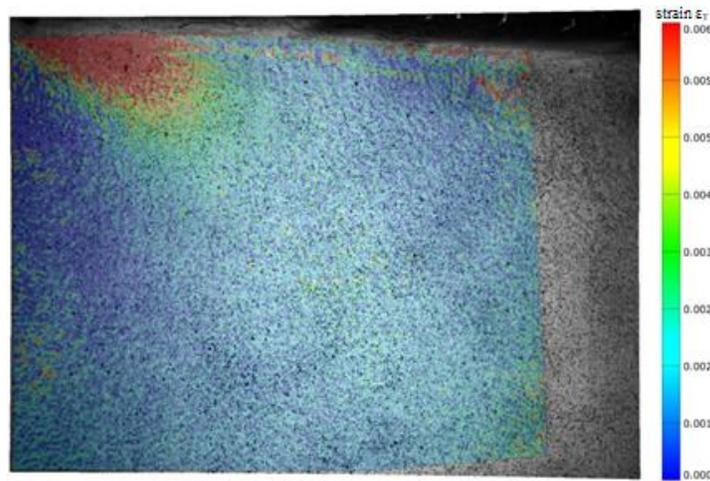
Figure 40. True Major Strain Field of Specimen 14-W21-L at 133 kips of Loading Before Failure

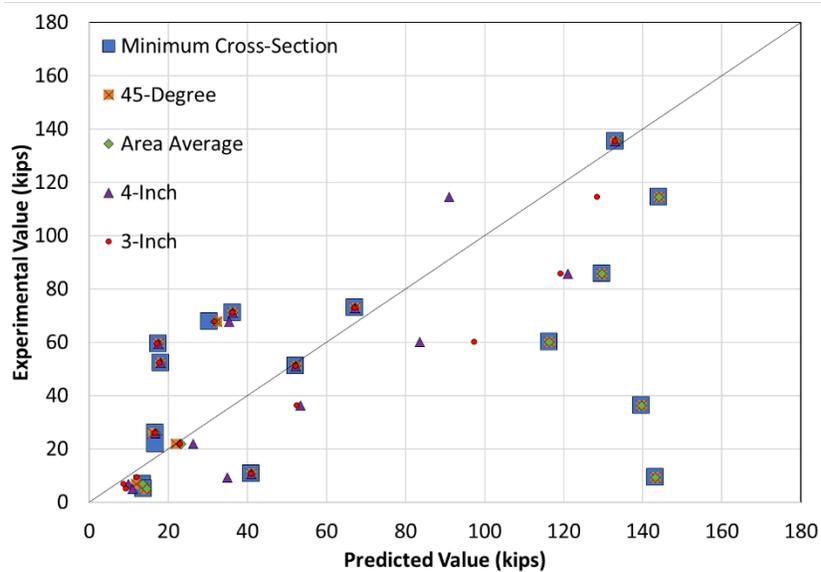
Figure 41. Prediction Error Plot of Maximum Experimental Shear Load vs. AASHTO Shear Capacity Using Five Thickness Measurement Methods

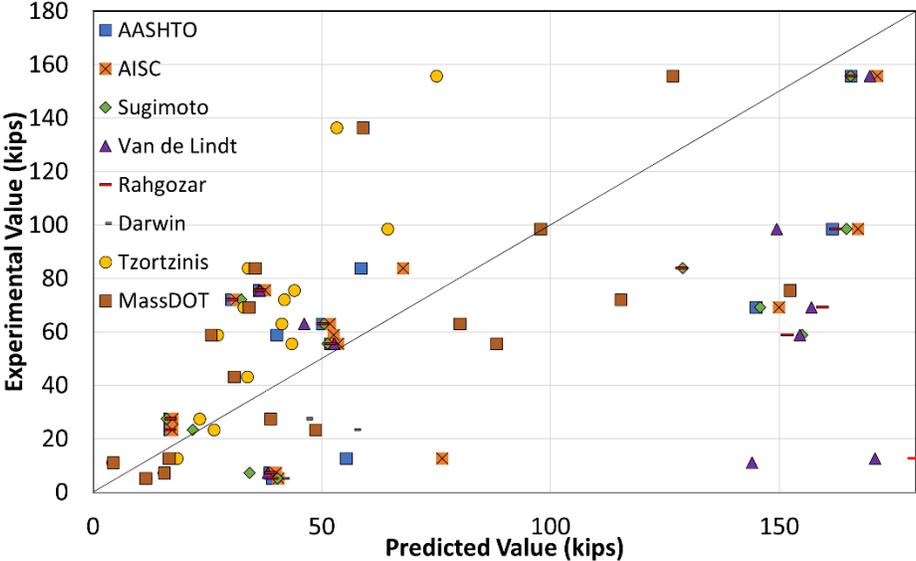
Figure 42. Prediction Error Plot for All Tested Calculation Methods

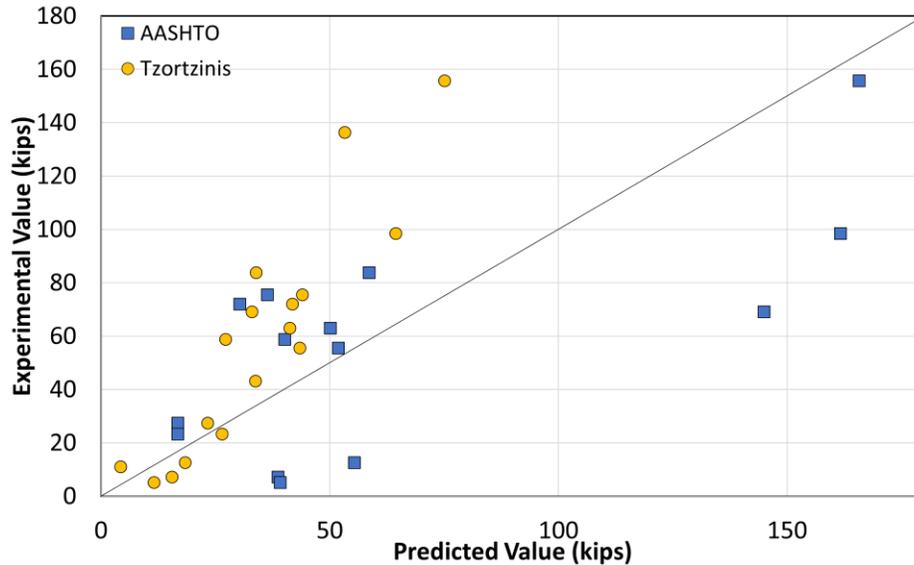
Figure 43. Prediction Error Plot for AASHTO and Tzortzinis et al. Capacity Calculations Using Remaining Average Thickness Over Corroded Web Portion

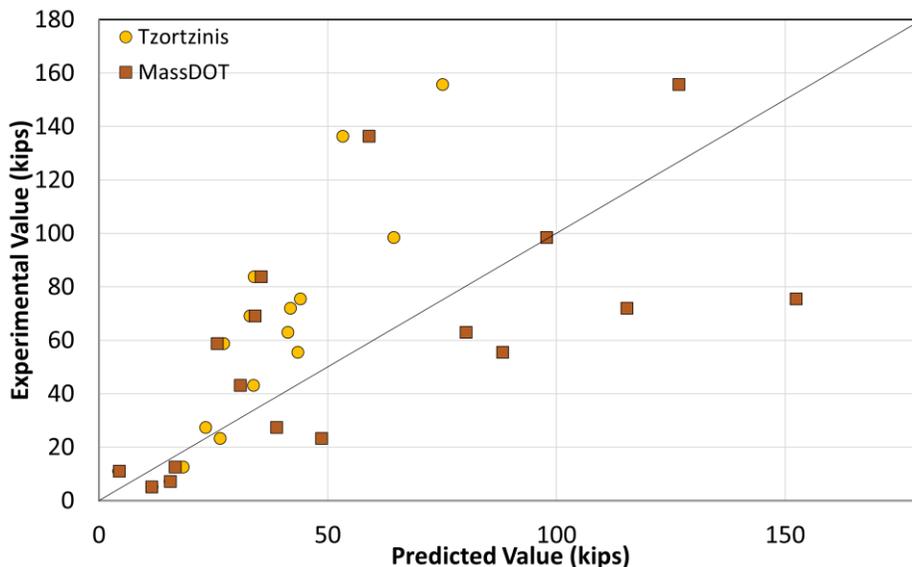
Figure 44. Prediction Error Plot for MassDOT and Tzortzinis et al. Capacity Calculation Methods

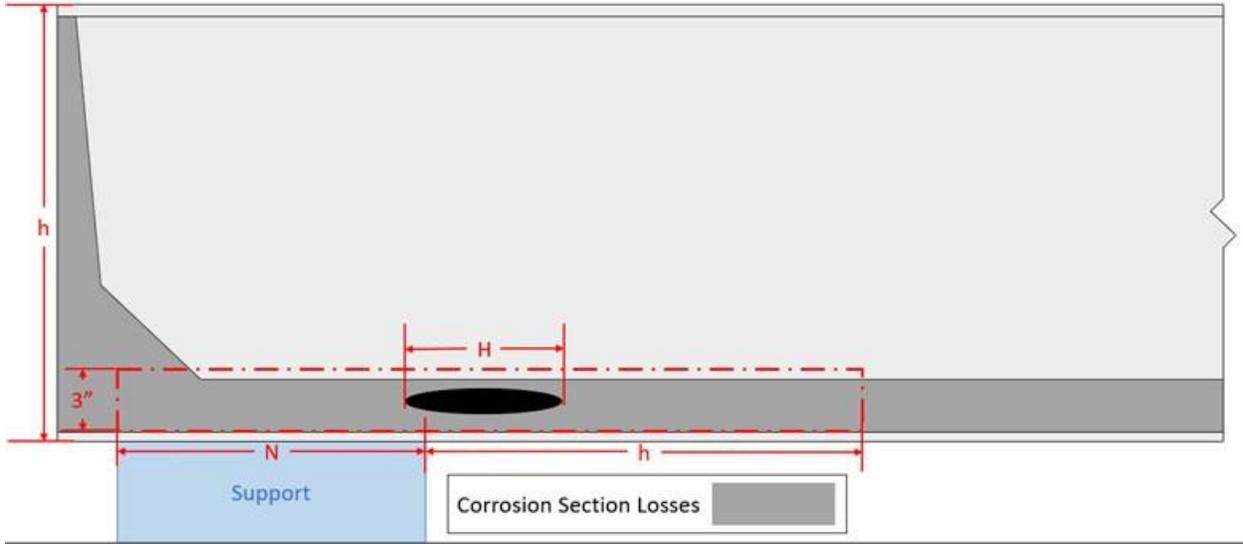
Figure 45. Critical Dimensions Used for Load Rating Corroded Steel Beams

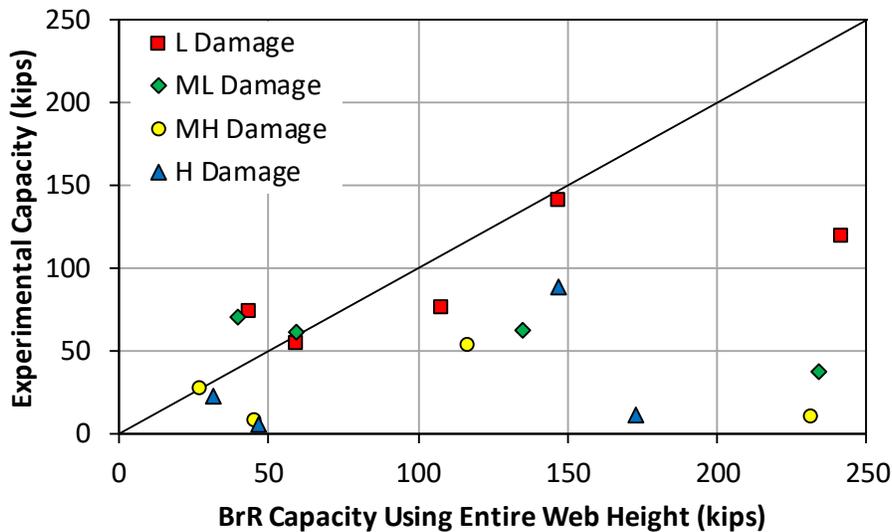
Figure 46. Comparison of Experimental and BrR Capacity. L = low; ML = medium-low; MH = medium-high; H = high.

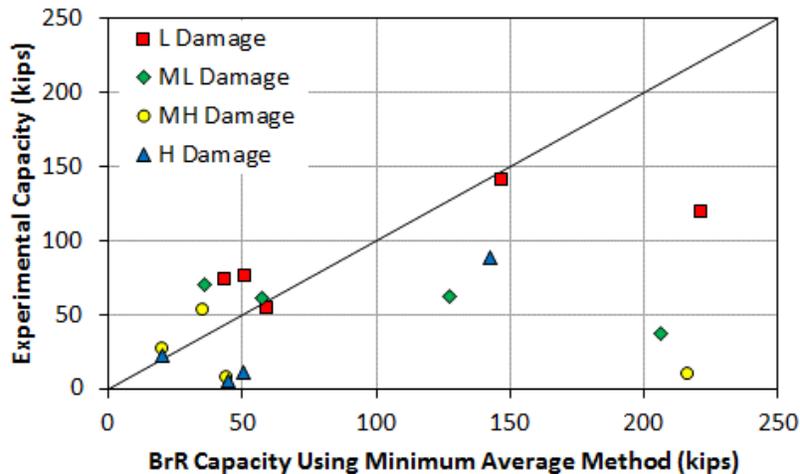
Figure 47. Comparison of Experimental and BrR Capacity Using the Minimum Average Method. L = low; ML = medium-low; MH = medium-high; H = high.

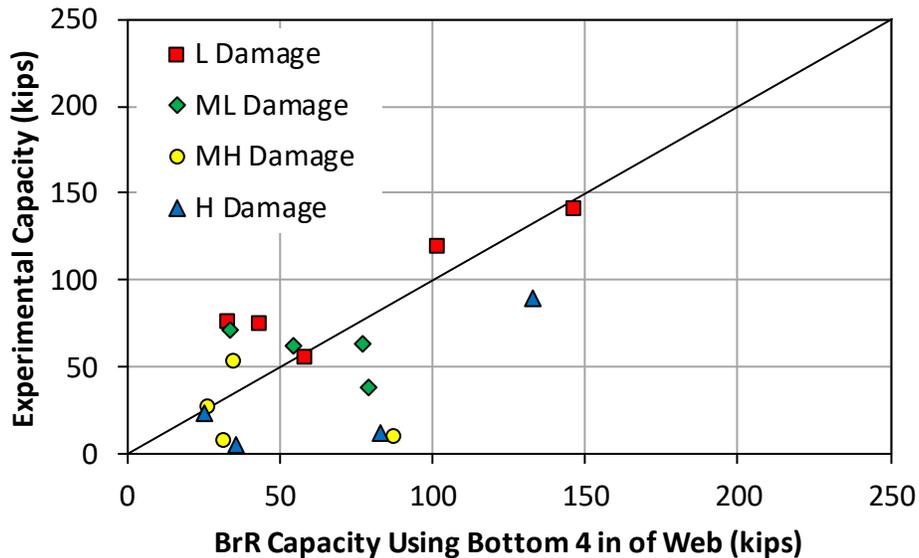
Figure 48. Comparison of Experimental and BrR Capacity Using Bottom 4 in of Web. L = low; ML = medium-low; MH = medium-low; H = high.

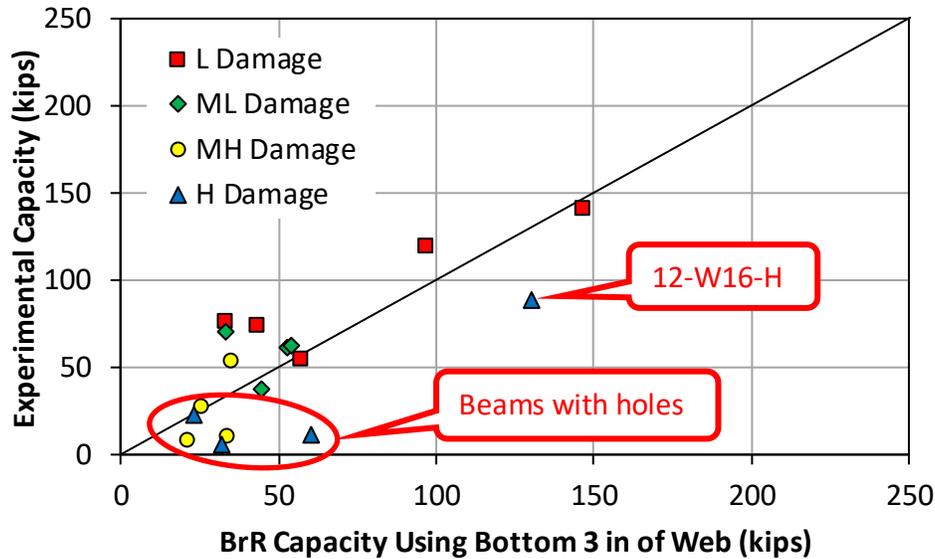
Figure 49. Comparison of Experimental and BrR Capacity Using Bottom 3 in of Web. L = low; ML = medium-low; MH = medium-high; H = high.

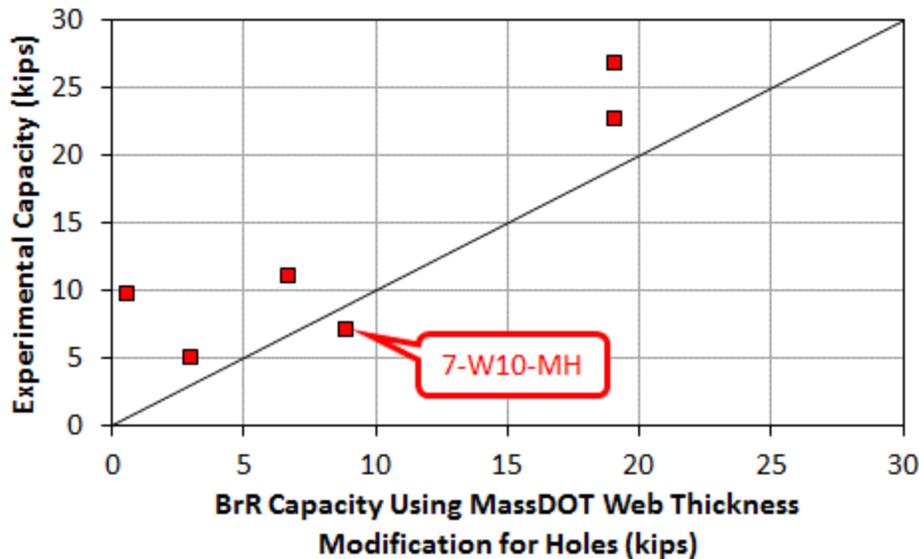
Figure 50. Comparison of Experimental and BrR Capacity Using MassDOT Effective Web Thickness Modification for Beams With Holes

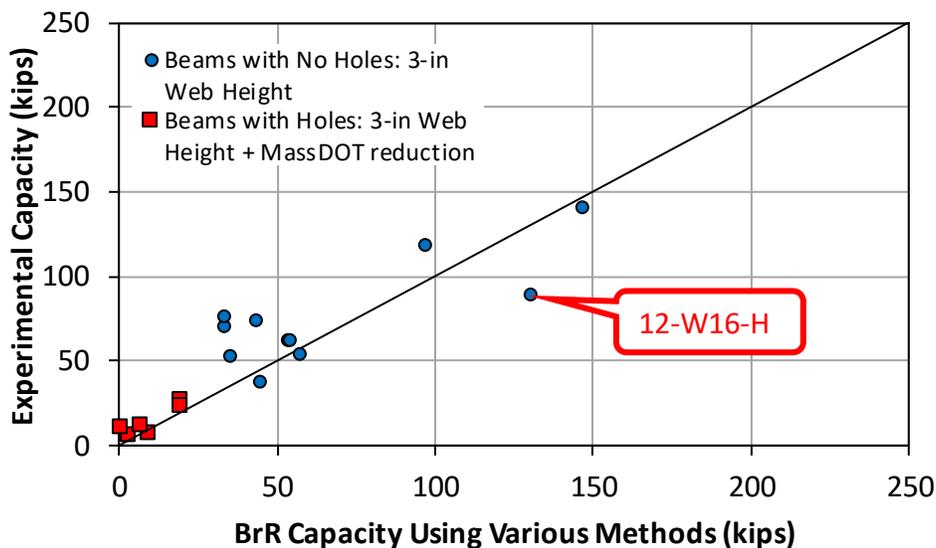
Figure 51. Comparison of Experimental and BrR Capacity Using Various Methods for Effective Web Thickness

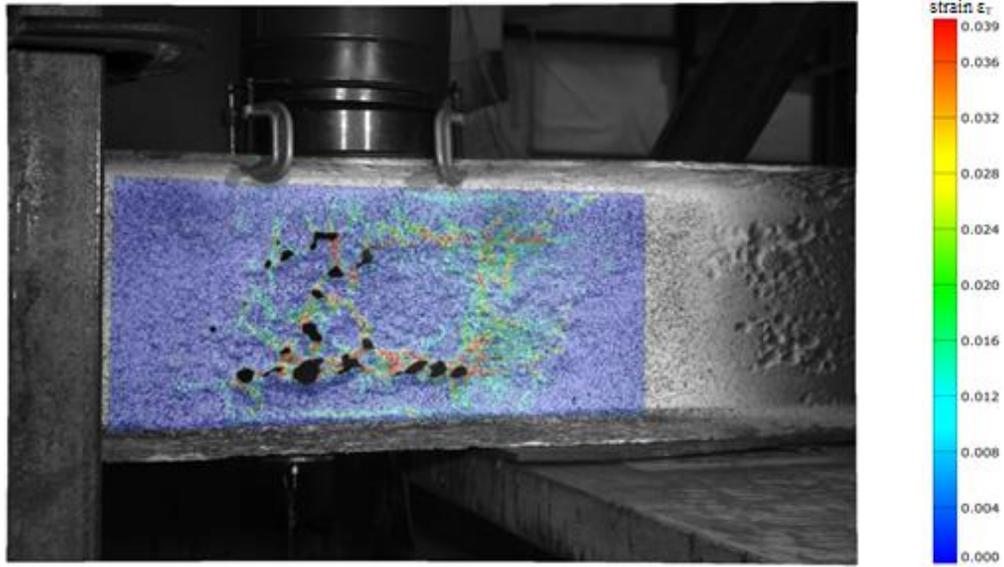
Figure A1. True Major Strain Field of Specimen 4-S8-H at 22.8 Kips of Loading Before Maximum Loading

The final high-damage S8x18.4 beam (Specimen4-S8-H) showed a similar strain development between the through-web holes (see Figure A1 in the Appendix).

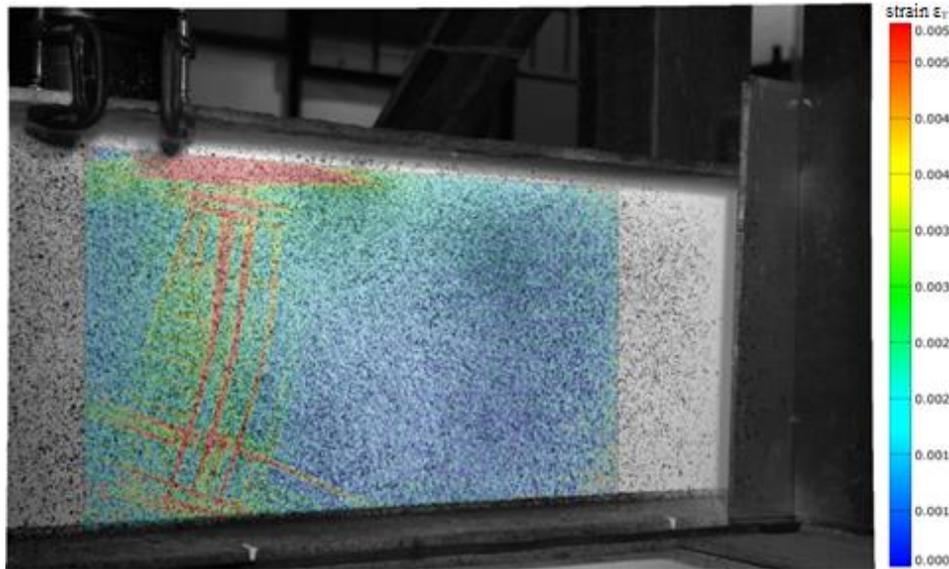
Figure A2. True Major Strain Field of Specimen 5-W10-L at 49.8 Kips of Loading Before Failure

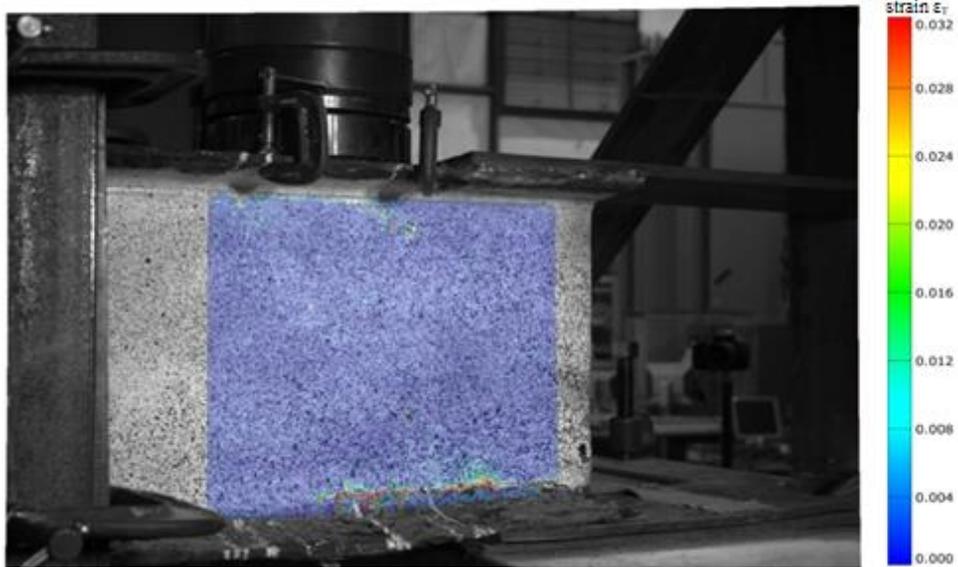
Figure A3. True Major Strain Field of Specimen 7-W10-MH at 0.45 in of Downward Vertical Displacement After Failure

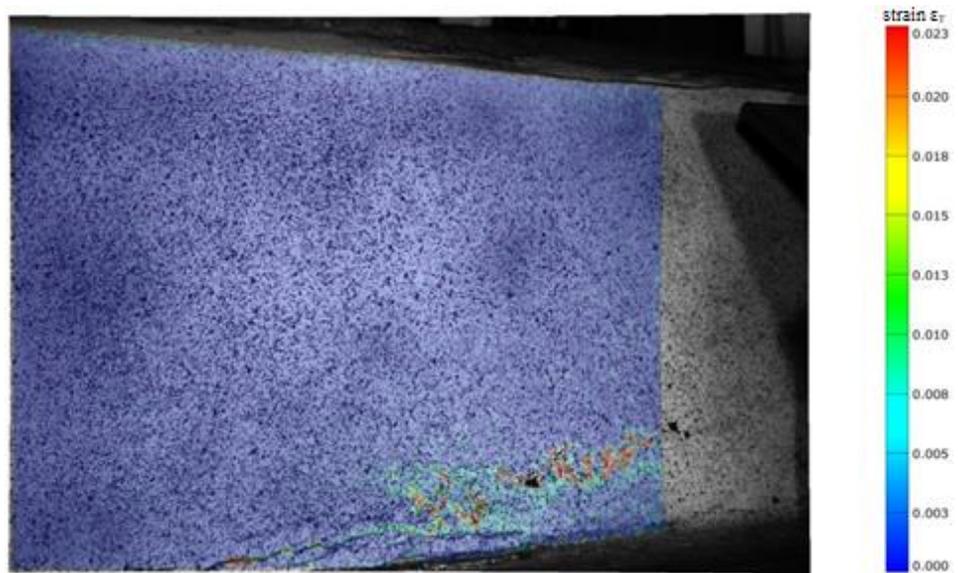
Figure A4. True Major Strain Field of Specimen 11-W16-MH at 55 Kips of Loading Before Failure

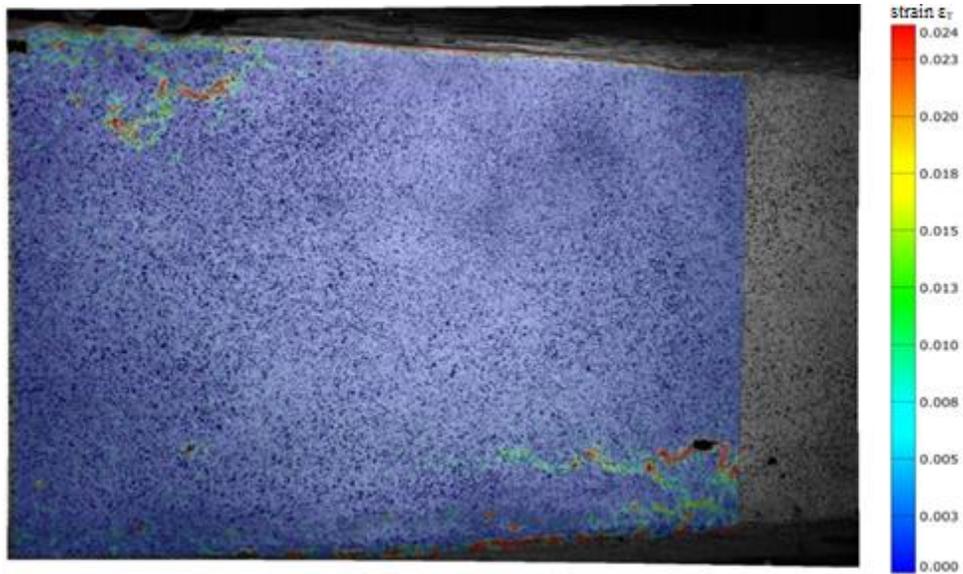
Figure A5. True Major Strain Field of Specimen 12-W16-H at 79 Kips of Loading Before Failure

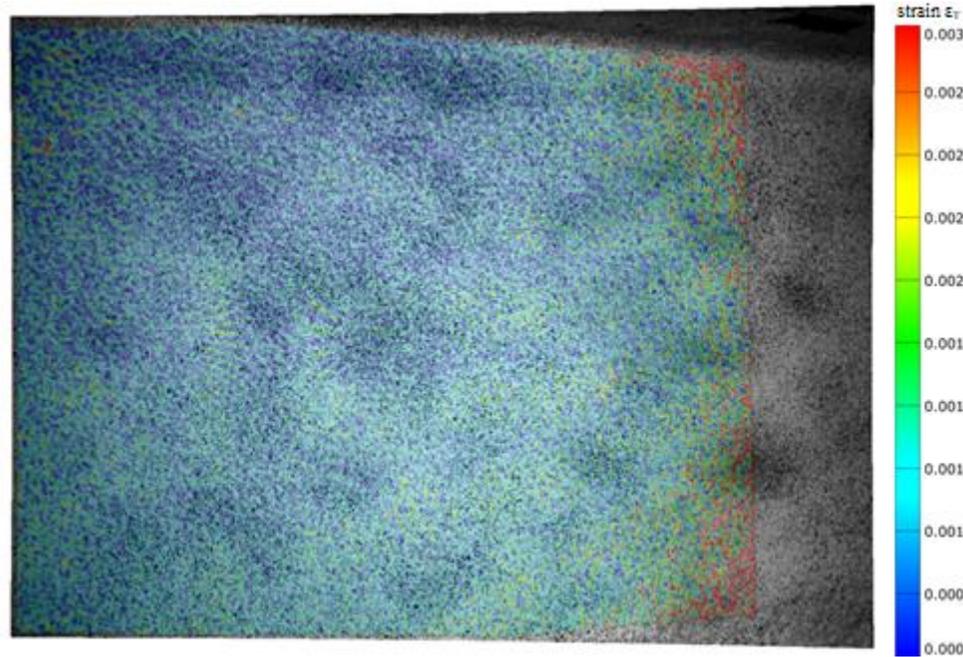
Figure A6. True Major Strain Field of Specimen 15-W21-ML at 45 kips Loading Before Failure

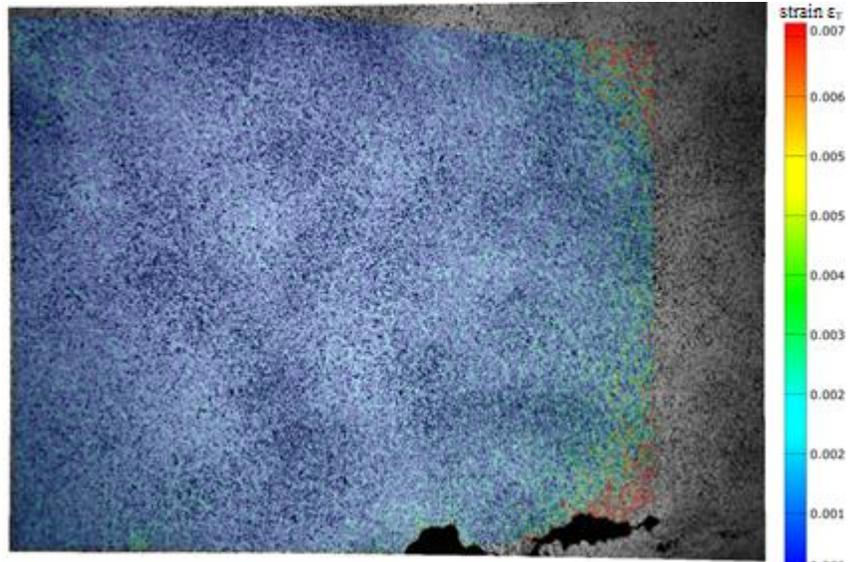
Figure A7. True Major Strain Field of Specimen 16-W21-MH at 0.15 in of Downward Vertical Displacement After Failure

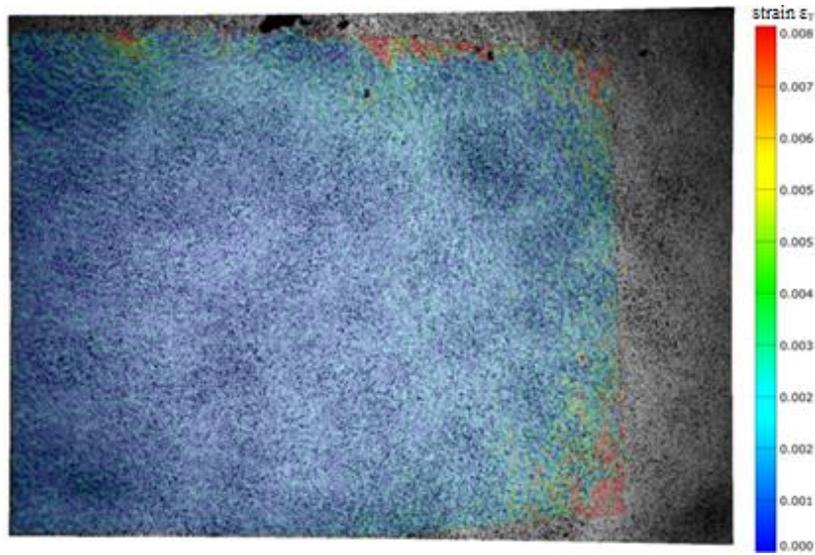
Figure A8. True Major Strain Field of Specimen 17-W21-H at 52 kips Loading Before Failure
