# Nondestructive Inspection Methods for Liquid Deicer Storage Tanks

**DEPARTMENT OF CIVIL AND ENVIRONMENTAL ENGINEERING  
VIRGINIA POLYTECHNIC INSTITUTE AND STATE UNIVERSITY**

**Final Report VTRC 23-R9**

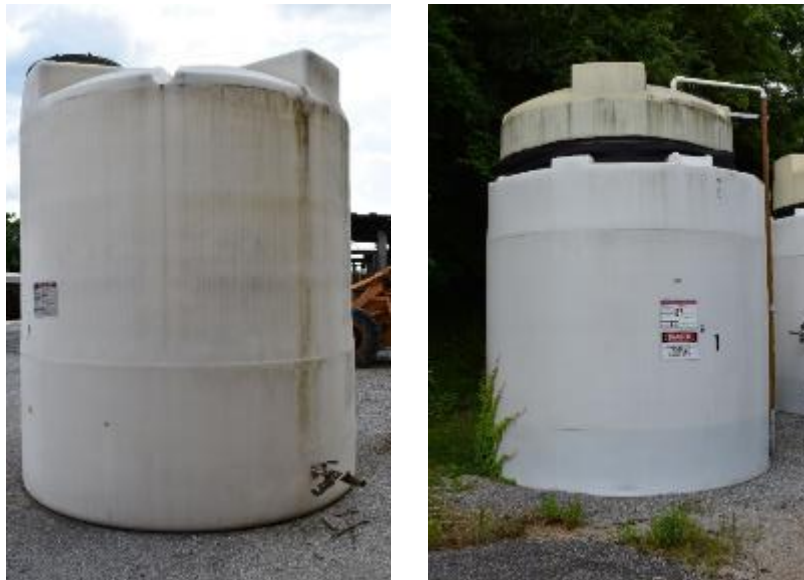
**Figure 1. Examples of single-walled (left) and double-walled (right) high-density polyethylene above ground storage tanks managed by VDOT**

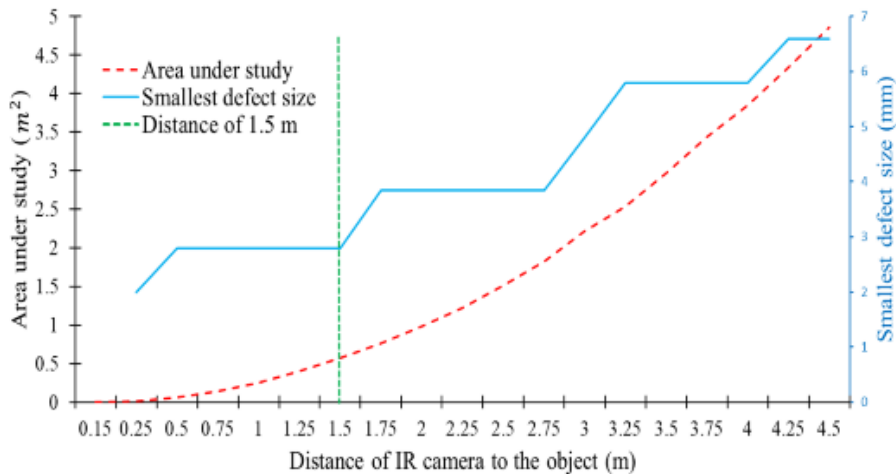
**Figure 3. Correlation between the infrared camera distance to the object and the area under study and the smallest observable defect size (note: 1 m = 3.28 ft, 1 mm = 0.039 in, and 1 m<sup>2</sup> = 10.76 ft<sup>2</sup>)**

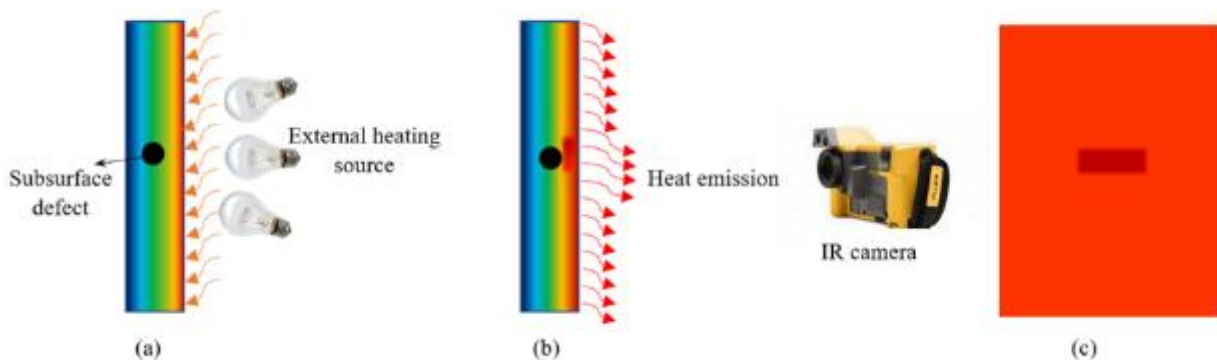
**Figure 9(a).** Schematic view of a plate cross-section during heating, (b) schematic view of the cross-section of a plate during Infrared thermography after removing the heating source, and (c) schematic view of a thermogram image with a contrast between the subsurface defect and surrounding area

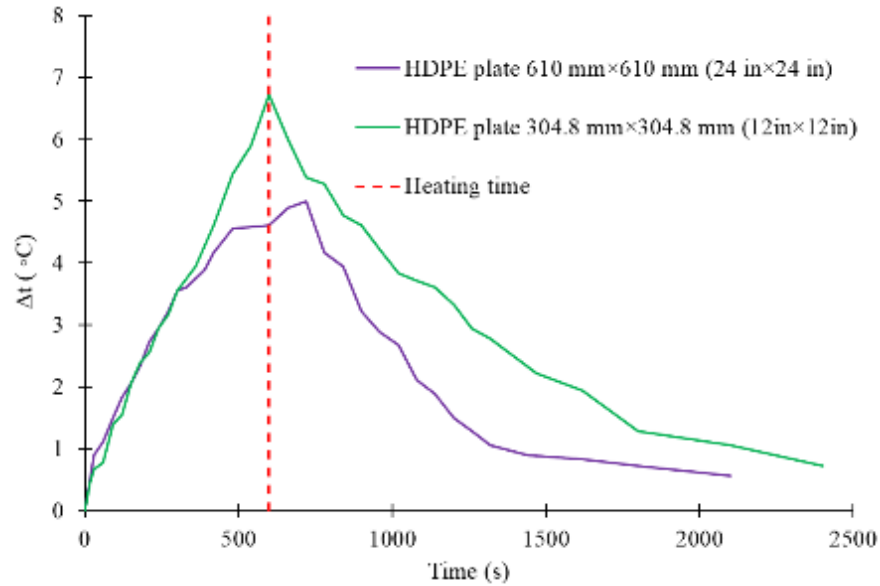
**Figure 10. Impact of dimension on the heat transfer in HDPE plates (note:  $(1^{\circ}\text{C} \times 9/5) + 32 = 33.8^{\circ}\text{F}$ )**

For this reason, the maximum temperature difference is lower in the plate with larger dimensions compared to the smaller plate with which the entire area is impacted by heating. These results show that when the specimen size increases, more energy (i.e., power and time of heating) is required to manipulate the temperature of the HDPE and induce the same thermal gradient over the thickness of the specimen. When the specimen size is small, the whole area is heated up, and the heat transfers only through the thickness of the sample. However, when the specimen size increases, the heat transfers in all directions of the HDPE plate and through the thickness of the sample. Therefore, it may reduce the efficiency of IRT in the field. Moreover, the conclusion on the impact of specimen size on IRT shows that, to apply IRT to the evaluation of HDPE ASTs in the field, a series of field tests are required to prove the efficacy of this technique.

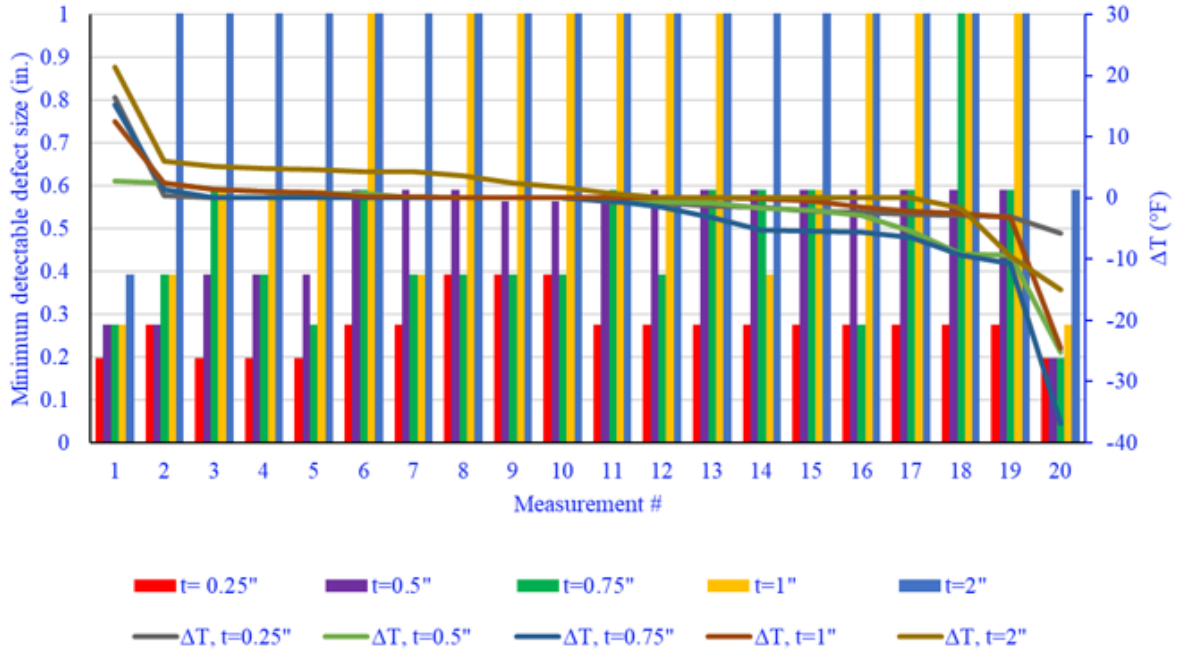
**Figure 13. Measurements of backside defects in all 20 measurements (a) R2 defects (b) R3 defects**

By comparing Figure 13a and Figure 13b, it can be concluded that the accuracy of IRT increases as the defects are located closer to the exterior surface. The smallest detectable R3 defect size for both HDPE plates with thicknesses of 0.5 in (12.7 mm) and 0.75 in (19.1 mm) was 0.1 in (2.8 mm), and for the rest of the studied thicknesses, the smallest detectable defect size was 0.2 in (5 mm). Contrary to R2 defects, R3 defects could be detected even when there is not a high initial thermal gradient ( $\Delta T \approx 0$ ) up until a thickness of  $t=2$  in achieving a high enough thermal gradient across the thickness becomes more difficult. Note that the detected underneath defects, R2 and R3, were located less than  $0.5t$  from the exterior surface of each plate. Since not all the defect sizes in each group could be detected, it can be concluded that the defect location is not the only parameter that defines the efficiency of IRT. Therefore, another parameter that describes the defect geometry should be considered.

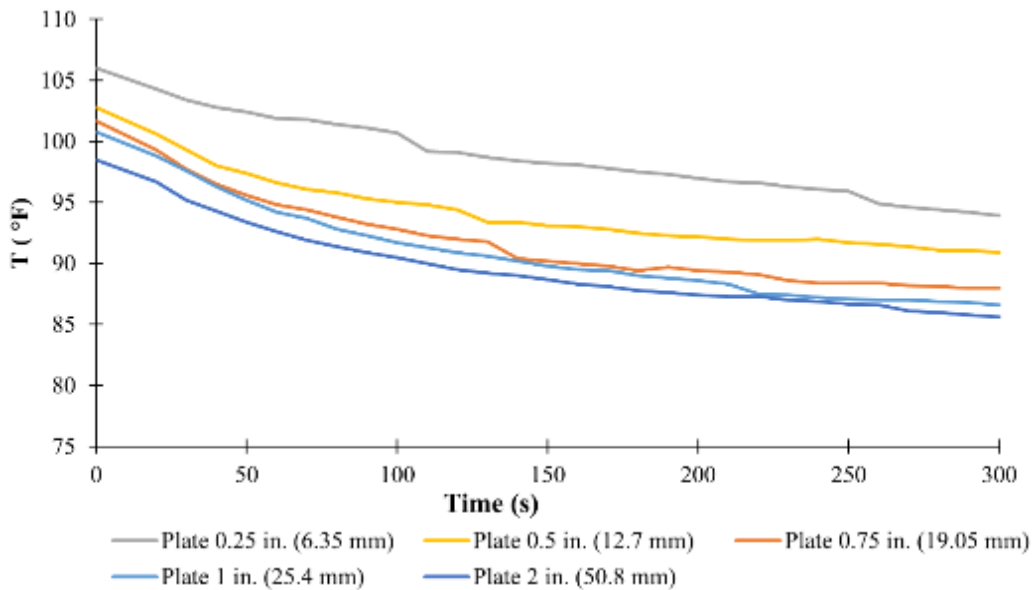
**Figure 18. Temperature change on the center of high-density polyethylene plates with different thicknesses during the cooling phase**

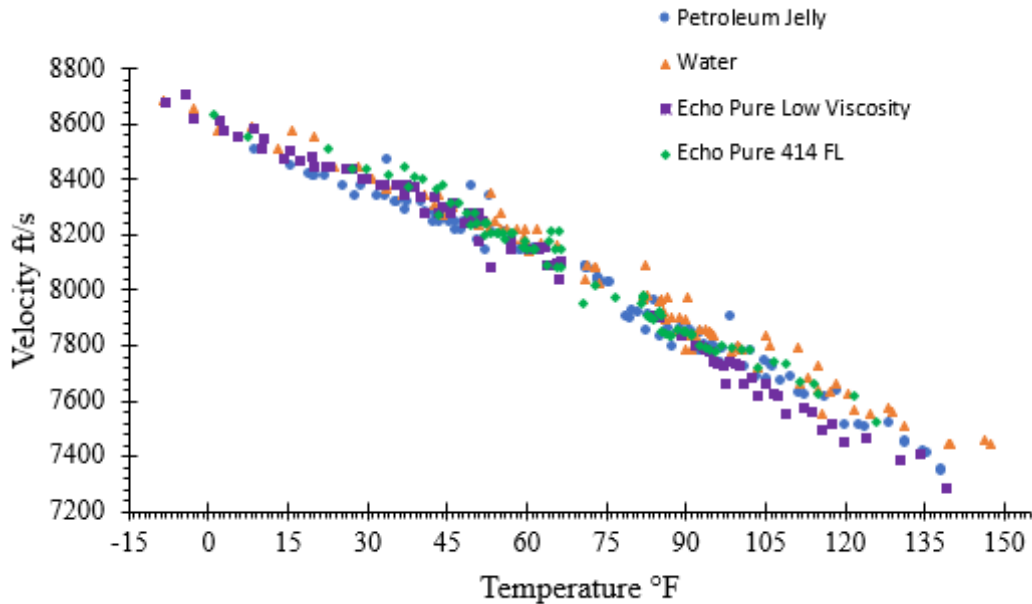
Figure 21. Sound wave velocity vs. temperature measured by using different couplants

To study the utilized couplant’s impact on the measured sound wave velocity, the experiment was repeated with four variations of couplants while testing a 0.5 in (12.7 mm) thick HDPE. The couplants used for this preliminary investigation were water, petroleum jelly, Echo Pure low viscosity, and Echo Pure 414 FL. The results in Figure 21 show that there is little to no effect of couplant type on wave velocity, at least for the couplants examined here.

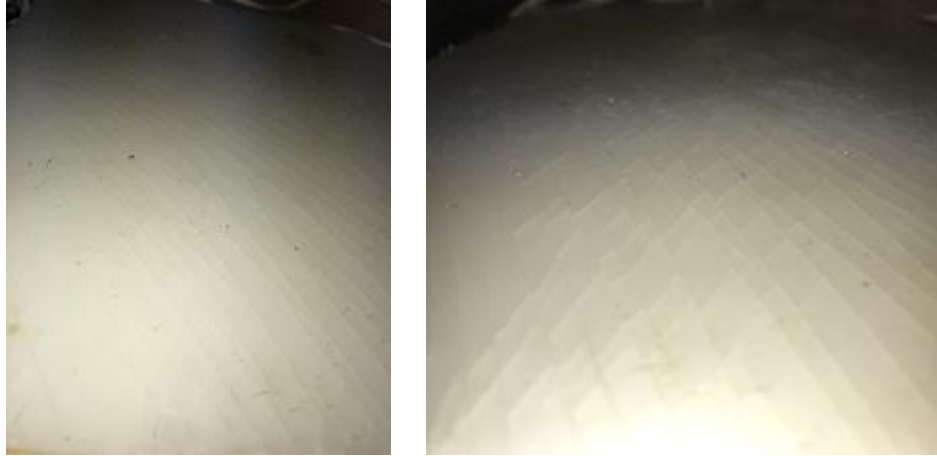
**Figure 22. Superficial cracks on the interior side of an old high-density polyethylene plate**

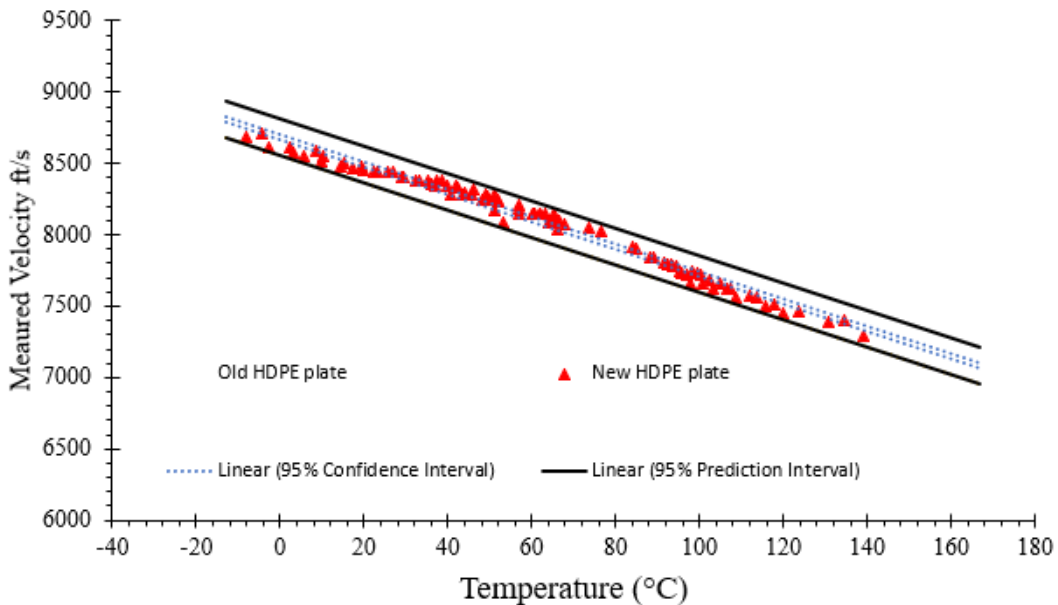
**Figure 23. Sound wave velocity comparison in a 0.375 in (9.5 mm) weathered high-density polyethylene plate and a new 0.5 in (12.7 mm) HDPE plate**

significant shallow cracking on the interior of the tank. Figure 23 compares the temperature difference between the new and weathered HDPE, demonstrating that most of the measured data was placed in the 95% prediction interval. These observations imply that weathering does not affect the sound wave velocity considerably.

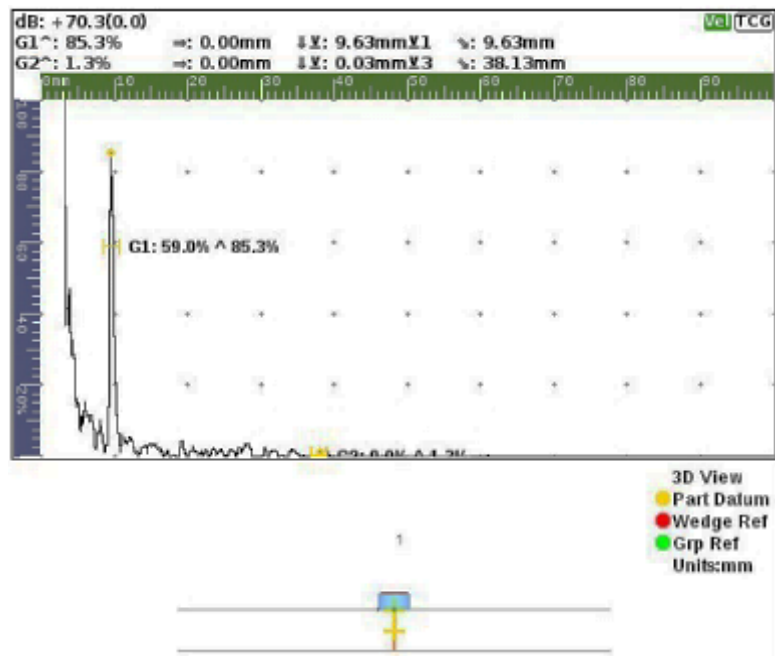
Figure 24. An interior defect (R2) detection on a 0.75 in (19.1 mm) thick high density polyethylene plate using pulse-echo ultrasonic testing (note: 1 mm = 0.039 in)

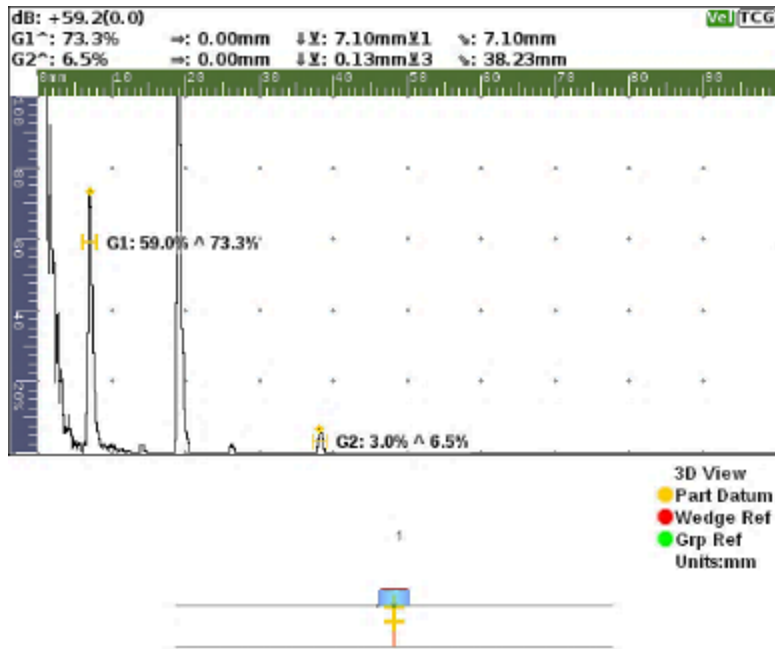
Figure 25. A subsurface defect (side hole) detection using pulse-echo ultrasonic testing (note: 1 mm = 0.039 in)

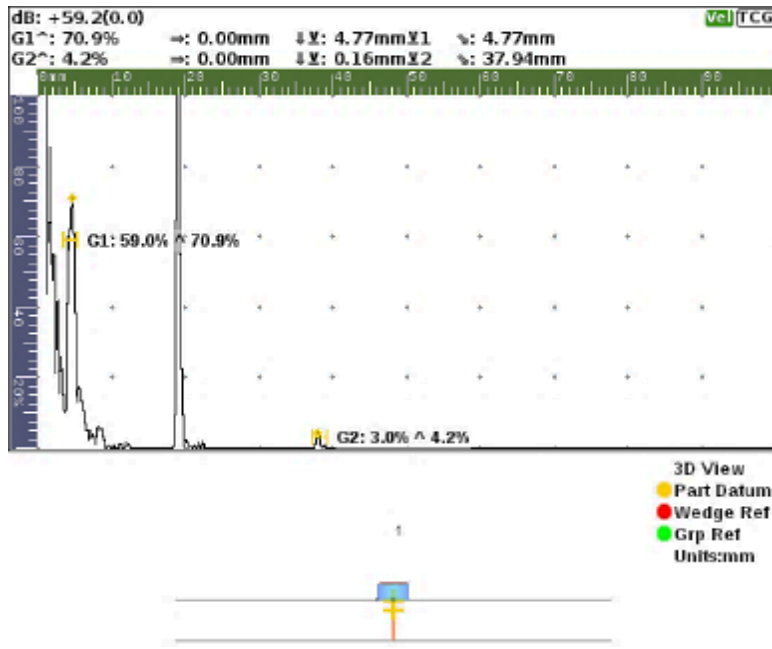
Figure 27. Pulse-echo ultrasonic testing on an area with two stacked defects (note: 1 mm = 0.039 in)

PEUT was also performed on a plate with two and four stacked side hole defects, shown in Figure 27 and Figure 28, respectively. By comparing the last two figures, it can be seen that the results resemble each other. These results indicate that PEUT is unable to characterize these stacked defects.

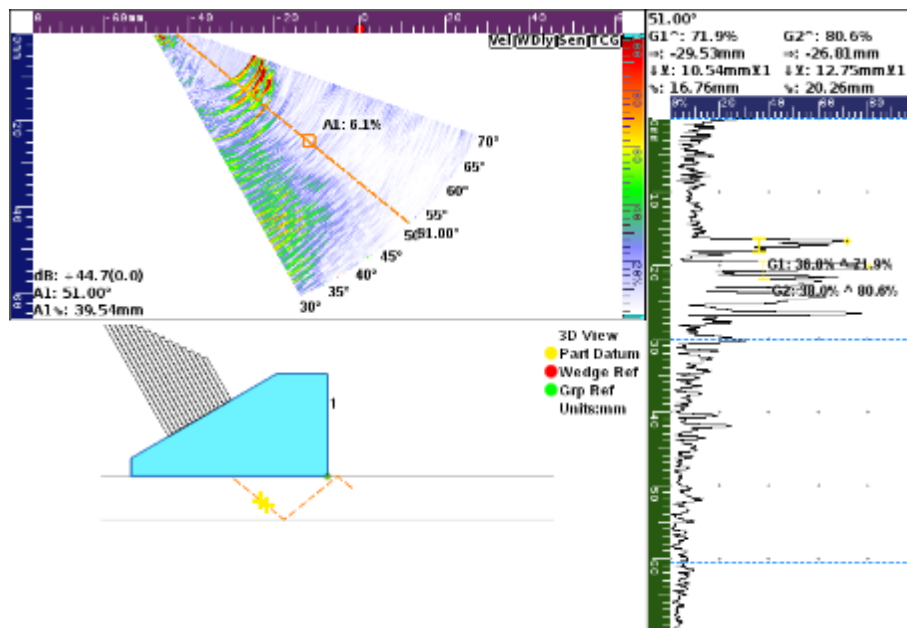
Figure 31. Phased array probe used for the detection of four stacked subsurface defects (note: 1 mm = 0.039 in)

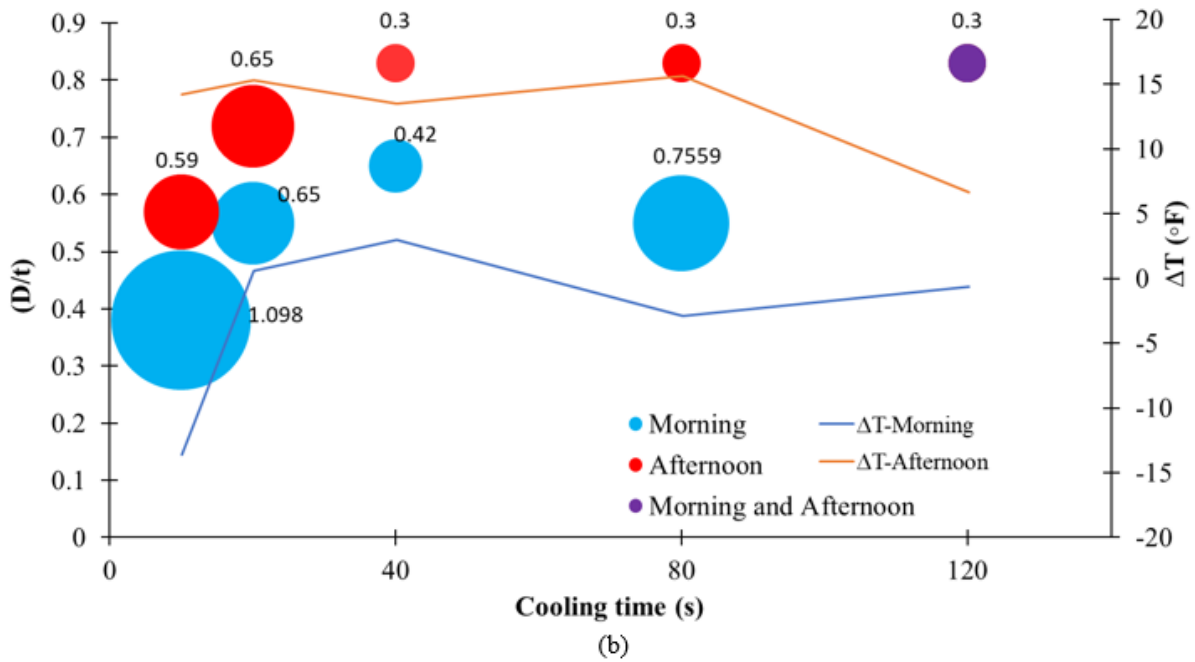
Figure 39. Characterization of the defects detected when the heating time was 40 seconds (a) east side and (b) west side (values next to each bubble represent the aspect ratio [AR]) (ideal case is when a smaller AR with a higher D/t has been detected).

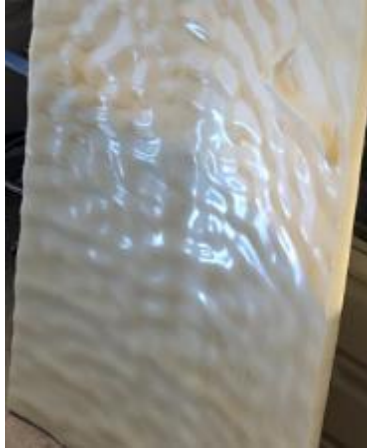
Figure 44. The wavy wall inside a High-Density Polyethylene Above-Ground Storage Tank

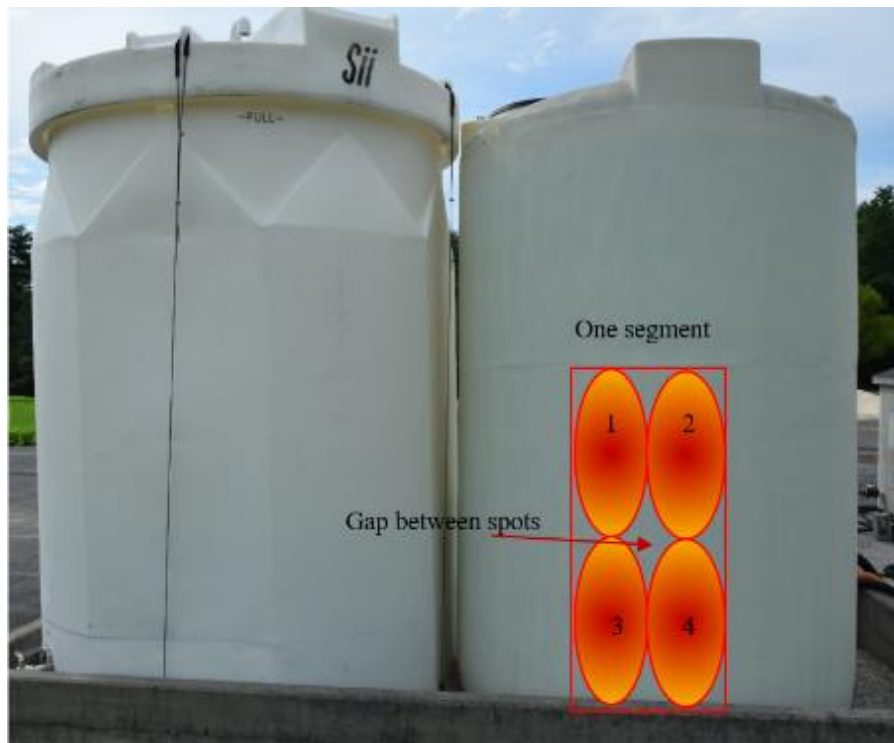
**Figure 48. The configuration of one segment consisted of four heated spots**
