# Suitability of Using Crushed Concrete Adjacent to Geotextiles in Underdrain Systems

## Second Phase: Field Trial Before Implementation

Final Report VTRC 25-R5

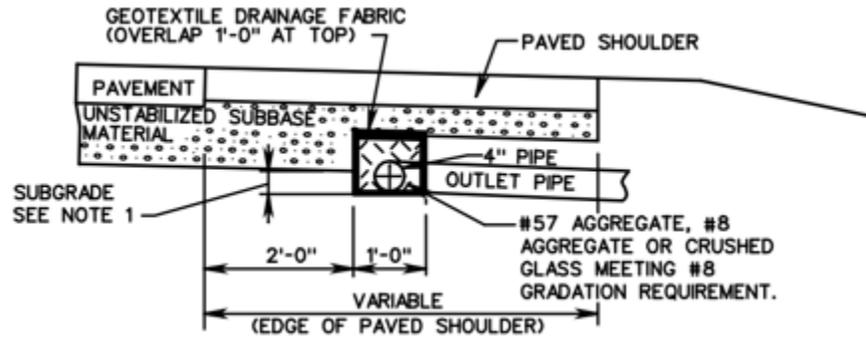
Figure 1. VDOT Standard Pavement: The UD-4 Edgedrain (Not to Scale)

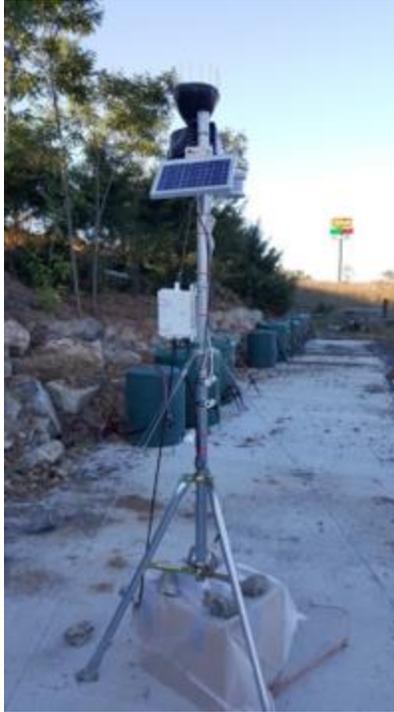
**Figure 2. Weather station installed at the test site**

The weather station consisted of temperature and relative humidity sensors, a rain gauge, a barometric pressure sensor, and a water level sensor. The complete weather station was purchased from Davis Instruments and connected to a 3G remote monitoring station that enabled the researchers to monitor and download data remotely.

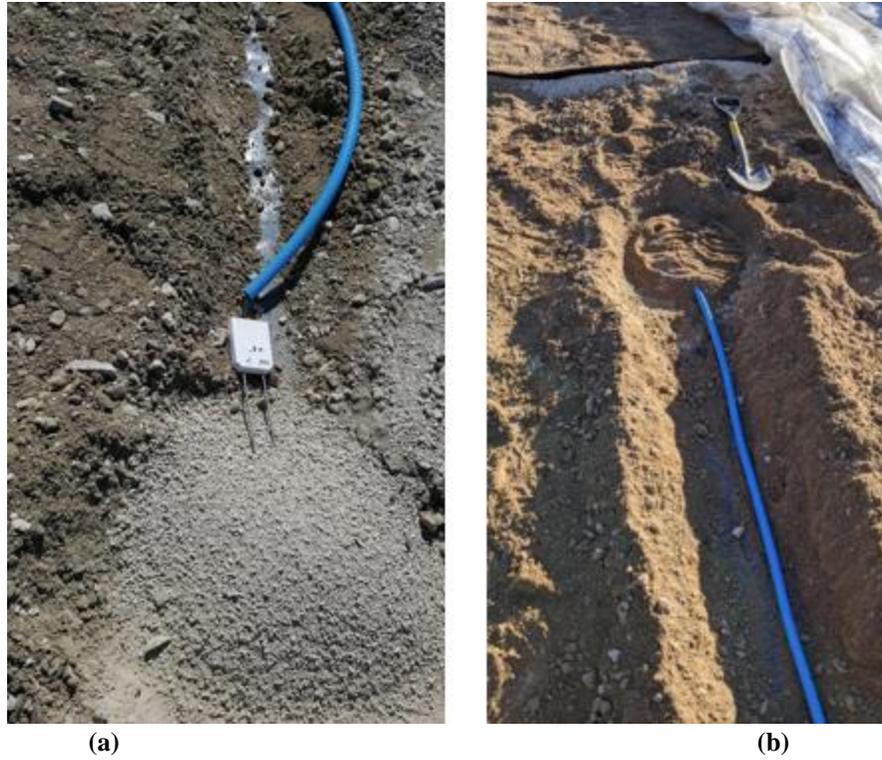
**Figure 3. Monitoring sensor (a) type and (b) installation within the base course of each test section**

Each test section was instrumented with a sensor located approximately at its center. The sensor was capable of recording the section's volumetric moisture contents and ground temperature (Figure 3). Each instrument from each section was connected to a data logger, which required the data to be downloaded in person to a computer periodically. The data logger system was installed within close proximity to the test sections and was powered by a solar panel (Figure 4). These instruments were installed to monitor the wetting and drying cycles of each test section.

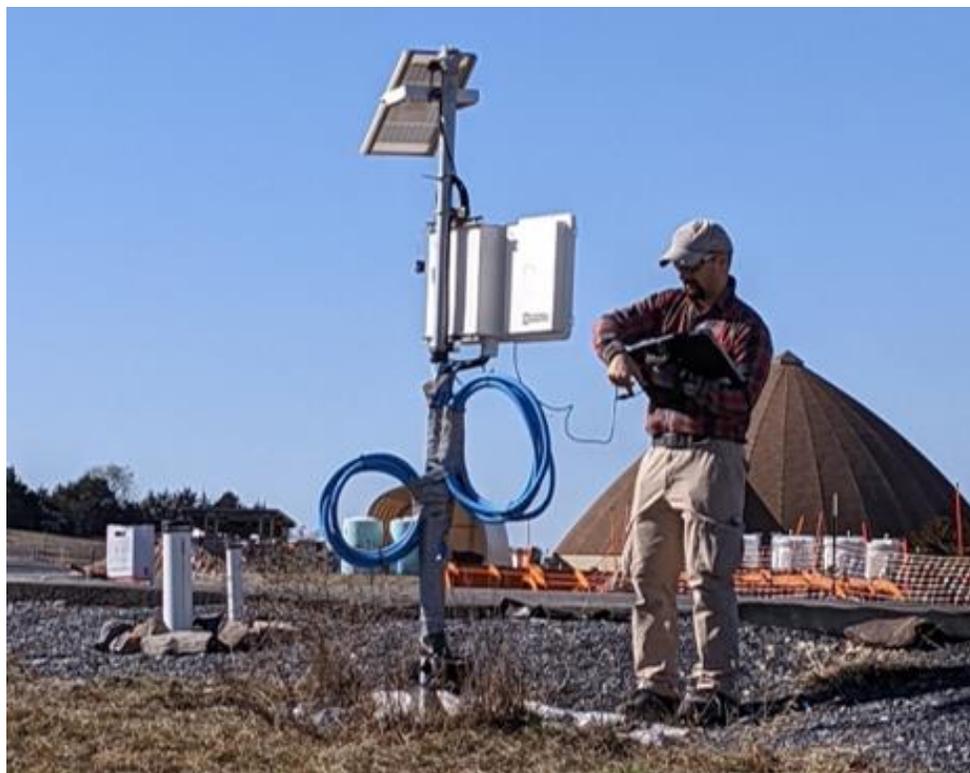
**Figure 4. The data logger pole for all sensors installed within the base course at the test site**

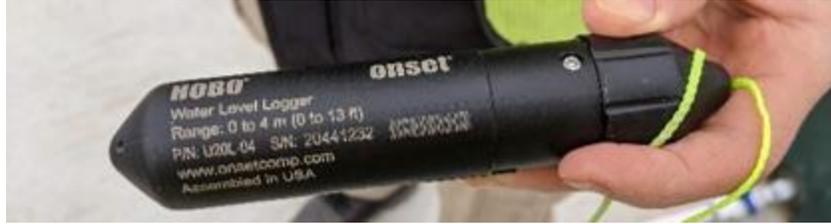
**Figure 5. Water level logger installed at each collection tank**

Each water collection tank was equipped with an Onset water level logger, which is a transducer that works with the pressure water exerts on the instrument (Figure 5). This instrument is designed to track data internally until a data collection cable is connected, after which the data can be downloaded to a computer. This instrument was placed at the bottom of each tank with a yellow rope. Whenever data was to be collected, the rope was pulled up and the instrument was retracted to download the data. Monitoring the water level in each tank was important to confirm that the infiltration water from each section reached the collection tanks. This dataset was also used to compare the accumulated quantities of water from different sections.

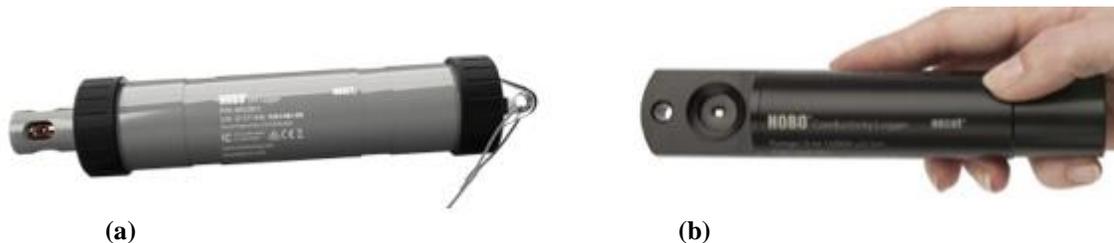
**Figure 6. The (a) pH and (b) electric conductivity (EC) logger sensors installed into the water collection tanks of the 100% unpaved CHCC test section**

The water collection tanks of the 100% unpaved CHCC test section was also equipped with Hobo pH and EC loggers (Figure 6). This dataset was used to monitor the changes in chemical variation of the outflow. Similar to the water level loggers, the pH and EC loggers also needed to be retracted periodically to download the collected data into a computer. These instruments were only installed into the collection water tanks of one section (as opposed to all sections) because of cost. The unpaved 100% CHCC section collection tanks were selected for these instruments because this section (at the beginning of the study) was believed to constitute the worst-case scenario in terms of potential tufa precipitation. One of these tanks also included a water level logger that was connected to the data hub at the weather station pole. This instrument was used to track the water level in real time to determine when to mobilize to the site for water sampling and tank emptying.

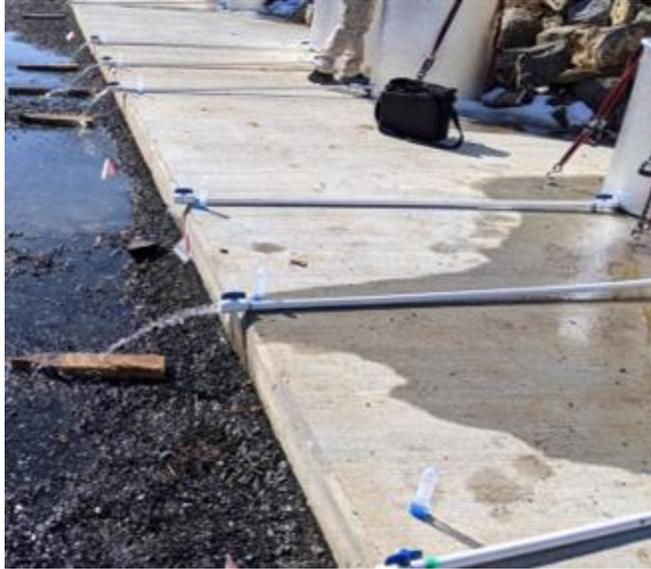
**Figure 7. Water sampling pipes from the collection tanks**

Whenever the water level logger in the water collection tank of the 100% CHCC unpaved test section indicated that the tank was filled up to two-thirds of its capacity, the GMU team mobilized to the site to empty and collect water samples from all of the tanks. Typically, this required water sampling approximately less than every two months. The only way the water could reach the collection tanks was through the rainwater infiltrating each section. Therefore, the regularly conducted chemical analyses of the collected water provided monitoring information regarding the interaction of the infiltrated rainwater with the aggregate in each test section. To allow the collection of water samples, each collection tank had a  $\frac{3}{4}$  inch PVC sampling pipe installed (Figure 7).

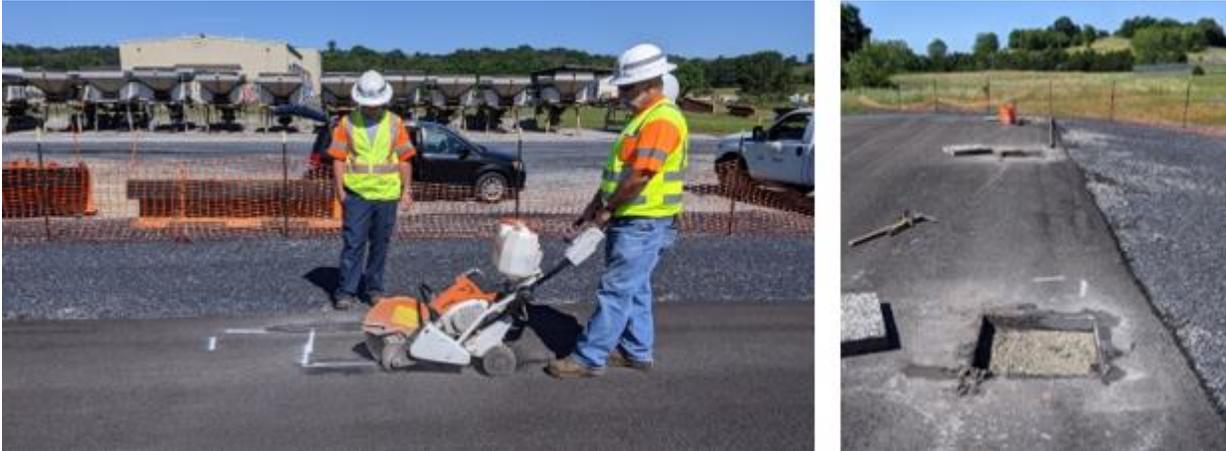
**Figure 8. Marking the pavement and cutting the asphalt overlay to exhume geotextile samples from paved sections**

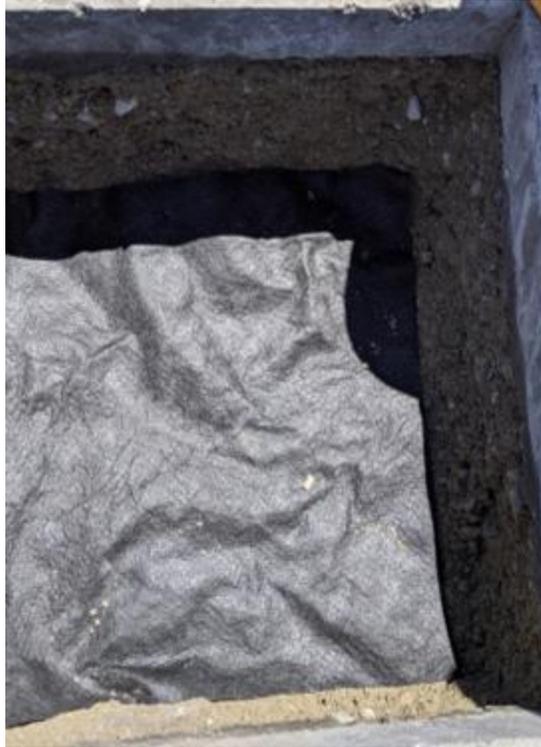
**Figure 10. Placing a piece of new geotextile over the cut area before placing the base course material back onto the edg drain geotextile**

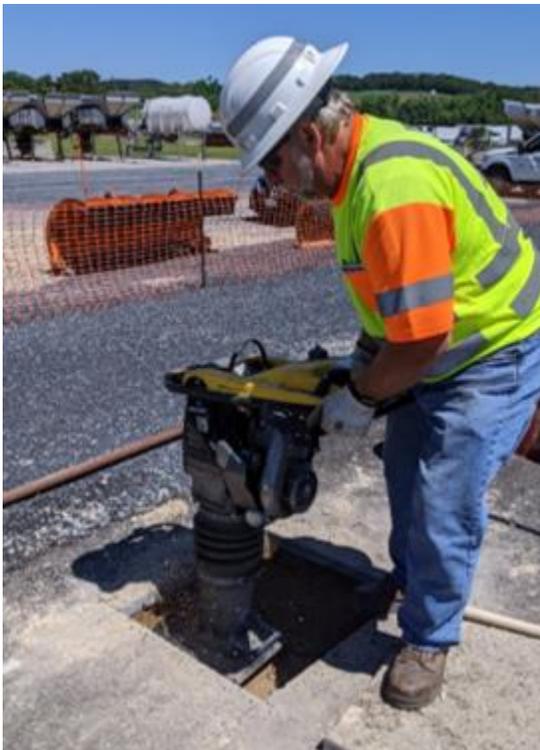
**Figure 11. Compacting the base course material back onto the edg drain geotextile**

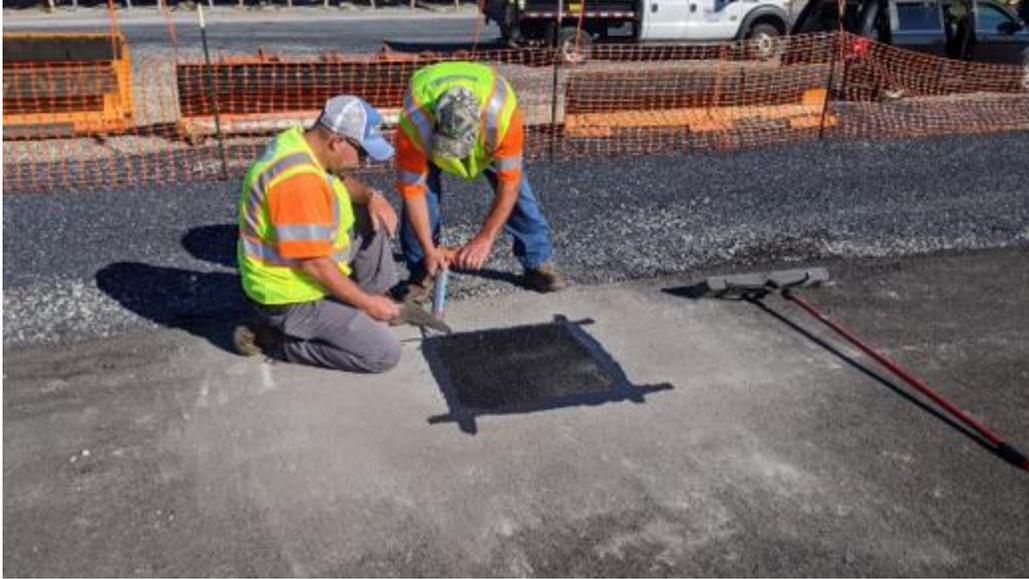
**Figure 12. Placing the asphalt block back onto the recompacted base course aggregate**

- 6- Placing the asphalt block inside the sampling area and sealing the joints using an asphalt joint filler (for paved sections only) (Figure 12).

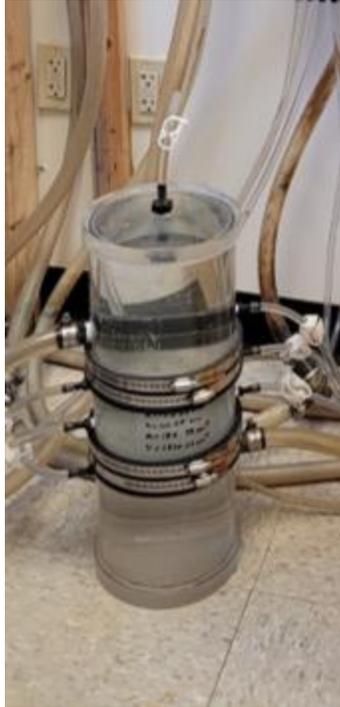
**Figure 13. Evaluating the permittivity of the geotextiles exhumed from the test site**

All exhumed geotextile samples from each test section were evaluated in the permittivity chamber for their ability to permeate water (permittivity) (Figure 13). The samples were air-dried prior to laboratory analysis, and a circular sample was cut off from the exhumed sample and soaked for at least 24 hours. The geotextile was soaked to fully saturate it before testing. The tests were started with an applied head of 10 mm until flow was stabilized. Afterwards, the applied head underwent 10-mm increments, and the permittivity ( $\psi$ ) values were recorded. For each test, triplicate virgin geotextile samples were also tested, and the ratio of the permittivity values of the exhumed and virgin geotextiles were reported in accordance with Equation 1.

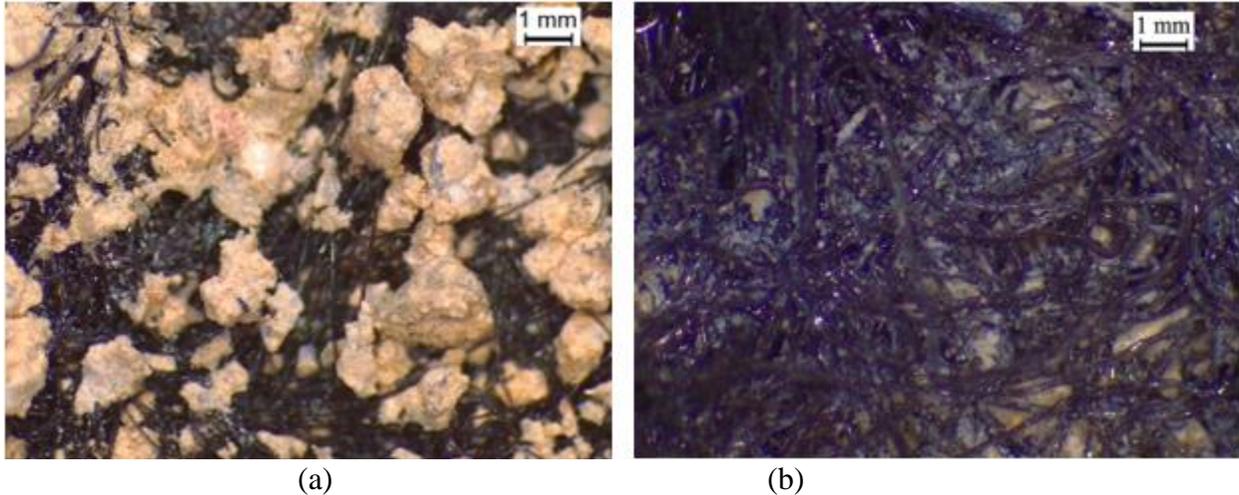
**Figure 14. A typical appearance of (a) physically migrated and (b) chemically precipitated particles on an exhumed geotextile**

Parts of all exhumed geotextile samples were cleaned and evaluated under the microscope. These parts were initially air-dried and cleaned using an archeologist brush and the smooth air blow technique. Cleaning was done to remove all particles that were thought to have physically migrated onto the filaments of the geotextile. The difference between the appearance of physically migrated and chemically precipitated particles is shown in Figure 14. The cleaning process required the use of a microscope, and it typically took about a week to completely clean the geotextile samples that were exhumed from one test section.

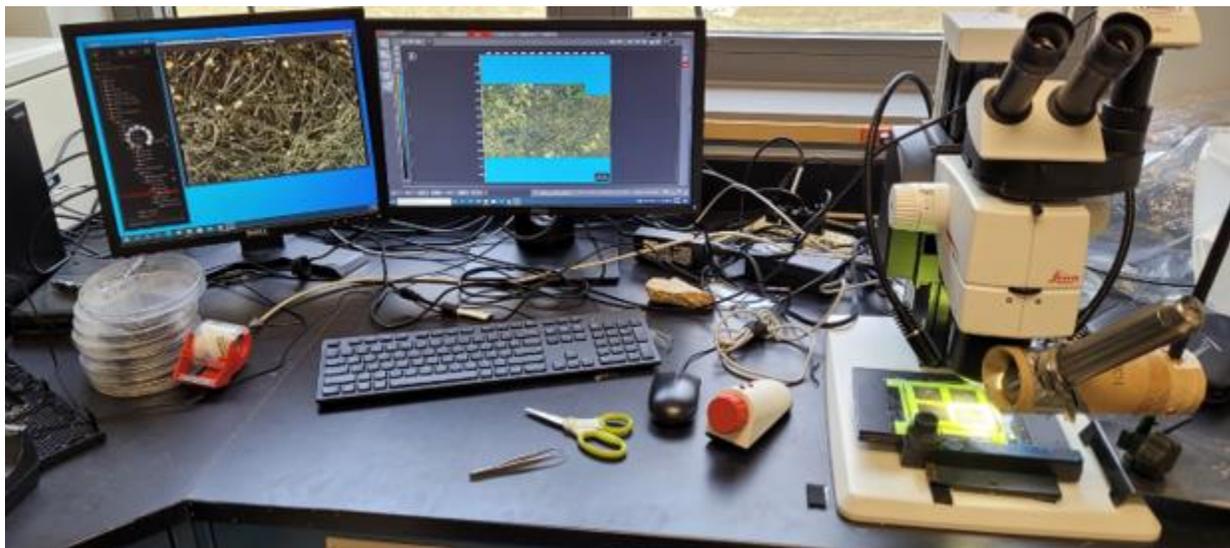
**Figure 15. The Leica M125 C microscope with an in-built 5 MP HD digital camera with a geotextile sample under analysis**

After removing all the physically migrated particles from the geotextile's surface, the samples were evaluated according to the image analyses process to quantify the percentage of the surface area of the geotextile that contained CHCC tufa ( $S_{tufa}$ ). The imaging was done using a Leica M125 C microscope with an in-built 5 MP HD digital camera (Figure 15). Microscopic images, with a small overlapped area on each consecutive picture, were continuously taken from a point of interest, with a magnification of 40 on both sides of the sample. Next, the images were stitched together using the Leica LAS EZ software to create a larger image. To quantify  $S_{tufa}$ , these large images were analyzed using the Leica LAS X software. This process allowed the surface area covered with the precipitate to be identified and quantified based on the calculated unit surface of various areas.

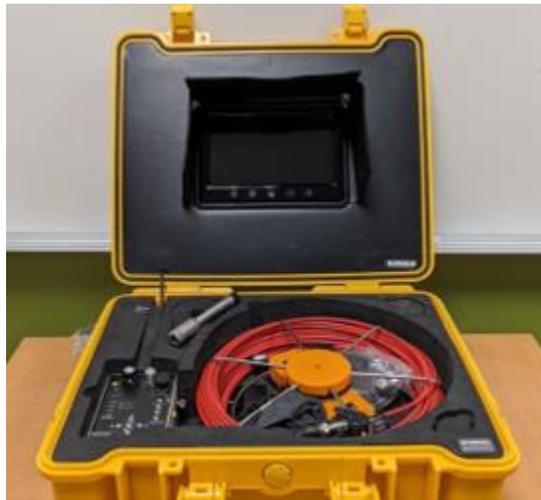
**Figure 16. The instrument used to survey the edgedrain and collection pipes at each section**

Each test section was designed to have T connectors that will allow for borescope surveys of both the edgedrain and collection pipes all the way from the test section to the collection tanks. The borescope used for this purpose was manufactured by Fiberscope (and named the Viper model by the manufacturer) and has a 0.67-inch waterproof mini camera head attached to a 50-ft long cable. The instrument allowed the camera feed to be monitored directly on an LCD monitor, and the survey results were recorded on a SD card. A photo of the system used in this study is provided in Figure 16. A field implementation of the borescope survey is shown in Figure 17.

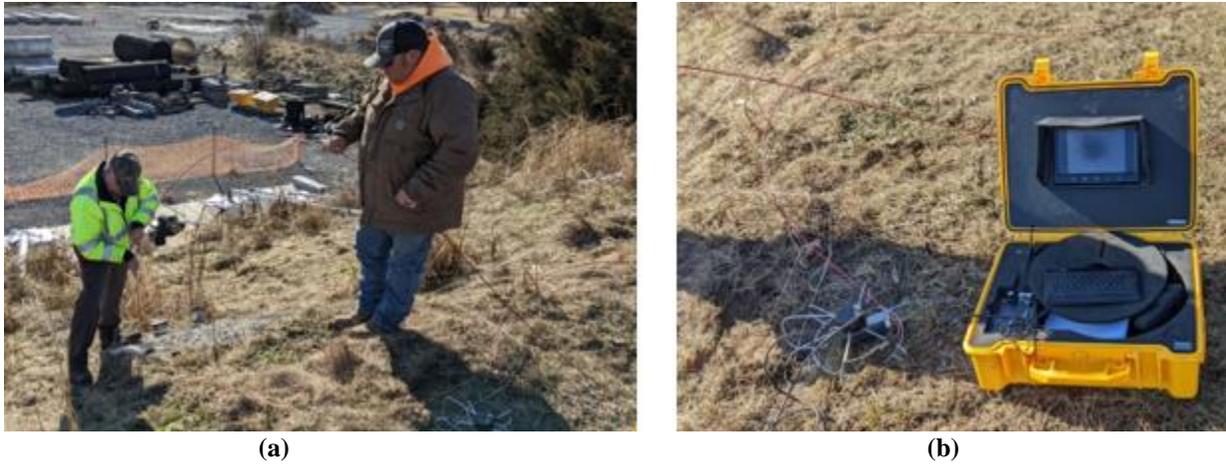
Figure 17. Insertion of the (a) borescope camera through the T connector and (b) monitoring and data collection on site

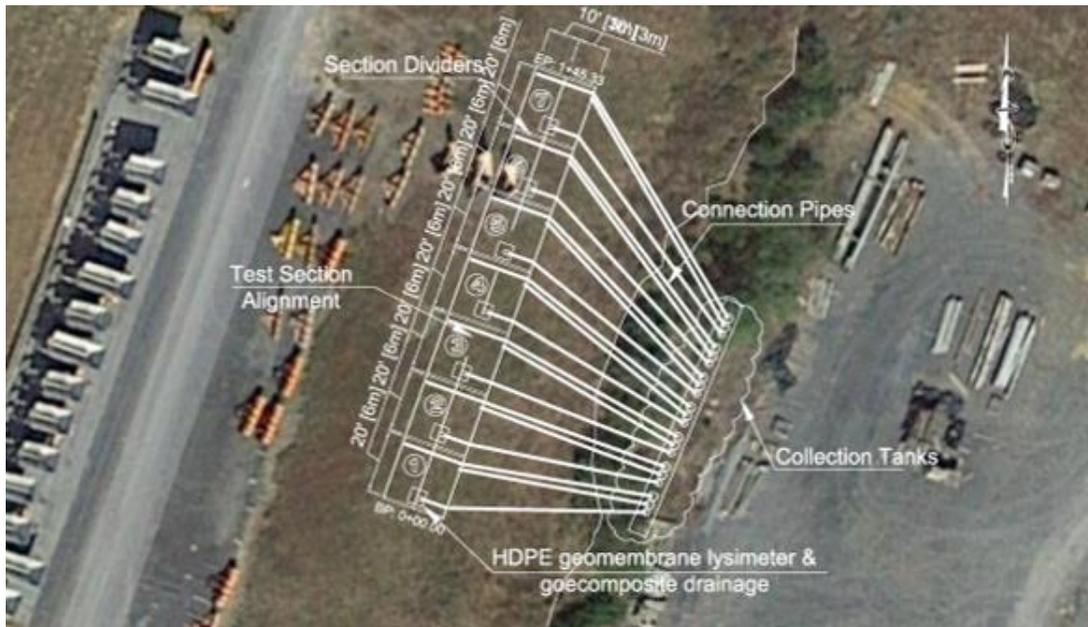
Figure 18. Schematic plan view of the designed test site (dimensions are in feet)

Figure 18 presents a layout of the test site, including the dimensions of each test section, the collection pipes connected to edgedrains in each section, and the collection tanks. The test site's design included seven different sections measuring 20 ft wide and 20 ft long each, with an overall grade difference of 2% between the beginning station point of 0+00 and ending station point of 1+45.33.

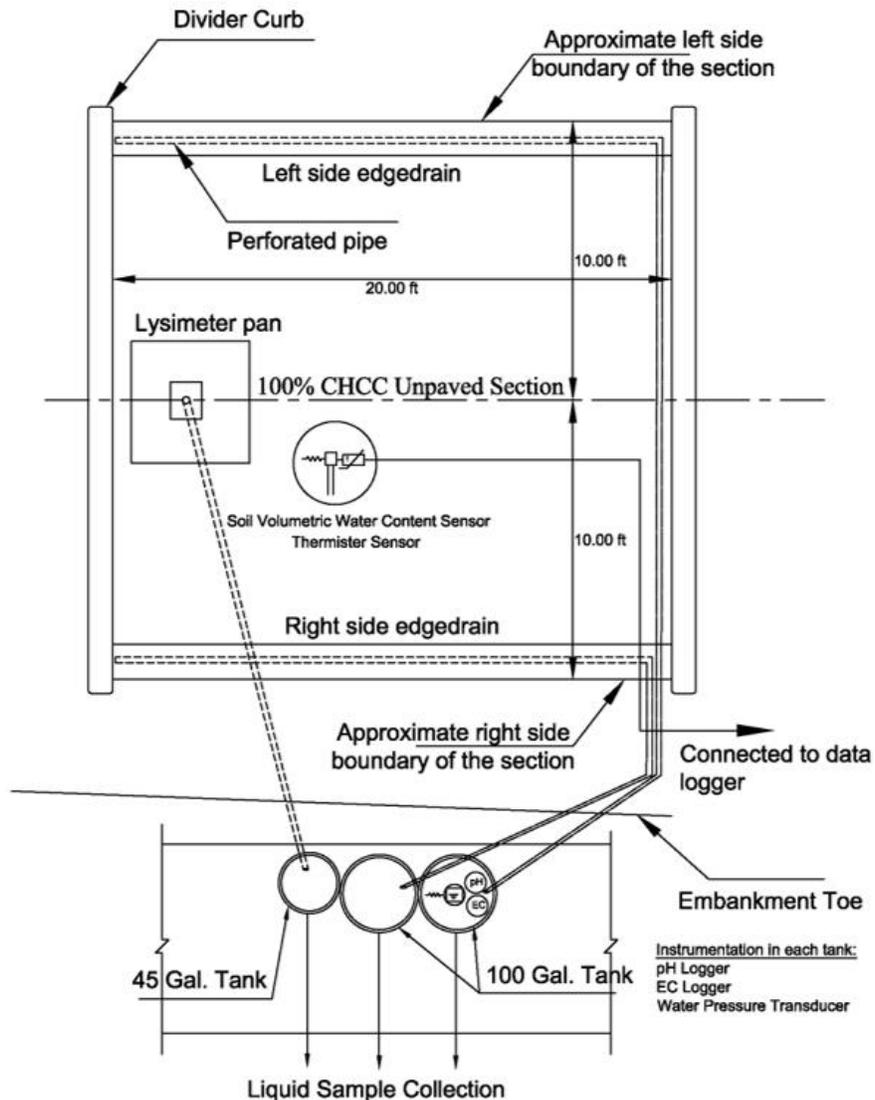
Figure 19. Plan view of a test section drainage system

of handling during construction. Figure 19 also shows a feature referred to as the “lysimeter pan.” This feature was added into the design as an additional way of collecting water from each section. This is not a feature of a typical roadway, and the intention was not to promote the inclusion of such a feature in future roadway designs. The lysimeter pan was designed to allow for the collection of the infiltrated water within each base course without going through the corrugated edgedrain pipes. It was designed as an experimental feature, and a collection pipe system from the lysimeter pan was designed to connect to a 45-gallon tank.

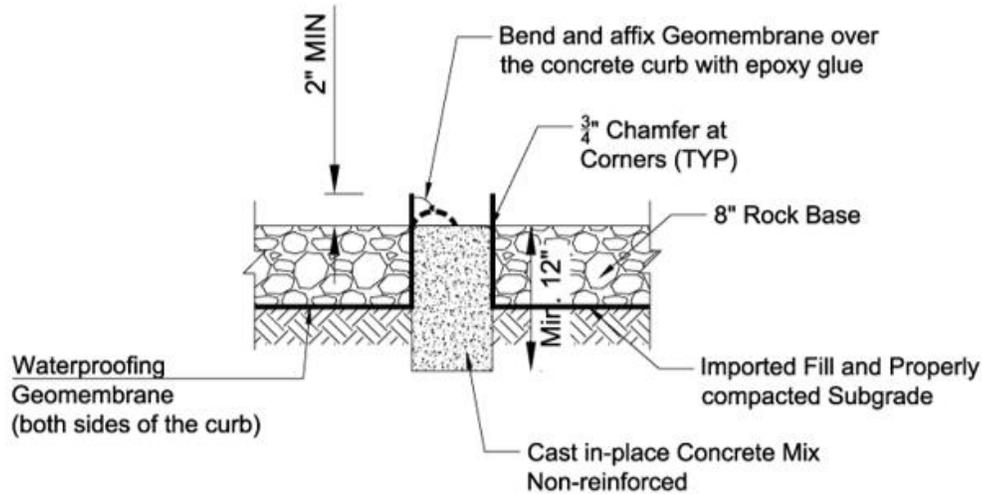
Figure 20. Details of the divider curb wall and geomembrane in each test section

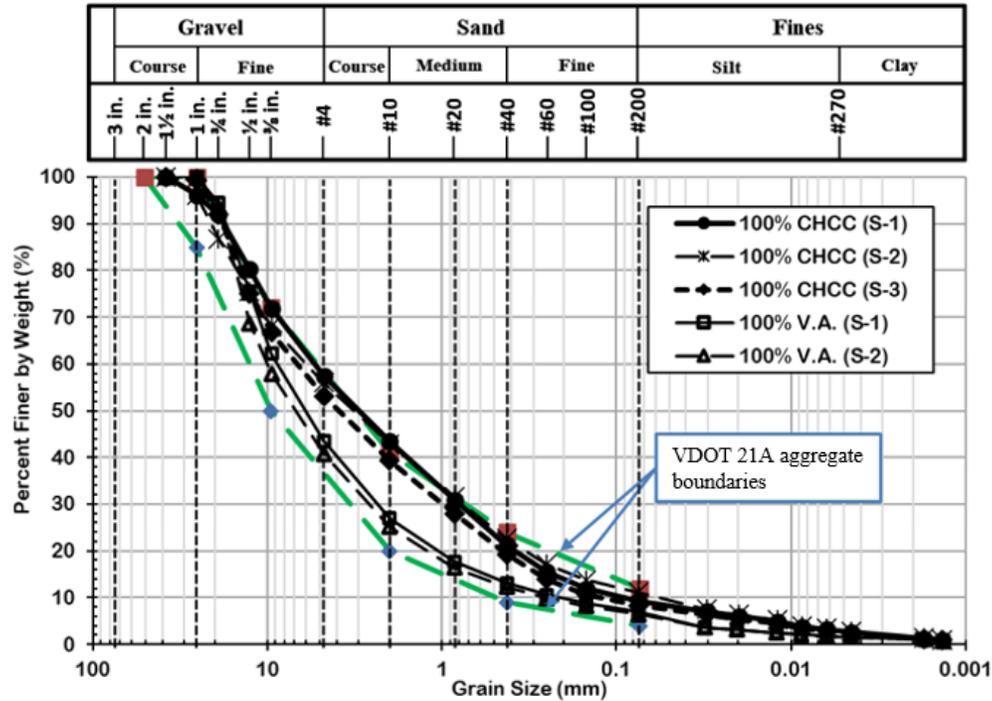
Figure 22. Grain size distribution of 100% CHCC and 100% V.A.

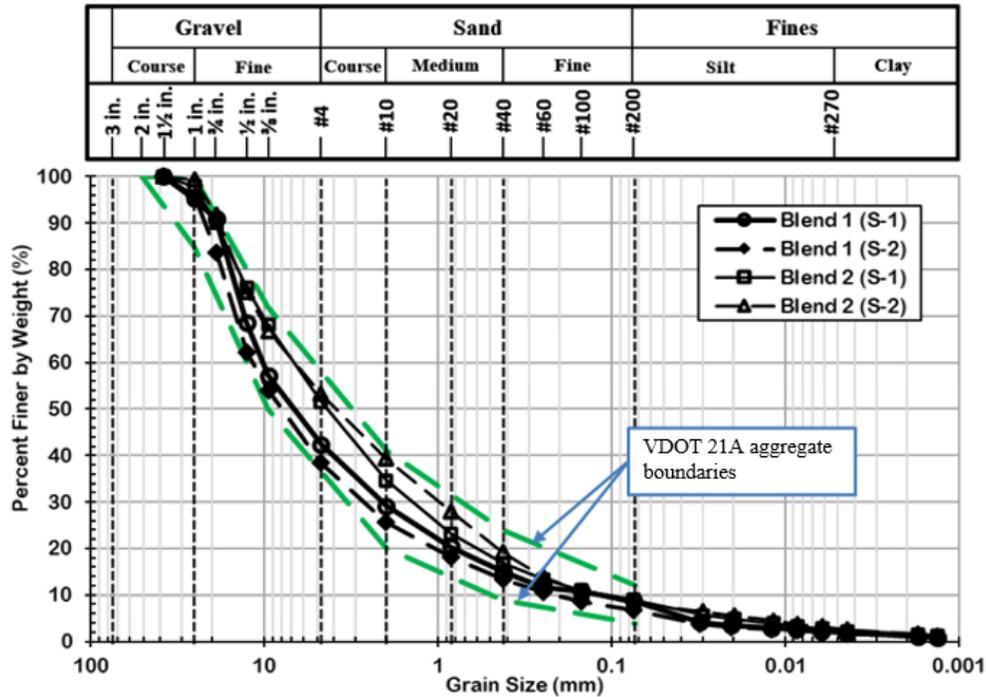
Figure 23. Grain size distribution of Blend 1 (40% CHCC + 60% V.A.) and Blend 2 (20% CHCC + 80% V.A.)

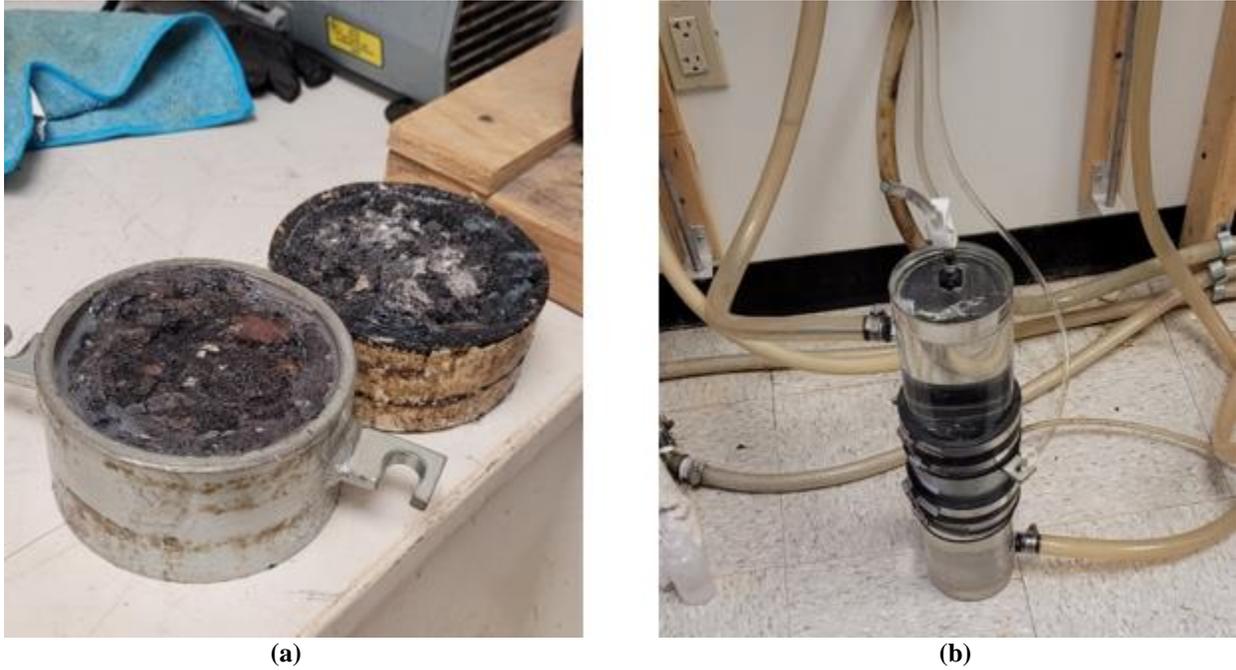
Figure 24. (a) and (b) 4-inch asphalt samples placed into a rigid wall permeameter for permeability testing under constant head conditions

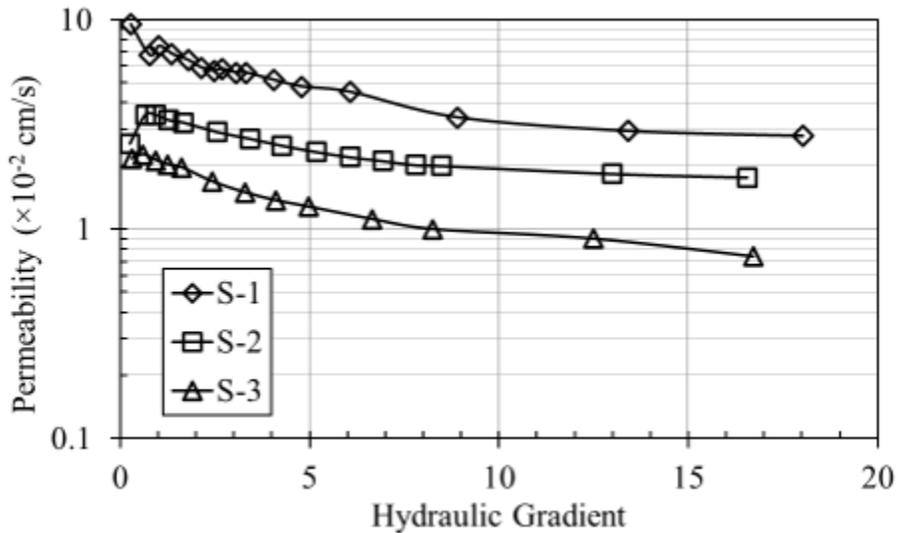
Figure 25. Measured permeabilities of the asphalt samples

measured hydraulic conductivity of the asphalt samples is shown in Figure 25. The average hydraulic conductivity at a hydraulic gradient of 1 was  $3.7 \times 10^{-2}$  cm/sec.

The permeability of the asphalt used in this study was higher than the desired range of asphalt permeability cited in the VTRC 21-R11 report (McGhee and Smith, 2020) but comparable to the permeability of the aggregate base course used in this study (Table 1). This condition allowed more water to infiltrate the asphalt than that may typically occur in roadways

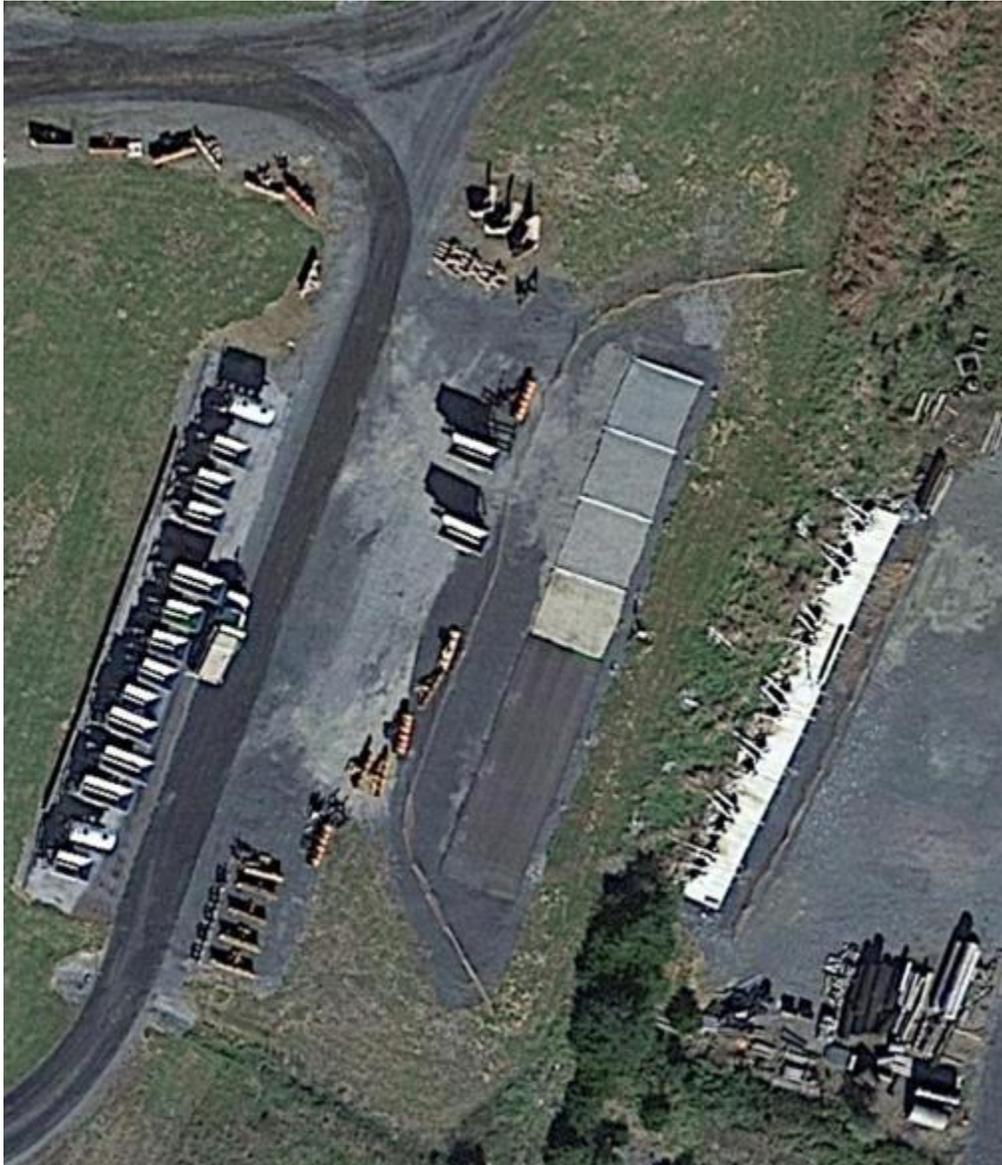
**Figure 26. A Google earth© photo of the completed test site showing the locations of the three paved and four unpaved sections and the collection water tanks adjacent to the site located downslope**

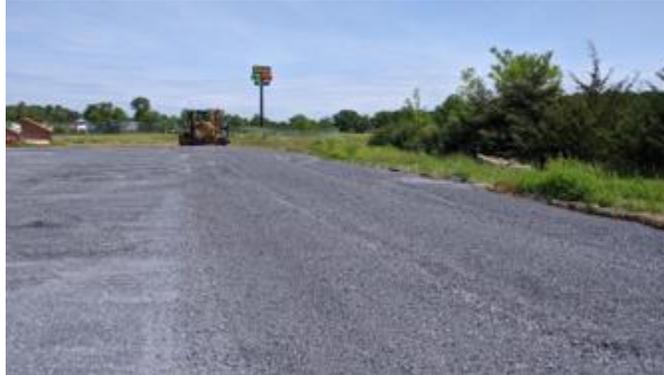
**Figure 27. Placement of crusher run as subbase**

- First, the site was prepared for construction, organic soil was removed, and the subgrade was prepared for the placement of subbase.
- Next, the crusher run was placed to create a subbase for the test site and establish 2% grades from one end of the test site to the other (Figure 27).

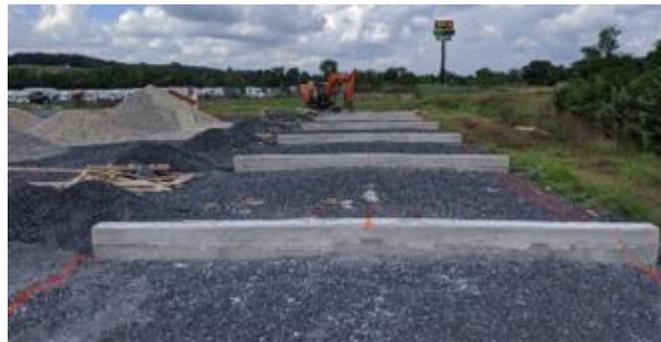
**Figure 28. Construction of curb wall dividers**

- Then, the subbase was excavated according to the divider curb wall locations; the concrete form was installed, and concrete was poured to create the curb wall dividers (Figure 28).

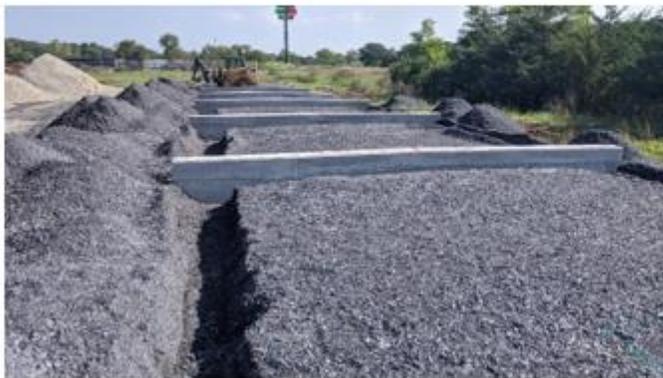
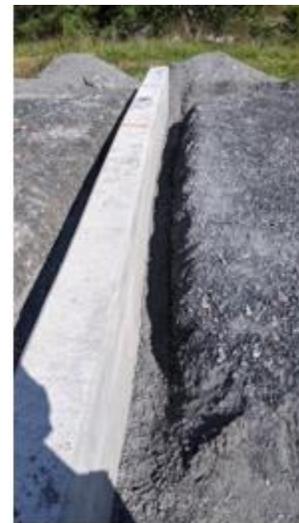
**Figure 29. Excavations of trenches to install (a) UD-4 edgedrains on both sides of each section and (b) collection pipes that will convey water from left-side edgedrain to collection tanks**

- The sides of each section were roughly excavated to create locations for installing the edgedrain systems and connecting the left-side edgedrain pipes with smooth collection pipes (Figure 29).

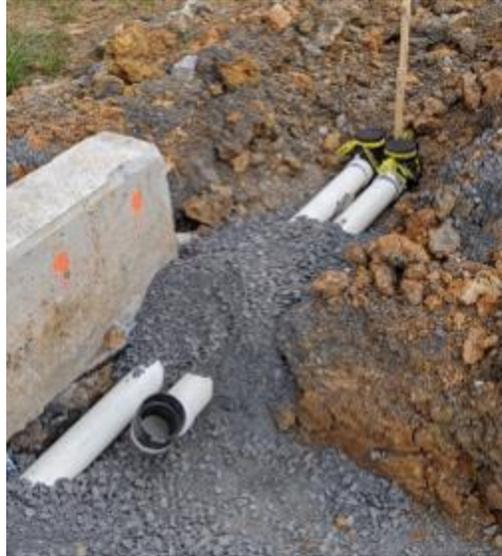
**Figure 30. Installation of collection pipes at the end of the edg drain trenches prior to the installation of the geomembrane liner**

- The collection pipes (4-inch smooth PVC pipes) were then installed (Figure 30). The pipe that is buried under the subbase in the left side of the photo in Figure 30 is the pipe attached to the left-side edgedrain pipe. The open end of the pipe on the right side is waiting to be attached to the perforated, corrugated right-side edgedrain pipe.

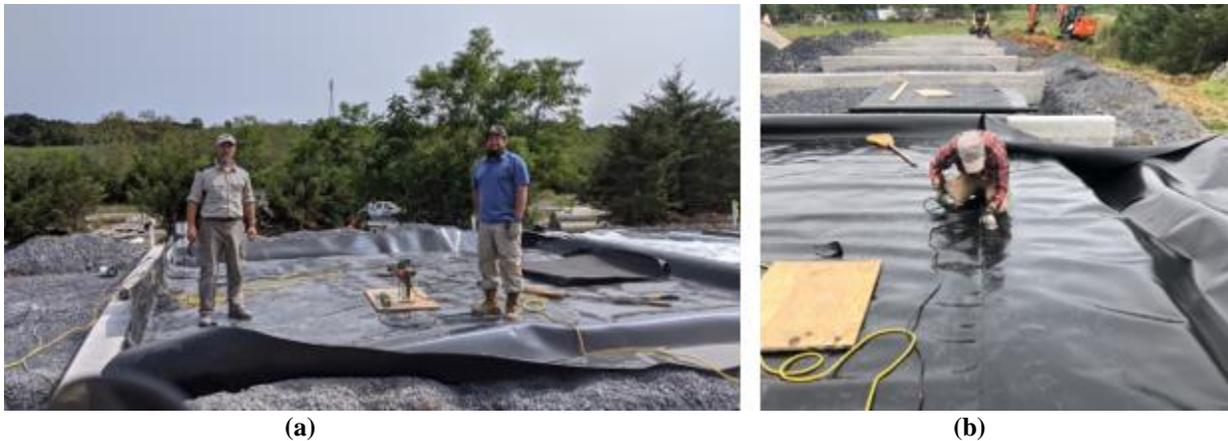
**Figure 31. Installation of the geomembrane hydraulic barrier (a) covering the entire section, and (b) the pieces are being welded together**

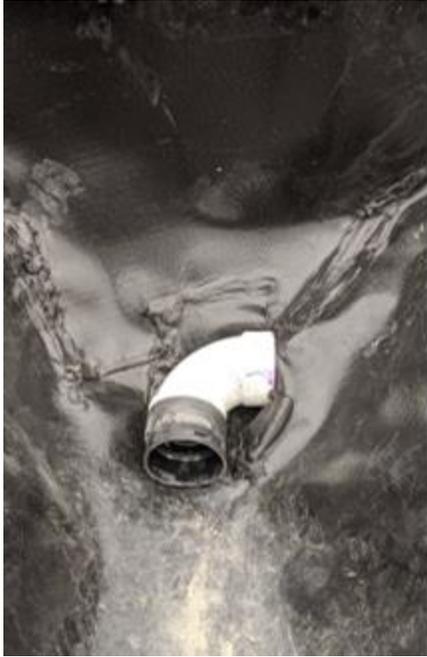
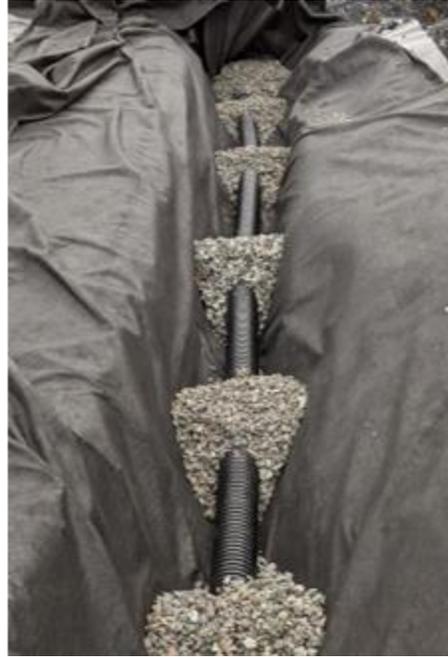
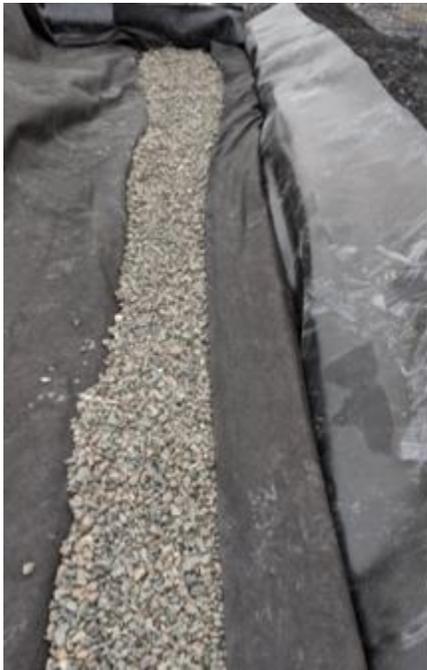
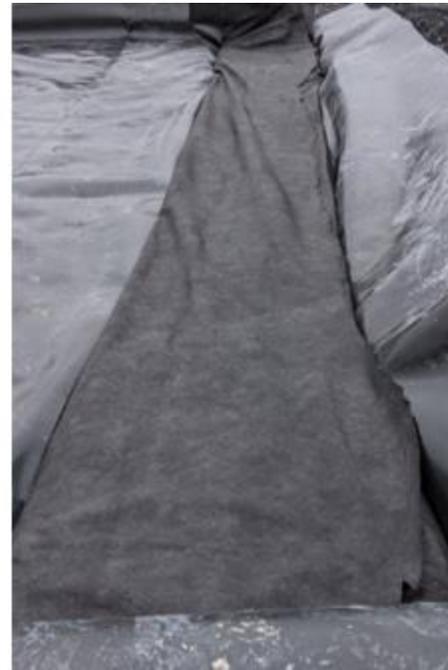
**Figure 32. Installation of the UD-4 edgedrains (a), installation of the connection port for the edgedrain and collection pipe, (b) placement of the nonwoven geotextile and perforated pipe, (c) placement of No. 57 stone, and (d) wrapping of the nonwoven geotextile over the stone**

- A geomembrane hydraulic barrier was installed in each section (Figure 31).
- UD-4 edgedrain installation, including placement of nonwoven geotextile, installation of the perforated corrugated pipes (which were connected to the collection pipes), placement of No. 57 stone, and wrapping of the nonwoven geotextile over the No. 57 stone, was done (Figure 32).

Underdrain systems were constructed on both sides of each test section (Figure 32). Therefore, theoretically, each tank served to collect infiltrated rainwater from half of a given test section. Consequently, outflow volumes from each water tank were normalized based on the ratio of the volume of flow recorded within each tank (m<sup>3</sup>) to half of the square meter of each test section (m<sup>2</sup>). Figure 46 shows the normalized outflow volumes of each water tank serving as a collection point for the underdrain systems constructed on each side (left and right) of the unpaved test sections.

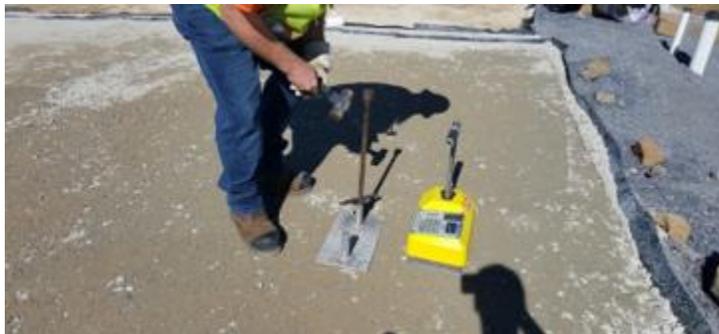
**Figure 33. (a) Placement of the loose unbound base course, (b) moisture conditioning, (c) compaction, and (d) density/moisture content confirmation**

- Placement of the unbound base course with different materials in each section, moisture conditioning, compaction, and density/moisture content confirmation were done (Figure 33). All base course materials in each section were compacted to at least 95% of the maximum dry density obtained using standard effort laboratory tests (VDOT VTM 1, 2017).

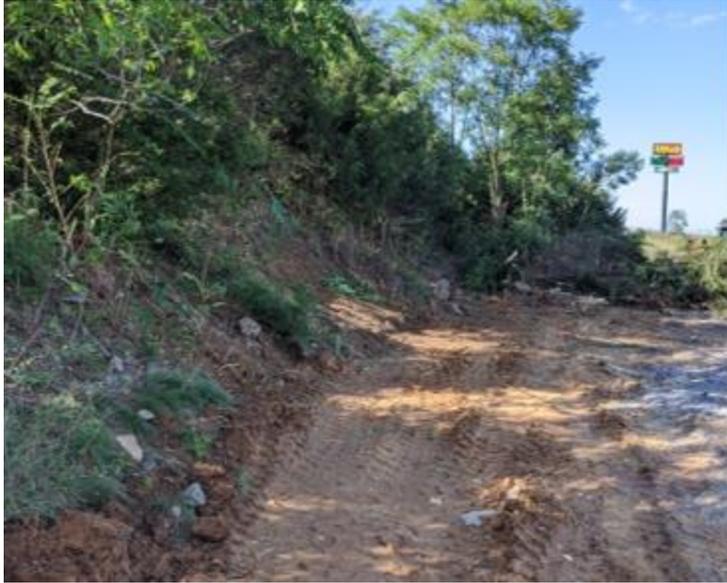
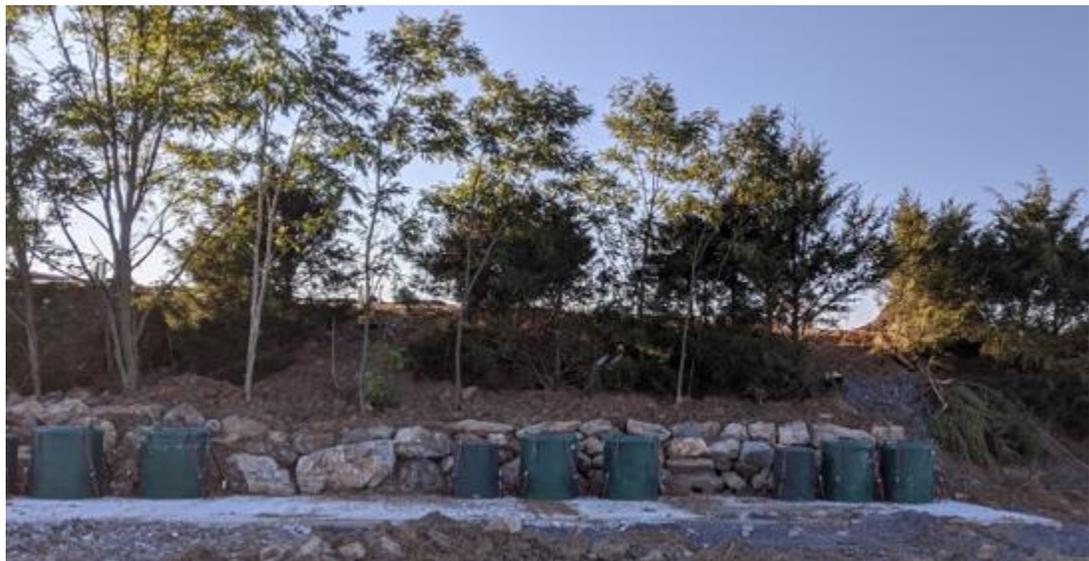
**Figure 34. (a) Removal of organic soil and preparation of subgrade to allow for the (b) construction of the concrete pad and (c) placement of one 45-gallon and two 100-gallon collection tanks at each section**

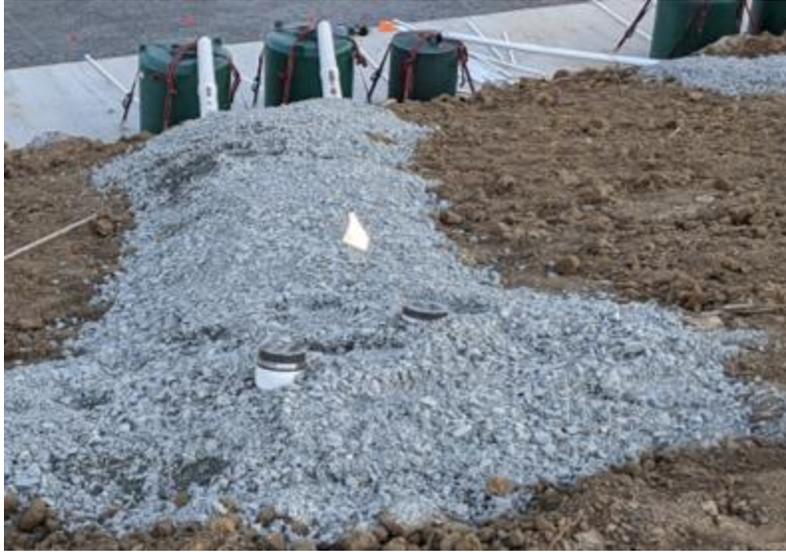
**Figure 35. Completion of the borescope T connectors along the slope and connection of the collection pipes and tanks at each section, located downslope from the test site**

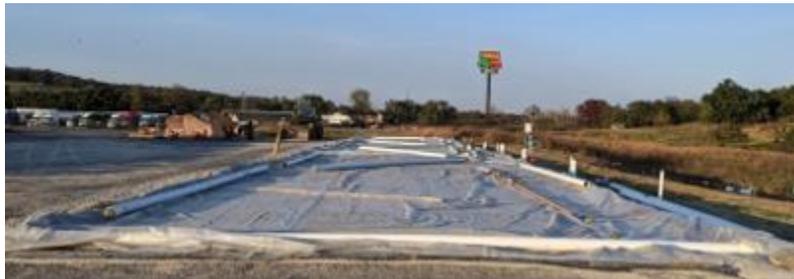
**Figure 36. Plastic sheets being placed over the entire site until the placement of the asphalt overlay**

From September 1<sup>st</sup> until the asphalt layers were placed, as soon as the construction of each test section was completed, that section was covered with plastic sheets (Figure 36).

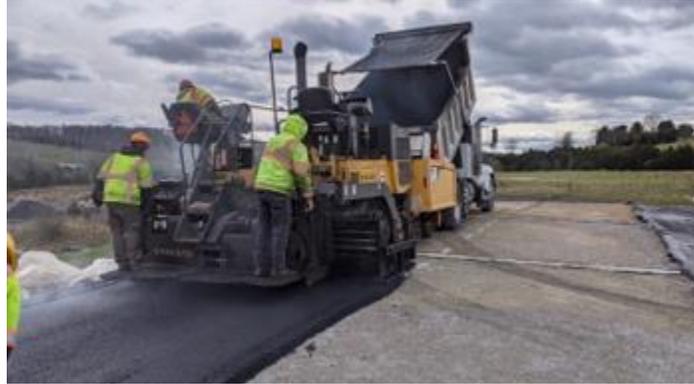
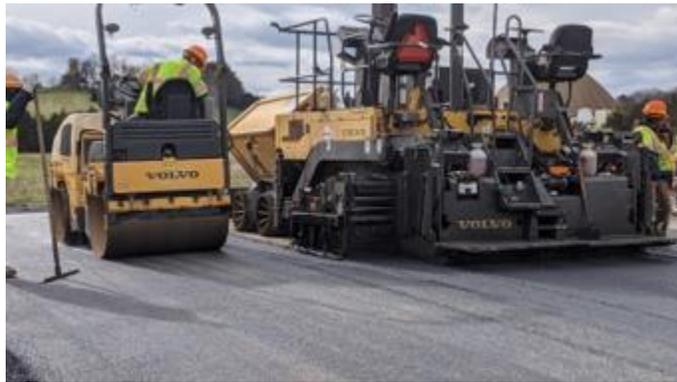
**Figure 37. Placement of (a) asphalt layer over the three sections and (b) compaction of the surface**

On December 1, 2020, Test Sections 1 (100% CHCC), 2 (Blend 1), and 3 (Blend 2) were paved by the Weatherman Collins Contracting team by placing surface mix directly over the base course (no prime placed) (Figure 37). During the first site visit after 6 months, the thickness of the asphalt layer was confirmed to be 2 inches, as intended during the design (Figure 38).
