# Suitability of Using Crushed Concrete Adjacent to Geotextiles in Underdrain Systems

## Second Phase: Field Trial Before Implementation

Final Report VTRC 25-R5

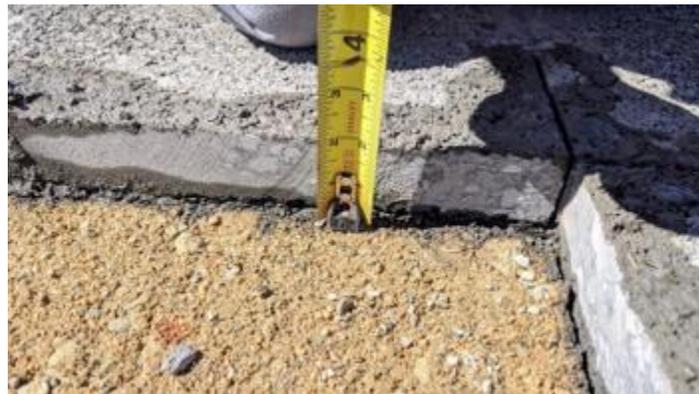
**Figure 38. Confirmation of the thickness of the paved asphalt sections**

On December 1, 2020, Test Sections 1 (100% CHCC), 2 (Blend 1), and 3 (Blend 2) were paved by the Weatherman Collins Contracting team by placing surface mix directly over the base course (no prime placed) (Figure 37). During the first site visit after 6 months, the thickness of the asphalt layer was confirmed to be 2 inches, as intended during the design (Figure 38).

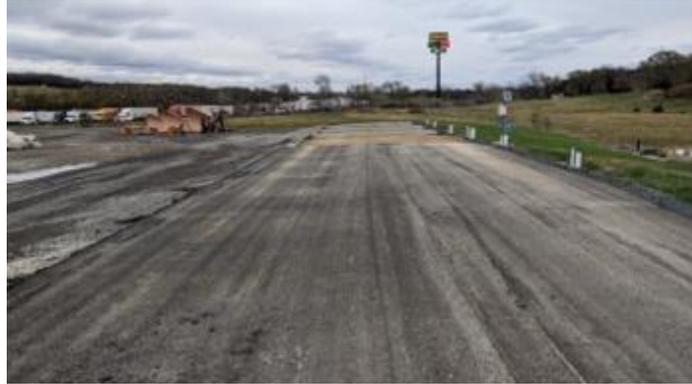
**Figure 39. The completed paved and unpaved test sections**

Immediately after the pavement operations were completed, the plastic sheets were removed from all sections, and data collection for the study officially started. This allowed the data collection from all sections to commence at the same time. Figures 39 and 40 show the finished test sections and connected collection tanks.

The corrugated edgedrains are connected to the smooth PVC pipes, which make a 90-degree turn to convey the water to the collection tanks (Figure 39a). The borescope surveys over

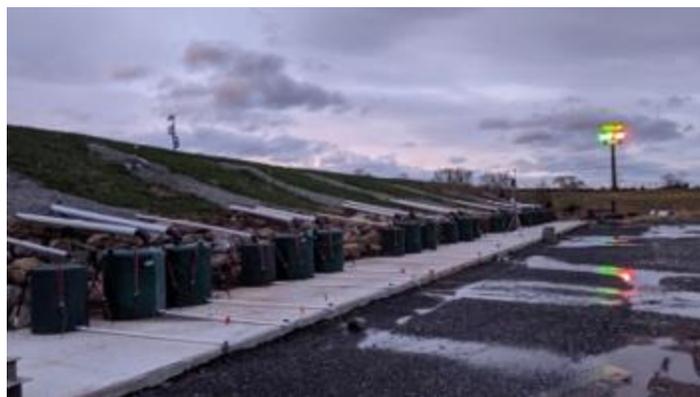
**Figure 40. Completion of the connection of the collection tanks to the collection pipes, which are connected to the edg drains at each section**

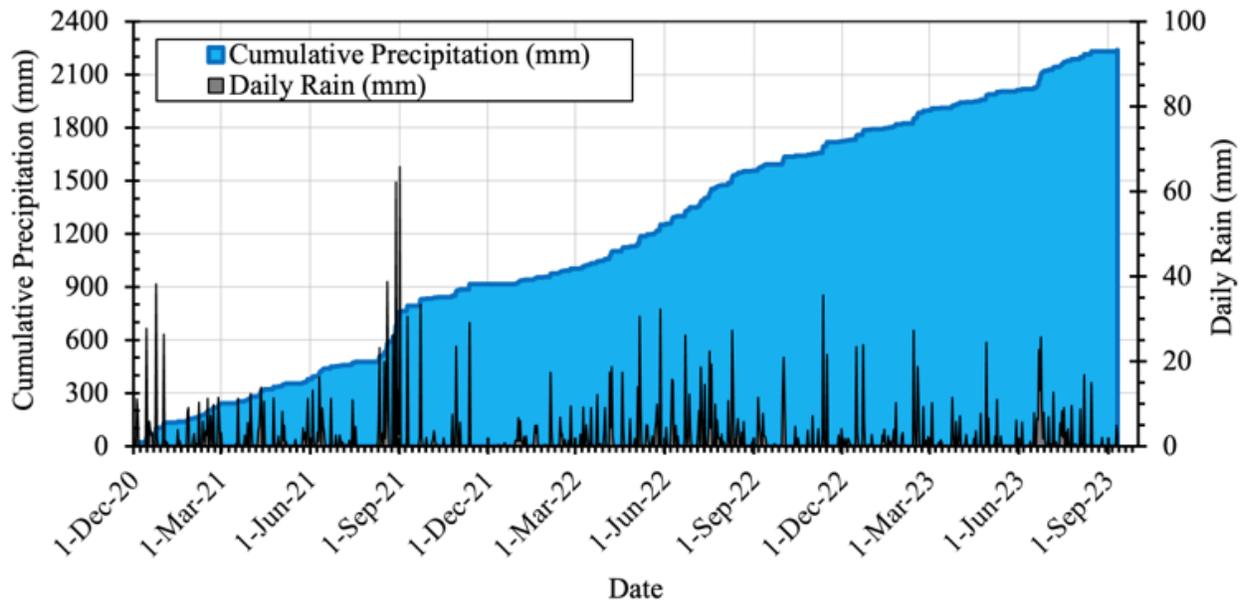
**Figure 41. Rainfall events and accumulated precipitation quantities for the site as recorded by the deployed weather station**

Figure 41 shows the maximum recorded daily rainfall at the site, as well as the calculated cumulative rainfall between December 1, 2020, and September 8, 2023. The data show that the site cumulatively received over 2240 mm (88 inches) of rain during the operation (y-axis on the left side). The highest daily rain events were observed between August and September 2021 (i.e., 62 mm; y-axis on the right side). The trends of rain data show that the selected site was appropriate for this study as no significant periods of drought were observed. According to the USGS website, when the daily precipitation reaches above 100 mm (4 inches), the rain event is considered to be of high intensity. Figure 41 shows that all the daily rain events at the test site were below 100 mm; therefore, they were categorized as frequent but of low intensity.

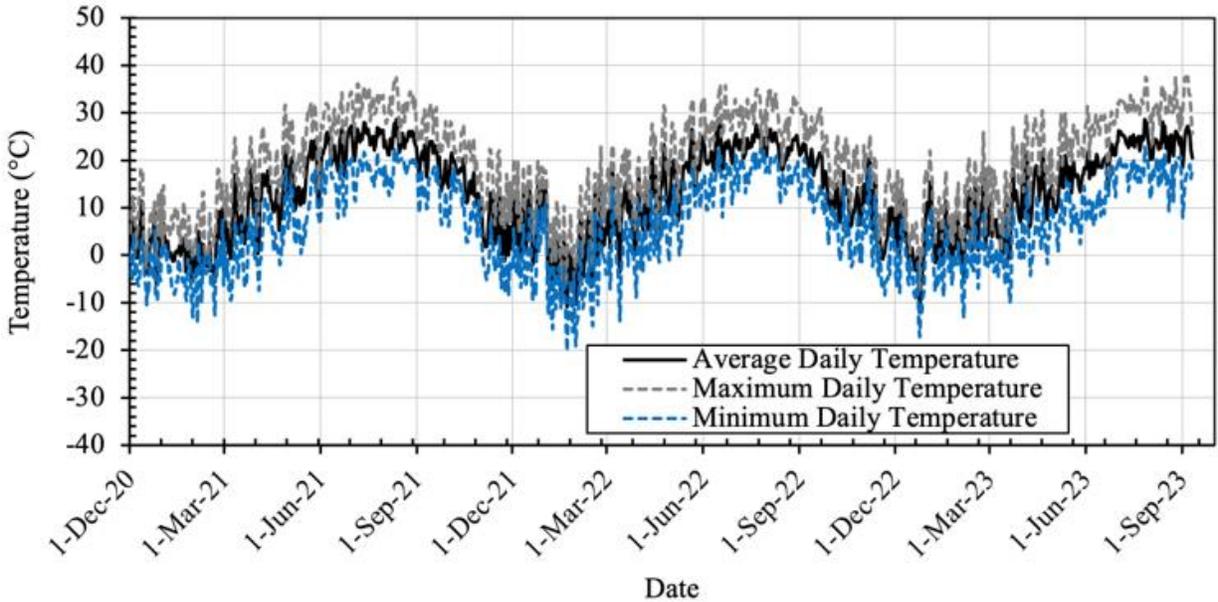
Figure 42. Average, maximum, and minimum daily temperature

Figure 42 shows the ambient temperature recordings observed at the site. The data show that in different seasons, the ambient temperatures changed as expected. On average, the temperatures were highest around August to the beginning of September and lowest around February to the beginning of March. The maximum temperature recorded was 37.6°C (99.6°F), with the minimum at -20.1°C (-4.2°F). On average, the difference between the colder and warmer seasons was approximately 30°C (86°F). Based on the minimum temperature periods seen in Figure 42, it appears that the ground was exposed to freezing temperatures between December through March. The trends of temperature data show that the selected site was appropriate for this study because it was exposed to the climatic effects of the four seasons (no time in which one climatic condition dominated).

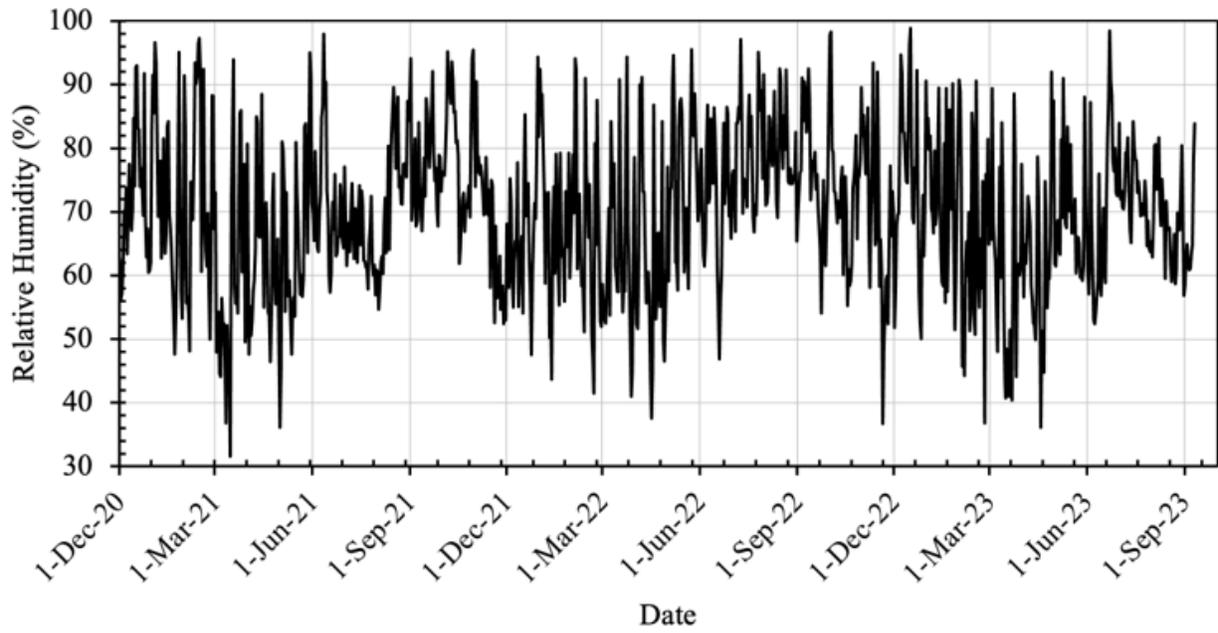
Figure 43. Recorded relative humidity at the test site

Figure 43 shows the recorded relative humidity (RH) data at the site. The data show that the ambient RH during the operation was mostly above 60%, with multiple peaks of above 95% throughout the wet seasons. During the driest periods, recorded RH values were between 30 and 50%. The carbonation rate of CHCC was found to be at its maximum at an RH of 40 to 80%, when the pores were moist (i.e., neither completely wet nor completely dry) (Kurdowski, 2014). The range of observed RH data shows that the selected site was appropriate for this study because most of the times, the observed RH values were favorable for the carbonation of CHCC (creating worst-case scenarios in terms of possible chemical precipitation of calcium-based compounds).

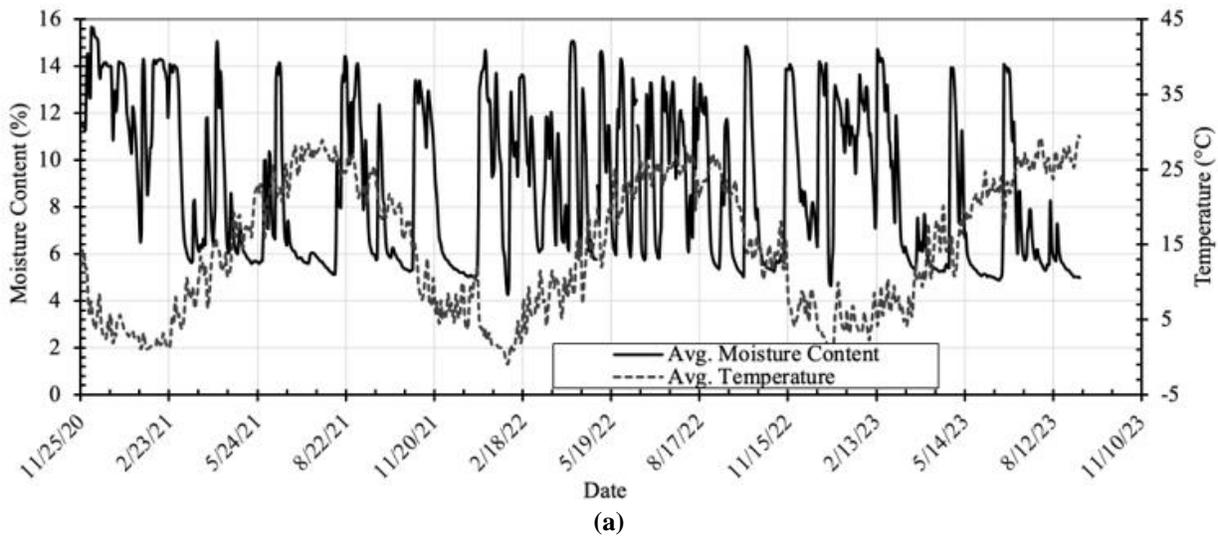
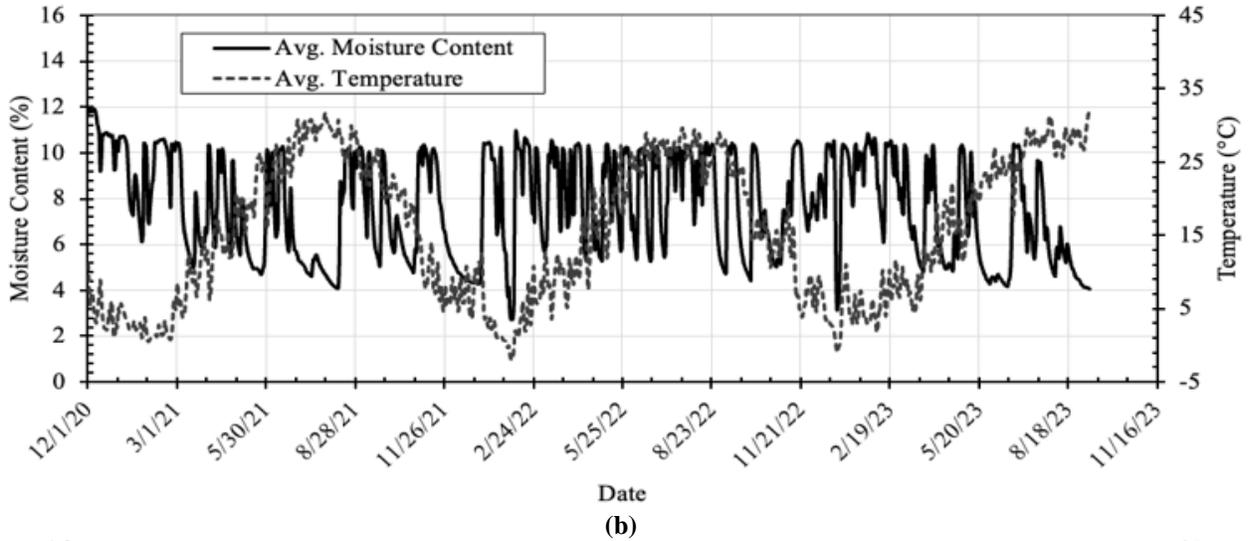
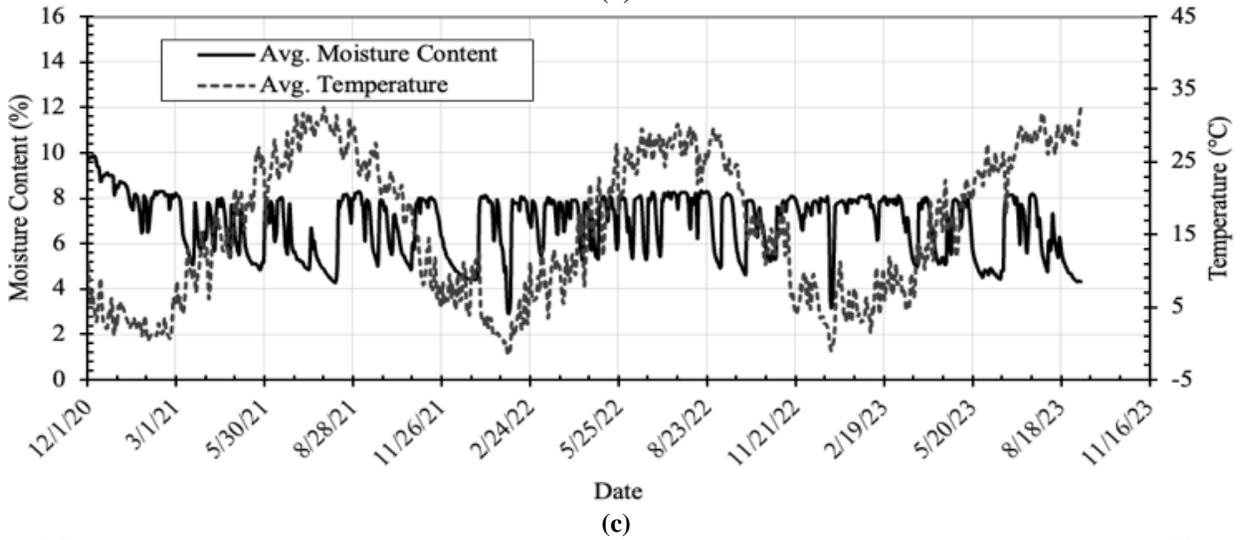
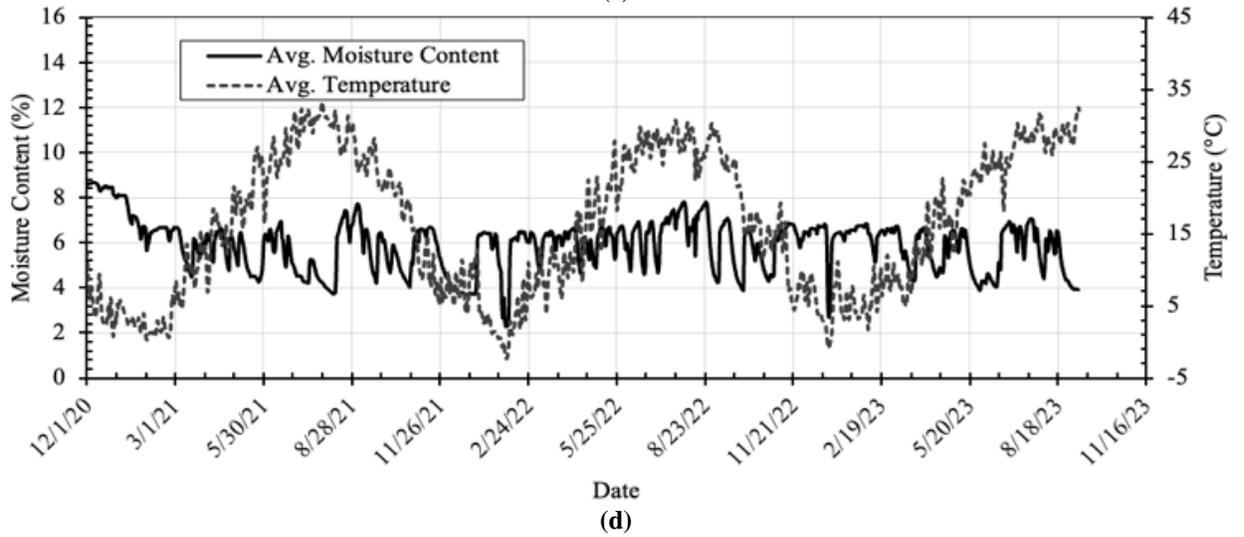
Figure 44. Daily average moisture content and temperature in the base course of the unpaved sections. (a) 100% CHCC, (b) Blend 1, (c) Blend 2, (d) 100% V.A.

Figure 44 shows the data obtained from the water content reflectometer/temperature sensors embedded in each unpaved test section. The values shown represent the average conditions observed for a given day.

The temperature fluctuations of the ground seen in Figure 44 for all sections are very consistent and were expected based on seasonal changes. The data obtained from the embedded temperature sensors correlate well with the ambient temperatures observed at the site (Figure 42). Table 4 shows the maximum and minimum observed temperatures at each section during this study. Considering that the base course was only 20 cm (8 inches) thick and had no pavement layer, the similarities between the ambient and ground temperatures are expected. The data show that around February of each year, the ground temperatures were below freezing.

The moisture content data of each unpaved section (Figure 44) also fluctuated with time. These fluctuations correlated well with the rain precipitation (Figure 41) and ambient temperatures (Figure 42) observed at the site. This indicates that in the unpaved sections, rainwater infiltrated the base course. Table 4 summarizes the general trends observed at each section, as relates to minimum and maximum moisture content data. This comparison showed that the unpaved 100% CHCC section had the highest moisture content fluctuations while the 100% V.A. section had the lowest. These were expected behaviors since CHCC is known to be hydrophilic (Yunusa et al., 2022), meaning it tends to absorb and hold water. The moisture content ranges observed in Blends 1 (40% CHCC) and 2 (20% CHCC) correlated well with this expected behavior, where the moisture content fluctuations decreased with decreasing CHCC content. Figure 44 shows that when the ground freezes (around February) the moisture content values decrease considerably, as expected. The overall data showed the expected behaviors and confirmed the accuracy of the instrument measurements.

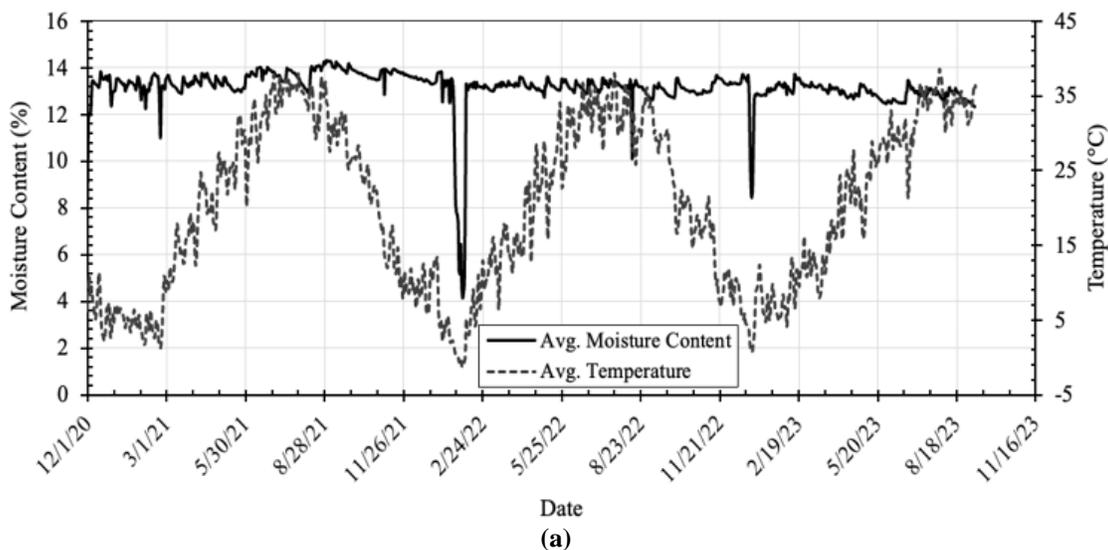
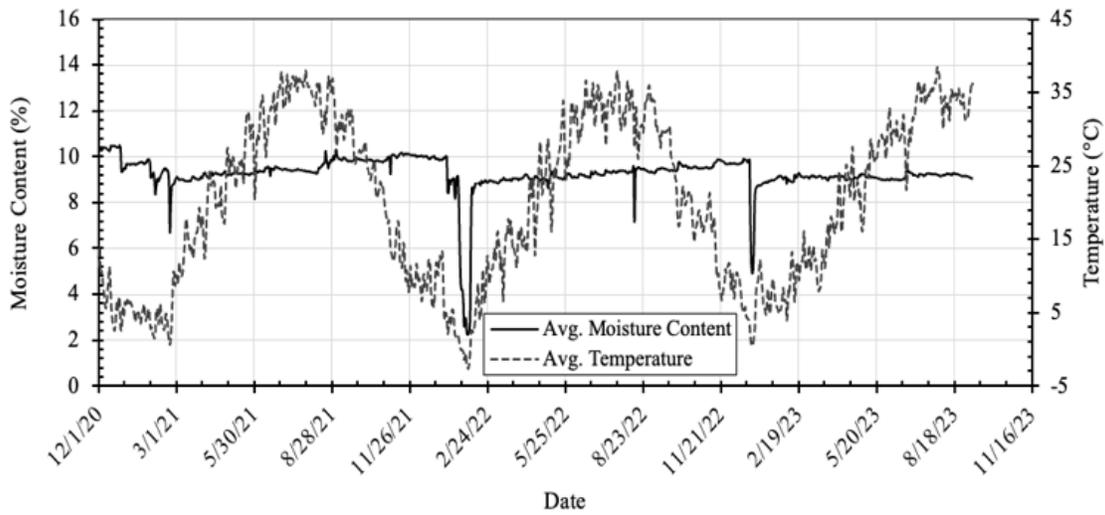
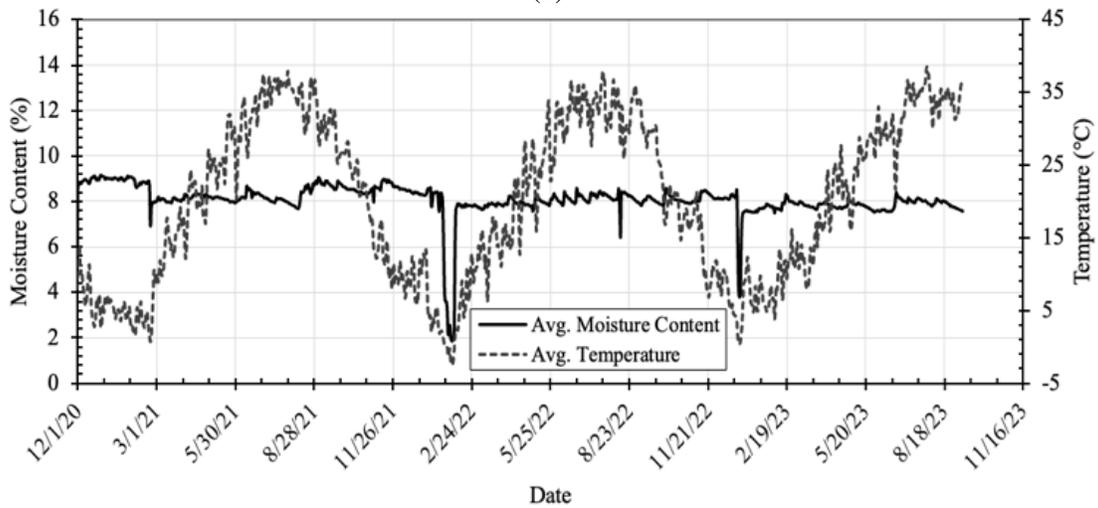
**Figure 45. Daily average moisture content and temperature in the base course of the paved sections. (a) 100% CHCC, (b) Blend 1, (c) Blend 2**

Figures 45 shows the data obtained from the water content reflectometers and temperature sensors embedded in each paved test section. Similar to those for the unpaved sections, the values shown for the paved sections also represent the average conditions observed for a given day.

As observed in the unpaved sections (Figure 44), the temperatures shown in Figure 45 show that around February of each year, the ground freezes at the paved sections. During these times, the water contents show considerably lower values (as observed in the unpaved sections). However, in other times when the ground is not frozen, the data seen in Figure 45 is different than the data from Figure 44. In the paved sections, the moisture content fluctuations appeared to be less frequent than what was observed in the unpaved sections (Table 5). Figure 45 also shows that overall, the moisture content of the paved sections appeared to be higher for longer periods compared to that for the unpaved sections. These comparisons indicate that the base course of the unpaved sections went through more wetting and drying cycles compared to that of the paved sections.

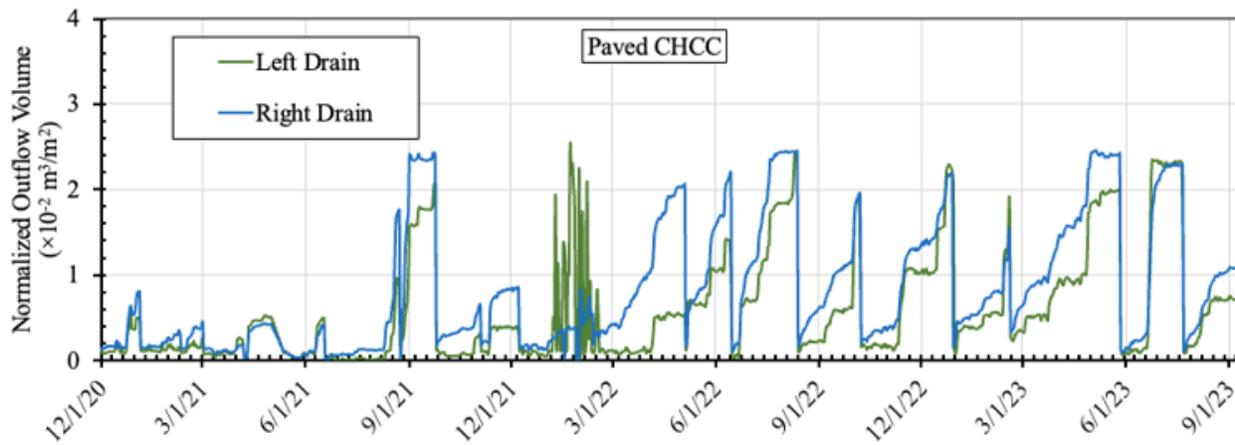
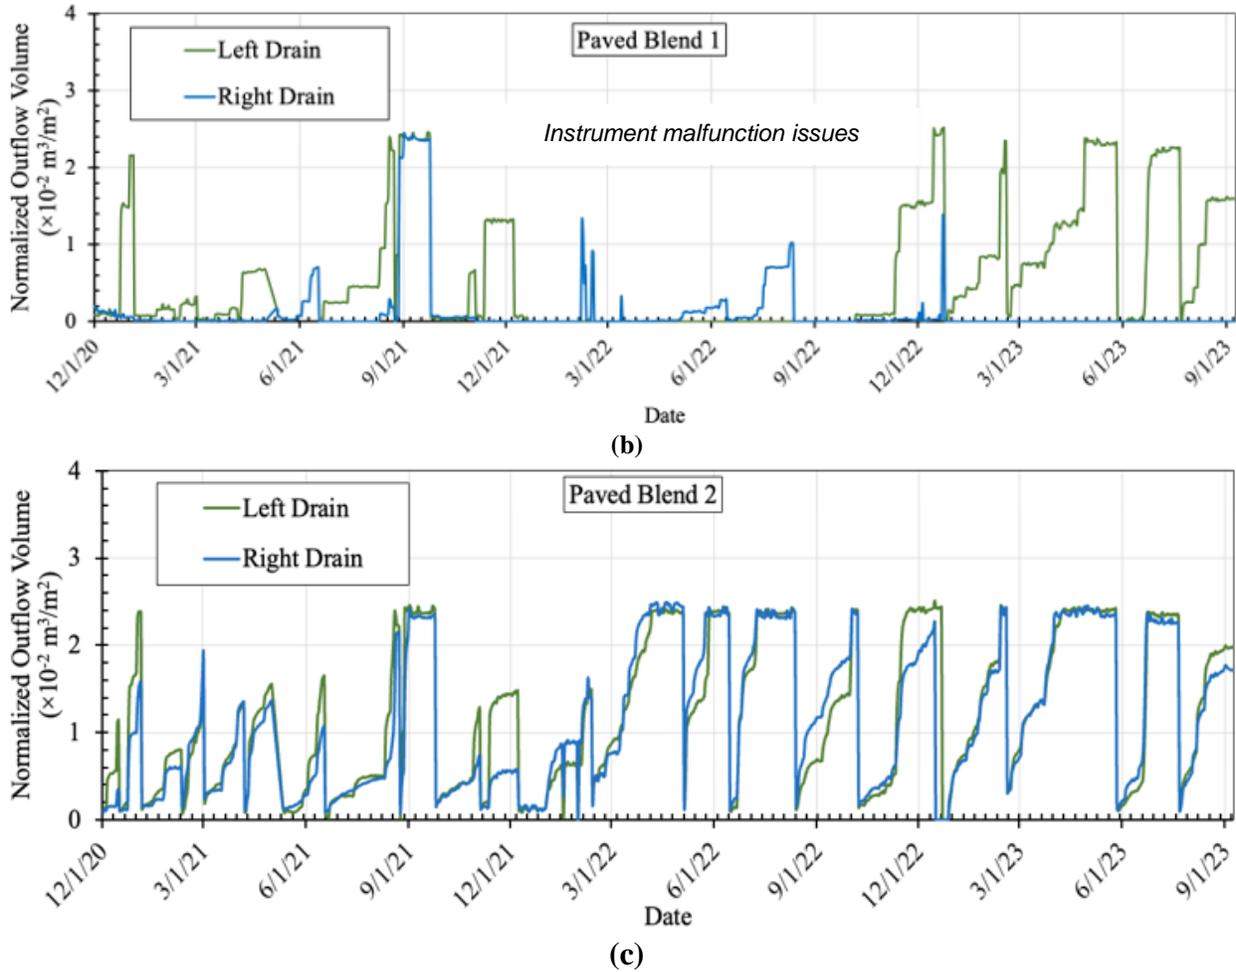
**Figure 47. Normalized outflow volume recorded for the paved sections (a) 100% CHCC, (b) Blend 1, (c) Blend 2**

Figure 47 shows the normalized outflow volumes from each water tank at each paved test section. The data for the paved Blend 1 section do not represent the complete picture because there were times when the instrument in both the left and right drain tanks malfunctioned. However, the data still show that water was able to reach the collection tanks. Overall, the data of all sections indicated that rainwater was able to infiltrate the pavement, and infiltrated water was able to reach the collection tanks.

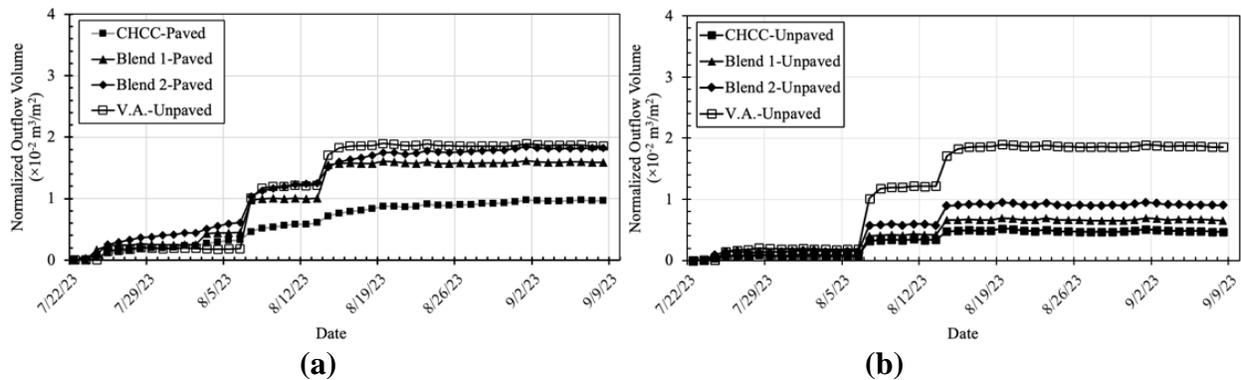
**Figure 48. Normalized outflow volumes recorded from the last cycle of water collection from the tanks**

were evaluated. Within this period, all the tanks continued to collect water as they were not yet full. Figure 48 shows the cumulative normalized outflow volume of the tanks from all sections. The significance of Figure 48 is that the data collected represent the performance of each section after 3 years of service. The increased normalized outflow volume in both the paved and unpaved sections observed in Figure 48 are associated with notable rain events between 08/06/23 and 08/13/23, as can be seen in Figure 41. This indicates that in all sections, the distribution of infiltrated water through the underdrain system into the collection tanks is still actively occurring after 3 years.

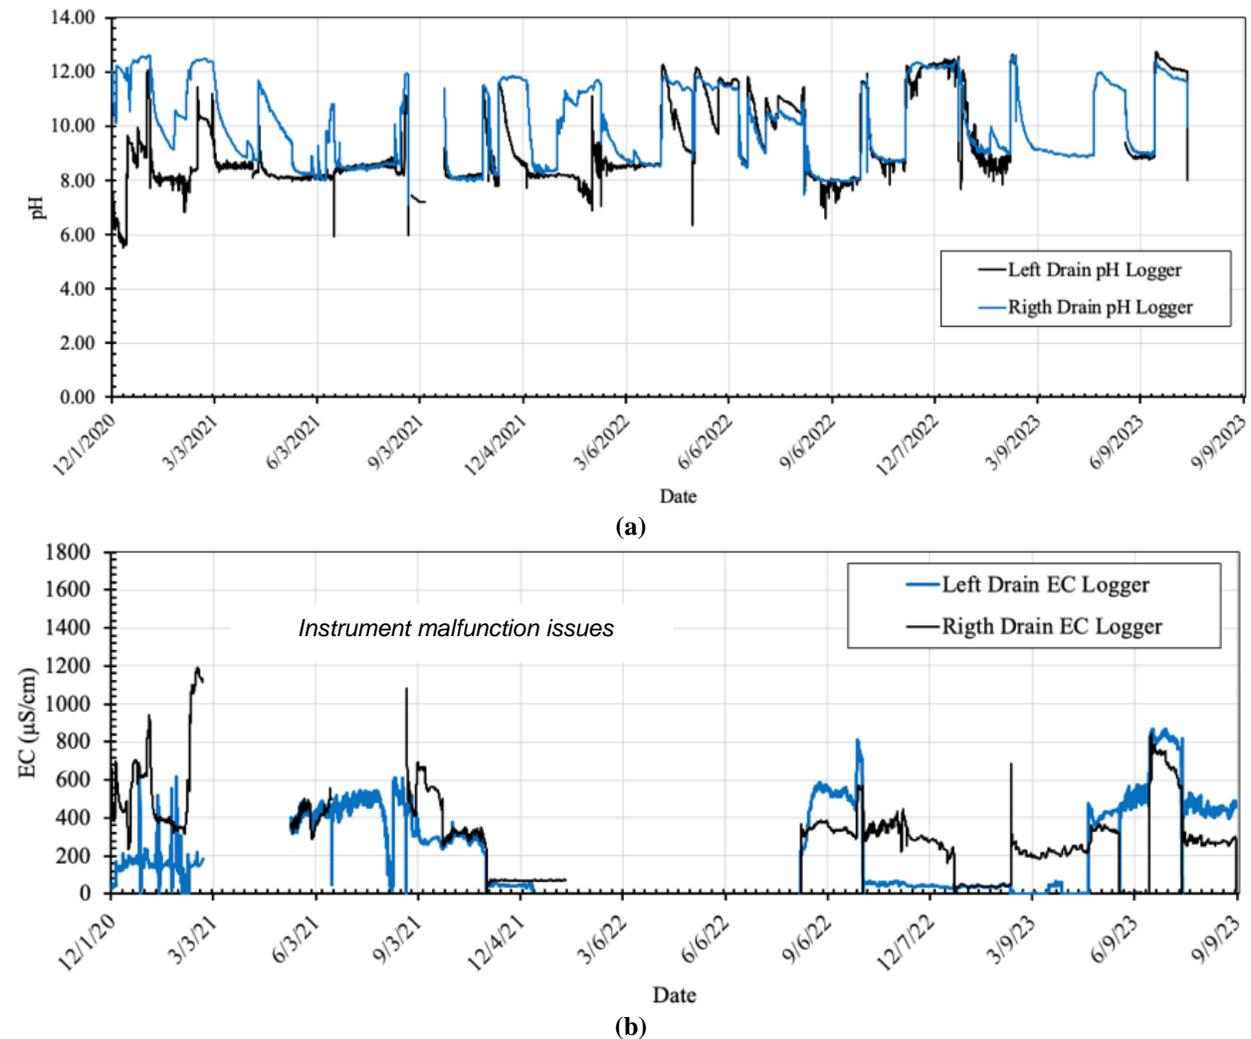
Figure 49. Monitoring data from the water collection tanks at the unpaved 100% CHCC section (a) pH, (b) electric conductivity (EC) (direct measurements from the field)

Figure 49 shows the monitoring data obtained from the instruments embedded in the water collection tanks of the unpaved 100% CHCC section. The EC probe had some issues; therefore, some of the data are missing. However, the fluctuations in pH and EC values indicate that some precipitation of Ca-based compounds might have occurred within the tanks. Higher pH conditions correlate to lower EC values and vice versa. This is an expected behavior, and the data show that the CHCC section is exhibiting the effects of carbonation due to wetting and drying cycles. Typically, a higher pH and lower EC indicates some form of precipitation of Ca-based compounds, while a lower pH and higher EC indicates a dissolution of Ca-based compounds.

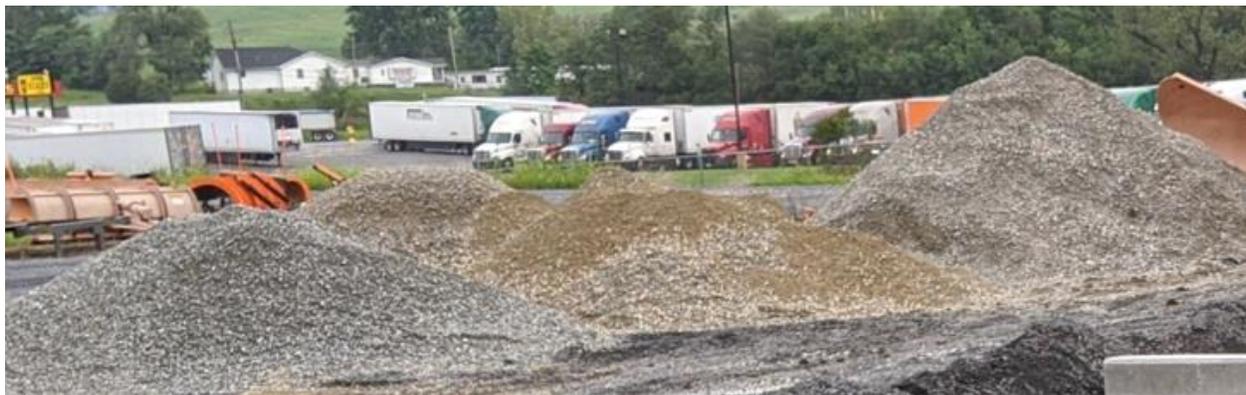
**Figure 55. A photo of the stockpiled base course materials on site during construction**

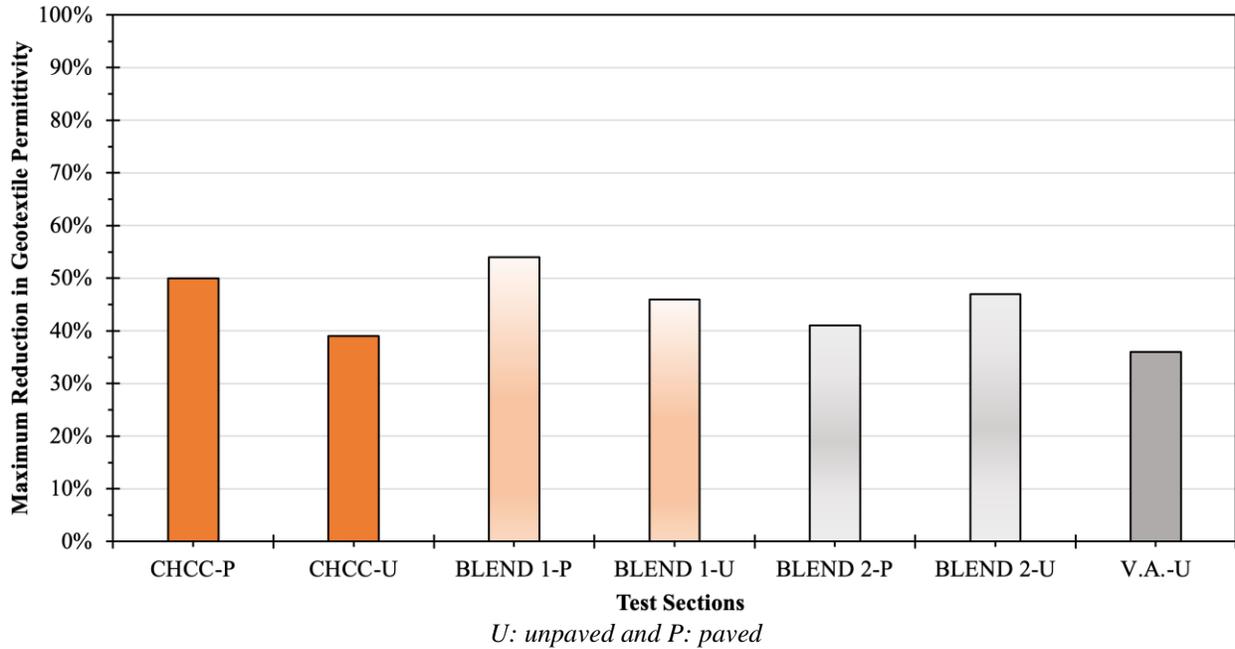
**Figure 56. Comparison of the maximum reduction in permittivity observed for the exhumed geotextiles from each section**

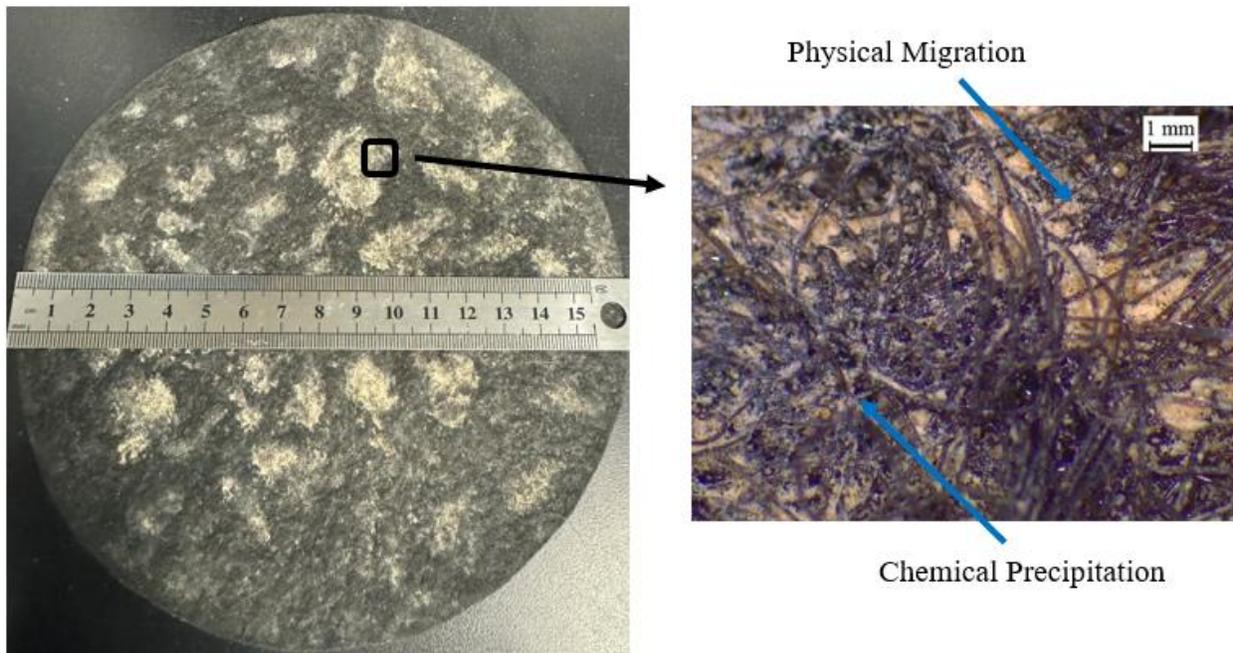
**Figure 57. A photo of the geotextile exhumed from the paved 100% CHCC section that was used for one of the permittivity tests**

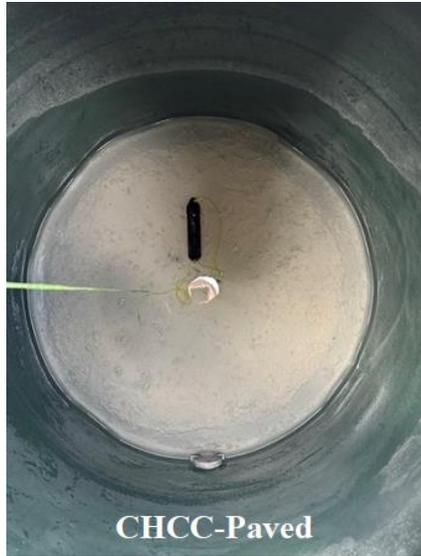
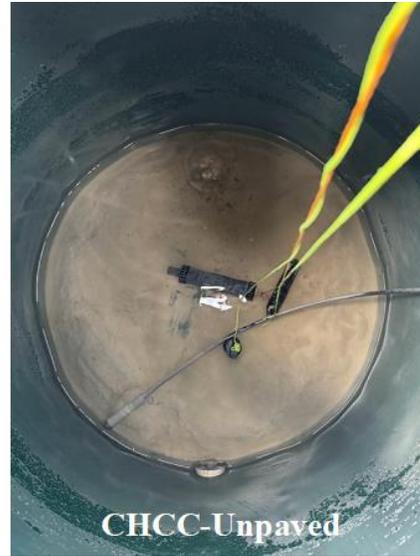
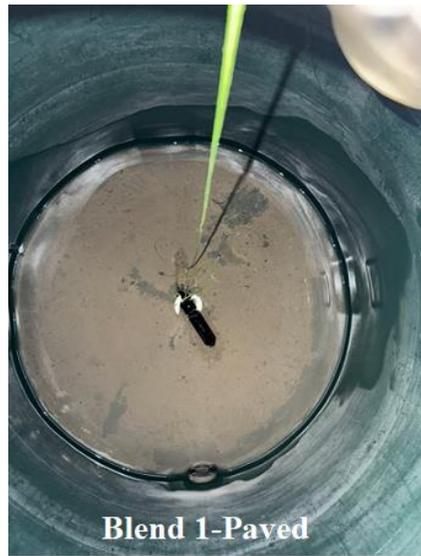
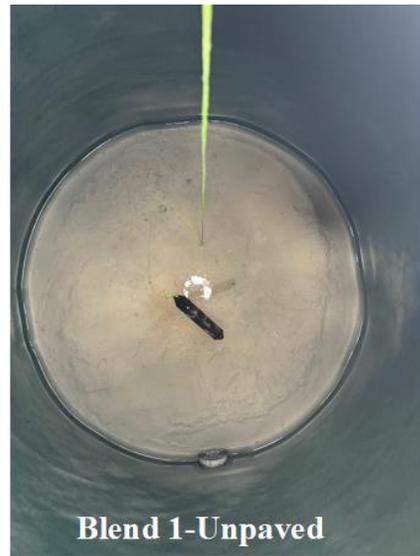
**Figure 59. Conditions of the accumulation inside the collection tanks at each section**

By the 33-month mark, the accumulation in all collection tanks at all the sections were noticeably more than the initial conditions. Figure 59 shows photos taken from inside the collection tanks at the end of 33 months. The conditions of the tanks for both left and right drains were not drastically different; therefore, only one of the tank photos is presented for each section.

The accumulation in the collection tanks is an indicator that fines (whether physical particles or tufa particles) were still able to migrate all the way through the edgedrain and collection pipes. None of the borescope data from the collection pipes and edgedrains showed clogging (a condition that impedes flow). However, surveys of the 100% CHCC and Blend 1 sections (both paved and unpaved) showed that some fine amount of tufa precipitation started to form in some areas within the collection pipes. Figure 60 shows a photo of the left drain of the paved 100% CHCC section after 33 months. In the same section, the edgedrain pipes showed only very minor signs of tufa precipitation on the edges of the corrugations (Figure 61).

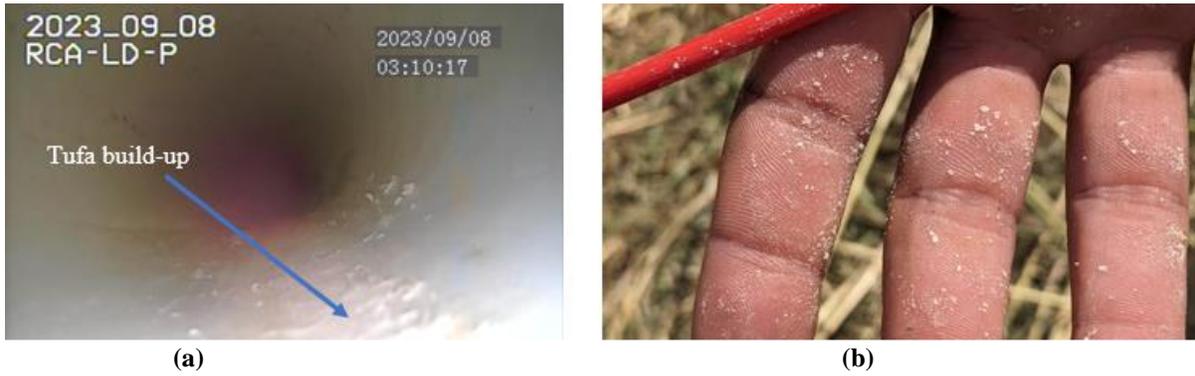
*RCA: CHCC; LD: left drain and P: paved*

**Figure 60. Tufa accumulation in the paved 100% CHCC section (a) inside the collection pipe and (b) smeared onto the borescope wire and hands**

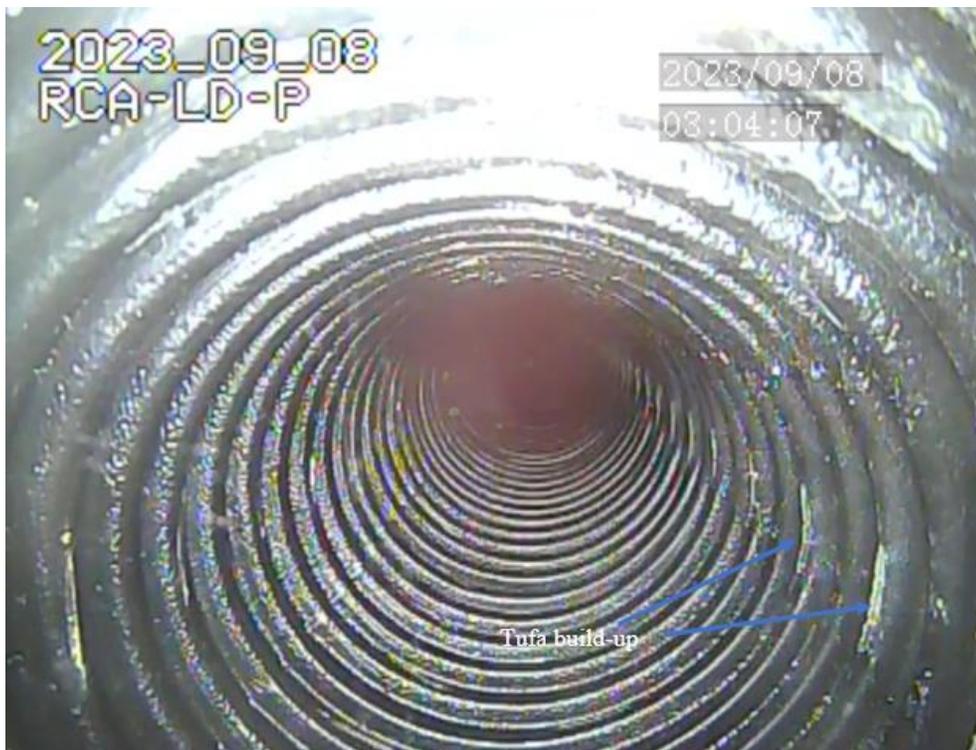
**Figure 61. Condition of the edgedrain pipe of the 100% CHCC paved section**

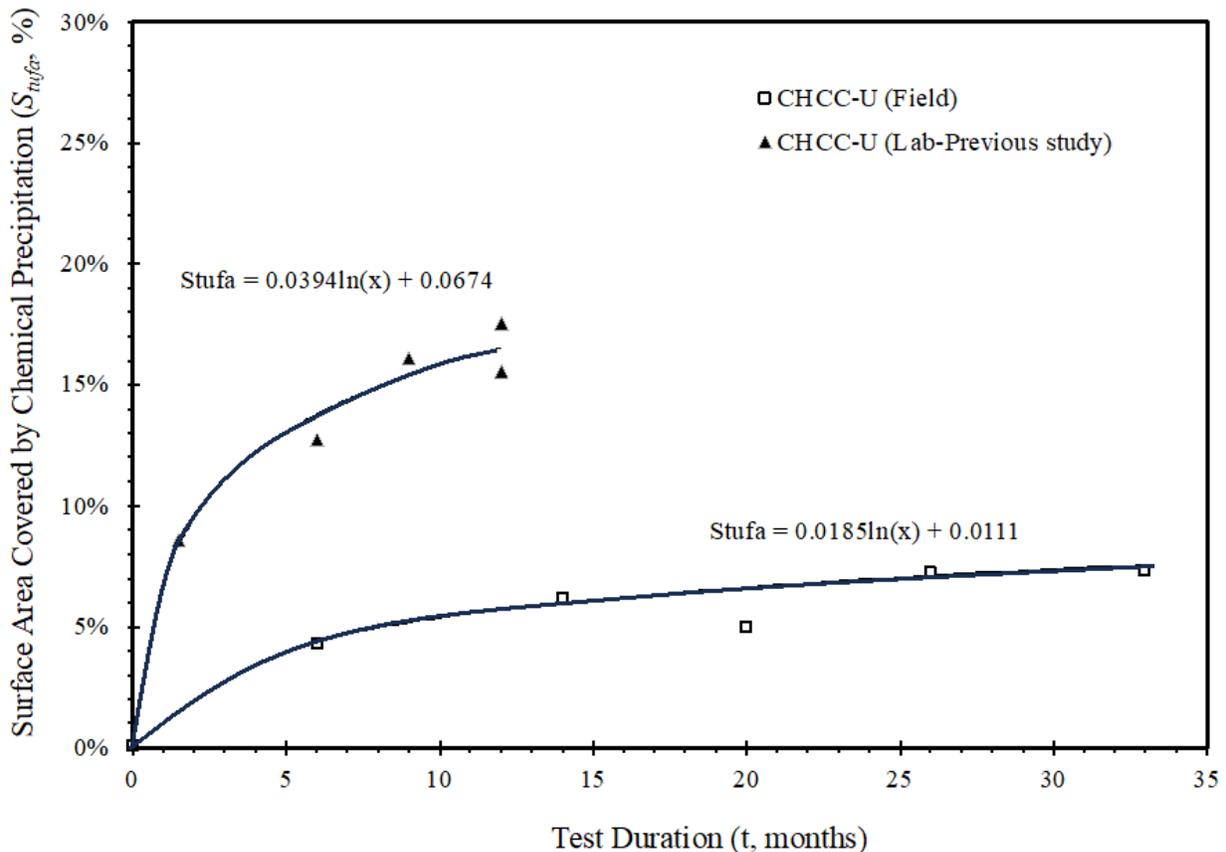
Figure 63. Comparison of the  $S_{tufa}$  in the unpaved 100% CHCC section from the previously completed laboratory study and the current field study

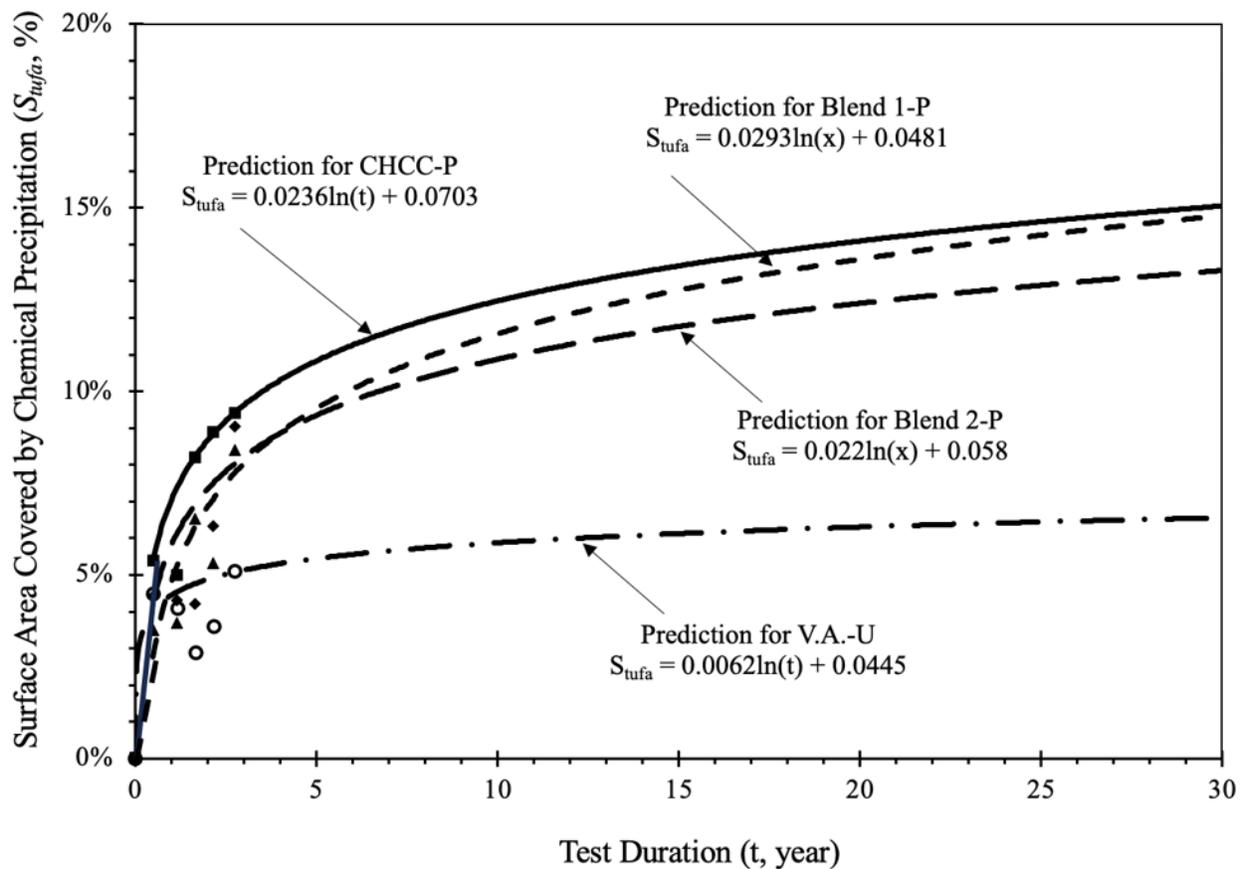
**Figure 64. Prediction of  $S_{\text{tufa}}$  over geotextile from paved sections and unpaved 100% V.A. section in this field study**
