Evaluation of Combining Heat Induction and Laser Ablation for the Removal of Potentially Hazardous Bridge Coatings

Final Report VTRC 26-R10

**EVALUATION OF COMBINING HEAT INDUCTION AND LASER ABLATION FOR
REMOVING POTENTIALLY HAZARDOUS BRIDGE COATINGS**

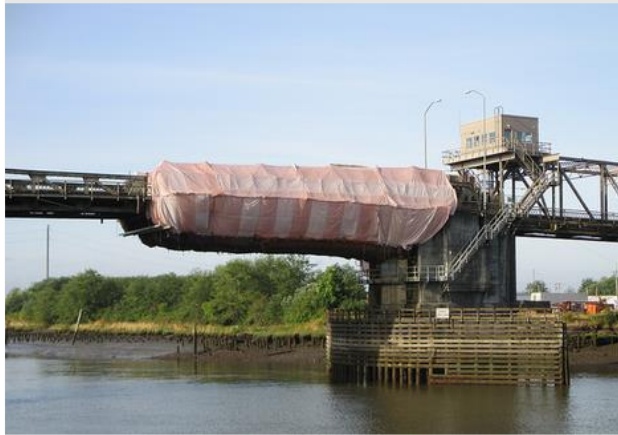
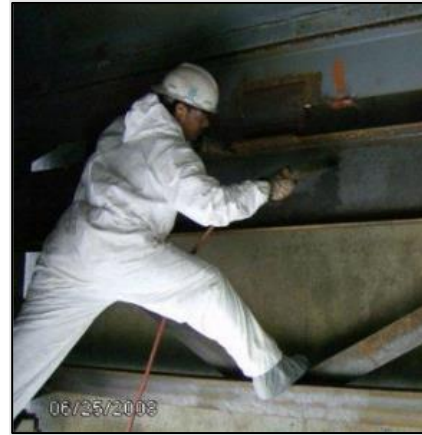
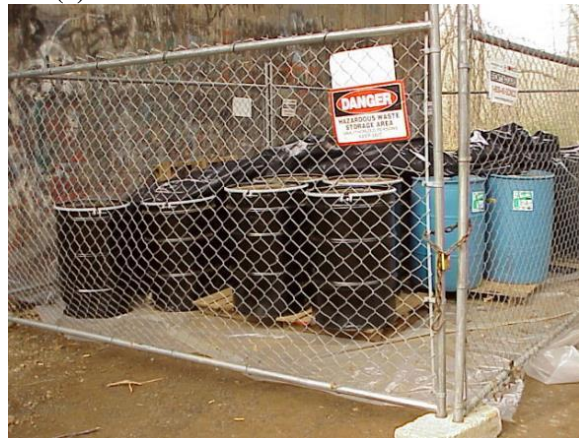
Figure 1. To Safely Remove and Dispose of Older Bridge Coatings with Lead-Based Coating; (a) The Old Coating Must Be Contained During Removal; (b) Workers Must Be Protected; (c) The Waste Material Must Be Properly Disposed

Typically, on large-scale projects like recoating steel bridge girders, coating removal and surface preparation are accomplished using abrasive blasting. The Virginia Department of Transportation (VDOT) commonly uses abrasive media like recycled steel shot to remove the old coating from steel bridge girders and prepare the surface for the new coating. This approach is effective but generates a lot of waste and requires a sizable effort to capture the generated airborne dust. Therefore, to perform this task properly, VDOT requires containment to ensure that the toxic waste is captured, workers have extensive personal protective equipment (PPE), and the old coating waste is properly disposed (Figure 1).

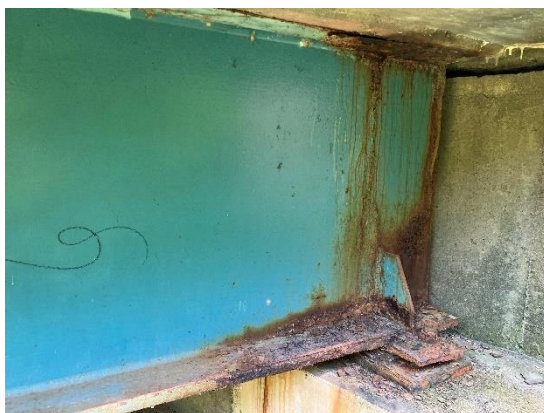
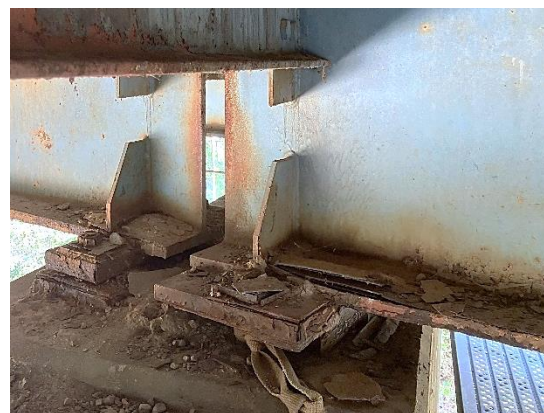
Figure 2. Coated Steel Girder End: (a) Exhibiting Significant Corrosion Damage Mainly at the Girder End and Bearing due to Salt and Water Penetrating through the Deck Expansion Joint Above; (b) Close-up of a Different Bearing at the Pier Shows the Voluminous Nature of the Rust Product that Formed from the Iron in the Steel

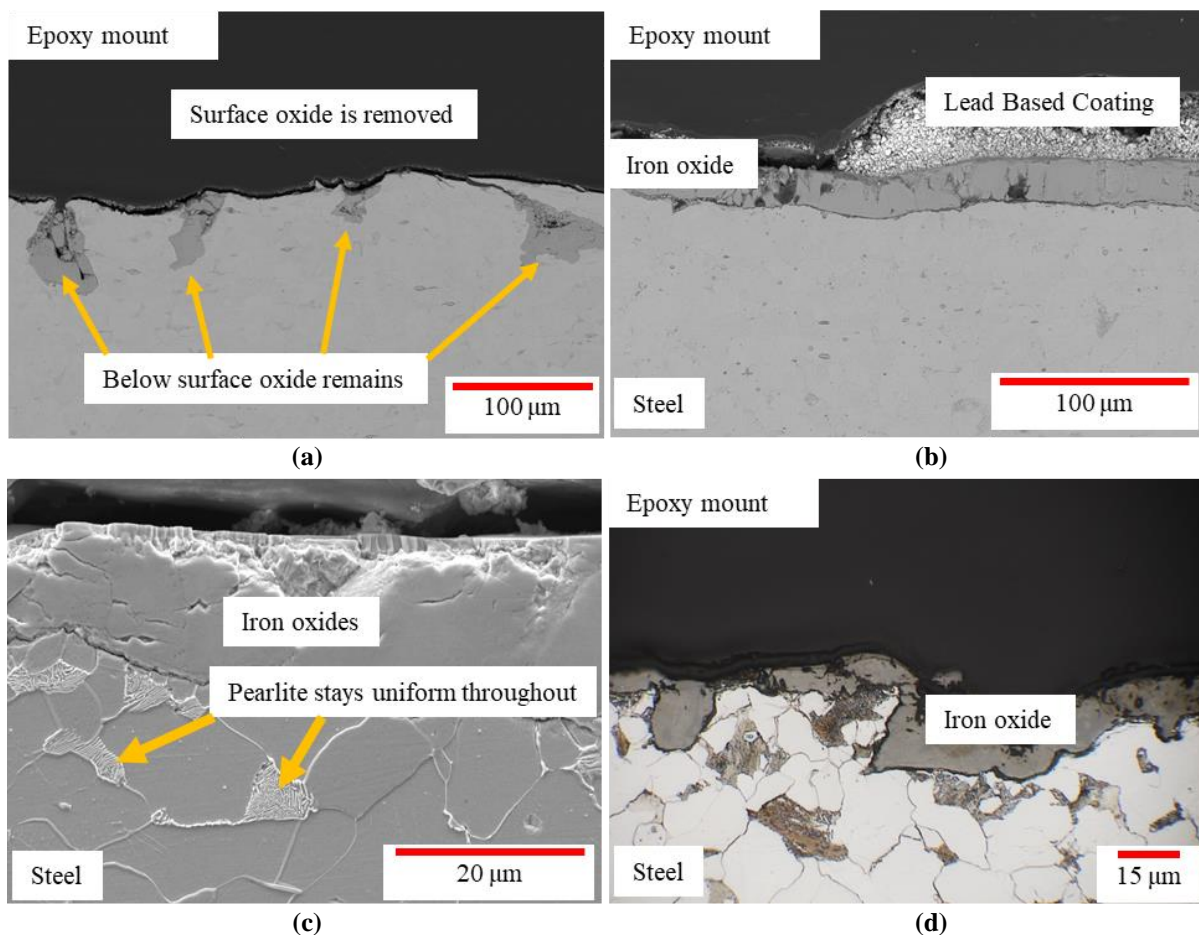
Figure 4. SEM Cross Section of: (a) GB Sample; (b) ICR Sample; (c) ICR+LACR Sample; and (d) Optical Micrograph of an ICR+LACR Cross Section. The GB cross section in (a) shows the presence of iron oxide inclusions below the steel surface that have been driven in from the GB process. The ICR cross section in (b) shows the remaining lead-based coating on top of the iron oxide that continuously covers the steel after ICR treatment. The ICR+LACR cross-section SEM micrograph in (c), centered on the interface between the iron oxide and steel, shows unaltered low-carbon steel microstructures below the iron oxide layer. The intact Pearlite shows that heating from ICR and LACR does not affect the steel microstructure. The ICR+LACR cross section in (d) shows the full removal of coatings and the iron oxide mill scale layer that stays intact across the steel surface. The “epoxy mount” label refers to a metallographic sample preparation process and

is labeled here for clarity. GB = grit blasting; ICR = induction coating removal; LACR = laser ablation coating removal; SEM = scanning electron microscopy.

The researchers compared cross sections of samples cleaned with ICR, ICR+LACR, and GB to evaluate their cleanliness after coating removal. Metallographic samples of LACR-only processed surfaces have been studied and discussed previously in a previous report (Fitz-Gerald et al., 2019). The researchers found that GB effectively removes all the coating layers, including the iron oxide layer, but also drives some of the iron oxide into the steel below the surface. Figure 4a shows both SEM and EDS maps of the GB surface in a cross section and how the iron oxide is driven into the steel because of the GB treatment. Although not tested in this research, the inclusions and crevices created by impacting the oxide layer could potentially introduce corrosion initiation sites by allowing electrolytes to enter and concentrate.

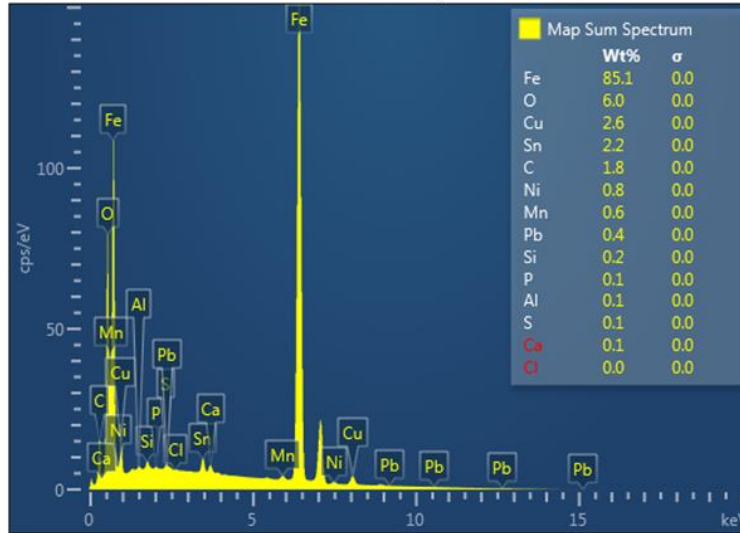
Figure 5. (a) Energy Dispersive Spectroscopy Map of the Grit Blasting Surface at 800x Magnification and (b) Corresponding Energy Dispersive Spectroscopy Spectrum Showing the Large Number of Elements Detected on the Grit Blasting Surface Even at this Length Scale. Dark blue = Pb (lead); light blue = Sn (tin); yellow = Cu (copper); green = O (oxygen); and red = Fe (iron). Al = aluminum; C = carbon; Ca = calcium; Cl = chloride; Mn = manganese; Ni = nickel; P = phosphorus; S = sulfur; Si = silicon; Wt = weight; σ = standard deviation.

Figure 5 shows an EDS map of a GB surface-to-surface chemistry and level of contamination. As evident in Figure 5, the GB surface contains many elements, likely introduced from the impacts of the GB media on the steel. Overall, the GB surface appears to contain many contaminants.

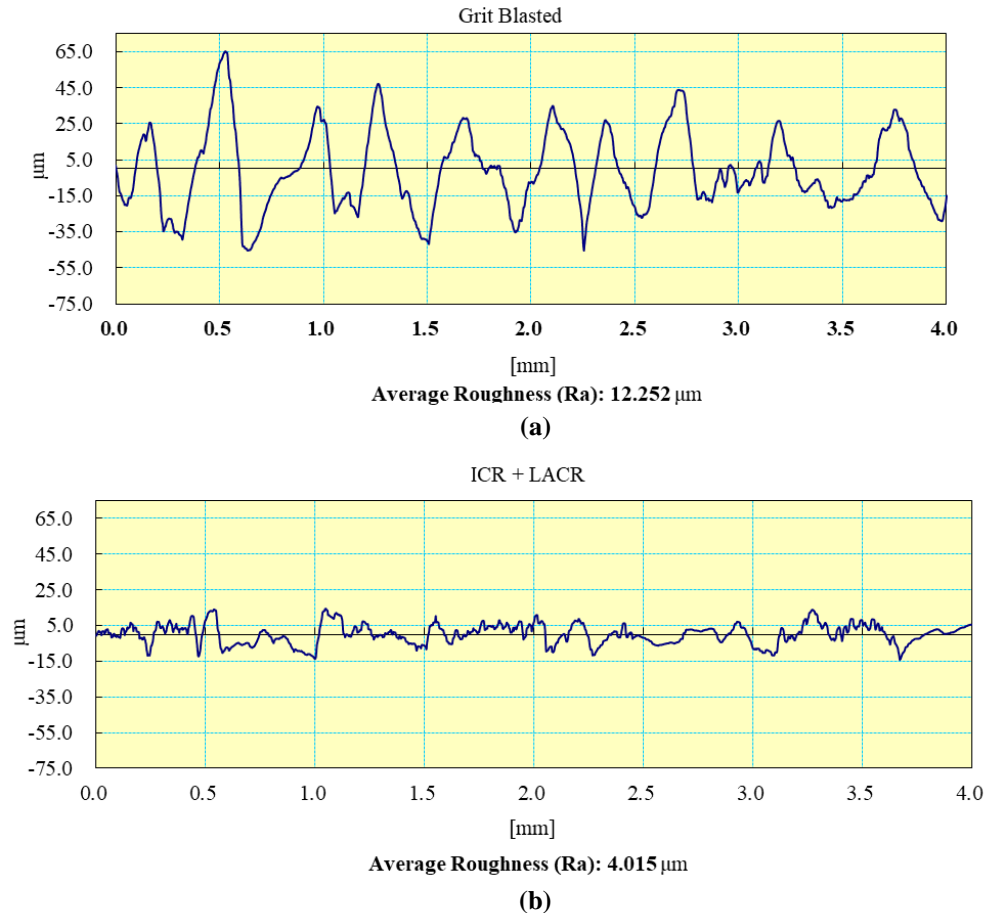
Figure 10. Representative Profilometry Scan Surface Roughness Profiles of: (a) The Grit Blasting Surface; (b) The ICR+LACR Surface. The average roughness for each surface is noted below each respective profile. ICR = induction coating removal; LACR = laser ablation coating removal.

Stylus profilometry was used to measure the macroscale surface roughness profile. Figure 10 shows the representative surface roughness profiles of the GB and ICR+LACR surfaces. An earlier report presented the surface profiles of the LACR-only processed surface. The profiles clearly show a difference in roughness, with respective average roughness values of 12.3 and 4.0 microns for the GB and ICR+LACR surfaces. The researchers also observed that the peak-to-valley ranges captured by profilometry closely match those that KTA measured.

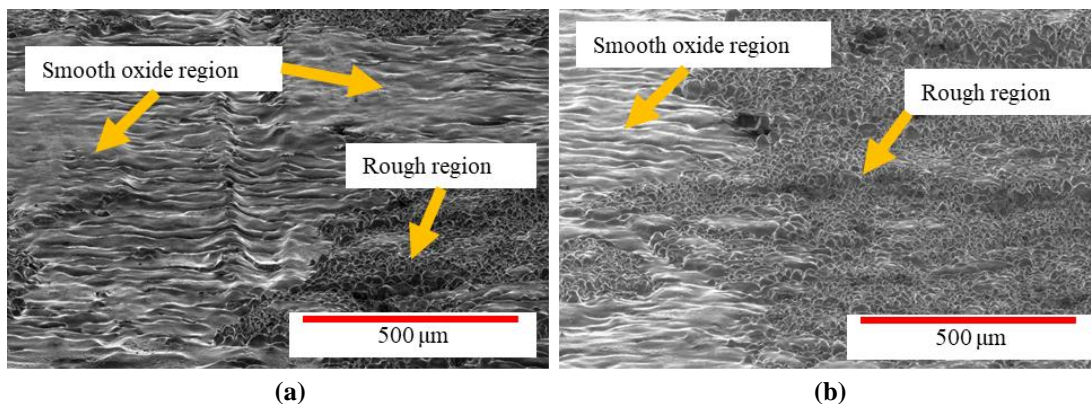
Figure 12. Scanning Electron Microscopy Micrographs Show the Distribution of Rough and Smooth Regions across the Surface of Induction Coating Removal and Laser Ablation Coating Removal Cleaned Samples. Both (a) and (b) show how the distribution of rough and smooth areas varies across the surface.

Similarly, SEM imaging of the ICR+LACR surface in Figure 12 shows how a relatively smooth surface is left. No bare steel is observed, and an iron oxide mill scale layer continuously covers the surface. On closer examination, the researchers observed two different roughness profiled regions on the surface. Both rougher and smoother surface regions were identified that were randomly distributed across the surface. The smoother areas consist of iron oxide, with a slowly undulating appearance without any sharp, distinct peaks or valleys. The rougher regions present well-defined and closely spaced peaks and valleys. These observations agree with the surface roughness measurements, which showed the high-frequency, low-amplitude surface profile.

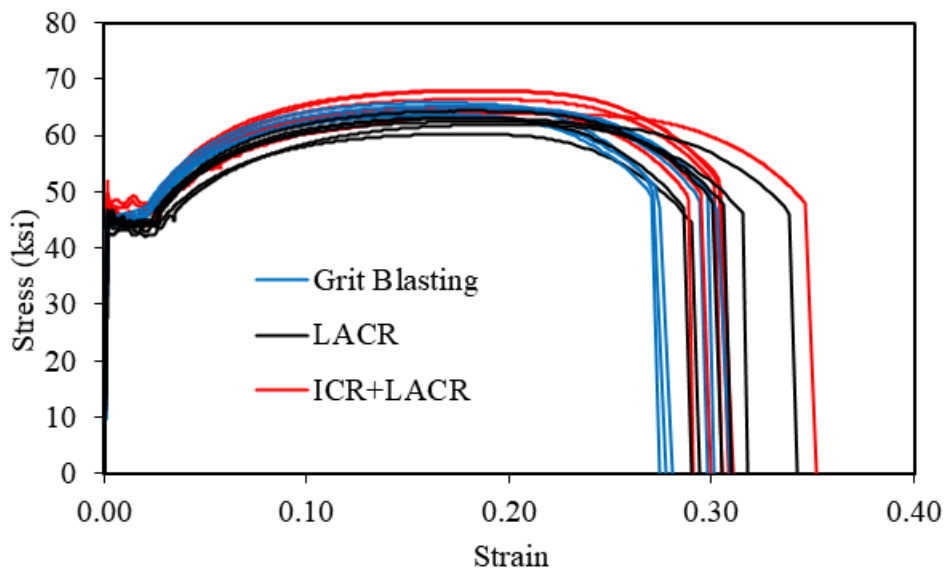
Figure 13. Stress versus Strain Data for Tensile Tests on Steel Samples Subject to Grit Blasting and Cleaned Using LACR and ICR+LACR with a Maximum Surface Temperature of 325 °F. ICR = induction coating removal; LACR = laser ablation coating removal.

Because the surface analysis showed that ICR was not effective at removing all the coating on the surface and therefore would not be used on its own for bridge coating removal, tensile testing was not conducted on the ICR samples. Figure 13 shows complete stress versus strain data for each tensile test. All the curves follow a typical stress versus strain behavior consistent with typical steels used for bridges from the 1940s. No indications suggest that either the LACR or ICR+LACR, when used within the parameters in this study, caused a change in the overall mechanical behavior of the steel. The variations in the curves are likely due to the expected variations in tensile testing of any steel samples.

Table 8 shows the average modulus of elasticity, yield stress, ultimate strength, and percentage elongation for each coating removal method. The modulus of elasticity of each of the three conditions is similar to the expected value of 29,000 ksi for steel. Because the steel for these samples was taken from a retired bridge, the type is unknown. However, based on the tensile test data, it appears to be similar to an ASTM A36 steel, which has a minimum yield strength of 36 ksi, a minimum ultimate strength of 58 ksi, and a minimum elongation of 23% (ASTM International, 2019). As Table 8 shows, the average yield stress, average ultimate strength, and average percentage elongation for each of the three conditions are similar, and all exceed the expected results for an ASTM A36 steel. It is important to note that the maximum measured surface temperature during ICR was 325 °F. If the surface temperature were to increase drastically, then changes in the mechanical properties could occur.

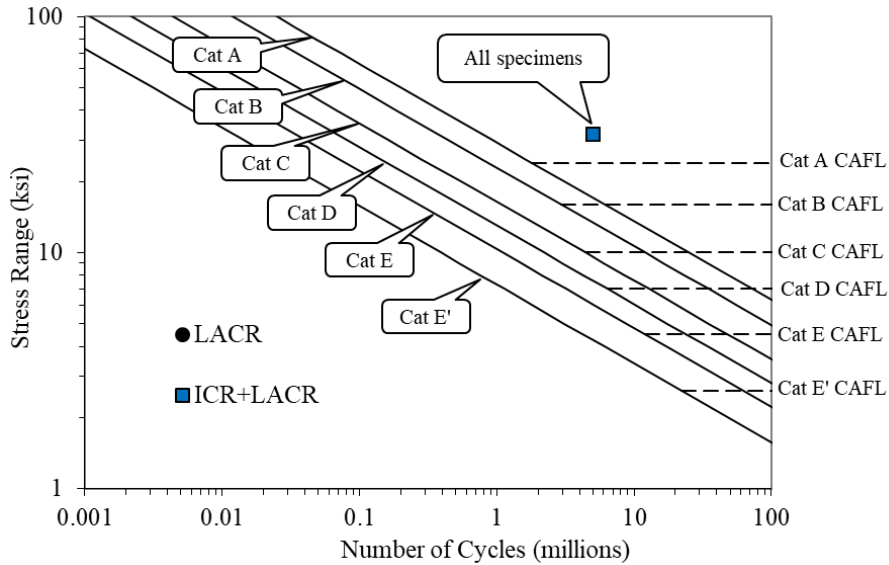
Figure 14. Fatigue Test Results on Steel Samples Subject to LACR and ICR+LACR with a Maximum Surface Temperature of 325 °F. CAFL = constant amplitude fatigue detail; Cat = category, representing AASHTO fatigue detail category; ICR = induction coating removal; LACR = laser ablation coating removal.

Figure 14 shows the fatigue test results of the LACR and ICR+LACR samples. In Figure 14, the solid lines represent the AASHTO fatigue detail categories A through E, whereas the dashed lines indicate the constant amplitude fatigue limits for each AASTHO fatigue detail category (AASHTO, 2020). As Figure 14 shows, all the samples reached 5 million cycles and were considered run-outs. This outcome is why all the results lie on the same point in the figure. All the data points lie above the line for a fatigue detail category A, which is steel base metal, meaning that the LACR or ICR+LACR samples can be expected to have similar fatigue performance compared with steel base metal not subject to any coating removal process. This result shows that LACR and ICR+LACR, when used at the parameters per this study, do not cause a degradation in the fatigue performance of the steel. Similar to the mechanical properties, increasing the surface temperature far past 325 °F could cause a change in fatigue performance.

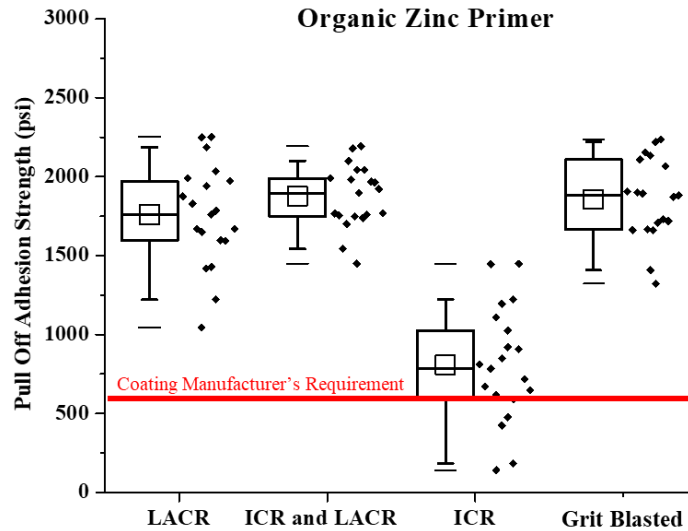
Figure 15. Pneumatic Adhesion Tensile Testing Instrument Test Results for the Organic Zinc Primed Surfaces. The red line at 600 psi marks the minimum accepted adhesion value, as stated by the coating manufacturer. The mode for each sample dataset is shown as a line through the middle of the box. The lower and upper bounds for the boxes are the 25th and 75th percentiles, and the whiskers represent the 10th–90th percentile range. Global minimums and maximums are represented with a short horizontal line below and above the whiskers, respectively. ICR = induction coating removal; LACR = laser ablation coating removal.

mode for each sample dataset is shown as a line through the middle of the box. The lower and upper bounds for the boxes are the 25th and 75th percentiles, and the whiskers represent the 10th to the 90th percentile range. Global minimums and maximums are represented with a short horizontal line below and above the whiskers, respectively. The horizontal red line across the graph represents the minimum accepted adhesion value of 600 psi, as stated by the coating manufacturer.

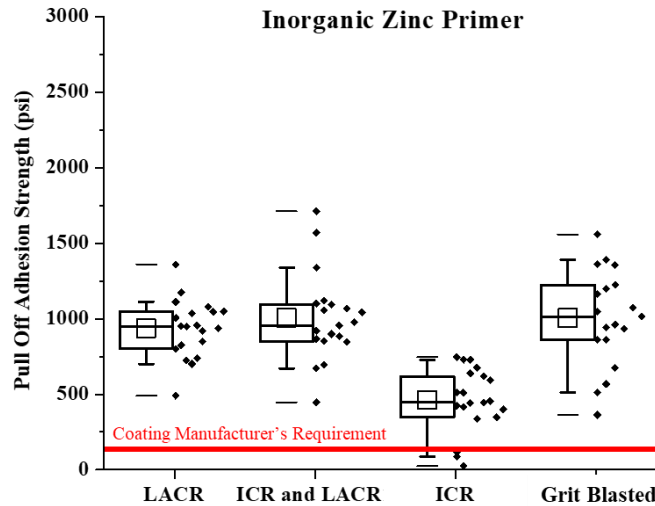
Figure 16. Pneumatic Adhesion Tensile Testing Instrument Data for the Inorganic Zinc-Primed Samples. The red line represents the minimum adhesion value of 200 psi, as stated by the coating manufacturer. The mode for each sample dataset is shown as a line through the middle of the box. The lower and upper bounds for the boxes are the 25th and 75th percentiles, and the whiskers represent the 10th–90th percentile range. Global minimums and maximums are represented with a short horizontal line below and above the whiskers, respectively. ICR = induction coating removal; LACR = laser ablation coating removal.

adhesion values for the ICR, LACR, ICR+LACR, and the GB surface were found to be 462.7, 935.6, 1,006.0, and 1,003.7 psi, respectively. In general, the samples recoated with IOZ primer displayed lower adhesion across all coating removal techniques compared with the OZ-coated surfaces. This result is likely due to the significantly lower strength and toughness of the inorganic silica matrix compared with the organic epoxy matrix binder used in the OZ primers.

In contrast to the OZ-coated samples, SEM analysis showed that the IOZ-coated samples exhibited both adhesive and cohesive failures, exposing the steel substrate and fracturing within the IOZ primer matrix. The IOZ primed surfaces showed regions of adhesive failure that still left the zinc pigment fully encapsulated within the silica matrix, and the cohesively failed regions tended to occur around the presence of aluminum particles that were present in the primer.

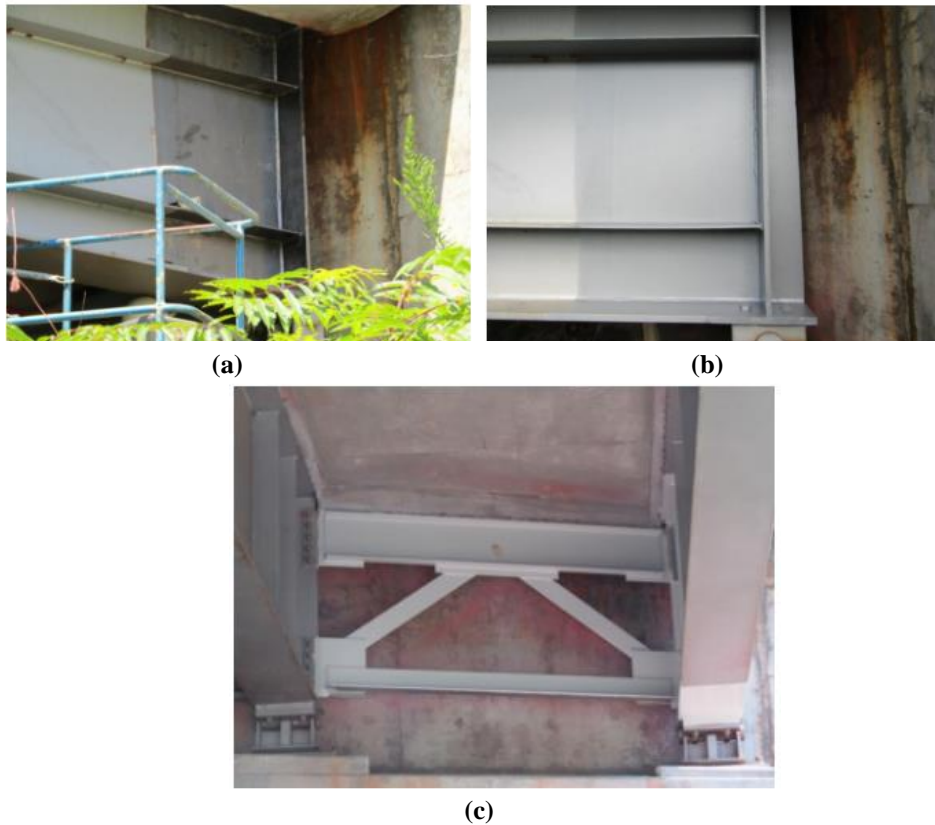
Figure 17. Laser Ablation Coating Removal and Recoating of Route 695 Bridge in August 2017 Showing: (a) After Coating Is Removed on Facia Girder Using Laser Ablation Coating Removal; (b) After Prime Coat Is Applied to Facia Girder No. 4 at Abutment B; (c) After Finish Coat Is Applied to Cross Frame between Girders No. 3 and 4 and to the Bottom of Girder No. 4.

According to VTRC Final Report No. 20-R1, the original coating on Route 695 Bridge had been in service for about 44 years before VDOT's first use of LACR on a bridge (Fitz-Gerald et al., 2019). Thickness measurements of that coating indicated approximately 6 mils on the girders and approximately 11 mils on the cross frames. After LACR was successfully completed in August 2017, as Figure 17 shows, the areas were recoated with a VDOT System F coating system. The inspector estimated that approximately 50 square feet of surface area had been cleaned with LACR during a 3-day period, with the LACR-cleaned surfaces being recoated each day with primer. The coating system used was an Epoxy Mastic Aluminum II primer with an Acrolon 218 HS finish coating. The inspector also noted that, although LACR was extremely clean and favorable for workers and the environment, the coating removal rate was too slow to be used for production.

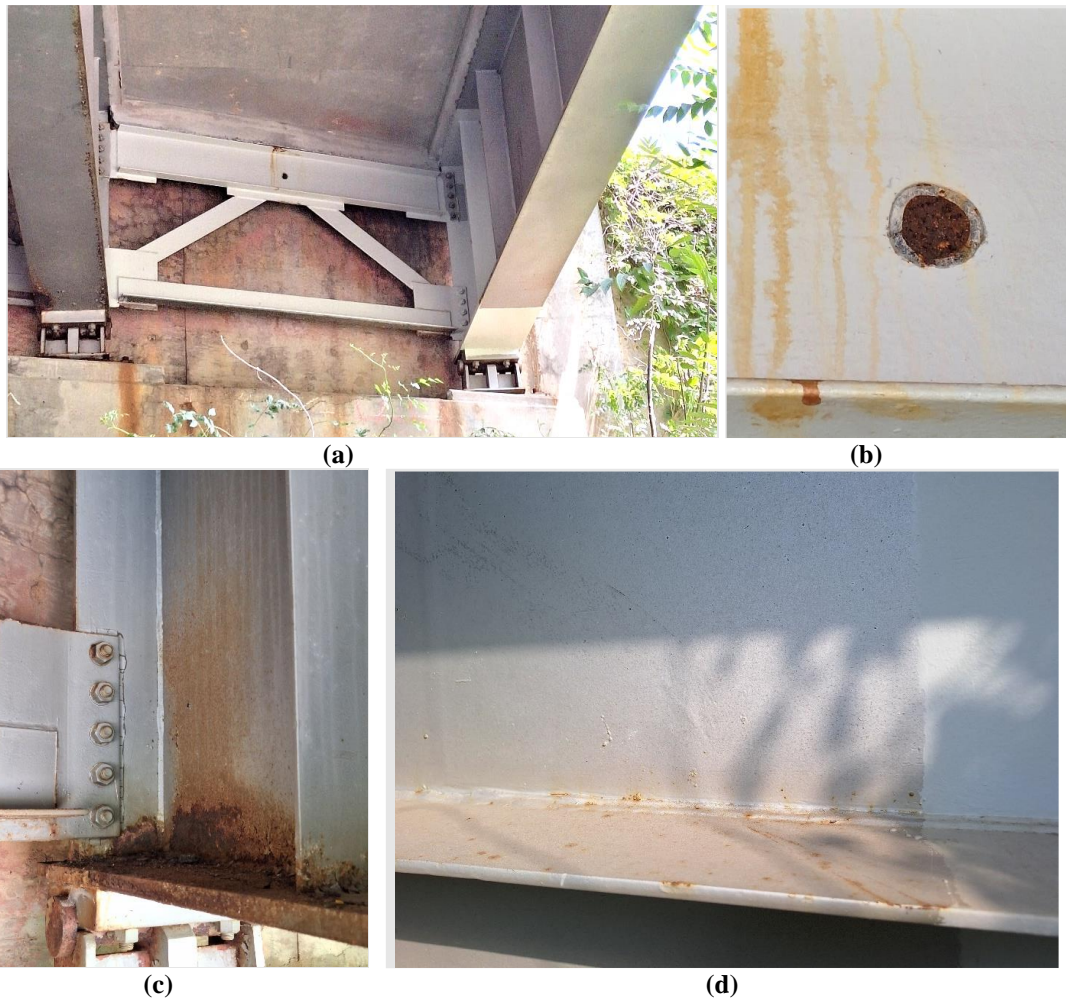
Figure 18. Examples of Areas Cleaned with LACR Alone and Recoated and Areas that Were Not. (a) The girder on the left (girder no. 3, near abutment B) was not cleaned and recoated, whereas the cross frame and girder end on the right (girder no. 4, near abutment B) were cleaned with LACR and recoated. (b) Magnified view of stain and uncoated test area on recoated steel cross frame is also seen near the top of the cross frame, shown in (a). The stain is due to a leaking joint, allowing moisture to seep between the bottom of the end bolster and the top of the secondary member interface because of the failed joint. The uncoated corroded area in the middle of the photo was intentionally left uncoated as part of the first study to observe a LACR cleaned but uncoated area over time. (c) Coating loss and exposed steel are shown where LACR repair would benefit the bridge by mitigating steel loss on the bottom flange and web at the bay 2 side of girder no. 3 near abutment B. (d) The transition on exterior girder no. 4 near abutment B from the original coating to the LACR cleaned and recoated area illustrating how the old coating has numerous small rust sites. LACR = laser ablation coating removal.

coating, meeting the requirements for VDOT Coating System F, had been reapplied to selected locations on the bridge. Before the field assessment, the researchers reviewed the interim 2016, 2018, 2020, and 2022 inspection reports. The reports indicated “rust/corrosion and paint peeling on structural steel,” some of which can be seen in Figure 17. Several photographs in the reports included examples of coating damage on the girders. However, during the field assessment in July, although several small rust spots were observed along the edge of the girder in the areas where LACR was used to prepare the surface, “paint peeling on structural steel” was not observed in the recoated areas, as Figure 18 shows.

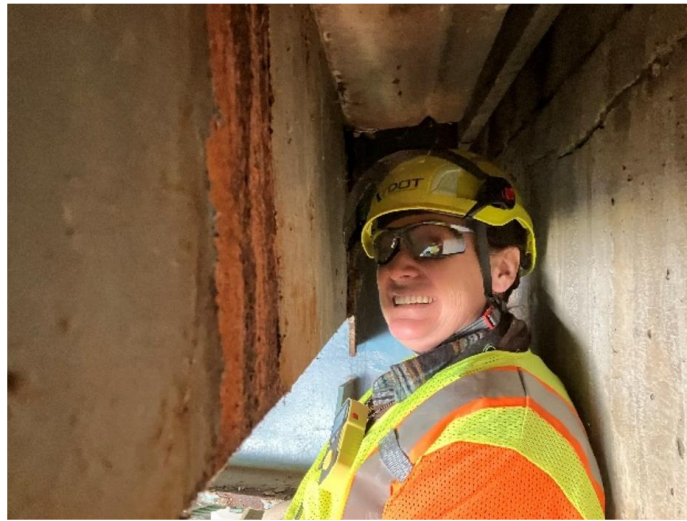
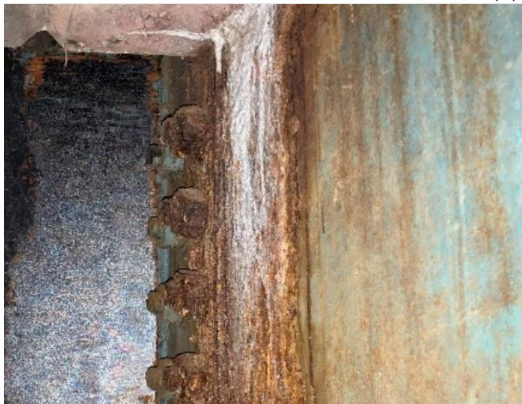
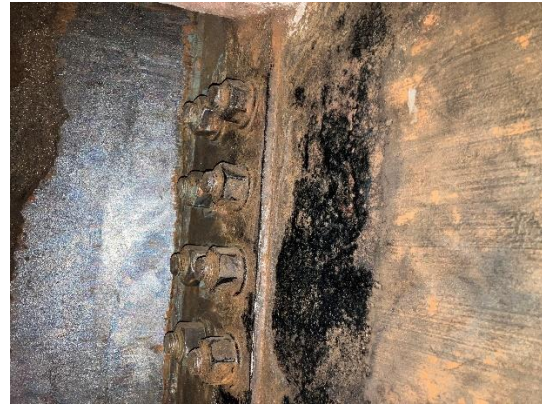
Figure 19. Difficulty Accessing the Back Wall Area with Induction Coating Removal and LACR and Flash Rust Comparison in this Area. (a) Capturing bay 1 channel 1, the diaphragm is close to the back wall. (b) Capturing bay 5 channel 3 after performing the final cleaning with LACR on the girder end but before mechanically removing the coating on the diaphragm and around the nuts, bolts, and washers; (c) After the diaphragm coating was removed and the steel was left uncoated overnight (less than 24 hours), but the LACR-cleaned surface did not change. LACR = laser ablation coating removal.

The tight area between the diaphragm and abutment back wall, as seen in Figure 19a, provided insufficient distance to clean the back of the diaphragms using the ICR and LACR equipment. As Figure 19b shows, the protruding girder sections were accessible to and cleaned by ICR+LACR. The areas on the backside of the diaphragm were cleaned using mechanical means. Having these two coating removal methods close together showed the difference in the rate of flash rusting when LACR and conventional coating removal methods are compared, which has been observed in laboratory work. As Figure 19c shows, the mechanically cleaned surfaces exhibited flash rust in less than 24 hours compared with the LACR-cleaned surfaces, which slowly showed flash rust after several days. Both the ICR and LACR heads require modification to access similarly tight areas.

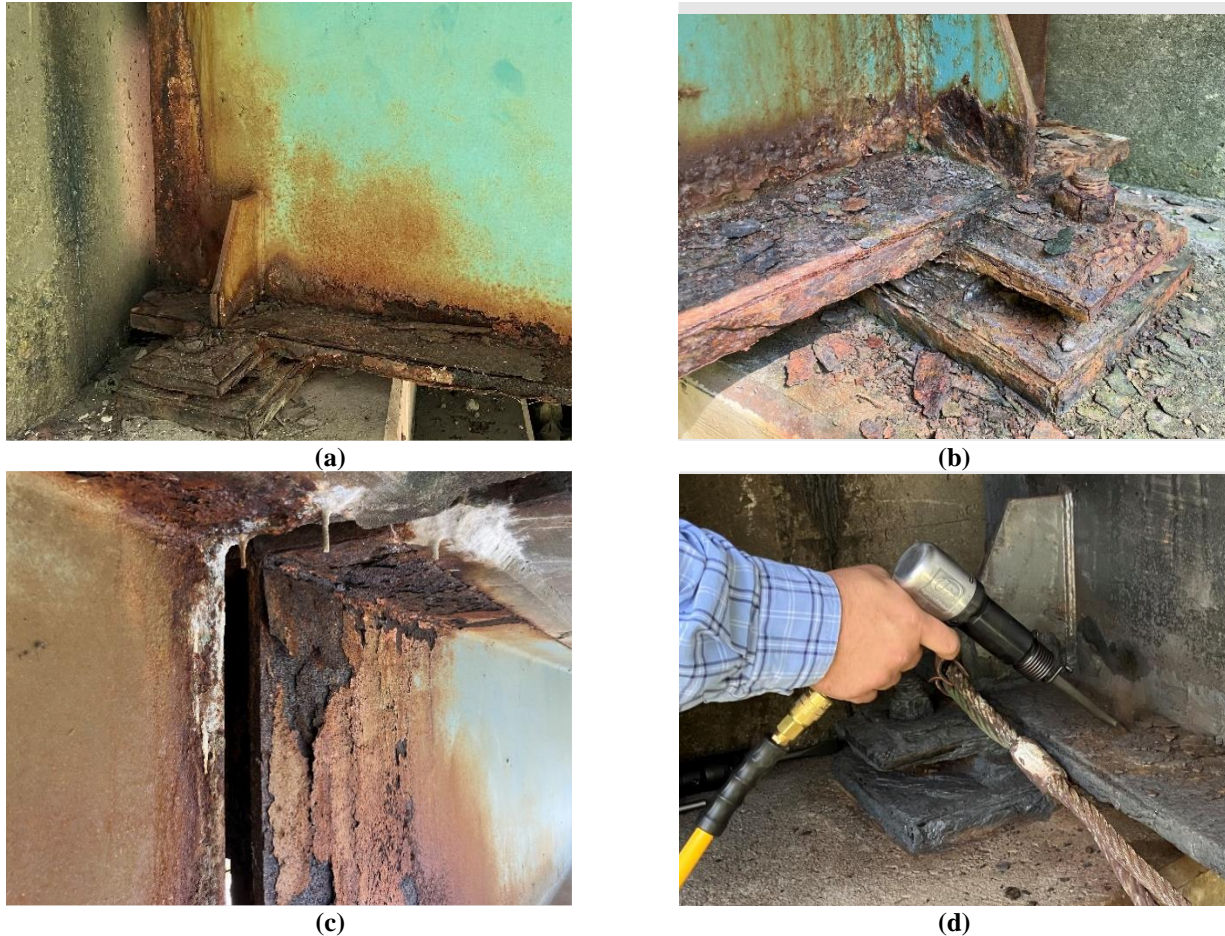
Figure 20. Rust Products on Bridge Girders and Bearings Result in Several Types of Corrosion, Including Lamellar and Pack Rust Formations, Often due to Leaking Bridge Joints. (a) Before coating removal, the web and bottom flange, plus the bearing, exhibit corrosion attack that is voluminous in nature. (b) Loose rust product and more adherent product are shown on the bearing, bottom flange, and web. (c) A more lamellar corrosion behavior is seen along the upper part of the web and the top flange. (d) Removing this product, which can be tightly adherent, can require mechanical removal, which is shown in this case using a pneumatic chisel breaking off the more tightly adherent product that must be removed to ensure salts (chlorides) are exposed and removed before performing a final cleaning step with Laser Ablation Coating Removal.

The thicker lamellar and pack rust formations in Figure 20 that existed on this bridge also required mechanical means to remove the adherent corrosion layer completely to ensure corrosion does not reinitiate. Ideally, this process would include the removal of all salts trapped between rust layers or other materials like bearing pads, but this step is not practical. Therefore, properly cleaning the accessible areas, like flanges, webs, and other uncovered steel surfaces before recoating them is important to mitigate continued corrosion loss of steel and rust staining after the steel is recoated.

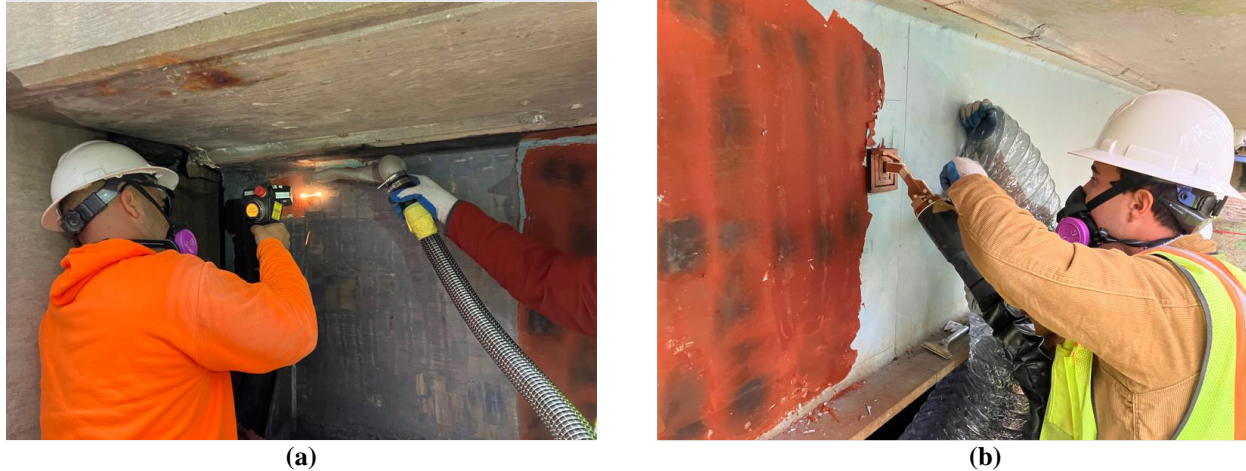
Figure 21. Fume Extraction Issues with LACR and ICR.(a) Employees observed using the effiSCAN LACR with the fume extraction nozzle removed; (b) The ICR unit was not equipped with any fume extraction, and workers were observed holding a 12-inch flexible duct near the work area in an attempt to capture dust and fume. ICR = induction coating removal; LACR = laser ablation coating removal.

The researchers observed visible fumes during all tasks the specialty subcontractor completed. The fume was most evident during the cleanLASER effiSCAN LACR unit usage, whose mounted fume extraction nozzle was cumbersome for the employees working in tight spaces. Employees were observed removing the LACR fume extraction nozzle during operation (Figure 21a). Even when mounted, the LACR fume extraction nozzle was several inches away from the coating surface, decreasing the nozzle's effectiveness. In addition, the ICR device was not designed with an integrated fume extraction nozzle, so capturing contaminants was less efficient (Figure 21b).

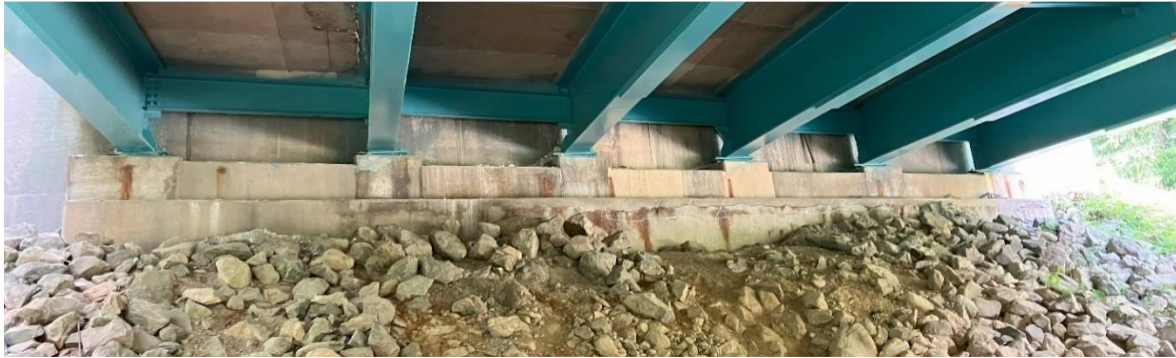
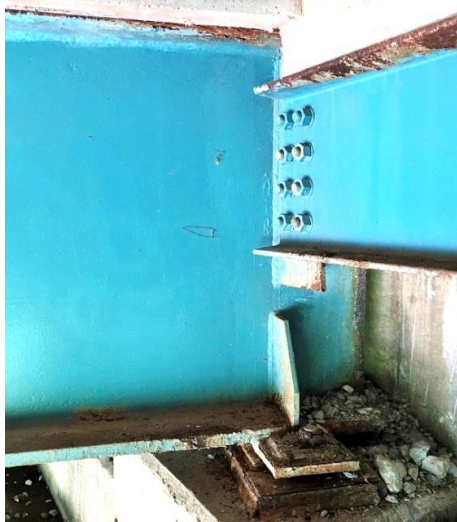
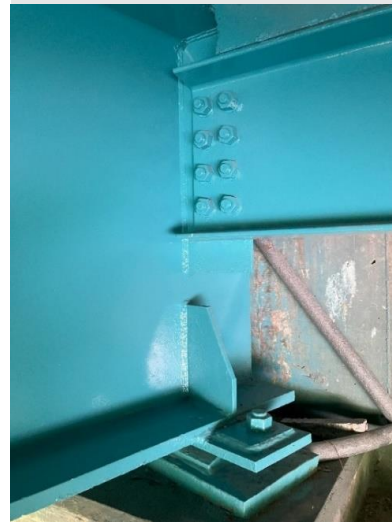
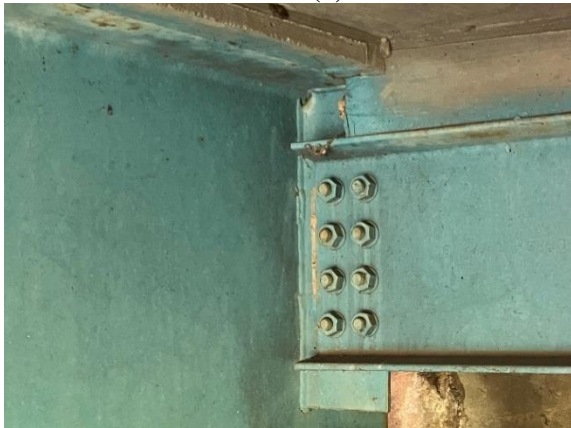
Figure 23. South Abutment A: (a) Overall Image After Recoating Was Completed; (b) Close-up Image of Diaphragm Connection to Girder 3 Outside (West) before and (c) after ICR+LACR Cleaning and Recoating; (d) North Abutment B Diaphragm Connection to Girder 5 before and (e) after Abrasive Blast Cleaning and Recoating Showing Similar Favorable Coating Condition Observed at Bolted Diaphragm Connections Where ICR+LACR Was Used. ICR = induction coating removal; LACR = laser ablation coating removal.

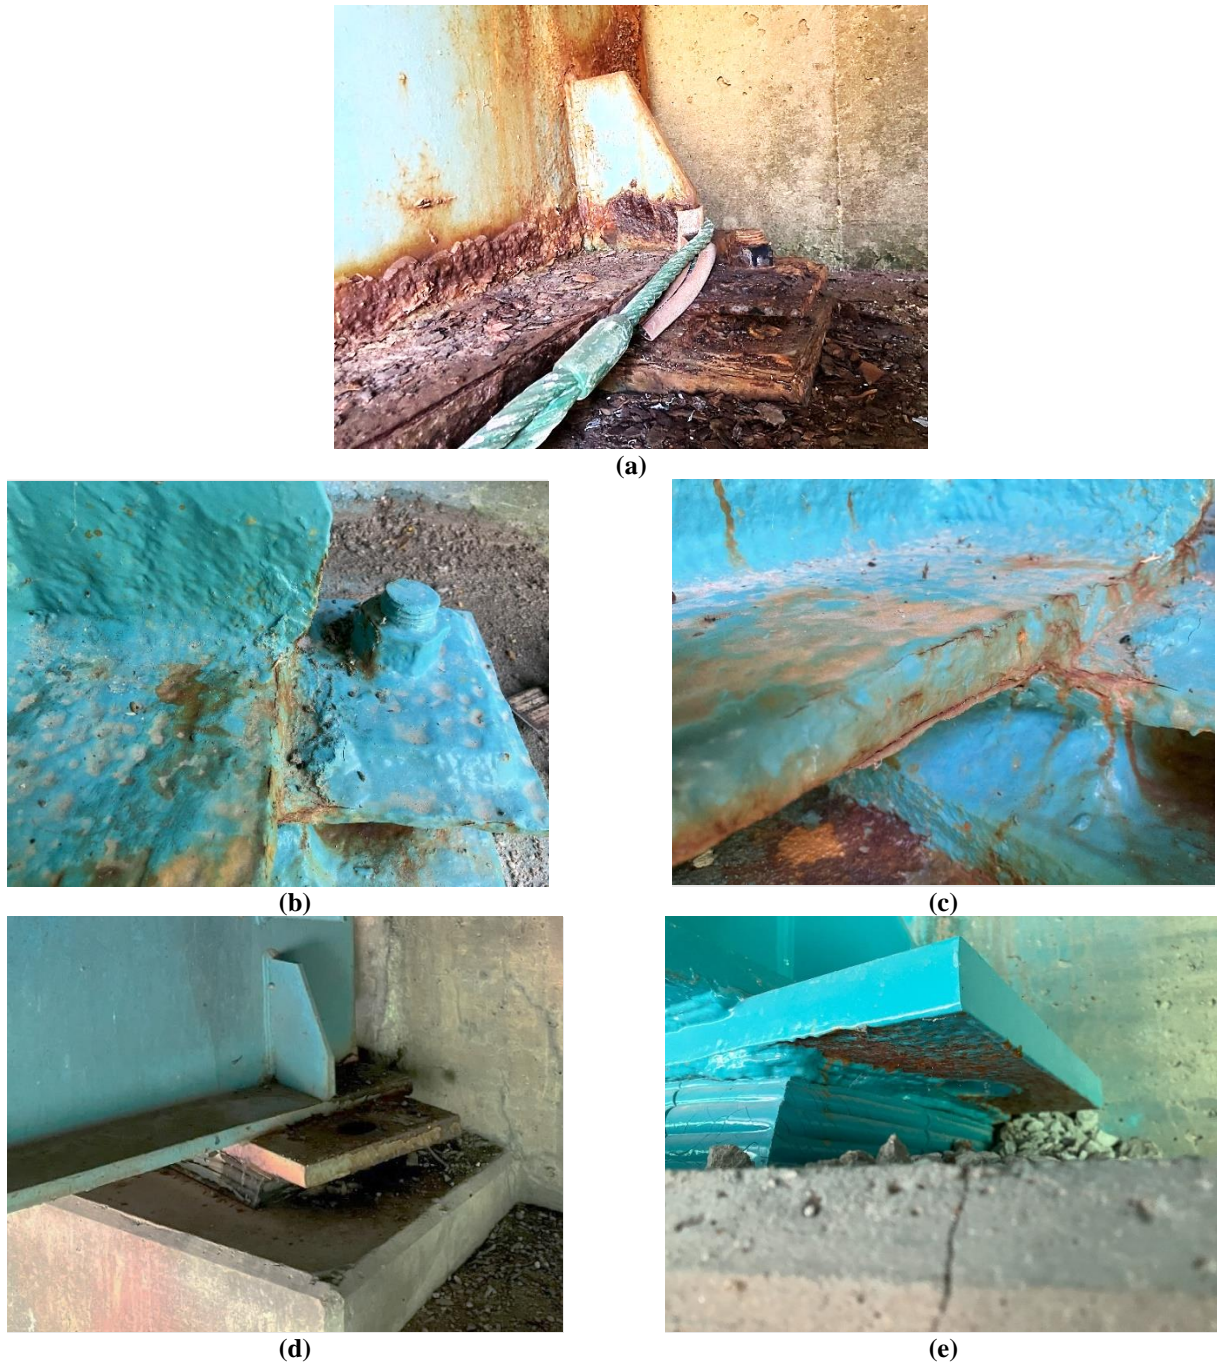
Figure 24. South Abutment A Girder No. 1: (a) Before Coating Removal, Showing a Cable Anchored above the Bearing for Abrasive Blast Cleaning by the Induction Coating Removal and Laser Ablation Coating Removal Specialty Subcontractor; (b and c) The Cable Passes between the Bolt and Stiffener before Recoating, Creating Difficulties Accessing this Area and Resulting in Rusting; (d) North Abutment B Girder No. 4 Bridge Bearing before and (e) after Abrasive Blast and Recoating Showing Rusting under the Plate due to Difficulties Accessing this Area.

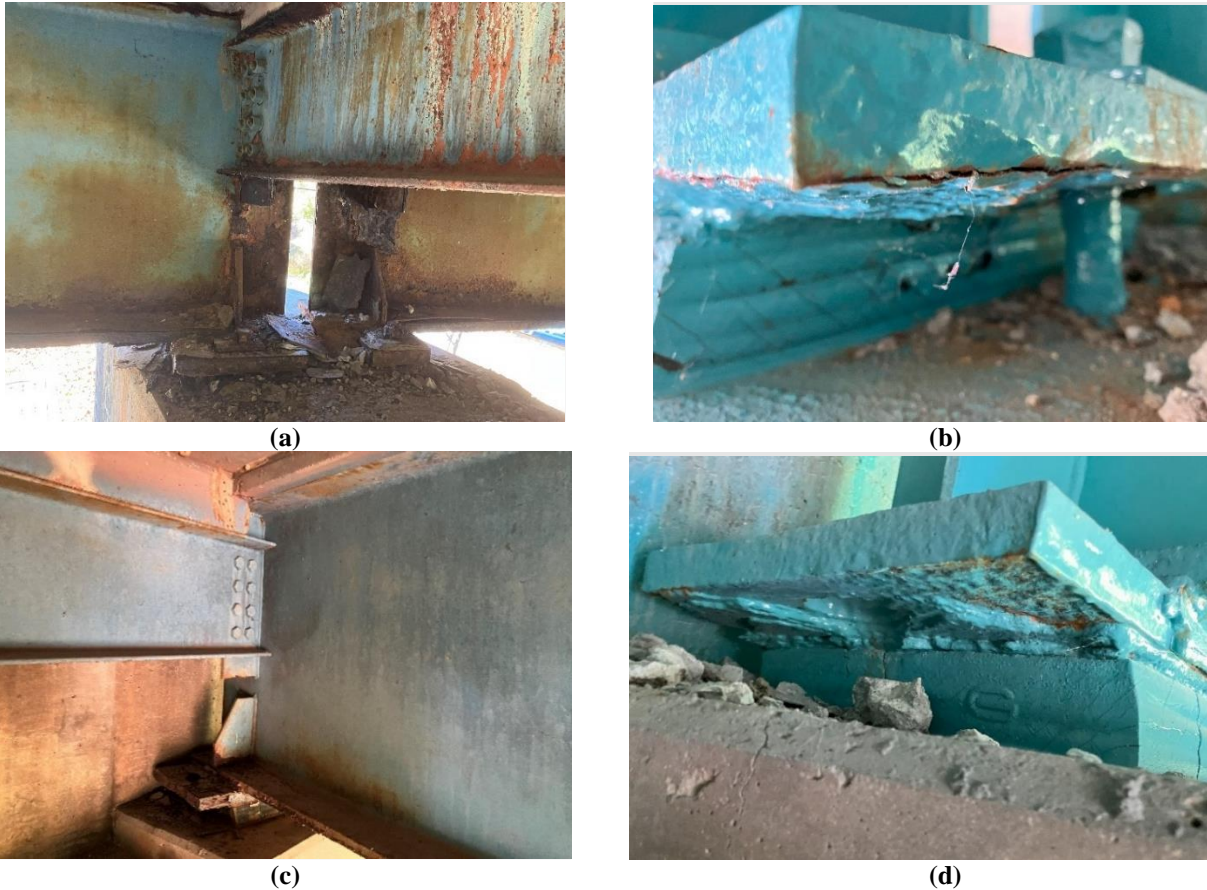
Figure 25. Pier 1 Girder No. 1 Interior: (a) Showing Pack Rust Under Sole Plate before ICR+LACR and then (b) after Sufficiently Cleaning Most of the Bearing Area with ICR+LACR but Leaving Some of the Pack Rust on the Bottom of the Sole Plate; (c) Abutment B Girder No. 4 Bridge Bearing before Abrasive Blast Cleaning and (d) also Showing Incomplete Removal of Pack Rust, Resulting in the Salt Initiating Corrosion Again. ICR = induction coating removal; LACR = laser ablation coating removal.
