STUDY OF BITUMINOUS SURFACE TREATMENTS IN VIRGINIA

Phase II — Summer 1964: Distribution Characteristics of Materials —
Effectiveness of One Size Aggregate — Setting Time

David C. Mahone
Highway Research Analyst

VHRC 70-R22

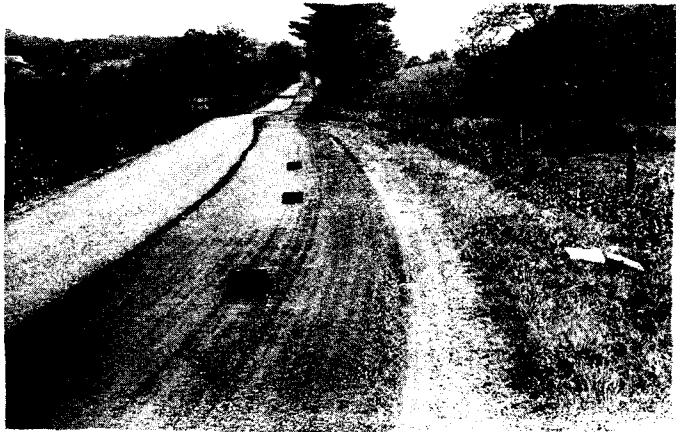
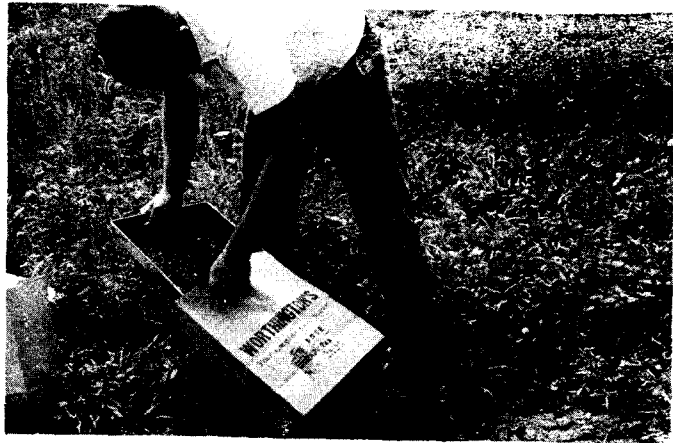
Figure 11. Check of longitudinal distribution of aggregate spreader by pan method.

Load Average. On Rt. 75 in Washington County eight trucks were operating. Tailgate spreaders were being employed and a 25 psy application of stone was intended. Stone distribution checks were made on three different days. For simplicity the results from only two trucks are given along with the grand average of all trucks for each day. The two trucks given represent the extreme values measured. The following table summarizes the results.

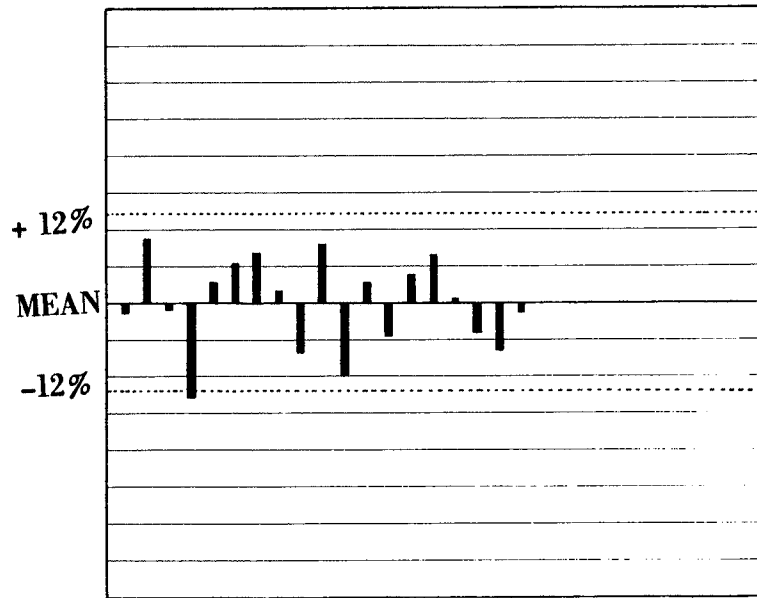
Figure 12. Lateral distribution patterns of four distributors as indicated by one cotton pad test of each. Tests made without nozzle adjustments.

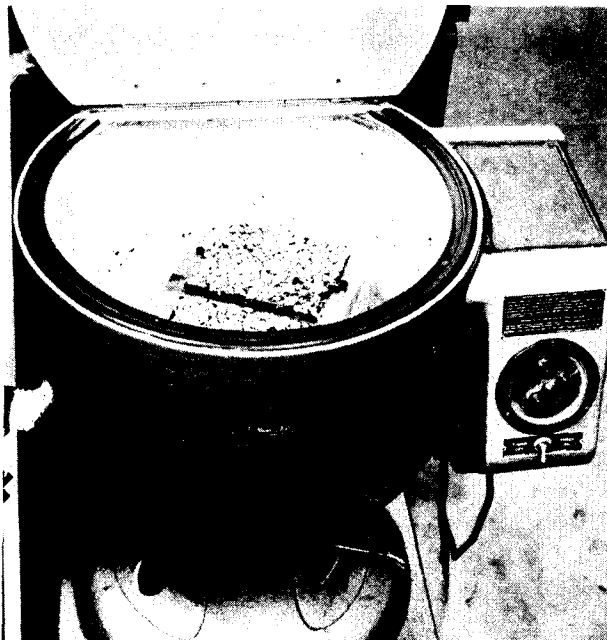
Figure 14. Centrifuge equipment for evaluating whip-off.
