CONCRETE DURABILITY STUDIES

Case Study # 3 — Severe Scaling of an Interstate Bridge Deck

An Example of Bridge Deterioration Promoted by Alkali-Carbonate Reaction

VHRC 70-R42

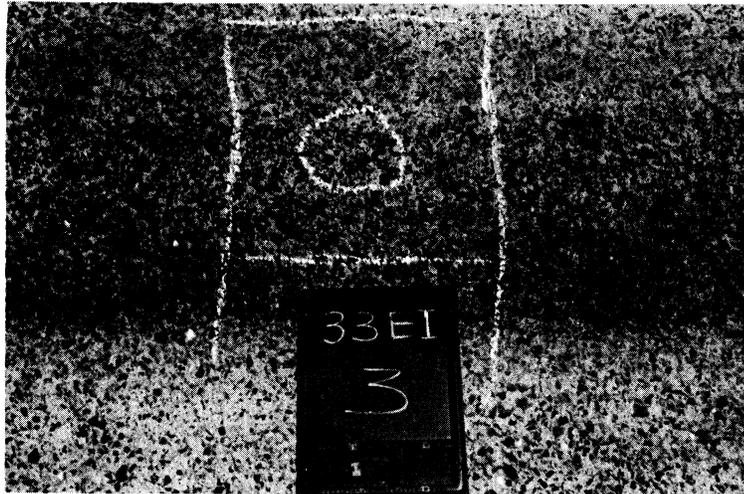
Figure 2. Typical view of severely scaled area in northern project.

Severe scaling on some of the bridges, which subsequently necessitated periodic repairs, was noted after the second winter; however, a detailed slab by slab survey of the decks was made in the summer of 1966 when the decks were about eight years old. The survey revealed two principal types of distress: (1) Scaling as shown in Figure 2, and (2) map or pattern cracking, shown in Figure 3, which in most cases is coincident with the scaling. The frequency of occurrence and the amount of area affected by this distress were vastly different for the northern and southern projects. Ninety percent of the decks on the southern project were free of pattern cracking, and of the 10% affected all had less than 25% of the area affected. Sixty-five percent of the decks in the southern project were free of scaling. Of the percent not free, 85% had less than 25% of the area affected. Figure 4 shows a typical view of the pavement condition in the southern area.

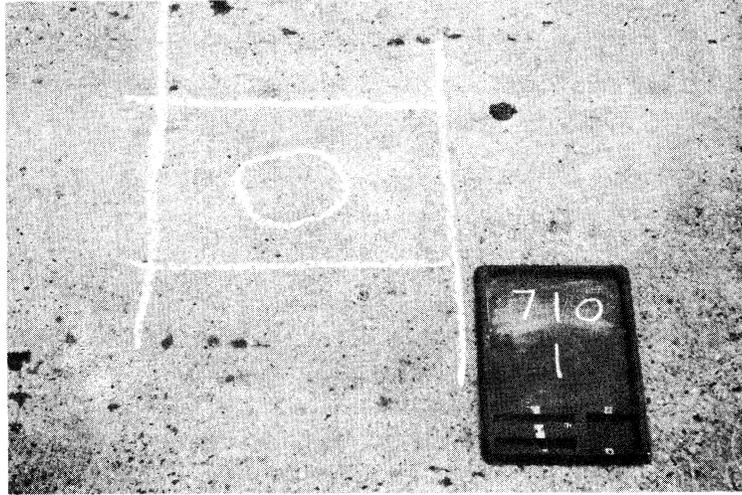
Figure 10. Core location on northern project showing healthy looking pavement, apparently free of scaling and cracks.

Interestingly, the interior polished surfaces of concrete cores from the first group, the so-called good areas from the northern project, such as that illustrated in Figure 10, show exactly the same features as those from the scaled areas the main difference between the concretes being the presence of surface scaling. These features are seen in Figures 11 and 12.

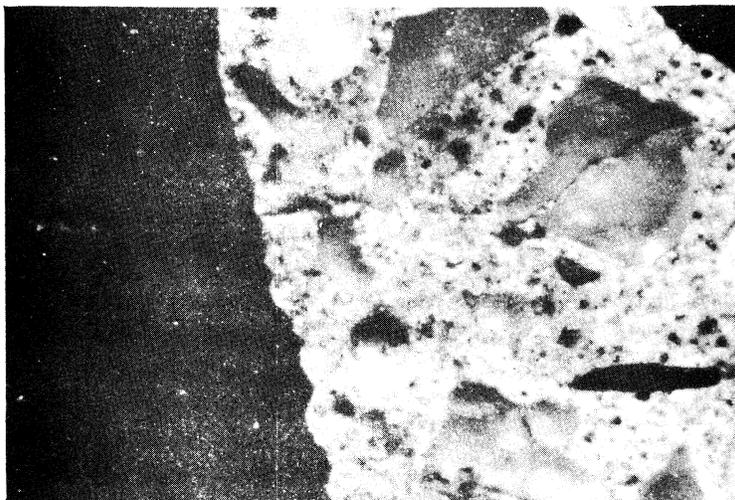
Figure 13. Detail view of coarse aggregate particle from northern project showing internal crack extending into paste and through fine aggregate particle.

Therefore for both surface conditions, i. e., scaled or unscaled, typically there are internal cracks or fractures that presumably originate from the coarse aggregate particles, extend into the paste (sometimes only a short distance), and dwindle to fine cracks or end as radial cracks against other coarse aggregate particles. More often, the cracks extend through the paste a greater distance, transect coarse and fine aggregate particles, and ultimately connect with other cracks of similar origin as seen in Figure 13.
