AN EXPERIMENTAL APPLICATION OF PERMA-BIND

Virginia Highway Research Council
(A Cooperative Organization Sponsored Jointly by the Virginia
Department of Highways and the University of Virginia)

September 1970
VHRC 70-R6

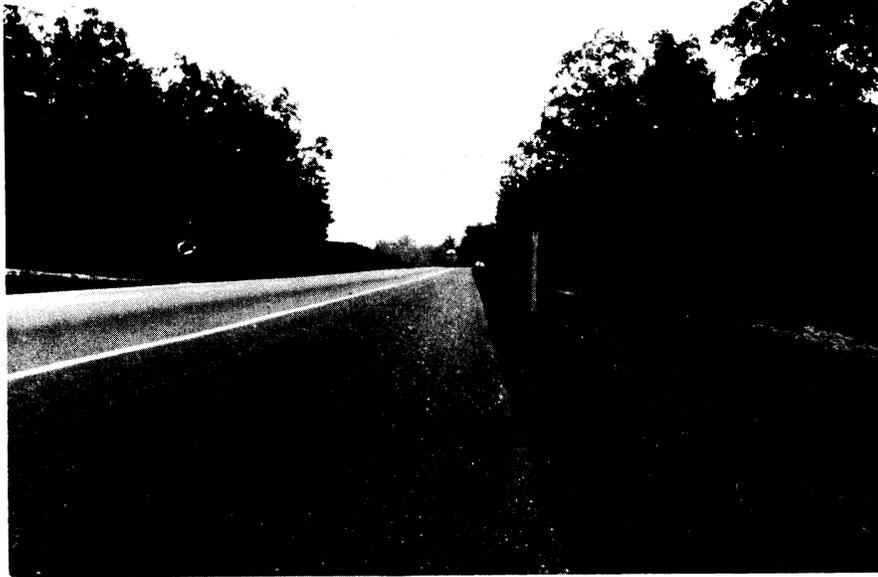
Figure 1. Untreated shoulder, southbound direction, Interstate 95.

Prior to application of Perma-Bind, the shoulder was in excellent condition with no cracks, holes, or other deterioration and was free from dirt, debris, grass, and other foreign matter. Figures 1 and 2, which are appended, show the condition of the shoulder. The shoulder was swept with a roller-type broom immediately prior to the application.

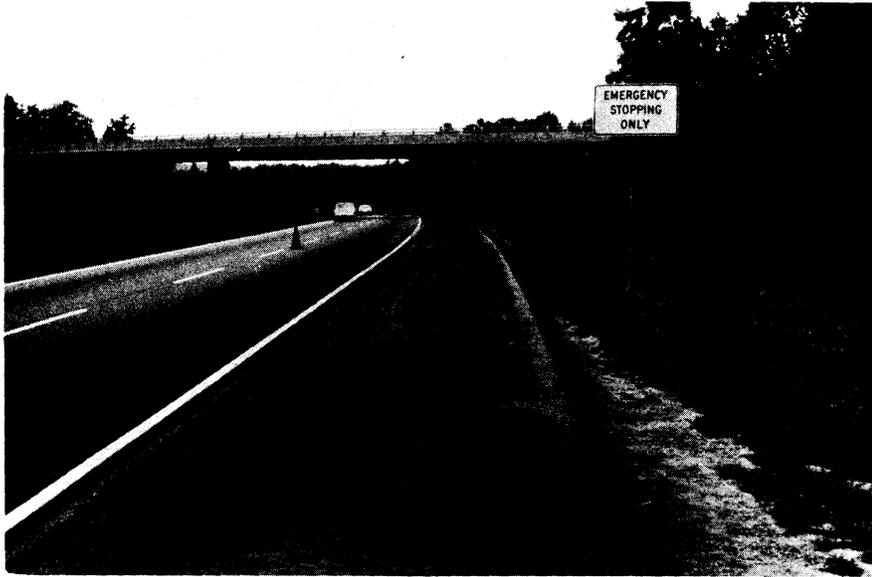
Figure 3. Uncured Perma-Bind (approximately 5 minutes after application).

The Perma-Bind was put in place between 3:00 p. m. and 3:12 p. m. on July 22, 1970, using an Etnyre distributor charged with 1,262 gallons. The distributor applied approximately 100 gallons a minute on a section 10 feet in width and 2.3 miles in length at a rate of $\pm .11$ gallons per square yard. The material was applied in an even coat and appeared to give a 100% coating. While wet the material had an appearance similar to that of glossy black enamel as shown in Figures 3 and 4.

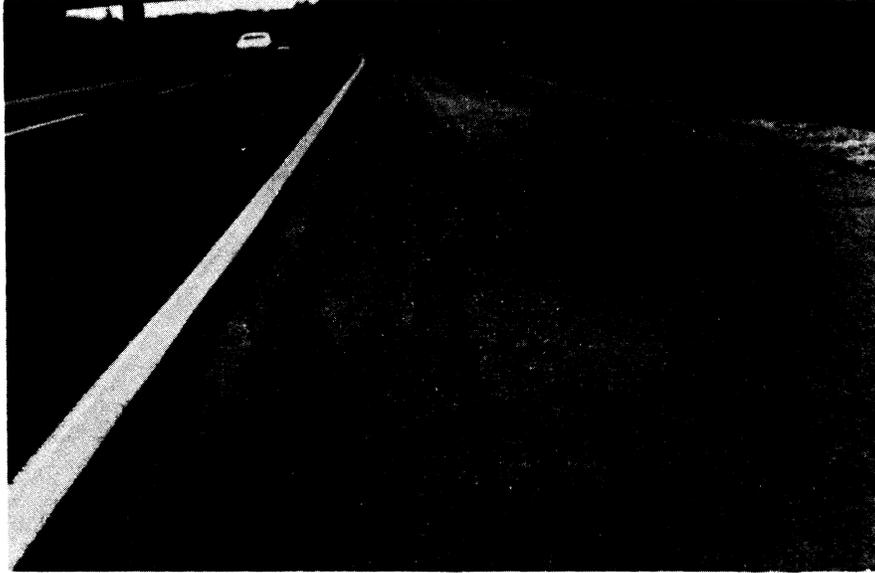
Figure 5. Vehicular tracking of Perma-Bind after 30 minutes of curing.

After thirty minutes of curing, tracking was observed but no pickup of the material was noted when an automobile was driven over it. Figure 5 shows the tracking thirty minutes after placement. The automobile was again driven over the material after one hour of elapsed time and no tracking occurred although the surface was still tacky. Two hours appears to be a sufficient amount of time for curing at this temperature and for this surface type before allowing traffic on the material. The surface temperature was 98° F., and the air temperature was 80° F. at 4:00 p. m.
