## FINAL REPORT

DURABILITY OF CERTAIN CONFIGURATIONS FOR  
PROVIDING SKID RESISTANCE ON CONCRETE PAVEMENTS

Virginia Highway Research Council  
(A Cooperative Organization Sponsored Jointly by the Virginia  
Department of Highways and the University of Virginia)

VHRC 73-R57

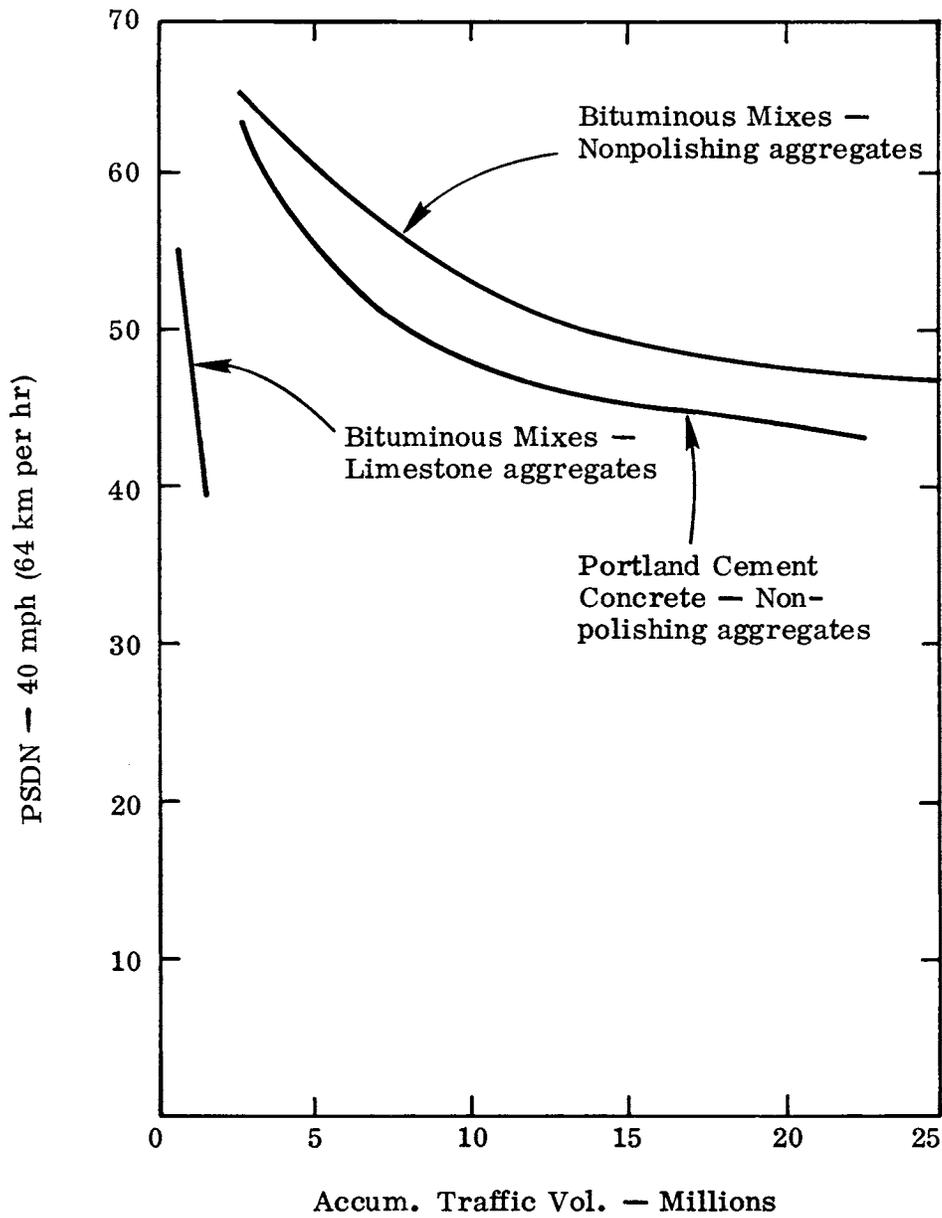
Figure 1. Traffic volume versus stopping distance car skid numbers (PSDN). (From reference number 23.

At certain time intervals, skid numbers ( $SN = 100 \times$  coefficient of friction) were obtained with a British Portable Tester (BPT) (48). At each interval an average of four tests was used. The plots are shown in Figures A-5 through A-8. Within the first 100,000 cycles the skid numbers dropped rapidly; afterwards a slight decrease and then a leveling off were observed. The skid numbers measured with the BPT were influenced mainly by the contact area, the microtexture, and the physical interference caused by the orientation of the grooves. The general trend of the curves approximates that shown earlier in Figure 1.

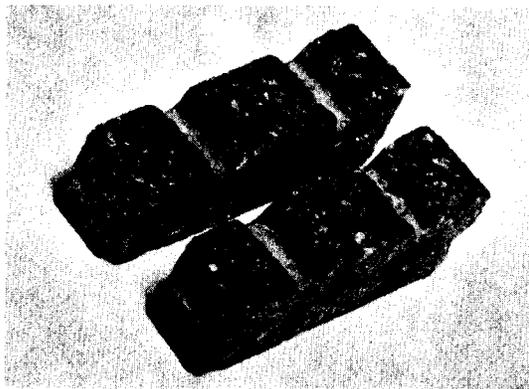
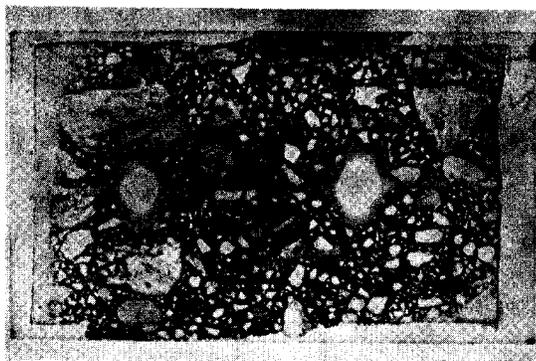
Chips cut at the surface of  
the sample

Chips mounted on a glass  
slide

A plan view

Figure 2. Thin section preparation of pavement core surfaces.

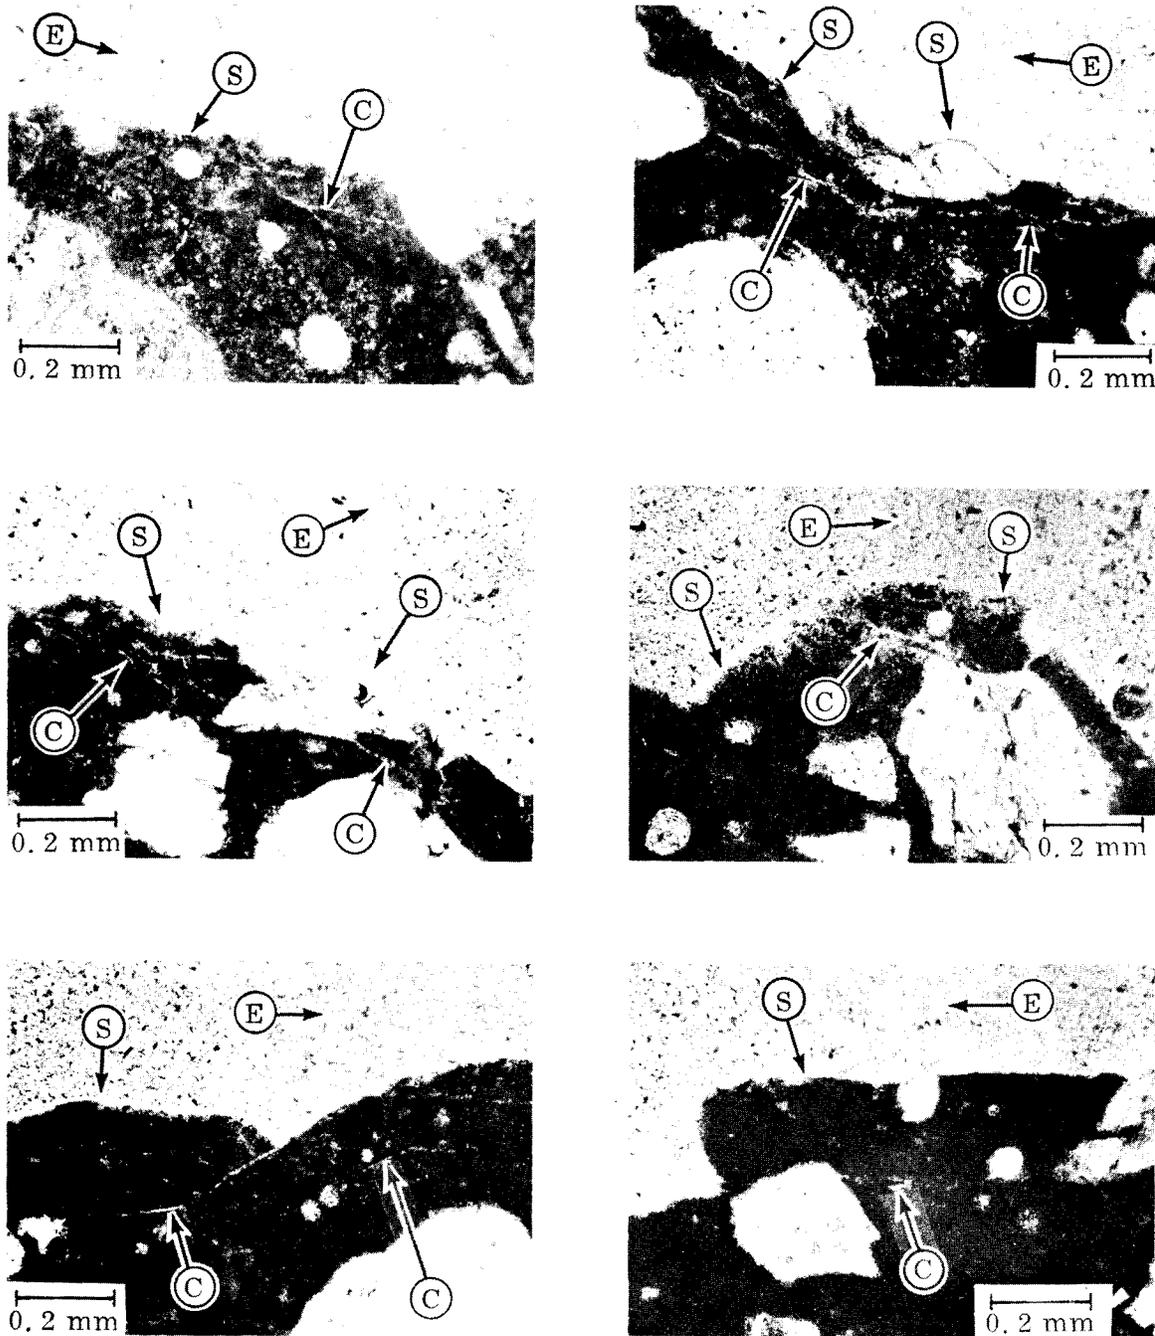
- Ⓔ Epoxy potting resin
- Ⓕ Surface profile
- Ⓖ Crack

Figure 3. Photomicrographs of thin sections showing surface cracks that cause flaking.

The thin sections obtained from I-95 showed a strong paste with a low water-cement ratio and air content. Most of the microcracks present in the paste occurred about 0.2mm below the surface. As shown in Figures 3 and 4, these cracks propagated parallel to the surface until the material enclosed became loose and was displaced. These flaking type cracks were considered to result mainly from the repetitive loads imparted by the traffic. Environmental effects cause cracks with different characteristics. Freeze and thaw cracks are deeper in the material and tend to be horizontal, usually about 2mm below the surface. Shrinkage cracks have a more random distribution and often concentrate at the paste aggregate interface. The association of cracking with the interface and/or the progression of the cracks through rather than around the aggregates depend upon material properties and that age at which the strain occurs. Hardened past has an elastic modulus of 1 to 4 x 10<sup>6</sup> lb/in<sup>2</sup> (7 to 28 GPa); whereas that of aggregates is 5 to 10 x 10<sup>6</sup> lb. in<sup>2</sup> (34 to 69 GPa). (28) This difference could cause cracks at the interface of the aggregates.

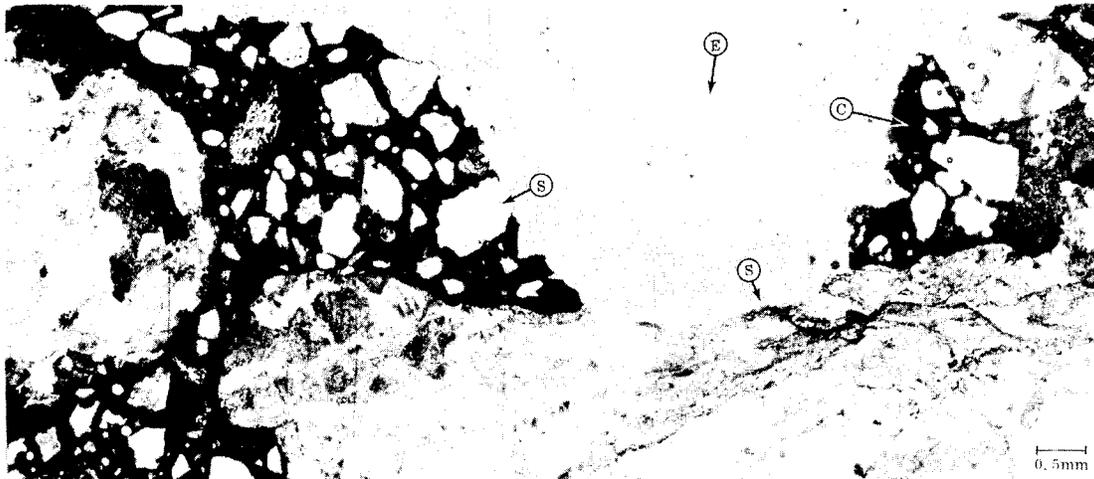
- Ⓔ Epoxy potting resin
- Ⓕ Surface profile
- Ⓖ Crack

Figure 4. A groove cut from I-95 is pictured in thin section. The bottom of the groove is round because of the saw cut. The arrow in the top picture points out a flaking crack enlarged in the picture at the bottom.

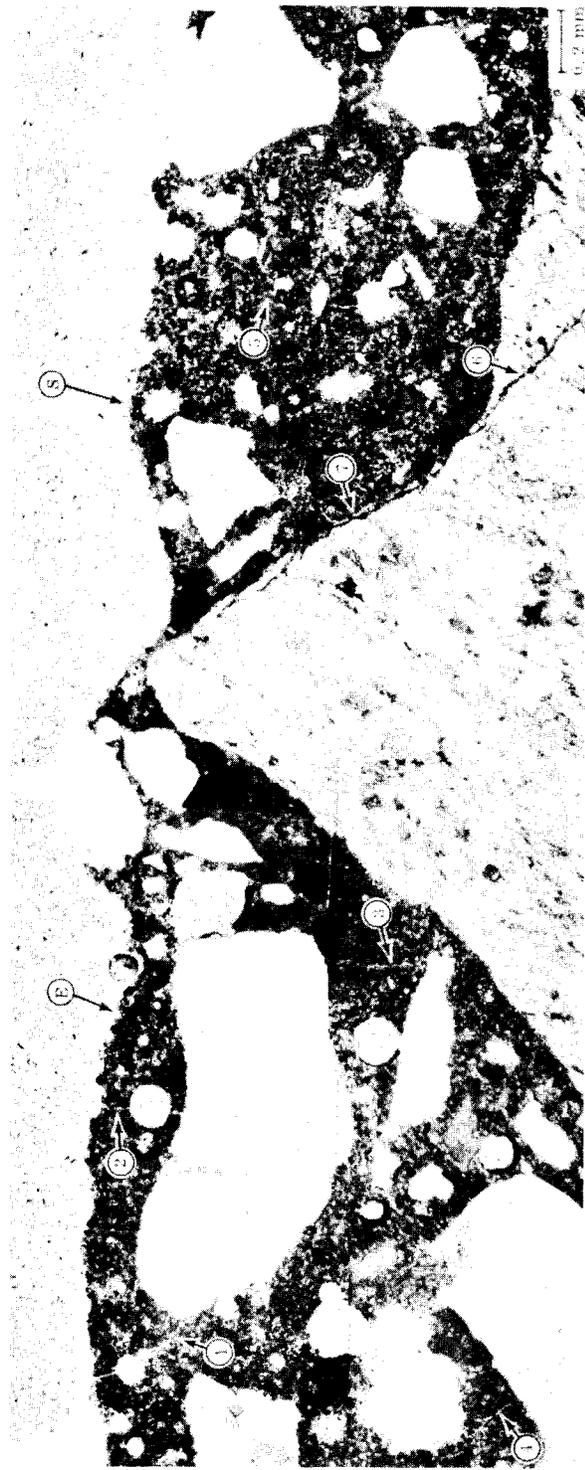
- (E) Epoxy potting resin
- (S) Surface profile

Figure 5. Cracks other than those that cause flaking in the near surface (1) and (2) show cracks perpendicular to the surface which penetrate into the material. Possibly the cracks will travel at the interface of the fine aggregate and the paste and dislodge the surface material. (3), (4), and (5) show cracks in the paste. (6) shows a preexisting crack in the coarse aggregate that propagates at the interface and into the paste. (7), (1), (2) and (5) show the influence of air voids on cracks.

In the strong paste, besides flaking, other types of cracks were seen, some at the paste aggregate interface, and some perpendicular to the surface and penetrating deep into the paste (possibly predetermined by an air void as shown in Figure 5) and some caused by crushing of the paste as shown in Figure 6.

In figure 5, crack number five looks as if it is discontinuous. A similar trend was observed in other cracks as well. However, as explained previously it is hard to determine the path and nature of the cracks.

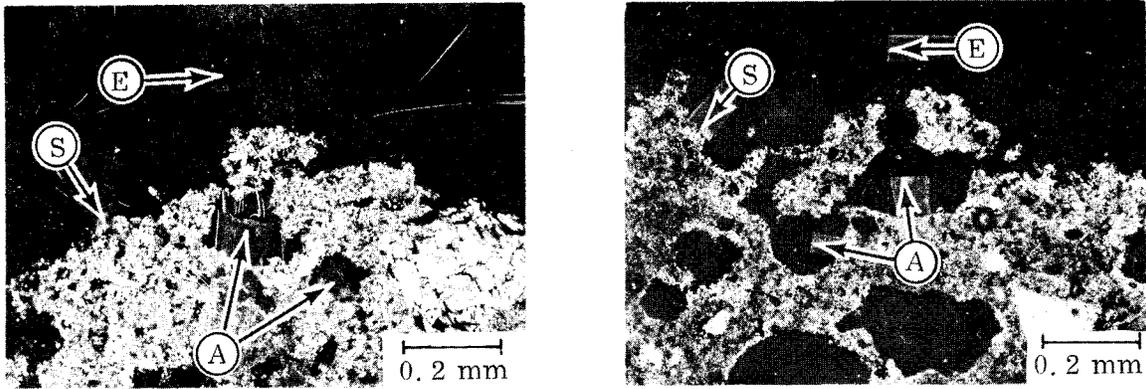
- (A) Air void
- (E) Epoxy potting resin
- (S) Surface profile

Figure 6. Photomicrographs showing the crushing of the paste predetermined by an air void.

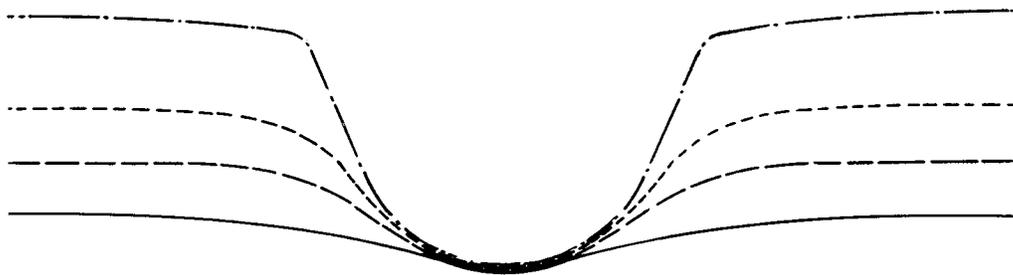
Figure 7. Progressive wear modeled after the specimens obtained from the grooved section of I-95 at intersection with Route 301. The bottom of the grooves is considered as datum.

In the less worn specimens where an appreciable groove depth was present more cracks were seen in the areas between the grooves than were seen in the highly worn specimens. In both cases the cracks were distributed evenly. This even distribution suggested that the fewer number of cracks in the worn grooved pavements was due mainly to the presence of tougher paste with fewer air voids away from the top surface. There were hardly any cracks at the bottom of the grooves. At the shoulders of the grooves, the locations where the groove meets the upper surface, flaking type cracks existed as shown in Figure 3. The shoulders of the grooves wore faster than the top surface, most probably because of a lack of restraint on one side and because of higher surface pressures imparted to them under a flexible tire. The tire might stretch and exert higher pressures at the edges. As the wear progressed the grooves widened until a level was reached where the groove disappeared. This is illustrated in Figure 7.

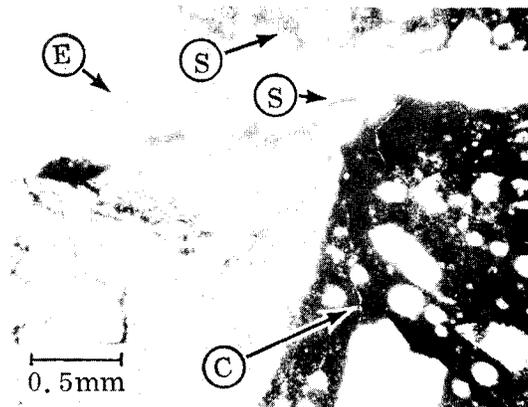
- Ⓔ Epoxy potting resin
- Ⓕ Surface profile
- Ⓖ Crack

Figure 8. In a few deep grooves a vertical crack near the groove was observed.

Both the longitudinal and the transverse grooves seemed to indicate the same trend as far as wear was concerned. In a few of the deep grooves a vertical crack near the groove was noticed as shown in Figure 8. Due to the limited quantity of samples studied, the existence of this crack was not attributed to any specific cause.

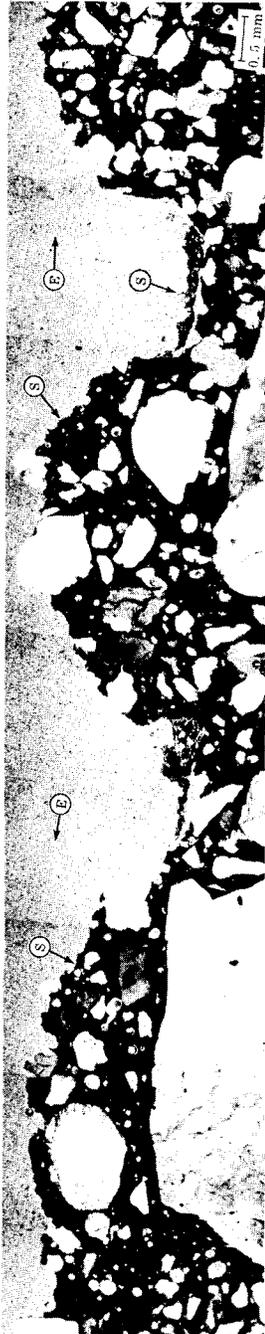
- Ⓔ Epoxy potting resin
- Ⓕ Surface profile

Figure 9. New section of I-64 east of Bottoms Bridge showed good microtexture, large number of asperities at the top surface and deposits of mortar at the bottom of the grooves.

This portion of I-64 had been opened to traffic recently. On the surface a very good microtexture, a large number of asperities and no polishing were observed, as seen in Figure 9. At the bottom of the grooves deposits of mortar were noticed (Figure 9). These might be due to the finishing operations when loose surface mortar might have been carried to the bottom of the groove.

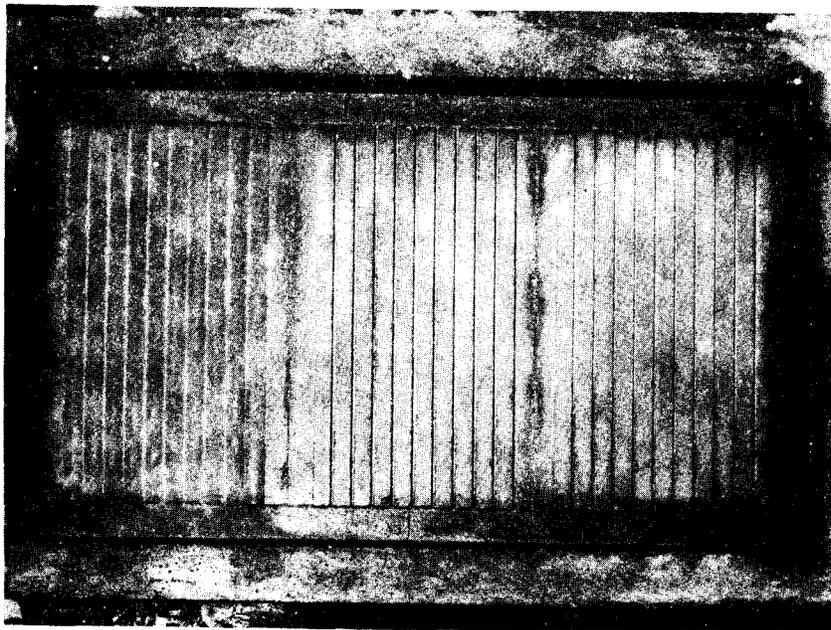
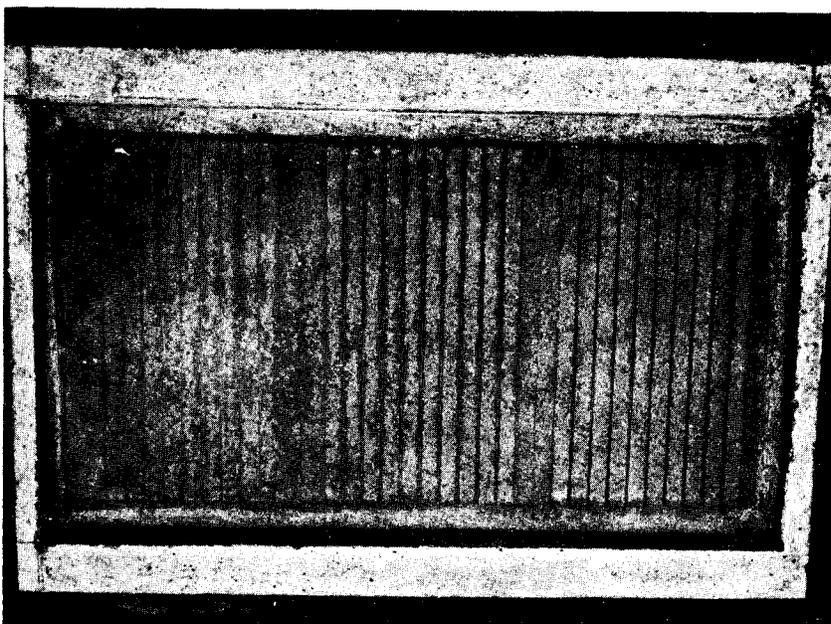
Before exposure to weathering.

After exposure to 50 cycles of weathering.

Figure 10. Freeze and thaw specimen with round, square and triangular grooved surfaces.

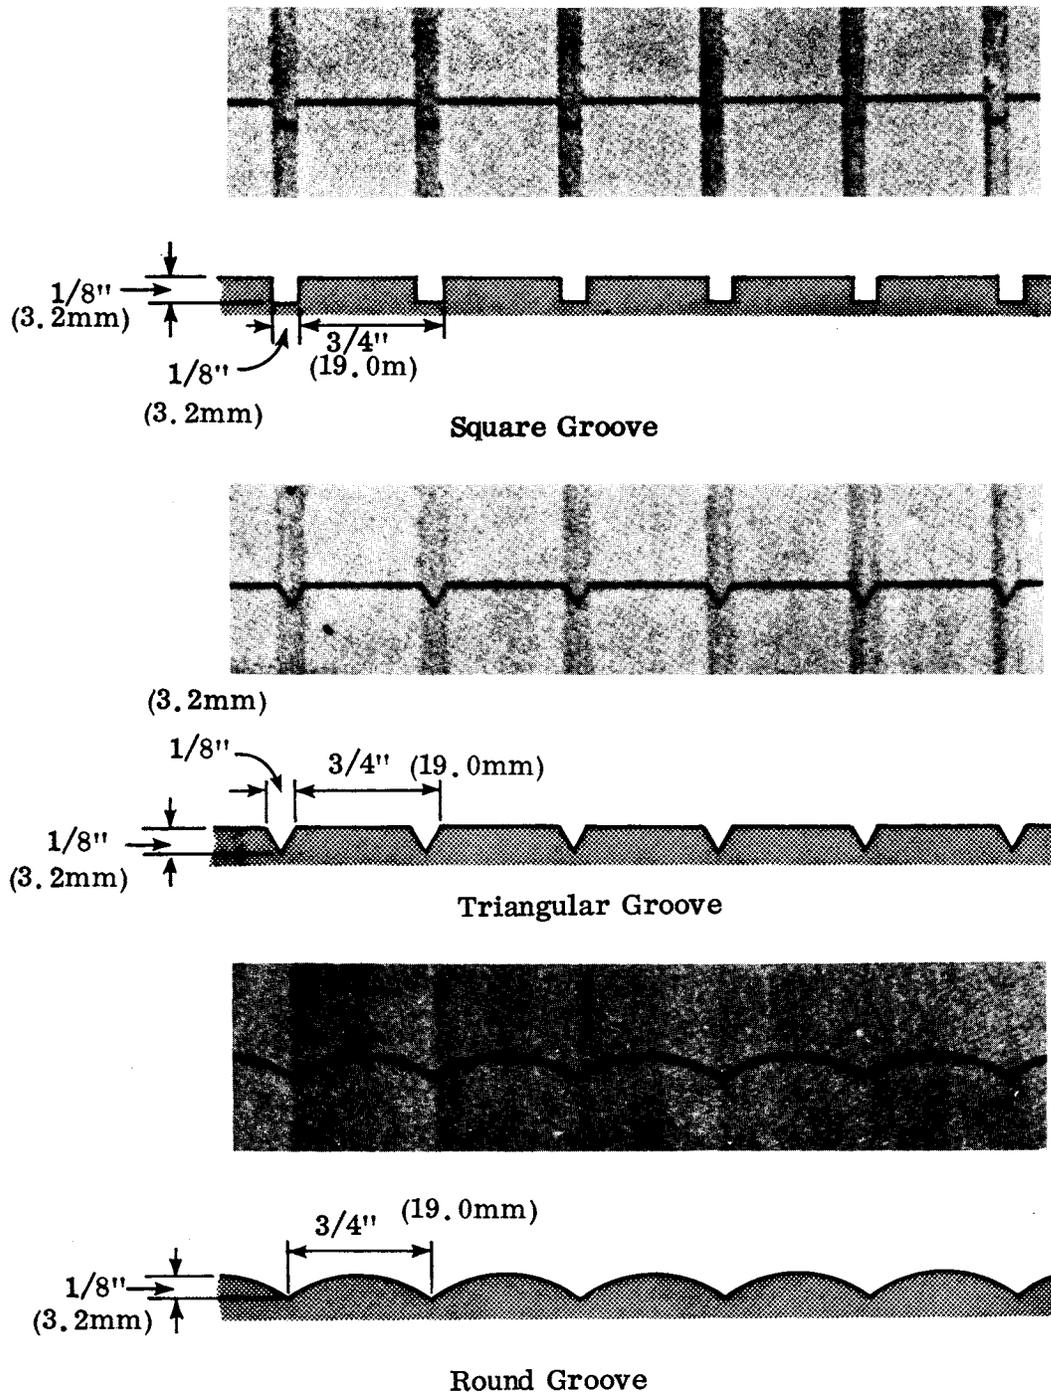
Figure 11. Uniform groove patterns chosen for the theoretical investigation of the wear mechanism.

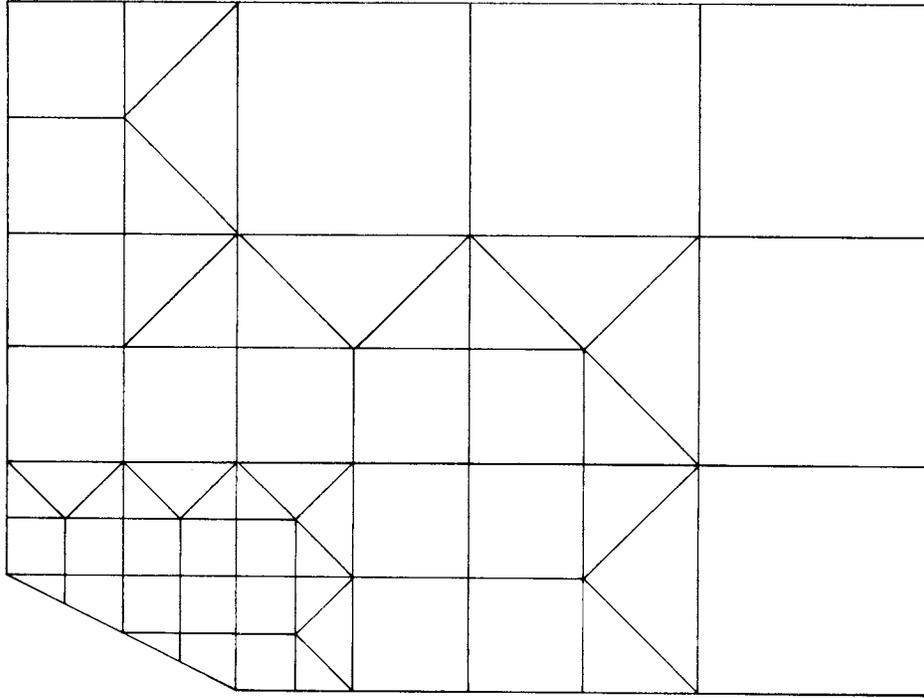
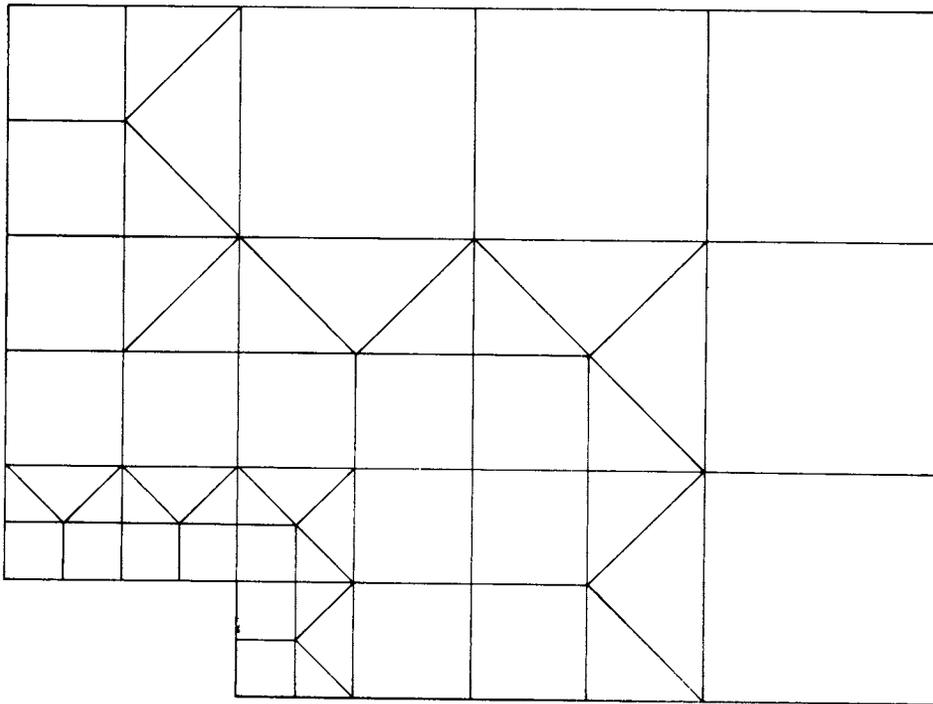
Triangular Groove

Square Groove

Figure 12. Half the groove and the surrounding mesh distribution formed by the two dimensional elements.

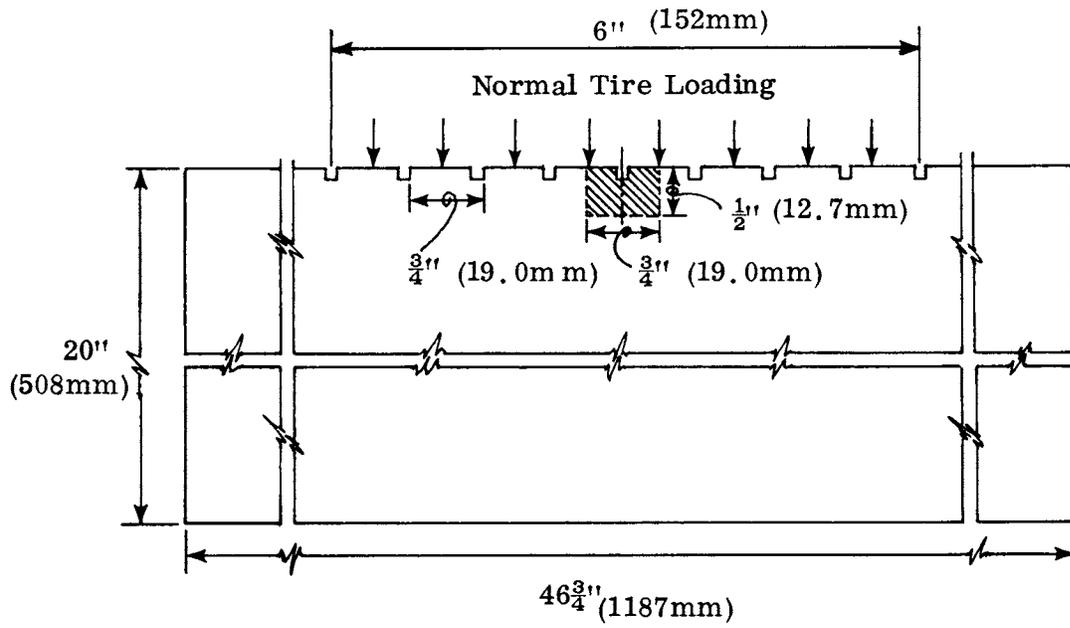
Figure 13. Loaded surface and the resulting area of influence constituted the large model "total system". The shaded portion with one groove represented the "small system".

It was necessary to choose the dimensions of the total system. If a body is loaded at a surface, a part of the body beneath the surface would be affected. The stresses would decrease as the depth increased. A point would be reached where the stress components would reach only a small percentage of the contact pressure and could be neglected. In the total system this depth would be well below the depth of the concrete pavement, which is usually 8" (203mm) or 9" (229mm). Below the pavement is the subbase, a layer with physical properties that are quite variable and hard to specify. In addition, the displacements and friction forces at the interface between the pavement and subbase are difficult to predict. Because of these complications, the total system was assumed to be of one material. Later as a check, the layer below 9" (229mm) of concrete was treated as a different material having an elastic modulus of 10% of that of concrete. Only a small variation of stresses was observed at the top surface and around the grooves under the tire loading. Based on Boussinesq's equation, which considers that the material is elastic, homogeneous, and isotropic, the depth of the total system was assumed to be 20" (508mm), beyond which the effect of the surface loading was negligible. (47) The width of this system was calculated to be 46 3/4" (1187mm) based on the 45° stress distribution approximation. This approximation assumes that at each depth the vertical stress is distributed on an area bounded by lines originating at the end of the loaded area and descending at an inclination of 45°.

The boundary conditions on the total system were chosen so that no vertical displacement at the bottom and no horizontal displacements at the far ends were permitted. The concrete on both sides of the total system would provide some restraint. However, some lateral movement at the ends would be expected. Therefore, another run of the same system was made with no prescribed boundary condition at both far ends. This assumption had negligible effects on the stresses at the center of the system where the small system was located.

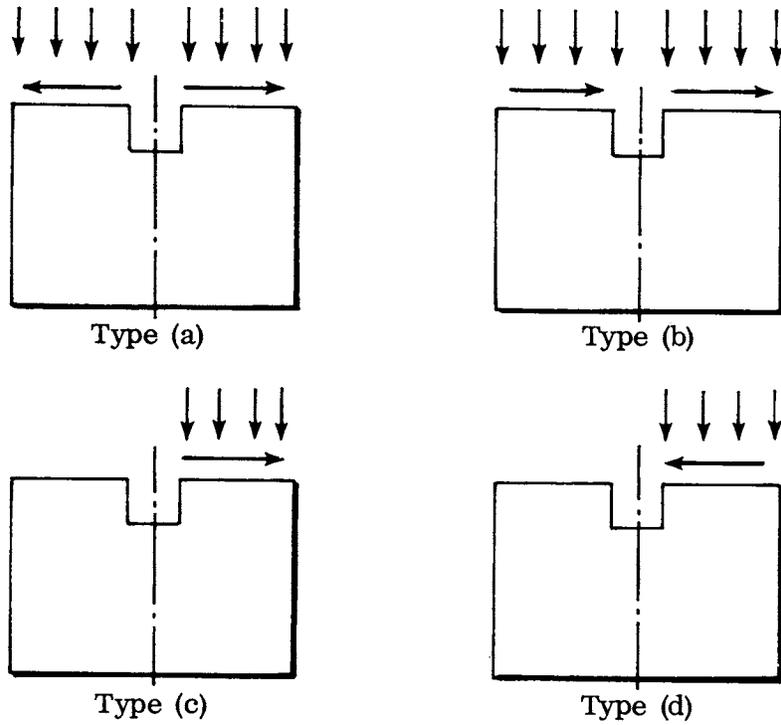
Figure 14. Different types of loading on a groove representing possible extreme cases and different modes of travel such as type (a) would occur along a straight road whereas type (b) would occur around the curves.

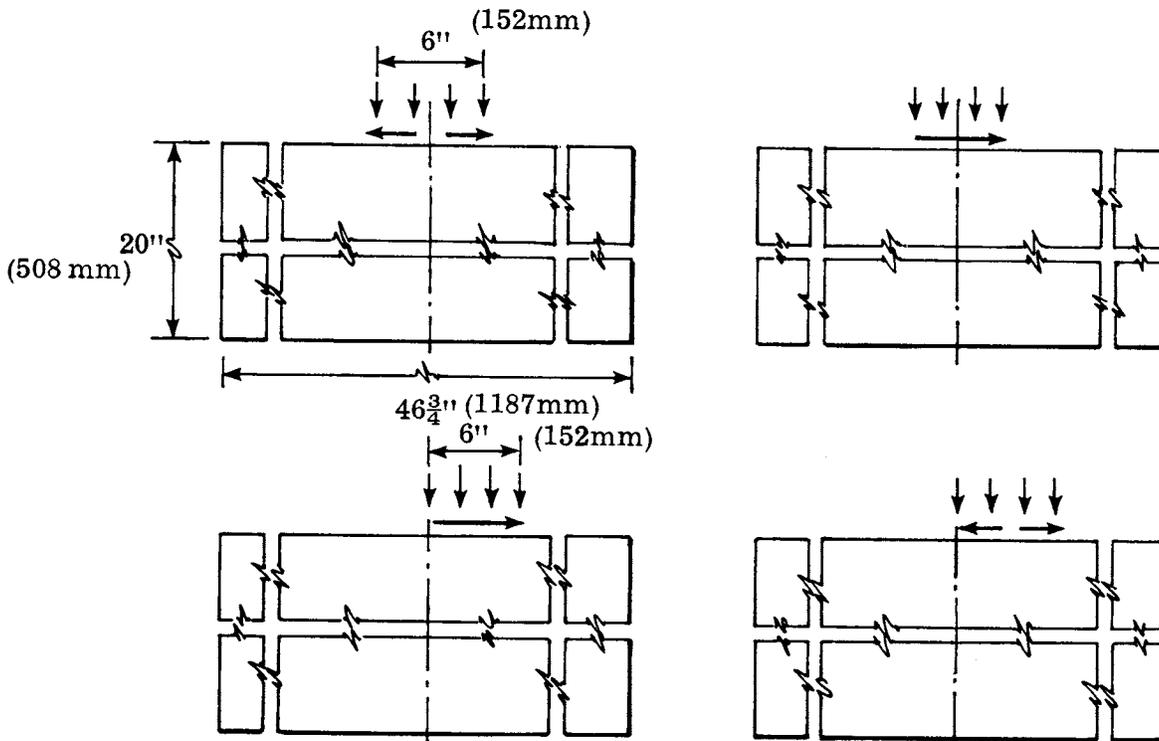
Figure 15. The total system was loaded as shown to obtain the boundary conditions for the small system.

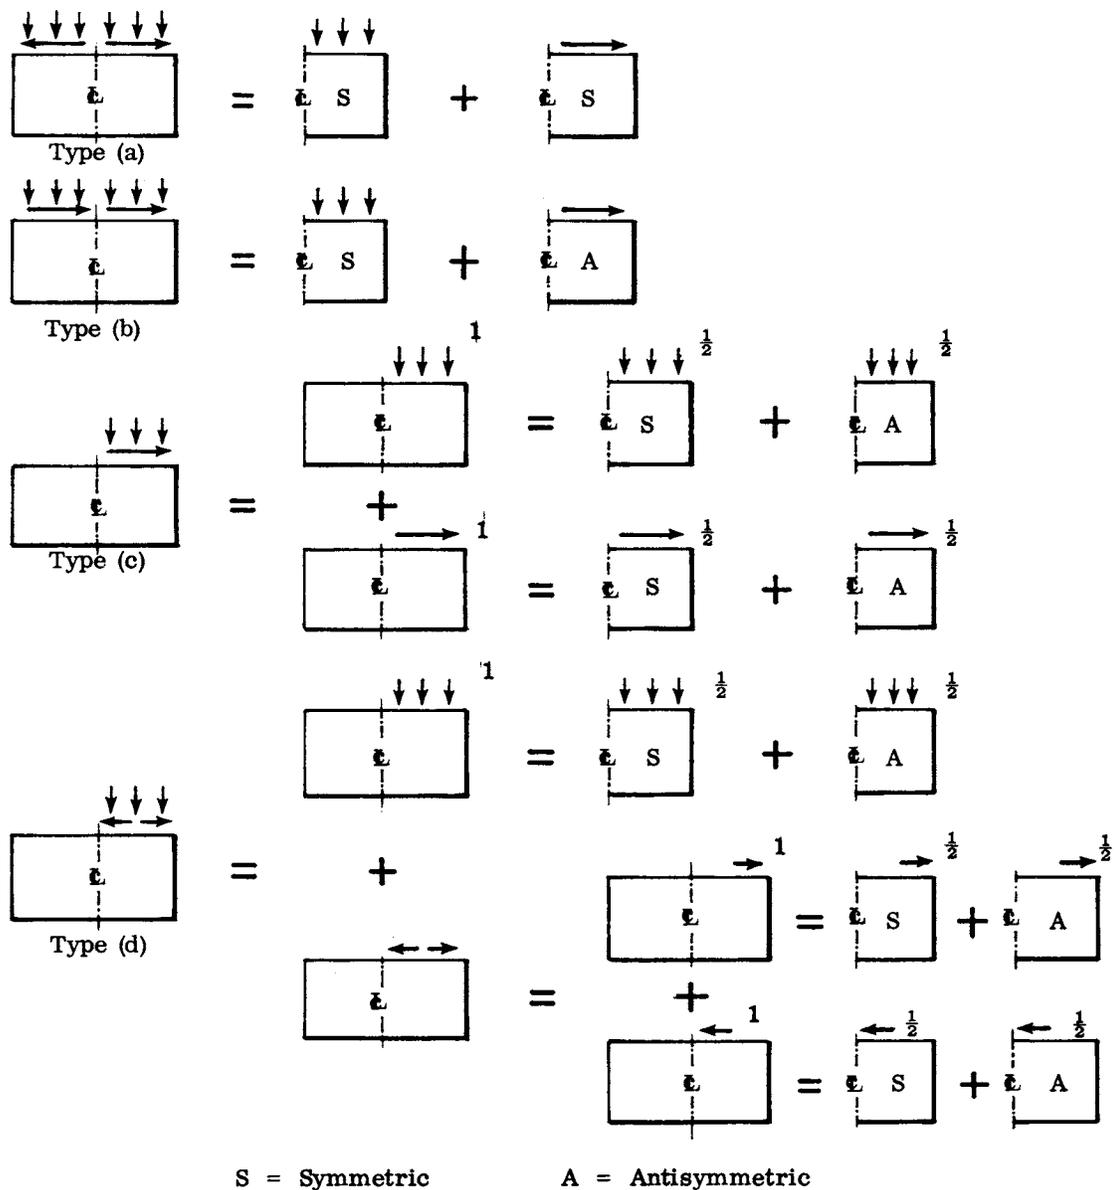
Figure 16. Superposition was used to obtain the boundary conditions and the stresses under the different loading conditions given in Figure 14.

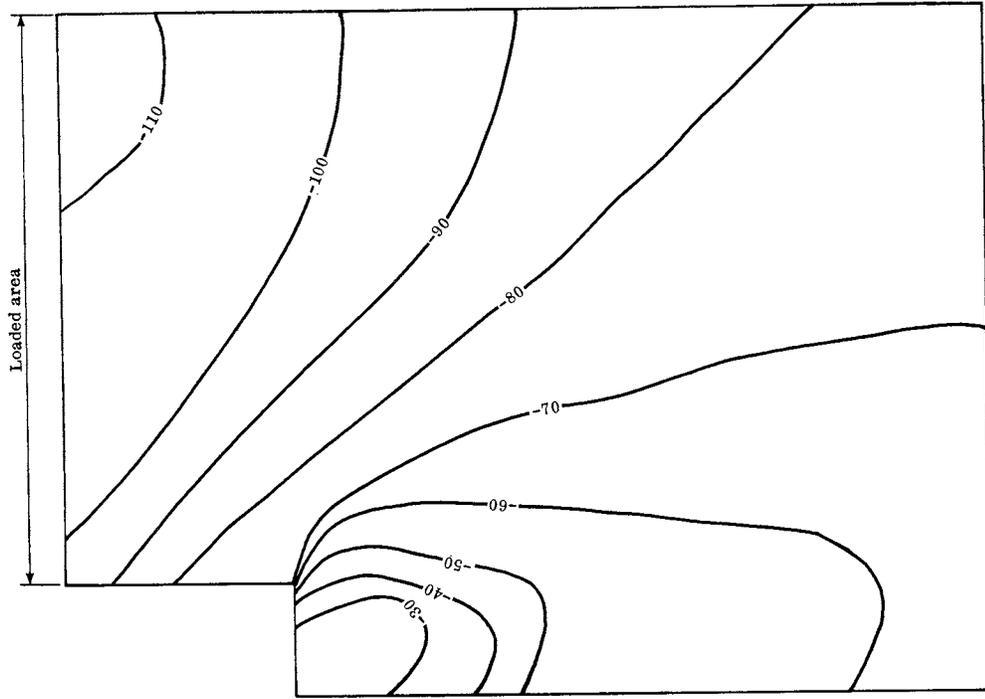
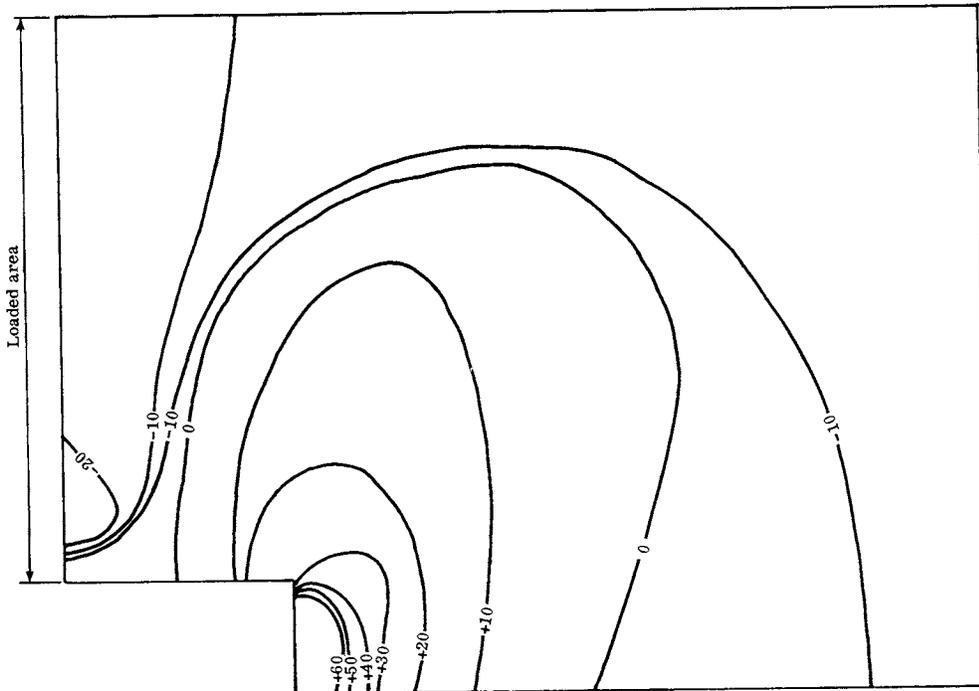
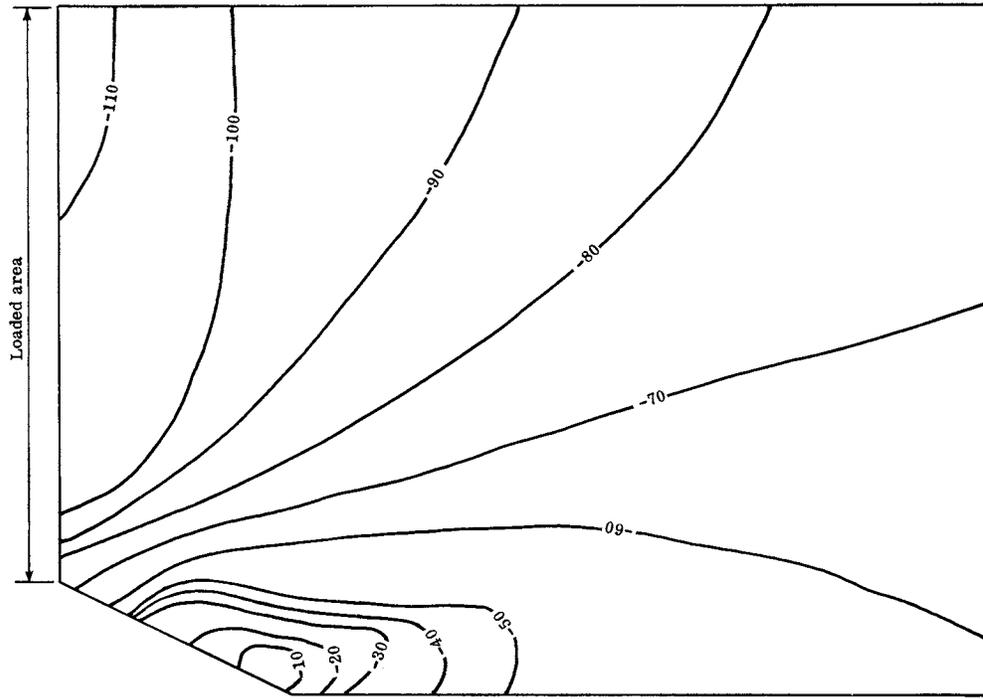
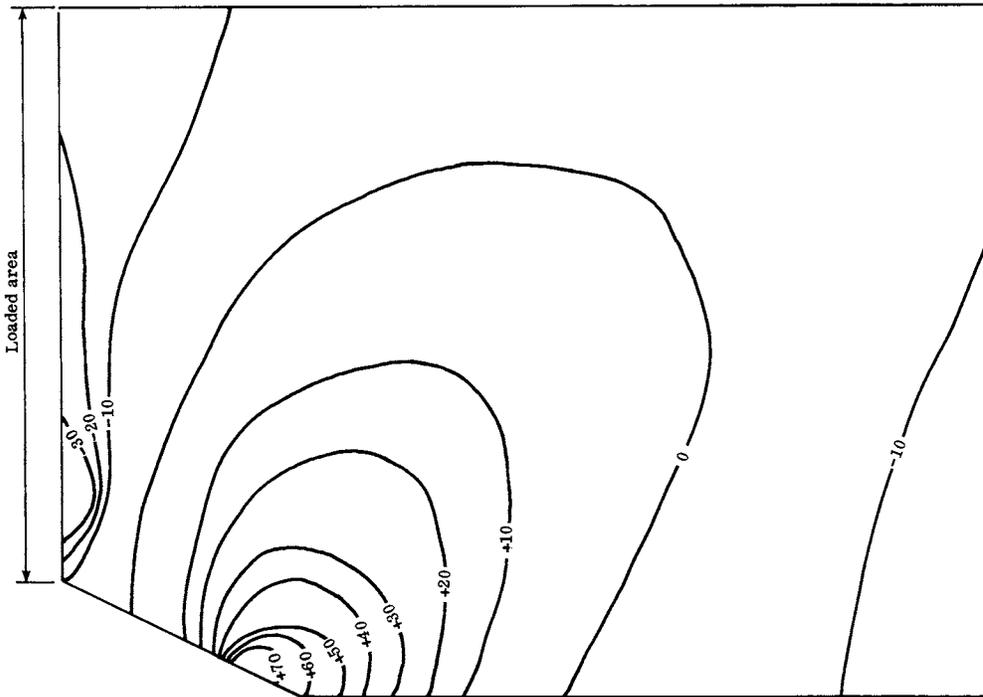
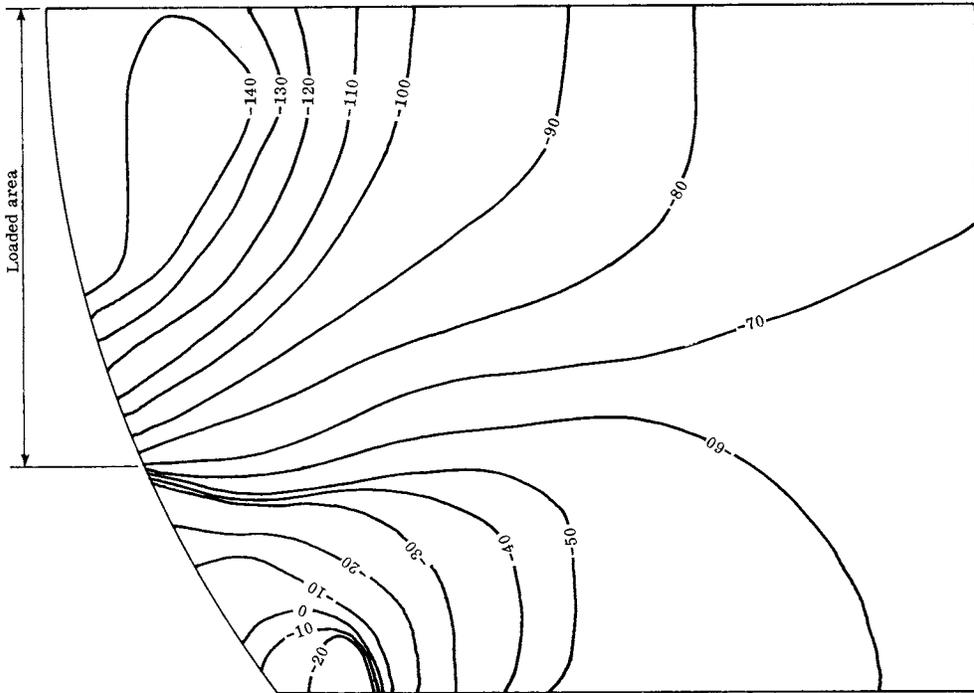
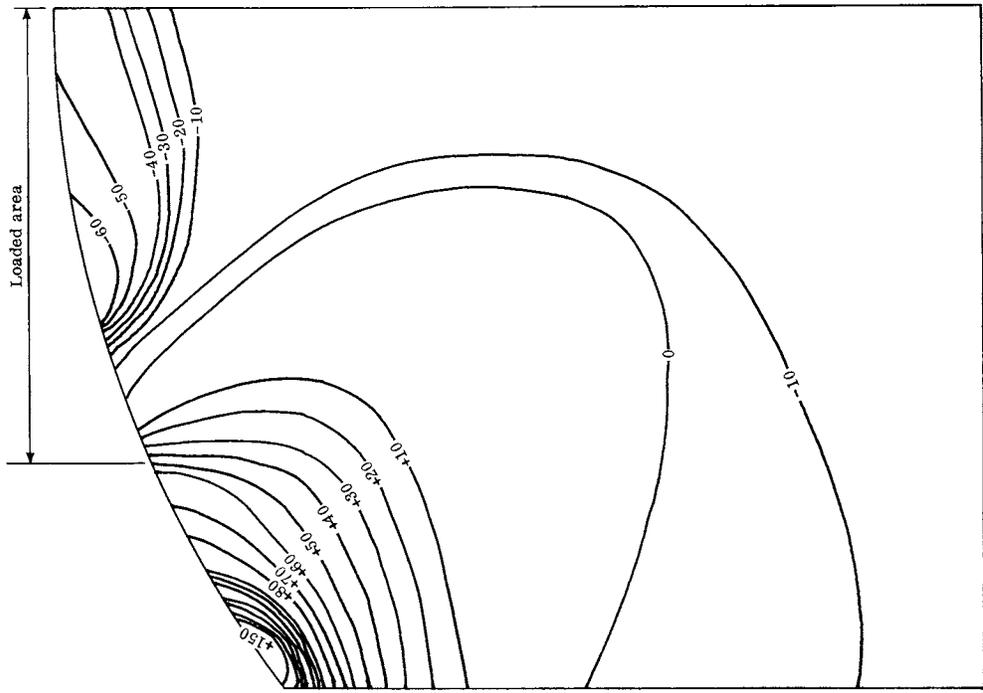
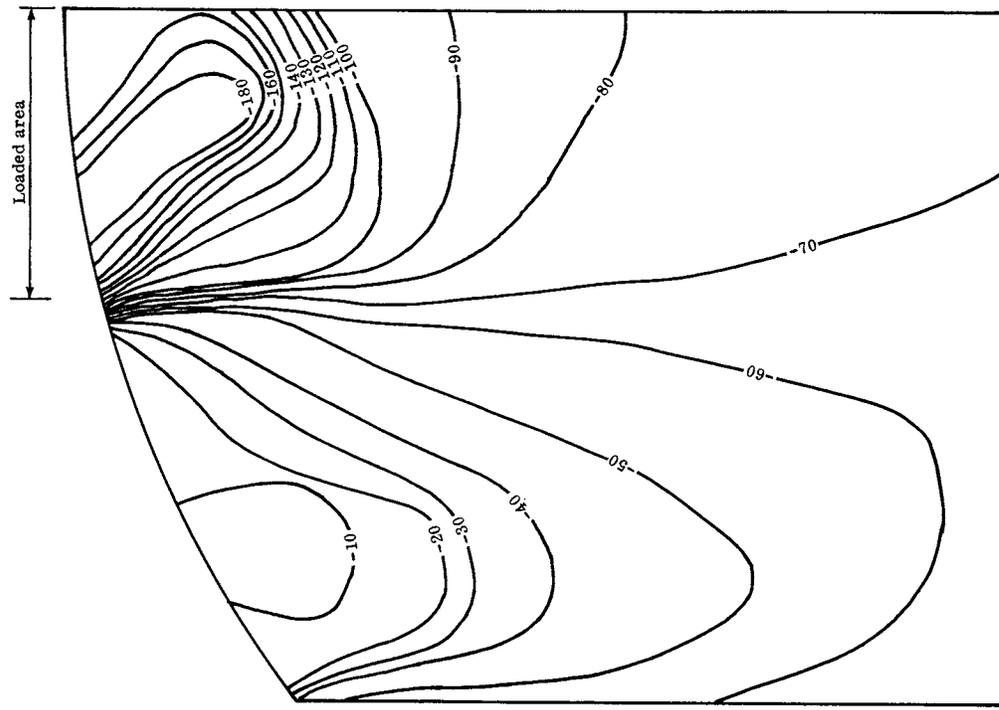
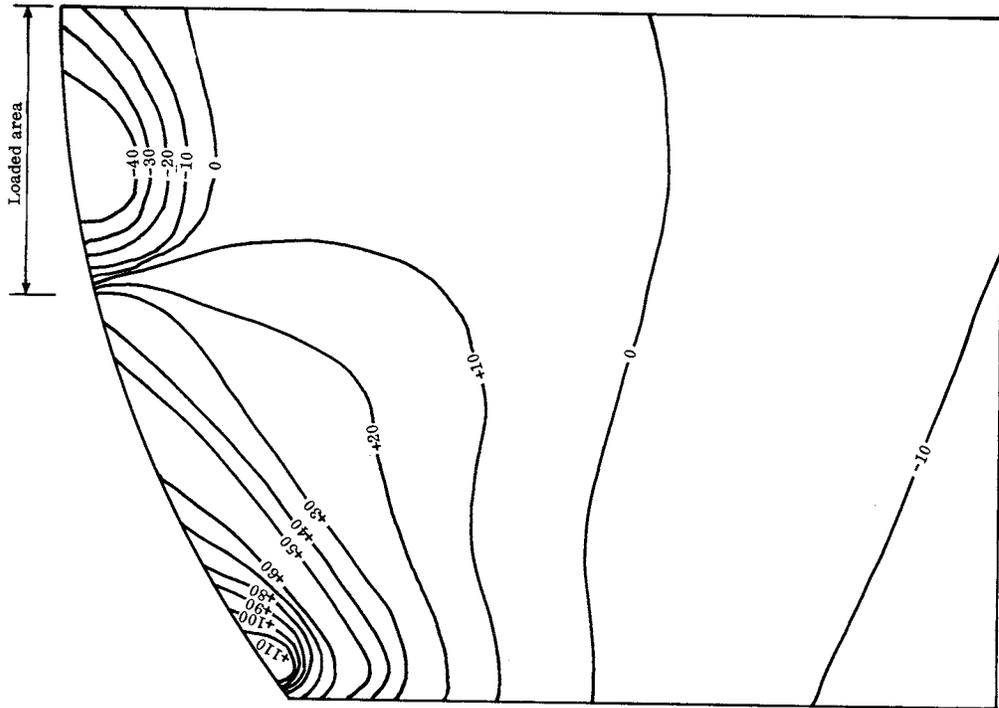
Square groove under 100 psi normal and 25 psi shear stress.

- (+) Principal tensile stresses in psi
- (-) Principal compressive stresses in psi

Figure 17. Stress contours showing the distribution of principal stresses  $\sigma_1$ , and  $\sigma_2$ .

Triangular groove under 100 psi normal and 25 psi shear stress.

Round groove under 125 psi normal and 31 psi shear stress.

Round groove under 200 psi normal and 50 psi shear stress.

For the 100 psi (689 kPa) normal and 25 psi (172 kPa) shear loading, the internal stresses in the concrete were well below levels sufficient to cause direct failure in concrete. In Figure 17, stress contours are plotted which show the distribution of principal stresses for type (a) loading (Figure 14), which along with type (c) gave overall high tensile stresses compared to the other types of loading.

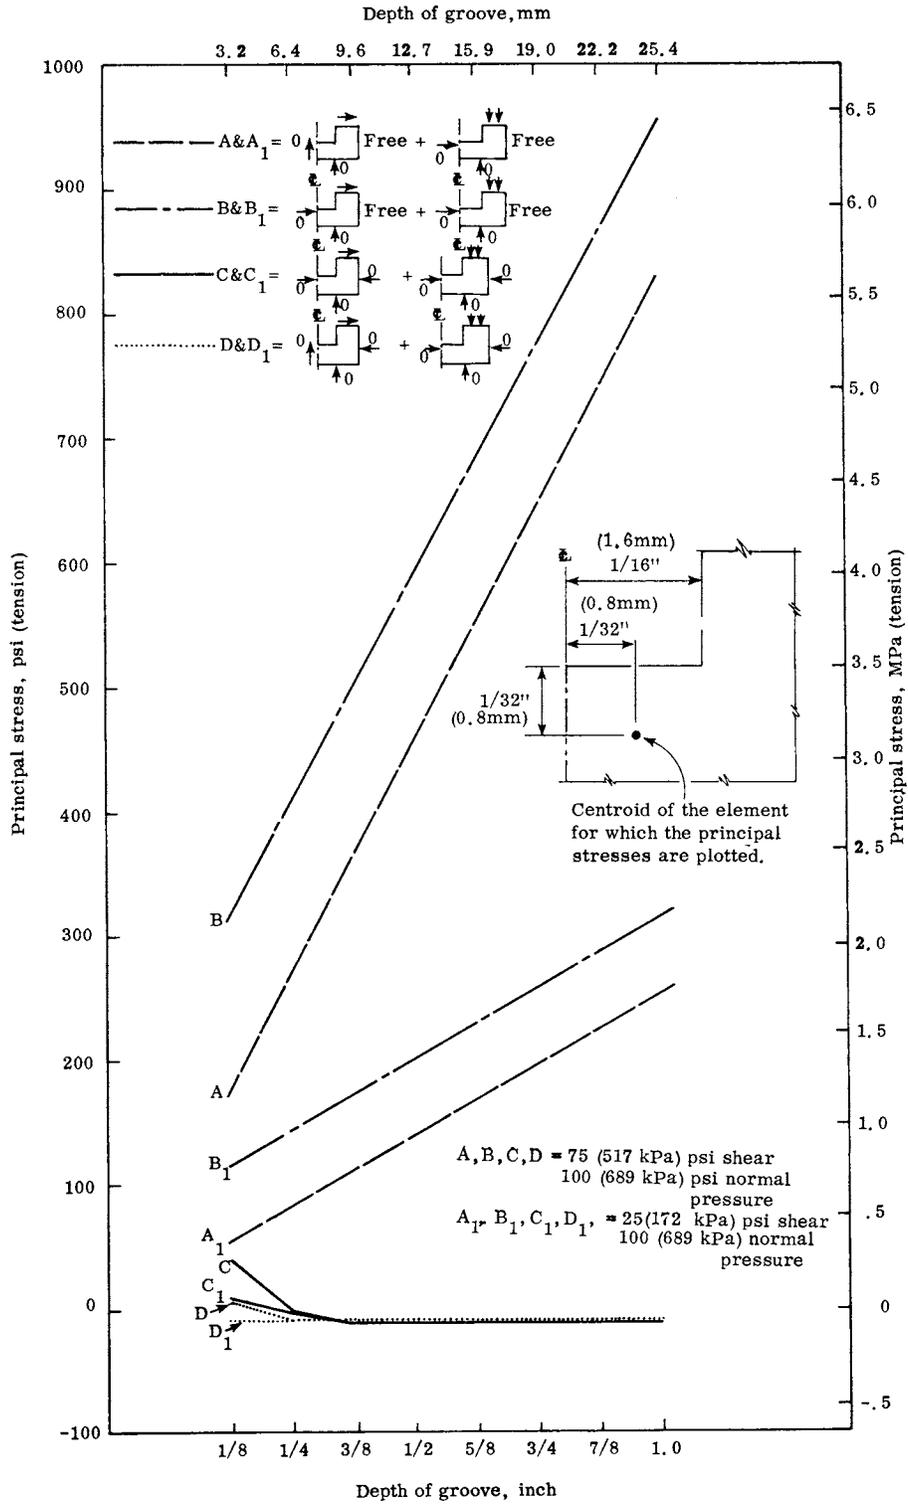
Figure 18. The effect of deeper rectangular grooves on the internal stresses for different loading and boundary conditions.
