## FINAL REPORT

DURABILITY OF CERTAIN CONFIGURATIONS FOR  
PROVIDING SKID RESISTANCE ON CONCRETE PAVEMENTS

Virginia Highway Research Council  
(A Cooperative Organization Sponsored Jointly by the Virginia  
Department of Highways and the University of Virginia)

VHRC 73-R57

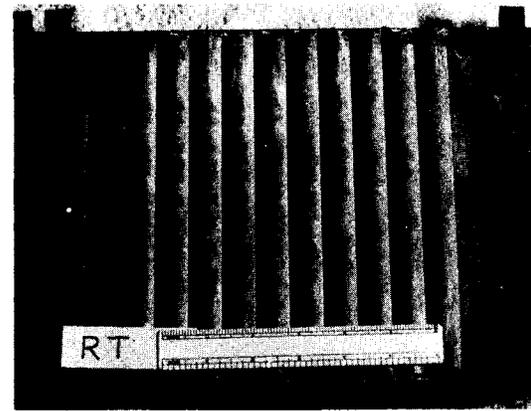
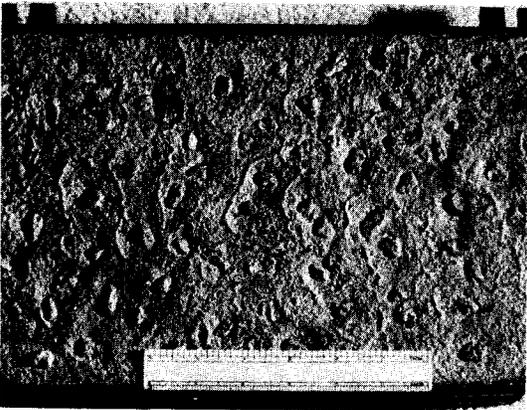
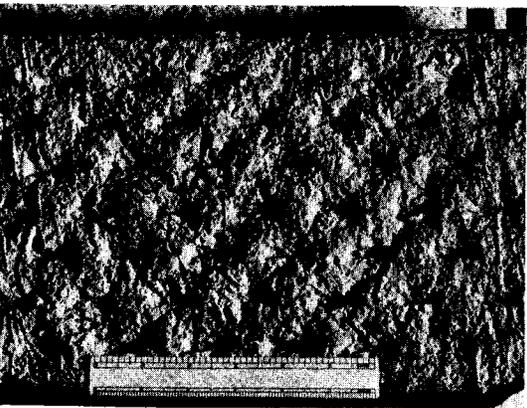
Figure A-1. Top view of the concrete slabs with various textures that were subjected to wear at the circular test track.

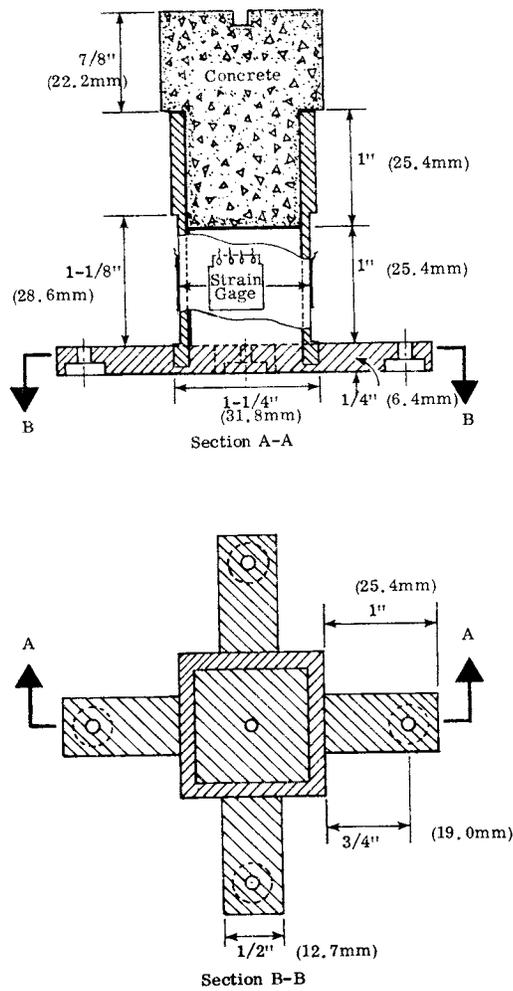
Figure A-2. A sensor was built to measure the surface forces.

A sensing instrument was located in a specimen having longitudinal grooves to measure the forces occurring at the tire-pavement interface. (Figures A-2 and A-3). These forces were intended to be used in the theoretical analysis as loads exerted on the surface.

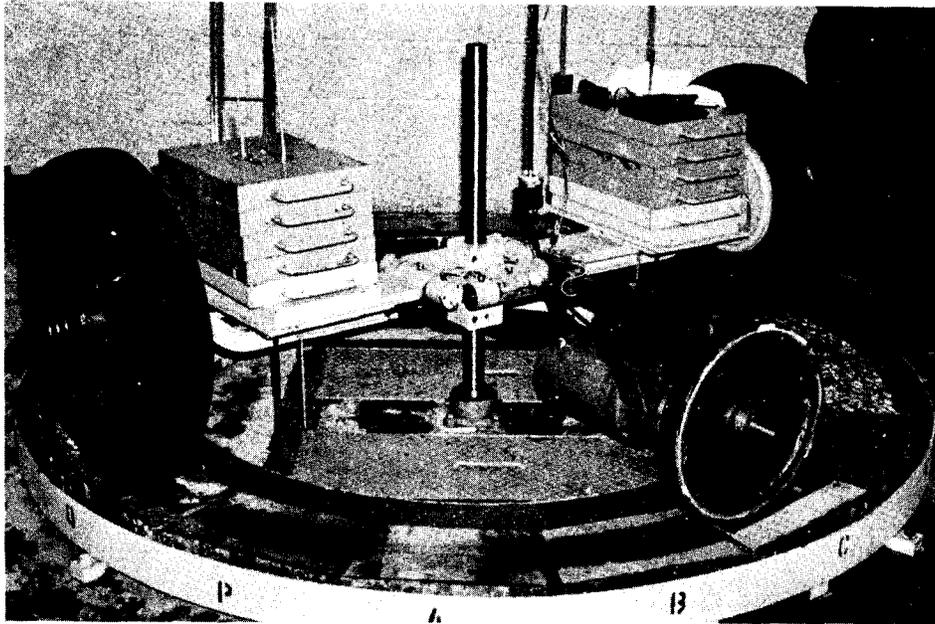
Figure A-4. Circular test track of the Maryland Road Commission used in the experimental phase.

All the specimens were subjected to wear at the test track of the Maryland Road Commission, shown in Figure A-4, for 835,000 cycles which is equivalent to 1,670,000 wheel passes. The test track is 6' (1.83 m) in diameter with two wheels connected to a central shaft, that rotates in a horizontal plane at 24 rev/min under a 1,000 lb. (454 kg) vertical loading on each wheel.

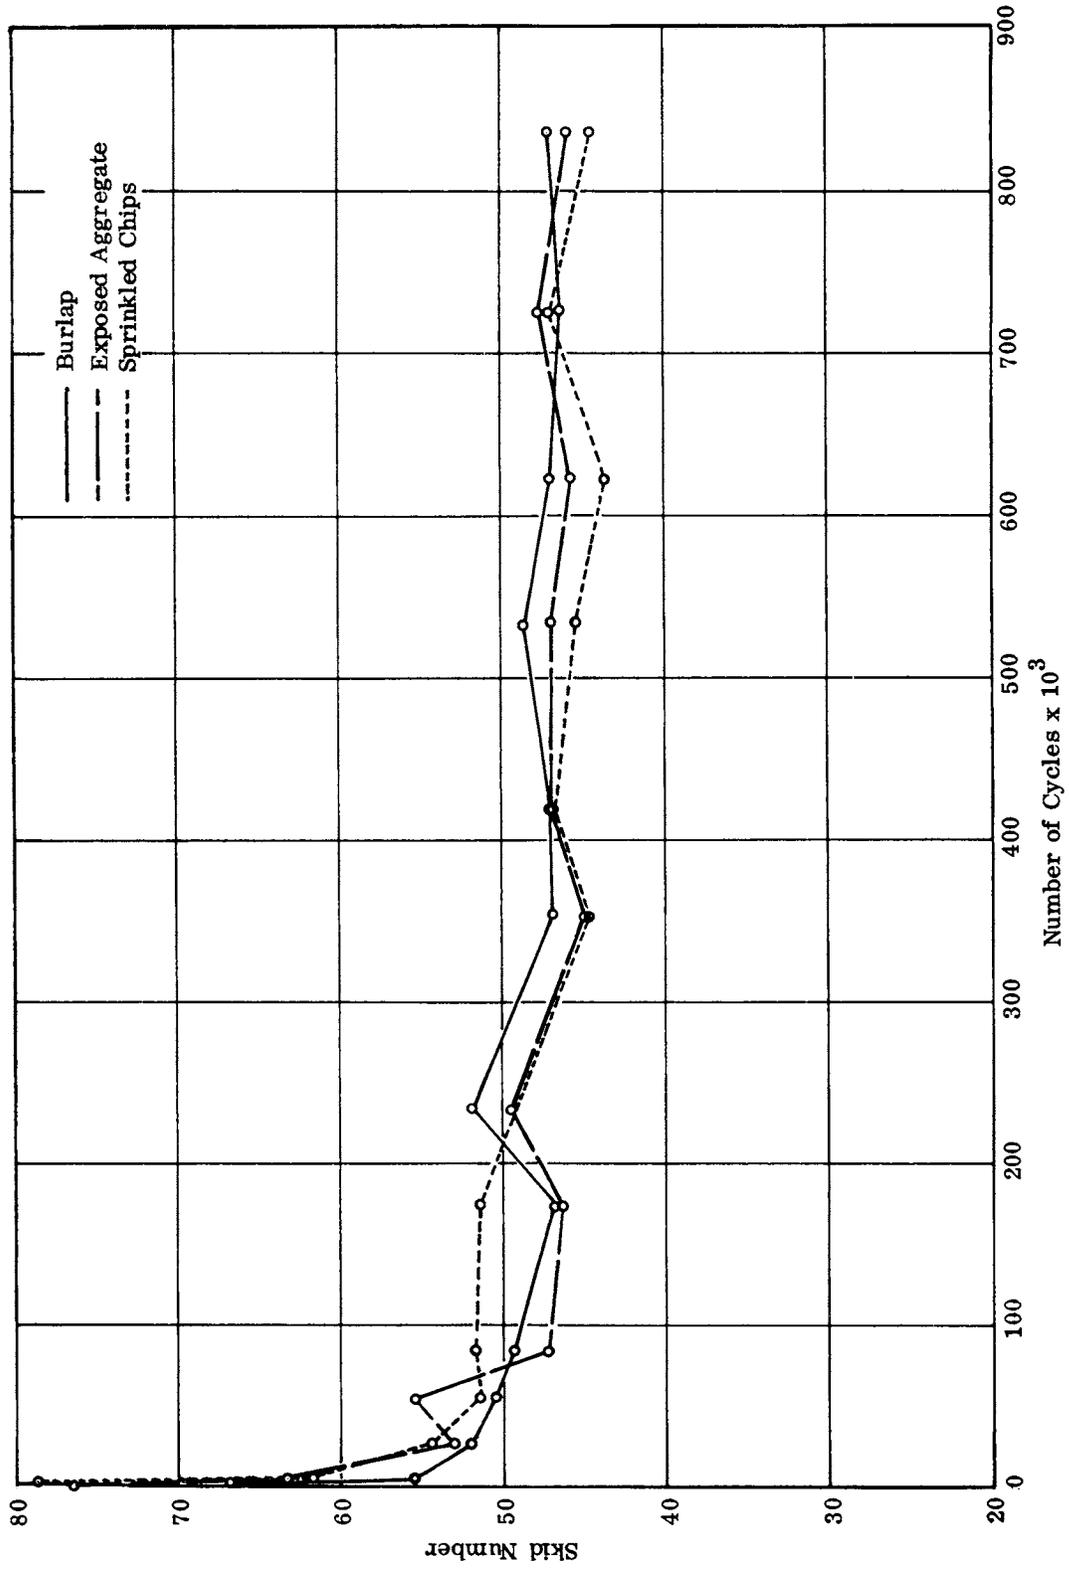
Figure A-5. Skid number vs. number of cycles for the random textures.

At certain time intervals, skid numbers ( $SN = 100 \times$  coefficient of friction) were obtained with a British Portable Tester (BPT) (48). At each interval an average of four tests was used. The plots are shown in Figures A-5 through A-8. Within the first 100,000 cycles the skid numbers dropped rapidly; afterwards a slight decrease and then a leveling off were observed. The skid numbers measured with the BPT were influenced mainly by the contact area, the microtexture, and the physical interference caused by the orientation of the grooves. The general trend of the curves approximates that shown earlier in Figure 1.

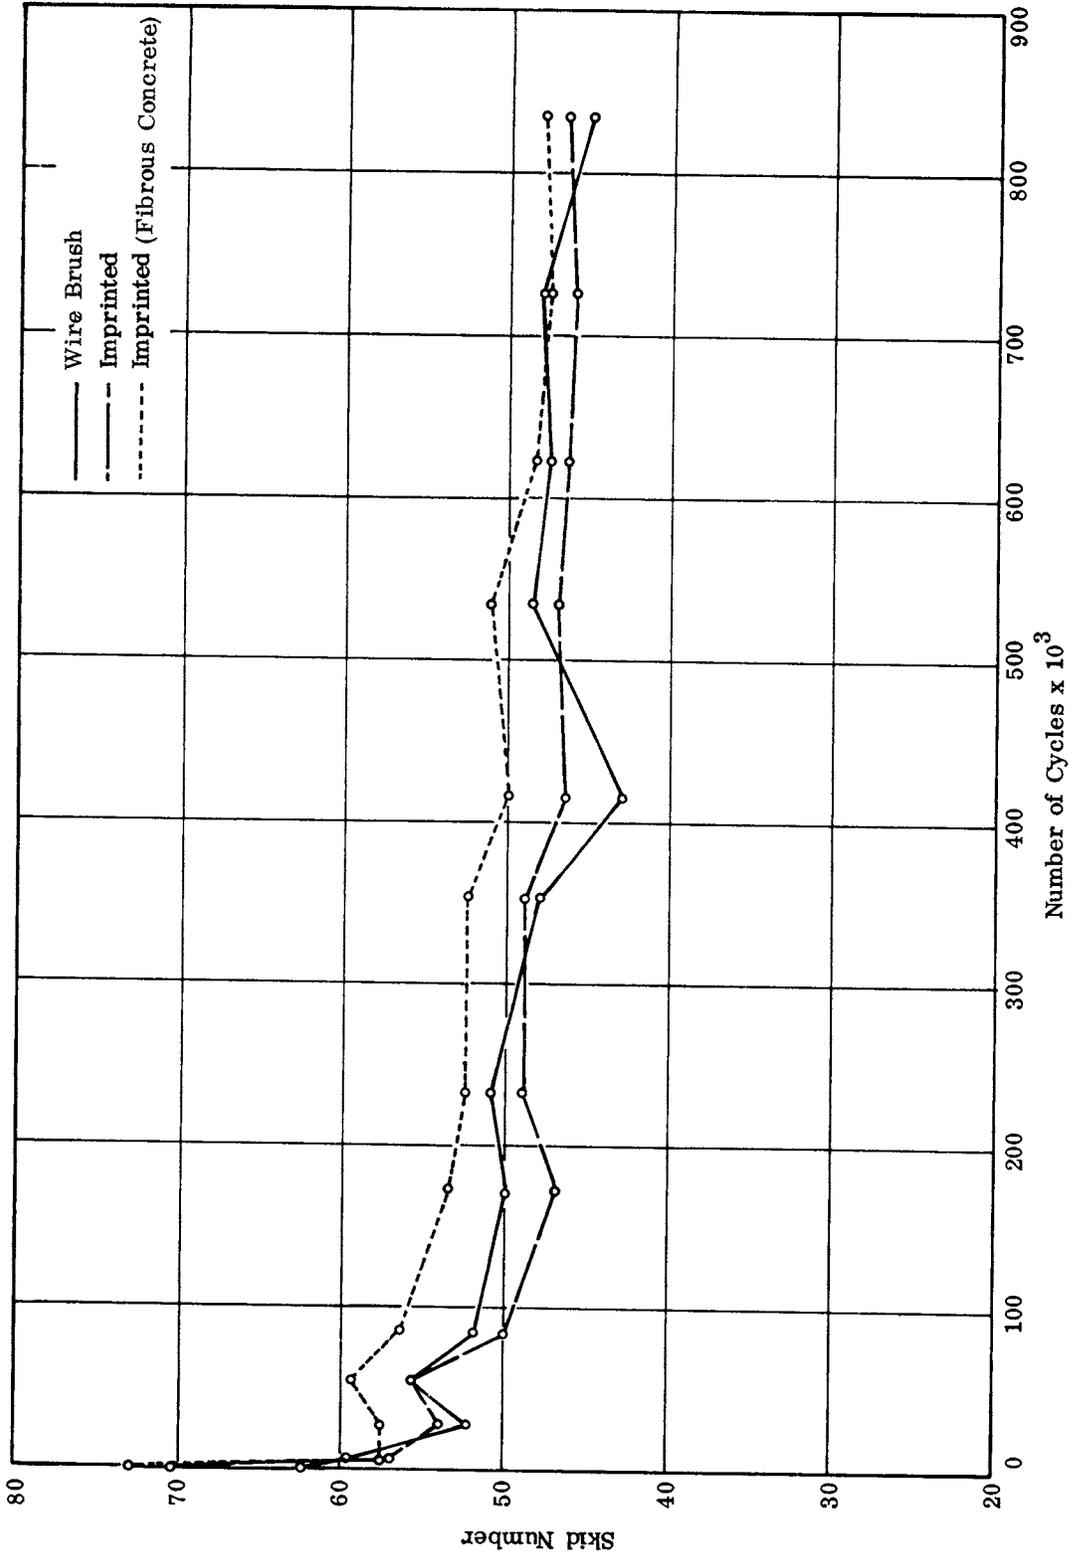
Figure A-6. Skid number vs. number of cycles for the random textures.

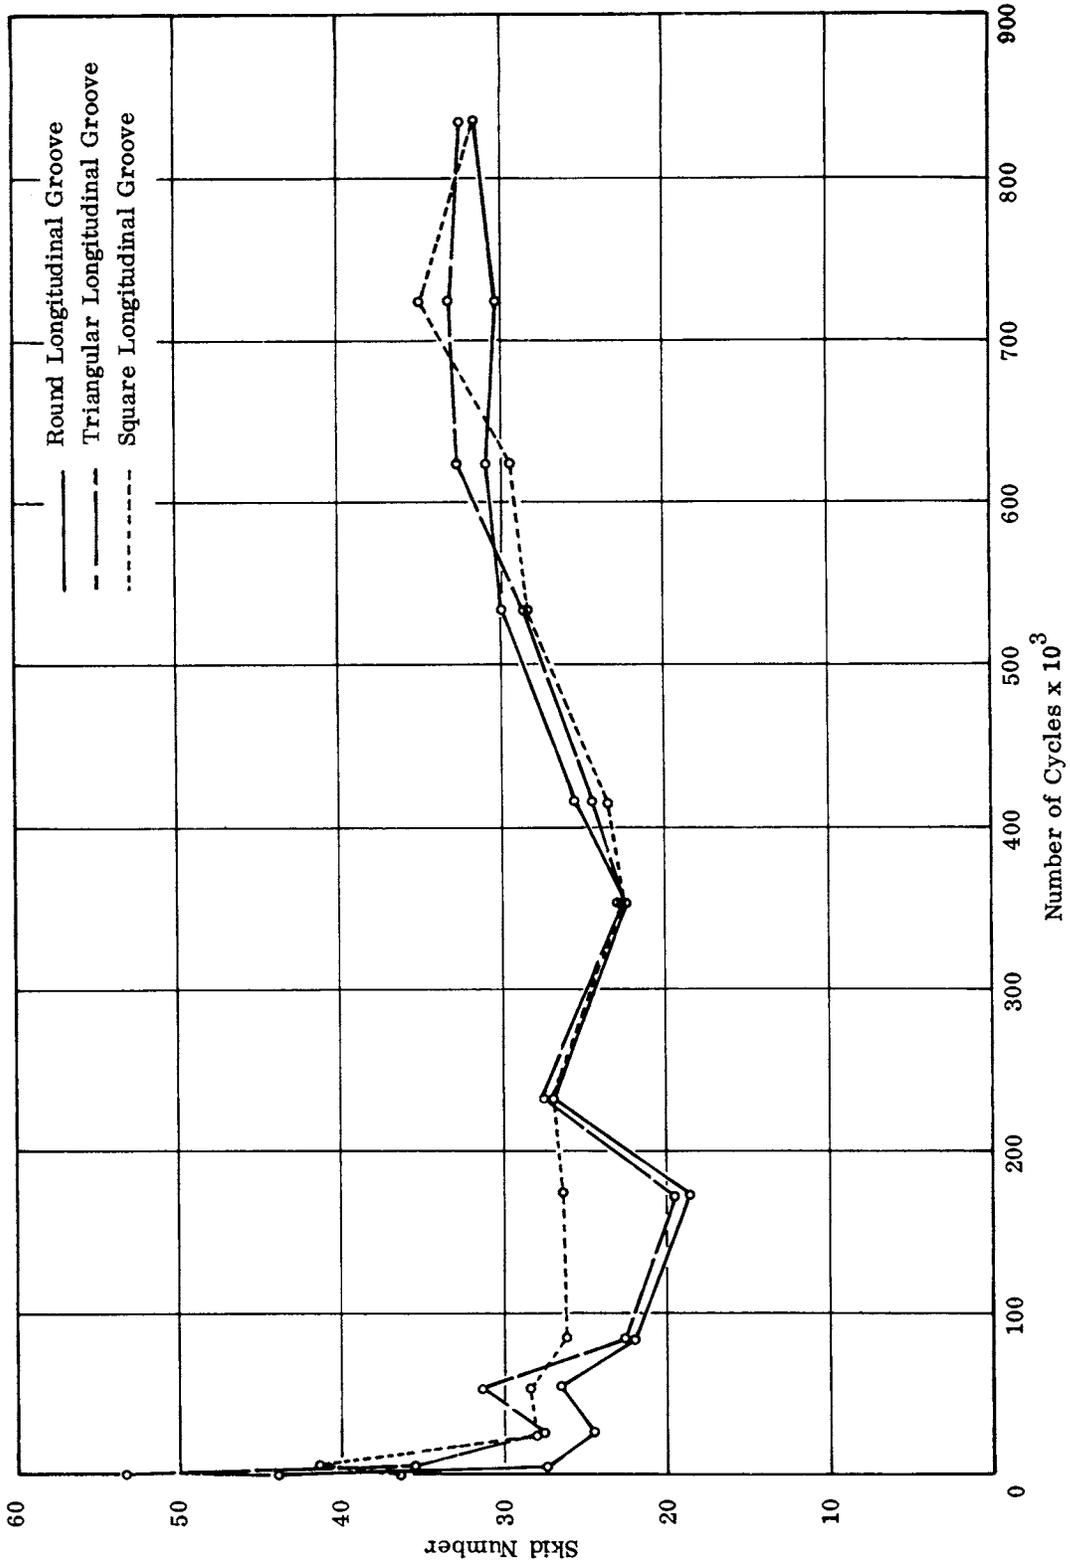
Figure A-7. Skid number vs. number of cycles for the uniform longitudinal grooves.

a satisfactory microtexture would be achieved. This happened in the case of longitudinal grooves after 500,000 cycles but did not increase the skid numbers appreciably. Uniform transverse grooves gave higher frictional values, probably because of the catching of the rubber slider of the BPT at the grooves. The slab with fibrous concrete showed more resistance than the one with plain concrete and the same texture. The rubber slider might have experienced more resistance because of the protruding wires. The fluctuation of the skid numbers for the same texture at increasing numbers of tire passes might have resulted from the varying microtexture exposed at the time of test.

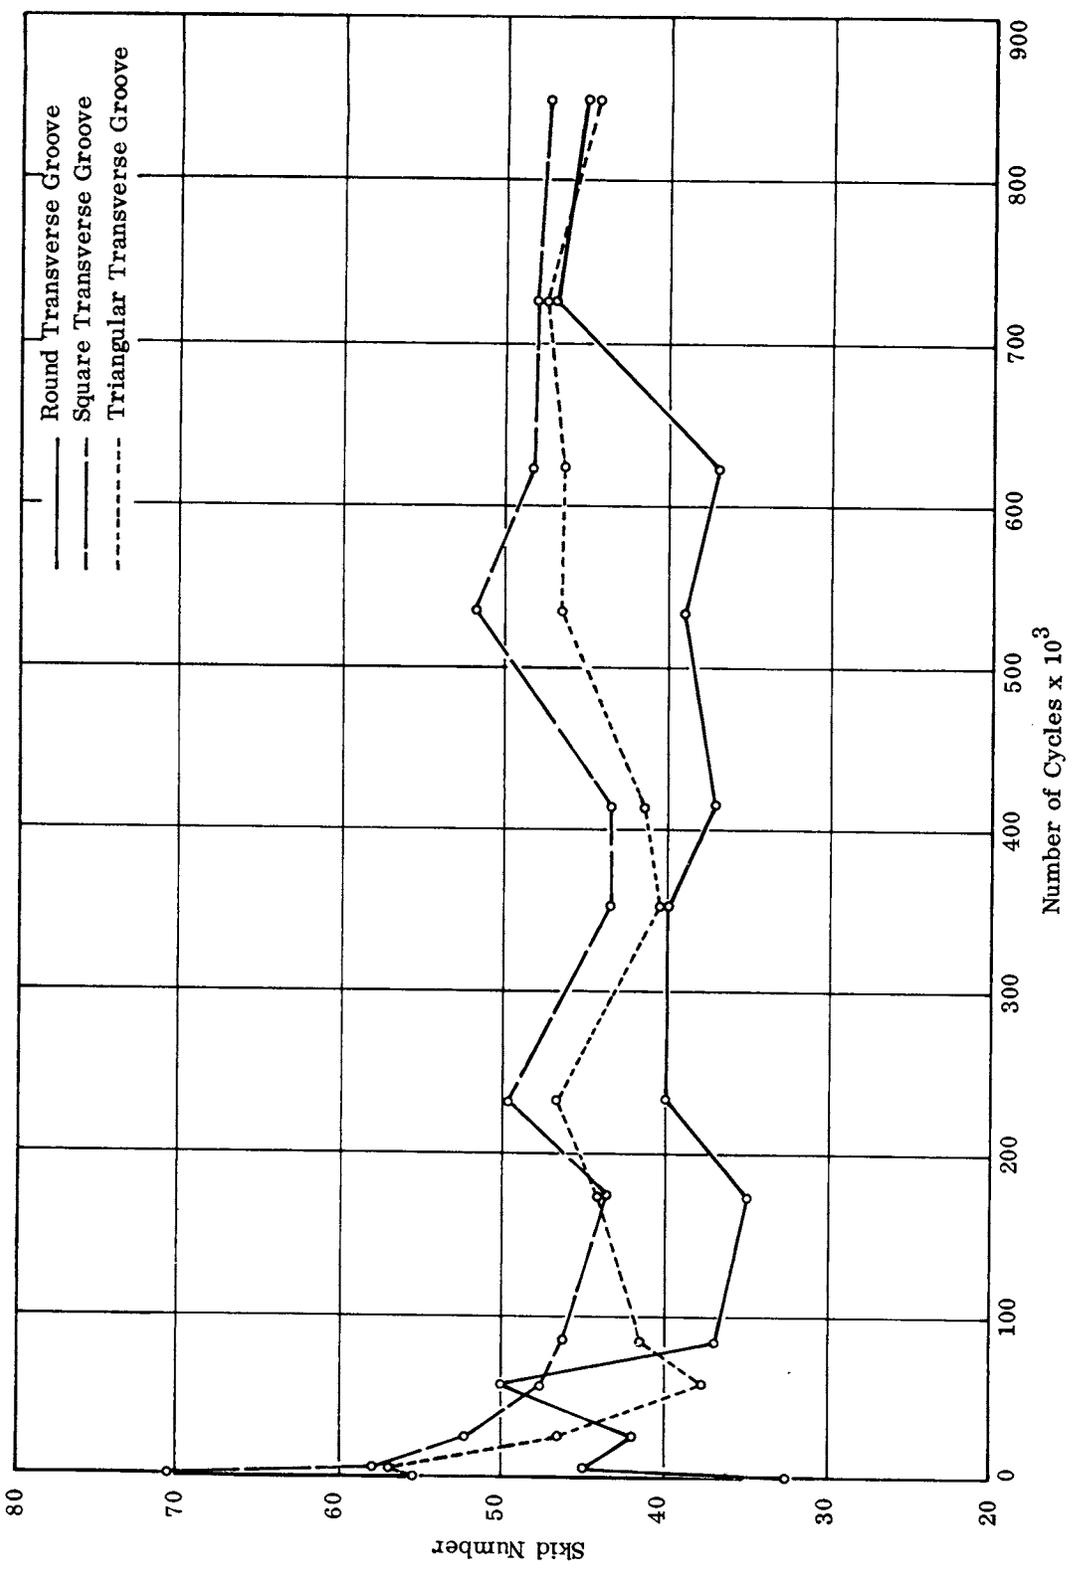
Figure A-8. Skid number vs. number of cycles for the uniform transverse grooves.

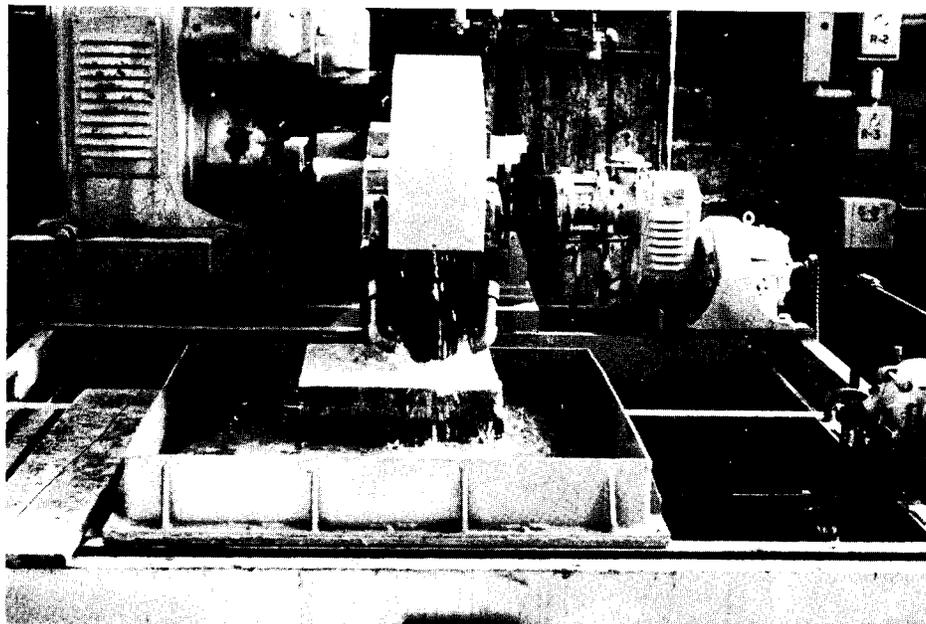
Figure A-9. Test apparatus consisting of rotating wheel.

Because of the difficulties encountered with the use of the circular test track concerning the degree of wear and the measurement of the surface forces, a different type of facility was investigated. This apparatus in Tennessee, shown in Figure A-9, consists of a wheel rotating in a vertical plane at constant speed about a fixed axle.<sup>(49)</sup> The wheel is kept on the specimen under a 270 lb. (122 kg) load. Higher loads cause rapid wear and damage to the rotating tire. The wheel rotates at a constant speed, equivalent to a vehicle's traveling at 10 mph (16 km per hr). The power required to keep this constant speed is recorded. Within a couple hours it is possible to obtain sufficient polishing to cause a slippery surface. However, consultation and some limited testing with this equipment revealed that it is doubtful that a significant decrease in texture depth could be achieved using the rotating wheel. For these reasons the remaining experimental phase of the work was directed and confined to observations on cores removed from pavements in service.
