EVALUATION OF RUMBLE STRIPS

Kurt A. Franke
Undergraduate Trainee

Virginia Highway & Transportation Research Council
(A Cooperative Organization Sponsored Jointly by the Virginia
Department of Highways & Transportation and the University of Virginia)

November 1974
VHTRC 75-R10

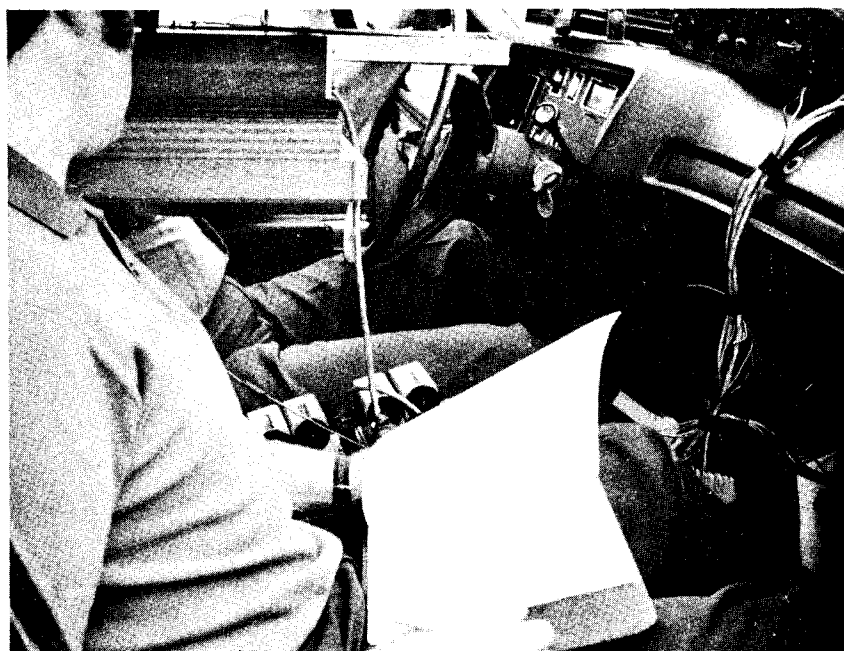
Figure 1. Recording device for roughness equipment located on seat of road roughness car.

The road roughness equipment measures the vertical movement between the passenger compartment and the rear axle of the automobile induced by pavement roughness. A braided cable connects the differential in the drive train with a roller switch, which in turn is secured to the passenger compartment. The switch is connected to an electrical counter that records variations from $1/8"$ (3.175 mm) to a maximum of $1 1/2"$ (38.1 mm) in increments of $1/8"$ (3.175 mm). With this equipment, the reaction of the rear axle to various spacings of rumble strips can be determined. Figures 1 and 2 show the equipment in the car.

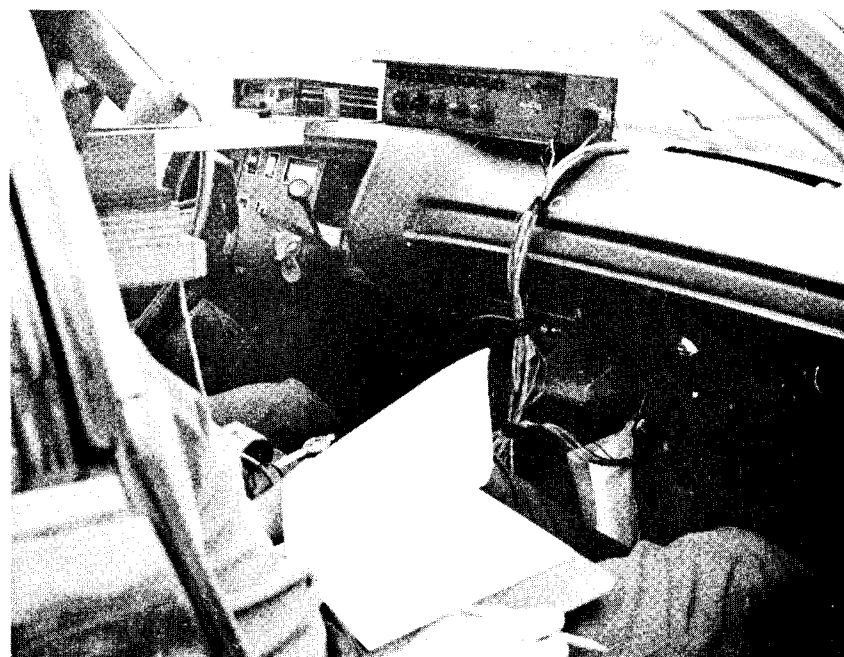
Figure 2. Roughness indicator located on dash of road roughness car.

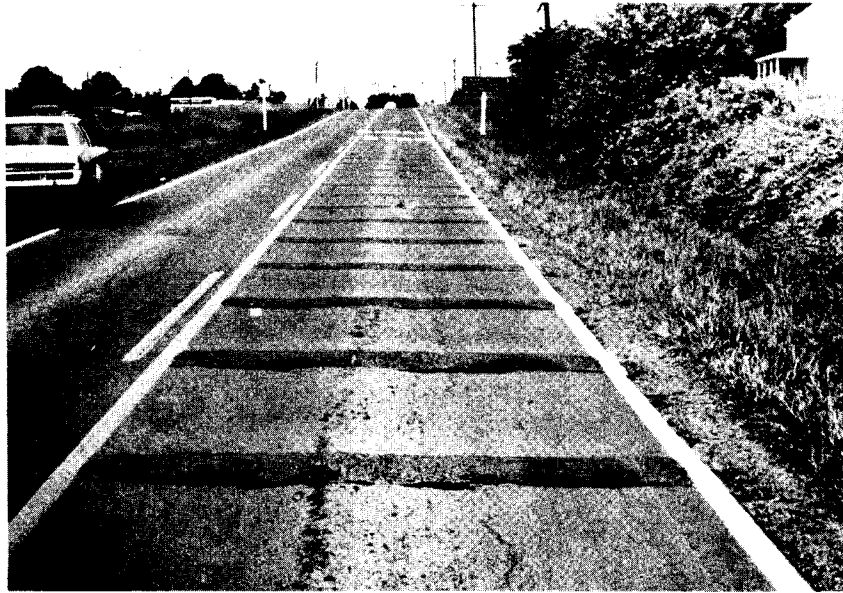
Figure 4. Rumble strips on Route 28 before the intersection of Route 17.

Figure 5. Close view of rumble strip on Route 28.

The first site is located on Route 28 in Fauquier County north of the intersection with Route 17. Its total length is 130' (39.6 m), with a 10' (3.05 m) separation between the strips. This 10' (3.05 m) separation is the same length as the average wheel base of the standard size American car. The site has build-up strips 1/4" (6.350 mm) high and 2' (0.61 m) wide. At this location the noise level and vibration increased as speed increased, thereby providing an increase in physical stimulus as the speed increased. Figures 4 and 5 show two views of this site.

The location in Virginia that seemed to be the most effective was at the approach of Route 28 to Route 17 in Fauquier County. At this site the spacing was 10' (3.05 m), the average wheelbase of an automobile, and the noise and vibration decreased as speed decreased. Strips cut into the pavement seemed to be as effective as built-up strips, as long as the strips are wide enough to allow the tire to descend into the cut.

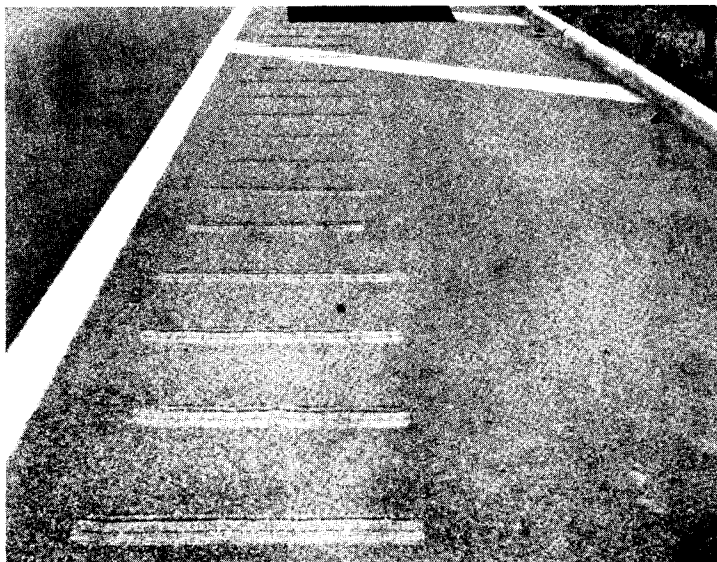
Figure 6. I-64, Afton Mountain.

Figure 7. Close-up of Figure 6.

The second site is on the shoulder of I-64 across Afton Mountain in Augusta County. It is located on the eastbound side between the exit ramp and the entrance ramp for Route 250. The purpose of this site is to evaluate rumble strips for their effectiveness in warning a driver who has left the roadway due to fog. The strips are cut into the pavement with a separation of 2.75' (0.838 m), a width of 7" (0.18 m), and a depth varying around 1/4" (6.34 mm). This site produced the most vibration at a speed of 30 mph (13 m/s), indicating a resonance at this speed which is an undesirable effect. Figures 6 and 7 provide two views of the site. There is another location on the exit ramp from the Afton overlook with a wider spacing, however, the strips there could not be evaluated due to the roadway's configuration making it unsafe to perform tests.

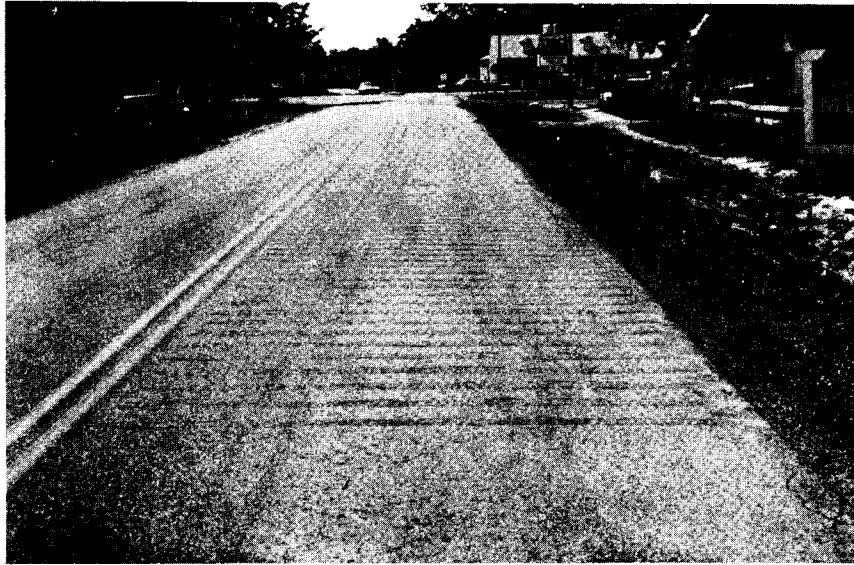
Figure 8. Rumble strips located on Route 606 before the intersection of Route 1.

Figure 9. Close view of the rumble strips on Route 606.

The third site (Figures 8 and 9) is located on Route 606 as it approaches Route 1 from the east in Spotsylvania County. There are two sections, each with a total length of 60' (18.3 m). The strips have a separation of 1.5' (0.46 m) and are built-up $1/8$ to $1/4$ " (3.175 - 6.35 mm) with a 7" (0.18 m) width. It is believed that the spacing at this site is too close, since low speeds caused an increase in the vibration and relative noise level.

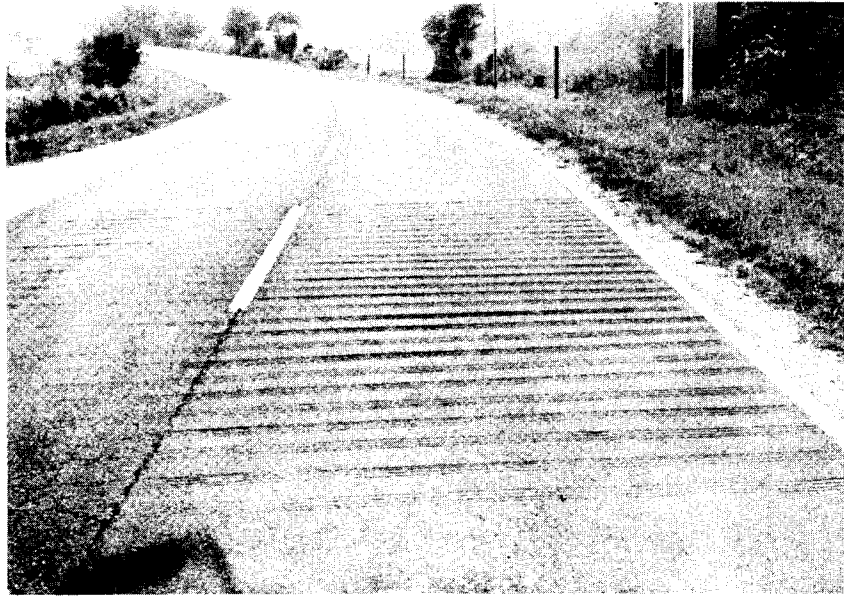
Figure 10. Rumble strips cut into Route 29 before Rapidan River.
View is opposing traffic direction (traffic lane).

Figure 11. Close view of rumble strips cut into traffic lane on Route 29.

Figure 12. Rumble strips cut into passing lane of Route 29 before Rapidan River. View is opposing traffic direction.

Figure 13. Close view of rumble strips cut into passing lane of Route 29.

The fourth site is located on Route 29 on the approach to the Rapidan River Bridge from the south in Greene County. There are two 32' (9.75 m) sections. Each strip was formed by cutting four $3/4$ " (19.05 mm) grooves in the pavement $3/8$ " (9.525 mm) apart to give a total strip width of 6" (0.15 m). These strips proved to be rather ineffective due to the narrow width of the grooves which did not allow the tires to descend into the groove. Figures 10 and 11 show the traffic lane which is quite worn. Figures 12 and 13 show the passing lane.

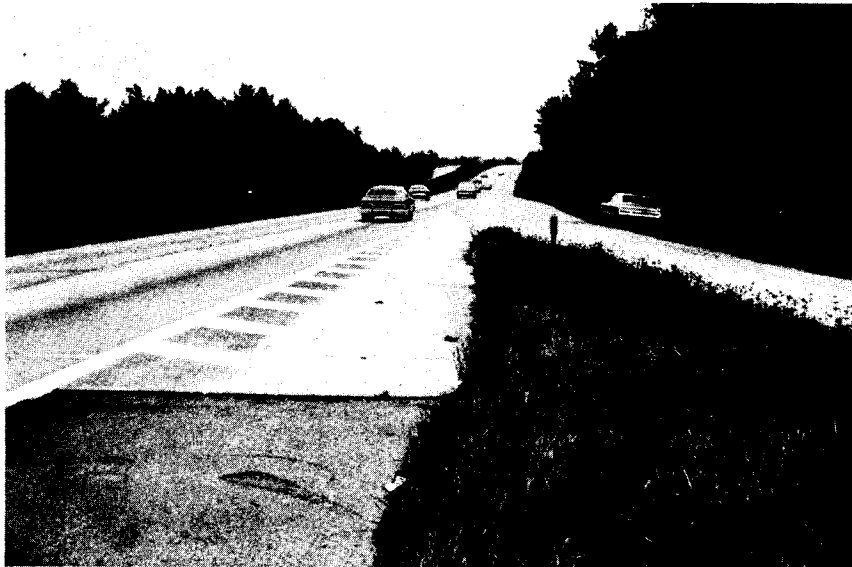
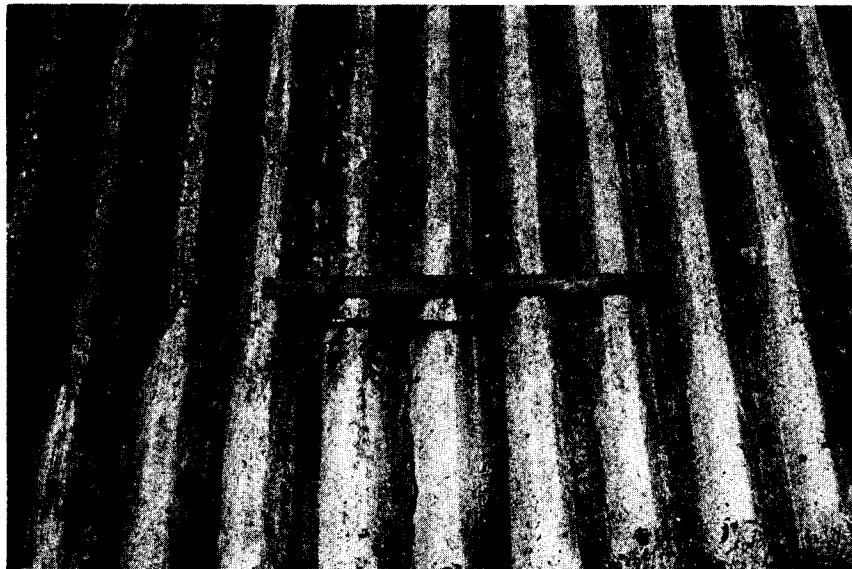
Figure 17. Rumble strips on interstate gore area.

Figure 18. Close view of the rumble strips on gore area.

The final site is in general the gore areas found on the first constructed interstate highways in the state. These strips are built-up with a height between 1 to 1.5" (25.4 - 38.1 mm), a width of 3" (76 mm), and a separation of 4" (102 mm). Figures 17 and 18 show views of the gore area.

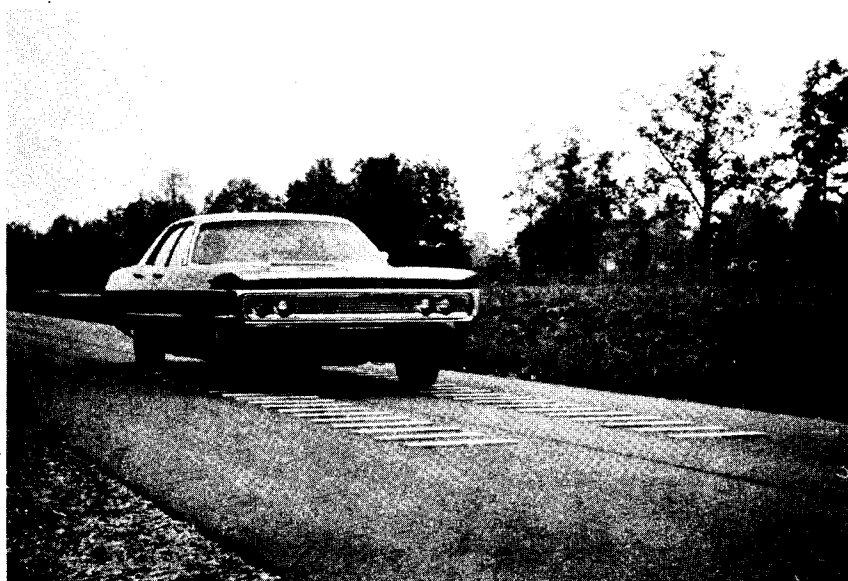
Figure 19. Road roughness car being used for testing at 70 mph (31 m/s).

Figure 20. Second view of 70 mph (31 m/s) test.

The testing involved setting out the strips at a particular spacing and then operating the car with the roughness equipment attached. The roughness tests involved three passes at each speed of 70, 60, 50, 40, 30, and 20 mph (31, 27, 22, 18, and 13 m/s) and any additional passes needed to check any unusual results. The sound tests were then conducted with the roughness equipment disconnected, and involved two passes at each of the aforementioned speeds, with additional runs being made if the readings varied more than .5 dBA. The sound meter was operated with the car's windows closed and the air conditioner and fan on the lowest setting. Figures 19 - 21 are views of the car in operation at 70 mph (31 m/s) and a view of the rumble strips (Figure 21). The data for these tests are located in Tables A-2, A-3, and A-4 in the Appendix.

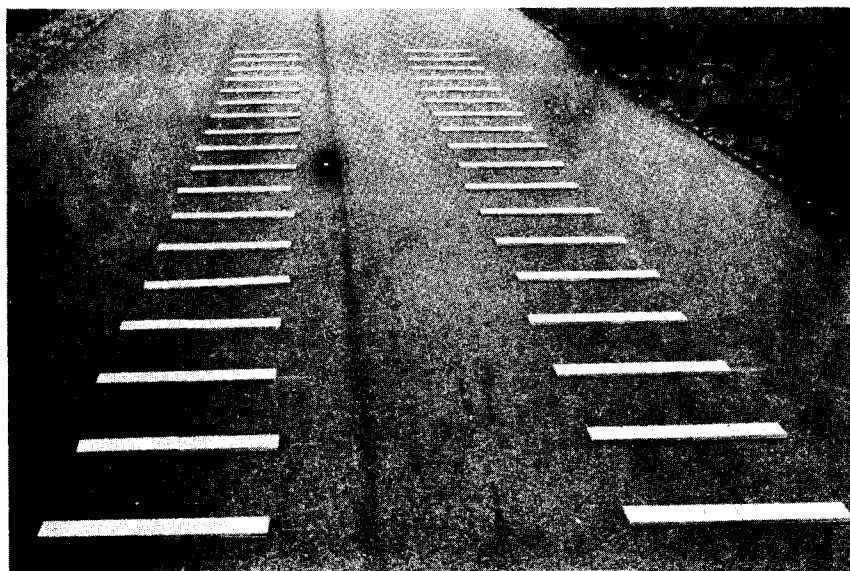
Figure 21. View of the plywood strips used for the rumble strips.

The final aspect of the study was to find a location to test a variety of spacings. An unopened rest area on I-64 between Gum Springs and Charlottesville proved to be an ideal location. Because of the rest area configuration, tests up to 70 mph (31 m/s) were possible. Four-inch (102 mm) wide plywood boards were used to make the rumble strips, whose height varied from 1/4 to 1/2" (6.35 - 12.7 mm). The strips were secured to the pavement with roofing nails and the spacings evaluated were as follows: 15' (4.57 m), 10.5' (3.20 m), 10' (3.05 m), 7.5' (2.24 m), 5' (1.52 m), 3.75' (1.14 m), 3.25' (0.991 m), 2.5' (0.762 m), 2' (0.610 m), and 1.25' (0.381 m).
