POOR VISIBILITY, A COMMON CAUSE OF WRONG-WAY DRIVING

N. K. Vaswani  
Senior Research Scientist

Virginia Highway & Transportation Research Council  
(A Cooperative Organization Sponsored Jointly by the Virginia  
Department of Highways & Transportation and the University of Virginia)

September 1975  
VHTRC 76-R14

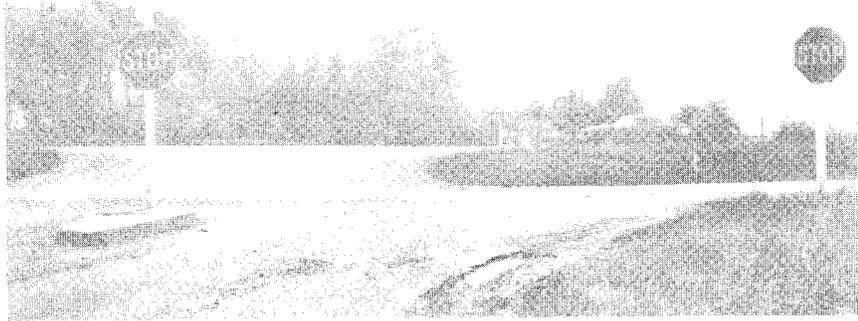
An example of the reflectance and visibility of road features other than signs which help the driver negotiate an intersection or an interchange is given in Figures 5 and 6. These figures are day and night photographs of a 4-lane divided intersection taken from the driver's position with the vehicle entering from the undivided crossroad. Both photographs were taken when the sky was clear. The night photograph was taken when the humidity was low and the road was dry, and hence at maximum visibility. A comparison of the two photographs shows that at night the luminosity and hence visibility decreases in the following order: (1) signs, (2) painted areas, (3) roadway and grass where the headlight makes a direct hit, and (4) unpainted concrete curb. It is, therefore, concluded that at night the driver is guided only by the high reflectance signs, painted curbs, guardrails, pavement markings, and other appurtenances, depending upon their reflecting power and the geometry of the road ahead. The comparison further shows that at night the informational devices visible to the driver are confined within a very narrow range of the low beams.

Figures 5 and 6, mentioned earlier to illustrate night visibility, are day and night photographs of a Tee intersection of Route 460, a 4-lane divided highway with a 2-lane crossroad, Route 647. It has the geometric drawbacks noted in the previous case, but the two westbound lanes of the divided highway adjacent to the crossroad are at lower elevations than the two eastbound lanes in the opposite direction on the other side of the median. This is the site of a wrong-way entry at night. As is evident from the night photographs, the two eastbound lanes are not at all visible when the driver enters the crossroad, but all signs are very clearly visible. The divided highway Tee intersection sign shown in Figure 16 will evidently inform the driver of the geometry of the intersection, which otherwise would be unknown to him. Since the crossover is not so wide, as not to be visible under low beam headlights while turning, left turn signs may not be necessary.

Figure 5. Daylight view from a crossroad of a 4-lane divided highway with the far lane higher than the near lane.

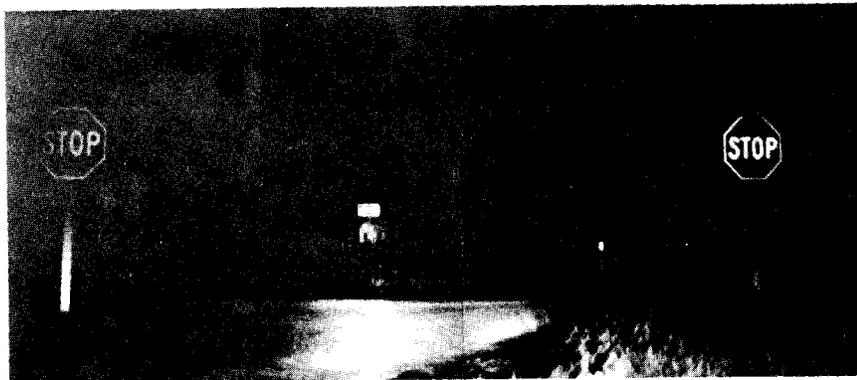
Figure 6. Night view from a crossroad of a 4-lane divided highway with the far lane higher than the near lane.

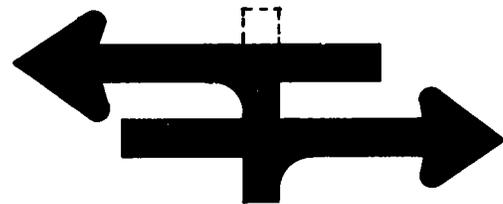
Delaware is using a similar sign with the addition of arrows as shown in Figure 10. They place this sign on all divided highway intersections, under the stop sign on the same pole. They have found it to be very effective in reducing wrong-way incidents.

DIVIDED HIGHWAY  
CROSSROAD

SAME AS LEFT WITHOUT  
THROUGH ROAD — (DOTTED LINE)  
DIVIDED HIGHWAY  
SIDE ROAD

SCREENED BLACK LETTERS ON BEADED WHITE SCOTCHLITE

Figure 10. Divided highways crossroad signs used in Delaware.

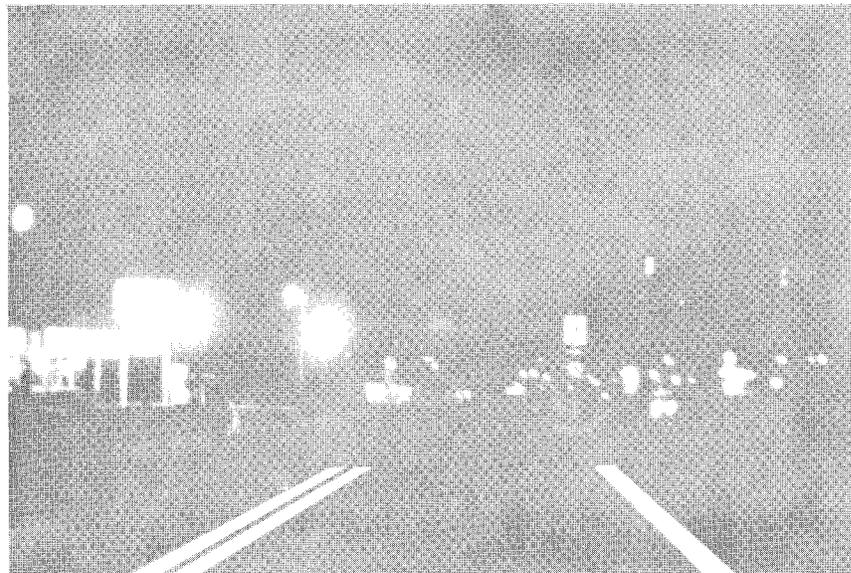
The site for this wrong-way entry is on Route 58 at South Hill. Day and night photographs of this site are shown in Figures 19 and 20, respectively. The pattern of yellow striping and continuation of the centerlines of the two traffic lanes that could be applicable in this case are shown in Figure 21. Since the striping was not provided nor were the centerlines continued, the wrong-way driver traveled from A to B as shown in this figure.

**Figure 20.** Route 58 at South Hill. Night photograph of the transition from 3-lane undivided highway to a 4-lane divided highway with no transitional pavement marking. Site of wrong-way entry.

1. The need for a proper pavement marking to separate the two opposite lanes in the transition on Route 58 at South Hill.
2. At night, because of a lack of depth visibility and limited side transverse visibility under low beam headlights, the driver does not have complete knowledge of the road features and geometrics. The driver at night is therefore guided by pavement markings, signs, and other reflective road features which are very close to him, depending upon their degree of visibility. The degree of his visibility and perception decreases with a decrease in the stimuli available to him. It is therefore the author's contention that drunken drivers are completely guided by what they see very close to the road surface, e. g. pavement edge markings.
