EVALUATION OF THE EFFECTIVENESS OF PRESSURE RELIEF  
JOINTS IN REINFORCED CONCRETE PAVEMENTS

K. H. McGhee  
Research Engineer

Virginia Highway & Transportation Research Council  
(A Cooperative Organization Sponsored Jointly by the Virginia  
Department of Highways & Transportation and  
the University of Virginia)

March 1976  
VHTRC 76-R48

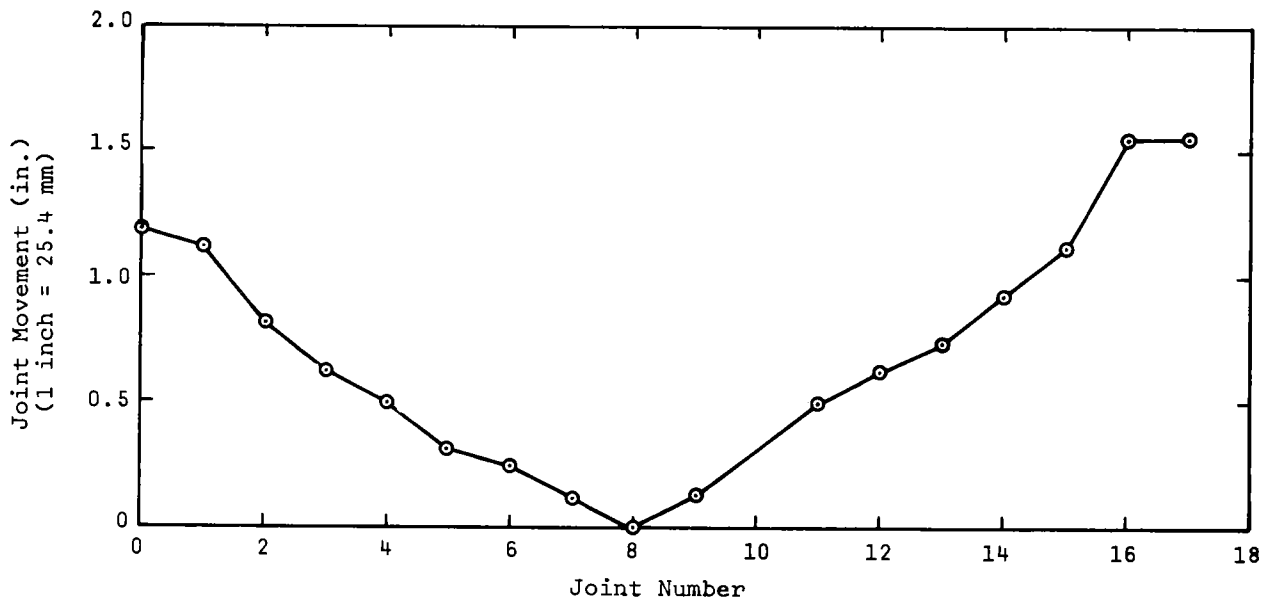
The movement of intermediate joints within a typical section having pressure relief joints at each end is indicated in Figure 1. The section comprised 17 slabs, each 61.5 ft. (18.8 m) long. Individual joint movements were measured from the saw marks in the

asphaltic concrete shoulder, as mentioned earlier. As would be expected, the movement was maximum at the pressure relief joints, gradually decreased toward the center of the section, and was negligible at the center. This behavior is also indicated in Figures 2, 3, and 4 for the movements at the relief joints, at a joint 1/4 of the way through the section, and at the midpoint of the section, respectively. In all cases, joint movement was toward pressure relief joints with the node point at midsection, which indicated a balance of pavement pressures and movements.

Figure 1. Joint shift between pressure relief joints.

It is clear from the above data that the relief joints provided were effective for at least the 1,000 ft. (300 m) contained in the typical section. Careful study of Figure 1 also suggests that the relief joints might have been capable of providing some stress relief for sections longer than 1,000 ft. (300 m). Theoretically, the joints are effective until there is more than one stationary joint at midsection. The determination of a maximum effective section length is not a straightforward procedure. A paradox develops when one considers that the more internal stresses a pavement contains, the longer will be effective section length. Conversely, when there are few internal stresses, the relief joints may be immediately effective over only a very short distance. In the latter case, the relief joints probably are not badly needed but will serve for a long period of time. Several examples of this type behavior occurred in Projects 1 and 2 where pressure relief joints were installed close to blowups. Because pavement pressures had already been relieved, these relief joints closed less than 1/2 inch (13 mm) during their first year in service.

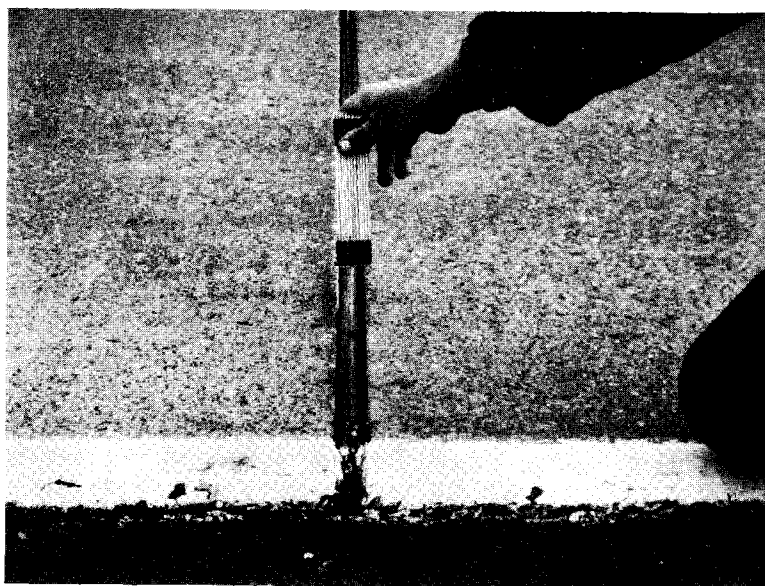
One type of undesirable behavior of joints between relief joints is demonstrated by the photograph in Figure 5, which shows an intermediate joint that has opened so widely that a preformed compression seal is no longer in contact with the walls of the joint. This behavior gives rise to the possibility of initiating a vicious circle where the provision of too much freedom of joint movement can create conditions where joint infiltration is aggravated, and, in turn, can require the provision of more pressure

Figure 5. Excessive opening of joint near pressure relief joint. Note that the preformed seal is pulled away.

relief. Such behavior occurs only at joints located very close to relief joints or to previous blowups. Since it is not possible to predict when excessive opening might occur, it appears that pavements having preformed seals should be observed very closely for some time after relief joints are installed. This possibility of excessive intermediate joint opening is one consideration which should not be overlooked when the decision to provide relief joints is being made. There may be instances where it would be advisable to install several relief joints for observation purposes, possibly one year before full pressure relief is contemplated. In this way, a final determination of the need for the joints could be made.

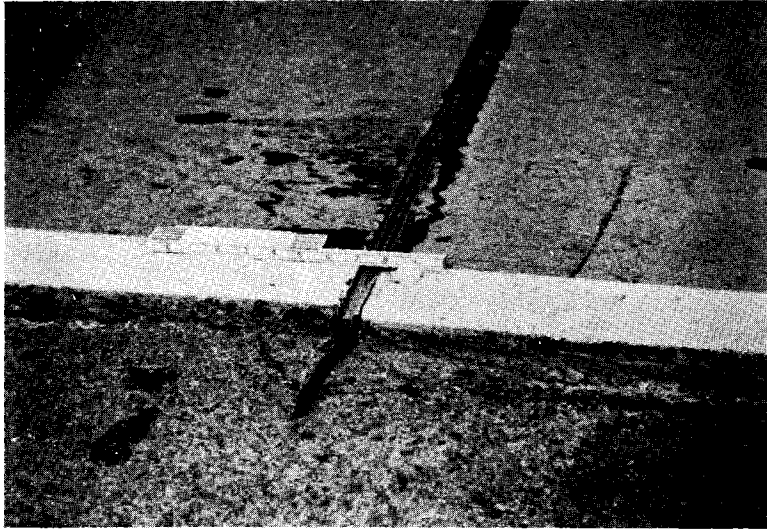
Figure 12. Joint faulting.

Examples of the above types of distress are given in Figures 10-14. It should be noted that joint crushing is not to be confused with the joint spalling associated with metal joint forming inserts discussed in an earlier report.<sup>(3)</sup>

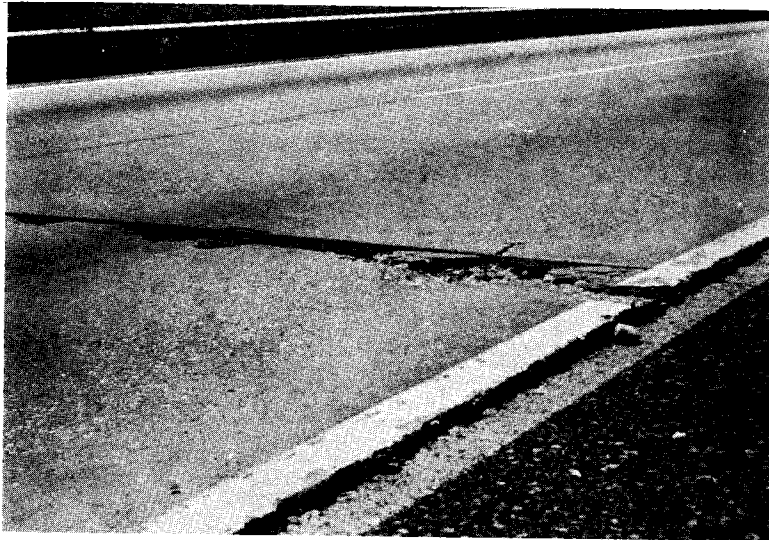
Figure 14. Joint crushing due to pavement pressures.
