EVALUATION OF SEVERAL TYPES OF  
CURING AND PROTECTIVE MATERIALS  
FOR CONCRETE

Part IV - Final Report on Performance

Howard H. Newlon, Jr.  
Assistant State Highway Research Engineer

August 1975  
VHTRC 76-R5

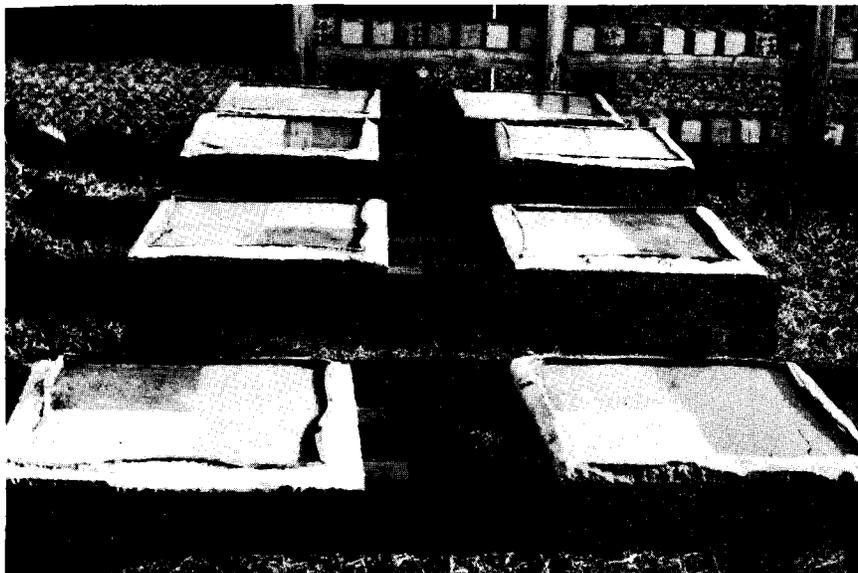
Figure 2. Slabs in outdoor exposure area.

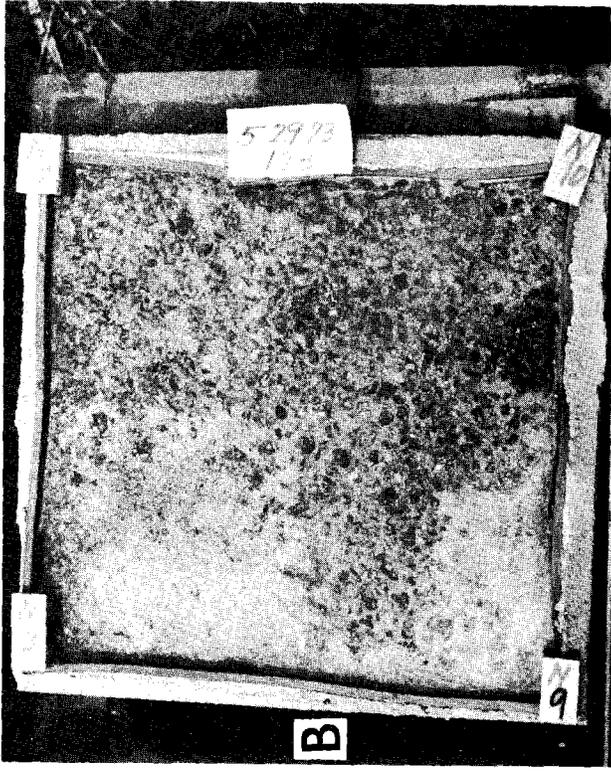
Figure 4. Appearance after deicing of conditions 3 (LMS + LOT), 9 (CRS<sub>2</sub> - L), 10 (CRS<sub>2</sub>(LP)), and 12 (CRS<sub>3</sub> - H).

- (A) Non-air entrained - 77 cycles (two winters)
- (B) Non-air entrained - 123 cycles (five winters)
- (C) Air entrained - 123 cycles (five winters)

Following completion of exposure and observations of the slabs stored out-of-doors, samples were taken for chloride analyses using the sampling and testing procedures described by Clear (1974). Initially, samples were taken from both the air entrained and non-air entrained blocks designated as Number 2, the appearance of which was illustrated in Figure 4. As was indicated in Figure 1, the curing treatment combinations represented on Block 2 were Conditions 3 (LMS + LOT), 9 (CRS<sub>2</sub> - L), 10 (CRS<sub>2</sub> - LP) and 12 (CRS<sub>3</sub> - H).
