FINAL REPORT
EVALUATION OF EROSION AND SILTATION
CONTROL FABRICS

David C. Wyant
Research Engineer

Virginia Highway & Transportation Research Council
(A Cooperative Organization Sponsored Jointly by the Virginia
Department of Highways & Transportation and the University of Virginia)

Charlottesville, Virginia
June 1976
VHTRC 76-R54

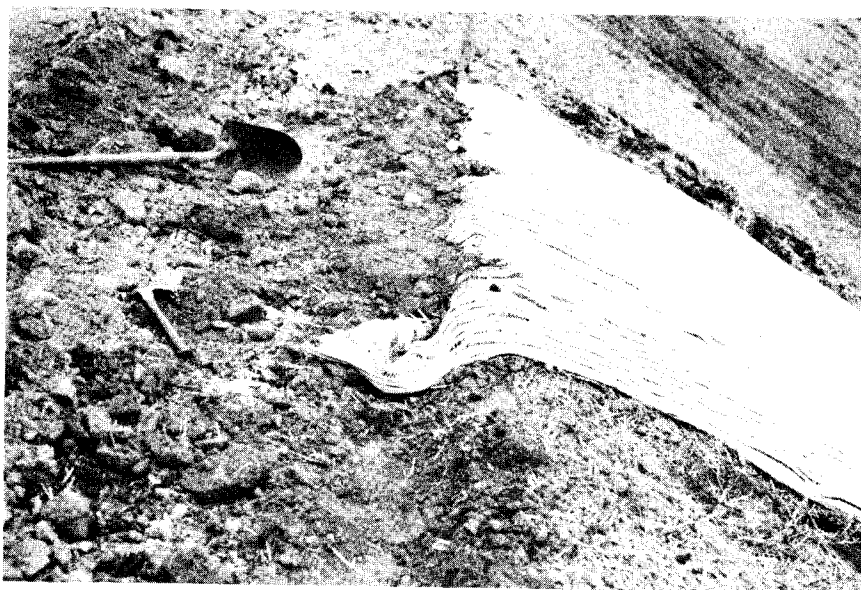
Figure 2. Anchoring Hold/Gro in the trench.

A 4 inch (10.1 cm) deep trench was dug one foot (0.3 meters) back from the top of the slope, and the upper end of the fabric was secured in the trench with six inch (15.2 cm) long metal staples (which were provided with the fabric) spaced 9 inches (22.9 cm) apart. After stapling, the fabric and staples were covered with soil for further anchorage (Figure 2). The fabric was then rolled down the slope and anchored at the bottom in the same manner as at the top. Staples were placed 3 feet (0.9 meter) on center in both the horizontal and vertical directions over the entire area covered.

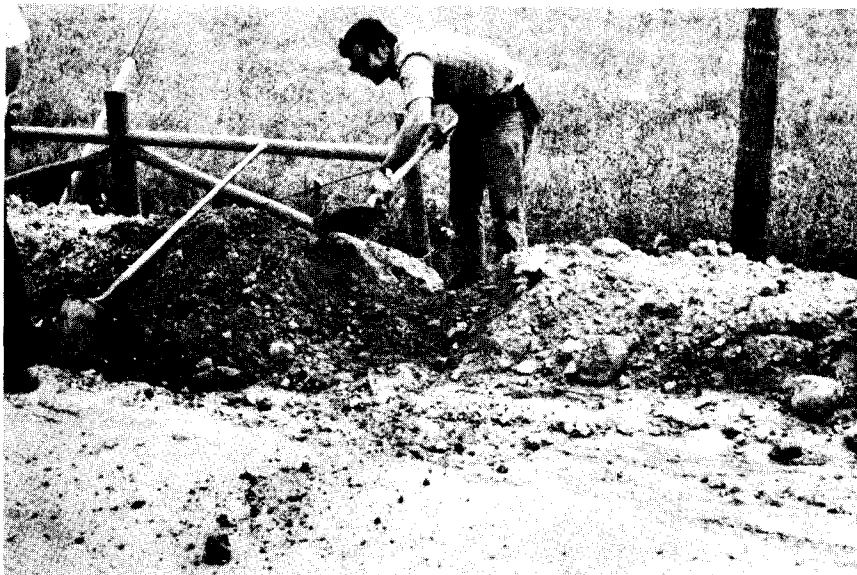
Figure 5. Temporary downdrain channel.

Two temporary downdrains and one ditch line of Griffolyn T-55 material were also installed on September 11. The drains were so designed as to carry rainwater, collecting between the earth berms on the roadway down a 2:1 slope into a straw bale barrier. Before the fabric was installed each of the temporary downdrains was shaped to help keep the runoff in the lined channel (Figure 5). The inlet end of the downdrain was buried and anchored at the top of the fill to prevent undermining (Figure 6), and the sides were secured with staples every 3 feet (0.9 meter) to prevent wind from blowing the fabric out of the channel.

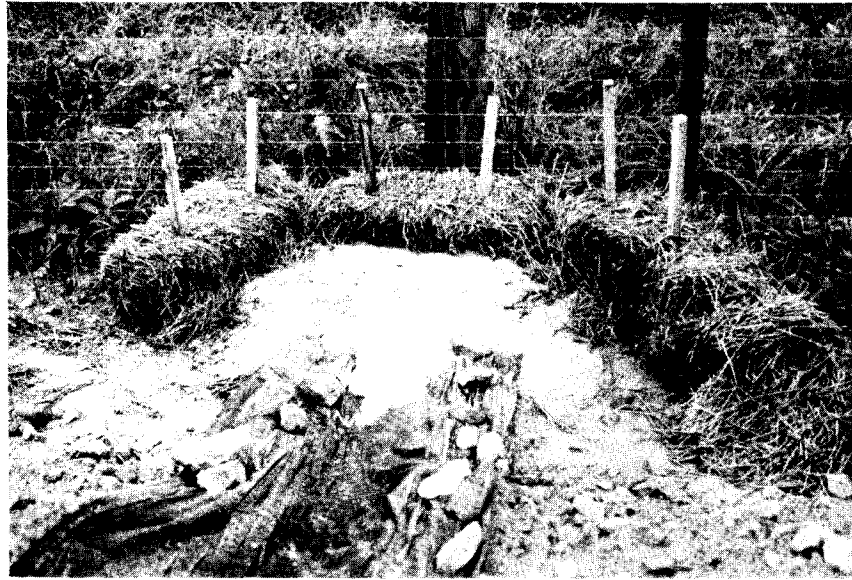
Figure 14. Silt transported by T-55 downdrain.

The Griffolyn T-55 material has a higher strength than the polyethylene sheeting, and in no instances was it torn by the force of the flowing water. Figure 14 shows the condition of Griffolyn T-55 after several weeks. No tears were created and the silt was carried down the slope into the straw bale barrier. This photograph is indicative of the results which are possible if the temporary downdrain is properly installed in a preshaped channel with accompanying anchored inlet end and sides.

2. Temporary Downdrains -- Although the Griffolyn T-55 material costs more than twice as much as polyethylene sheeting, it is strong and durable enough to be used several times on a construction project. If the T-55 material is properly installed, no tears are created by the flowing water to cause undermining of the fabric as is the case with polyethylene. The cost of repairing the undermining by the contractor could well justify the initial higher cost for the T-55 material. Therefore, it is recommended that Griffolyn T-55 material be used as temporary downdrains and ditch liners.
