PARTIAL-DEPTH REPAIR OF JOINTED PCC PAVEMENTS:  
CAST-IN-PLACE AND PRECAST PROCEDURES

Samuel S. Tyson  
Research Engineer

Virginia Highway & Transportation Research Council  
(A Cooperative Organization Sponsored Jointly by the Virginia  
Department of Highways & Transportation and  
the University of Virginia)

January 1977  
VHTRC 77-R37

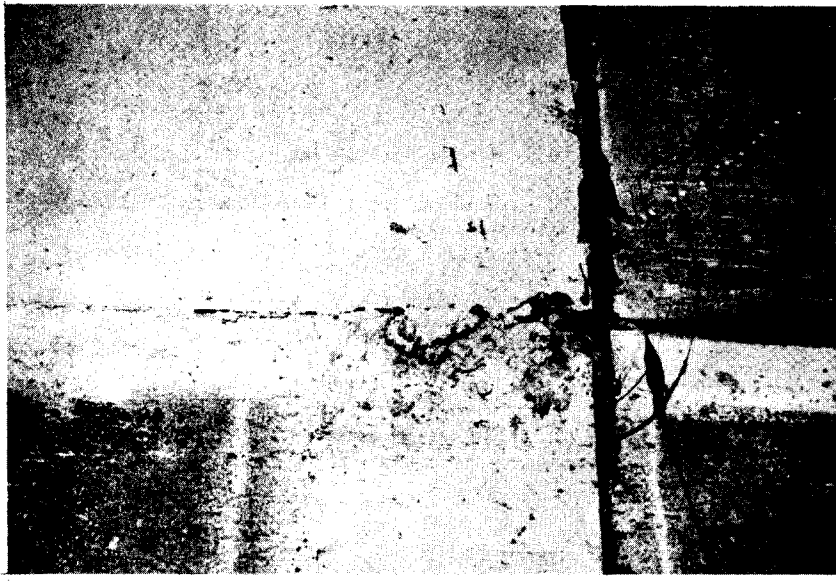
Figure 3. Raveling and minor spalling of partial-depth patch cast without forming at pavement centerline.

The centerline joints between pavement lanes are provided to prevent warping stresses. The patch shown in Figure 3 was cast directly against the adjacent slab at the centerline joint, and raveling and minor spalling resulted from movement at this location due to normal warping stresses. This problem can be overcome by inserting a polyethylene strip along the centerline joint prior to casting the repair concrete.

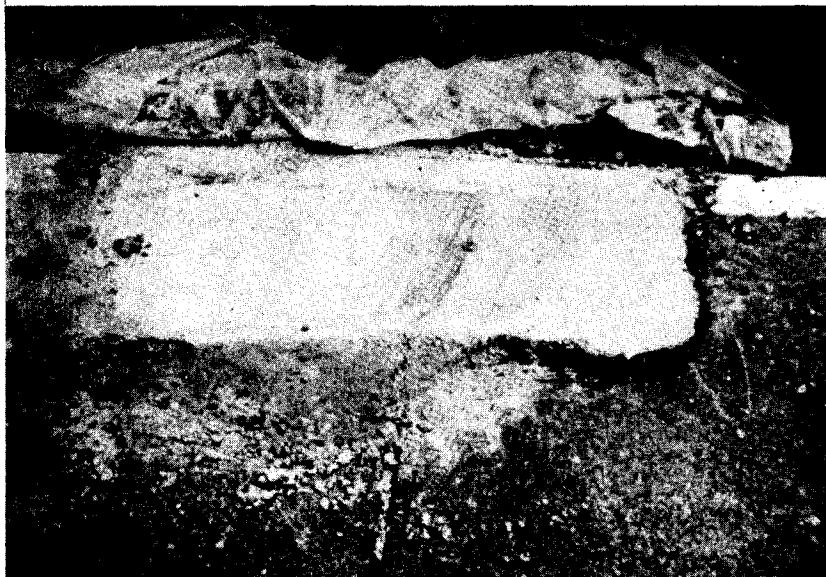
Figure 4. Partial-depth patches cast without proper forming at transverse joint.

A large number of partial-depth patch failures have resulted from no forming or inadequate forming at the transverse joint. In Figure 4 two patches are shown that have been cast together across the transverse joint. Before the transverse joint could be sawed and sealed the slab movements had disrupted the patches.

While the problem in Figure 4 is apparent and the disruption occurred soon after the patches were installed, other aspects of inadequate transverse joint forming are equally damaging. Table 1 gives performance data for 1,000 patches on one project on which casting was followed by insertion of a thin metal strip to form the transverse joint. Subsequently, the joints were sawed and sealed. Within 30 days, 9% of these patches had failed, and at an age of 1 year 95% had failed. The failures could not be attributed to continued general deterioration of the pavement because, as shown in Table 1, additional failures in the surrounding concrete were relatively minor.

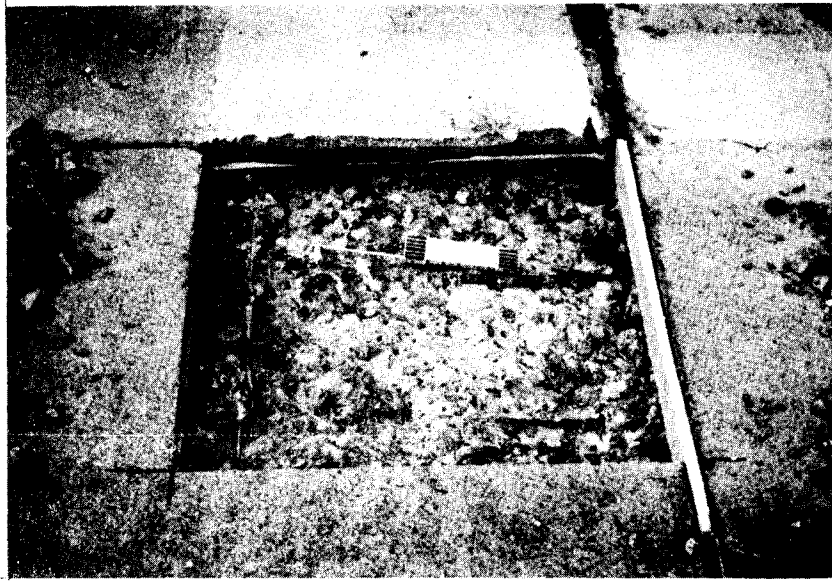
Figure 5. Proper insertion of styrofoam to form transverse joint (right) and polyethylene strip to form centerline joint (top).

Further studies showed that the patch failures resulted from a failure to form the total depth of the patches at the transverse joints. The lower portions of the partial-depth patches were therefore in contact with the adjacent slabs and the patches were subjected to the destructive effect of hydrothermal slab movements. The same type of concrete, as well as several other types, has since been installed with complete success in partial-depth patches using the forming technique shown in Figure 5. This technique utilizes a rectangular strip of styrofoam cut to form the full width and depth of the transverse joint for each patch. A polyethylene strip for forming the centerline joint is also visible in Figure 5.

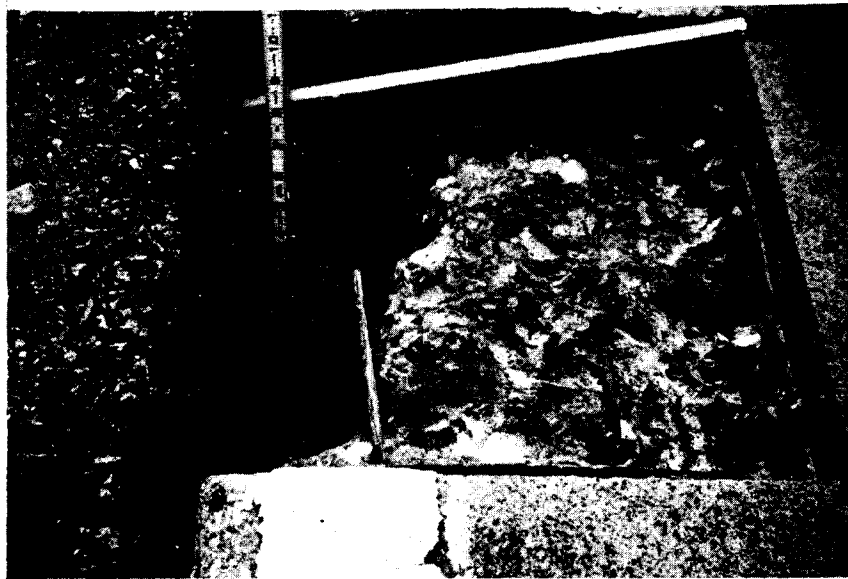
Figure 6. Corner location after removal of concrete showing partial-depth and full-depth zones.

A similar problem has occurred in patches at the pavement shoulder. At this location repairs are normally needed for a unique combination of partial-depth and full-depth deterioration. Figure 6 shows a repair location of this type that was formed only in the upper area of the transverse joint face. The unformed lower portion of the transverse joint permits the vertical section of repair concrete to receive disproportionately high compressive loads across the transverse joint from the adjacent slab. After two years, patches of this type developed a splitting tensile failure as shown in Figure 7.

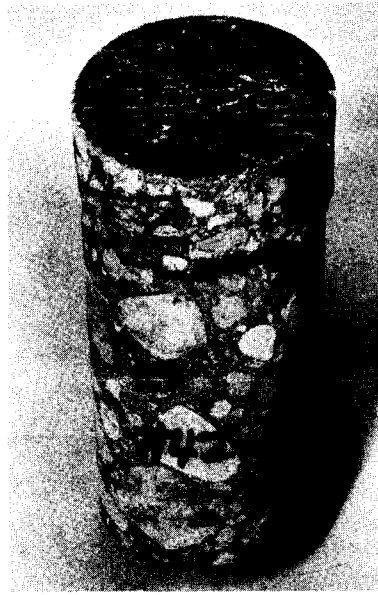
Figure 9. Large void in zone between patch and underlying old concrete due to inadequate consolidation.  
Note: Core dimensions are 4 in. x 9 in.  
(100 mm x 230 mm).

Figure 9 shows a core drilled from the central portion of a patch that emitted a hollow sound when struck with a hammer. The large void in the zone between the repair concrete and the underlying old concrete is clearly indicative of inadequate consolidation. This patch and others emitting a similar hollow sound when struck failed by cracking and spalling after being in service for less than one year. These patches were installed using the manual rodding and tamping method of consolidation.

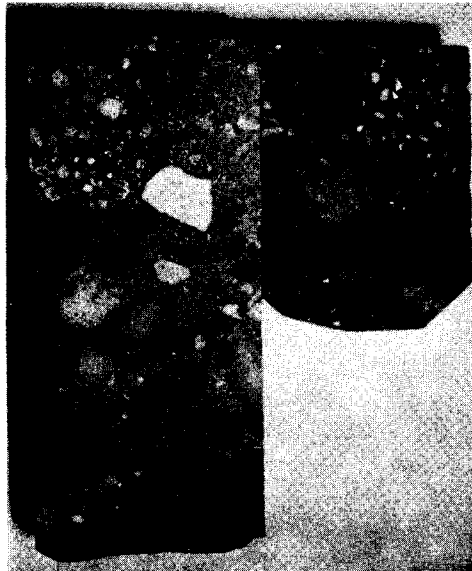
Figure 10. Incomplete consolidation in vertical section of core. Note: Core dimensions are 4 in. x 9 in. (100 mm x 230 mm).

The marginal quality of patches represented by the core in Figure 10 has become apparent, however, in that a significant number of these patches have not provided satisfactory service. An early form of distress in such patches has been the occurrence of separations along the vertical interface between the patches and the existing pavement. The initial appearance of this distress may be seen on the top surface of the core in Figure 11. The vertical sections of this core are shown in Figure 12, where it may be observed that the repair concrete became dislodged from the pavement concrete in the process of preparing the sections. The repair concrete shown in Figure 13 exhibits a honeycombed condition similar to but more extensive than that shown in Figure 10. The distress observed at the pavement surface in Figure 11 is therefore concluded to be primarily the result of inadequate consolidation.

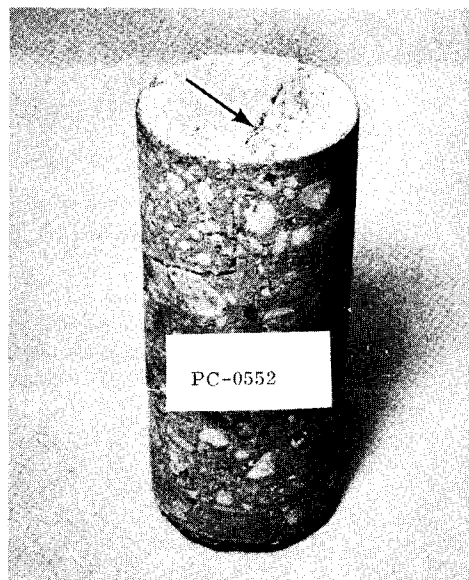
Figure 11. Appearance at pavement surface of distress between patch and existing concrete. Note: Core dimensions are 4 in. x 9 in. (100 mm x 230 mm).

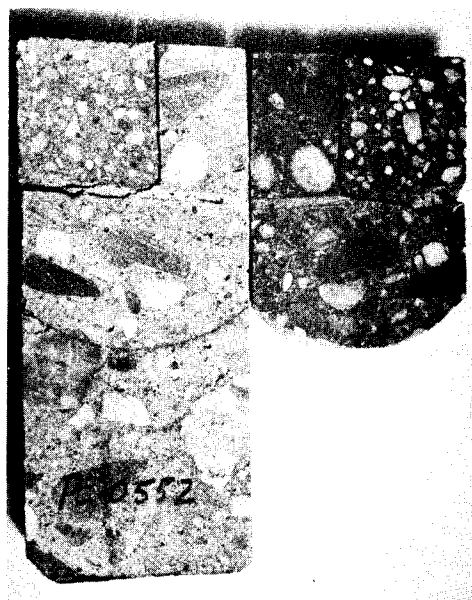
Figure 12. Vertical sections prepared from the core shown in Figure 11.

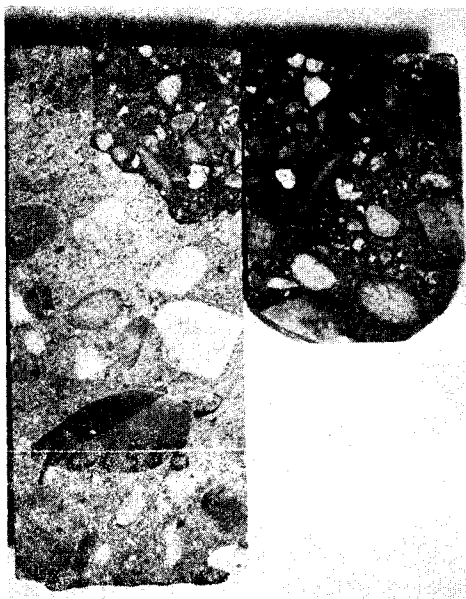
Figure 15. Typical core section from patch where planned pattern for internal vibration was used.  
 Note: Core dimensions are 4 in. x 9 in.  
 (100 mm x 230 mm).

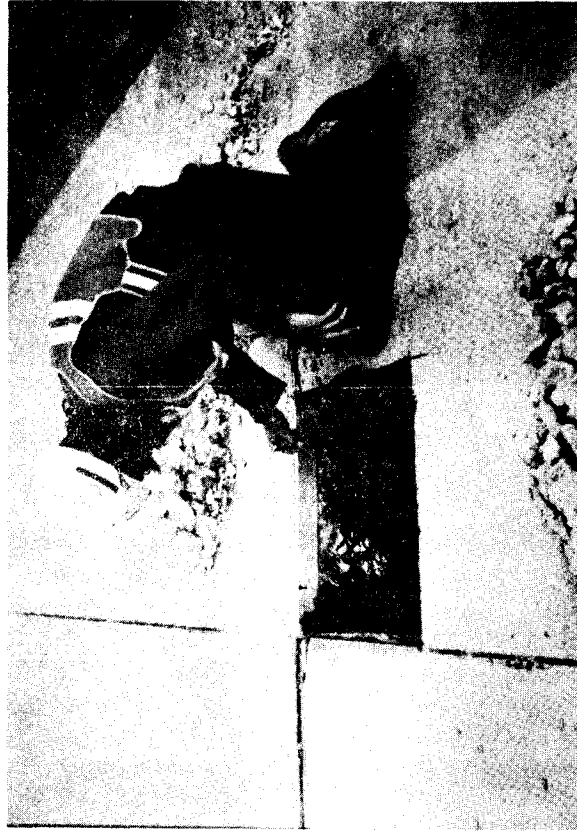
Figure 17. Thin coating of cement paste improves early bond development between repair concrete and pavement.
