FINAL REPORT
EVALUATION OF RECYCLED ASPHALTIC CONCRETE

C. S. Hughes
Assistant Head

Virginia Highway & Transportation Research Council
(A Cooperative Organization Sponsored Jointly by the Virginia
Department of Highways & Transportation and
the University of Virginia)

August 1977
VHTRC 78-R9

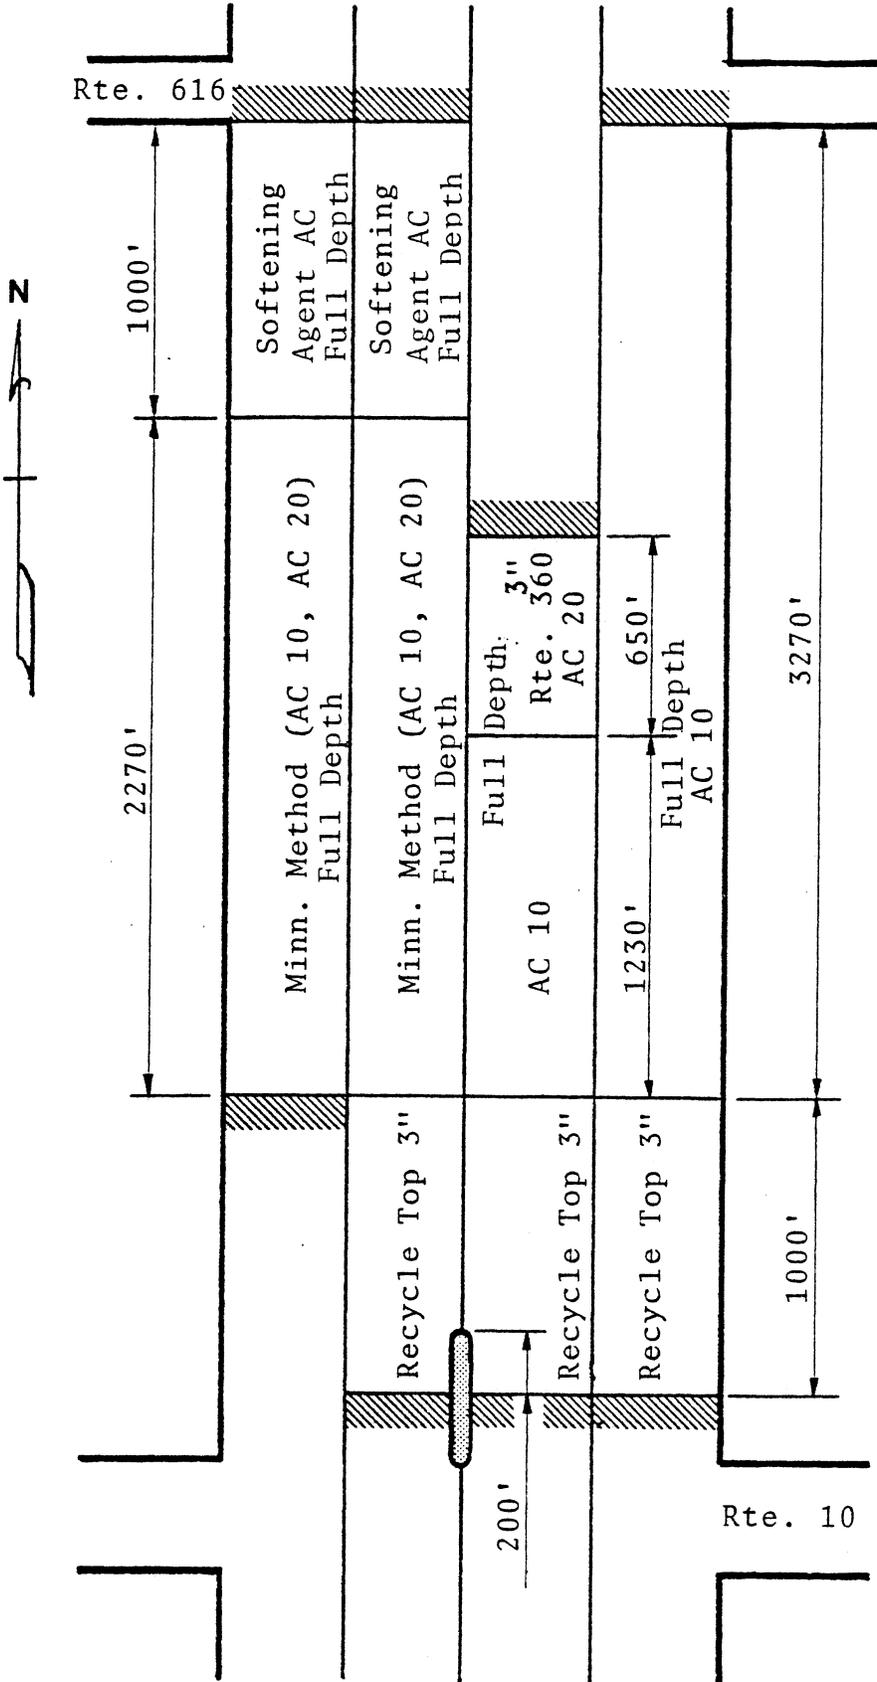
Figure 1. Schematic of project limits and variables.
 Basic Conversion Units: 1-in. = 25.4 mm
 and 1-ft. = .3048 m.

The asphaltic concrete pavement recycled was roughly a 5,000' (1,525 m) section of U. S. Route 1 in Chesterfield County (from the intersection with Route 10 to the intersection with Route 616) with a portland cement concrete base overlaid with several layers of asphaltic hot mix. Figure 1 is a schematic of the project limits and variables. This road is a 4-lane highway with an ADT of about 17,200, of which 15% are trucks and buses. In its entirety, the project involves approximately 6,200 tons (5,630 Mg) of recyclable asphaltic concrete.

However, in order to improve the riding surface obtained in 1976, an additional 125 psy of mix was applied to the entire project (shown in Figure 1) as recycle overlay only. This last mix used was a 40% blend of recycled pavement because it seemed to handle better than the 50% blend.

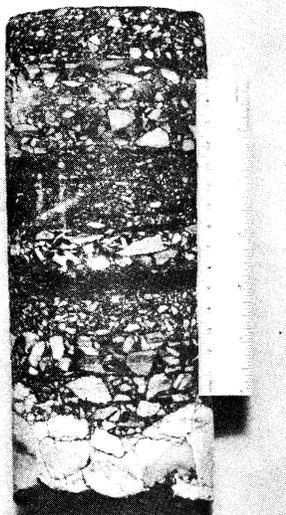
Figure 2. Core showing typical number of overlays on concrete base.

Cores were taken from each lane of the existing roadway to gain an indication of the types of asphaltic concrete used in the overlays. A typical core is shown in Figure 2. Since some of the overlays were placed in the 1930's and others have been added in various stages since that time, a conglomeration of layers was found. Some sections had four layers of asphalt, others had as many as six making up a total overlay thickness of 5.5" (140 mm).

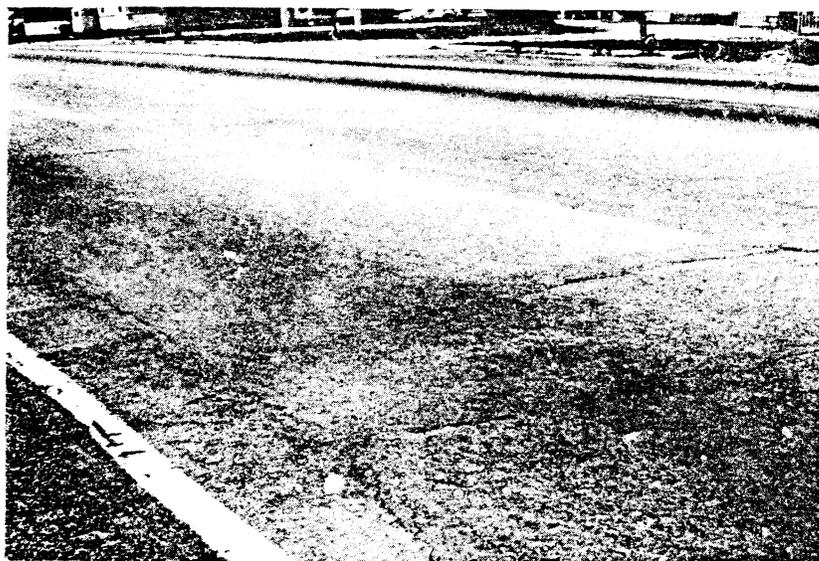
Figure 3. Pavement condition that made recycling feasible.

Reflection cracks from the concrete had come through the asphaltic layers and had created a rough riding condition (Figure 3), which was the primary reason for rehabilitating the pavement.

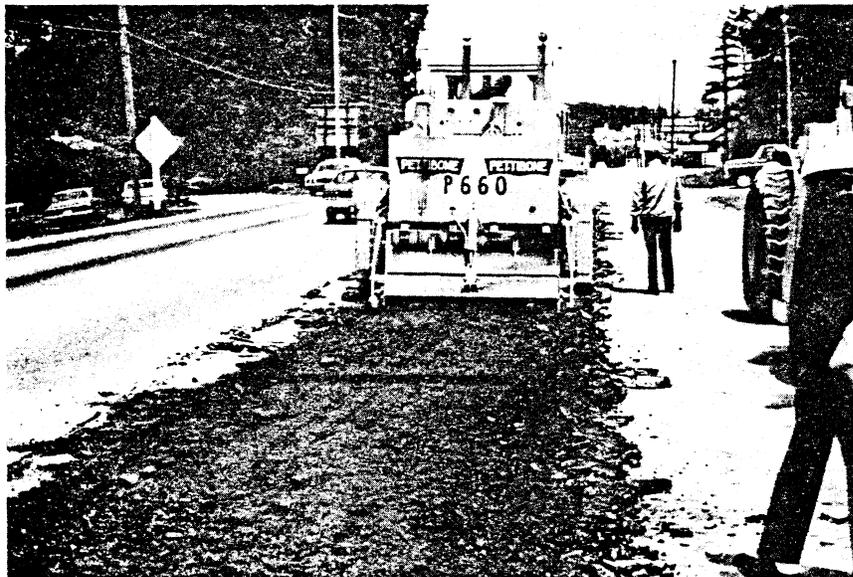
Figure 4. Pettibone pulverizer in use.

The project began May 24, 1976. Warren Brothers had decided to try both a Pettibone Pulverizer (Figure 4) and a Galion Planer (Figure 5) to remove the asphaltic concrete layers. This operation was experimental in that the Department was interested in seeing what type of product could be obtained by these machines. Warren Brothers also felt that the equipment might produce a gradation that would not have to be crushed and would therefore reduce hauling and crushing costs.

The equipment did, in fact, produce a material that did not require additional crushing. Table 3 shows the gradation produced by the Pettibone and Galion machines. The Pettibone removed the entire 5.5" (140 mm) of plant mix and the Galion removed the top 2" (50 mm).

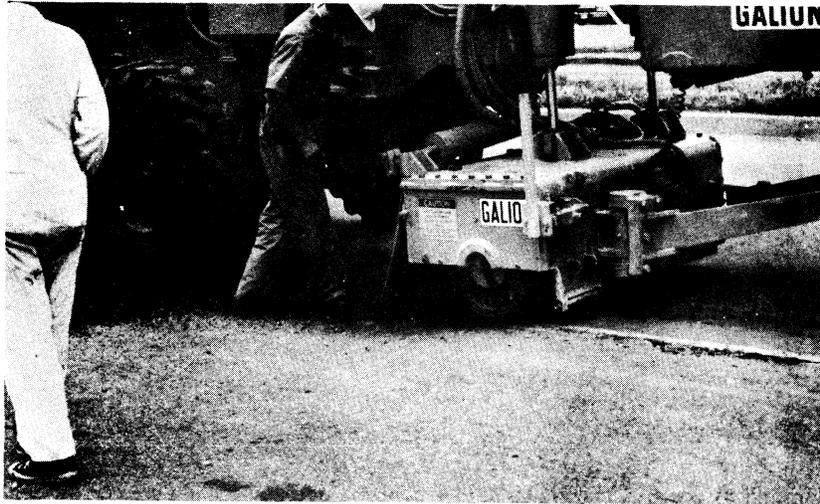
Figure 5. View of Galion scarfier.

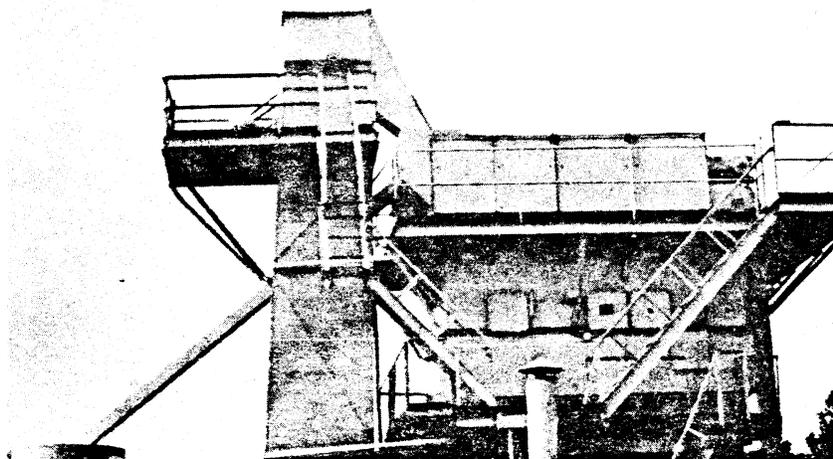
Figure 6. No stack emission visible.

The originally anticipated blue smoke appeared to be a function of plant production and dryer buildup. When the plant production was low (40 to 45 tons/hr. [36 to 41 Mg/hr.]) because of the buildup of material on the dryer walls and flights, the smoke was not visible (Figure 6). When the plant production was increased (60 tons/hr. [54 Mg/hr.]) and the material was still building up on the dryer, the blue smoke did appear (Figure 7). This variability in blue smoke is obvious from the opacity results previously mentioned. Plant production was low, ranging from 77 tons/day (70 Mg/day) to 353 tons/day (320 Mg/day). This relatively low rate resulted from many factors. The slow removal of the material from the road, the clogging of the dust collector and dryer that required stopping the plant frequently for cleaning, and attempts to eliminate the blue smoke and the buildup all contributed to the low production.

A scaled-down model of the prototype smoke collector designed by the Massachusetts Institute of Technology for Warren Brothers was used and did appear effective in eliminating the smoke. This apparatus is an electrofluidized sand bed collector. The smoke-laden air is passed through the fluidized sand bed. Both the sand particles in the bed and the particulates in the smoke are electrically charged at high voltage to cause the smoke to be collected by the sand particles. The hydrocarbon smoke particles form an oily residue on the sand particles which can be returned to the plant process during normal operation to become part of the hot mix.

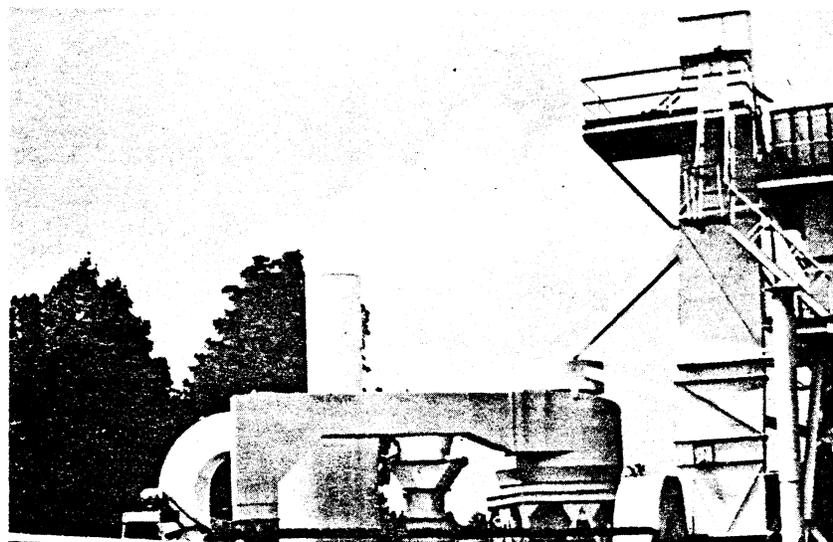
Figure 7. Blue smoke coming from stack.

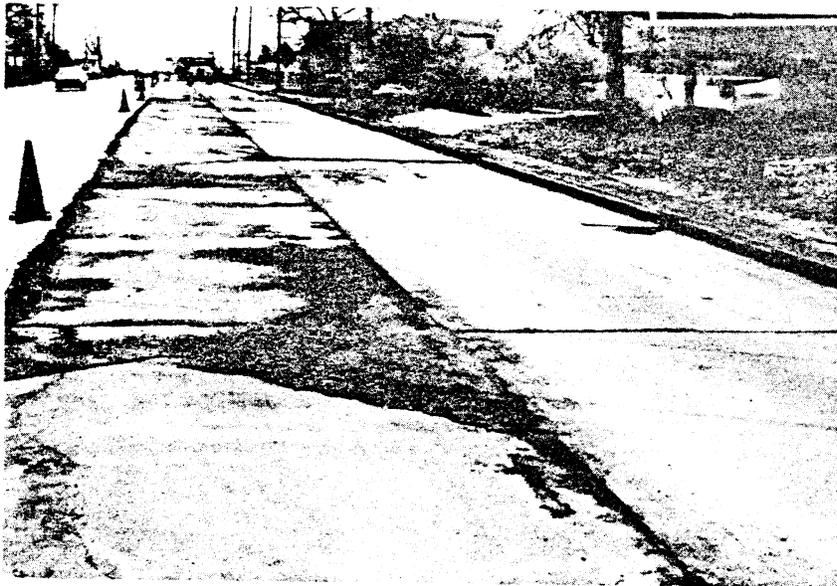
Figure 8. Road mix material in passing lane at same elevation as traffic lane.

These results are not much different from those obtained from the road cores (Table 2), particularly the penetration and softening point, and it was thought the problem apparently was caused by the fine gradation and/or high asphalt content.
