INTERIM REPORT

POLYMER IMPREGNATED BRIDGE SLABS

February 1980

VHTRC 80-R34

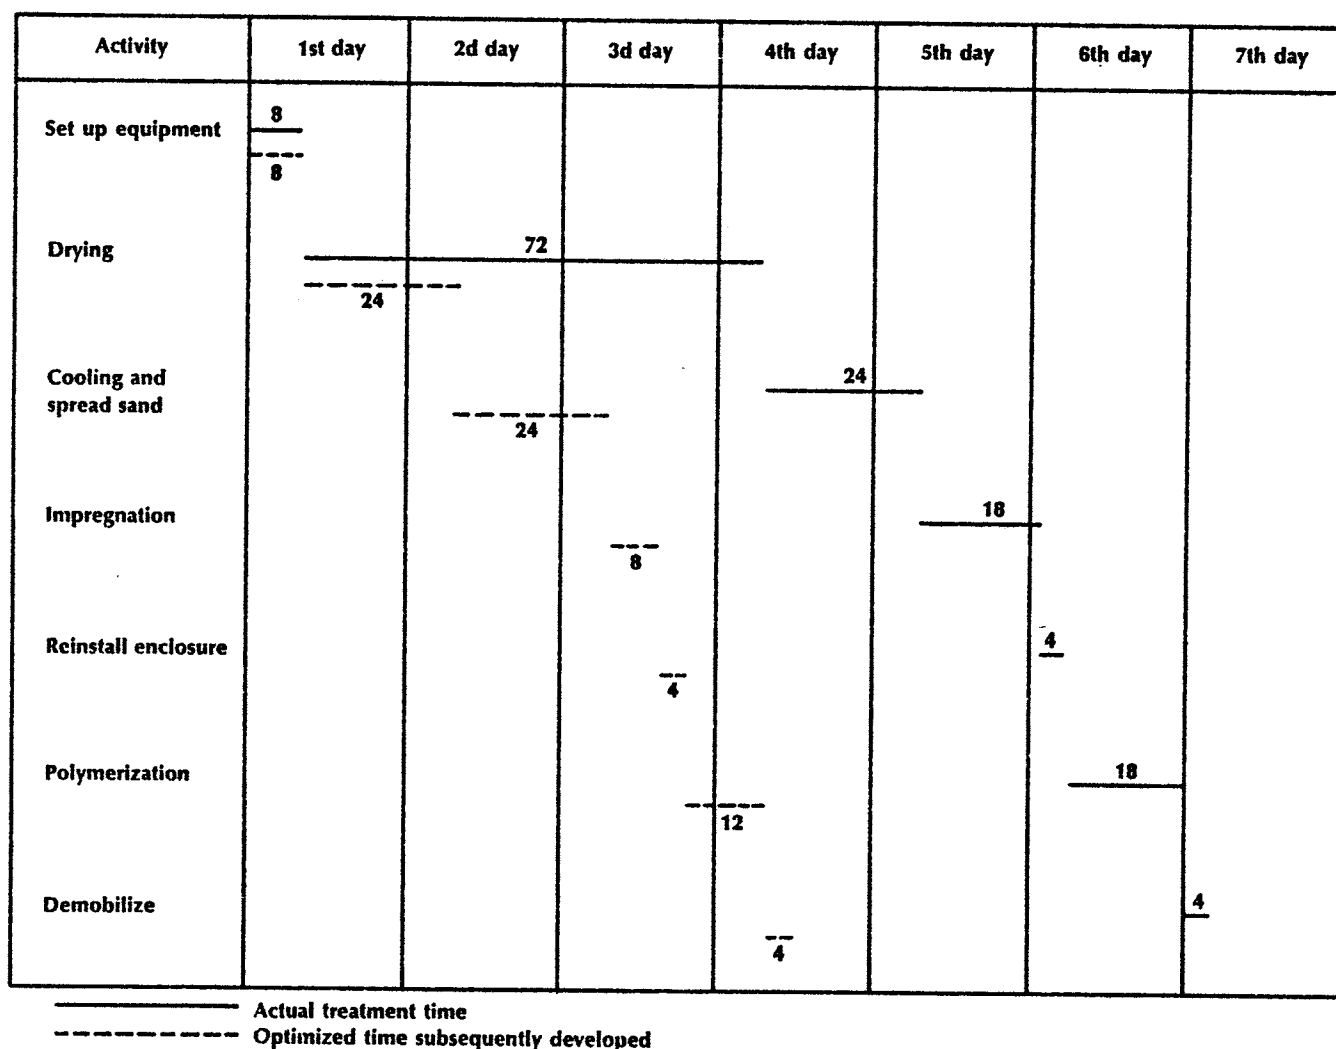
Figure 1. Surface impregnation time schedule (in hours).
(From reference 7)

The time schedule for the activities in this surface impregnation process is shown in Figure 1, along with the optimized time schedule subsequently developed for other treatments.⁽⁷⁾ In the original field treatment process a propane-fired forced hot air heating system was used to dry the concrete and to polymerize the monomer. Later installations have shown that further reductions in the drying and polymerization times can be achieved using either gas-fired radiant heaters or electric infrared heat sources.^(8,9)

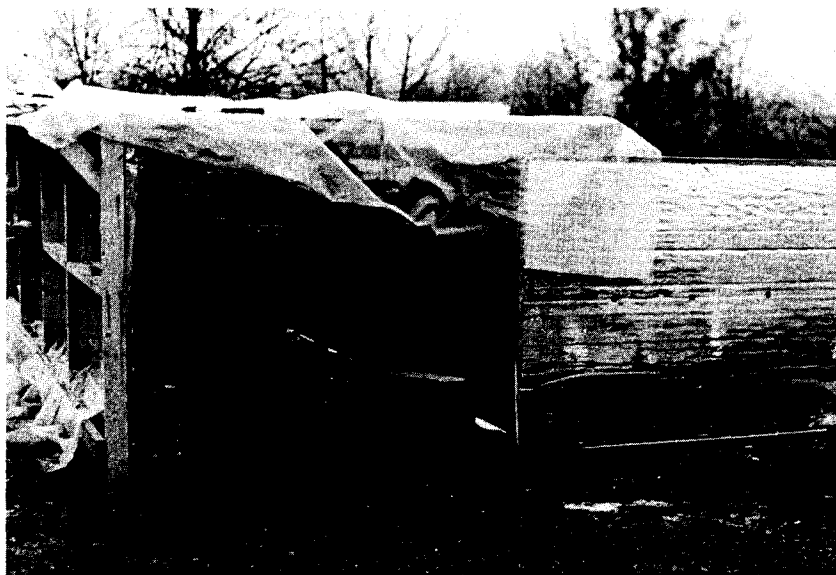
Figure 2. Enclosure for drying slabs.

The enclosure used for the drying step is shown in Figure 2. The timber frame enclosure had interior walls and a ceiling made of insulated reflective sheeting and an open bottom. This construction provided a well-insulated enclosure that was light and easily placed over each slab.

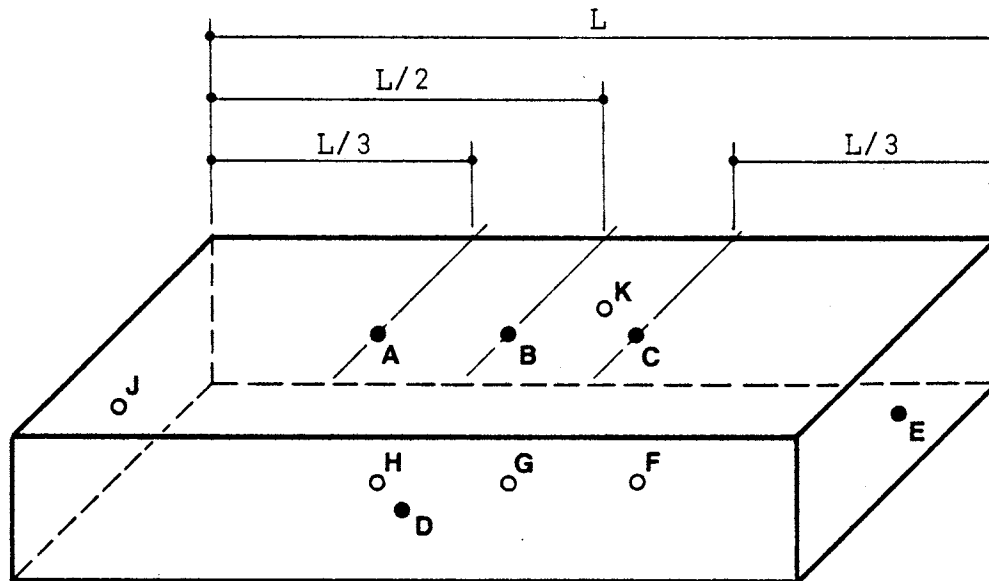
A - Top left:	Surface	(Slab 1, 5, 3, 6)*
	1 in.-depth	(Slab 5, 6)*
B - Top middle:	2 in.-depth	(Slab 3)*
C - Top right:	4 in.-depth	(Slab 1, 5, 3, 6)*
	Surface	
	1 in.-depth	
	4 in.-depth	
D - Near side:	Surface	
E - Right end:	Surface	
F - Bottom right:	Surface	
	2 in.-depth	
G - Bottom middle:	4 in.-depth	
H - Bottom left:	Surface	
	2 in.-depth	
J - Left end:	Surface	(Slab 1, 5, 3, 6)*
K - Far side:	Surface

NOTE: Slab dimensions: 3 ft. x 10 ft. x 12 in.
 (0.9 m x 3.1 m x 305 mm)
 1 in. = 25.4 mm

*Slab numbers for which temperature record from given location was used to plot Figures 5,6,7 and 8.

Figure 4. Thermocouple locations in precast slabs.

Temperatures were monitored at a number of locations on the surfaces and at interior points as indicated in Figure 4.

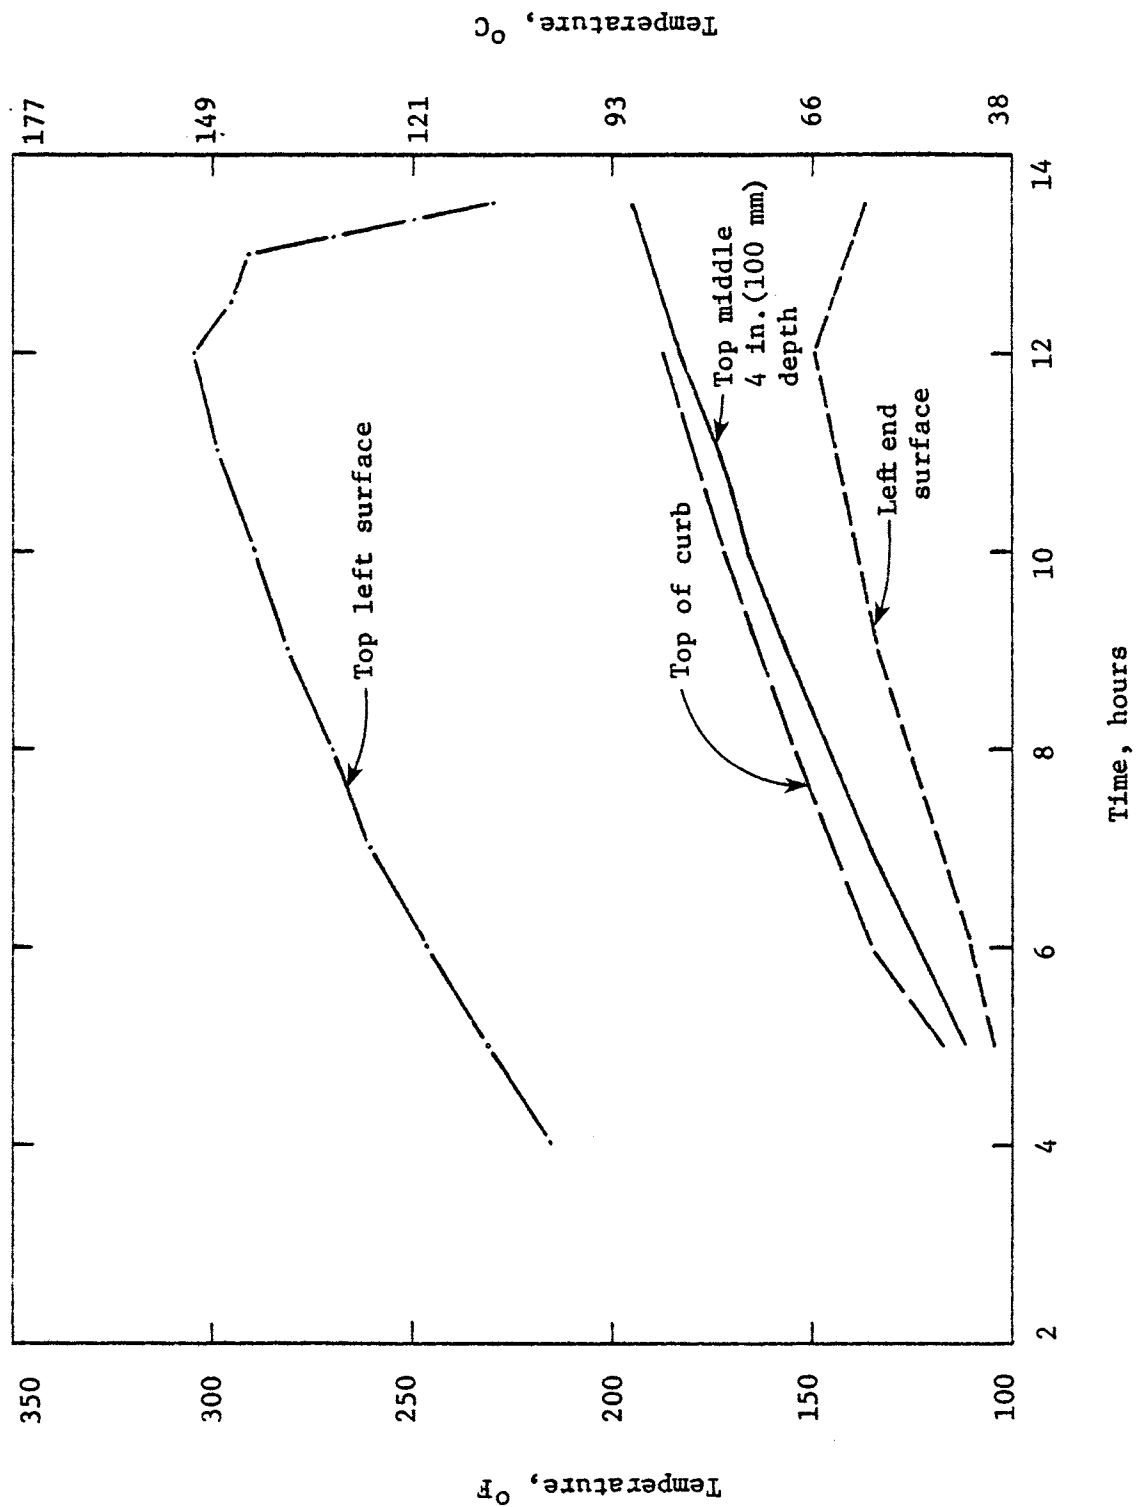
Figure 5. Temperature record during drying phase at selected locations for Slab 1.

The major portion of the drying-heating phase for slab number 1, a curb section, is shown in Figure 5. Unfortunately, the thermocouples at the 1-in. and 2-in. (25- and 50-mm) depths were not functioning so the temperatures at these depths could not be monitored. The heaters were individually powered so they could be turned off as needed during the heating phase to prevent overheating of individual areas of the slab surface. In this and subsequent drying phases, the top left surface thermocouple is used to indicate the surface temperature of the slab since all thermocouples across the bottom and top surfaces followed these temperatures closely.

The heating of slab number 1 was continued for 13 hours, at which time all heaters were turned off and venting of the enclosure was begun to cool the slab prior to removing it from the drying enclosure. As can be seen in Figure 5, a maximum temperature of approximately 200°F (93°C) was reached at the 4-in. (100-mm) depth, which suggests that adequate temperatures for drying should have been attained at shallower depths.

The other observation from Figure 5 is that the temperature of the end surfaces was not sufficient to promote drying. The left end surface temperatures, representative of temperatures at both ends of the slab, did not exceed 150°F (66°C) during the drying phase.

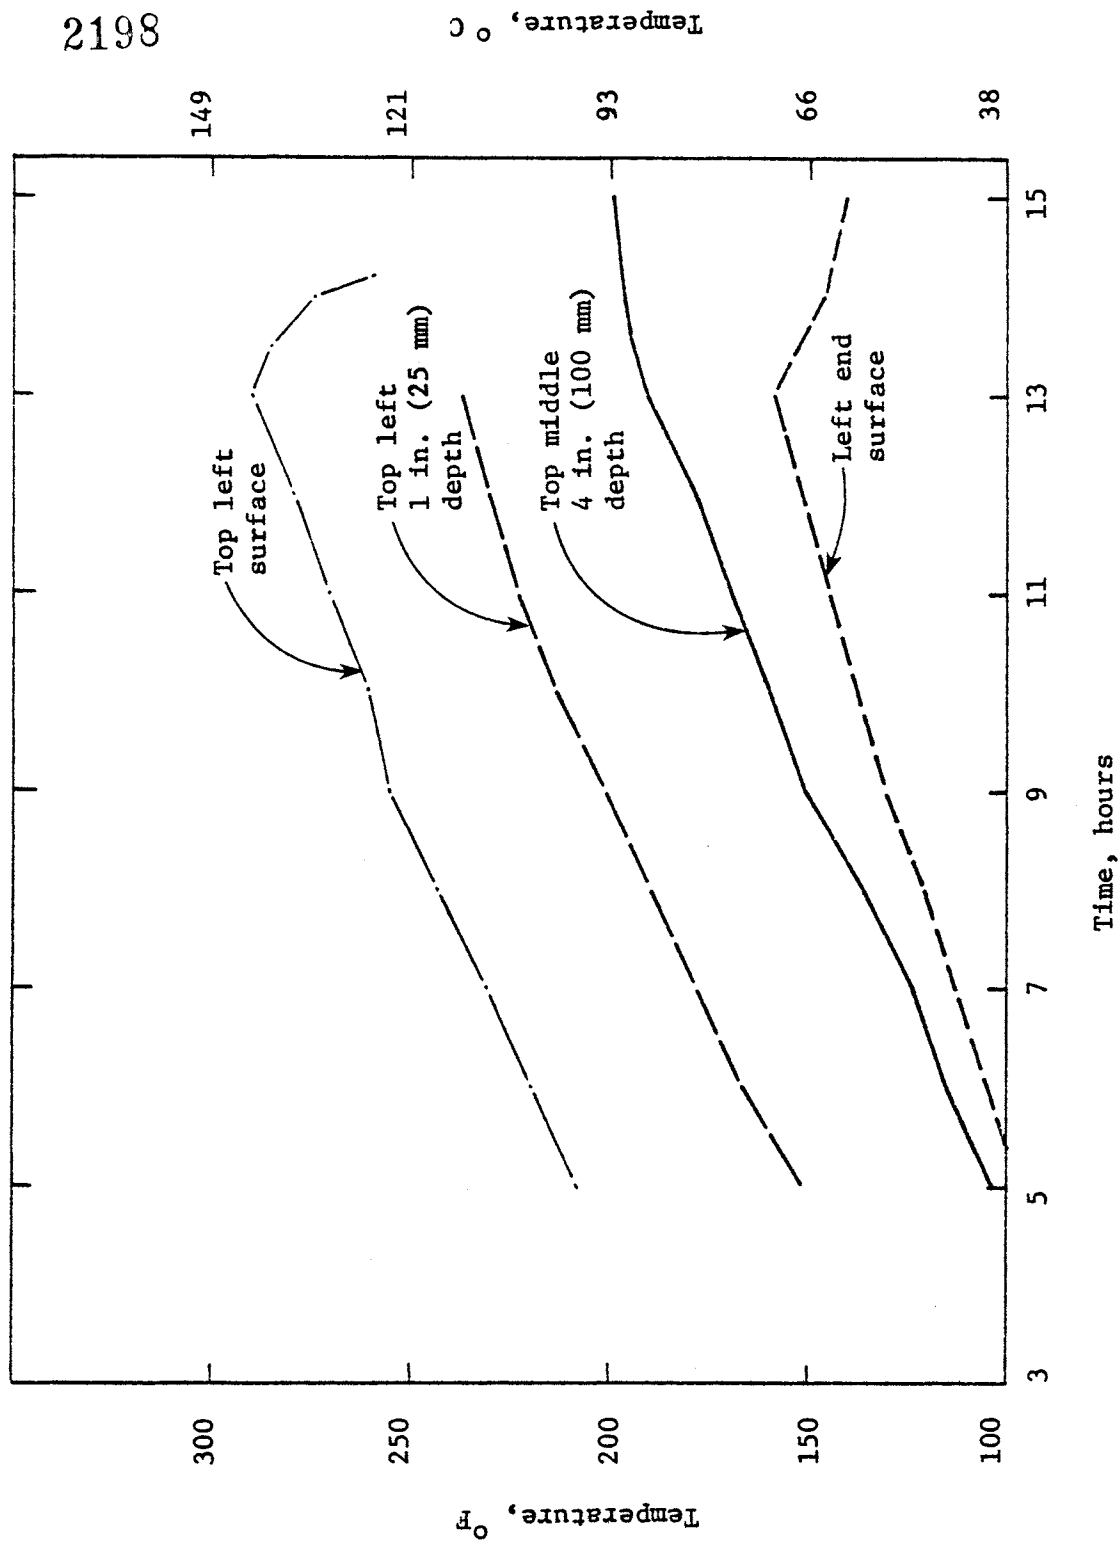
Figure 6. Temperature record during drying phase at selected locations for Slab 5.

The insulation around the bottom portion of the drying enclosure was improved and the same heating procedure was followed for slab number 5. In Figure 6 it can be seen that similar temperatures were attained at the points of interest. In this case the thermocouple at the 1-in. (25-mm) depth was functioning and indicated a temperature of 240°F (116°C) before the power was terminated after 13.5 hours of heating. The overall temperatures were not significantly different from those in Figure 5 for slab number 1.

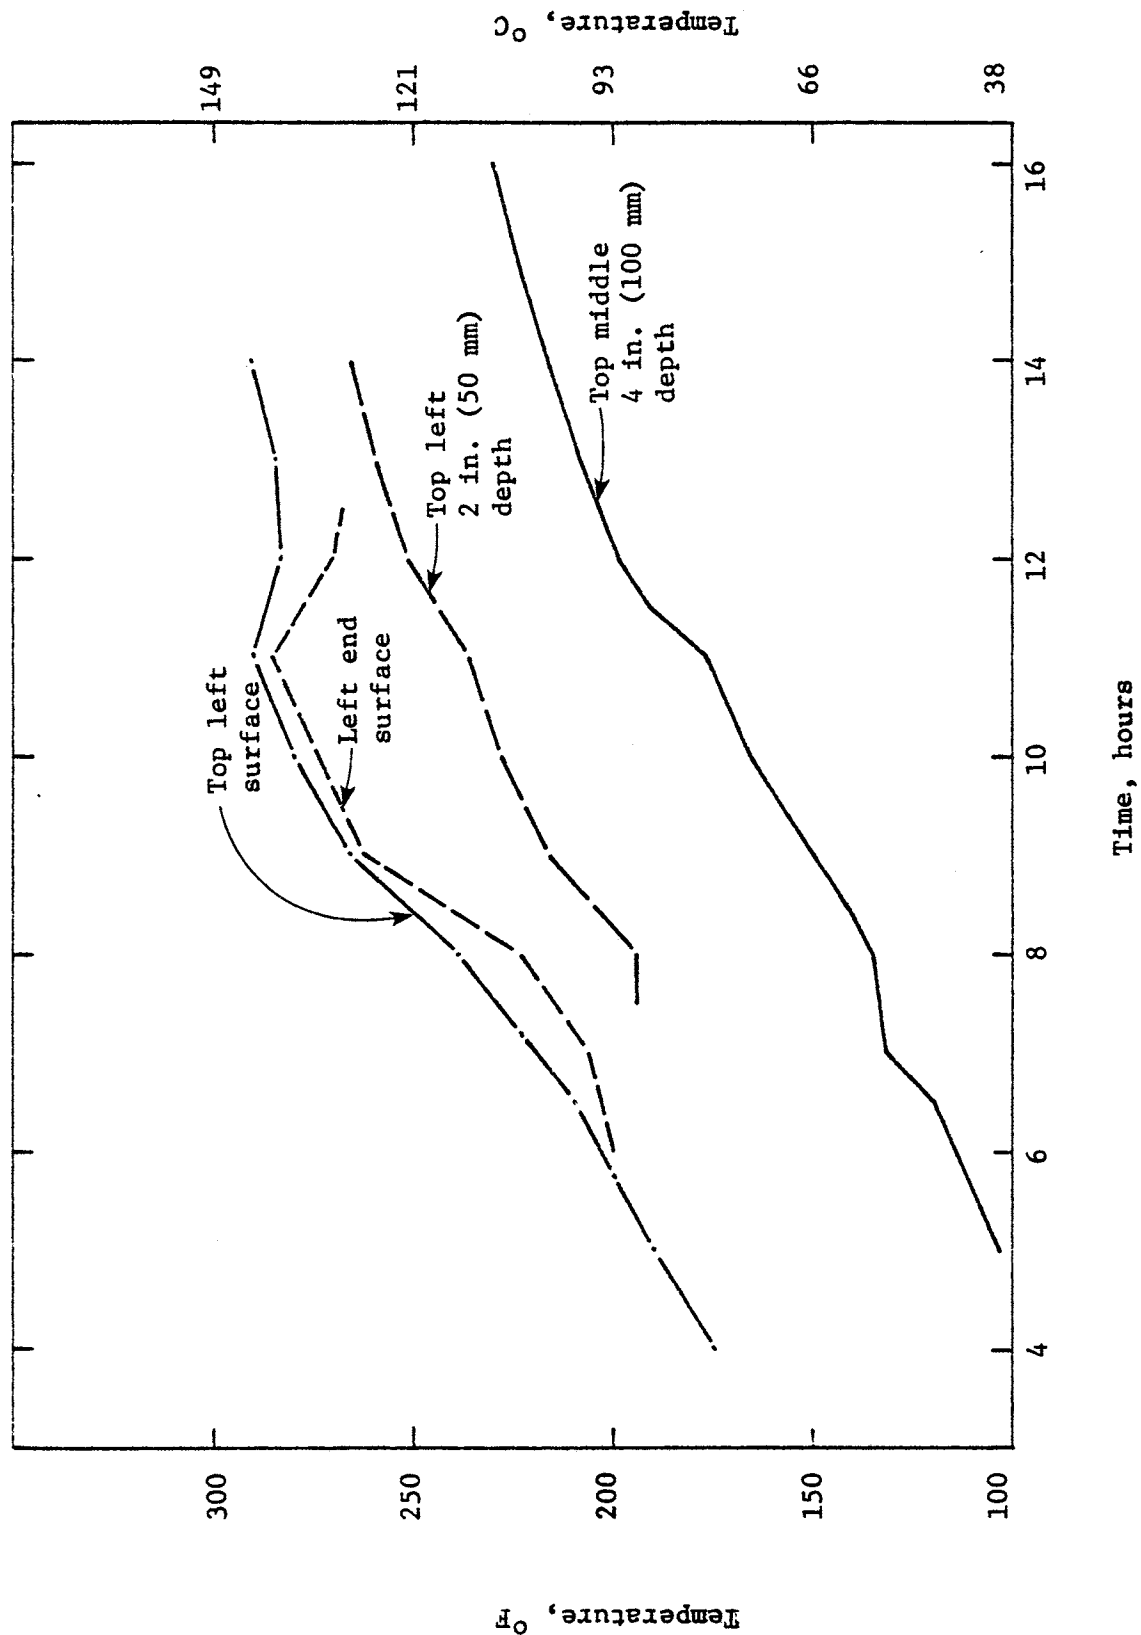
Figure 7. Temperature record during drying phase at selected locations for Slab 3.

During the third drying phase the system was modified after about 8 hours of heating by adding a portable oil-fired, hot air blower. The temperatures for slab number 3 in Figure 7 can be seen to rise more rapidly after this point. The heating was continued for 16 hours, during which time the temperatures at the 2-in. and 4-in. (50-mm and 100-mm) depths reached 265°F and 230°F (129°C and 110°C), respectively. A significant improvement in the heating was noted in that the temperatures at the end surfaces paralleled the heating curve for the top and bottom surfaces. This suggests that the slab may have been heated sufficiently on all surfaces to allow impregnation of the monomer.

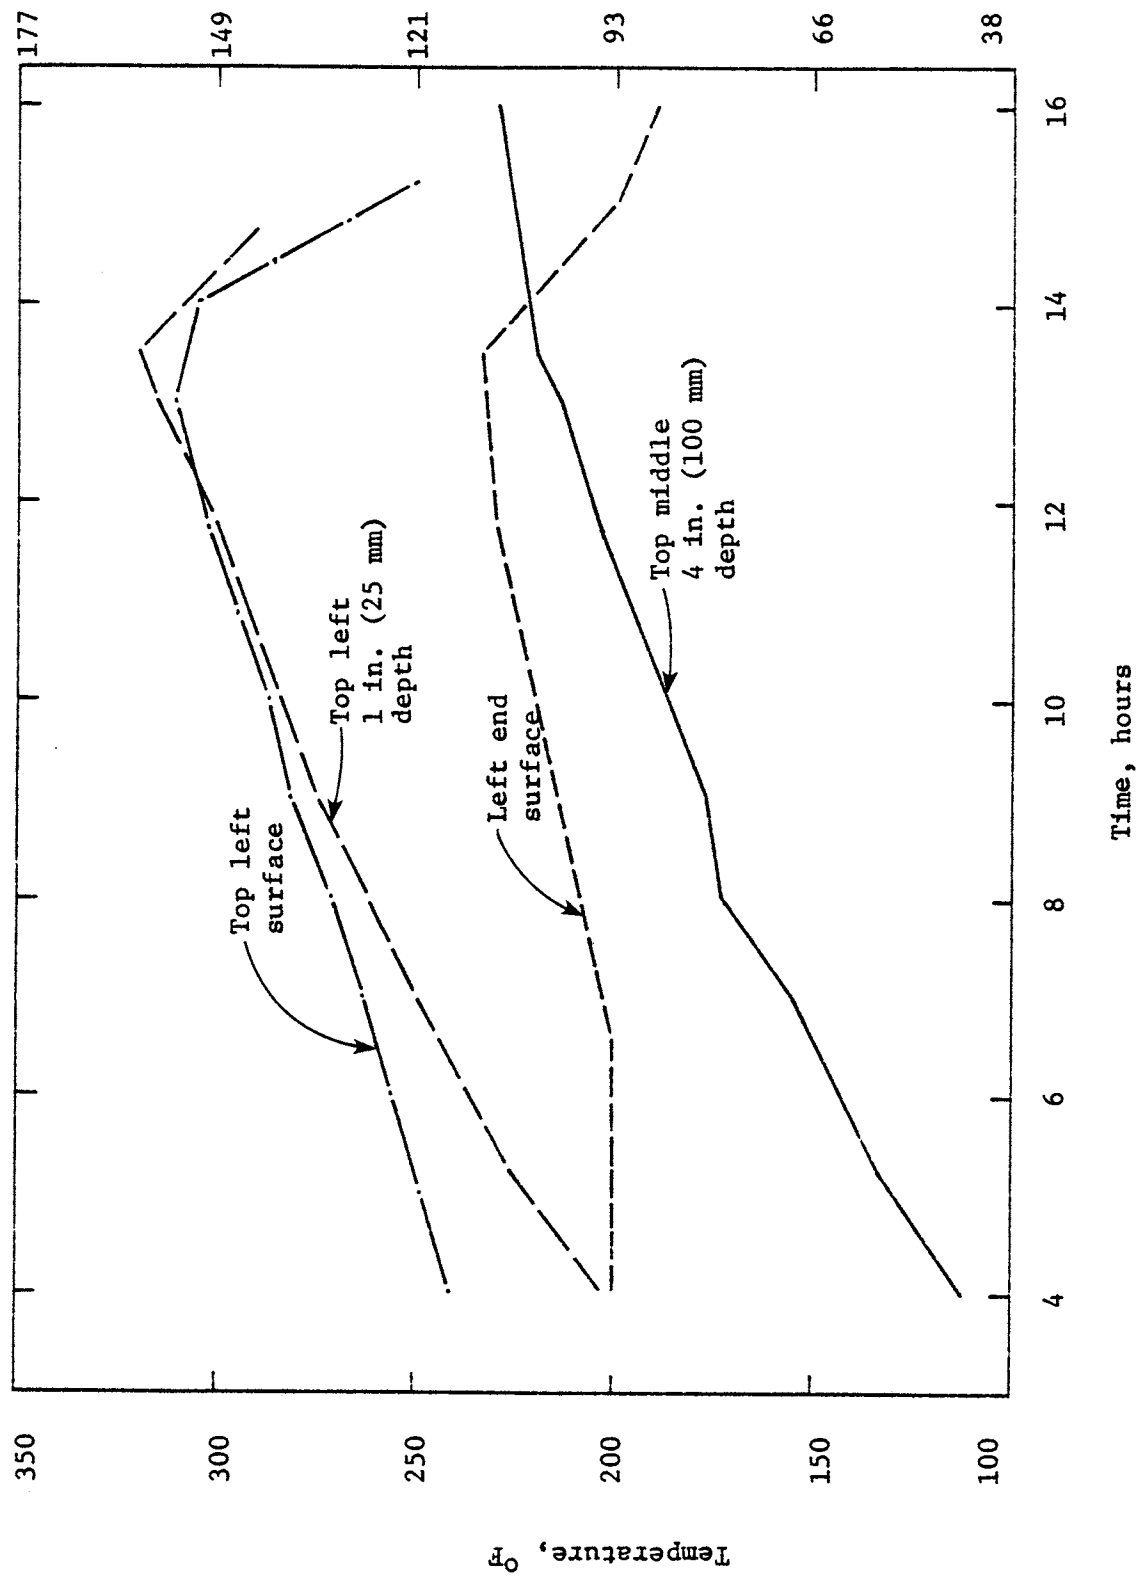
Figure 8. Temperature record during drying phase at selected locations for Slab 6.

The dual heating system was used for the drying phase for slab number 6. From the heating record for this slab, shown in Figure 8, it is seen that some variations in the maximum temperatures attained are apparent at all locations except the 4-in. (100-mm) depth. The heating was extended in this case from 16 to 18 hours, then all heaters were cut off and venting was begun. The end surfaces reached a maximum temperature of 235°F (113°C). In Figure 9 the drying enclosure containing the electric infrared heaters is shown with the oil-fired, forced air heater installed at one end.

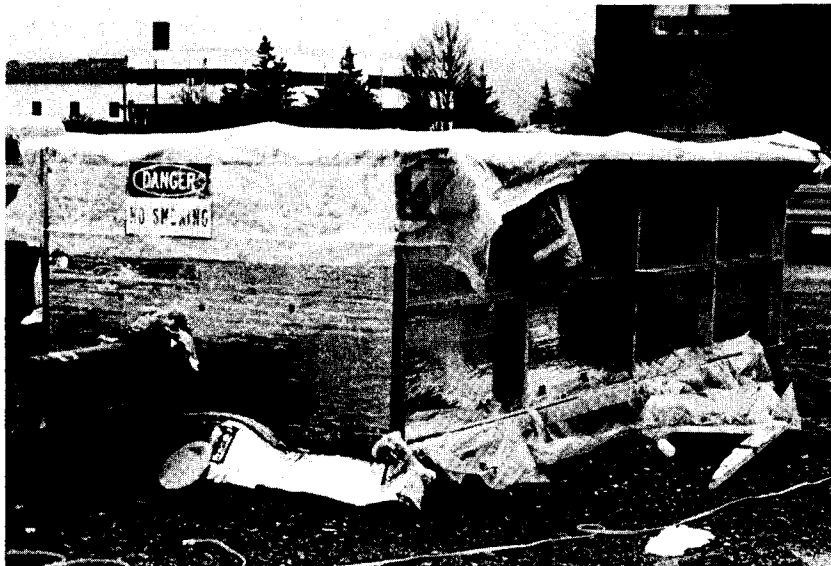
Figure 9. Oil-fired, forced air heater installed at end of drying enclosure to supplement electric infrared heaters.

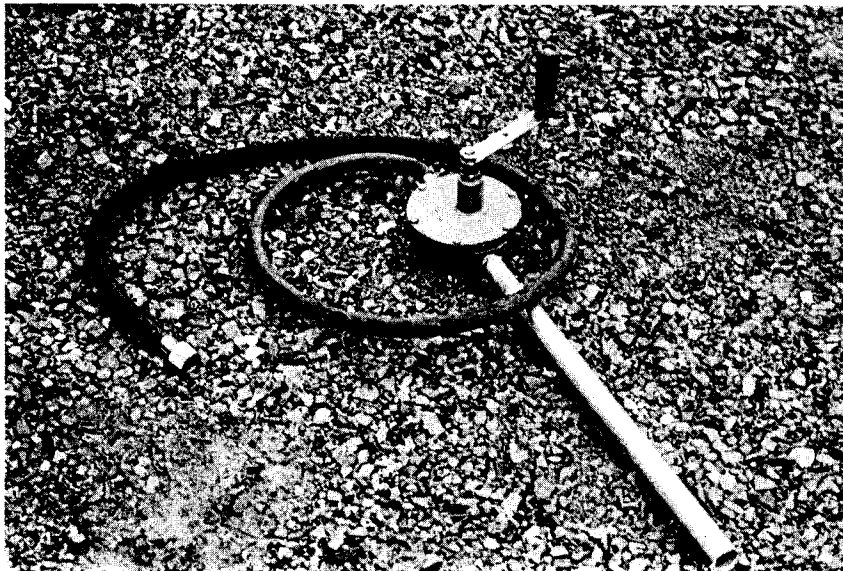
Figure 10. Hand-operated fuel pump for transferring monomer.

Each slab was soaked in the monomer bath for 6 hours. During the soaking period, the tank was covered with a sheet of polyethylene and plywood covers to retard evaporation of the monomer. After the soaking period, the monomer was pumped out of the tank and returned to shipping drums using hand-operated fuel pumps such as the one shown in Figure 10. A small amount of monomer, perhaps a gallon (3.8 liters), could not be pumped from the bottom of the tank.

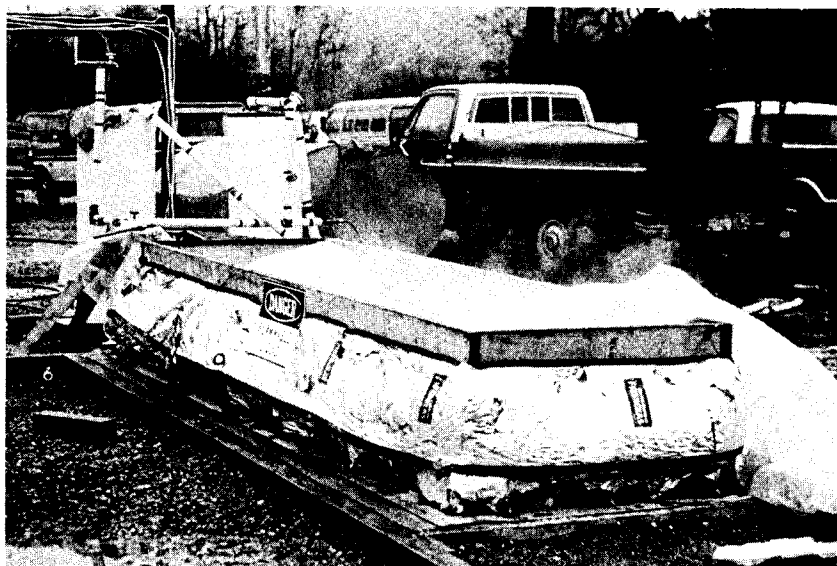
Figure 11. Insulated aluminum tank used for monomer soak and hot water bath.

The polymerization step was begun immediately after the monomer soaking period. After the monomer was pumped from the aluminum holding tank, the slab was shrouded with a polyethylene sheet and the tank was refilled with water to cover the slab. The water was cycled from this water bath with an electric pump and a system of pipes and valves into two 50-gallon (190-liter) water heaters shown in the background in Figure 11. Periodically as the water heaters raised the temperature of the static water to 170°F (77°C), the water was recycled into the tank holding the slab. Concurrently, four submersible, 240-volt coil heaters in the holding tank were powered continuously to help raise the temperature of the bath. While the water heater tanks were recovering, the pump was used to circulate water through the soaking tank to assure a distribution of uniformly heated water.

A period of 4 to 5 hours was required to bring the water in the holding tank up to a temperature of 170°F (77°C). An additional 4 hours were required to raise the temperature at the 2-in. (50 mm) depth within the concrete to this temperature. The temperature of the water bath was maintained at the curing temperature range of 160° to 200°F (71°C to 93°C) for the next 4 hours by operating the submersible heaters and the circulating pump.

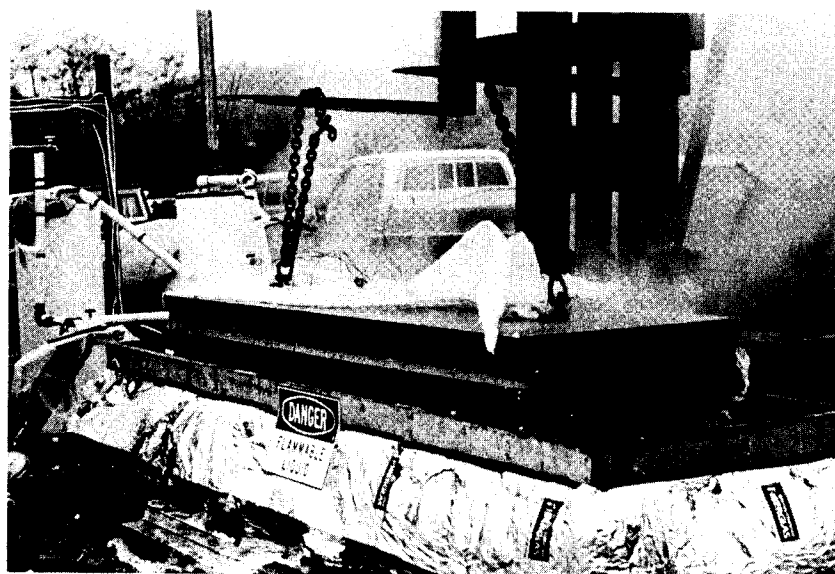
Figure 12. PIC slab being removed from tank.

The water was pumped from the bath after an elapsed time of 12 hours. Figure 12 shows a slab being lifted from the tank. The white sheet of material on top of the slab is a layer of polymerized monomer. As mentioned earlier, this monomer remained in the tank after the monomer soaking and, being less dense than water, floated at the surface of the water bath, where it polymerized.

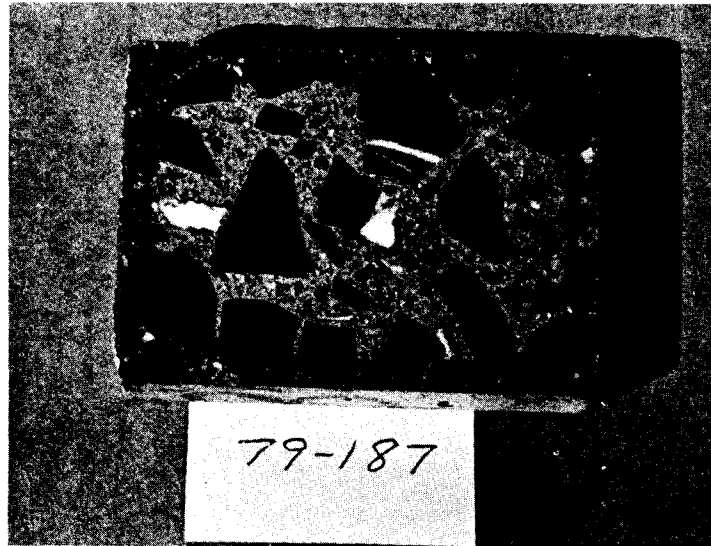
Figure 13. PIC zone around 3.0 x 4.0 in. (76 x 102 mm) prism section.

Several specimens of each type were cut and polished to determine the depth of polymer in them. It was found that the polymer impregnated zone appeared darker than the unimpregnated concrete, and that the difference in coloration was more easily distinguished after the polished specimens were heated in an oven for about 10 hours at 150°F (66°C) to drive away moisture from the unimpregnated concrete. The specimens were marked with dark ink just inside the polymer impregnated zone. Photographs of two specimens are shown in Figures 13 and 14, where it may be observed that the depth of polymer impregnation varied from 0.25 to 0.40 in. (6 to 10 mm).

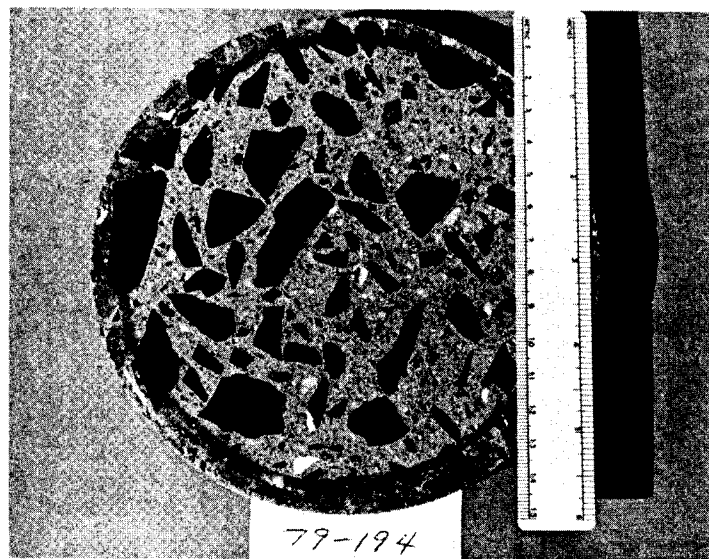
Figure 14. PIC zone around 6.0-in. (152-mm) diameter cylinder section.

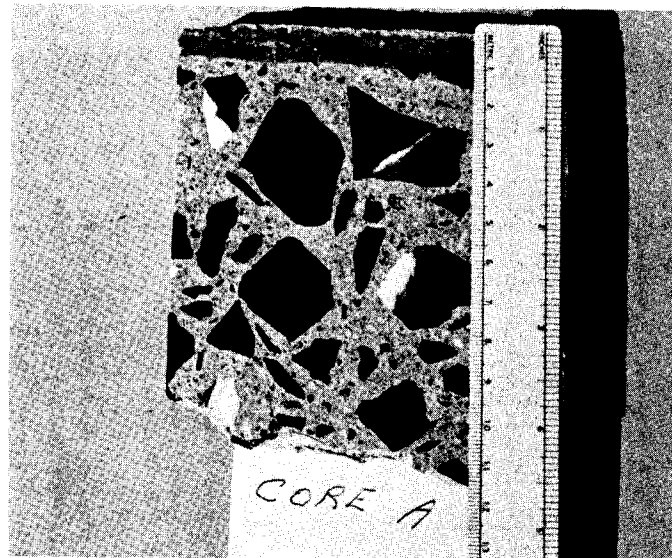
Figure 15. PIC zone in upper portion of core section from slab no. 1.

Cores were taken from the top surface of each of the polymer impregnated slabs. These cores, measuring 4 in. (102 mm) in diameter, were cut vertically, polished and dried in the same way that the polished specimen sections were handled. Photographs of the core sections are shown in Figures 15, 16, 17 and 18. This arrangement of the cores corresponds to the chronological arrangement of the heating records shown in Figures 5, 6, 7 and 8. It may be observed in Figures 15 through 18 that the average depth of polymer impregnation is 0.25, 0.50, 0.75 and 1.00 in. (6, 12, 18 and 25 mm), for slabs 1, 5, 3 and 6 respectively. These results indicate a gradual improvement in the drying phase, which can be observed in the heating records in Figures 5 through 8, as the operation progressed. The best drying was achieved for the fourth slab, as reflected in the depth of polymer impregnation, and the heating record for this slab should be used as a guide for any further treatments using similar equipment.

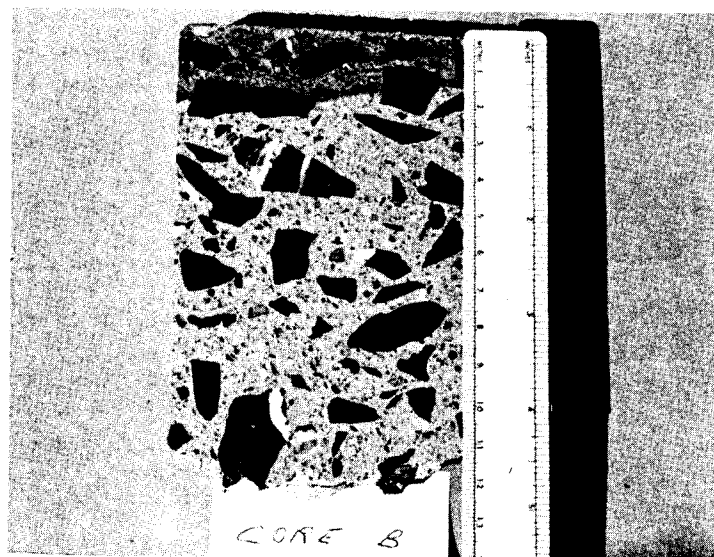
Figure 16. PIC zone in upper portion of core section from slab no. 5.

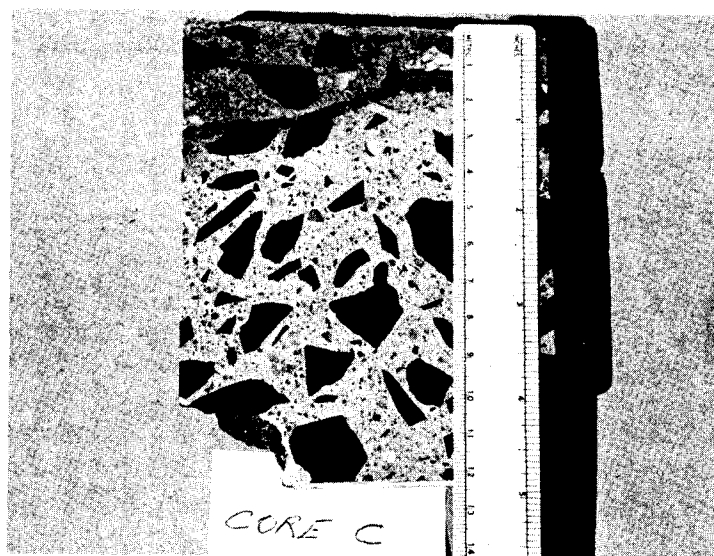
Figure 17. PIC zone in upper portion of core section from slab no. 3

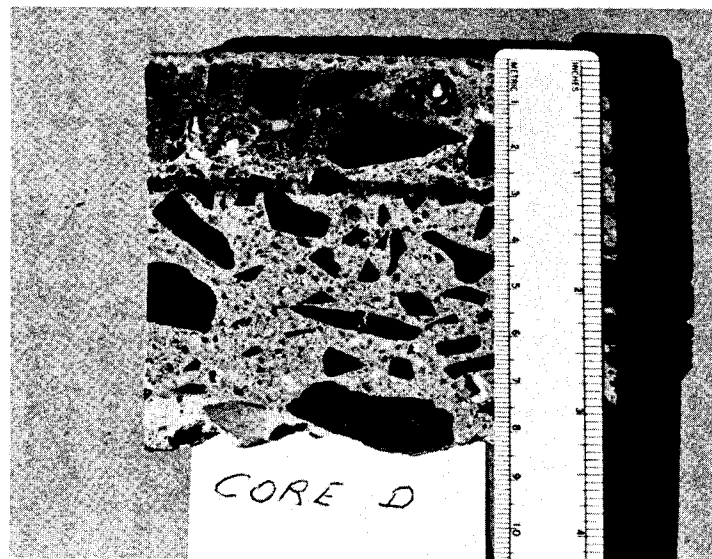
Figure 18. PIC zone in upper portion of core section from slab no. 6.

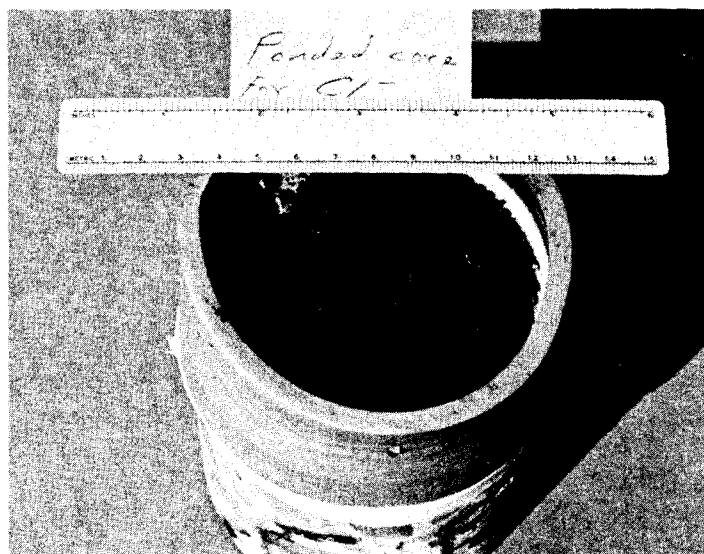
Figure 19. Method for ponding 2% NaCl solution on top surface of cores from PIC slabs.

Core samples were taken from each of the four PIC slabs and two control slabs to determine the amounts of Cl^- that would penetrate these concretes. Since the polymer treatment was applied to the top surface of the cores it was necessary to devise a method of exposing this single surface to Cl^- ponding. A method was devised, as shown in Figure 19, for attaching rubber dikes to the upper portions of the cores so that approximately a 1-in. (25-mm) depth of 2% NaCl solution could be ponded on the top surfaces of the 4-in. (102-mm) diameter cores. The cores were ponded continuously for 90 days. The samples from the cores for chloride analyses were cut from average depths of 0.3 and 0.8 in. (7 and 19 mm) below the central top surface of the cores.

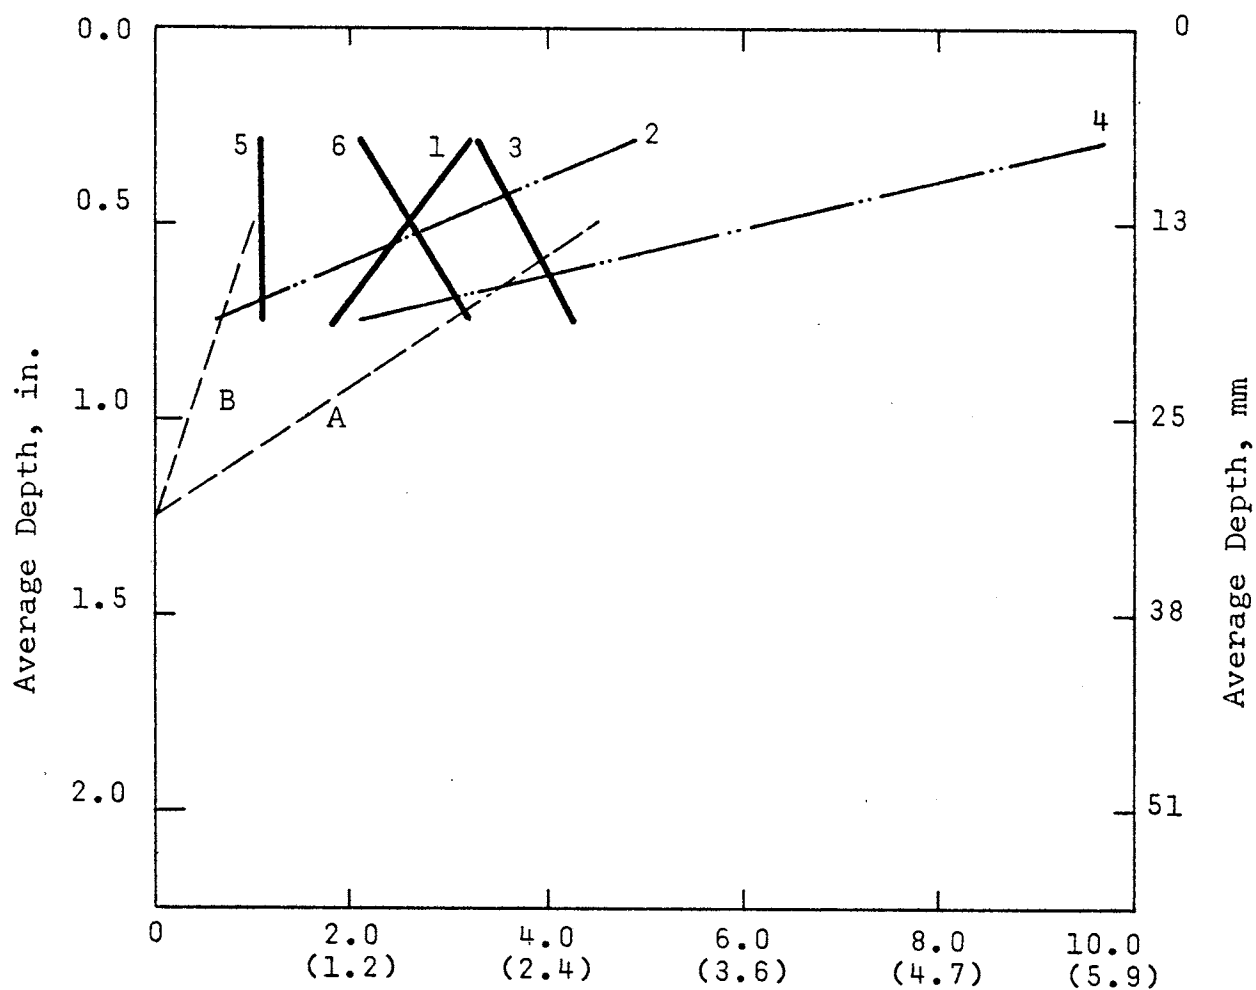
Penetrated Chloride Content, lb. Cl⁻/yd.³ (kg Cl⁻/m³) of Concrete

- Cores, Control (Slabs 2, 4)
- Cores, PIC (Slabs 1, 5, 3, 6)
- - - Cylinders: A, Control (average of three)
- B, PIC (average of three)

Figure 20. Penetration of Cl⁻ into concretes ponded (cores) with or submerged (cylinders) in 2% NaCl solution.

Because the penetrated Cl^- contents, represented by averages in Table 6, were quite variable among the cores, the same data are represented in graphic form in Figure 20 for individual cores. The plots for cylinders, however, are based on averages of three values since there was relatively little variation among values for replicate specimens of this type.

In Figure 20 the effect of the polymer treatment is still seen to be a reduction of the Cl^- penetration at depths nearest the exposed surfaces of both cylinders (compare upper point of A to B) and cores (compare upper points of 2 and 4 to 1, 5, 3 and 6). However, while the penetrated Cl^- contents for lines 2 and 4 and A and B approach or reach a zero concentration at a depth of approximately 1.0 in. (25 mm), this does not appear to be the general tendency for lines 1, 5, 3 and 6 representing cores from the PIC slabs. The PIC cores, while allowing significantly reduced quantities of Cl^- to occupy the sampling zone near their surface, did not reduce the rate at which the Cl^- reached the lower depth. The chloride penetrations exhibited in Figure 20 for PIC cores from slabs 1, 5, 3 and 6 indicate that despite the beneficial effect of the polymer loading in the upper zone of the concrete, the polymer treatment procedure has introduced a mechanism which counteracts this effect and possibly accelerates the rate of Cl^- penetration at lower depths.
