PERFORMANCE OF TEMPORARY CONCRETE TRAFFIC BARRIERS
DURING THE WIDENING OF I-95

Frank N. Lisle
Research Scientist

June 1982
VHTRC 82-R57

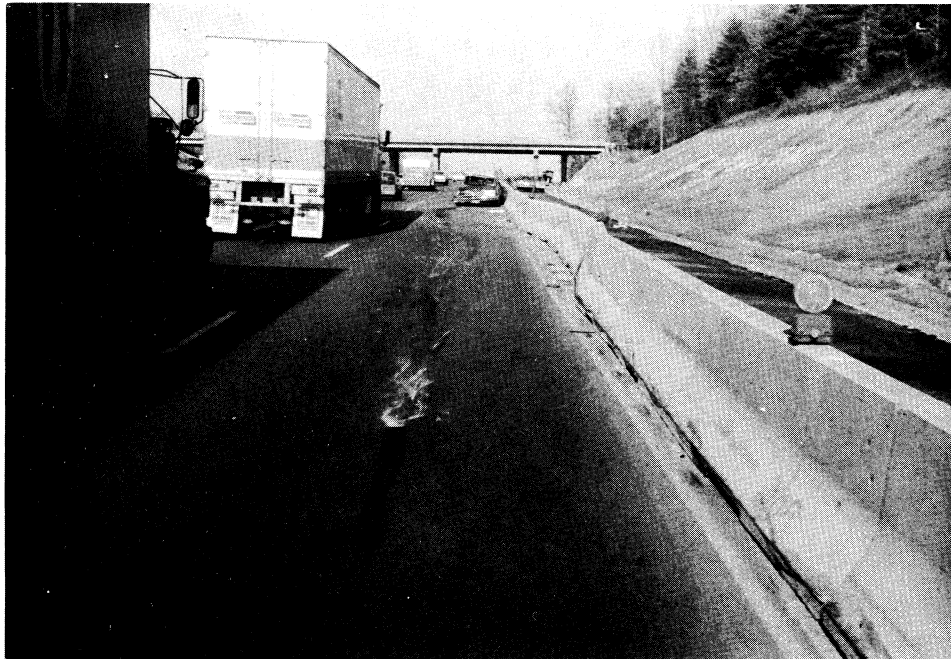
Figure 5. Car forced into barrier by tractor-trailer changing lanes displaced five units. (Virginia Department of State Police photo.)

On the 5 reported accidents involving the barrier, 2 resulted in injury and 3 in property damage only. Two of the impacting vehicles remained in the lane adjacent to the barrier after contact with the barrier, 1 was subsequently impacted by another vehicle in the lane adjacent to the barrier, 1 infringed on the adjacent lane, and 2 crossed into the adjacent lane. The barrier was struck first in 2 of the 5 accidents, and in the remaining ones a vehicle sideswiped another before impacting the barrier. The typical barrier displacement due to vehicle contact was less than 1 ft. However, larger deflections were noted in 2 accidents, one of which involved a full-size car being forced into the barrier by a tractor-trailer changing lanes. Five barrier units were displaced in the configuration shown in Figure 5 with a maximum deflection of 3 ft. The barrier system did not fail and there were no injuries.

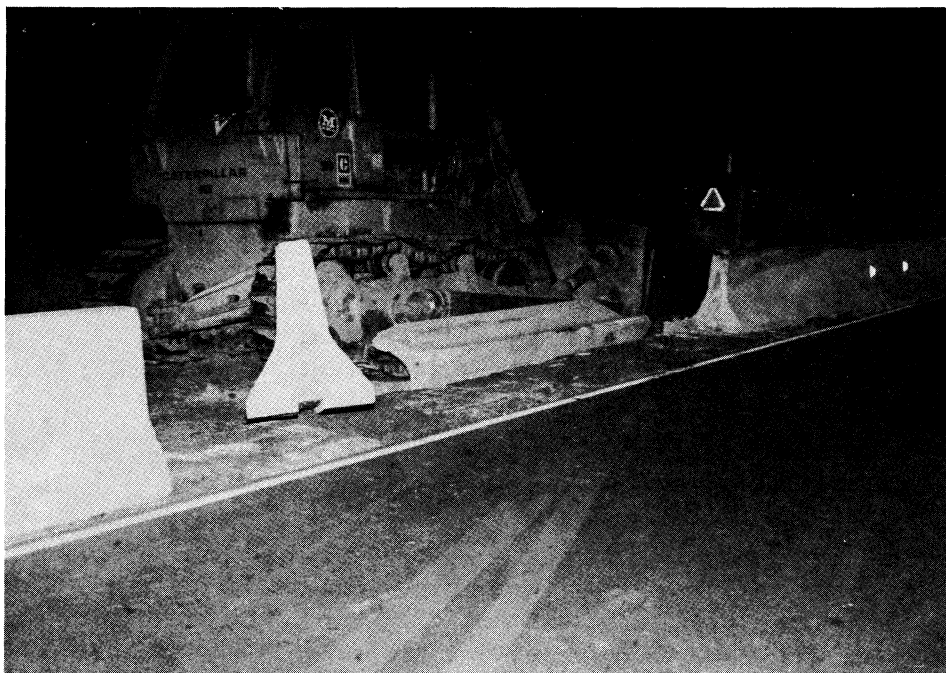
Figure 6. Two compact cars impacted the PCTB system at high speeds and large angles and caused the system to fail. (Virginia Department of State Police photo.)

The only reported accident in which the barrier system failed involved two compact cars that sideswiped each other on the right shoulder, then came across the roadway and impacted the barrier. One vehicle, traveling at 55 mph prior to the accident, impacted the barrier at approximately a 25° angle. The left front tire climbed up and over the barrier, and the vehicle traveled approximately 20 ft. with the left front wheel over the back side of the barrier before coming off the barrier and overturning in the roadway. The second vehicle, traveling at 75 mph prior to the accident, impacted the barrier at approximately a 20° angle and was redirected. The vehicle came to rest next to the guardrail on the opposite side of the roadway. Five people were injured in this accident, 4 in the overturned vehicle and 1 in the other vehicle. Two barrier units were knocked completely into the work area as shown in Figure 6. Three barrier joints failed. As with the accident in the construction zone on the Virginia Beach-Norfolk Expressway where the barrier system failed,⁽⁵⁾ the impact conditions described above were severe when compared to those under which strength tests on permanent barriers are made.
