RAISED MARKERS PLACED IN PAVEMENT GROOVES

Frank D. Shepard
Research Scientist

Virginia Highway & Transportation Research Council
(A Cooperative Organization Sponsored Jointly by the Virginia
Department of Highways & Transportation and
the University of Virginia)

March 1983
VHTRC 83-R31

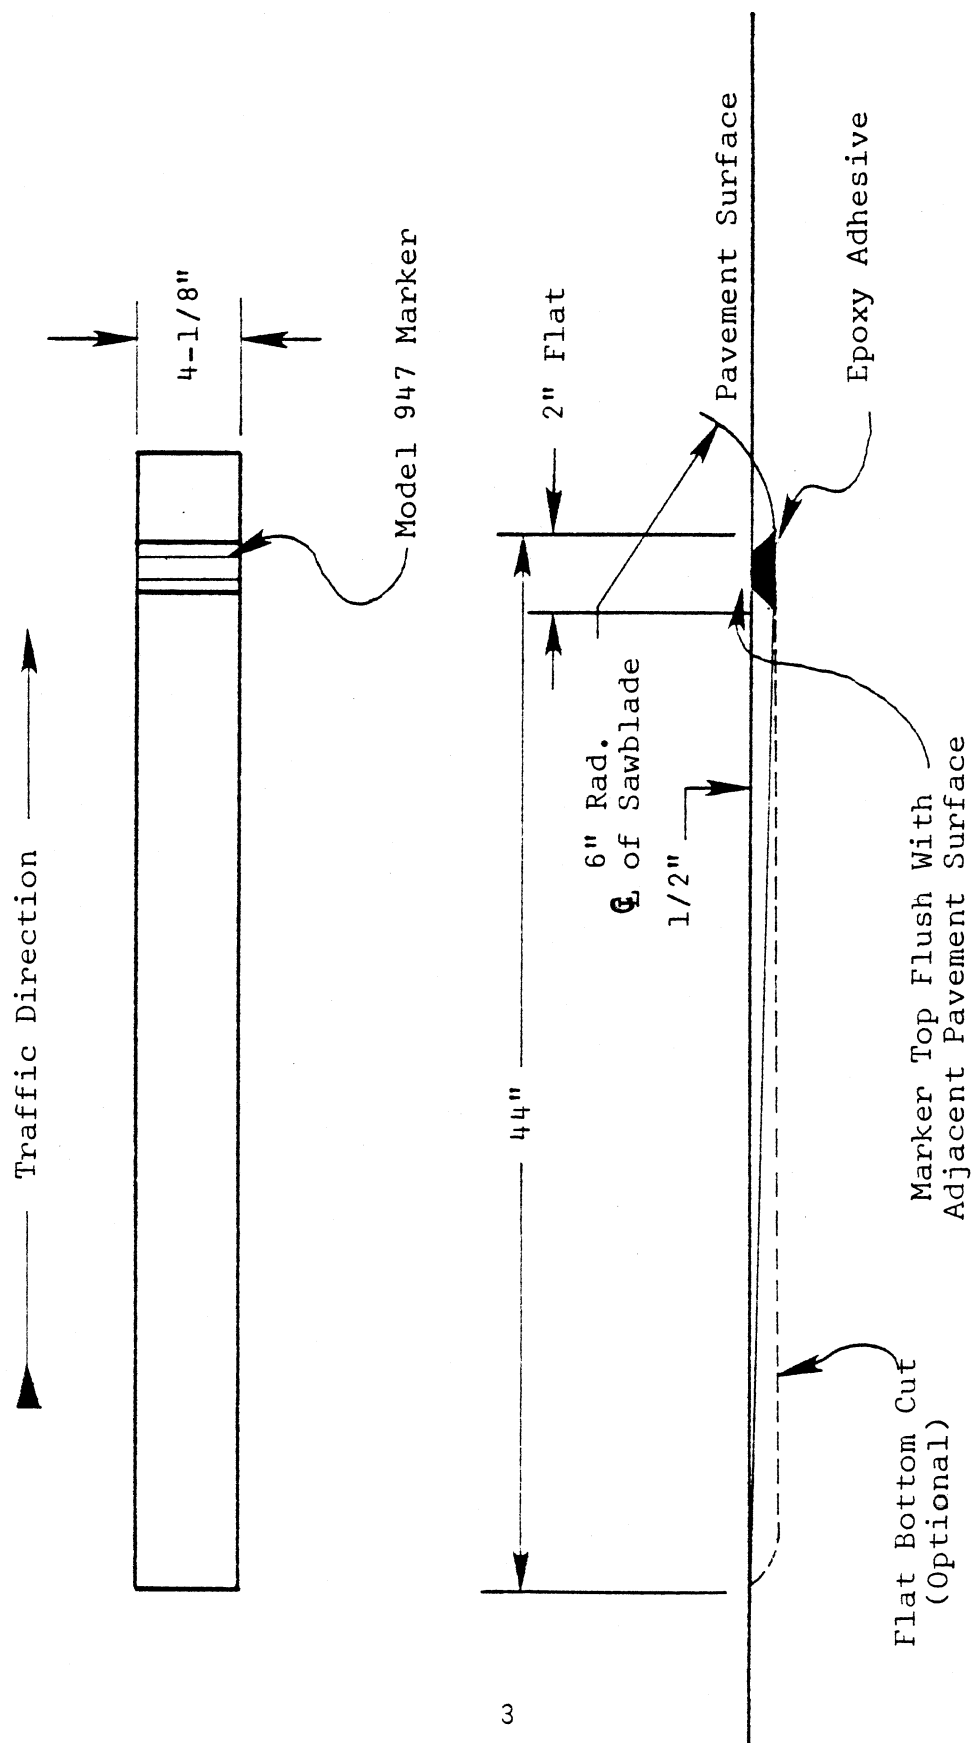
Figure 1. Schematic of groove.

Figure 1 is a schematic of the groove, which is 44 in. long, 4-1/8 in. wide, and tapers to a depth of 1/2 in. where the marker is placed. (The marker is 1/2 in. high.) Figures 2 and 3 show the groove being cut into the bituminous pavement and dried with an air hose, while Figures 4 and 5 show the epoxy adhesive being applied by hand and the marker being placed in the groove.

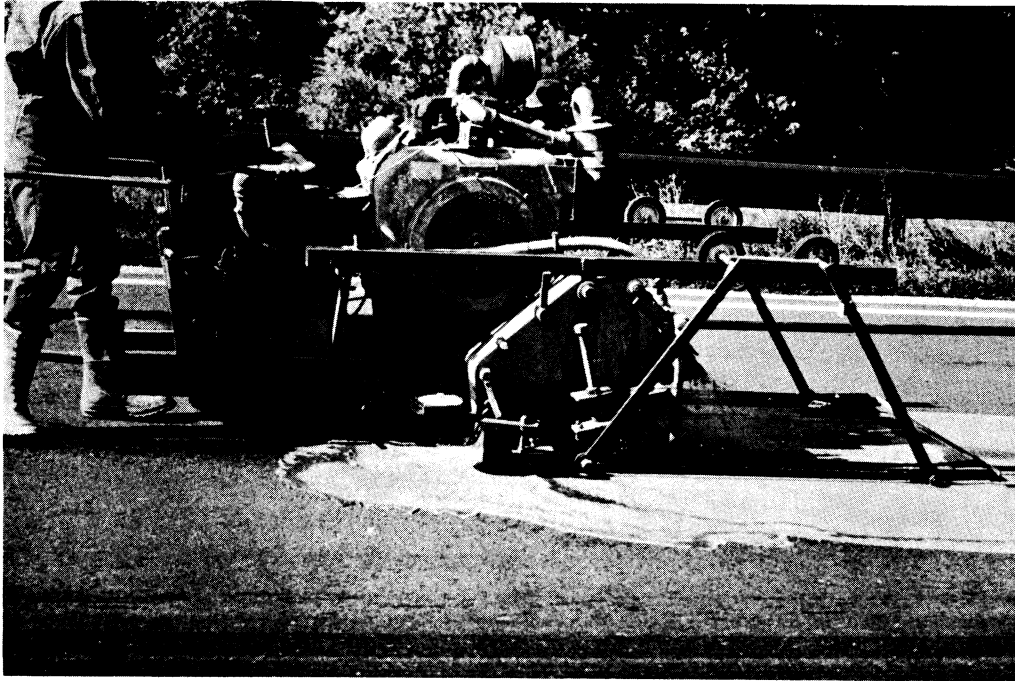
Figure 2. Groove being cut into the pavement.

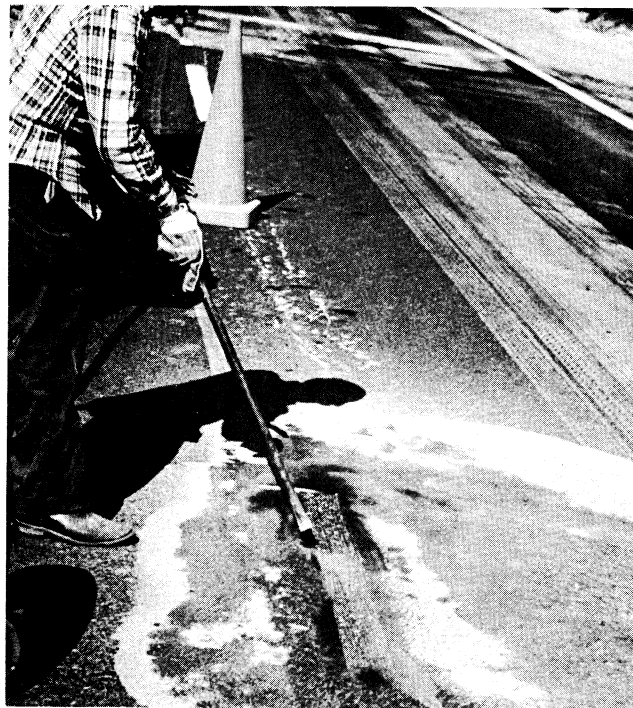
Figure 3. Groove being dried with an air hose.

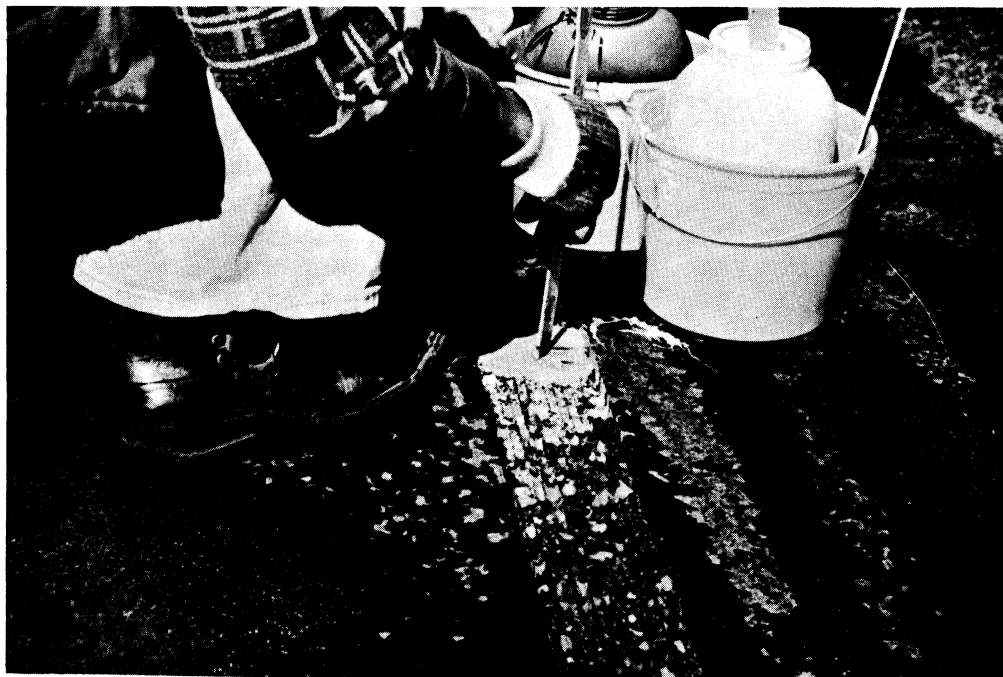
Figure 4. Epoxy adhesive being applied.
