STATE DEMONSTRATION PROJECT: LOOP DETECTORS

Virginia Highway & Transportation Research Council
(A Cooperative Organization Sponsored Jointly by the Virginia
Department of Highways & Transportation and
the University of Virginia)

January 1985
VHTRC 85-R21

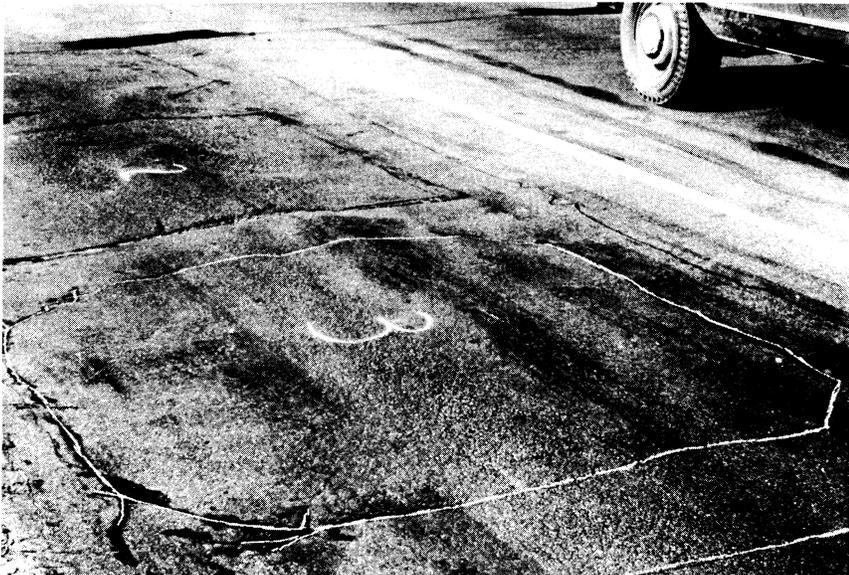
Figure 1. Loop distortion at site of Demonstration #1.

At that point, the test loops had been through three winters and three summers and, as indicated previously, had not yet failed. All loops, however, had begun to deform as the pavement continued to buckle under the adverse traffic and geometric conditions. Significant displacements in the saw cuts had occurred, particularly across the lane. In fact, a failure appeared imminent. Figure 1 shows an example of this displacement. The saw cuts have been highlighted with chalk.

The severe distortion of the pavement at the site necessitated repair. Accordingly, on September 13, 1984, the surface was removed with a heater plane and the section was repaved. In the process, the test loops were ripped out, thus cancelling further evaluation of the site.

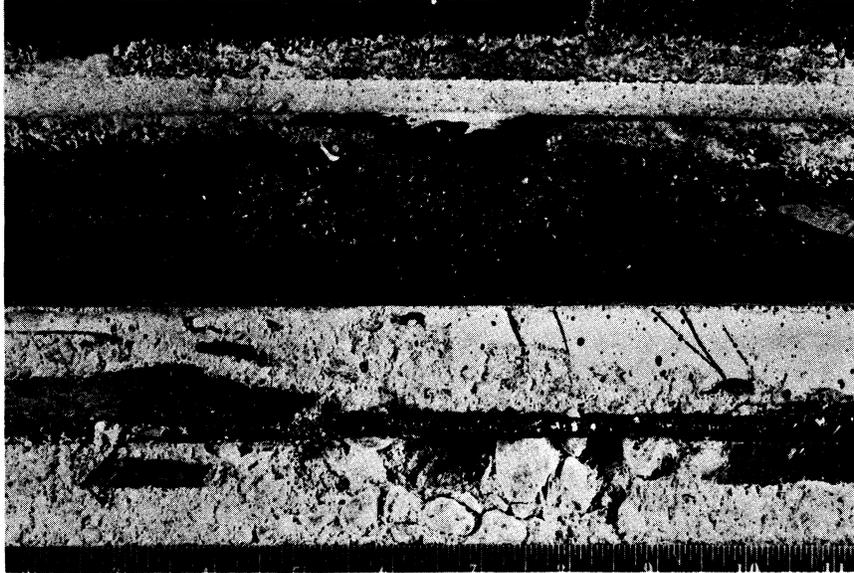
Figure 7. Deterioration at beam/sealant interface.

The beams were then subjected to more severe testing; that is, the metal containers were filled with water such that freezing occurred with the beams saturated. Since the beams were saturated, de-bonding between the sealant and sides of the saw cut became more apparent than before, as the pressure created by the expansion of the freezing water caused rapid deterioration of the beam. The beams were subjected to approximately 160 more cycles of freezing and thawing. The problems with the 3M sealant mentioned previously became much more severe; in fact, two of the asphalt test beams split in two along the sealant/saw cut interface. The other soft, pliable sealant, Seallex, also experienced a similar problem; that is, it pulled away from the sides of the saw cut in both asphalt and concrete test beams. No problems occurred with the test beams using the hard, rigid sealants. No differences in the performance of the sealant in the two widths of saw cuts, in concrete, and in asphalt were detected. Figure 7 shows examples of beam deterioration at the interface.

Thus, the results indicate that hard, rigid sealants perform better than soft, pliable sealants in laboratory simulation of freezing and thawing. The width of saw cut does not seem to affect performance. Likewise, sealant performance in asphalt and concrete does not seem to differ. Although the testing was patterned after a formal ASTM test procedure, it should be reemphasized that there is no absolute correlation between the lab test and field performance. In other words, the differences in performance between the soft and rigid sealants may not occur in the field or, more likely, may occur after such a time period that it becomes irrelevant compared to the life of the pavement.
