RELATIONSHIP BETWEEN PROPERTIES OF HARDENED CONCRETE  
AND BRIDGE DECK PERFORMANCE IN VIRGINIA

Howard Newlon, Jr.  
Research Director

Hollis N. Walker  
Research Scientist

February 1985  
VHTRC 85-R23

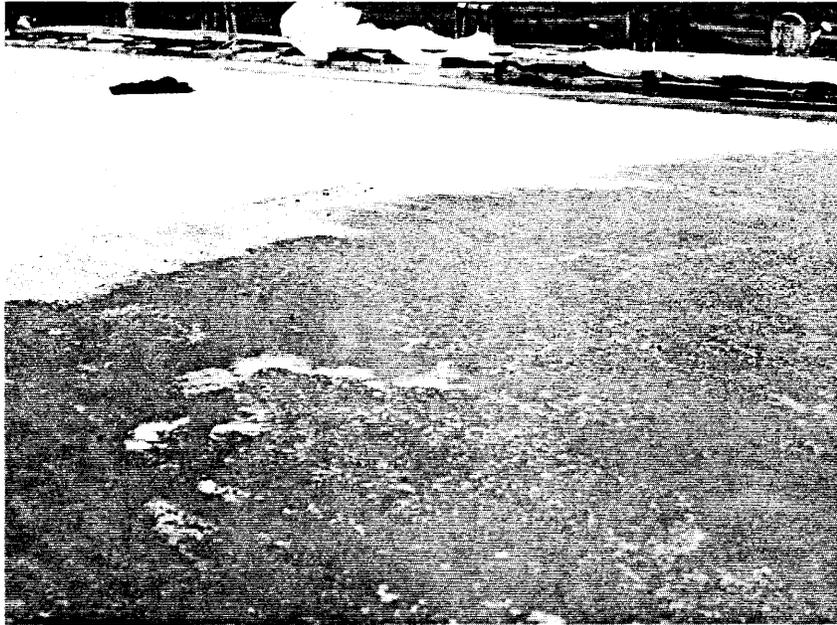
Figure 32. View of span of bridge #5 following the rainstorm — 1963.

Figure 32 is a view of the center portion of bridge #5 following the rainstorm, and Figure 33 a photograph taken in 1971 at approximately the same location. The primary defect is random cracking. The performance of the span under comparatively heavy traffic was somewhat better than would be expected. Sample 5-2 came from an area in the foreground of Figure 32. Figure 34 is a close-up of a vertical section through the surface. The intermingling of the curing compound with the reworked surface is obvious. Also obvious is the network of fine cracks which obviously will manifest themselves as pattern cracking of the surface. The termination of the cracks at the intersection with the curing compound below the surface is striking. This is consistent with the differences in absorption values in core 5-2 with depth as shown in Table 7, and the differences in chloride penetration for the two samples for bridge #5 shown in Figure 4. The isolated area of high corrosion potential shown in Figure 16 at the eastern corner of the slab was the area from which the screed rail was removed. Obviously, without knowledge of the special conditions during placement, variations in performance and in the properties of the concrete in the cores would be difficult to explain. It might also be observed that the rejection of the concrete and the lack of sufficient trucks due to the simultaneous placement of two decks resulted in delaying the job so that it was exposed to the thunderstorm. Had the delays not occurred, the deck would probably have been completed and cured with resulting satisfactory properties and performance.
