# EVALUATION OF A MOVABLE CONCRETE BARRIER SYSTEM

B. H. COTTRELL, Jr.  
Senior Research Scientist

TRANSPORTATION RESEARCH COUNCIL

1. Report No. FHWA/VA-94-R10		2. Government Accession No.		3. Recipient's Catalog No.	
4. Title and Subtitle <i>Evaluation of a Movable Concrete Barrier System</i>			5. Report Date January 1994

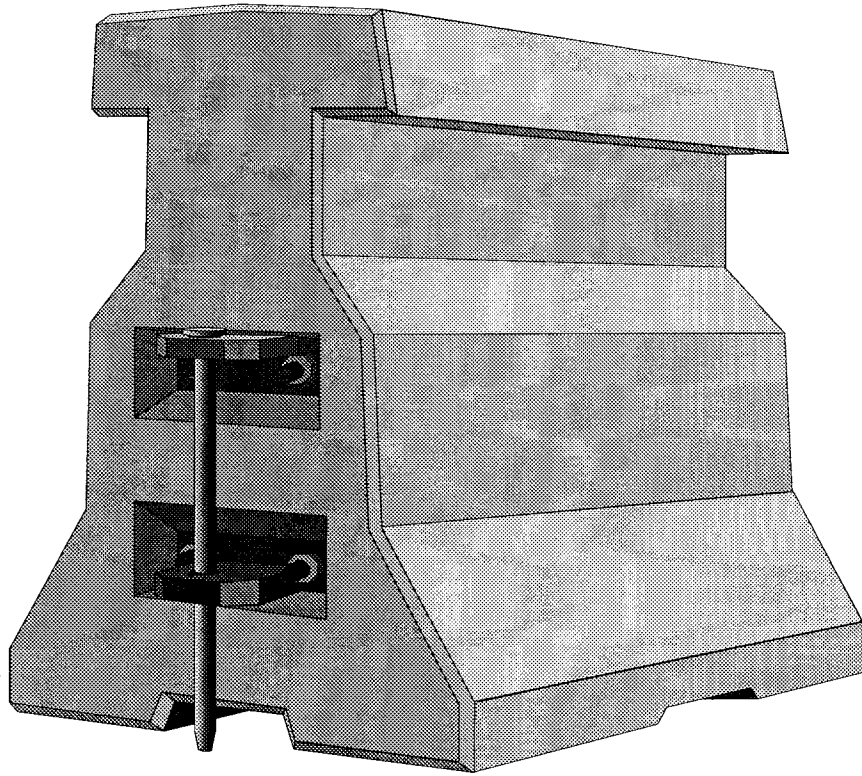
The movable concrete barrier (MCB) system (see Figure 1) consists of segments 1 m (39 in) long, 0.8 m (32 in) high, and 0.6 m (24 in) wide at the base. Each segment weighs approximately 635 kg (1400 lb) and is connected by two hinges attached to each end of the segment. The barrier is moved with a trans-

Figure 1. A section of the movable concrete barrier with a hinge.

port/transfer vehicle (TTV) that lifts the segments off of the pavement and laterally repositions them at distances from 1.2 to 5.5 m (4 to 18 ft) at speeds of about 8 kph (5 mph) (see Figure 2). The MCB system is manufactured by Barrier Systems, Inc. (BSI) and is called the Quick Change MCB System.

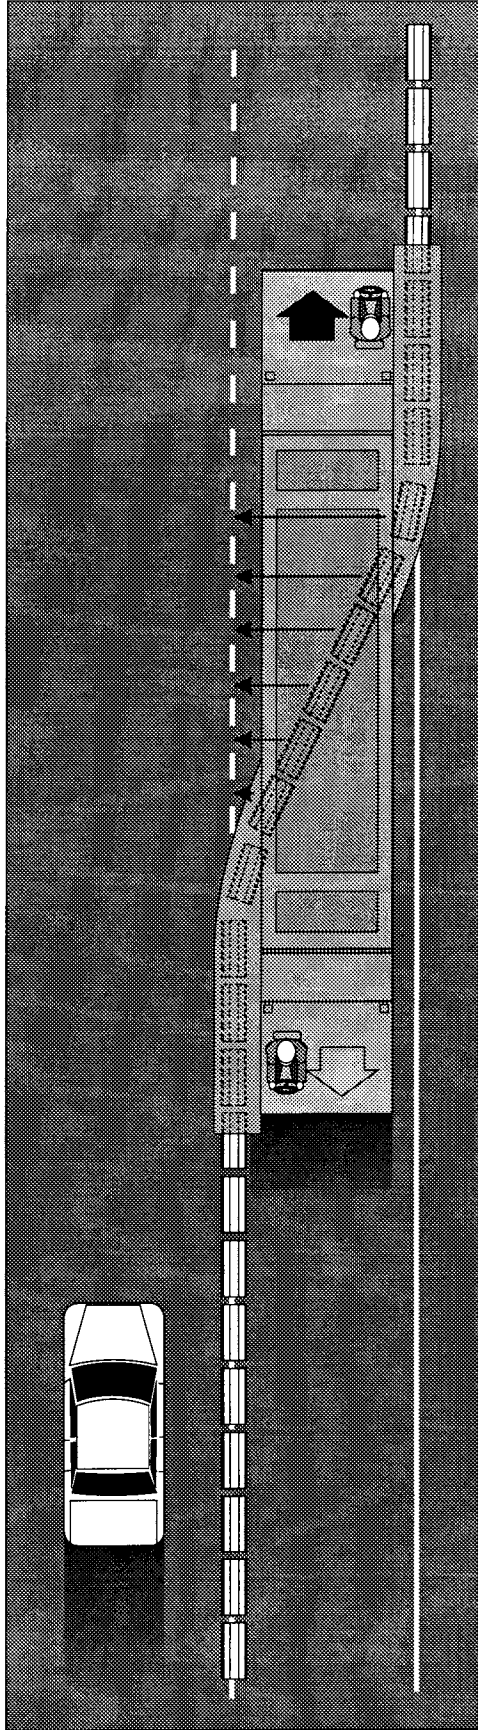
Figure 2. The transfer process.

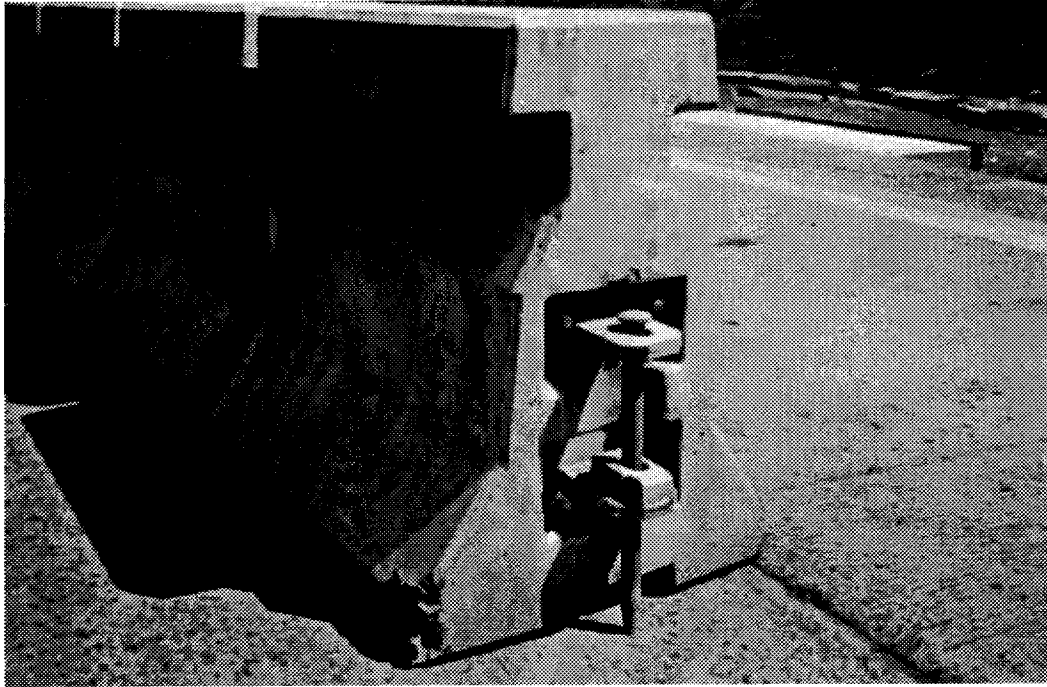
Shipments of the MCB began arriving at the construction site in May 1991, and by June the barriers were in place. During the initial months of operation, it was noted that during the transfer process, the bottom corners of adjacent barriers were making contact causing the corners to crack and break (see Figure 3). According to BSI, this chipping of barrier corners is viewed as a wear-

Figure 3. Photo of a MCB with chipped corner.

ing in or seasoning of the MCB; it has occurred on all projects using MCB.<sup>1</sup> The chipping was superficial and did not affect the structural character of the MCB. The likelihood of chipping is increased when transfers are made at an excessive speed. On both projects, about 30 to 40 percent of the MCBs had chipped corners after about 6 weeks of use. The contractors agreed to reduce the speed of the barrier transfer. The chipping ceased after about 3 months.

1. *The recommended speed of the TTV-3 during the transfer process should be emphasized at the beginning and throughout the project to minimize the chipping of the barriers.*

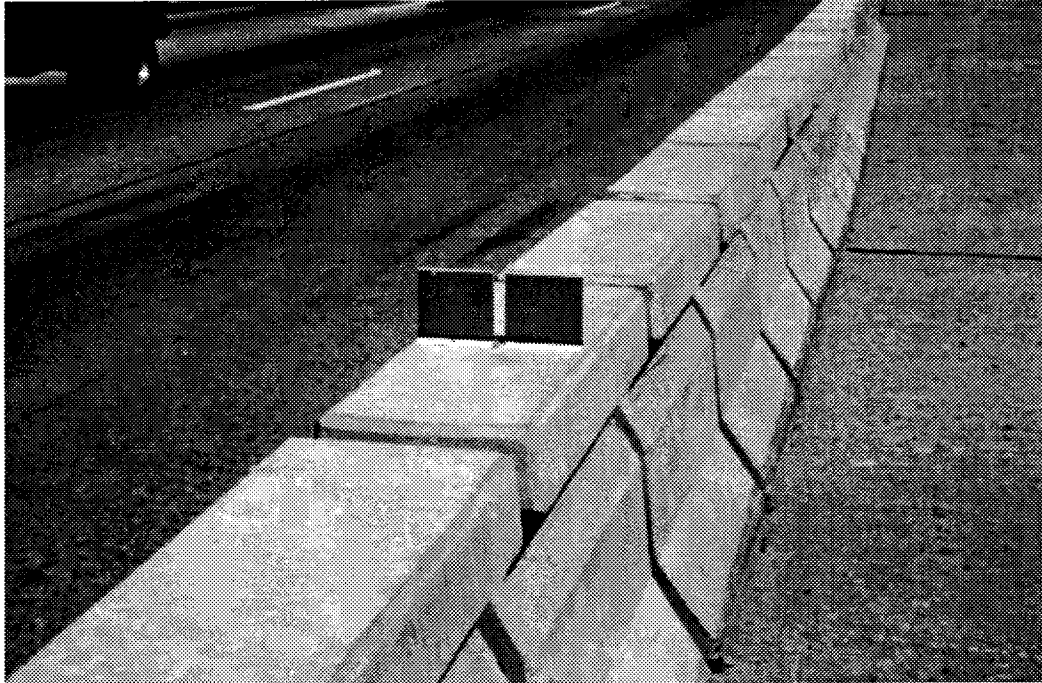
Two types of delineators were mounted on the MCB. A side-mounted standard plastic delineator was spaced every 12.3 m (40 ft) at a maximum height of 0.6 m (25 in). Also, two 104.04 cm<sup>2</sup> (16 in<sup>2</sup>) yellow reflective sheeting panels were mounted side by side on top of the MCB at 24.6 m (80 ft) intervals as shown in Figure 4. The panels were fastened to the MCB with a rubber attachment that allowed the panels to bend backwards as the barrier was moved by the TTV. The delineators performed well; they didn't fall off the MCB nor hinder the TTV's operation.

Figure 4. Yellow reflective-sheeting panels mounted on the MCB.

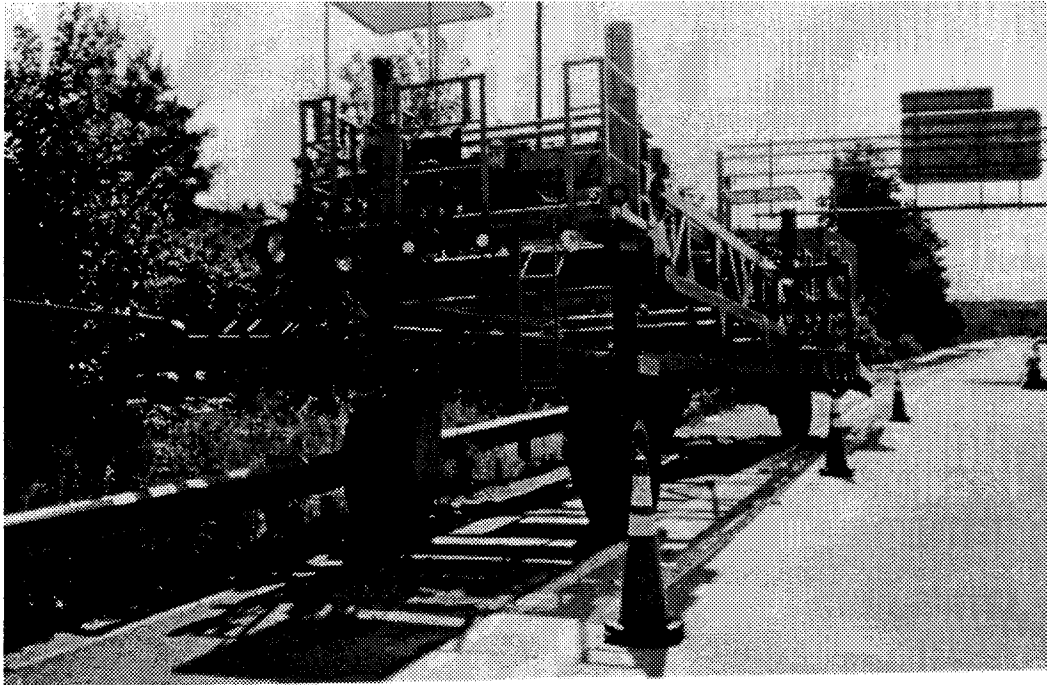
vehicle moves along the highway. The TTV-3 and conveyor system are shown in Figures 5 and 6, respectively. Although the TTV-3 is also capable of picking up as many as 15 barriers at one time and transporting them to another site, this feature was not used on the I-66 projects. The TTV-3 is powered by a 6 cylinder turbocharged John Deere diesel engine and has two operating ranges, low, up to 11.2 kph (7 mph) and high, 12.9 to 32.2 kph (8 to 20 mph).<sup>2</sup> The typical TTV-3 is 14.2 m (46.5 ft) long and 3.4 to 4.1 m (11 to 13.5 ft) wide with a 9.3 m (30.5 ft) wheel base and weight of 14,515 kg (32,000 lbs).<sup>2</sup> Two operators, one guiding each end of the TTV-3, were used to make the MCB transfer (lane closing/opening). Using an intercom system with headsets, the operators talked to each other to coordinate and facilitate TTV-3 operations.

Figure 5. TTV-3.

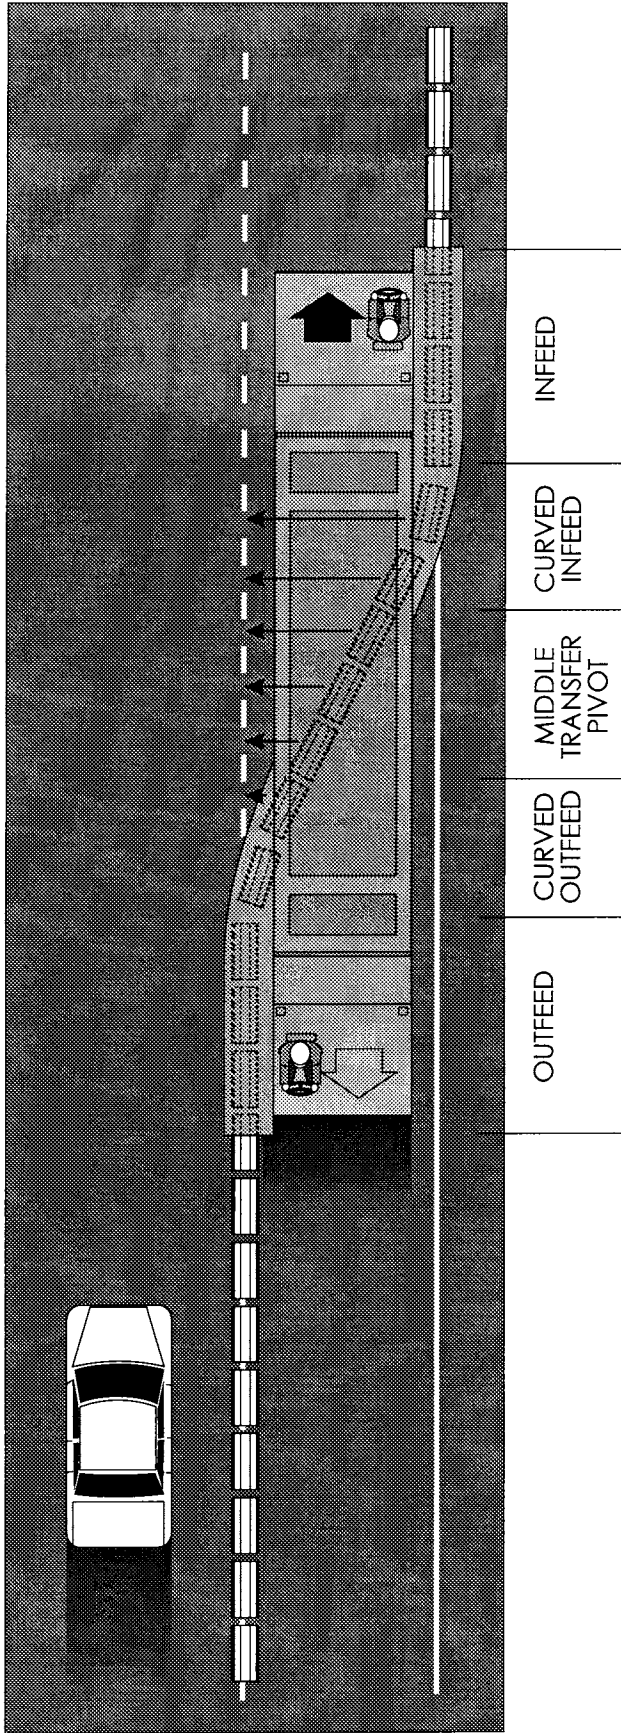
The TTV-3's s-shaped conveyor system has five parts: infeed and outfeed sections, curved infeed and outfeed transfer sections, and the middle transfer pivot (Figure 7). As the TTV-3 moves forward to make a transfer, the infeed section connects with the MCB and lifts it off the road. The curved infeed transfer section moves the MCB to the middle transfer pivot, which diagonally moves the MCB to the curved outfeed transfer section. The outfeed transfer section realigns the MCB to its final position where it is lowered to the road and released by the outfeed section.<sup>2</sup>

Figure 7. Components of the conveyor system.

It is roughly estimated that (1) wheels in the curved infeed and outfeed transfer section should be replaced every 20 hr of operation and (2) wheels in the straight sections—the infeed, middle transfer pivot, and outfeed sections—should be replaced every 40 to 60 hr.<sup>2</sup> These estimates were cited by a BSI official. This would amount to wheel replacement at a minimum of about every 2 months. According to a VDOT inspector, wheel replacement was more frequent at the beginning of the project. This is probably because there was more wear and tear on the wheels when the operators were inexperienced with the TTV-3 and transfer operations. Also, the wheels were checked daily for tightness because loose wheels can damage the barrier.

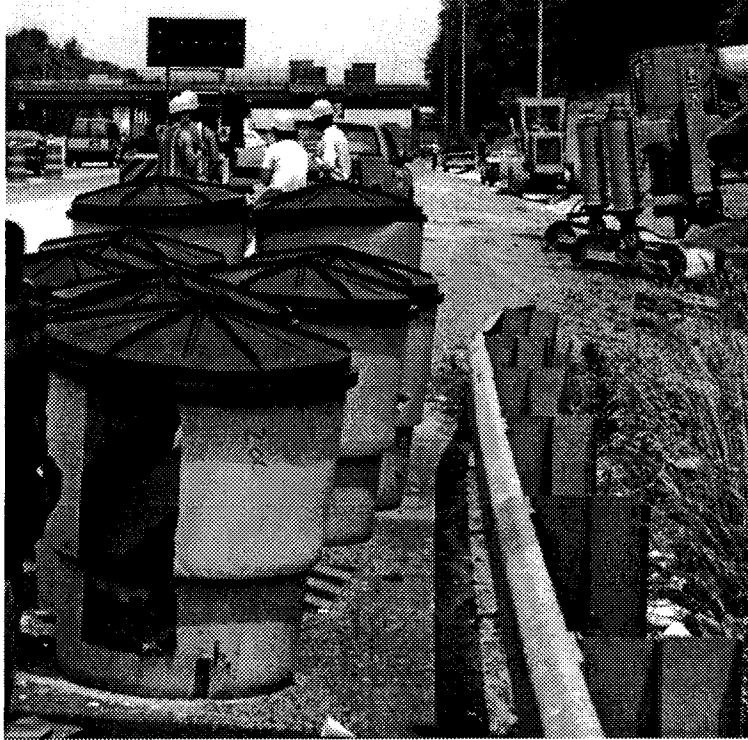
Figure 9. Type 2-11 attenuator: sand barrels.

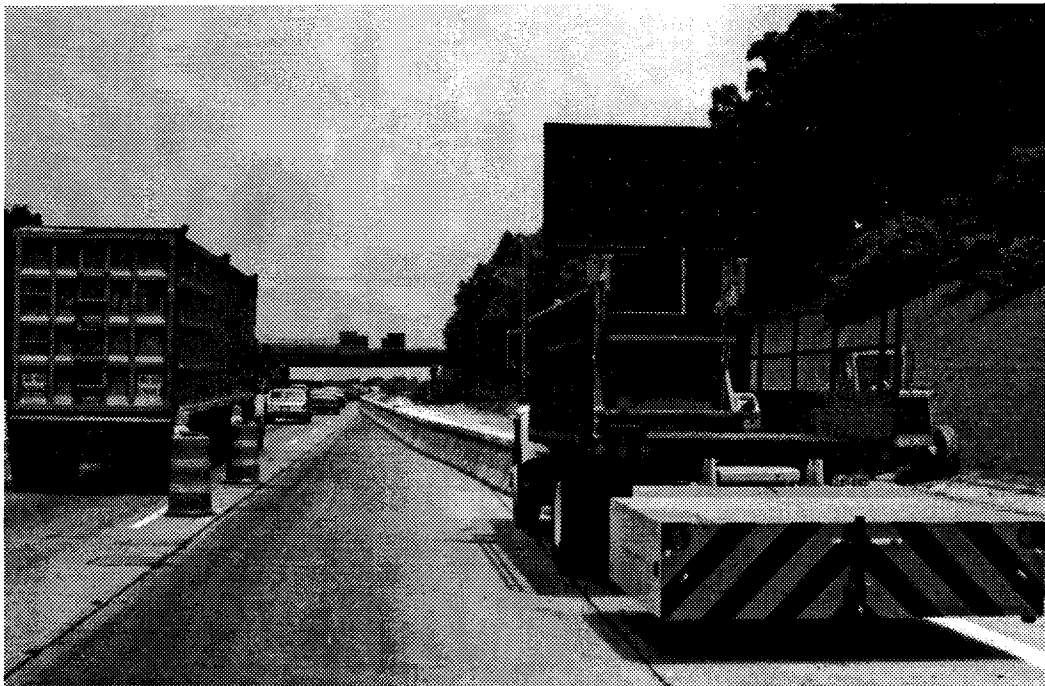
Figure 10. Photo of the TMCC.

A substantial additional cost for the MCB system was the cost of the TMCC. The special provision for TMCC specified a per-hour pay unit, and the charge per TMCC for both projects was \$10 per hr. Obviously, the special provision's pay unit was established for short-term use of the TMCC. On the average, two TMCCs were used on each project for as long as the MCB was on the road. In other words, two TMCCs were used continuously during the project. For Project 1, the estimated cost for TMCCs was \$260,000 for 15 months, and for Project 2, the estimated cost was \$155,000 for 9 months. In the future, by using a flat fee pay unit for the TMCC, a cost of about one-third to one-fifth of that charged for these projects could be expected.

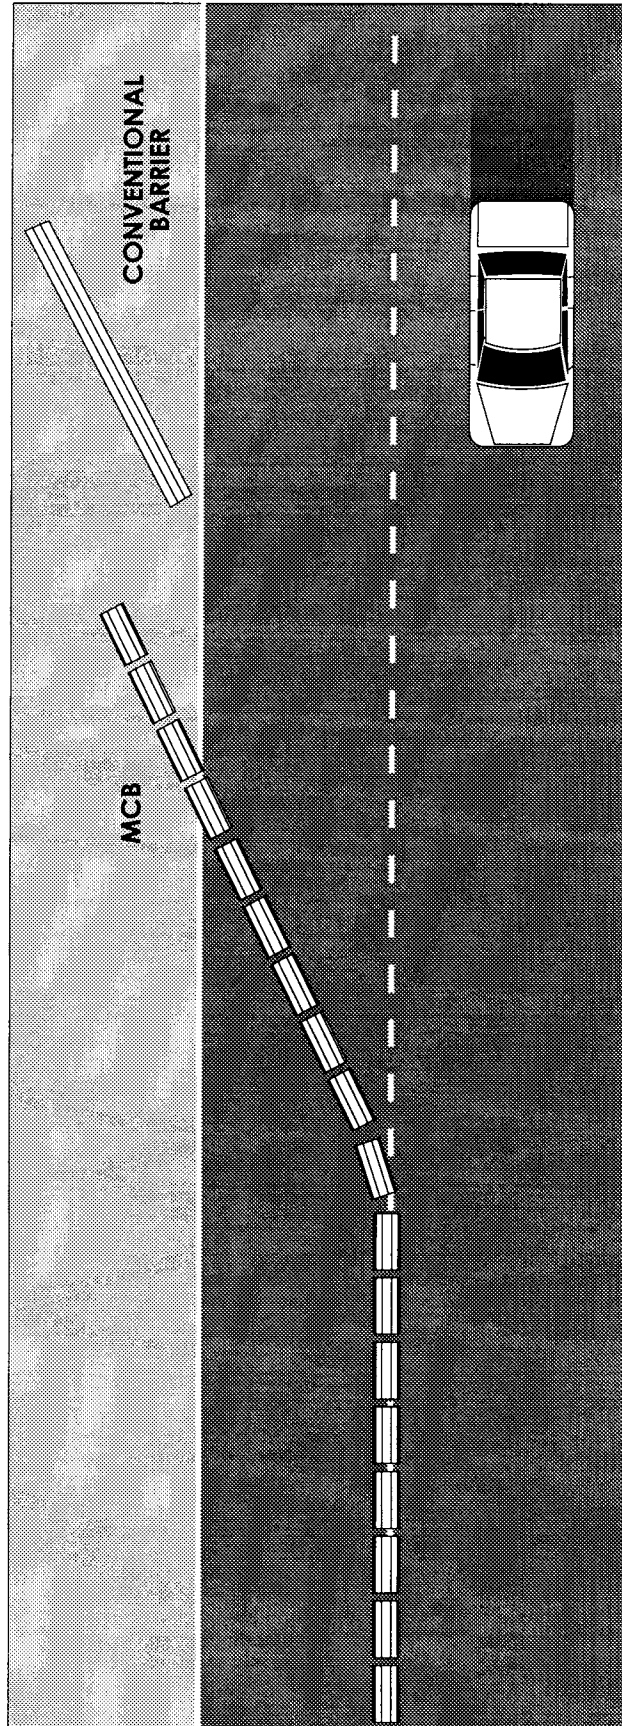
During one phase of Project 1, a conventional concrete barrier taper was used to protect the MCB. The conventional barrier end was protected by a Guardrail Energy Absorbing Terminal (GREAT) attenuator (see Figure 8). The first sections of the MCB were also in a taper when positioned on the shoulder and when transferred for a lane closure (see Figure 11). Although this arrangement provided adequate protection of the end of the MCB, it was harder for the TTV-3 to pick up the MCB in the taper; thus, the TTV-3 speed was reduced during the transfer. The TTV-3 operators have to maneuver the TTV-3 at an angle to move the MCB taper. This puts additional stress on the TTV-3 and conveyor rollers. The contractor's project manager thought that this was a better method of protecting the end of the barrier despite the difficulty in moving the MCB taper. Consequently, this arrangement may be worth trying on a future project. Another portable crash cushion that may be worth trying in the future is under development under the Strategic Highway Research Program's (SHRP) Work Zone Safety Devices program. A tilt bed with rows of rollers allow the sand barrels to be easily unloaded and loaded on the tilt bed with assistance from an electric winch.<sup>4</sup>

Figure 11. Sketch of the conventional concrete barrier protecting the end of the MCB.

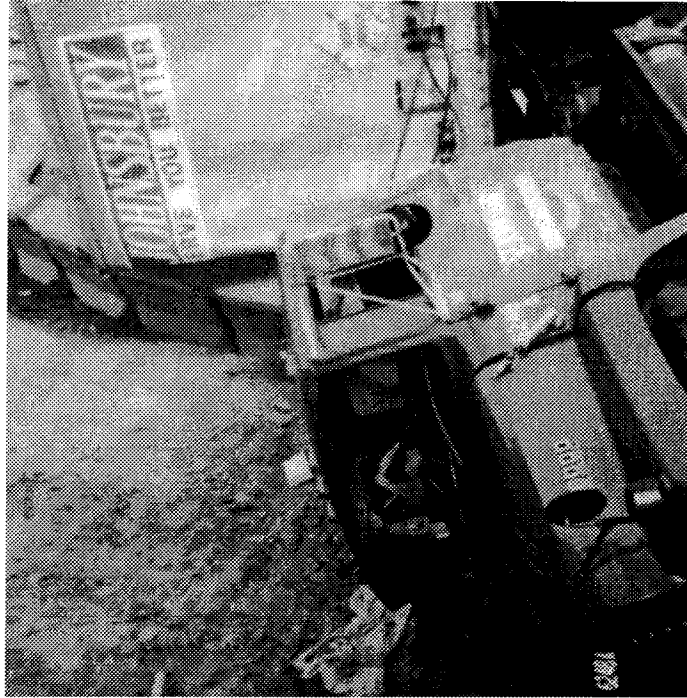
At approximately 9:30 A.M., a tractor trailer traveling west on Thursday, April 9, 1992, had a swaying trailer that caused the driver to lose control, side-swipe a car, cross the median and eastbound lanes, and hit the MCB that was on the right shoulder. The truck broke the barrier wall and came to rest on the right shoulder of the eastbound roadway on its right side with the front portion of the tractor on top of the MCB (see Figures 12 through 14). About 46 to 50 m (150 to 163 ft) of barrier were displaced. This is approximately equivalent to 45

Figure 13. Truck and displaced MCB.

to 50 MCBs. Emergency operations required the removal of additional MCBs, bringing the total number of displaced barrier sections to 63. Four sections were severely damaged and were replaced, and a total of 67 barrier sections were reset. It took about 5 hr to remove the truck from the scene and an additional 4 hr to reset the 67 barrier sections. The eastbound roadway was closed for about 30 minutes beginning at 10:00 A.M. to allow emergency vehicles to extricate the driver (who did not appear to have any life-threatening injuries) and for 1 hour beginning at 1:00 P.M. to remove the truck. The right lane was closed until 6:30 P.M. Damages were estimated at \$54,400.

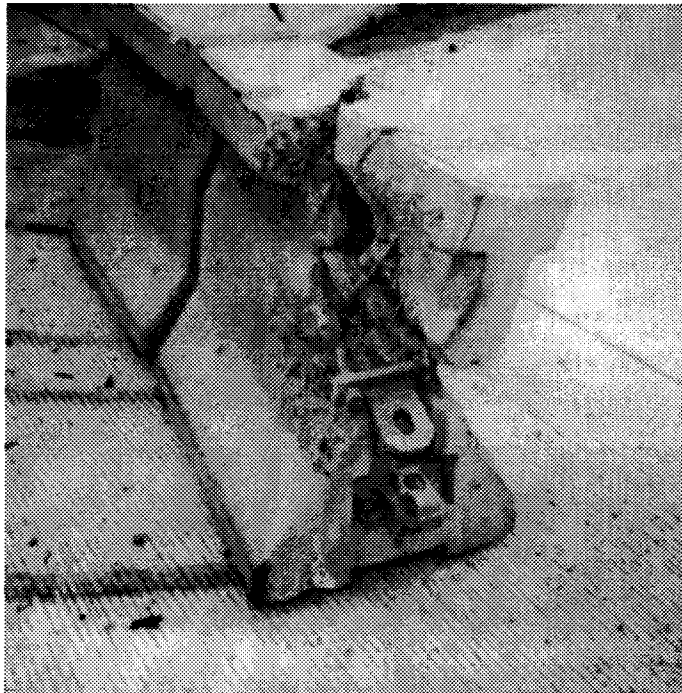
Figure 14. A damaged MCB section.
