INVESTIGATION OF RETROREFLECTIVE SIGN MATERIALS AT PASSIVE RAILROAD CROSSINGS

VIRGINIA TRANSPORTATION RESEARCH COUNCIL

Report No. VTRC 95-R22	Report Date June 1995	No. Pages 35	Type Report: Final Report	Project No.: 9122-030
				Contract No.:
Title and Subtitle Investigation of Retroreflective Sign Materials at Passive Railroad Crossings				Key Words Railroad Crossings Safety Crossbucks Retroreflective Materials
Author(s) Stephen C. Brich				
Performing Organization Name and Address: Virginia Transportation Research Council 530 Edgemont Road Charlottesville, Virginia 22903-0817				
Sponsoring Agencies' Names and Addresses Virginia Department of Transportation University of Virginia 1401 E. Broad Street Charlottesville Richmond, Virginia 23219 Virginia 22903				
Supplementary Notes				
Abstract The goal of this study was to determine the best configuration of retroreflective material on Railroad Crossing (crossbuck) signs and posts for improving the visibility and safety of passive highway-railroad grade crossings at night. The material costs of upgrading existing crossbucks with the retroreflectorized crossbuck systems were also explored. Five configurations for marking crossbuck

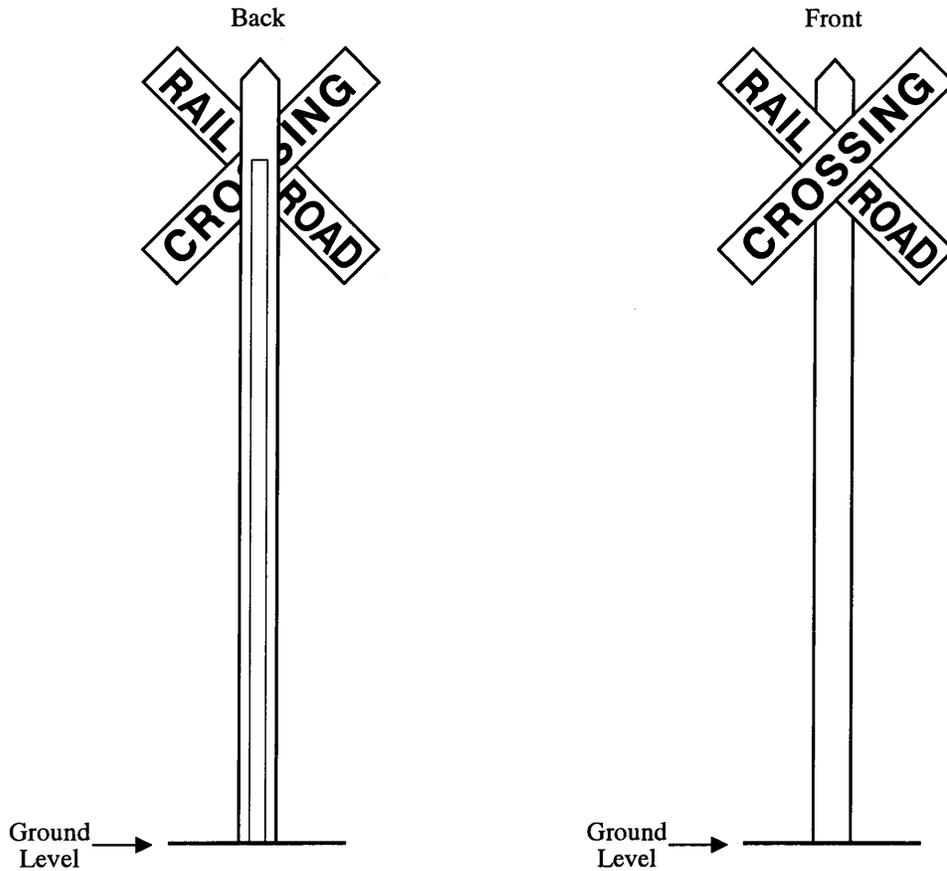
Figure 1

System No. 1

System No. 1 Characteristics

- Double-sided crossbucks with VIP™ sheeting
- 2 inch wide VIP™ sheeting installed on backside of post
- VIP™ sheeting is applied to post at or near ground level, to center of crossbuck mounting

Location Installed

- State Route 701 in Lunenburg County
- DOT-AAR No. 715-148J

After reviewing the literature and practices reported by other states, five marking configurations for passive highway-railroad grade crossings were developed (Figures 1-5). These configurations, or systems, are based on markings used in other states, modified in some cases by research findings. The characteristics and location of each system are noted in the figures.

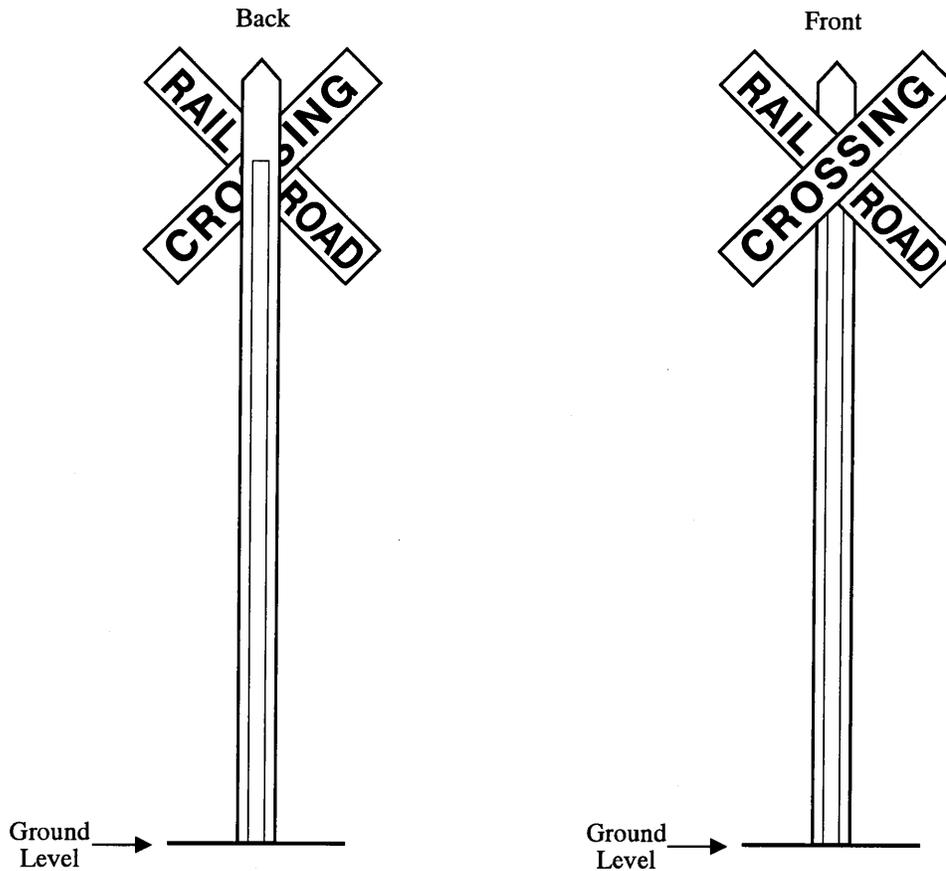
Figure 2

System No. 2

System No. 2 Characteristics

- Double-sided crossbucks with VIP™ sheeting
- 2 inch wide VIP™ sheeting installed on frontside and backside of post
- VIP™ sheeting is applied to post at or near ground level, to center of crossbuck mounting

Location Installed

- State Route 623 in Charlotte County
- DOT-AAR No. 714-112X

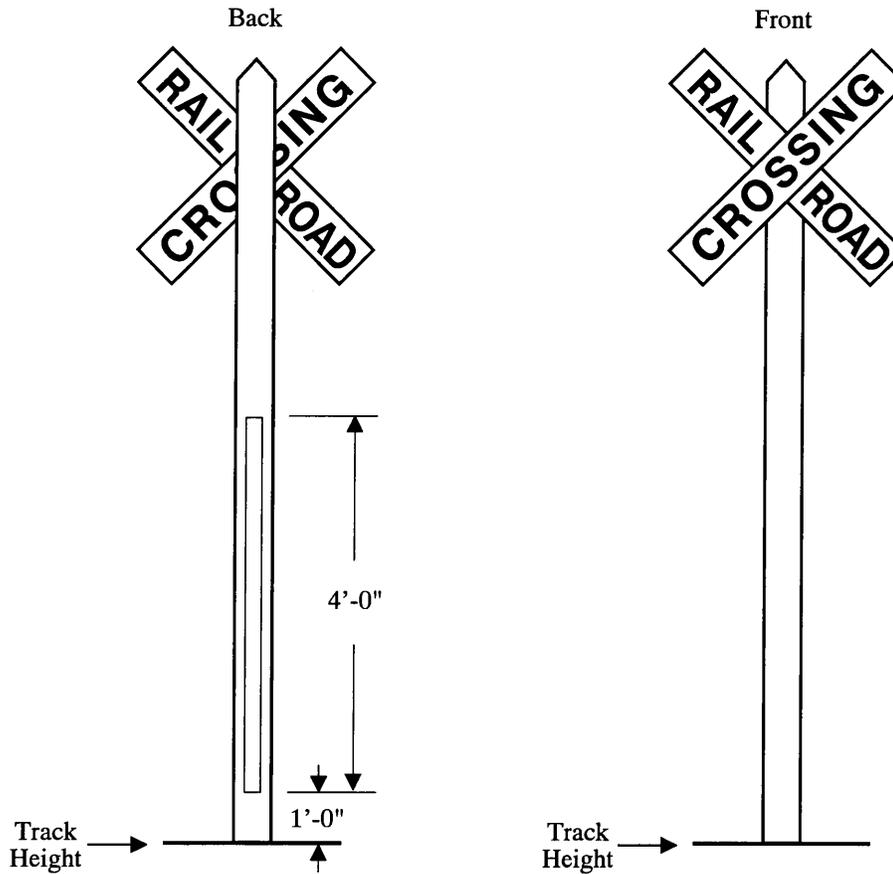
Figure 3

**System No. 3
(Minnesota System)**

System No. 3 Characteristics

- Double-sided crossbucks with VIP™ sheeting
- 2 inch wide by 4 feet long VIP™ sheeting installed on backside of post
- VIP™ sheeting is applied to post 1'-0" above a line parallel to the top of the track and intersecting the post.

Location Installed

- State Route 704 in Prince Edward County
- DOT-AAR No. 715-150K

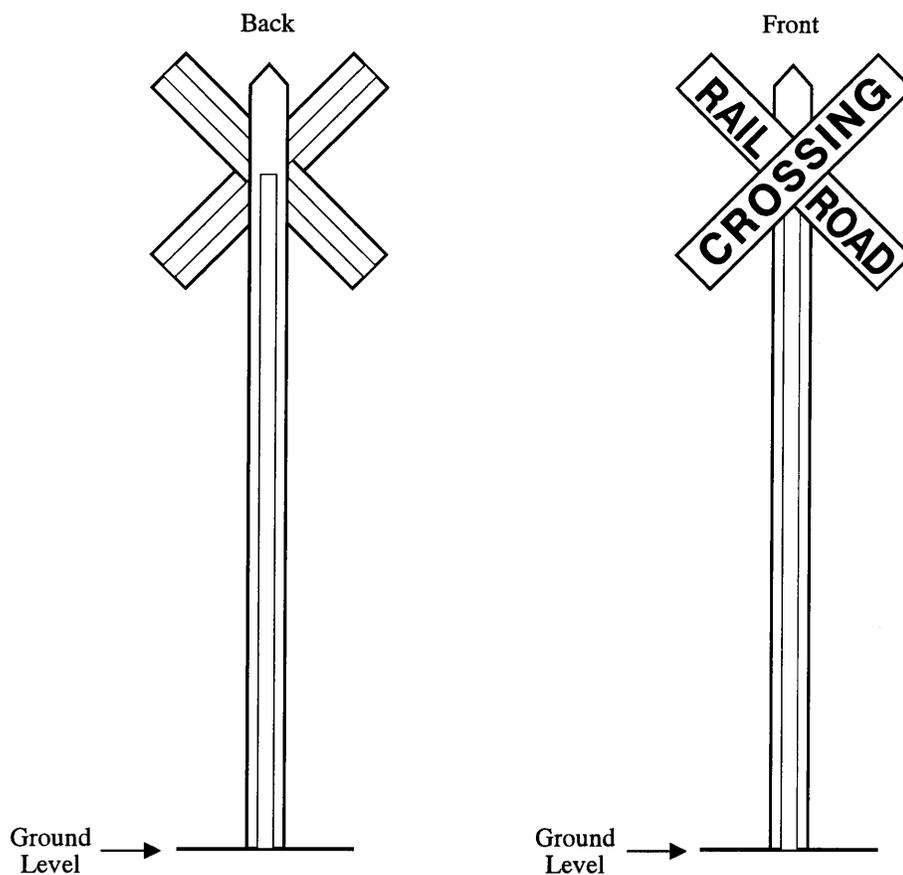
Figure 4
System No. 4

System No. 4 Characteristics

- Existing standard crossbucks
- 2 inch wide VIP™ sheeting installed on frontside and backside of post
- VIP™ sheeting is applied to post at or near ground level, to center of crossbuck mounting
- 2 inch wide VIP™ sheeting installed to back of crossbuck blades

Location Installed

- State Route 673 in Prince Edward County
- DOT-AAR No. 715-157H

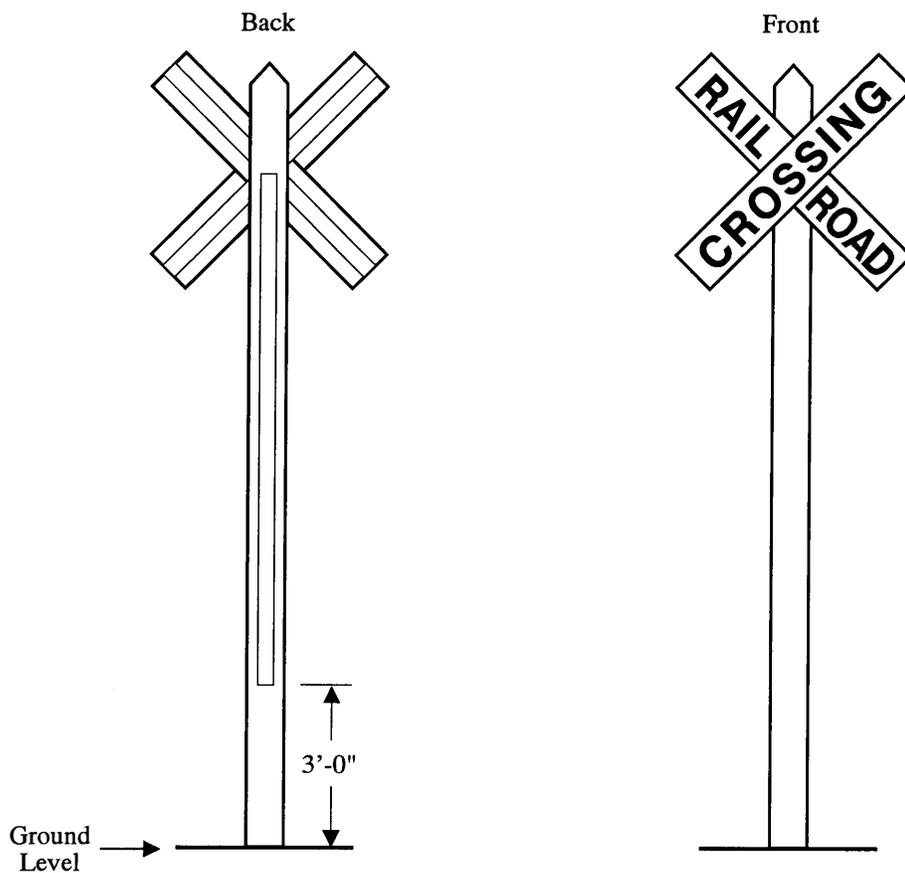
Figure 5
System No. 5

System No. 5 Characteristics

- Existing standard crossbucks
- 2 inch wide Diamond Grade™ sheeting installed on backside of post
- Diamond Grade™ sheeting is applied to post 3'-0" above ground level
- 2 inch wide Diamond Grade™ sheeting installed to back of crossbuck blades

Location Installed

- State Route 685 in Lunenburg County
- DOT-AAR No. 715-147C

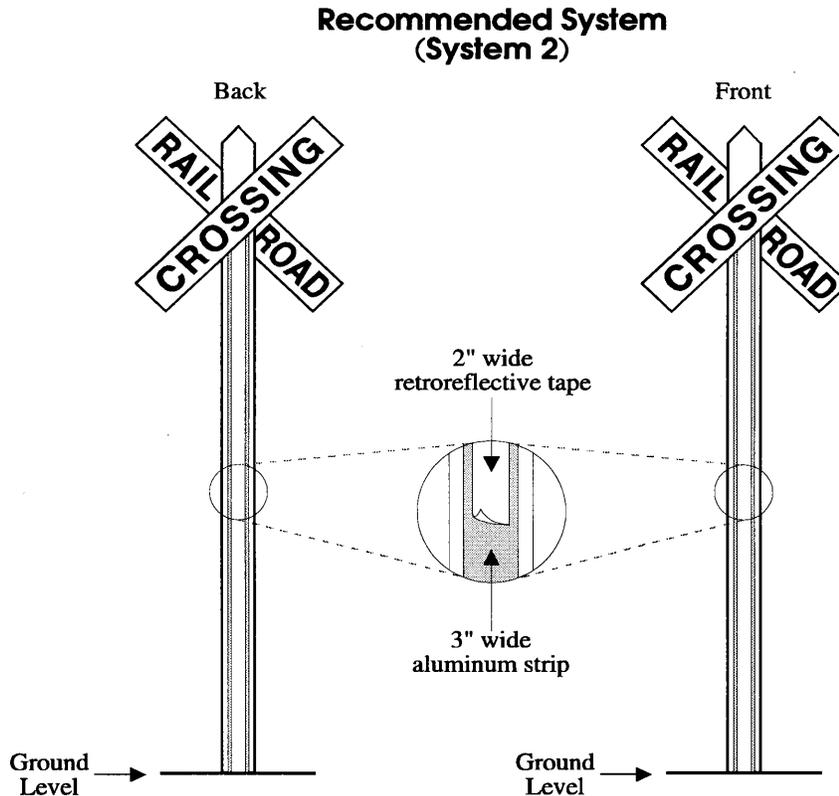
Figure 11

- Upgrading all public, passive grade crossings to System 2, consisting of highly retroreflective double-sided crossbucks, 0.040 inches (1.02 mm) thick, 3 inches (7.62 cm) wide, with 9 foot (2.74 m) aluminum strips applied to the front and back of the posts, and highly retroreflective 2 inch (5.08 cm) wide tape applied to the aluminum strips on both sides of each post (Figures 11, 12).

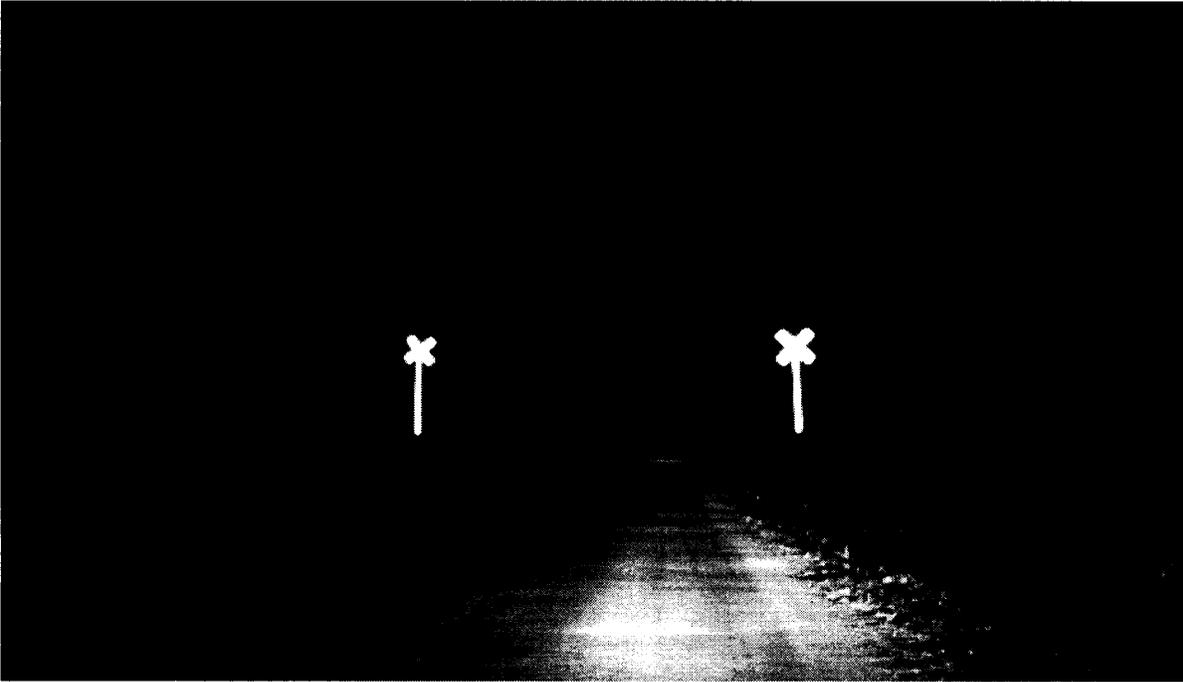
Figure 12. System 2 at night under low-beam conditions.

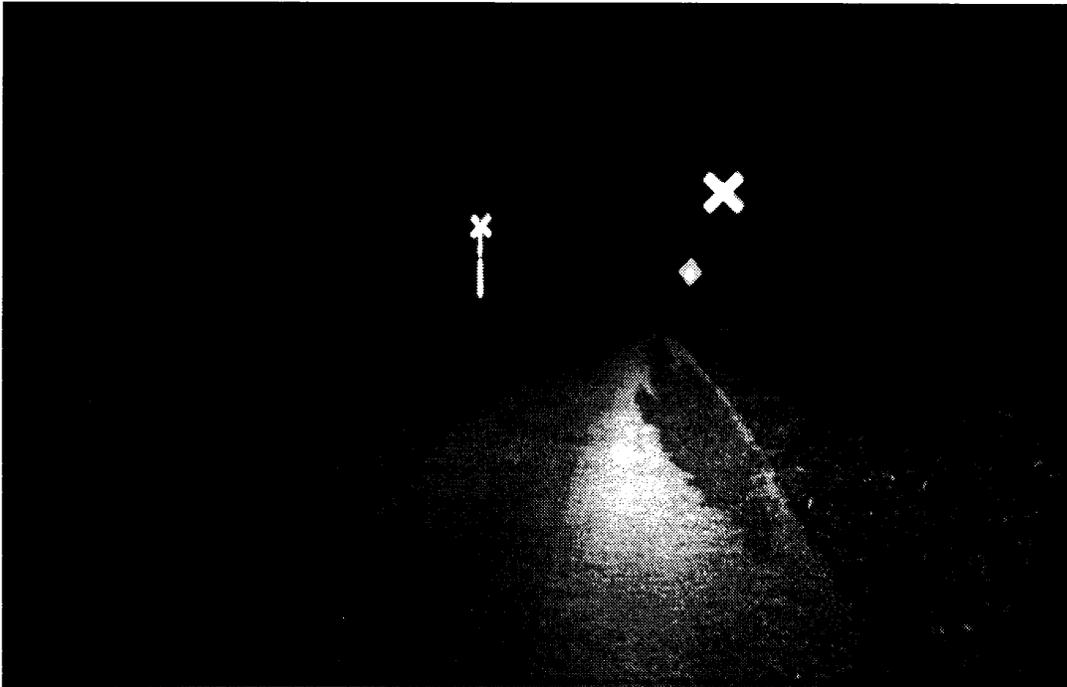
Photograph 6a- System 1, Northbound, Low Beam, 200 feet (61 meters).

Night photographs were taken of each approach to the five crossings using only the low and high beams from a vehicle for illumination (Appendix A, Figures 6-10). The researchers also videotaped driving through the crossings at night. Each location was driven through twice, once with low beams and once with high beams. The researchers videotaped a train traveling through each crossing, using only the high beams of a vehicle for illumination. The photographs and the videotape were then used as the media for a subjective analysis.

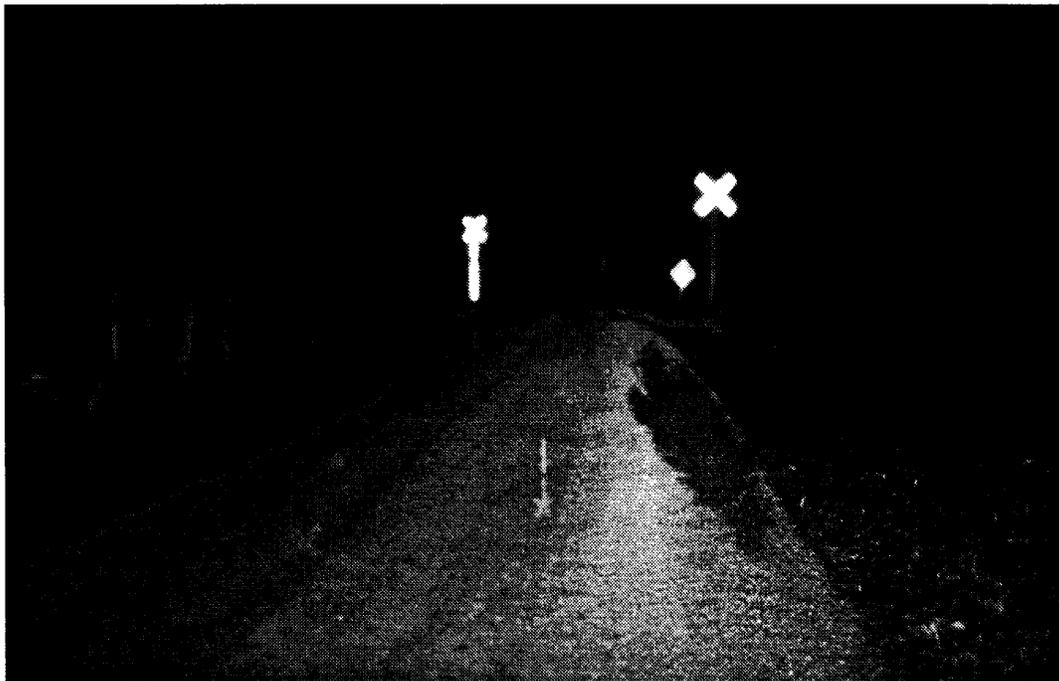
Photograph 6a- System 1, Northbound, High Beam, 200 feet (61 meters).

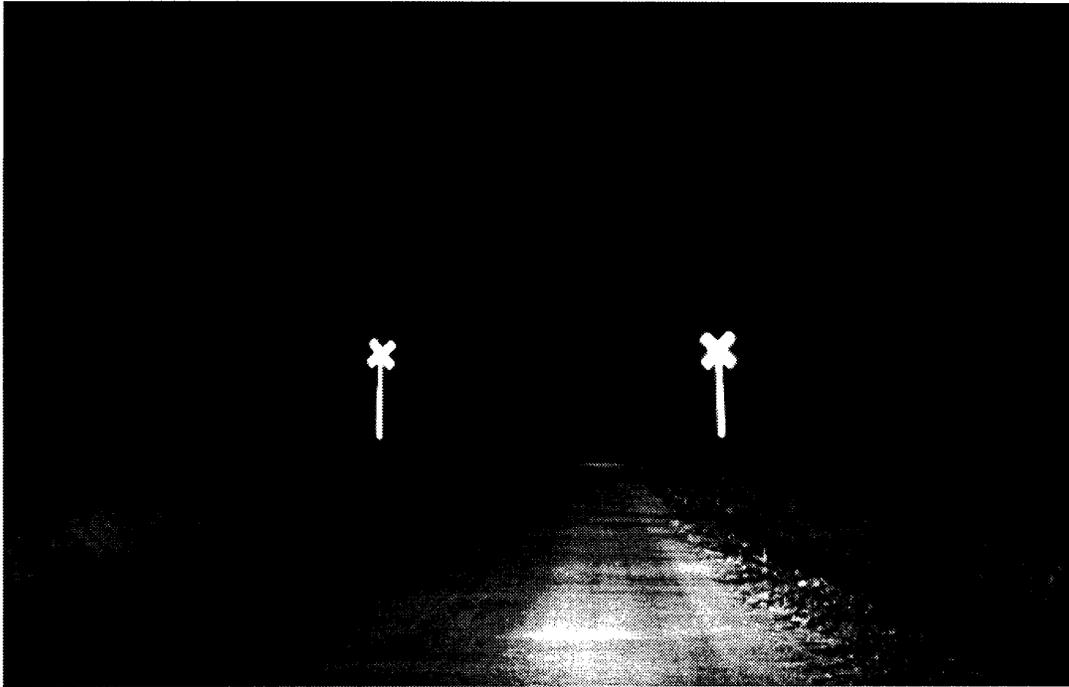
Photograph 7a- System 2, Eastbound, Low Beam, 200 feet (61 meters).

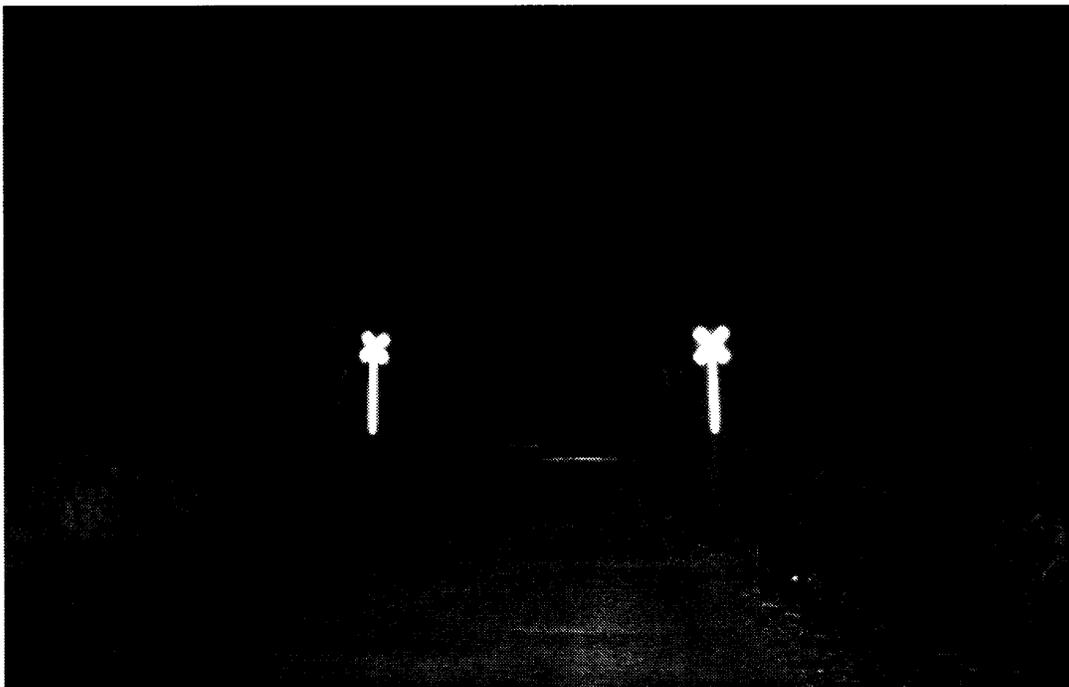
Photograph 7b- System 2, Eastbound, High Beam, 200 feet (61 meters).

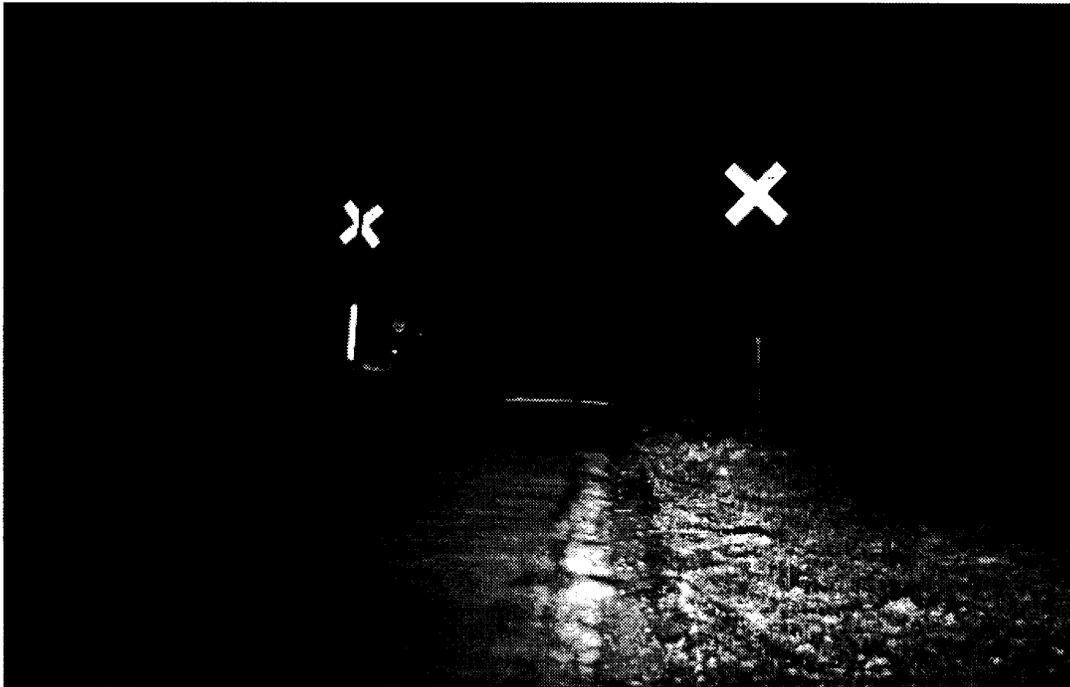
Photograph 8a- System 3, Northbound, Low Beam, 130 feet (40 meters).

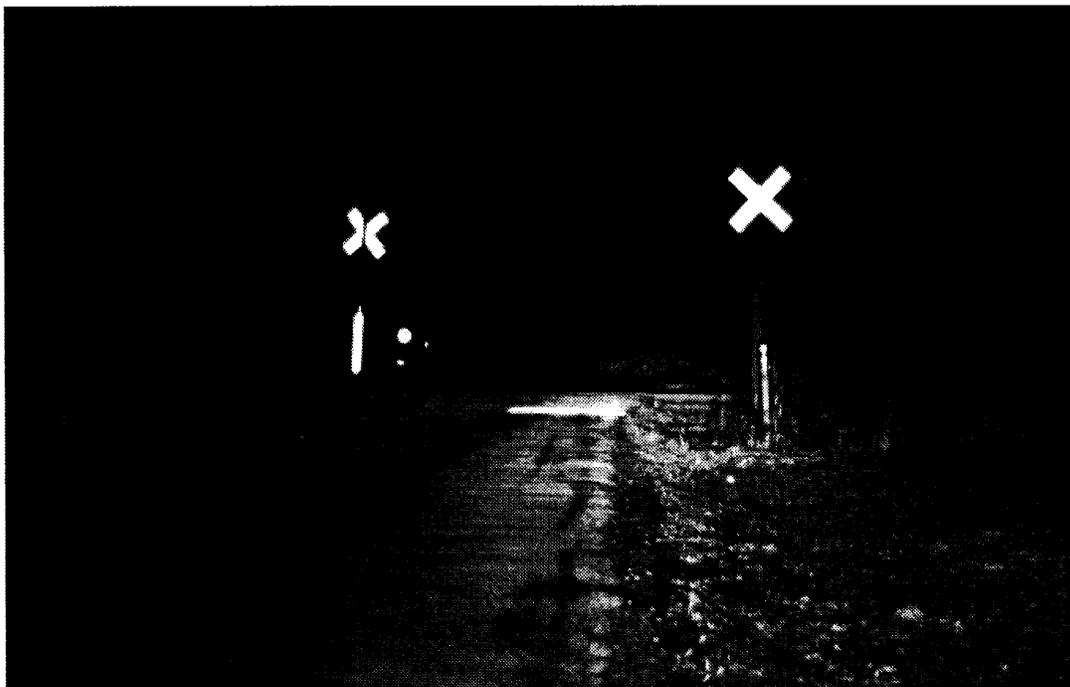
Photograph 8b- System 3, Northbound, High Beam, 130 feet (40 meters).

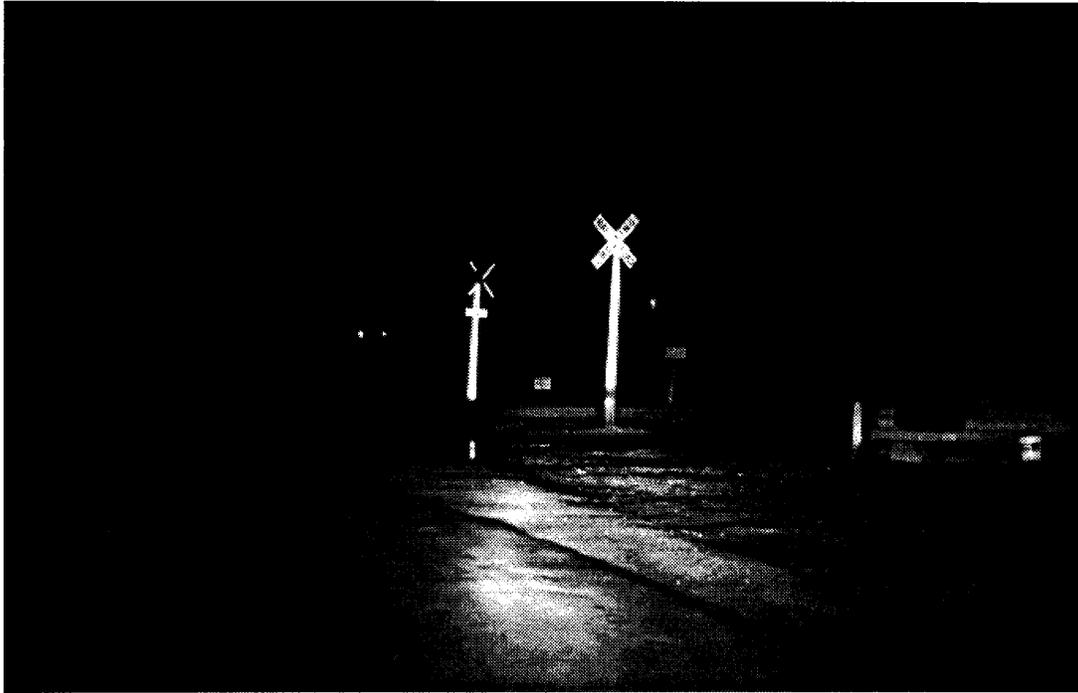
Photograph 9a- System 4, Southbound, Low Beam, 150 feet (46 meters).

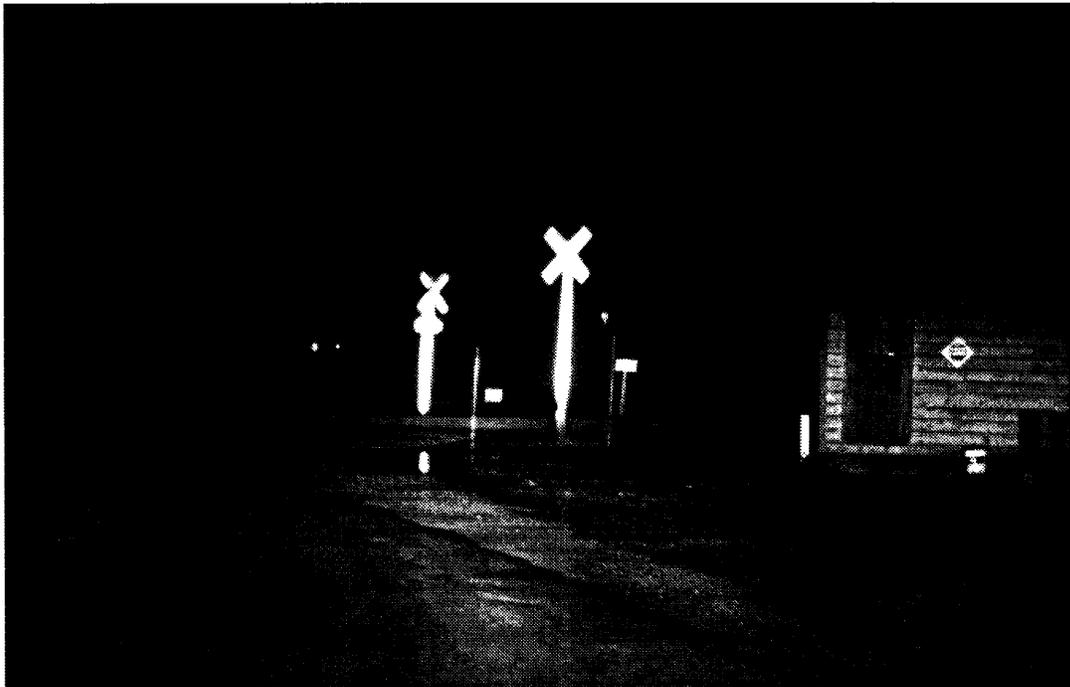
Photograph 9b- System 4, Southbound, High Beam, 150 feet (46 meters).

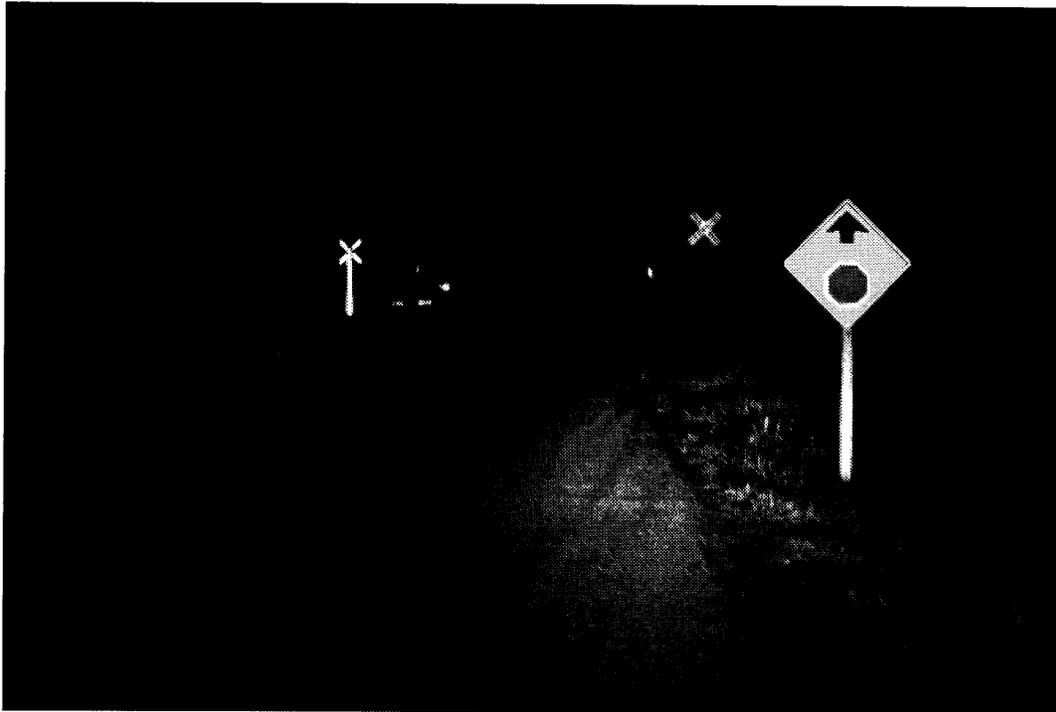
Photograph 10a- System 5, Northbound, Low Beam, 200 feet (61 meters).

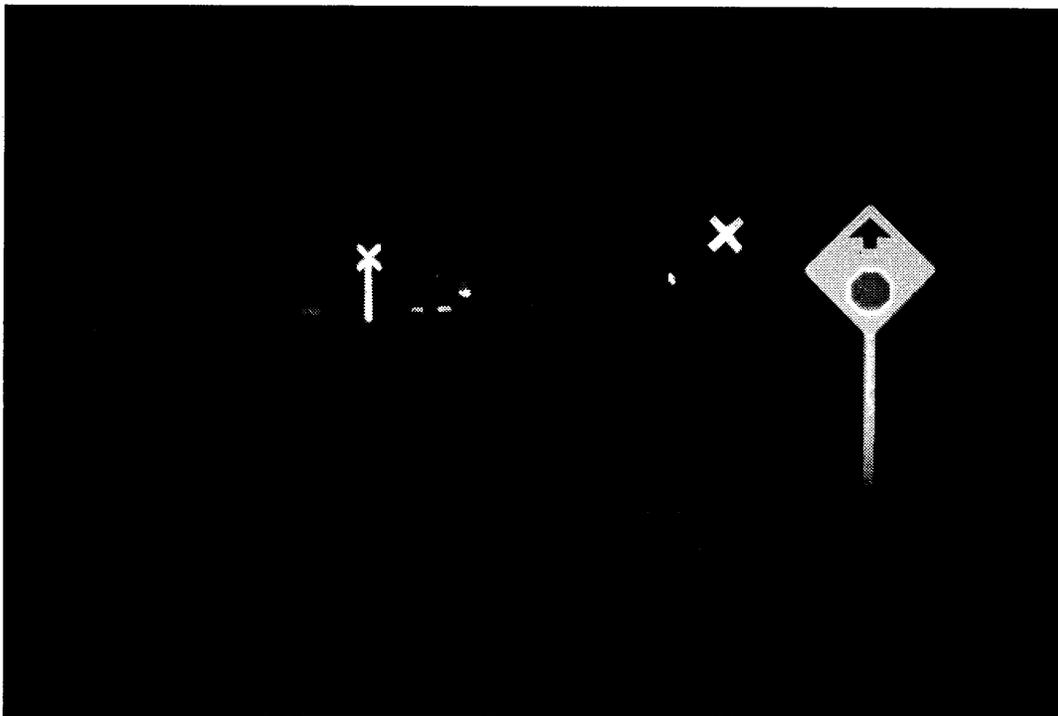
Photograph 10b- System 5, Northbound, High Beam, 200 feet (61 meters).
