FINAL REPORT

# ACOUSTIC EMISSION MONITORING OF STEEL BRIDGE MEMBERS

April 1997  
VTRC 97-R13

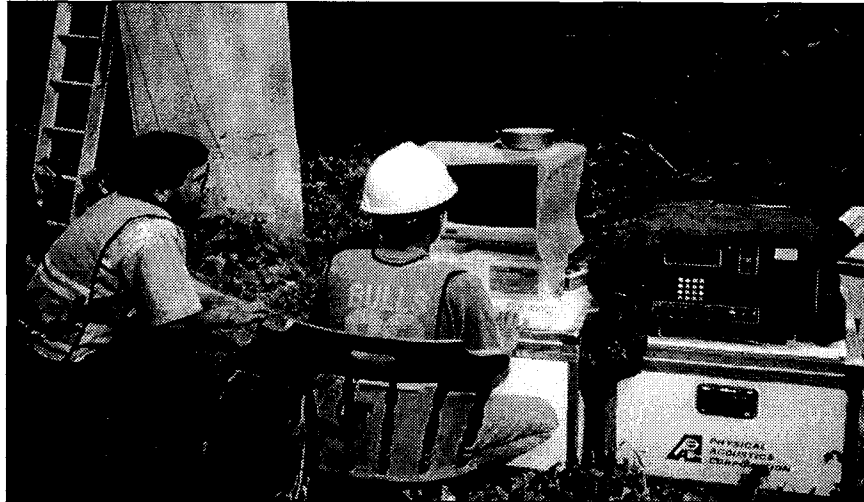
Figure 1. Spartan AT data acquisition system

Of the 8 channels available, 6 were used for performing signal measurements. These channels hold the circuitry that output the time domain parameters of an AE event such as counts, rise time, energy, peak amplitude, RMS, and duration. The two remaining channels were used to digitize and store AE waveforms using the PAC TRA212 Transient Recorder Analyzer system.

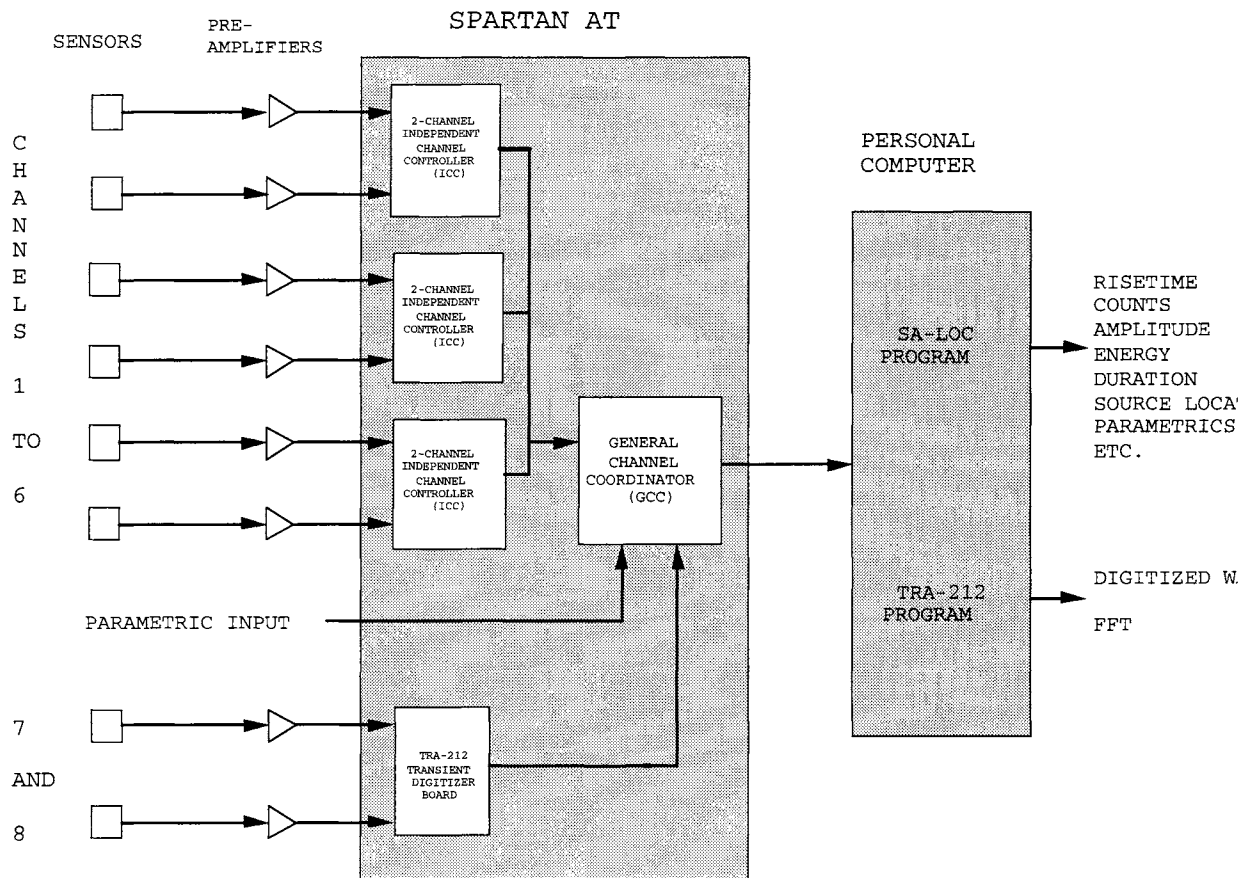
Figure 2. Bridge instrumentation

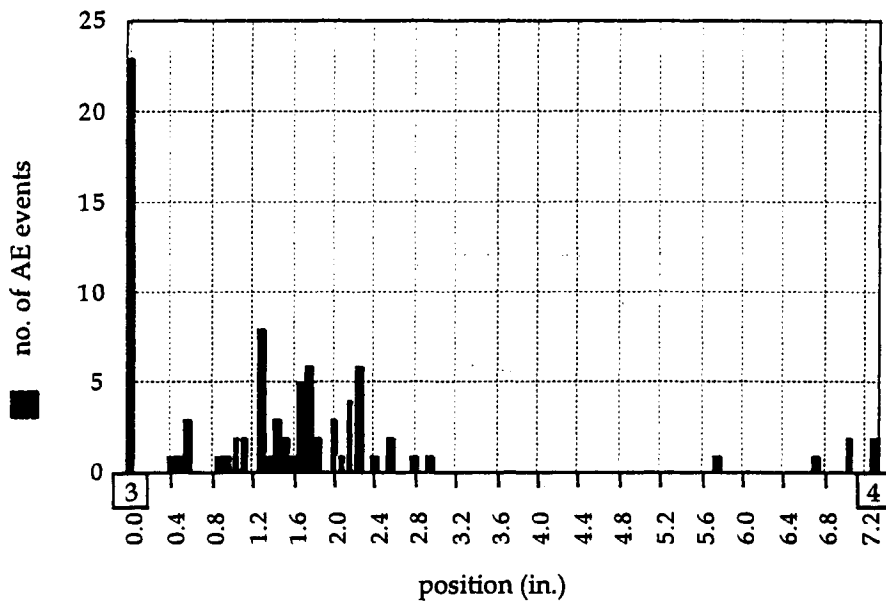
Figure 9. Source location results for Test 2: (a) without guard sensors, (b) with guard sensors

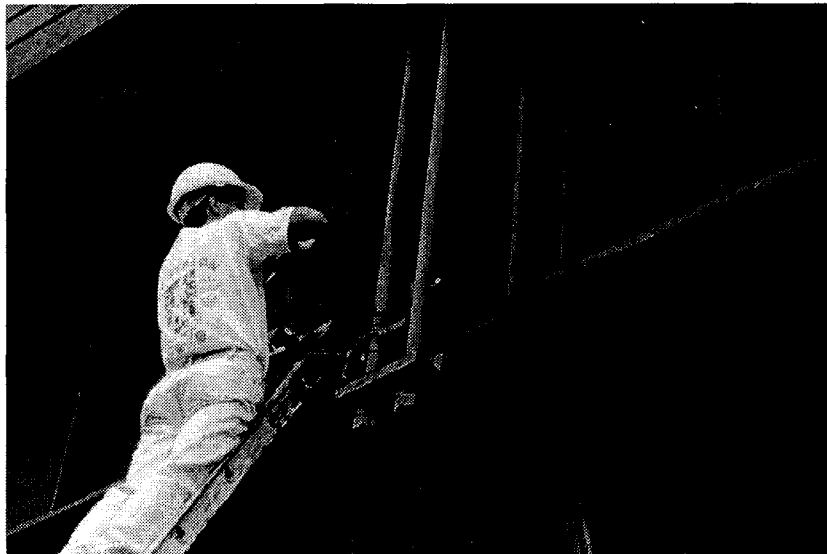
*Figure B1. Pin and hanger connection, Rte. 460 bridge in Glenlyn, Virginia*
