**PERFORMANCE
OF A CONDUCTIVE-PAINT ANODE
IN CATHODIC PROTECTION SYSTEMS
FOR INLAND CONCRETE BRIDGE PIERS
IN VIRGINIA**

1. Report No. FHWA/VTRC 98-R7	2. Government Accession No.	3. Recipient's Catalog No.	
4. Title and Subtitle Performance of a Conductive-Paint Anode in Cathodic Protection Systems for Inland Concrete Bridge Piers in Virginia		5. Report Date September 1997

September 1997
VTRC 98-R7

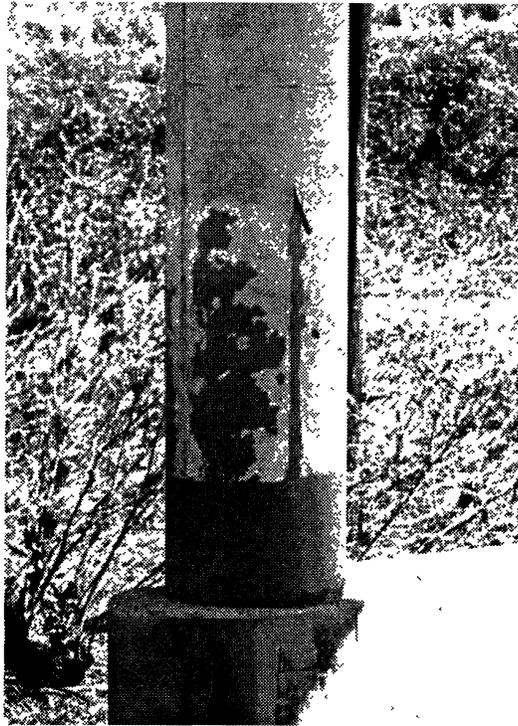
Figure 14. Damage of Conductive-Paint Anode System on Footing of Pier Protected by CP System 1.

Table 7 lists the extent of the damage to the paint on each of the 10 piers protected by System 1, which is 8 years old. As indicated, the damage ranged from 0 to 2.50 m², or 0 to 2.40 percent, of the total painted area on each pier. In comparison to the damage on most of the piers, the damage of 2.40 percent on pier 3 of the southbound bridge was relatively large and unusual. Since the damage was restricted to the pier footing on the upstream side (Figure 14), it was attributed to abrasion and impact damage caused by recent severe flooding that sent timber debris crashing against the pier. When this unusual damage is excluded from consideration, the damage from natural degradation of the conductive paint system ranged from only 0 to 0.37 percent. It must be noted that most of the damage occurred on the ends of the pier caps (Figure 15), where they are not sheltered from rain by the bridge deck above. This indicates that such areas are more exposed to rain, which may result in more discharge of current in those areas during rain and, therefore, relatively faster degradation of the paint. A consolation is that the concrete in such areas in pier caps is typically considerably less susceptible to rebar corrosion, because it is not directly below deck joints. Nevertheless, this aspect will have to be considered carefully in the design of future CP systems of this type.

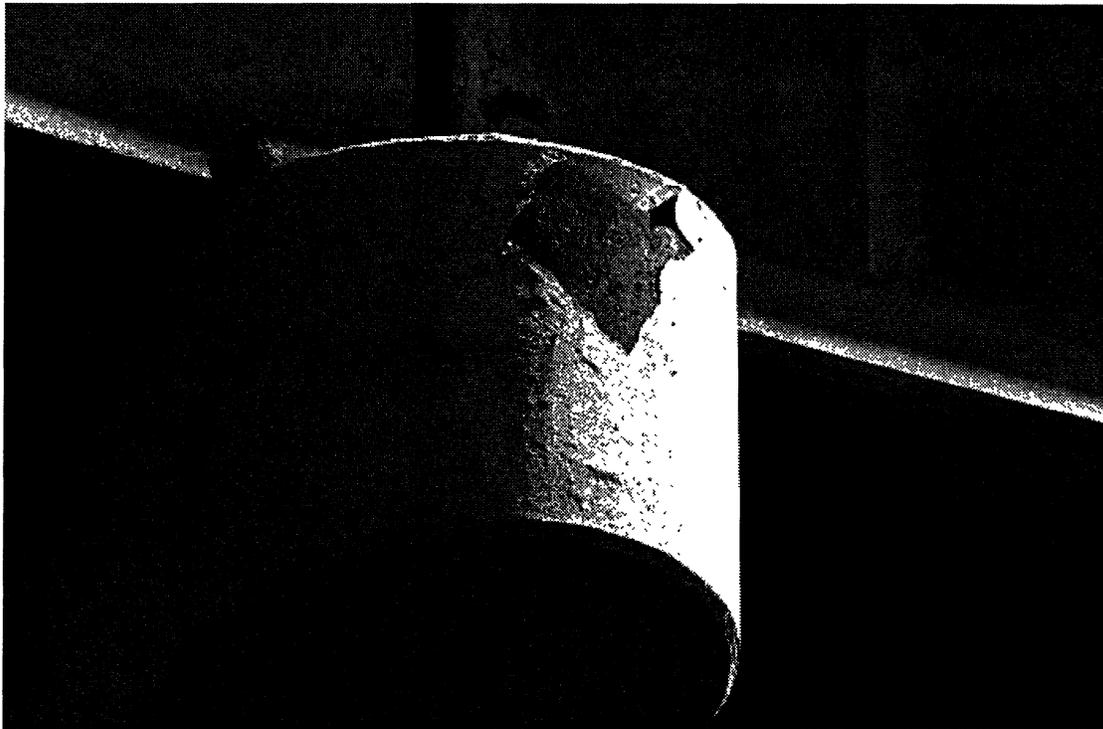
Figure 15. Damage of Conductive-Paint Anode System at End of Pier Cap Protected by CP System 1

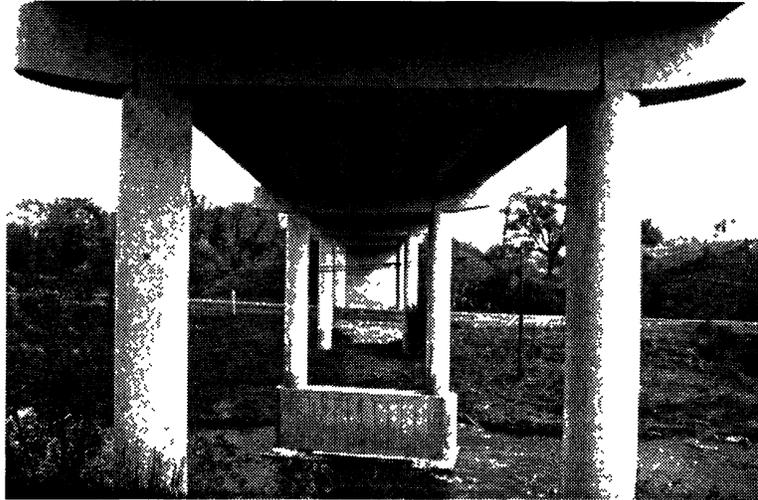
Figure 17. View of CP System 1 as of April 1977

In general, the overall condition of the conductive paint in both systems appeared to be very good, as shown in Figures 17 and 18. Therefore, it can be concluded that the conductive-paint anode is holding reasonably well, so far. It must be emphasized, however, that similar good results would likely not be obtained if the conductive paint was used on concrete members that are constantly wet, e.g., concrete piles in marine environments, especially if the paint is applied near the edge of the water. The important key to remember is that no paint or coating will last long when used on a substrate that remains wet all the time; the more frequent the substrate becomes wet, the faster the paint will deteriorate.

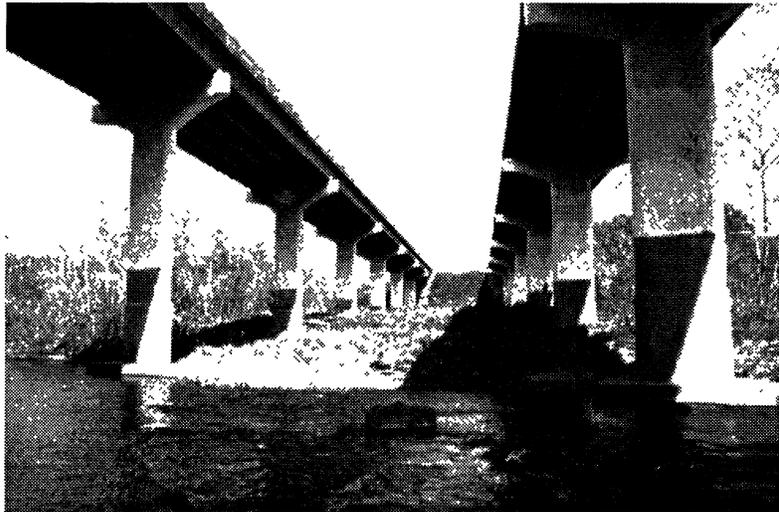
Figure 18. View of CP System 2 as of November 1996
