*Microwave Detection of Fatigue Cracks in
Specially Prepared Steel Specimens*

Final Report

**Virginia Transportation Research Council
530 Edgemont Road
Charlottesville, VA 22903**

VTRC 99-CR3

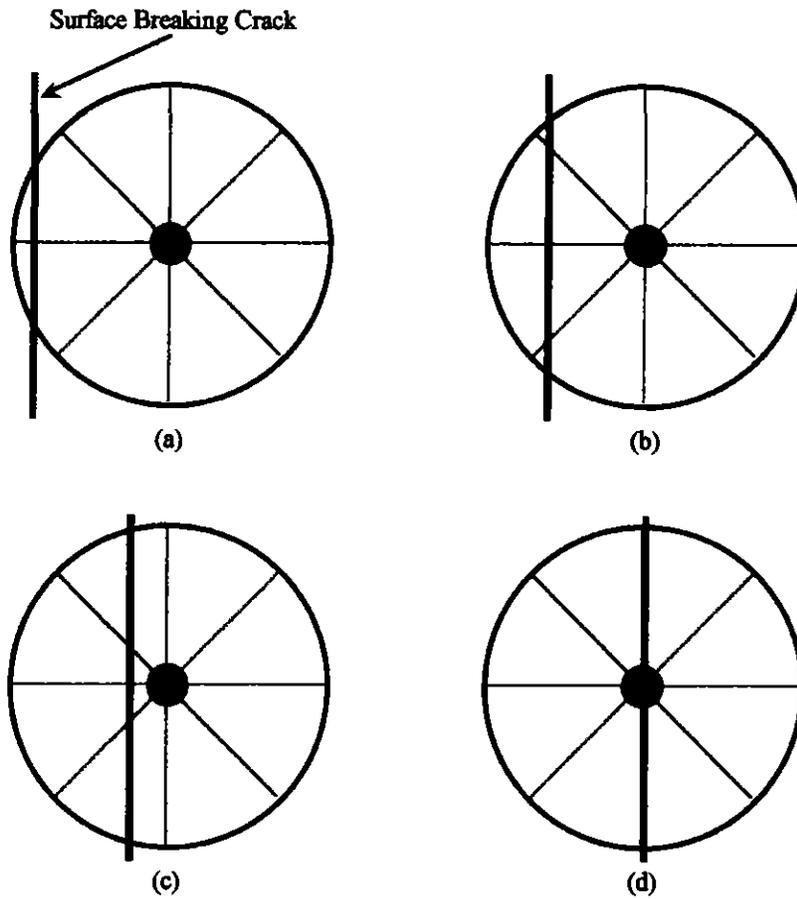
Figure 4: Interaction between current distribution and a surface breaking crack as it moves from the outer conductor to the inner conductor (a to d) of an open-ended coaxial probe aperture [25].

open-ended coaxial aperture, the coaxial line is considered to be short-circuited. This means that microwave currents will be induced on the surface of the metal plate. These currents follow the electric field lines and their amplitudes decrease as a function of distance away from the inner conductor (towards the outer conductor) [25]. Figure 4 pictorially describes the process of current distribution perturbation as half of the coaxial aperture scans a crack. Namely, a surface breaking crack on a conductor surface perturbs the current flow as the crack moves from the outer conductor towards the inner conductor. Since the current distribution has axial direction and the crack does not, as the crack moves from the outer conductor to the inner conductor, the current distribution becomes increasingly perturbed (Figure 4a-c). In addition, the magnitude of the surface currents increases as a function of decreasing distance from the inner conductor. Moreover and unlike open-ended rectangular waveguide aperture probes, the electric field polarization is axial which makes crack detection much more independent of the crack relative orientation than open-ended waveguide probes. This is an important feature of this probe. When the crack coincides with the inner conductor the current distribution is minimally (hardly any) perturbed, and a similar situation to that of the short-circuited case when the crack is outside the aperture occurs (Figure 4d). As the crack continues to move towards the outer conductor, on the other side, the opposite is repeated.

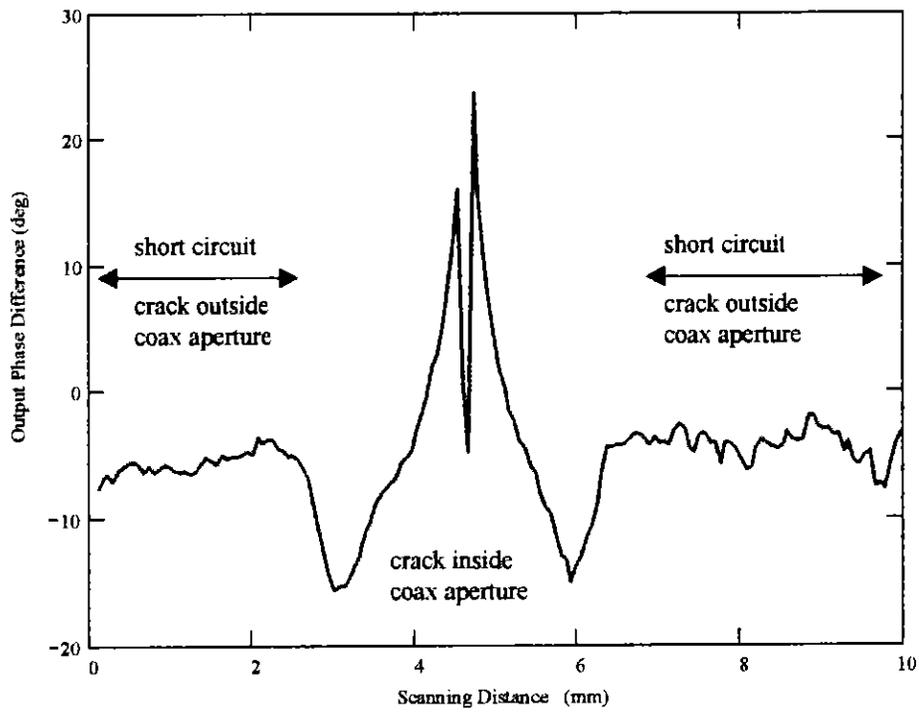
Figure 5: Crack characteristic signal of a machined notch at 9 GHz using coax # 3.

to this varying reflection coefficient gives an indication of the presence of the crack [25,26]. This distinct signal is referred to as the “*coax crack characteristic signal*”, and it gives a clear indication of the presence of a crack. Figure 5 shows a typical coax crack characteristic signal for a machined slot with a width of 0.2 mm and depth of 0.4 mm using coax # 3 (see Table I) at a frequency of 9 GHz. It is important to note that this is a typical signal for a machined slot in a flat and smooth aluminum specimen. The introduction of a slight liftoff and coatings such as rust and paint along with sever surface roughness (such as weld joints) alters the shape of this signal. In such cases the two distinct sides of this signal combine together producing one signal or “a bump or a dip” in between the two short circuit regions. Also, in these cases, the short circuit regions do not remain as flat and uniform, as shown in Figure 5.

Another issue that must be mentioned is that when detecting cracks on welds, due to the lack of relatively smooth scanning surface, the measurement results can significantly be different in shape compared to the results shown in Figure 5. In some cases where the crack is between two weld "humps", this probe may not be able to detect the crack.

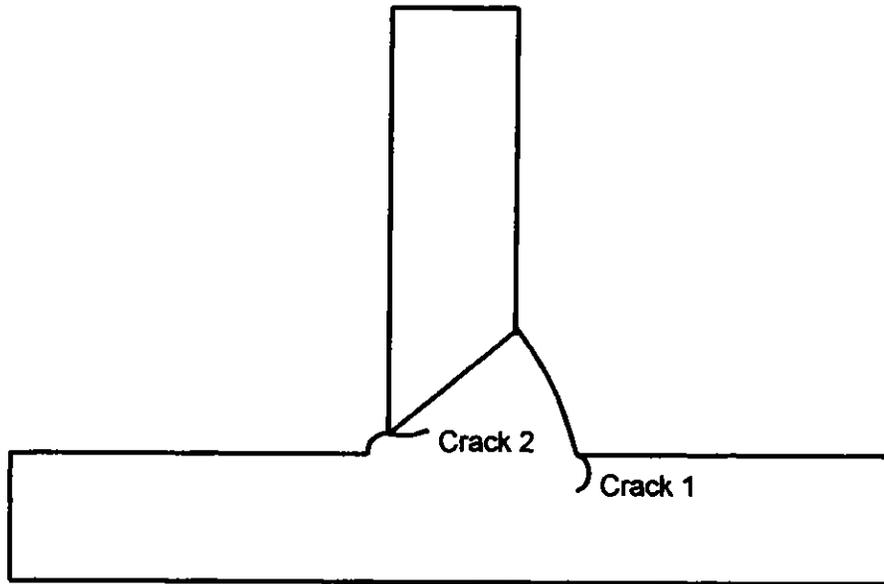
Defect No.	Defect Type	Defect Length(mm)	Distance From Datum (mm)	Max UT Indication db	Angle
1	Centerline Indication	64	74.9	N/A	N/A
2	Transverse Indication	5.8	192.8	N/A	N/A

Figure 10: The cross-section geometry of sample T1495.

- 3- Two T-shaped samples each made of two plates (A and B) where plate B was welded perpendicularly to the middle of plate A, with each sample containing two cracks (Figures 10 and 11), these samples are called T1495 and T1496. Sample T1495 had two cracks that were on the weld. Crack one was a centerline indication with a length of 64 mm, and crack two was a transverse indication with a length of 5.8 mm. Sample T1496 also had two cracks that run along the edge of the weld. Crack one was a toe indication with a length of 71 mm, and crack two is a root indication with a length of 34 mm.

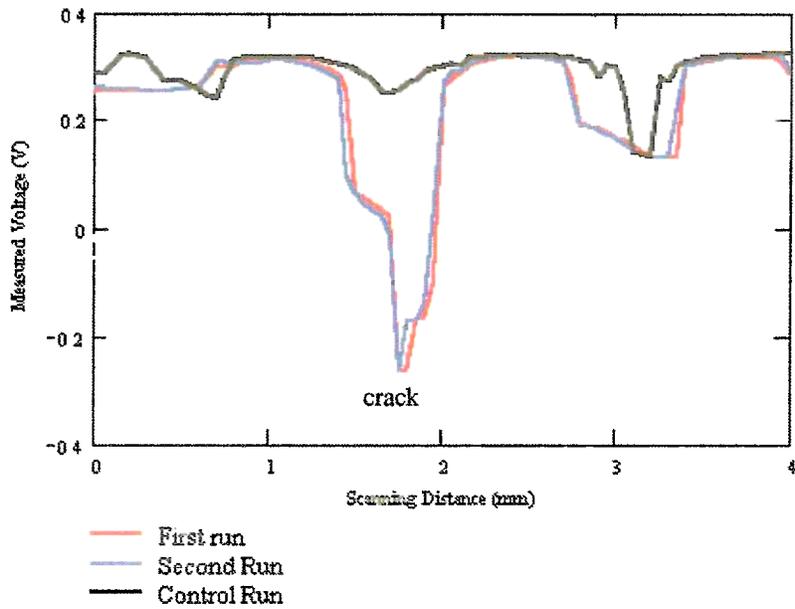
Figure 15 Crack characteristic signal of the first crack on sample PL1497 at 11.9 GHz using coax # 3

The same setup used to detect the cracks on the pipe specimen was used to inspect the two flat plate samples PL1497 and PL1498 of this group. Figure 15 presents the results obtained from scanning the first crack in sample PL1497 at 11.9 GHz. The crack was relatively close to the weld line and this made it relatively difficult to scan across the crack. Thus, this scan and many others were conducted, on this sample, by positioning the probe in between the crack and the weld line and then moving it across the crack. That is why the signal indicating the presence of the crack is close to the beginning of the scan. The presence of the crack is indicated by the peak obtained between 0.5 mm and 1 mm on the scanning distance axis. The cracks on the PL1498 were on the weld line and consequently there was no way, at that time, to scan across the cracks.

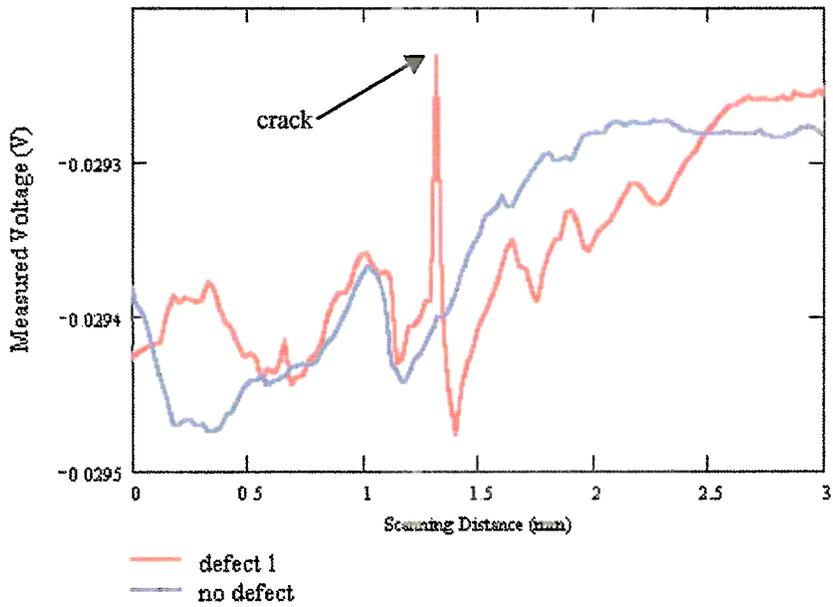
Figure 16 Crack characteristic signal of the first crack on sample T1495 at 11.9 GHz using coax # 3

The T-plate specimens (T1495 and T1496) were inspected next. Specimen T1495 had a crack on side B that is perpendicular to the weld line. Figure 16 shows two 4 mm-long scans of the first crack on this specimen at a frequency of 11.9 GHz twice with the crack

present and once over an area devoid of cracks. The presence of the crack is detected as indicated in Figure 16. The two scans of the crack, shown in Figure 16, were conducted to check the repeatability. The signal detected due to the presence of the crack is clearly distinct from the signals obtained from outside the crack region (and from the region with no crack denoted as “control run”). The results indicate the sensitivity of the probe to the presence of the crack, as well as the repeatability associated with this technique once a crack is detected. The cracks on the second specimen T1496 were on plate A and were very close to the weld line. Again there was not enough space to scan across the crack. Later on in the study, we were able to modify the scanning procedure and were able to detect such cracks, as will be explained later.

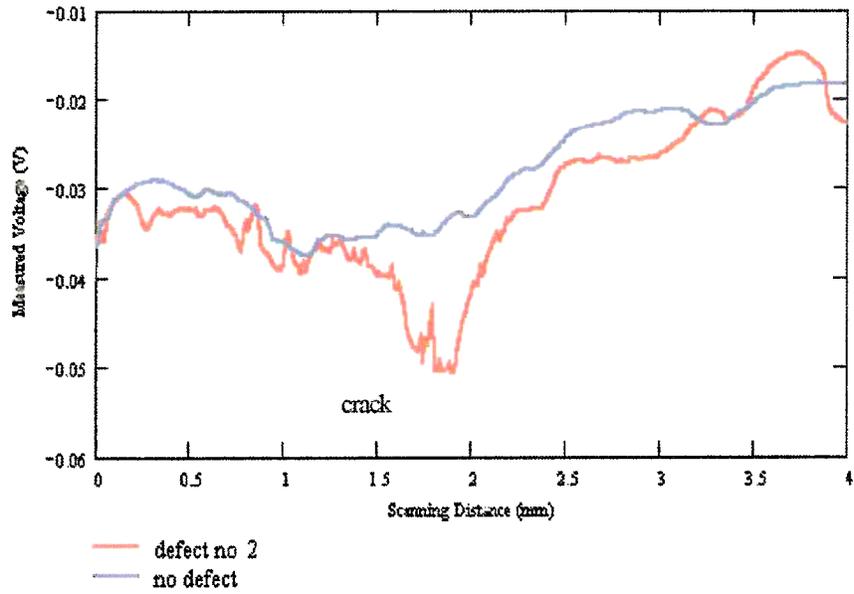
Figure 17. Crack characteristic signal of the first crack on sample PL1497 at 24 GHz using coax # 3

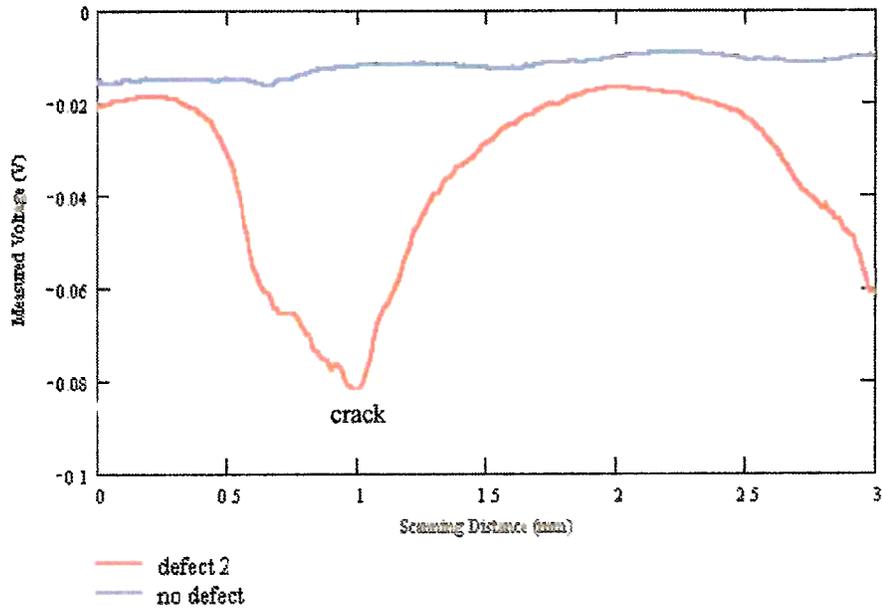
Figure 19 Difference between the two signals shown in Figure 18

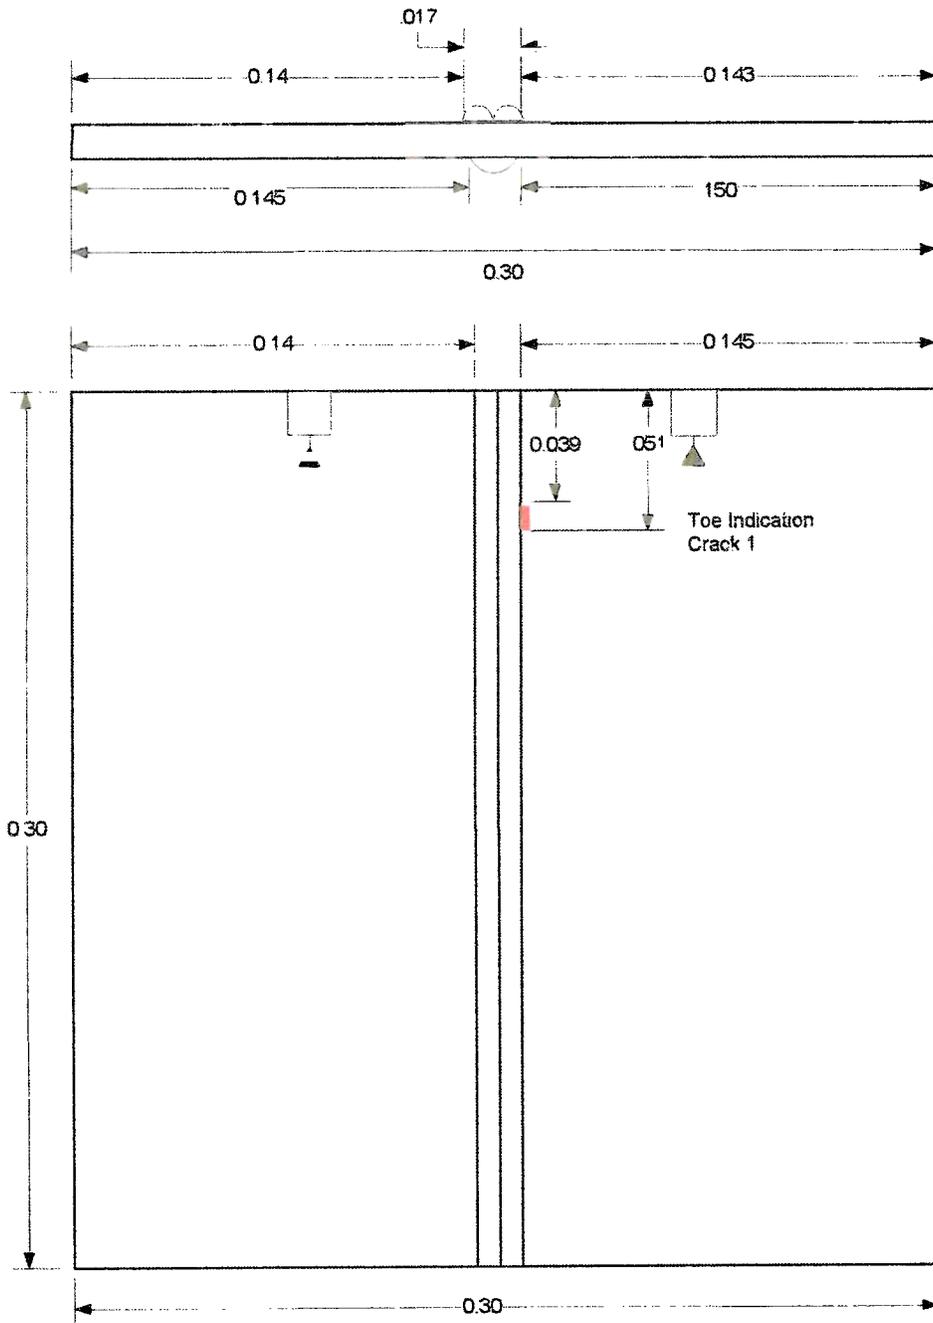
Figure 25a The side and top views of the geometry of sample PL4295 (dimensions are in mm)

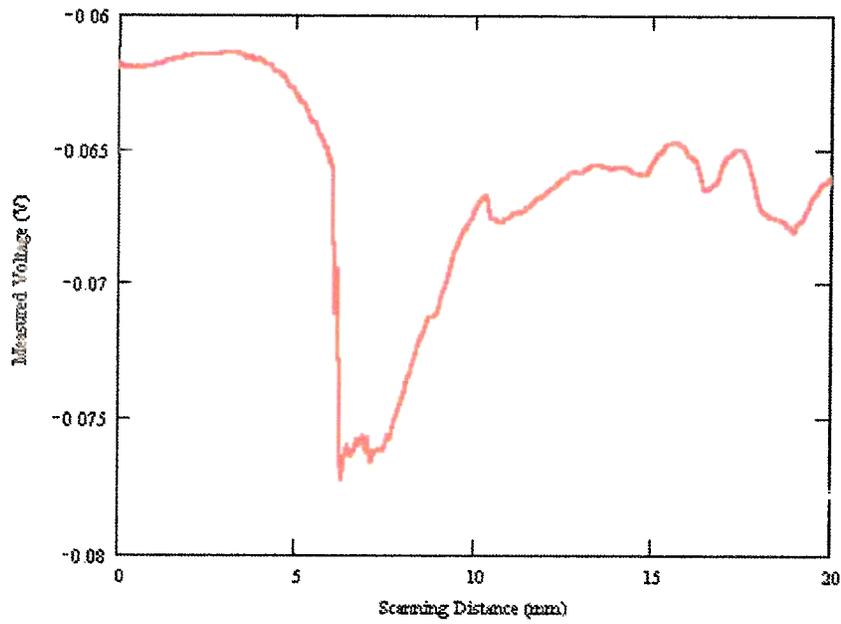
Figure 42. Crack characteristic signal of the first crack on sample PL4295 at 32.15 GHz using coax # 3

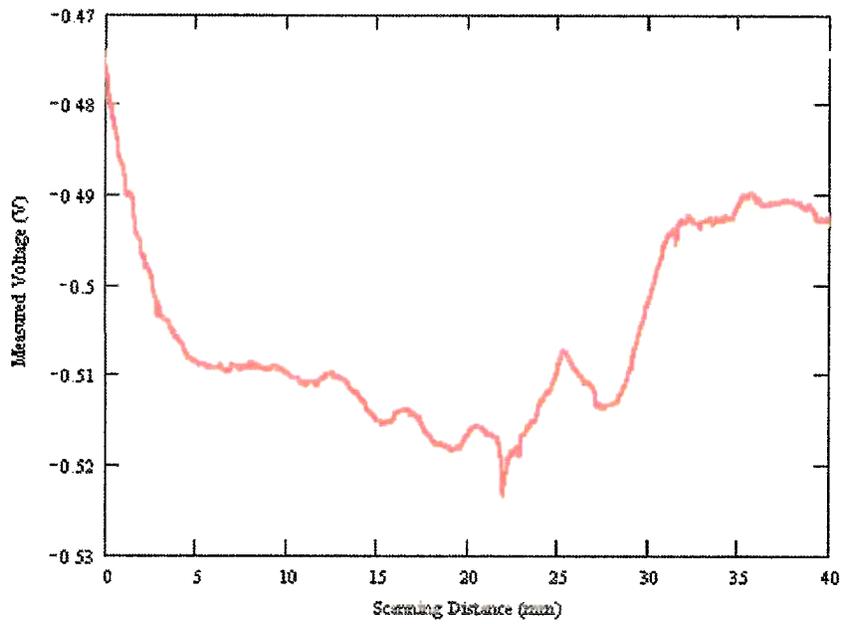
Figure 43. Crack characteristic signal of the second crack on sample PL4295 at 31.4 GHz using coax # 3

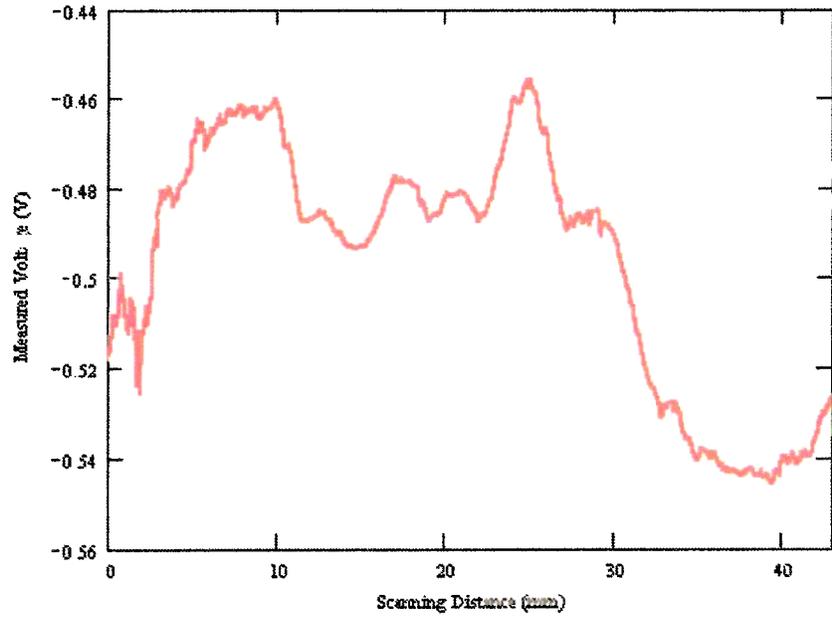
Figure 44 Crack characteristic signal of the second crack on sample PL4295 at 31.6 GHz using coax # 3

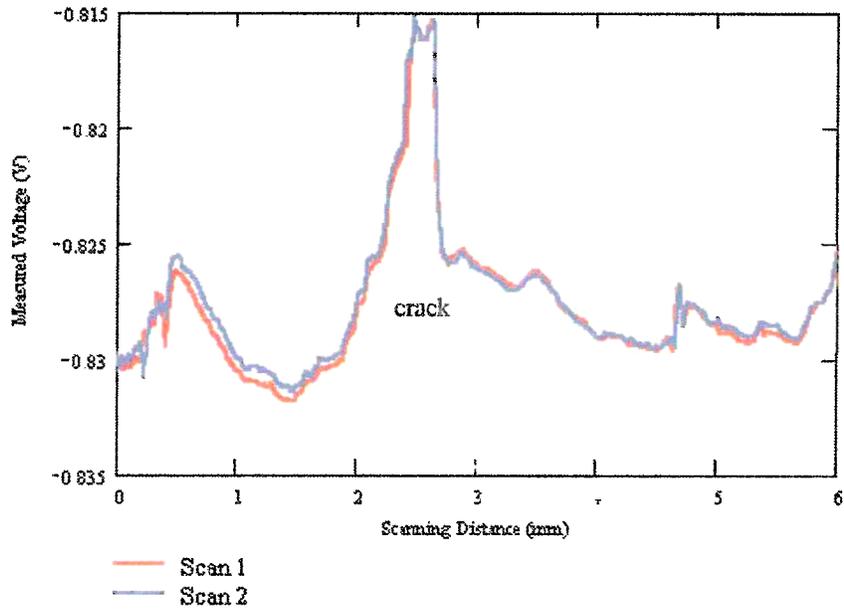
Figure 48. Crack characteristic signal of the first crack on sample T4297 at 35.6 GHz using coax # 2

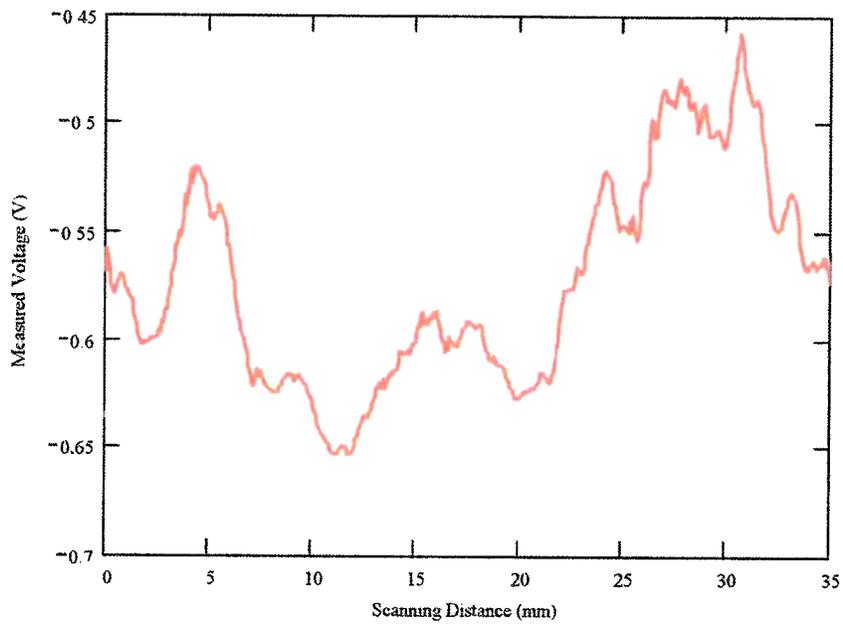
Figure 65 Crack characteristic signal of the second crack on sample PL4295 at 32.0 GHz using coax # 3

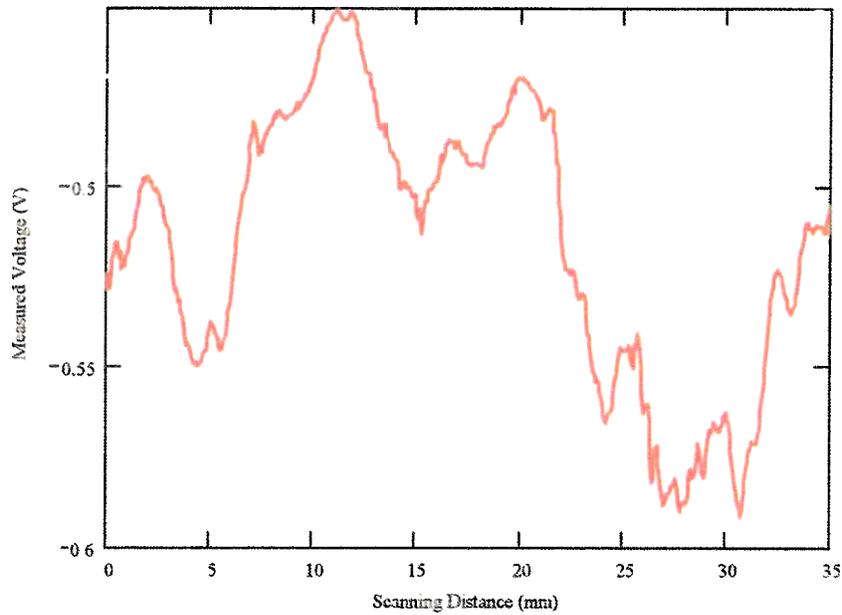
Figure 66 Crack characteristic signal of the second crack on sample PL4295 at 32.7 GHz using coax # 3

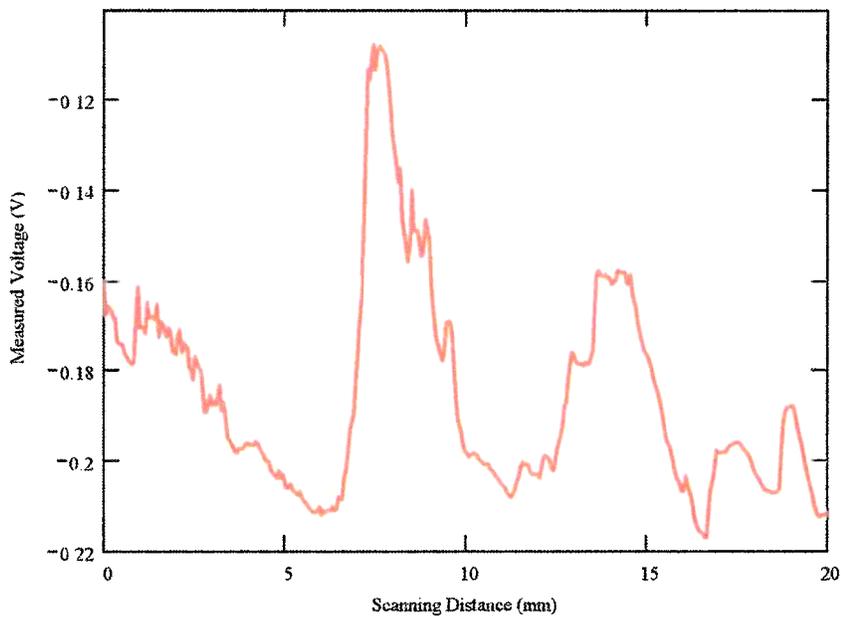
Figure 75 Crack characteristic signal of the first crack on sample PL4295 at 30.6 GHz using coax # 3

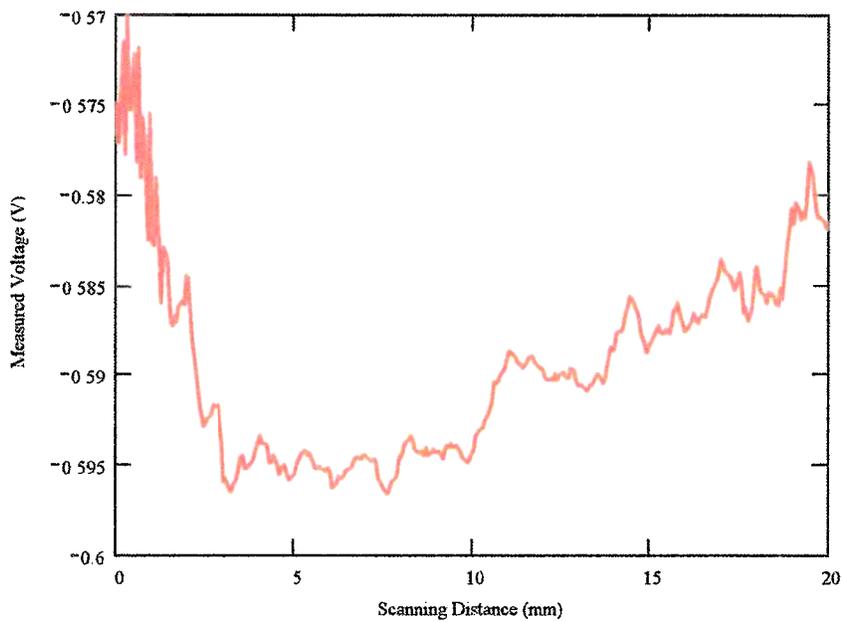
Figure 81 Crack characteristic signal of the first crack on sample PL4295 at 30.6 GHz using coax # 3

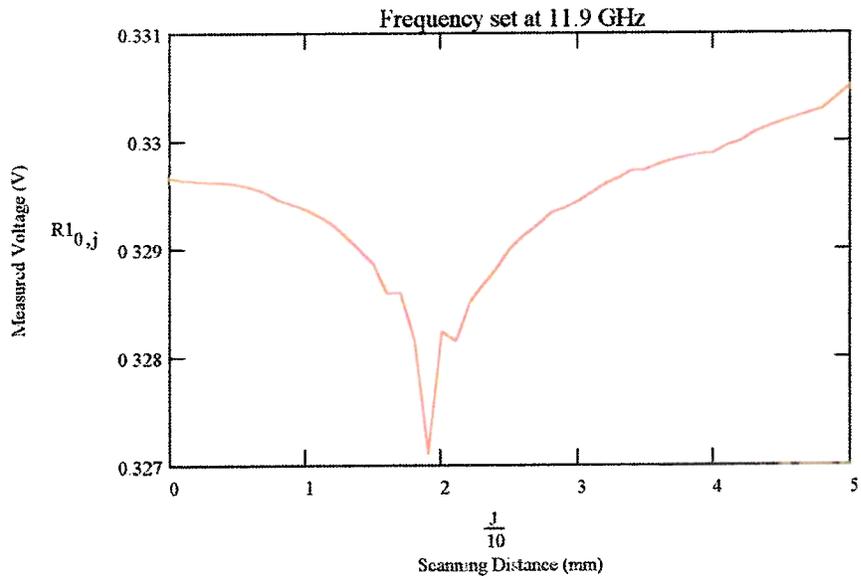
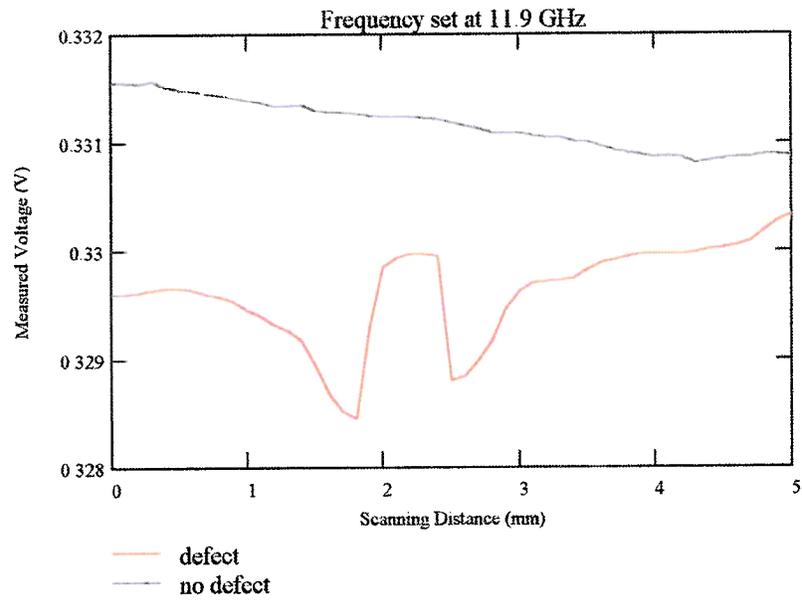
I. Pipe Sample
A. Crack #1

Frequency Band: X-band
Orientation: Scan perpendicular to crack length
Scan Resolution: 0.102 mm per step
Scan length: 20 mm
Frequency: 11.9 GHz

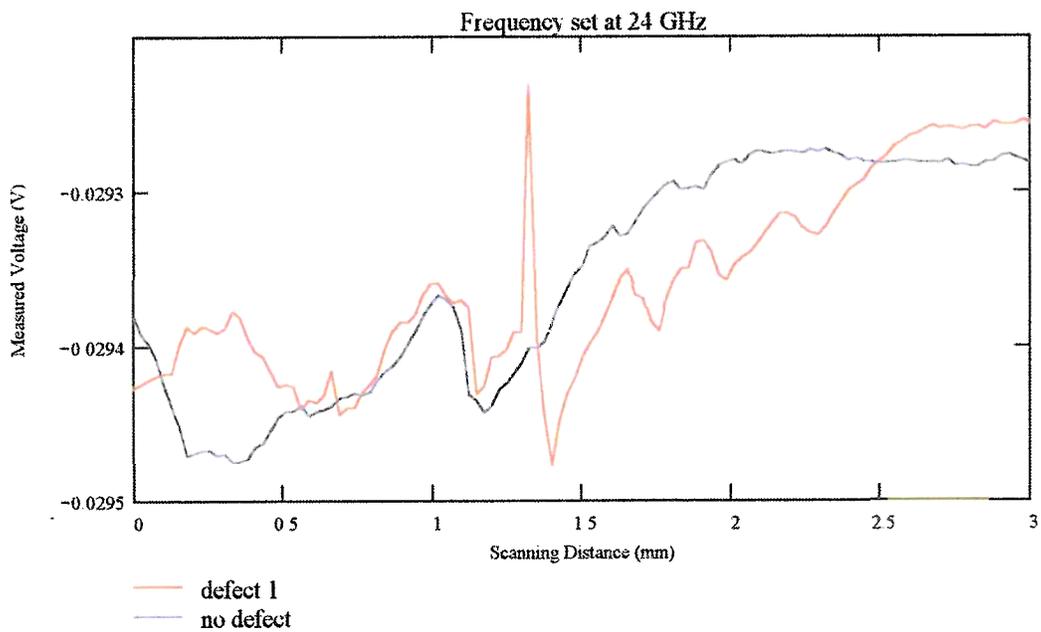
This is a Centreline Indication crack. The length of the crack is 1.45 in. This crack runs parrallel to the welded joint.

Frequency Band: K-band
Orientation: Scan perpendicular to crack length.
Probe: coax no 3
Scan Resolution: 0.0255 mm
Scan length: 3 mm
Frequency: 24 GHz

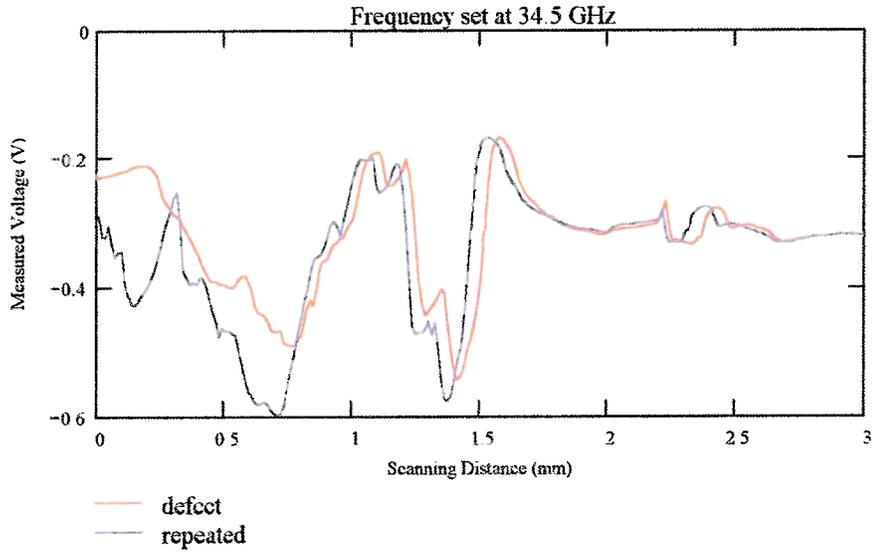
Frequency Band: Ka-band
Orientation: Scan perpendicular to crack length
Probe: coax no. 3
Scan Resolution: 0.0255 mm
Scan length: 3-4 mm
Frequency: 34.5 GHz

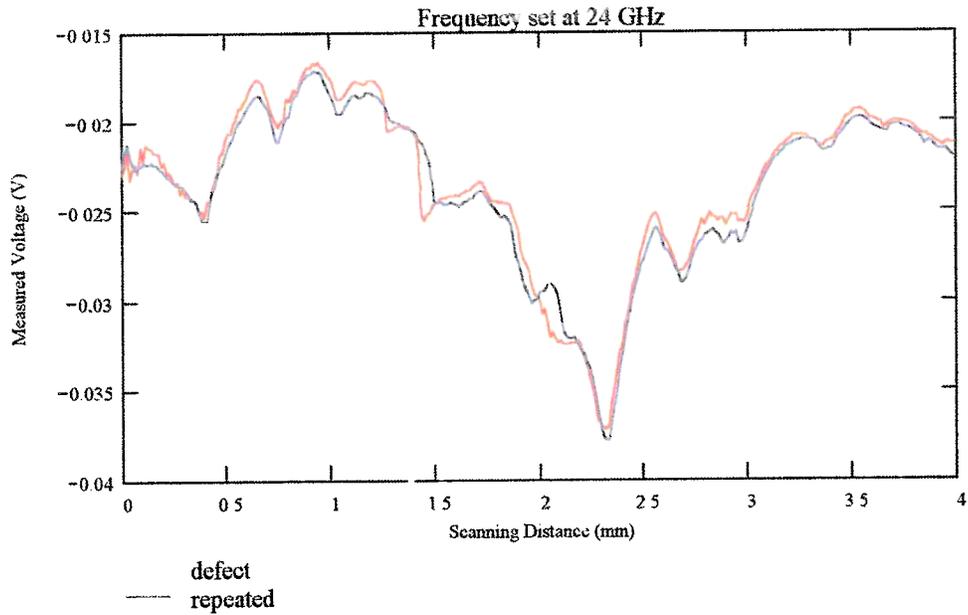
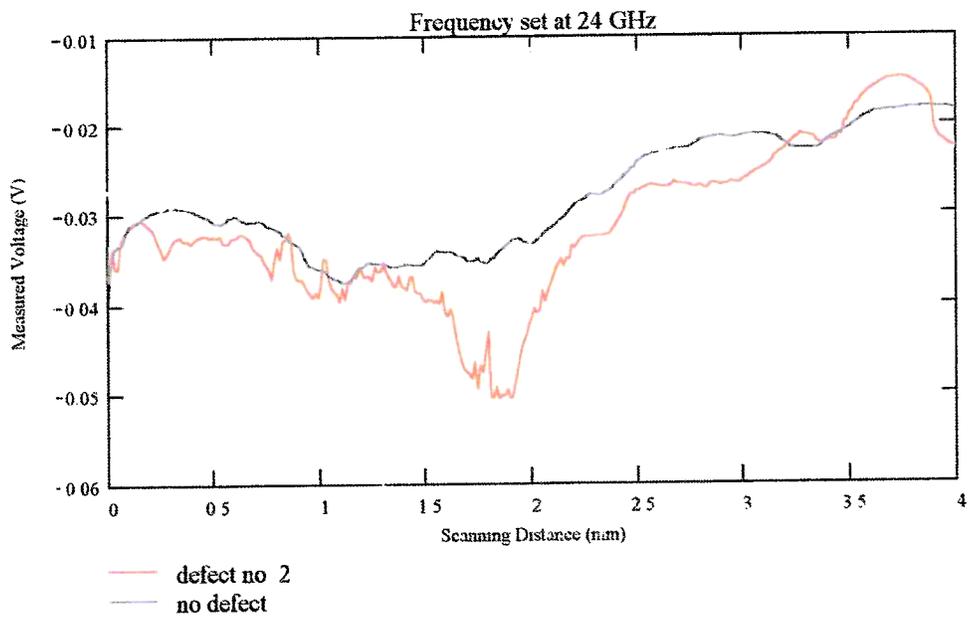
B Crack #2

the This is a Transverse Indication crack. The length of
the crack is 0.43 in. This crack runs perpendicular to
the welded joint

Frequency Band: K-band
Orientation: Scan perpendicular to crack length.
Probe: coax no. 3
Scan Resolution: 0.0127 mm
Scan length: 4 mm
Frequency: 24 GHz

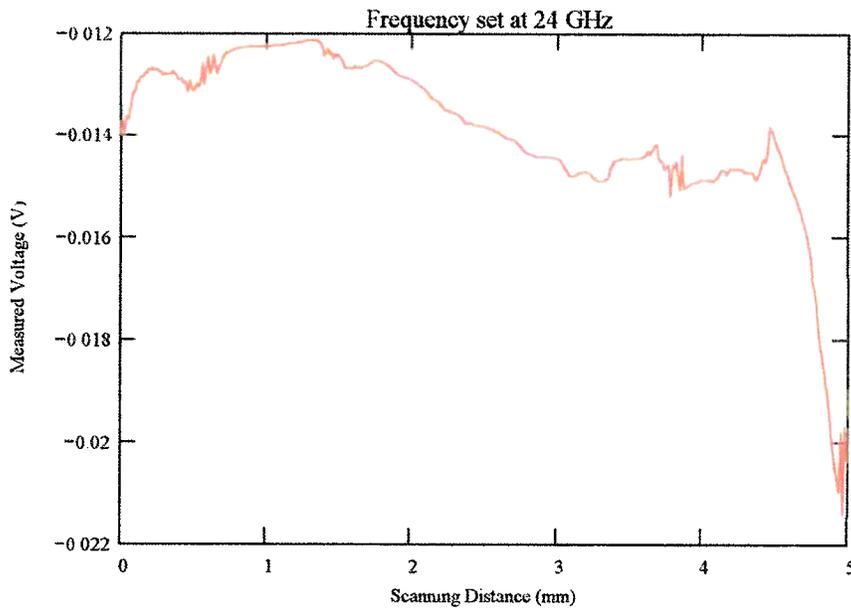
This is a Root Indication crack. The length of the crack is 0.94 in. This crack runs parallel to the welded joint.

Frequency Band: K-band
Orientation: Scan perpendicular to crack length.
Probe: coax no. 1
Scan Resolution: 0.0127 mm
Scan length: 5 mm
Frequency: 24 GHz

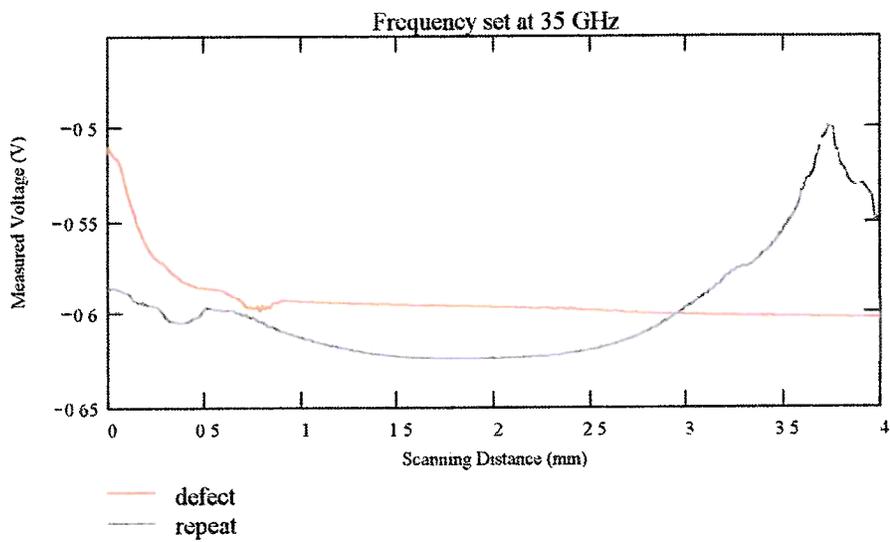
Frequency Band: Ka-band
Orientation: Scan perpendicular to crack length.
Probe: coax no. 3
Scan Resolution: 0.0127 mm
Scan length: 4 mm
Frequency: 35 GHz

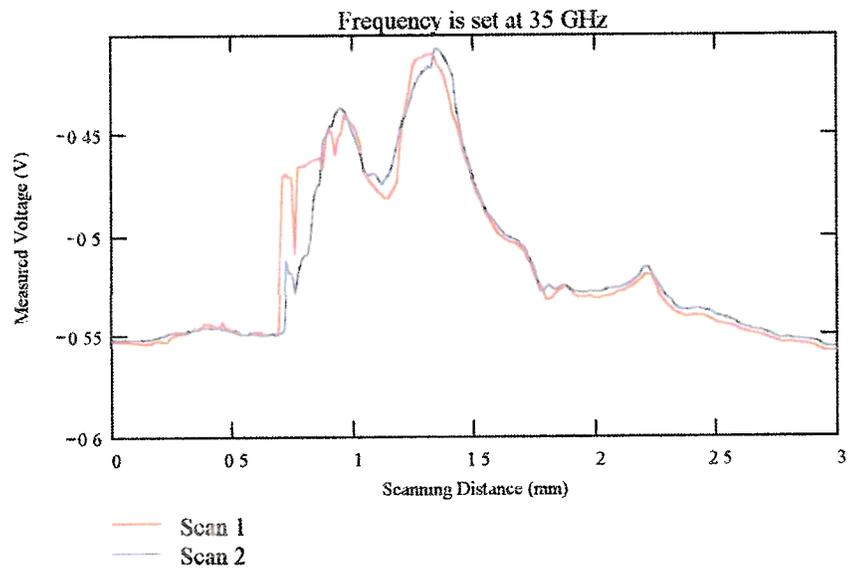
Frequency Band: Ka-band
Orientation: Scan parrallel to crack length
Probe: coax no. 3
Scan Resolution: 0.0127 mm per step
Scan length: 3 mm
Frequency: 35 GHz

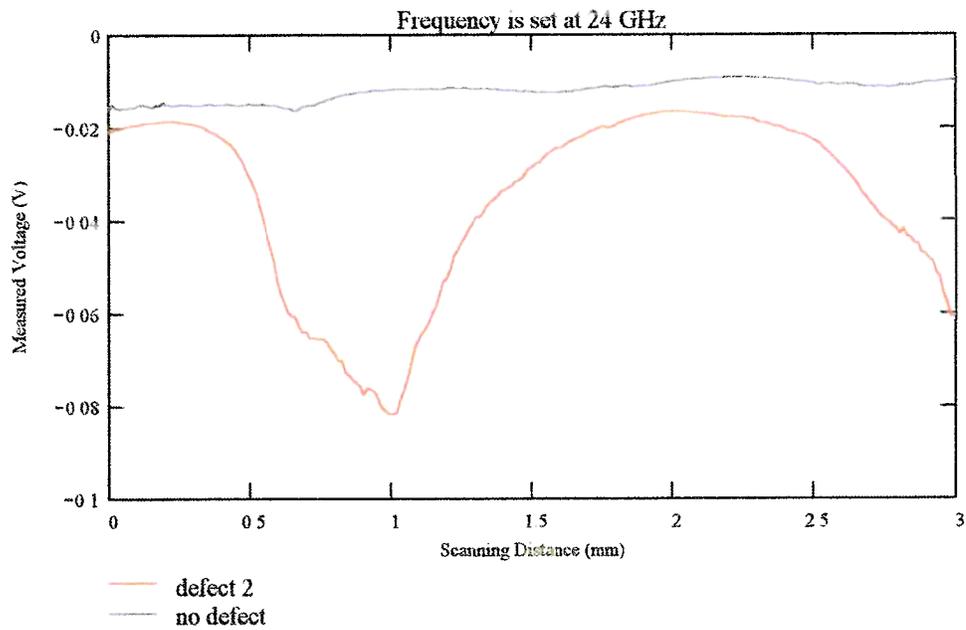
B Crack #2

This is a Transverse Indication crack. The length of the crack is 0.23 in. This crack runs perpendicular to the welded joint

Frequency Band: K-band
Orientation: Scan perpendicular to crack length
Probe: coax no. 3
Scan Resolution: 0.0127 mm per step
Scan length: 3 mm
Frequency: 24

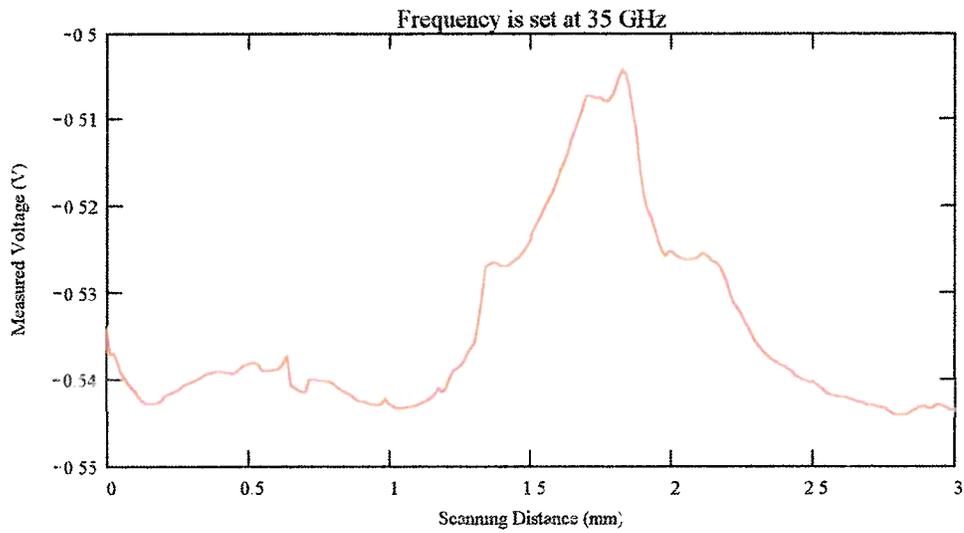
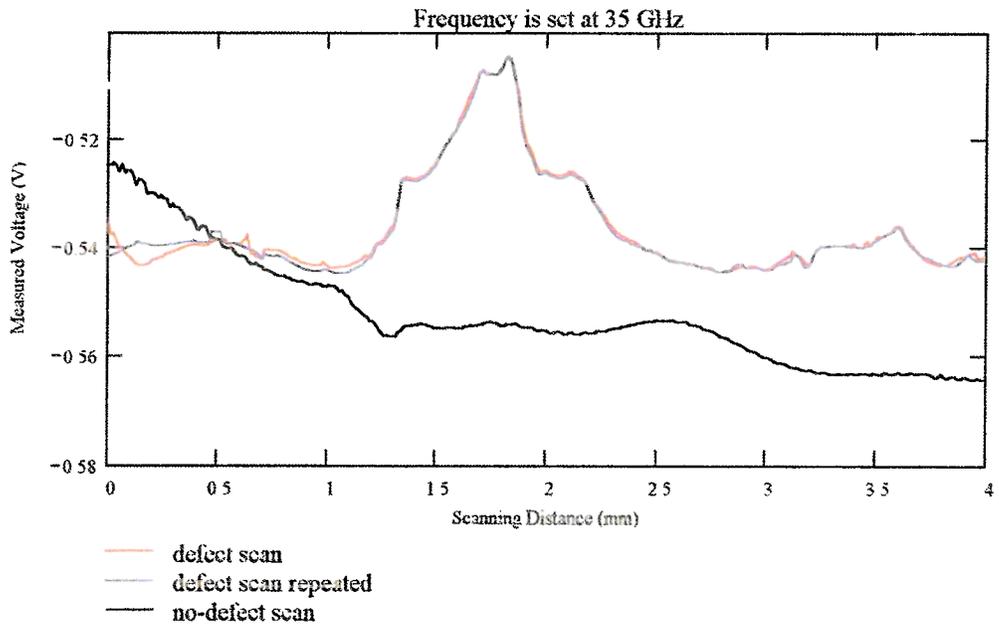
Frequency Band: Ka-band
Orientation: Scan perpendicular to crack length.
Probe: coax no. 3
Scan Resolution: 0.0127 mm per step
Scan length: 3-4 mm
Frequency: 35

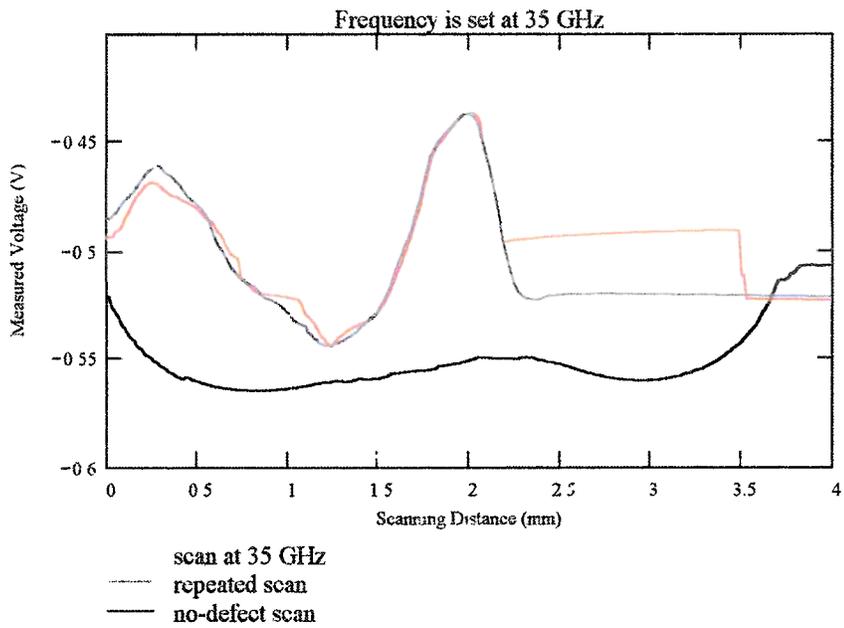
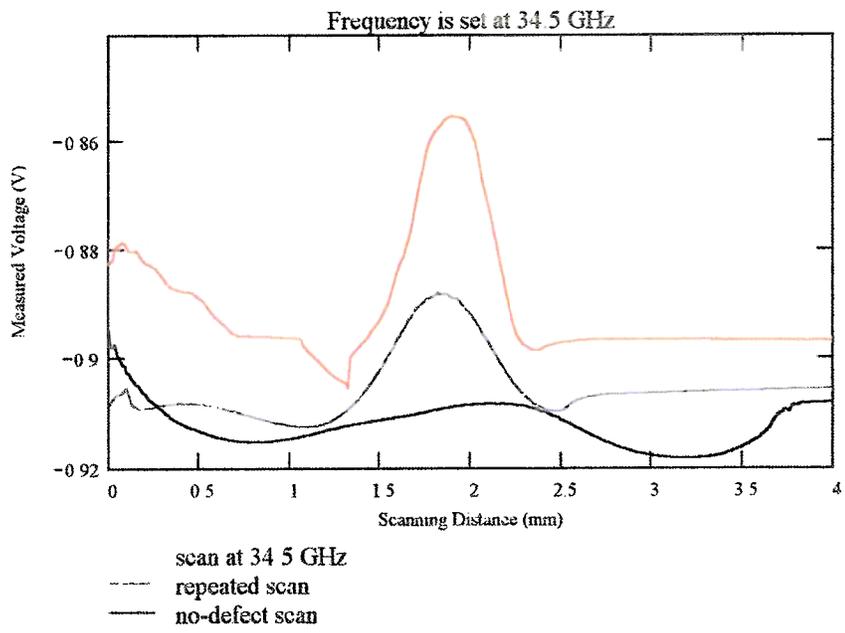
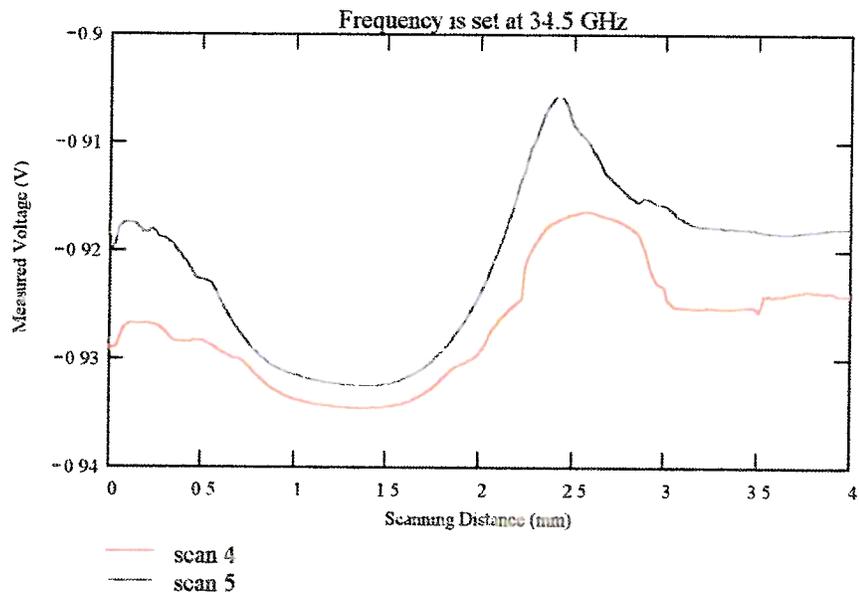
Frequency Band: Ka-band
Orientation: Scan perpendicular to crack length
Probe: coax no 3
Scan Resolution: 0.0127 mm per step
Scan length: 4 mm
Frequency: varies

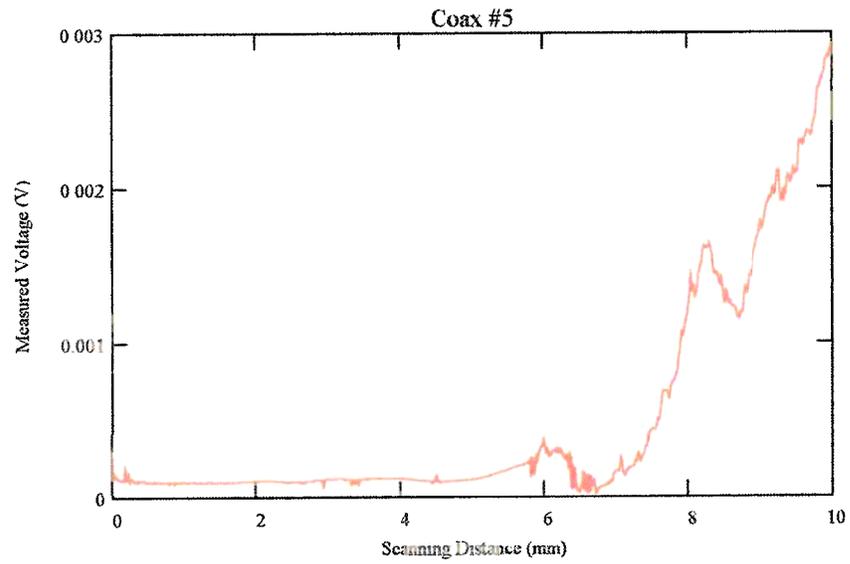
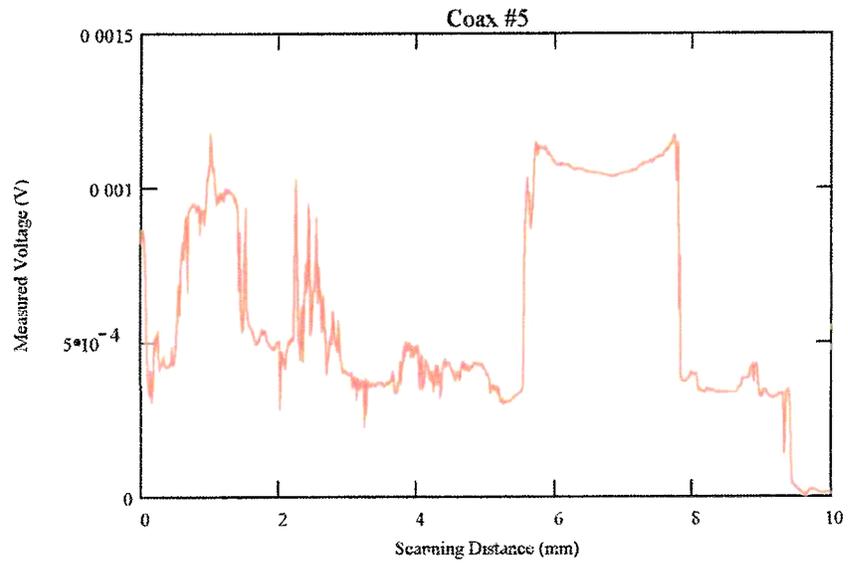
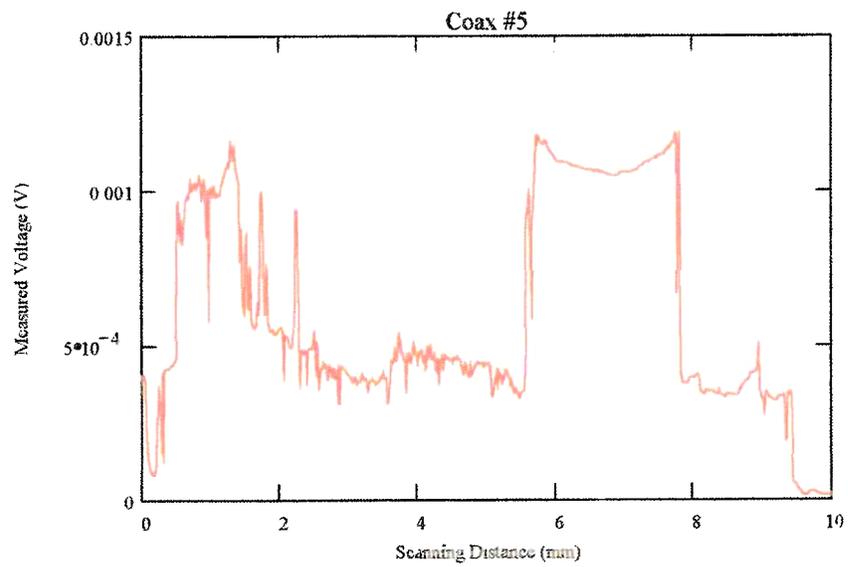
B Crack #2

This is a Root Indication crack. The length of the crack is 24 mm. This crack runs parallel to the welded joint.

Frequency Band: K-band
Orientation: Scan parallel to crack length
Probe: Coax no. 6, Coax no. 5
Scan Resolution: 0.127 mm per step
Scan length: 10 mm
Frequency: 24 GHz
