*Microwave Detection of Fatigue Cracks in
Specially Prepared Steel Specimens*

Final Report

**Virginia Transportation Research Council
530 Edgemont Road
Charlottesville, VA 22903**

VTRC 99-CR3

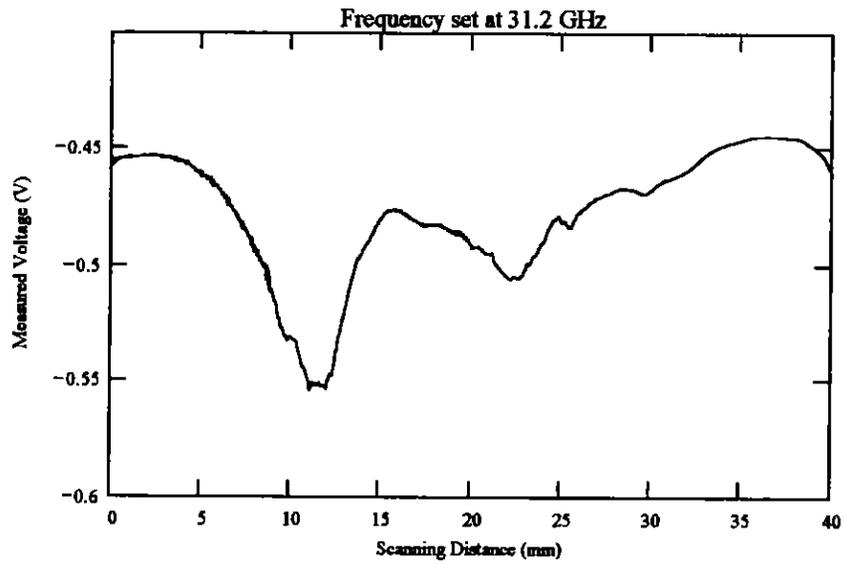
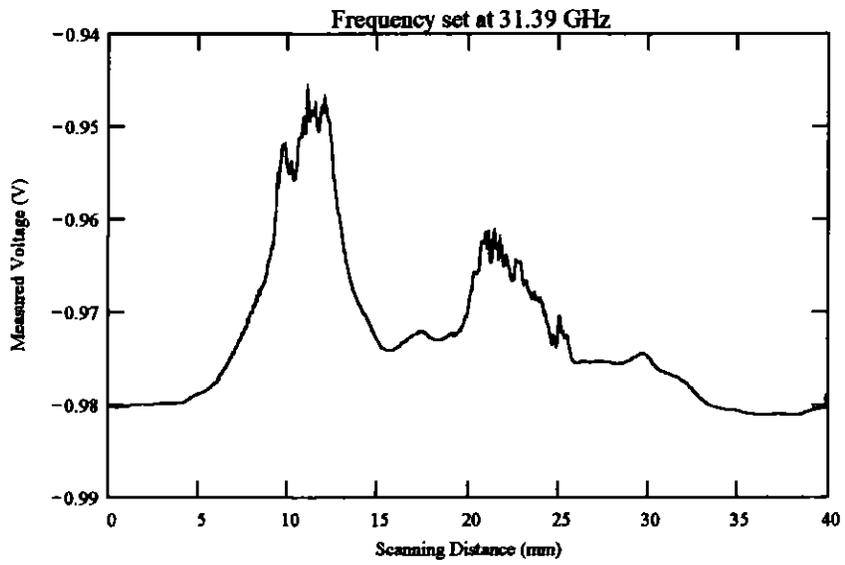
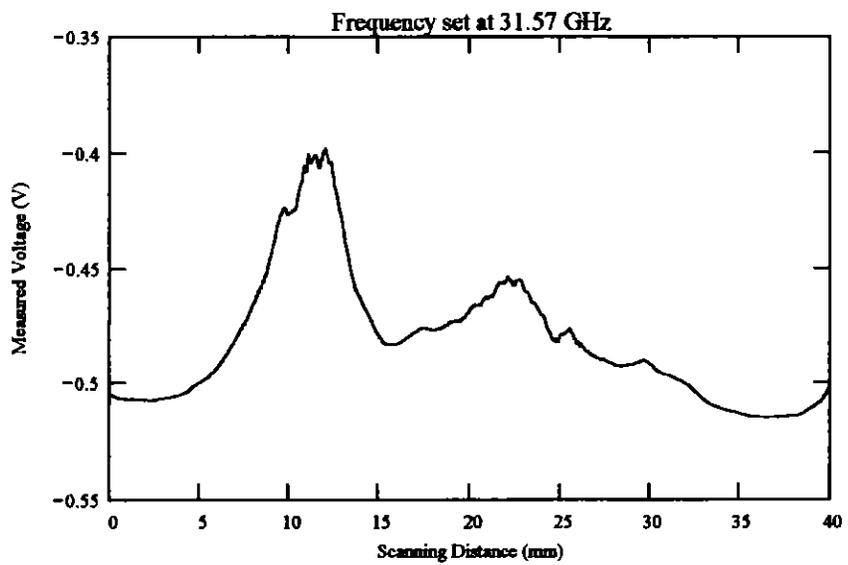
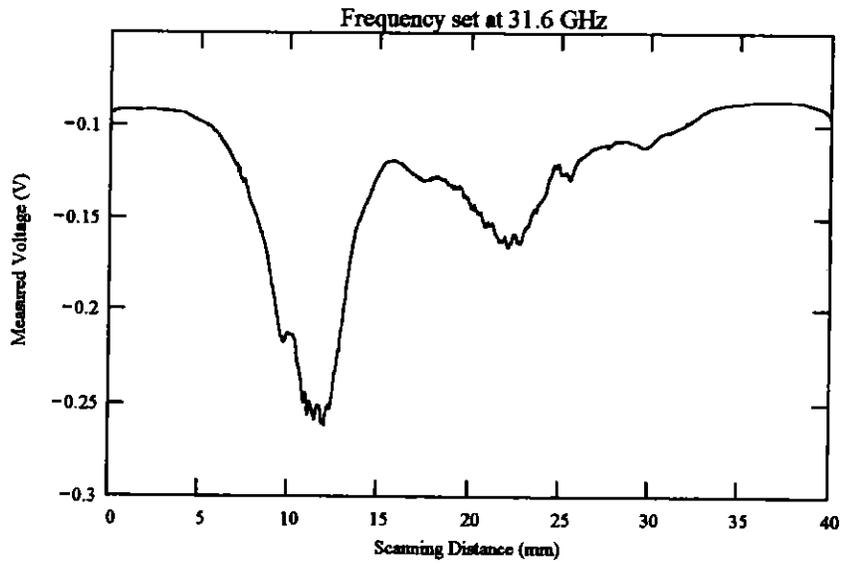
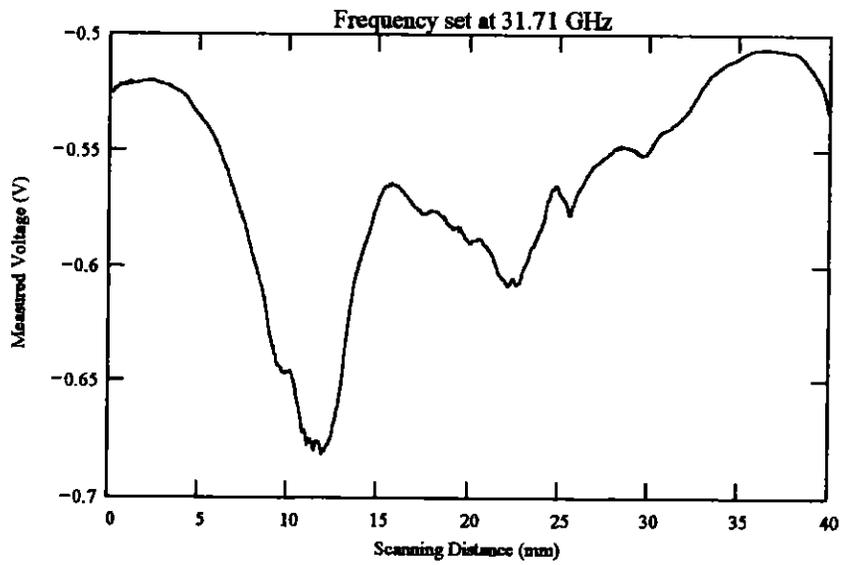
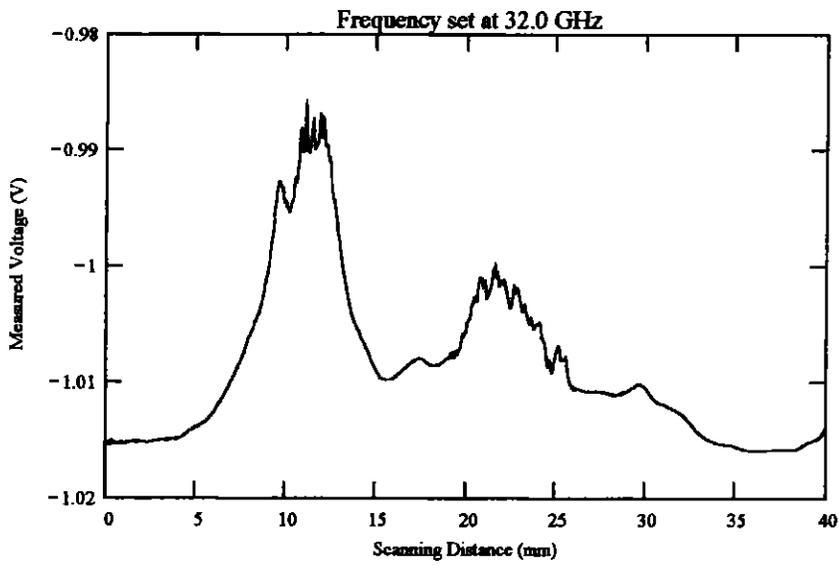
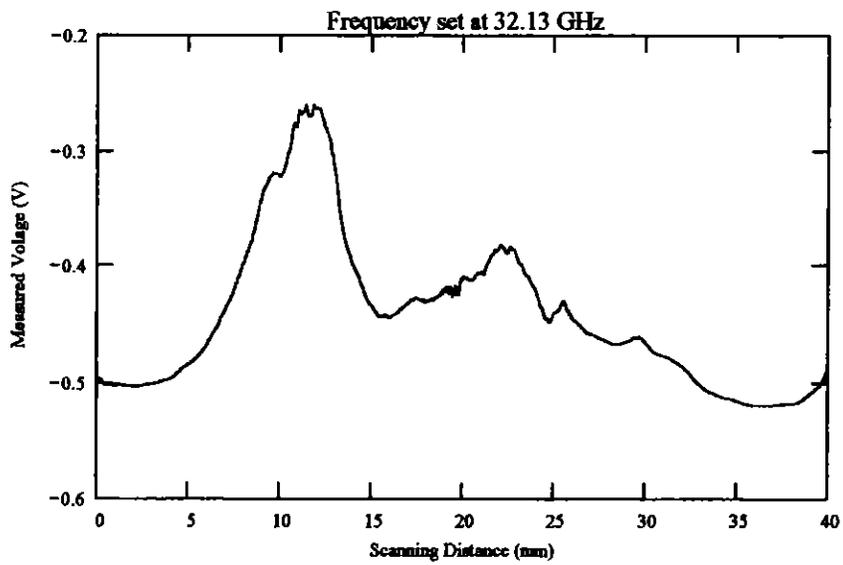
Frequency Band: Ka-band
Orientation: Scan parallel to crack length.
Probe: Coax no. 3
Scan Resolution: 0.064 mm per step.
Scan length: 40 mm
Frequency: Varies

This is a Toe Indication crack. The length of the crack is 30 mm. This crack runs parallel to the welded joint.
