EVALUATION OF THE INSTALLATION AND INITIAL CONDITION OF HIGH PERFORMANCE CONCRETE OVERLAYS PLACED ON ROUTE 60 OVER LYNNHAVEN INLET IN VIRGINIA

1. Report No. VTRC 99-IR4		2. Government Accession No.		3. Recipient's Catalog No.	
4. Title and Subtitle Interim Report: Evaluation of the Installation and Initial Condition of High Performance Concrete Overlays Placed on Route 60 Over Lynnhaven Inlet in Virginia				5. Report Date April 1999

April 1999
VTRC 99-IR4

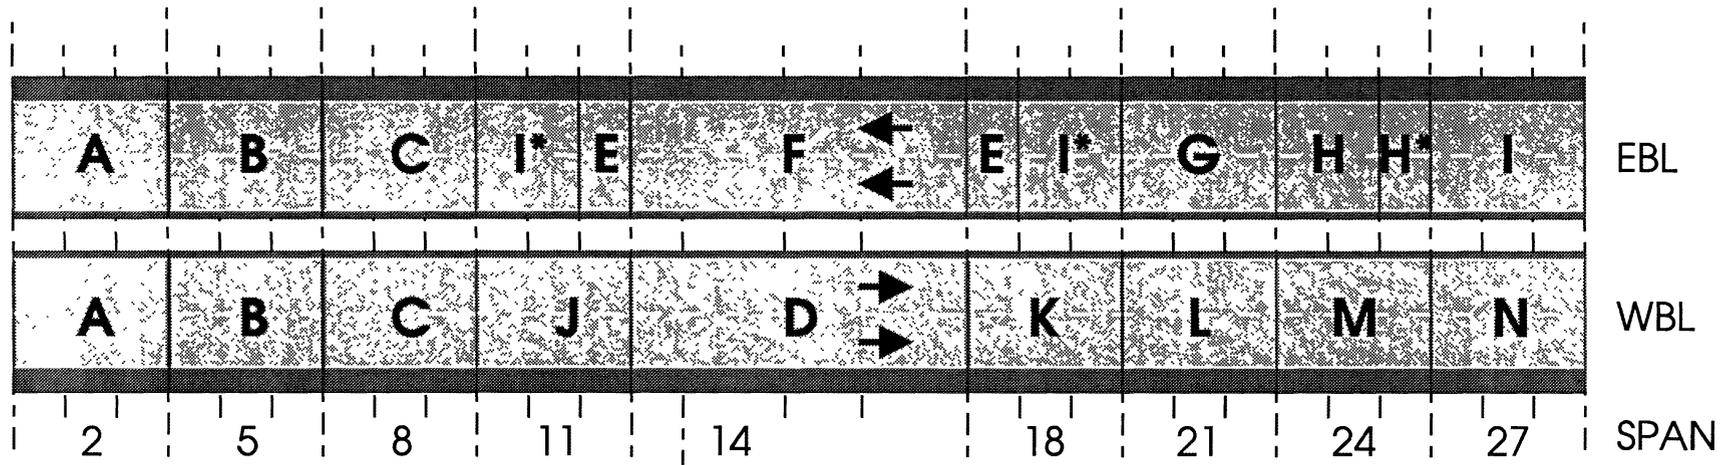
A: 7% SF

B: 5% SF, 35% S

C: 5% SF, 15% FA

D: 15% LMC

E: 13% SF, 15% FA

F: 13% SF, 15% FA,
19 mm, (3/4 in)

G: 7% SF, RCI

H: 7% SF, ACI, A

H*: 7% SF, ACI

I: 7% SF, DCI, P

I*: 7% SF, DCI

J: 40% S

K: 7% SF, CQI

L: 7% SF, POF

M: 7% SF, STF

N: 7% SF, PPF

Figure 1.1. The plan view for the overlays on the two 28-span bridges on Rte. 60 over the Lynnhaven Inlet.

A site location map for the two bridges is shown in Figure 1.1. Initially, the westbound bridge (WBL) was overlaid while traffic used the eastbound bridge (EBL). Then, traffic was detoured to the WBL while the EBL was overlaid.

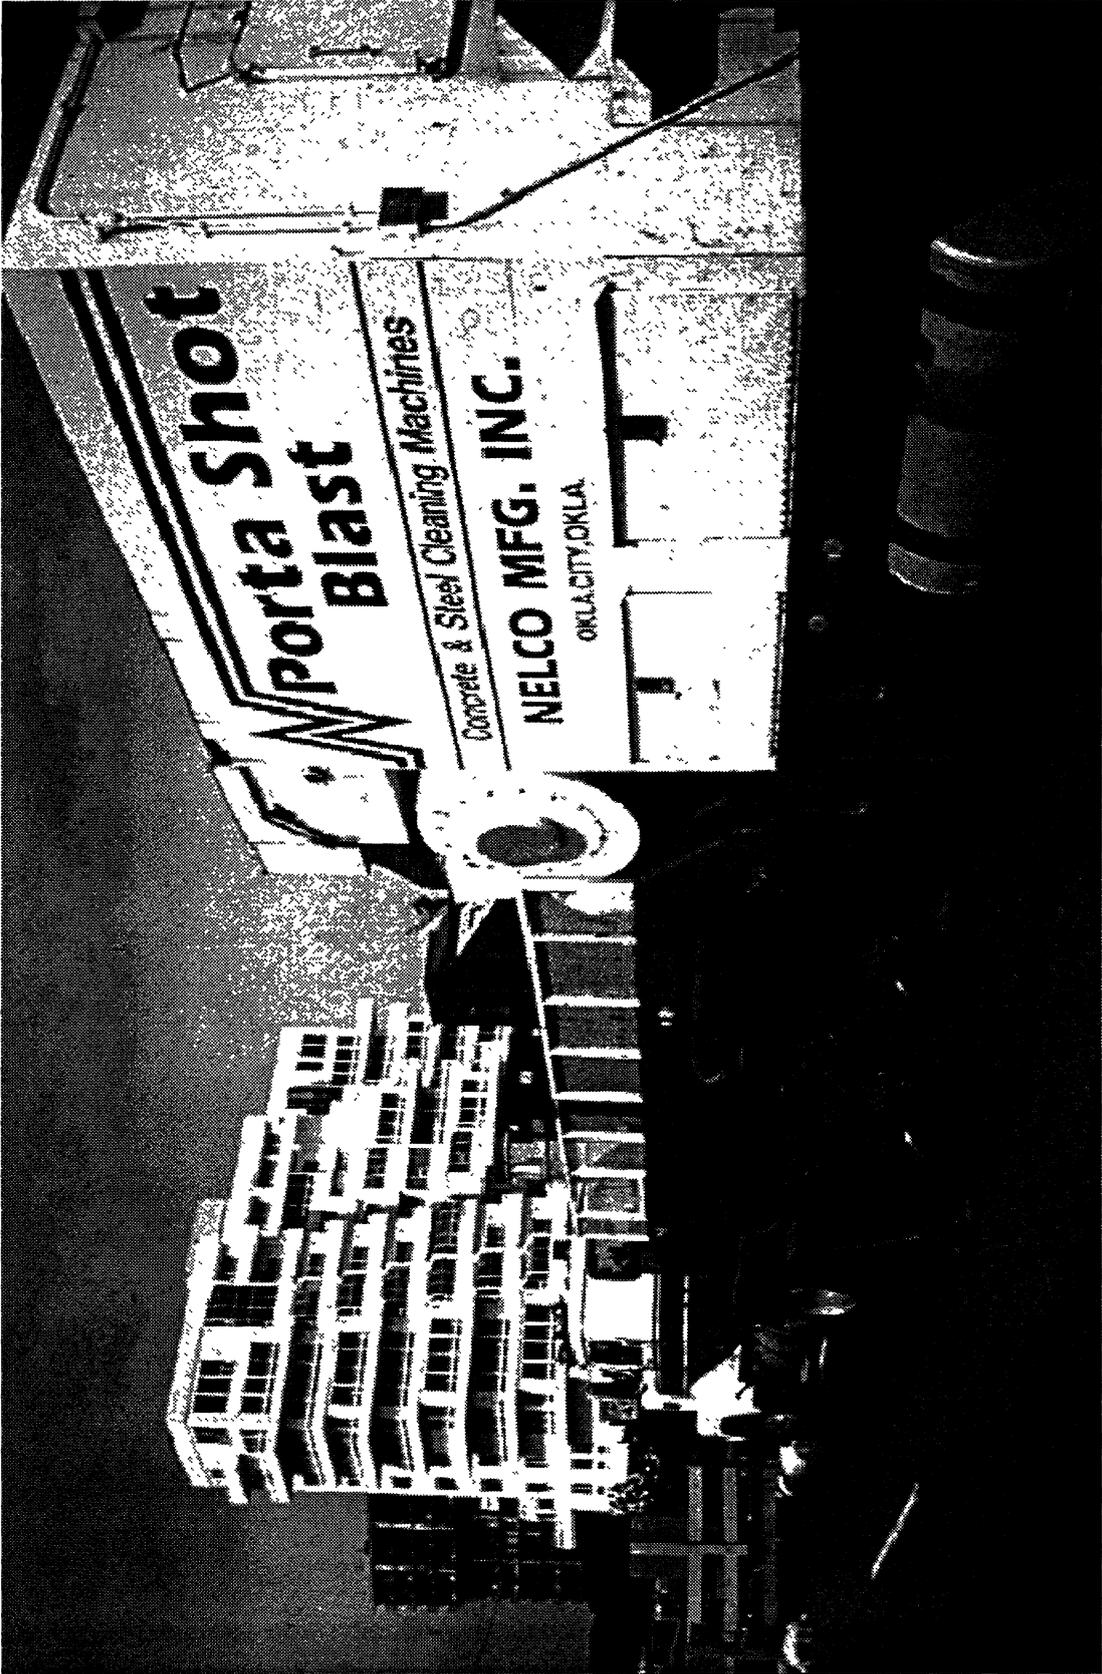
Figure 3.1 Shotblast equipment with six side-by-side blasting heads used to shotblast large areas of the deck.

Prior to placement of the concrete overlay, the entire deck surface was cleaned and roughened by shotblasting (Figure 3.1) to remove asphaltic material, oils, dirt, rubber, curing compounds, paint, carbonation, laitance, weak surface mortar, and other potentially detrimental materials that may have interfered with the bonding or curing of the overlay and to provide a macrotexture depth of at least 1.5 mm (0.06 in) in accordance with ASTM E965. Hydroblasting was an acceptable alternative to shotblasting, but Class A scarification was not permitted.

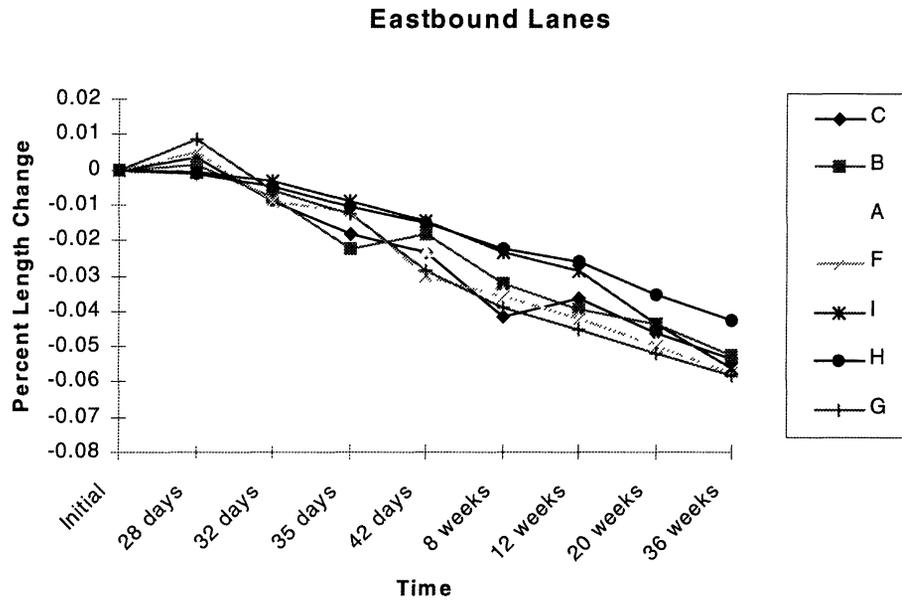
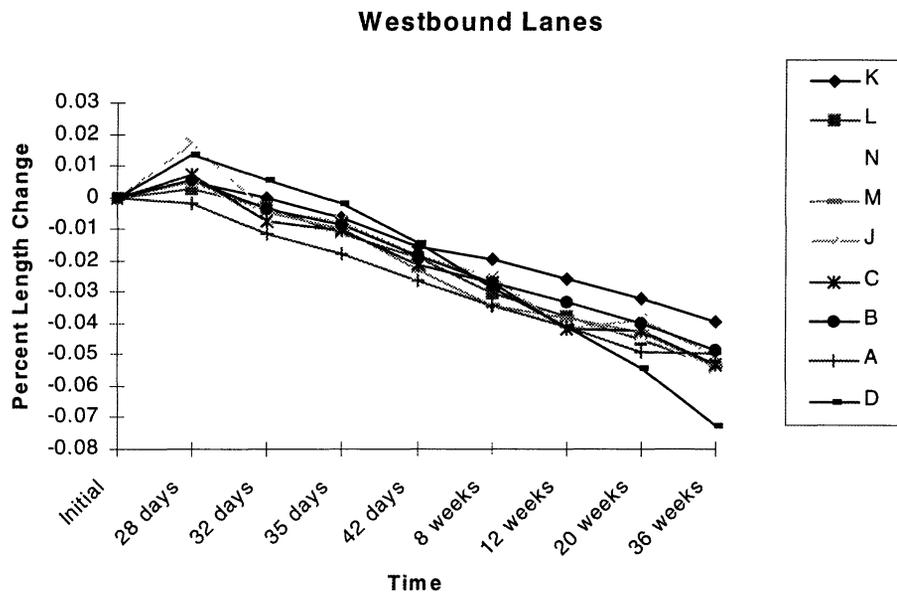
Figure 4.1 Graph of length change versus age of concrete

Three length change specimens were prepared from each of two samples of concrete taken during the overlay placements. The specimens were cured next to the bridge for approximately 20 hours, transported to the laboratory over the next 3 hours, and removed from their molds between 23 and 24 hours of age. The initial length was measured at 24 hours of age, and the specimens were placed in a moist curing room. Once the moist curing period was complete, specimens were moved to the laboratory and stored on racks at approximately 50% relative humidity. The length as a function of age is plotted in Figure 4-1. In general, the concrete batches displayed similar trends during the drying period. Exceptions to this included the LMC (D), which showed less shrinkage than the others in the first few weeks but more toward the end of testing, and the CQI (K) mix, which displayed less shrinkage throughout the testing. ACI (H) also showed low shrinkage.
