Report No.	Report Date	No. Pages	Type Report: Final	Project No.: 70983
VTRC 05-CR9	January 2005	36	Period Covered: 10/01/03 to 12/31/04	Contract No. 04-0627-10

**FIELD INVESTIGATION OF HIGH PERFORMANCE PAVEMENTS
IN VIRGINIA**

Contract Research Sponsored by
Virginia Transportation Research Council

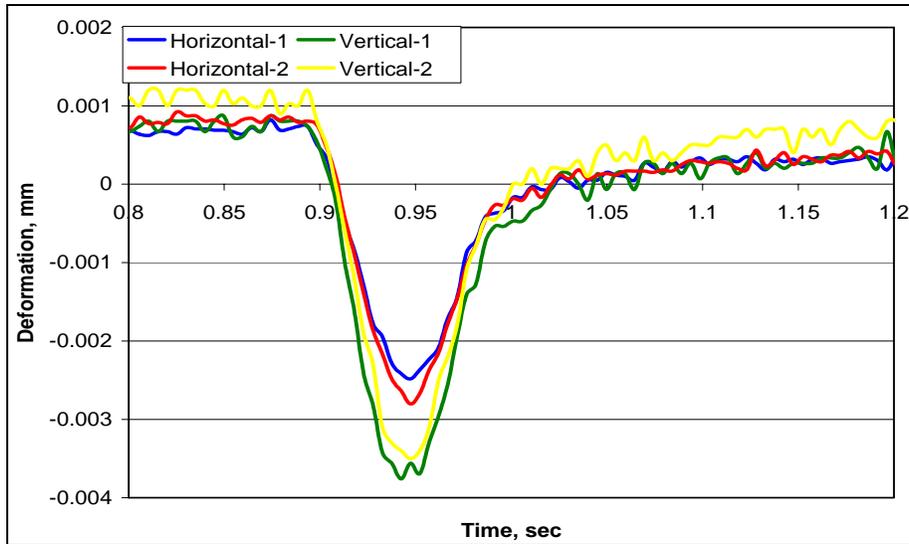
Figure 3. Measured deformations during a resilient modulus test

The tests were performed using an MTS servo-hydraulic machine. Horizontal and vertical deflection measurements were taken over a 25 mm (1 in) gauge length on both sides of the specimen. The data collected include the applied load and the horizontal and vertical deformations. All tests were performed at 25 $^{\circ}$C (77 $^{\circ}$F). Specimens were stored in the laboratory at room temperature (25 $^{\circ}$C). Before being tested, specimens were placed in an environmental chamber at 25 $^{\circ}$C (77 $^{\circ}$F) for a period of 1 hour. Typical measured deformations during the resilient modulus and the creep tests are presented in Figure 3 and Figure 4, respectively.

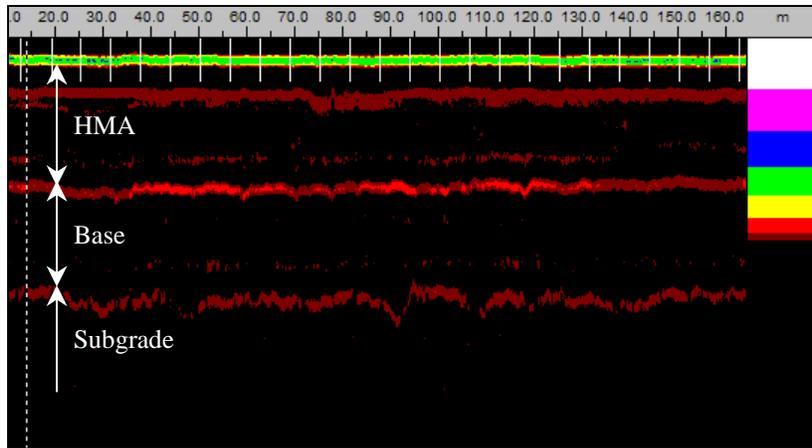
Figure 5. Raw GPR data, Site 03, center of the lane, flexible pavement

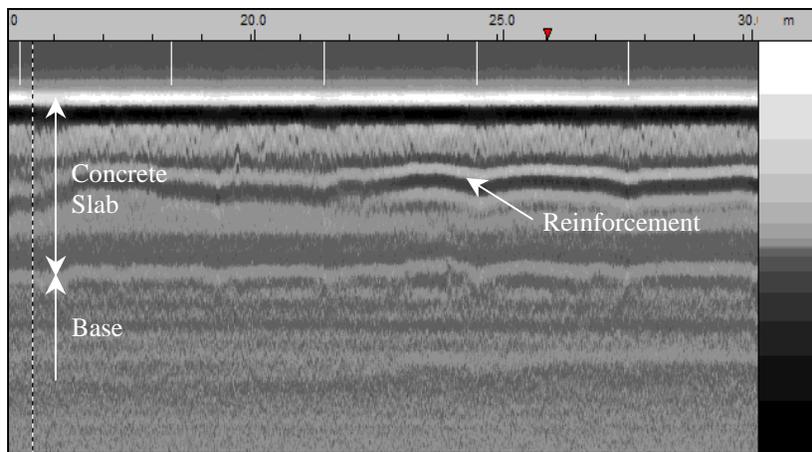
Figure 6. Raw GPR data, Site 04, center of the lane, CRCP

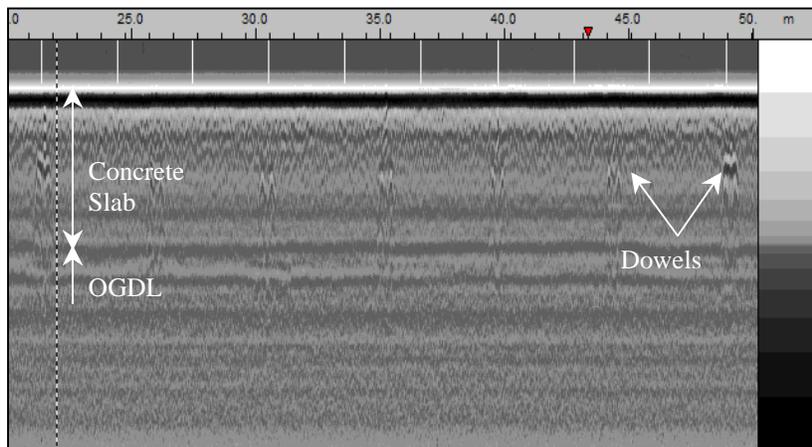
Figure 7. Raw GPR data, Site 07, center of the lane, JPCP

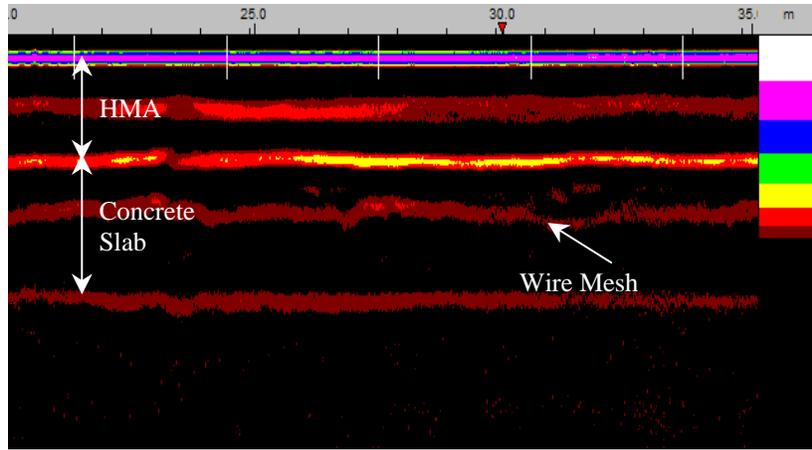
Figure 8. Raw GPR data, Site 08, center of the lane, composite pavement

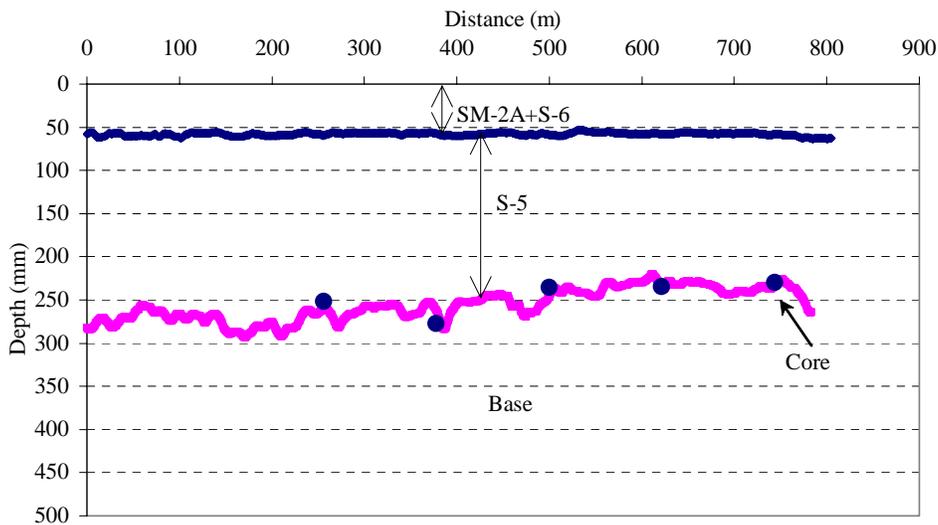
Figure 9. Layers' thicknesses for Site 01 (lane center)

Figure 9 and Figure 10 shows the GPR thickness results for the detected layers from Site 01 at the center of the lane and at the right wheel path, respectively. For comparison purposes, the thickness measured directly on the cores taken from the different sites are also depicted in these figures at their respective locations. Detailed layer thickness results for all the tested sites are available from the authors.

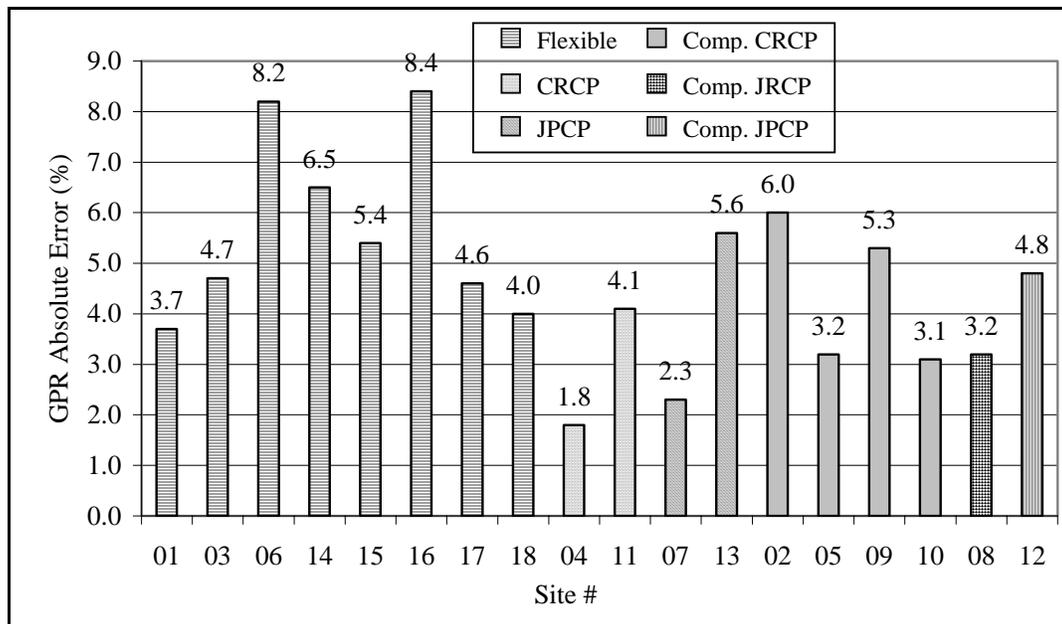
The estimated average GPR thickness errors found for all the sites are summarized in Figure 11. According to these results, the average absolute thickness error varied between 1.8% for Site 04 to 8.4% for Site 16. The average absolute GPR thickness error for all sites was approximately 4.7%. It should be mentioned that for the composite sections, the GPR error was estimated for the HMA layers only due to the unavailability of the thickness of the concrete slab

Finally, it is worth noting that the errors found for some sites (such as Sites 06 and 16) were due to several factors including:

4. Broken cores made it difficult to measure accurate layer thicknesses.

5. The system cannot separate the reflections resulting from distinct adjacent layers with comparable dielectric constants, which results in using an erroneous dielectric constant for computing the layer thicknesses. This situation is usually encountered for very old pavements having many thin overlays of different ages (such as in Sites 01, 02, 05, 15, 16, and 17).

Figure 11. Average GPR absolute thickness error per site

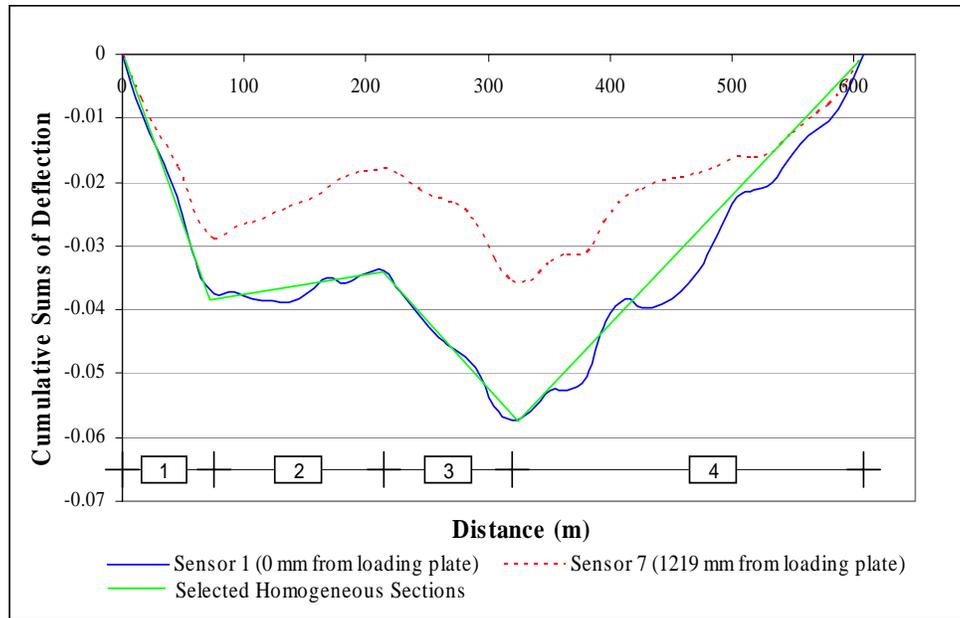
Figure 12 illustrates the homogeneous sections obtained for Site 02. Two sensors were selected to obtain homogeneous sections: (a) maximum deflection (sensor at 0 mm from loading plate center); and (b) Sensor 7 (sensor at 1219 mm from loading plate center). Sensor 7 was selected instead of Sensor 9 because the cumulative sums of deflection of the last sensor tend to be too flattened thus the changes in the homogeneous sections cannot easily be identified.

Figure 12. Homogeneous sections based on cumulative sums of deflection (Site 02)

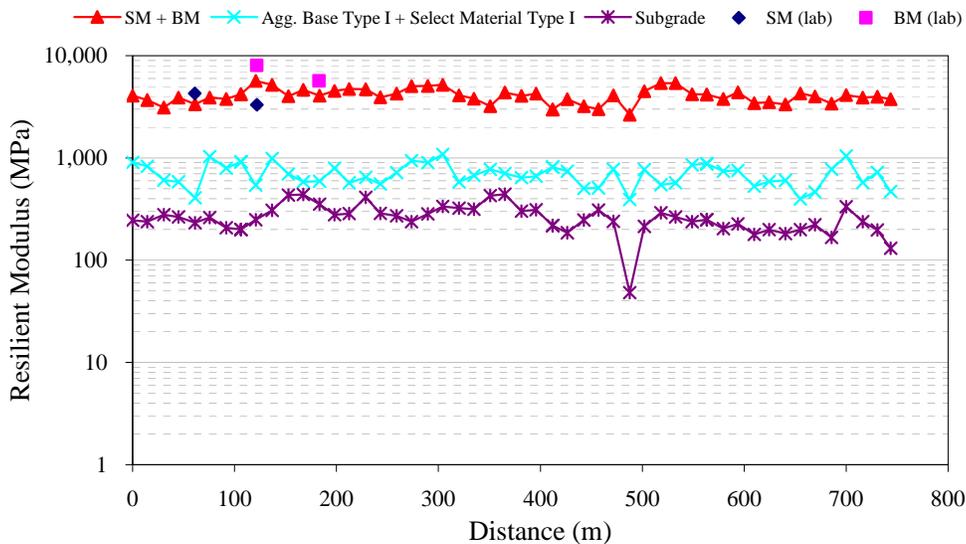
Figure 13. Backcalculation results, Site 16 (flexible)

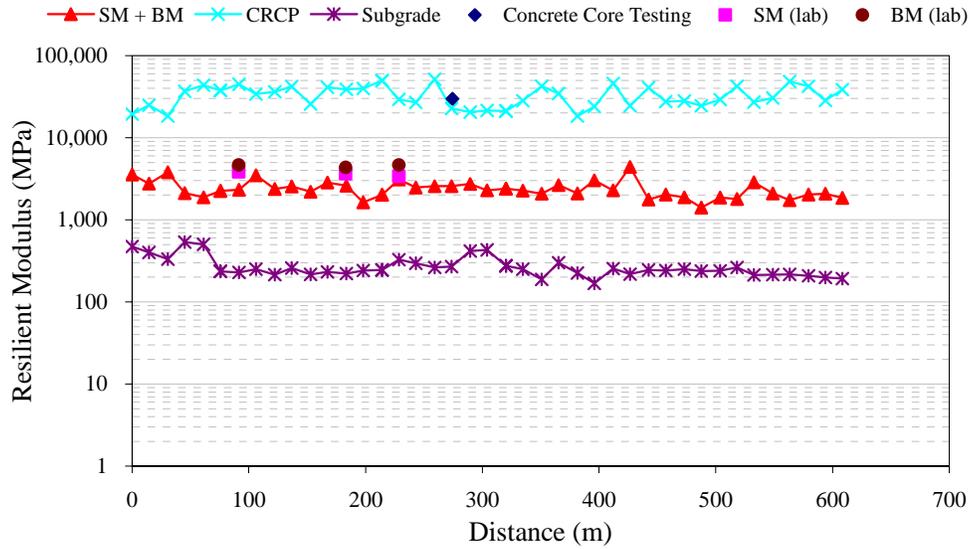
Figure 14. Backcalculation results, Site 02 (composite)

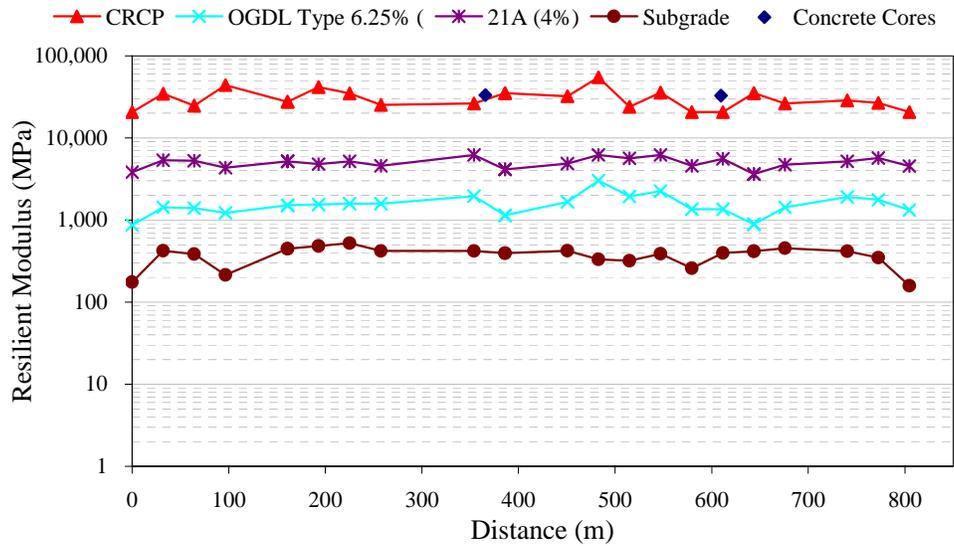
Figure 15. Backcalculation results, Site 11 (CRCP)

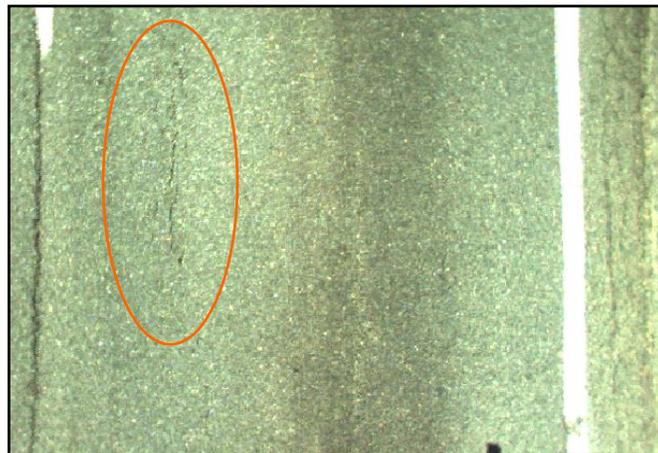
Figure 16. Example of low severity alligator cracking

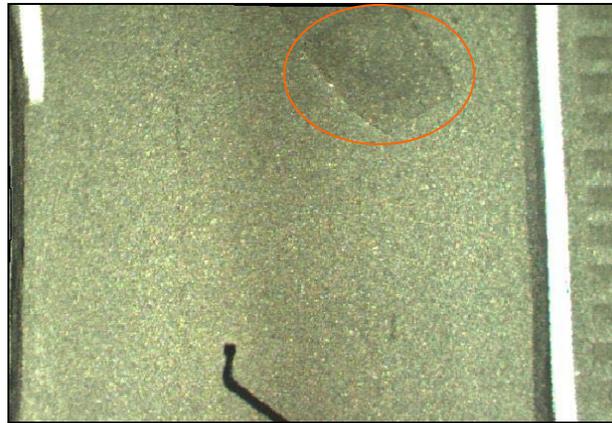
Figure 17. Example of patching

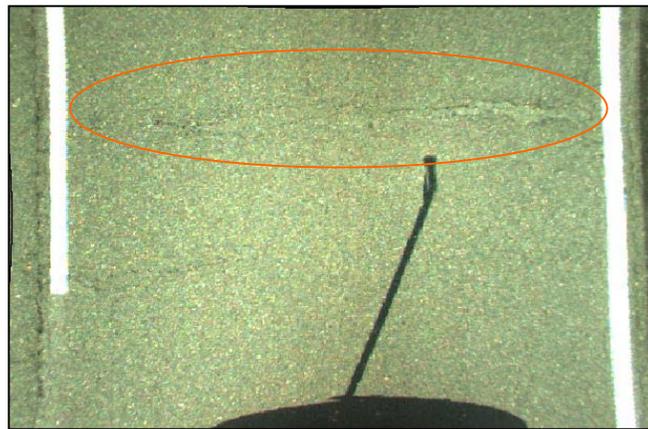
Figure 18. Example of transverse cracking

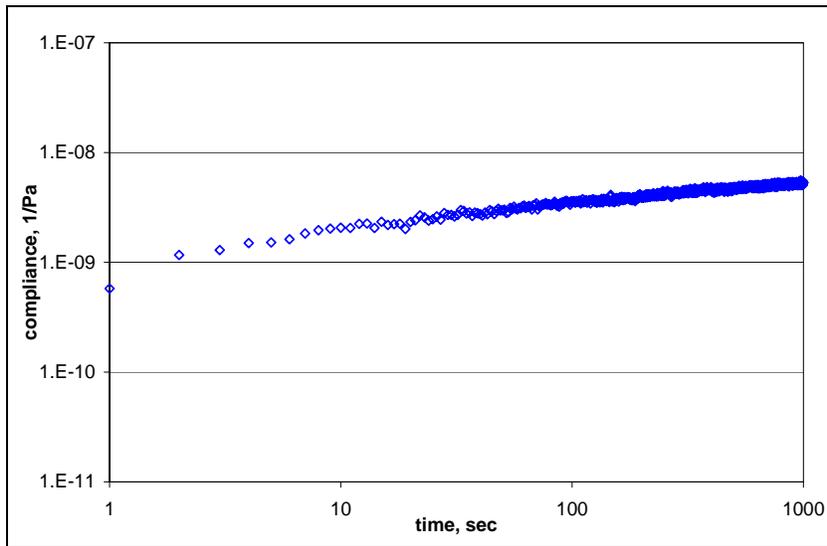
Figure 19. Creep compliance for Site 05 (wearing surface)

Figure 19 shows the creep compliance results for the wearing surface mix of Site 05. Results for all the other sites are available from the authors.

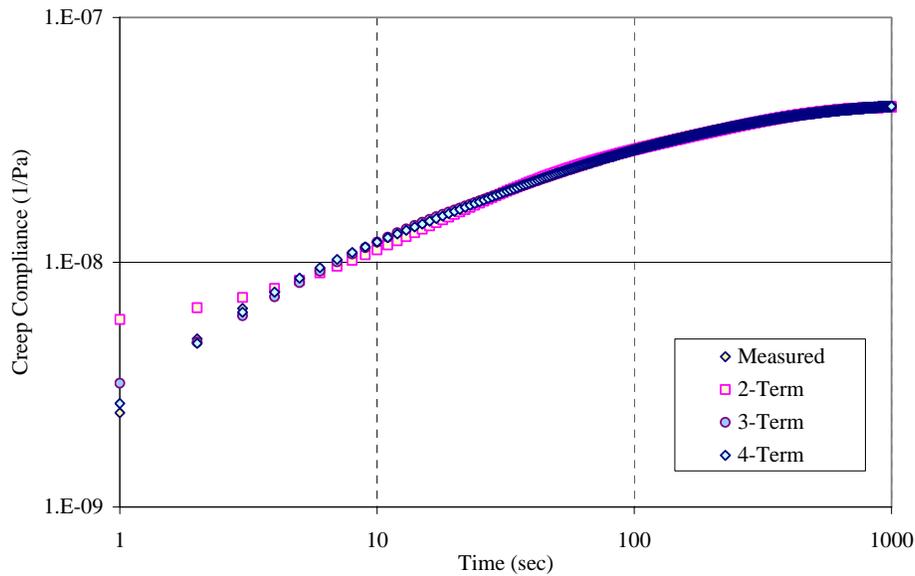
Figure 20. Comparison between measured and calculated creep compliance for different Prony series

To obtain the material constants in Equation 1, a number of Prony series terms were assumed to cover the considered time span, and the fitting process was then conducted using nonlinear regression to find the retardation times and the coefficients of the Prony series using the SAS statistical package. In general, three to four Prony series terms were used to obtain an accurate fit (see Figure 20 for illustration). The fitted creep compliance was then used to predict the relaxation modulus, E(t), by using Equation 2 (Kim *et al.*, 2002):
