Modified Fiber Reinforced Concrete Repairs for Corroded Steel Beam Ends

Final Report VTRC 26-R15

Title:
Modified Fiber Reinforced Concrete Repairs for Corroded Steel Beam Ends

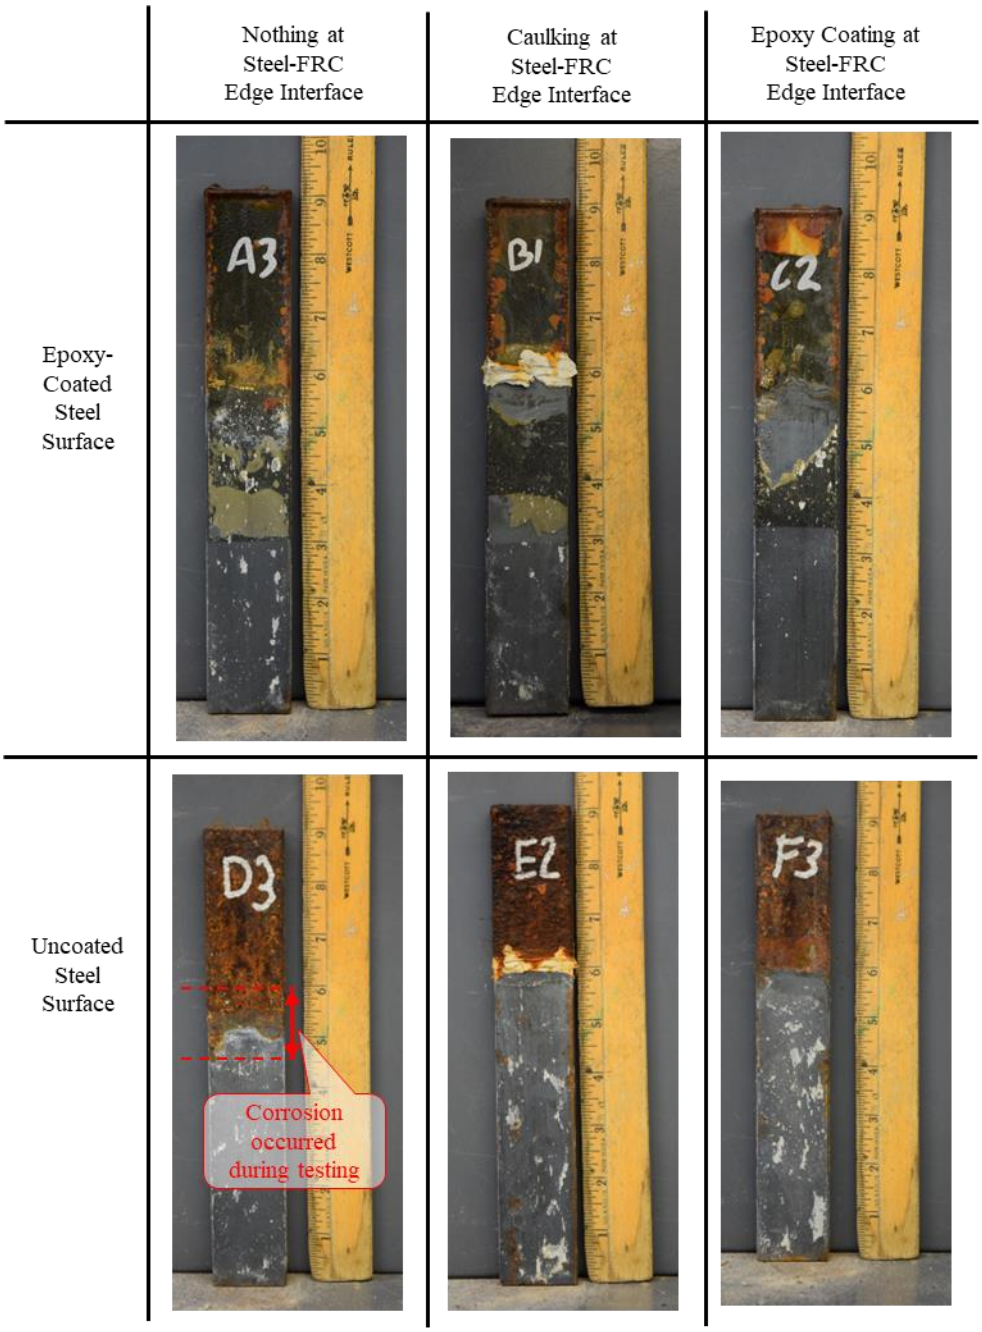
Figure 8. Photos of the Steel Plates After Removal from Engineered Cementitious Composite for Each Sample Type After Durability Testing

All the photos in Figure 8 include a ruler for scale and to aid in indicating corrosion to the portion of the steel plate embedded in ECC. Because the bottom 6 inches of each steel plate were embedded in ECC, the 6-inch marking on the ruler can be used as a reference point. Any material above that mark on the steel plate was expected to have corroded because it was exposed during the durability testing. Any material below that mark on the steel plate was embedded in the concrete. Thus, corrosion on that portion of the steel plates indicates that saltwater penetrated between the steel-ECC edge interface to cause the corrosion.

As the photos in Figure 8 show, only one sample type displayed any noticeable corrosion below the 6-inch mark on the ruler. This sample consisted of an uncoated steel surface, and nothing was applied to the steel-FRC edge interface. Based on the three samples of this type tested, the corrosion extended approximately 1 to 1.5 inches below the 6-inch mark on the ruler. It is not surprising that this sample type displayed corrosion because it was the least corrosion resistant of all the sample types. Because nothing had been applied to the steel-FRC surface, the saltwater applied during the durability testing likely infiltrated this edge interface and easily caused the uncoated steel to corrode.

The other five sample types experienced little or no corrosion below the 6-inch mark on the ruler, indicating that the treatment applied to the sample type effectively prevented corrosion on the embedded portion of the steel. This result means that applying caulking or epoxy coating effectively prevents saltwater infiltration at the steel-FRC edge interface. Both options can be easily applied to an actual FRC beam end repair in the field, making them simple, effective options for extending the service life of FRC beam end repairs. The epoxy-coated steel with nothing applied to the steel-FRC edge interface also performed well, with no additional corrosion on the steel plate. This option could be applied in the field, but the entire steel beam end to be encased in FRC must be coated. This option would likely be more time-consuming and costly than applying caulking or coating to the steel-FRC edge interface.

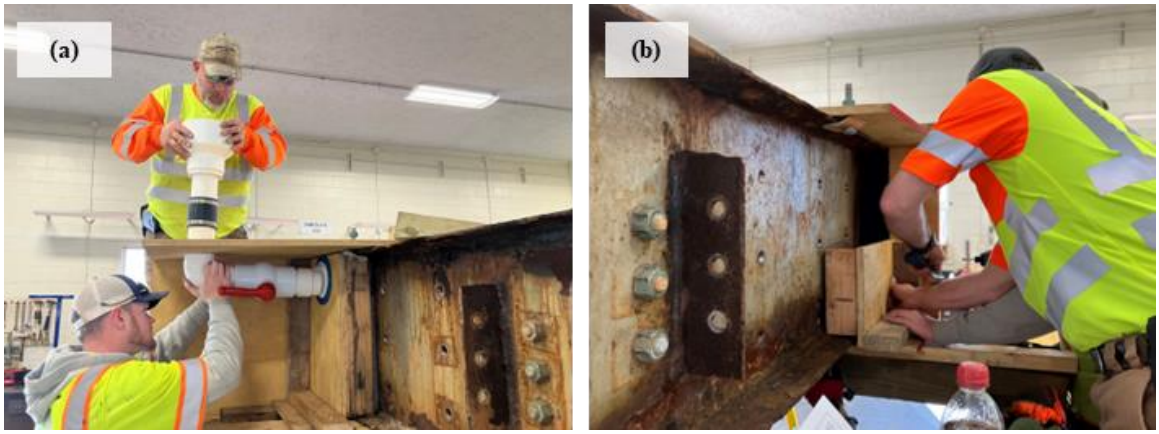
Figure 10. Formwork During Mockup: (a) Full-Depth Repairs; (b) Partial-Depth Repairs

As Figure 10 shows, the full-depth repair included PVC piping to simulate placing FRC through a bridge deck on top of the beams. The PVC piping system added some complexity to the mockup, but the district work crew successfully constructed it. They noted that the full-depth formwork with PVC piping systems would be difficult to construct on bridges with close beam spacings, such as those on steel beam bridges with timber decks.

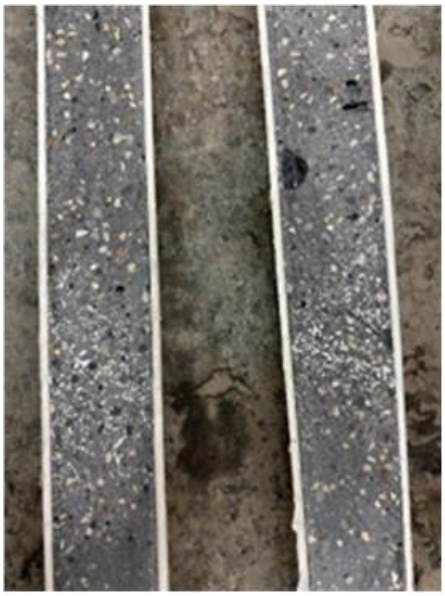
With a recommended maximum water amount of 0.5 gallons per bag, a slump flow value of 24 inches was achieved, resulting in well-distributed fibers and aggregate dispersion (Figure 13). Strength tests were also performed on samples made using this mixture (Table 3). As Table 3 shows, all tests produced satisfactory strength values.

Figure 13. Mixture with the Recommended Amount of Water and a Slump Flow of 21 Inches Had Good Distribution of Steel Fibers

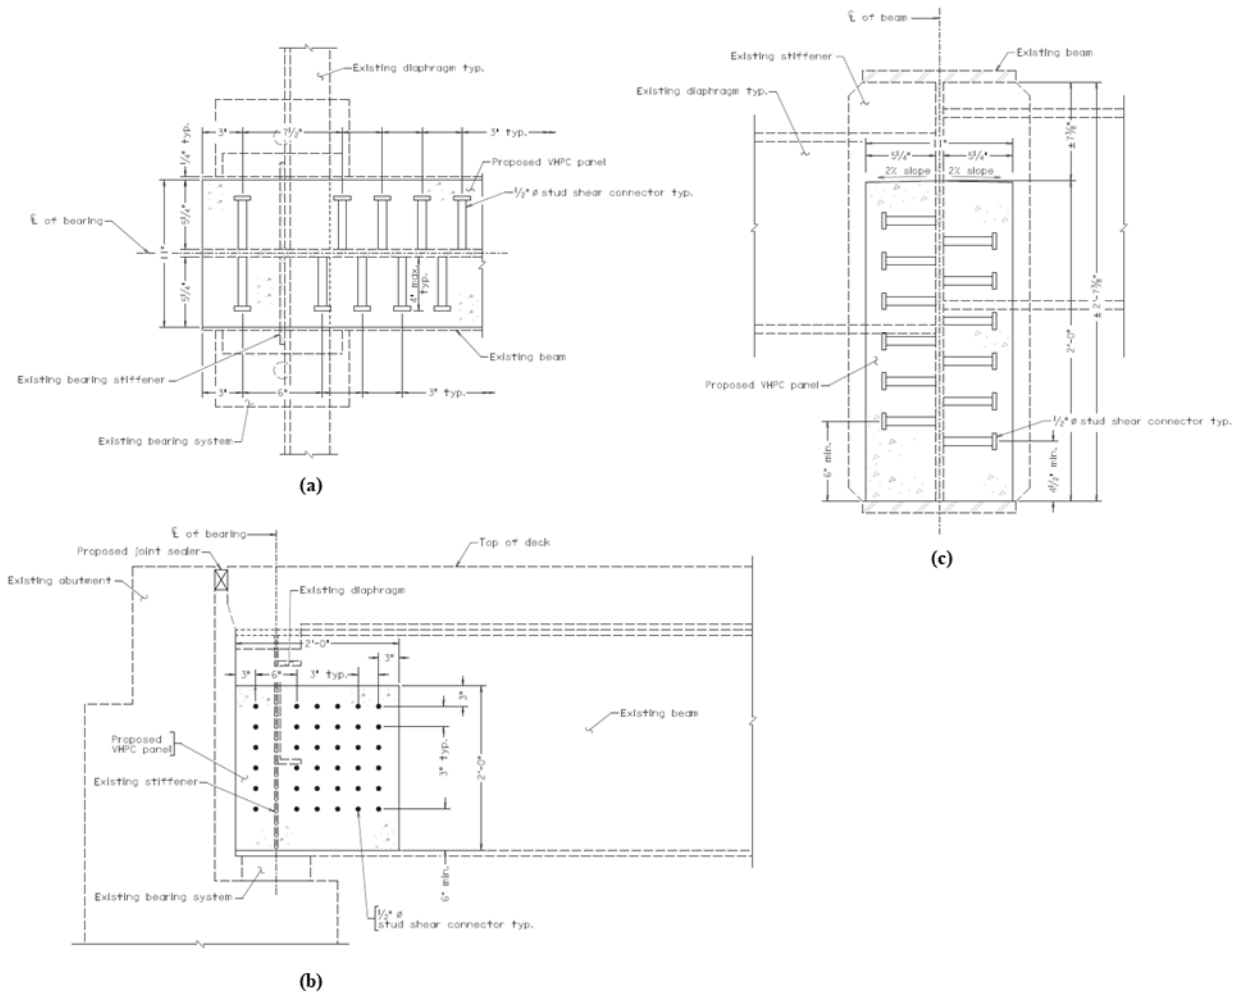
Figure 14. Drawings for Initial Implementation of Fiber Reinforced Concrete Beam End Repair Project in VDOT's Northern Virginia District: (a) Plan View; (b) Elevation View; (c) Section View

As noted, the VDOT Northern Virginia District used the FHWA guidance on UHPC beam end repairs to develop designs and details for the FRC beam end repairs for the Bristow Road Bridge project. The FHWA guidance recommends that the designer determine the strength limit states from three possible loading scenarios: live load only, entire design load, or restoration of original capacity. The VDOT Northern Virginia District elected to use the entire design load to be conservative. Using the FHWA design guidance and experience with using FRCs in the past, the district specified a compressive strength of 12,000 psi, leading to the selection of VHPC. The district also specified using 1/2-inch diameter welded shear studs to transfer load between the existing steel beam and the VHPC panels. Overall, the district noted that the design process was relatively easy. Figure 14 shows drawings of the details for the VHPC beam end repairs on the Bristow Road Bridge.

existing beams were made from uncoated weathering steel, so no coating removal was required. The district noted that some shear studs had to be moved slightly from the locations specified in the drawing in Figure 14 to avoid areas with extensive corrosion. The district noted that it was difficult to have a standard plan for the stud locations because the corrosion on all 10 beam ends was slightly different. After the studs were welded, all the formwork was constructed for the partial-depth repairs. Figure 16 shows examples of one of the beams after the studs had been welded and the formwork constructed.

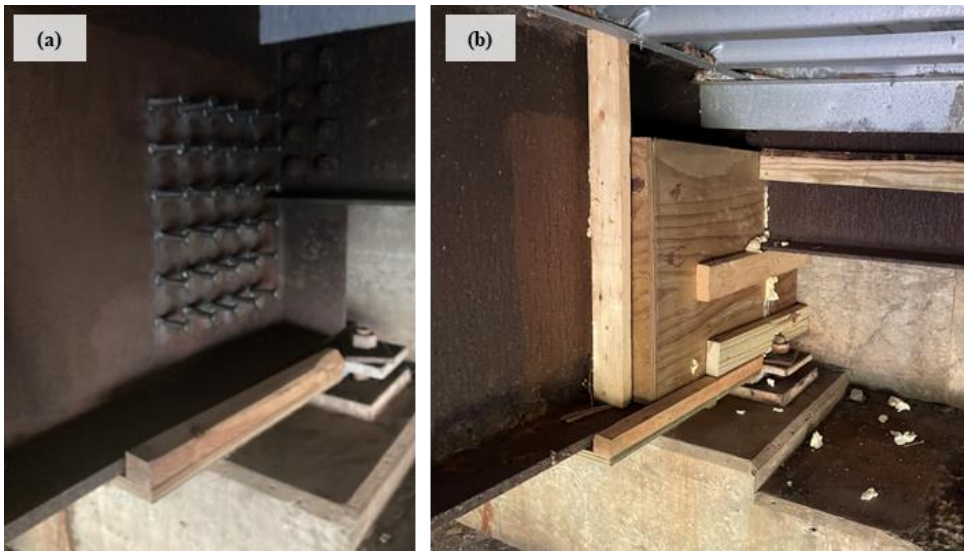
Figure 16. Photos of Bristow Road Bridge Repairs Before Fiber Reinforced Concrete Installation: (a) Shear Studs After Welding; (b) Formwork

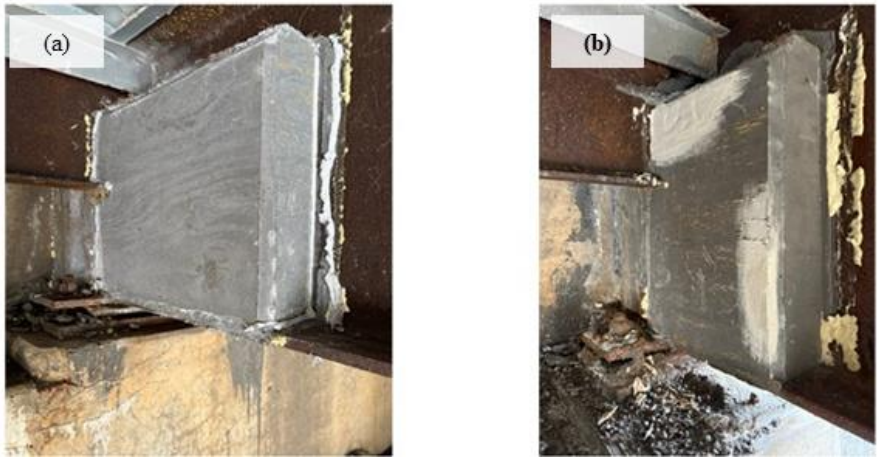
Workers tapped the forms with a hammer to aid in proper consolidation, even though the VHPC was a self-consolidating mixture. However, when forms were demolded after approximately 1 week, surface imperfections indicated a lack of fiber consolidation, clumping, or balling. Figure 19 shows photos of proper and imperfect surface finishes. Even though good finished surfaces were obtained in some cases, clogging of the flow through fiber conglomeration or lack of sufficient consolidation occurred in other cases. This occurrence raised awareness of the need for mechanical vibration in future projects rather than simply tapping the formwork with a hammer. The district indicated that they used ECC to patch the imperfect surfaces. The district also placed ECC at the steel-VHPC edge interface to seal out moisture and salts and prevent future corrosion.

Figure 19. Photos of Bristow Road Bridge Repairs After Formwork Removal: (a) Proper Surface Finish; (b) Imperfect Surface Finish Requiring a Patch
