INTERIM REPORT

FIELD EVALUATION OF CORROSION INHIBITORS FOR CONCRETE: INTERIM REPORT 2: EVALUATION OF INSTALLATION AND INITIAL CONDITION OF BRIDGE REPAIRS DONE WITH CORROSION-INHIBITING ADMIXTURES AND TOPICAL TREATMENTS

VIRGINIA TRANSPORTATION RESEARCH COUNCIL

June 1999
VTRC 99-IR5

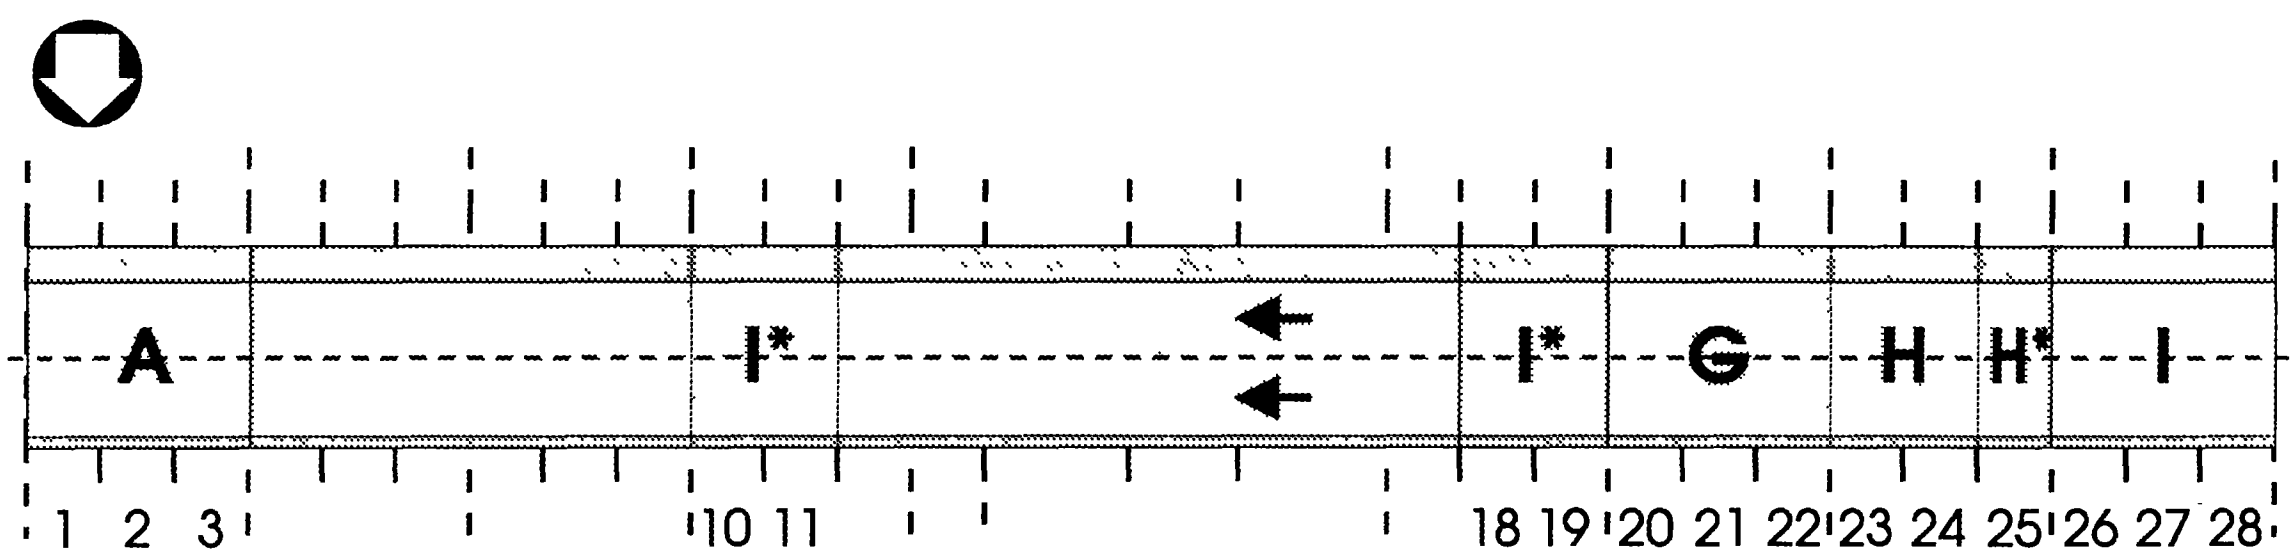
Figure 1. Route 60 EBL. over Lynnhaven Inlet

A: 7% silica fume (SF), spans 1,2 & 3

G: 7% silica fume, rheocrete corrosion inhibitor (SF, RCI), spans 20, 21 & 22

H: 7% SF, armatec corrosion inhibitor (ACI), armatec application (A), spans 23 & 24

H*: 7% SF, ACI, span 25

I: 7% SF, inorganic corrosion inhibitor (DCI), postrite application (P), spans 26, 27 & 28

I*: 7% SF, DCI, spans 10, 11, 18 & 19

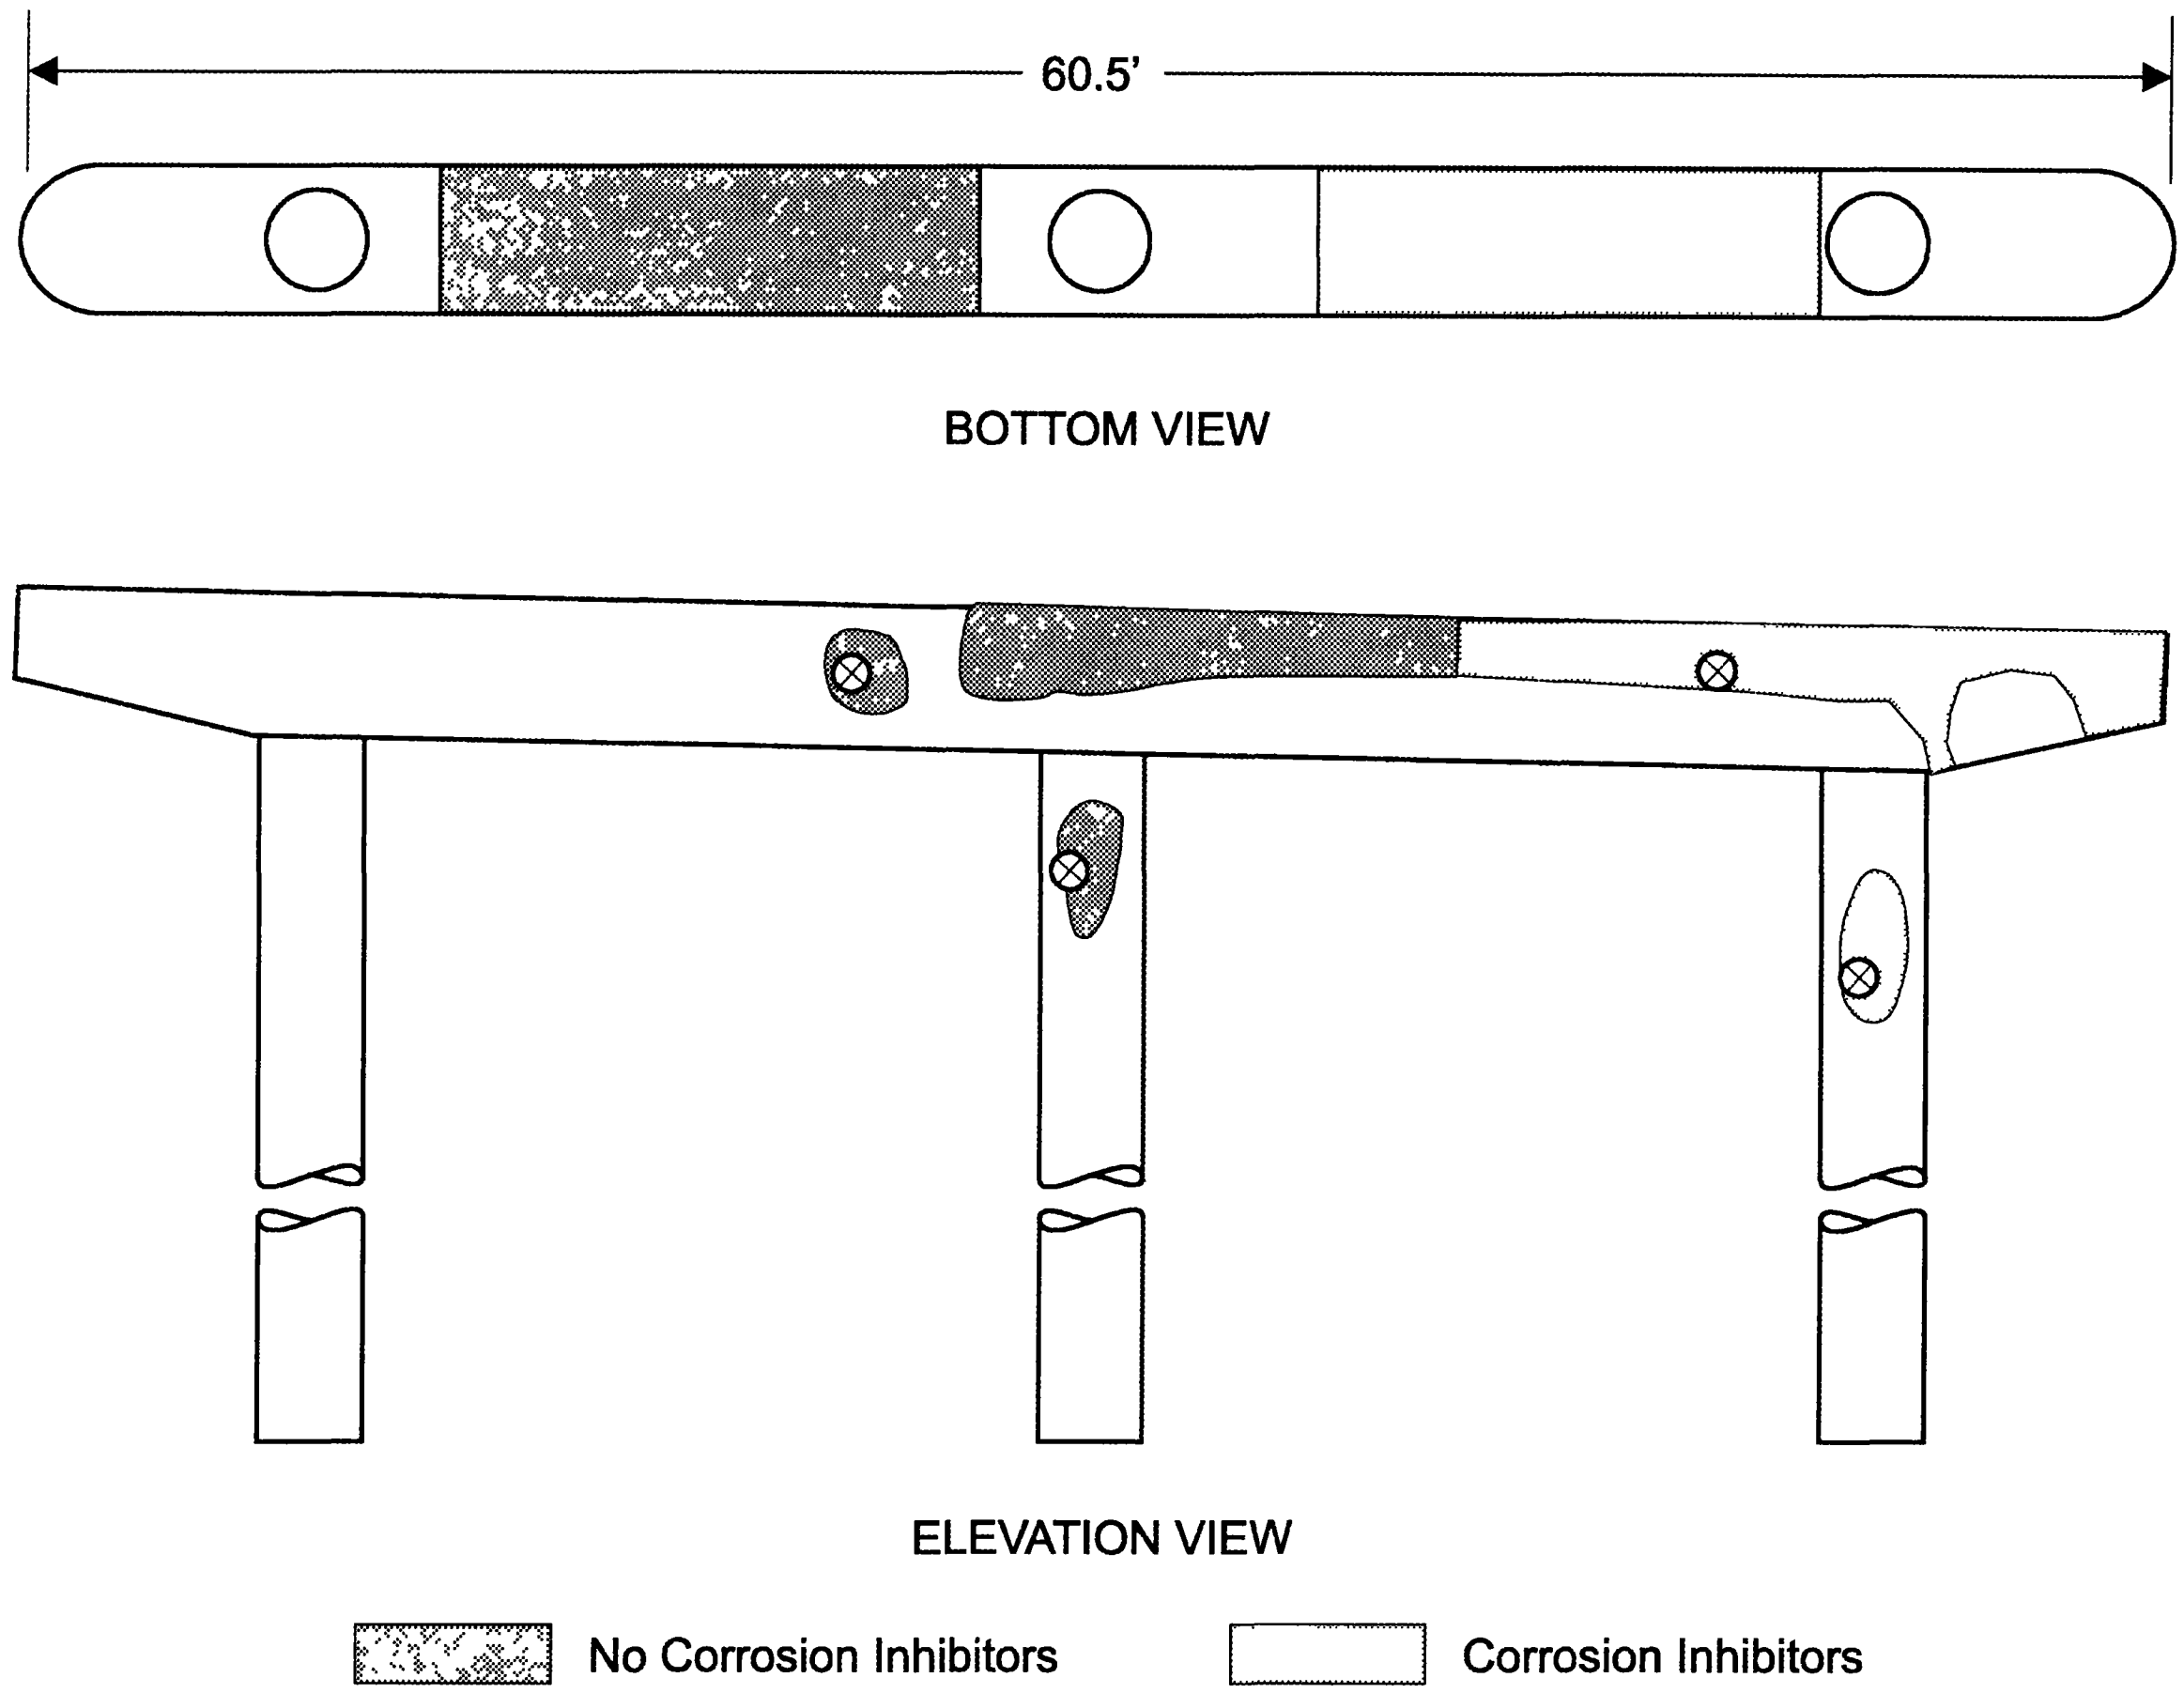
Figure 6. I-77, Big Walker Mountain

The bridge at the Big Walker Mountain has three spans. The second pier in the northbound lanes was repaired with shotcrete in September 1997. As shown in Figure 6, some

areas had shotcrete with silica fume, and in other areas the silica-fume shotcrete contained a calcium nitrite corrosion inhibitor. The deteriorated concrete was removed by pneumatic hammer. Prior to shotcreting, the area was sandblasted, probe areas were selected, and wires were connected. The area that contained the shotcrete with the corrosion inhibitor also had the topical application of Postrite.
