**DETERMINATION OF REMAINING FATIGUE LIFE OF WELDED STUD DETAILS
ON OVERHEAD ALUMINUM SIGN PANELS IN VIRGINIA**

Project Manager
Michael C. Brown, Ph.D., P.E.
Research Scientist
Virginia Transportation Research Council

March 2005
VTRC 05-CR10

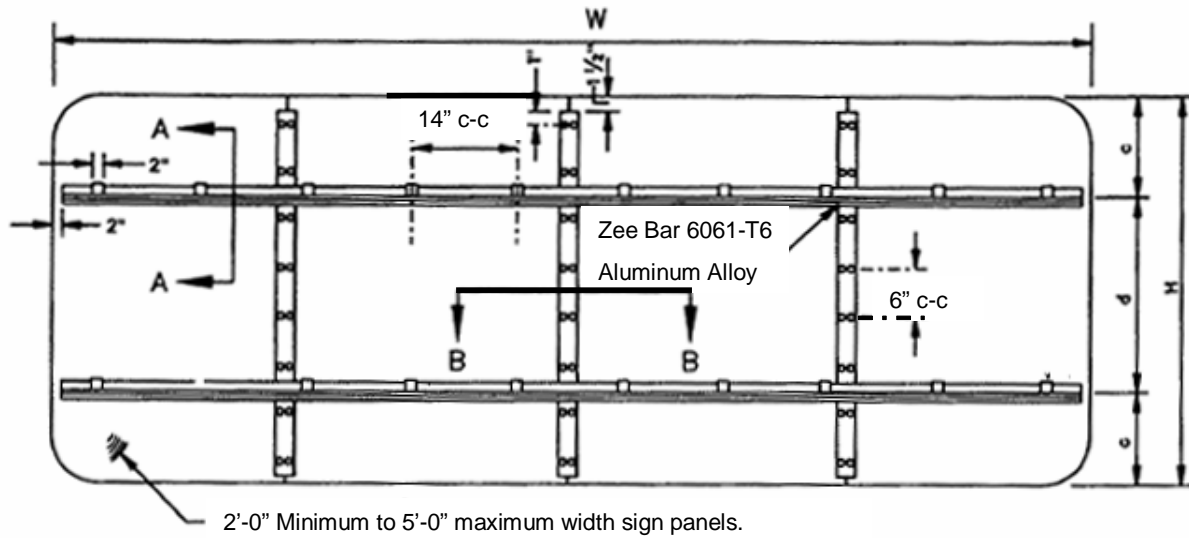
Figure 5. Sign Detail.

From the early 1980s until recently, the Virginia Department of Transportation (VDOT) has used a sign detail, as seen in Figure 5, connecting the sign panel to the support structure. The signs consist of multiple aluminum panels, varying in width from 2 to 5 feet with heights up to 18 feet, which are joined together using the connection clip detail seen in Figure 6. Threaded studs that are welded to the back of the panel connect the sign panel to the supporting structure. Figures 7 and 8 show the clip and z-bar connection detail. These welded connections are spaced 14 to 16 inches horizontally on center and 20 to 51 inches vertically on center over the entire sign as seen in Figure 9. There are currently about 4,000 signs that contain this clip and z-bar detail in Virginia.

VDOT halted its production of the signs with this clip-angle connection detail many years ago, however, some contractors continued to use this detail until early in 2004. One of the reasons some VDOT Districts stopped using the clip and z-bar connection was because the studs can shear if the nuts were more than “hand-tightened” during installation. Figure 10 shows studs that failed during tightening in the laboratory. Other districts, however, did not stop allowing contractors to install this connection detail until early in 2004, after a few known sign failures in the field.

In April 2003, a sign failed and fell in the Hampton Roads District causing a traffic accident. Another sign failed in the Fredericksburg District in March 2004, luckily not causing injury. It was observed that these failures occurred due to the threaded studs “popping off” the sign panels. The failure mechanism was observed to be fatigue of the weld connecting the panel to the stud, caused by natural and/or truck-induced wind gusts. From inspection of other signs that had failed connections, but had not fallen, it was concluded that the bottom edge and corner connections are more susceptible to failing. After the edge connections fail, the interior connections start to fail. This can be described as an unzipping of the sign connections. A failed sign and stud can be seen in Figures 11 and 12.

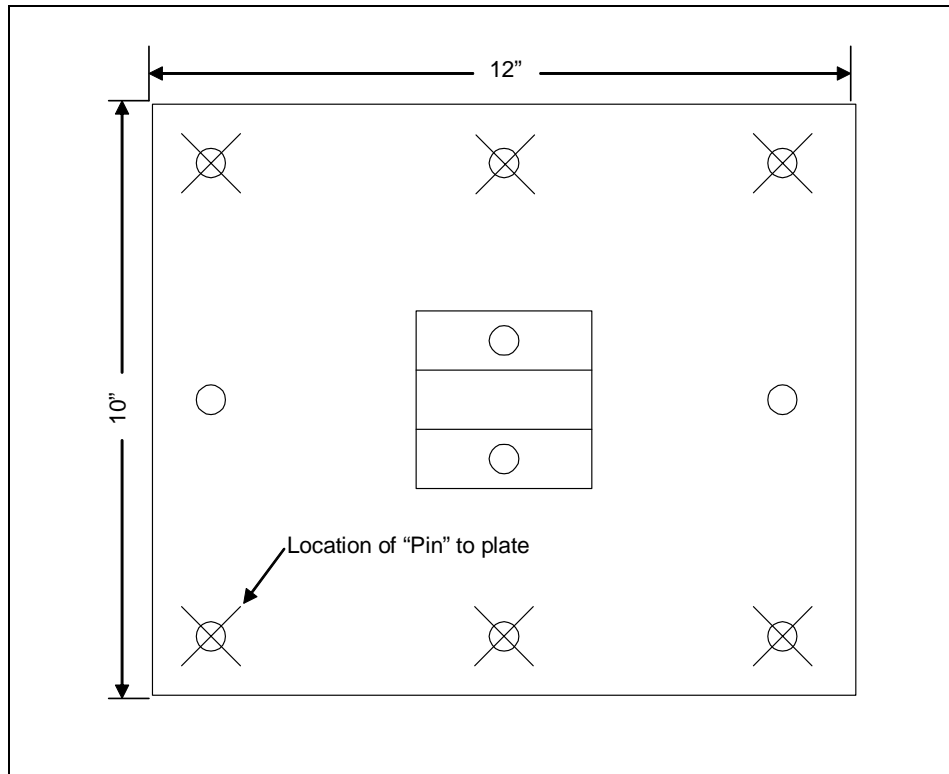
Figure 18. "Interior" Connection.

The sign specimen was first pinned on all four sides, as seen in Figure 18, to simulate an interior connection. The nuts were hand tightened on the studs. Repetitive pseudo-static tests were first performed on the interior test specimen to determine the stress distribution between the forces in the two studs. This was done by loading and unloading the specimen to 200 lb force. Bolt gages were installed in the threaded studs for these tests to determine the force distribution between the two studs during loading. Once this relationship was established, multiple pseudo-static tests at loading rates of 2-3 lb/sec were run to failure to determine the ultimate pseudo-static strength of a connection. Figure 19 shows a specimen during a pseudo-static test. Fatigue tests were then run at stress ranges starting at half of ultimate pseudo-static strength based on the pseudo-static test results. Table 1 shows the type of tests run and how many specimens were run at each load.

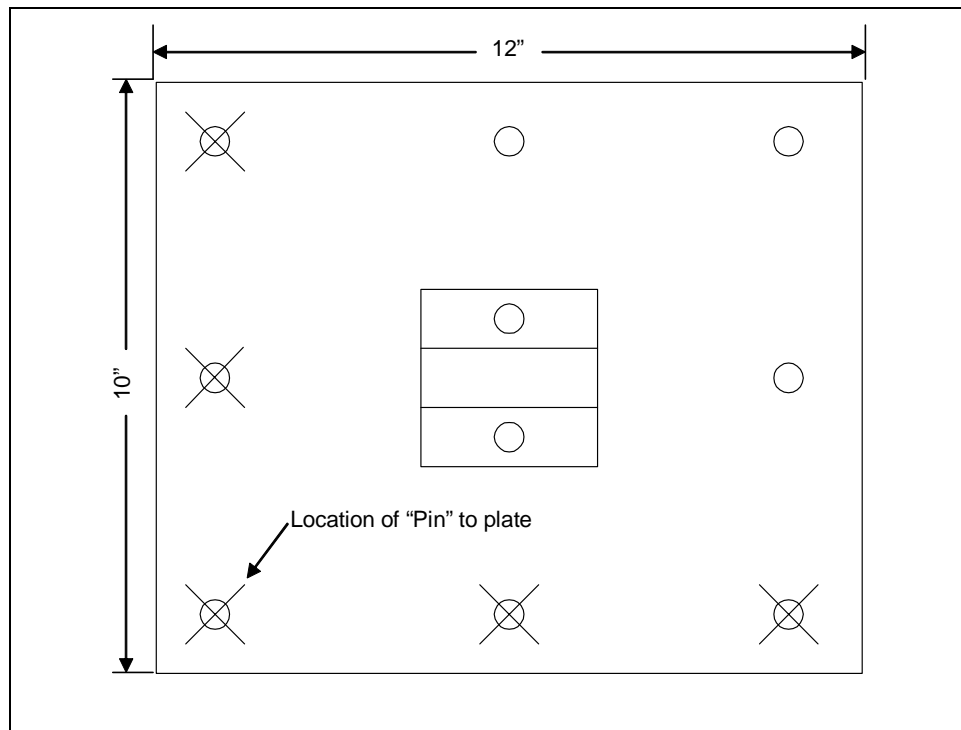
**Figure 20. “Exterior” Connection.****Table 2. Corner connection Tests**

To simulate an exterior connection, the specimen was pinned on two sides, as seen in Figure 20, with the nuts hand tightened on the studs. Pseudo-static tests to failure were first run to determine the maximum static strength. The first fatigue tests were then performed at the same levels as the interior connections. Fatigue tests were also run at other stress levels as seen in Table 2.

The average pseudo-static strength was found to be 780 lb from the three pseudo-static tests. The individual strengths were 790, 720, and 830 lb. The failures were similar to that of the interior connections tested under pseudo-static loading, showing that the welds popped off.

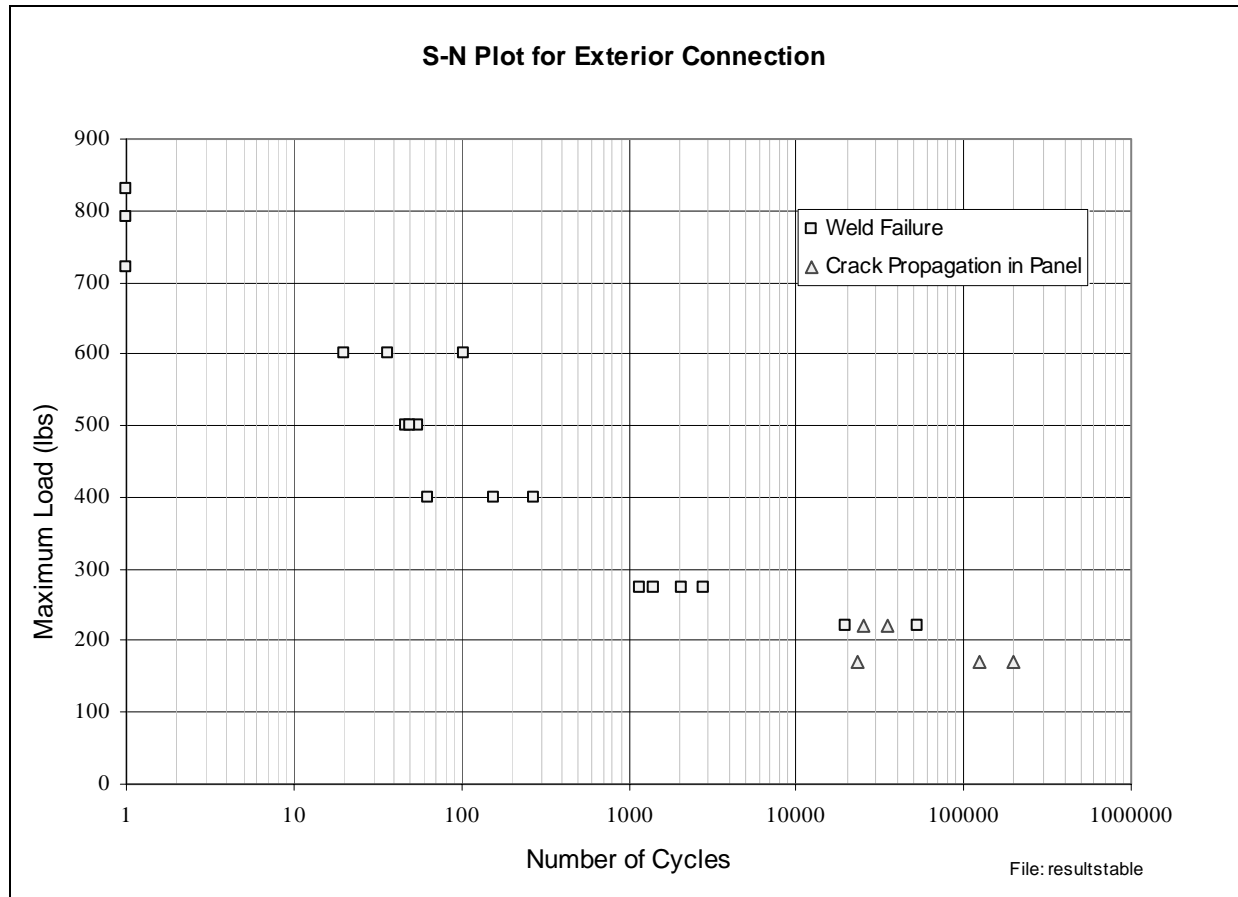
Figure 25. S-N Plot of Exterior Connection.

The connections tested at higher stress range exhibited failures of the weld between the stud and panel. Lower stress ranges exhibited cracking of the panel. Table 5 shows the results of the tests run, as well as the failure mechanisms. An S-N curve was developed from the exterior connection tests as seen in Figure 25.

Stress Range	Number of Cycles			
60-600 lb	37	103	20	
50-500 lb	55	47	49	
40-400 lb	63	268	157	
27-275 lb	1,160	1,417	2,800	2,050
22-220 lb	52,800	19,640	35,000*	25,000*
17-170 lb	200,000*	125,000*	23,000*	
10-100 lb

* crack in panel, not weld failure

The exterior connection was tested with the same objective as the interior fatigue connection, to start at a high stress range and progress to lower stress ranges until the infinite life stress range was determined. The exterior connections were observed to have lower pseudo-static strengths than the interior connections. This was expected due to the larger deformation and bending stresses induced on the stud connection. The weld fracture was the controlling failure mechanism at approximately 1.5 times that of hurricane design forces. The test panels exhibited base metal failure and cracking instead of a weld fracture at load ranges lower than 220 lb. The test panel tested at a load range of 100 lb exhibited an extended fatigue life. This load range is still above hurricane gusts of 90 mph and just below gusts of 120 mph for the sample sign. Under this loading type, the signs should not fail under common wind gusts. Because the tests did not model the failures found in the field, it is presumed that the loading conditions used for these tests did not properly simulate those found on full size signs in service.

1. *Inspections and retrofitting scheduling should be increased because of the statistical uncertainty.* Because there are so many uncertainties observed about how the signs are manufactured and erected it is suggested that the inspection process be accelerated.
2. *Full size highway signs that are still in use should be gauged and monitored to determine what type of loading to which they are subjected.* There are some issues concerning which signs should be tested because wind loads can be site specific. It is suggested that signs in the same area or setting as known failures be gauged.
3. *Full scale testing with wind loads may be the proper way to test the highway signs.* This requires multiple signs, which can be a problem because they are not readily produced anymore.
