Report No. VTRC 06-R9	Report Date October 2005	No. Pages 30	Type Report: Final	Project No. 76634
				Contract No.
Title: Forensic Investigation of Concrete Pavement: U.S. 460, Appomattox Bypass				Key Words: Concrete pavement, Appomattox Bypass, pavement failure, drainage
Authors: Shabbir Hossain, Ph.D., P.E., and Mohamed Elfino, Ph.D., P.E.				
Performing Organization Name and Address: Virginia Transportation Research Council 530 Edgemont Road Charlottesville, VA 22903				
Sponsoring Agencies' Name and Address Virginia Department of Transportation 1401 E. Broad Street Richmond, VA 23219				
Supplementary Notes				
<p>Abstract</p> <p>This report describes the investigation of structural failure in a section of the Appomattox Bypass along U.S. 460 in the town of Appomattox, Virginia. The bypass is a four-lane divided highway. The section that was investigated is an 11-year-old section of jointed plain concrete pavement located approximately between mile post 8.10 and mile post 8.35 in the eastbound lane.</p> <p>A forensic investigation was conducted to identify the causes of failure and determine reasonable remedial measures. The investigation included a visual condition survey, non

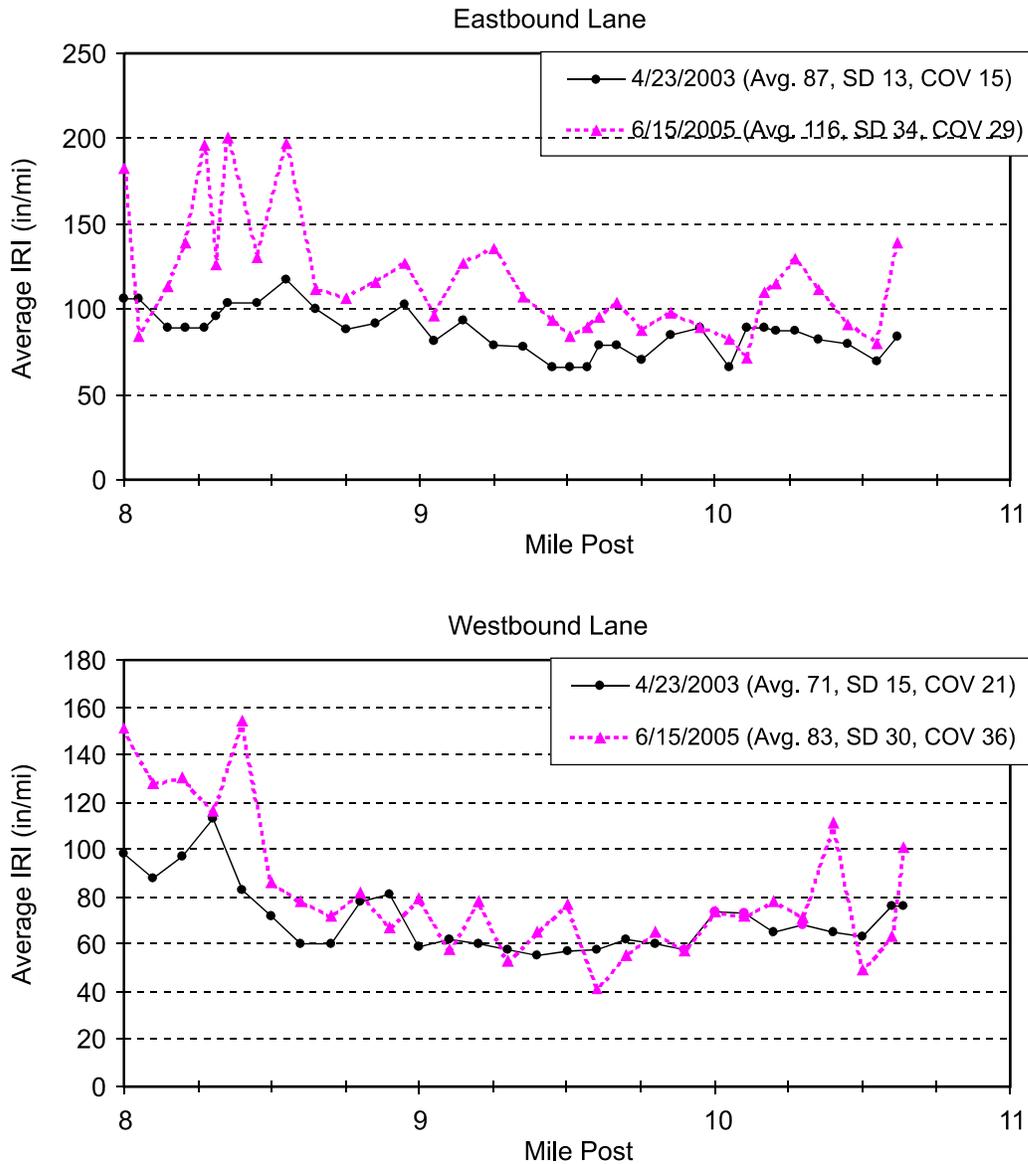
Figure 3. IRI Values from Profiler Testing: Eastbound and Westbound Travel Lanes

VDOT's Asset Management Division also conducts yearly distress surveys, which included roughness/ profile measurements. The IRI values were obtained from the division for 2003 and 2005. Average IRI values are presented and plotted in Figure 3. Results of tests conducted in 2003 for the eastbound lane had an average IRI of 87, a standard deviation (SD) of 13, and a coefficient of variation (COV) of 15; in 2005, the average was 116, the SD was 34, and the COV was 29. This indicates progressive deterioration in the ride quality. Tests conducted in 2003 for the westbound travel lane revealed an average IRI value of 71, a SD of 15, and a COV of 21; in 2005, the average was 83, the SD was 30, and the COV was 36. This also is an indication of progressive deterioration in the ride quality. It is to be noted that the ride quality is

worse in the eastbound lane, which coincides with the structural condition being worse in the eastbound lane. Obviously, the residency also replaced more slabs in the eastbound lane. It is also noted that the area under investigation had a relatively high IRI because of faulting and mid-slab cracks.

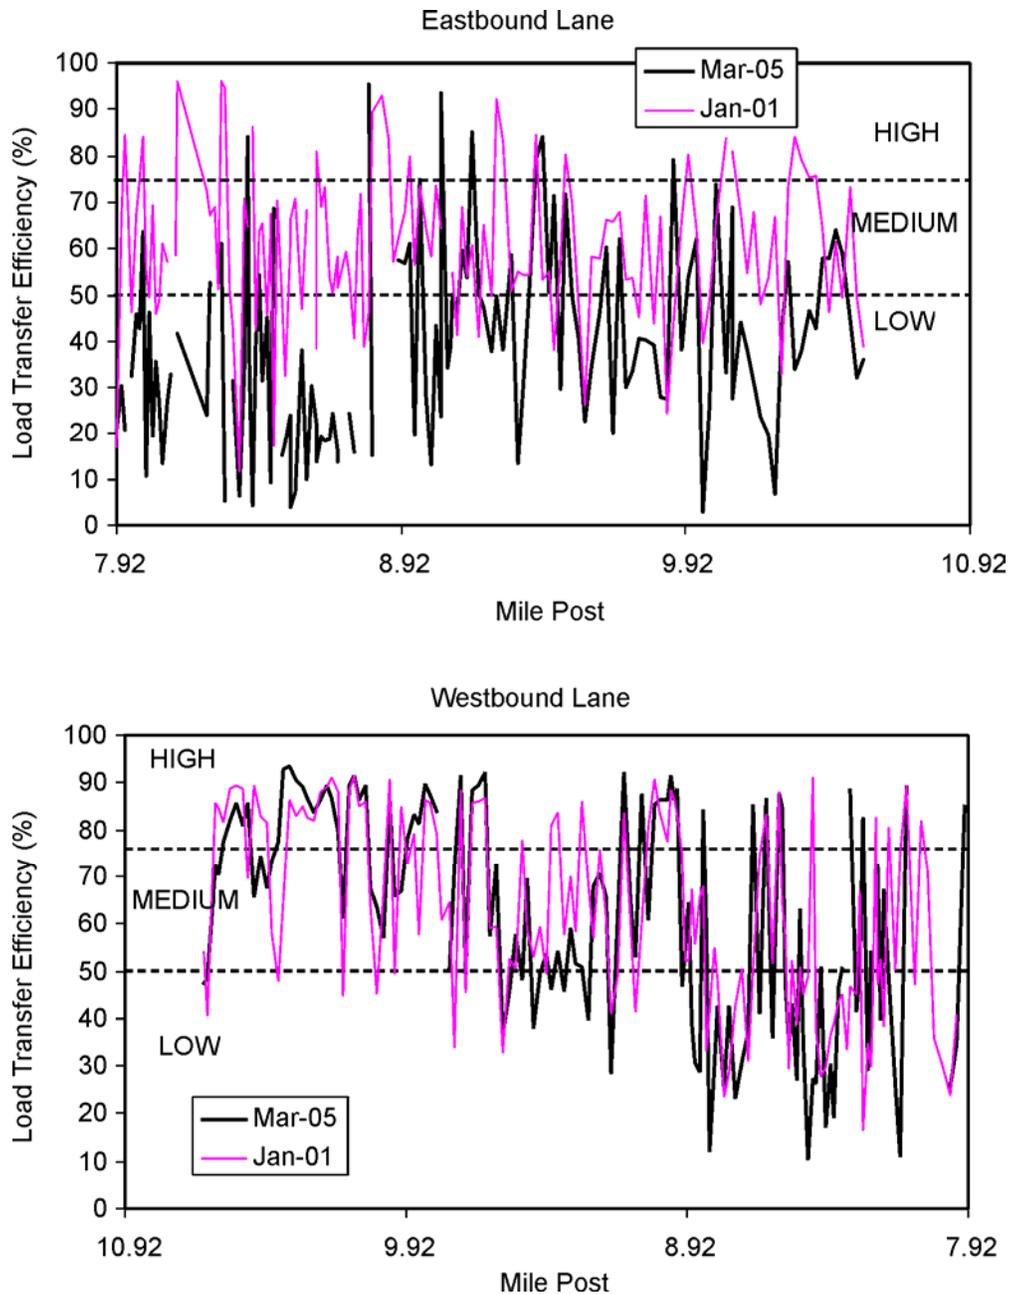
Figure 4. Load Transfer Efficiencies Measured with FWD test for 2001 and 2005

The structural condition and integrity of the existing concrete pavement was evaluated using a FWD. Data have been collected over the last few years for the Appomattox Bypass. Both mid-slab and joint load transfer tests were included into the testing program. The LTE is defined as the ratio between the deflection of the unloaded slab and the loaded slab times 100. The LTEs are presented in Figure 4 for the years 2001 and 2005. Several years of LTE statistics are presented in Table 4. In order to investigate the gradual progression of load transfer failure, data were grouped according to low (< 50%), medium (51%-75%), and high (> 75%) and presented in Figure 5. It is important to note that only 15% of the total joints were tested every year except for 1998, when all the joints were tested. The testing load was different

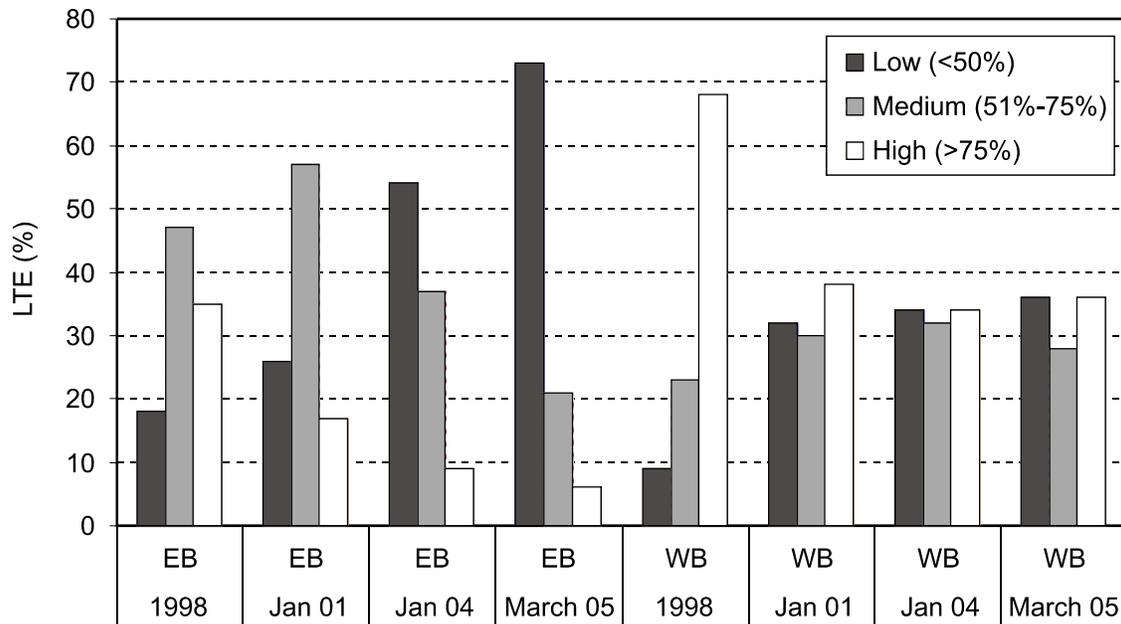
Figure 5. Progression of Load Transfer Efficiencies

in 1998; it was 9,000 pounds instead of the 16,000 pounds used in all other years. The testing temperature was also varied, as shown in Table 4. The data from July 2003 were discarded because it was suspected that the joints were locked during the testing because of the relatively high temperature. It is obvious from Figure 5 that the eastbound lane is deteriorating at a faster rate than is the westbound lane.
