## Survey of Cathodic Protection Systems on Virginia Bridges

STEPHEN R. SHARP, Ph.D.  
Research Scientist

MICHAEL C. BROWN, Ph.D., P.E.  
Research Scientist

**FINAL REPORT**

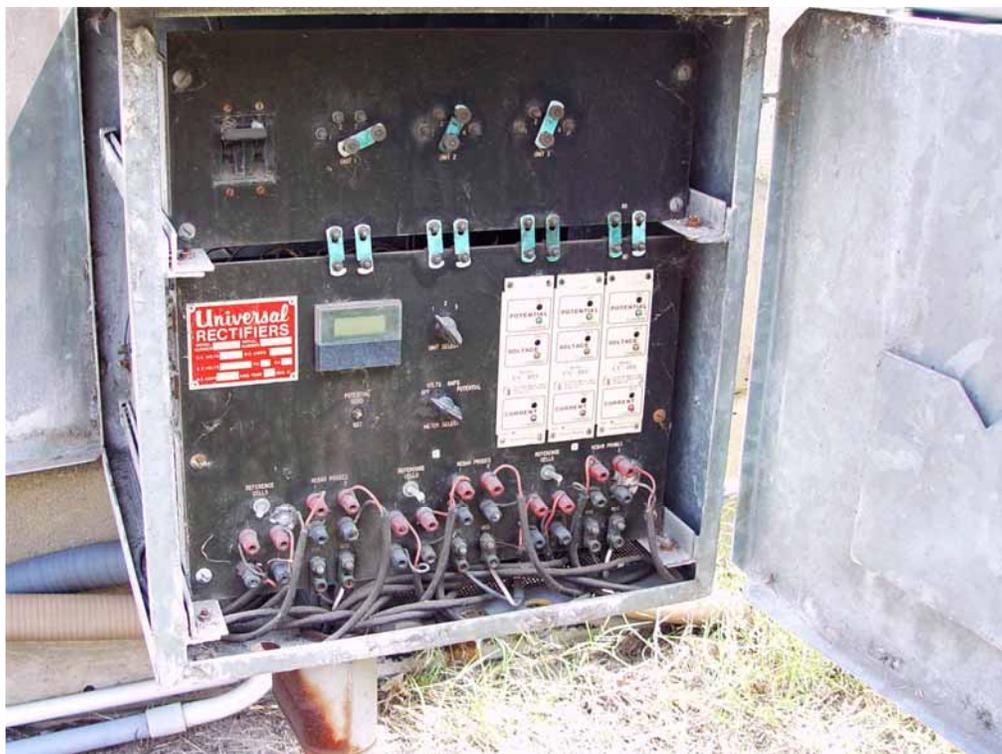
**Figure 6. Control Unit for Cathodic Protection System: I-64 EBL Over 13th View Street**

The slotted conductive polymer system installed in the deck (see Figure 7) contained niobium-copper primary anode wires and supplemental secondary anodes of carbon strand, each laid in saw slots 3/8 in to 1/2 in wide by 3/4 in deep and filled with a conductive polymer grout made of vinyl-ester resin and carbon black. A similar system had been installed in 1983 on an inland structure along Route 15 over the Willis River in Buckingham County, Virginia. Within the first 2 years of operation of this type of system on each structure, there was evidence of degradation of the conductive grout caused by acids generated at the anode surfaces (Virmani and Clemeña, 1998). A visual inspection of the deck (Zone 1) indicated discoloration in some areas of the concrete adjacent to the slotted anodes (Swiat and Bushman, 1989). Swait and Bushman (1989) concluded the life of the deck system would be directly related to the time it would take for the system to damage the concrete. Subsequently, Zone 1 of the 13th View Street structure was deactivated.

The system denoted Zone 2, on the east pier, was an arc-sprayed zinc coating comprising an approximately 20-mil-thick layer of 99% pure zinc applied to the sandblasted concrete surface. Current was supplied to the zinc via titanium distributor bars 1/2 in wide by 4/100 in thick coated with mixed metal oxide (Swiat and Bushman, 1989). Zone 3, on the west pier, was

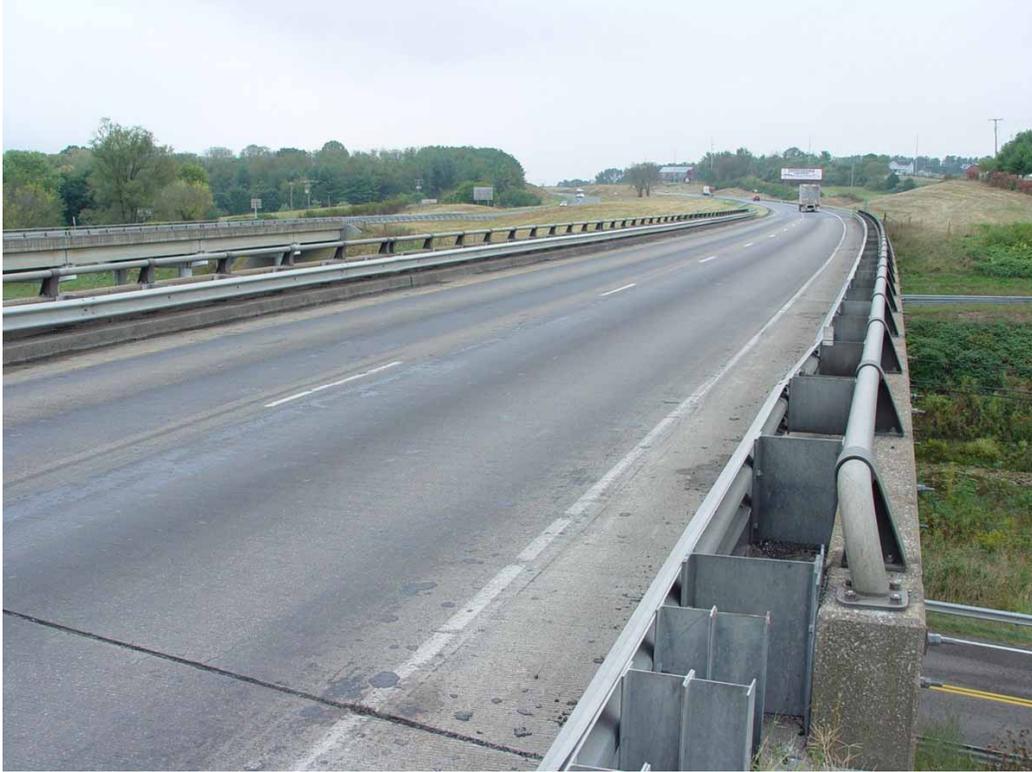
**Figure 15. I-81 SBL Over Mill Creek**

These bridges (NBL SN 2014, SBL SN 2015) in Mount Jackson, Virginia, received ICCP systems in 1989 designed to mitigate corrosion in the piers and caps (Clemeña and Jackson, 1997). These are parallel inland structures located over fresh water and a secondary highway, and they are exposed to chlorides during winter because of the use of deicing salts on I-81 (Figure 15). The anodes are an electrically conductive paint system with an embedded platinum-niobium-covered copper wire. The conductive paint shows signs of adhesion failure over approximately 5% to 10% of the surface, as shown in Figure 16.

An experimental remote monitoring system using a conventional telephone modem was applied to this system. The most recent bridge inspection reports, dated August 24, 2005 (Smoot 2005a,b), indicated that the substructures for both the NBL and SBL structures were in overall good condition except for hairline map cracking in pier caps in the shotcrete repair areas and bleeding of the carbon black of the conductive coating through the surface cosmetic coating layer (Figure 17). The decks were protected by a 1¼-in latex-modified concrete overlay and were reported to be in good condition.

At the present time, there appears to be power supplied to the system, but there are no records available of routine monitoring. Interviews of district structure and bridge personnel indicated that no one at the district or residency had been acquiring or receiving any sort of status reports on the systems. It is recommended that the system be more closely evaluated to determine if it is functioning and that the status of the remote access monitoring system be ascertained.
