FINAL
CONTRACT REPORT
VTRC 10-CR3

**RAPID REPLACEMENT OF TANGIER ISLAND
BRIDGES INCLUDING LIGHTWEIGHT AND DURABLE
FIBER-REINFORCED POLYMER DECK SYSTEMS**

1. Report No.: FHWA/VTRC 10-CR3	2. Government Accession No.:	3. Recipient's Catalog No.:	
4. Title and Subtitle: Rapid Replacement of Tangier Island Bridges Including Lightweight and Durable Fiber-Reinforced Polymer Deck Systems		5. Report Date: September 2009

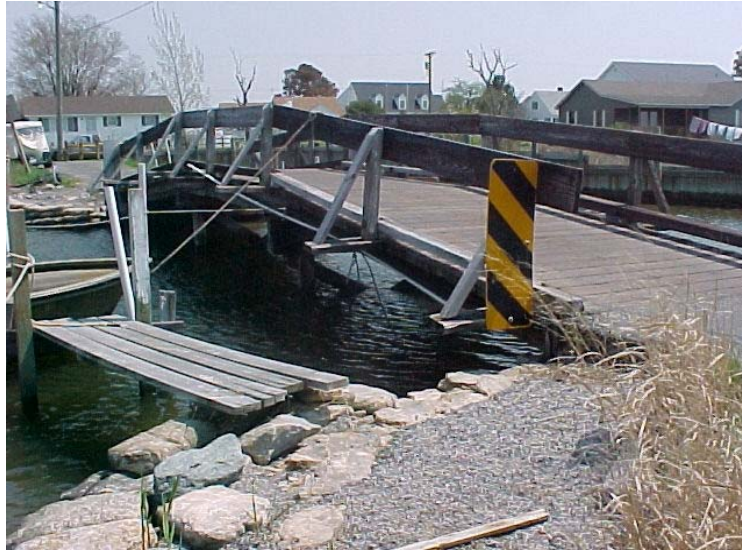
Figure 1. Tangier Island timber bridge

The Virginia Department of Transportation's (VDOT) Hampton Roads District scheduled two bridges on Tangier Island for replacement during 2004. Figure 1 shows a photo of the pre-replacement condition of the two bridges. The harsh environmental conditions of the Chesapeake Bay present a durability challenge to the bridges of Tangier Island. Complicating the accessibility to repair and retrofit of these structures is the limited accessibility to the island: i.e. only by air or water. Two bridges were replaced with 55 ft single span bridges of the type shown in Figure 2. The superstructure of each bridge is parallel galvanized steel through trusses with fiber-reinforced polymer (FRP) deck panels to reduce maintenance and increase durability. Moreover, the modularity and lightweight nature of the FRP decks allowed for rapid replacement of these bridges, ensuring continued accessibility of emergency vehicles to the inhabitants of Tangier Island.
