Short-Term Evaluation of a Bridge Cable Using Acoustic Emission Sensors

1. Report No.: FHWA/VTRC 10-R24	2. Government Accession No.:	3. Recipient's Catalog No.:	
4. Title and Subtitle: Short-Term Evaluation of a Bridge Cable Using Acoustic Emission Sensors		5. Report Date: May 2010

FINAL REPORT
SHORT-TERM EVALUATION OF A BRIDGE CABLE
USING ACOUSTIC EMISSION SENSORS

May 2010
VTRC 10-R24

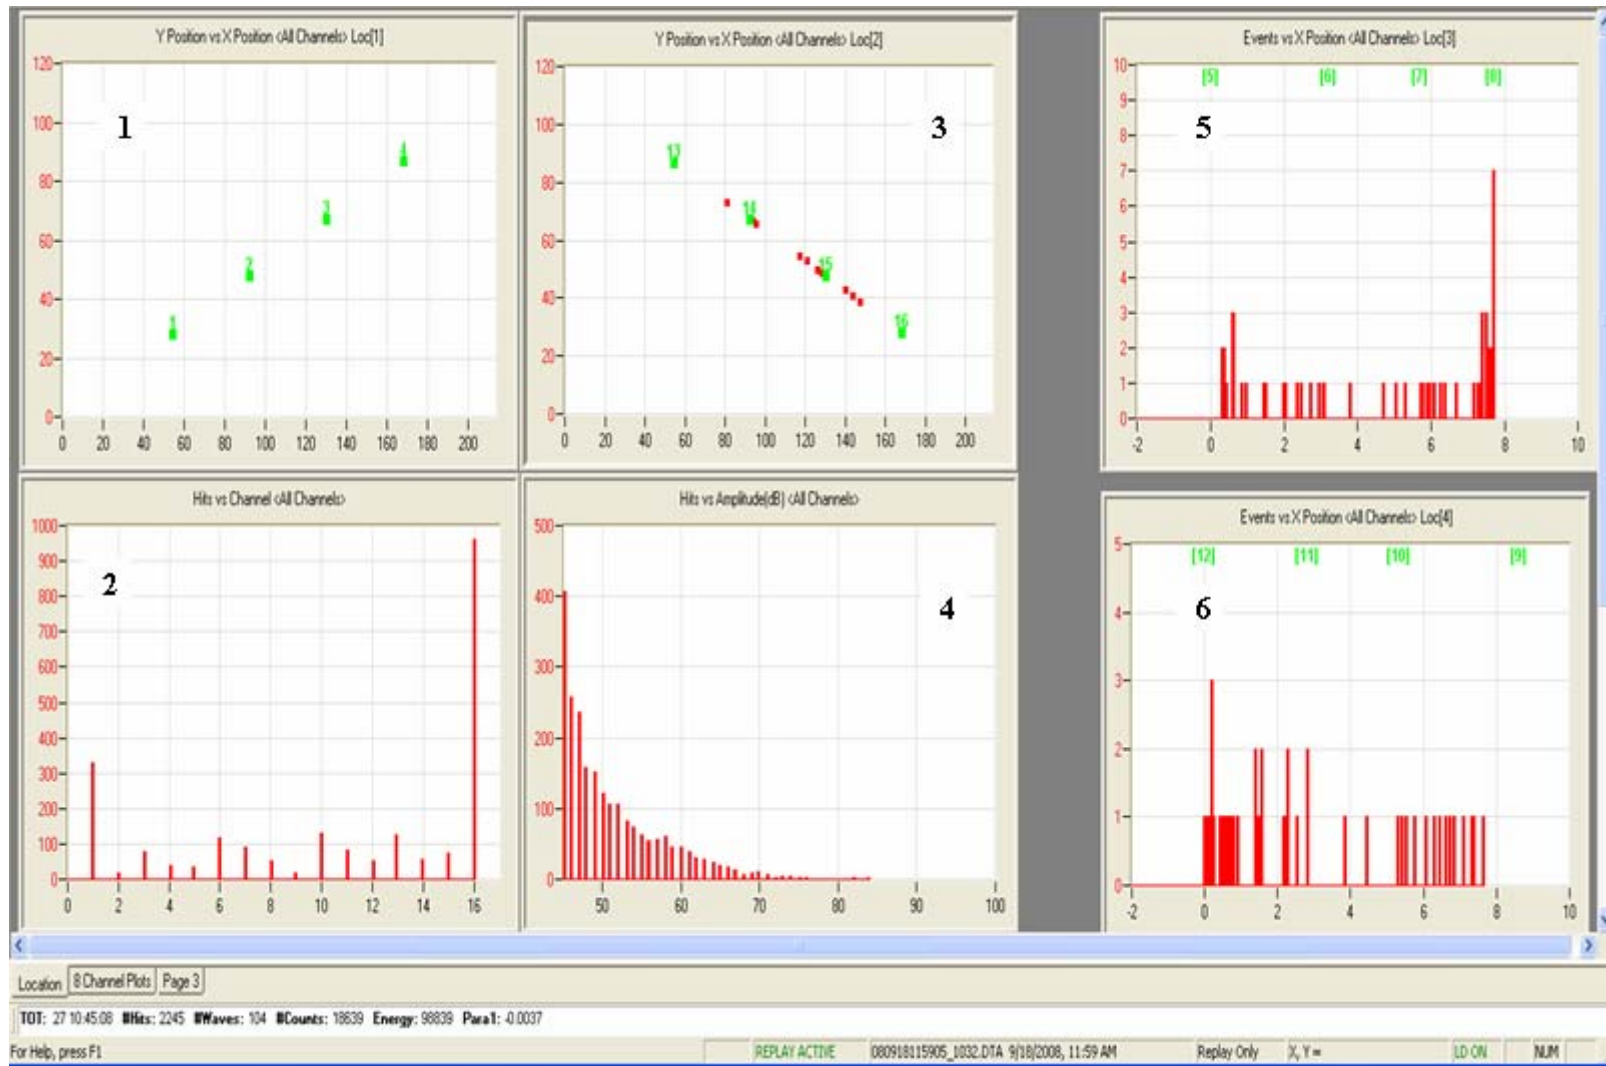
Figure 7. Sample 2D Plot of Data Representing AE Events (Hits), Their Amplitudes, and Dates and Times Recorded, October 11-15, 2008

1. *AE signals related to damage of the cable strands are supposed to be dramatic.* These will have high energy, a high amplitude, and a very short duration. The AE amplitudes from Sensors 2 through 4 and 13 through 15 installed on the stay-cable, shown in Window 4 of Figure 7, are feeble and very weak, indicating an absence of any break, crack, or damage to the cable strands during the event. In fact, the responses correspond to the feeble AE sources unrelated to the cable. The weather data during the period confirmed the AE source to be the raindrops hitting the cable. The AE sensors have detected even such weaker hits. The smaller dots appearing in between the sensor installation points (larger square symbols adjacent to the sensor number) in Window 3 in Figure 7 indicate the actual locations of falling raindrops.

2. *AE signals from Sensor 1 and Sensor 16, which are the two sensors closest to the stay-cable deck anchorage points, also exhibited hits.* As shown in Window 2 of Figure 7, Sensor 1 measured more than 300 hits and Sensor 16 measured more than 900 hits during the October 11 through 15, 2008, test period. The dots in Window 3 represent locations where AE generated because of falling raindrops along the sensor installation points. The absence of dots between the sensor installation points (larger square symbols adjacent to the sensor number) in Window 1 indicates that the AE source is outside the location perimeter of Sensors 1 through 4. These responses occurred when there was no rain on the bridge and might have been the result of cable vibrations caused by higher winds or blowing debris striking the cable/anchorage region. However, confirmation of this would require further investigation.

3. *VDOT's Richmond District Bridge Division should evaluate the stay-cable anchorage regions more closely using AE and determine the source of the AE signal detected during this study and which anchorage regions show the greatest acoustical activity. VTRC should provide guidance for this recommendation when requested.*

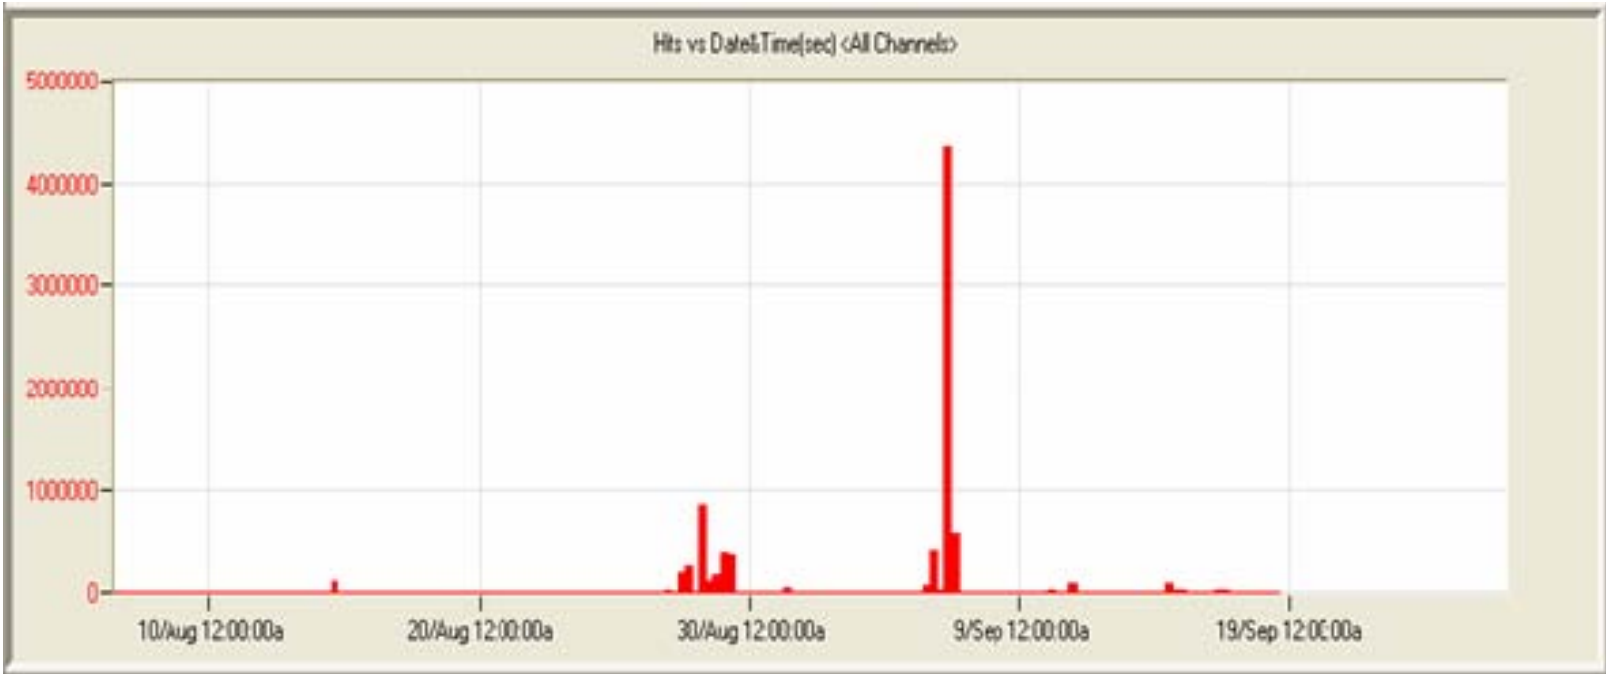
Figures 11 and 12 show intense AE activity across the center of the saddle region. Sensors 6 and 11 are located near the center of the saddle on its west and the east faces, respectively (Figures 11 and 12). The most likely source of this activity is the initiation of a new crack or growth of a pre-existing crack. AE signal signatures and data analysis show the presence of both. The dates and times of the activities in Figures 11 and 12 are shown in Figure 13, where the number of hits is plotted against the date and time of occurrence on August 28 and

Figure 13. AE Events recorded by All Sensors, August 12-September 25, 2008. The number of hits is plotted here as a function of dates and times.

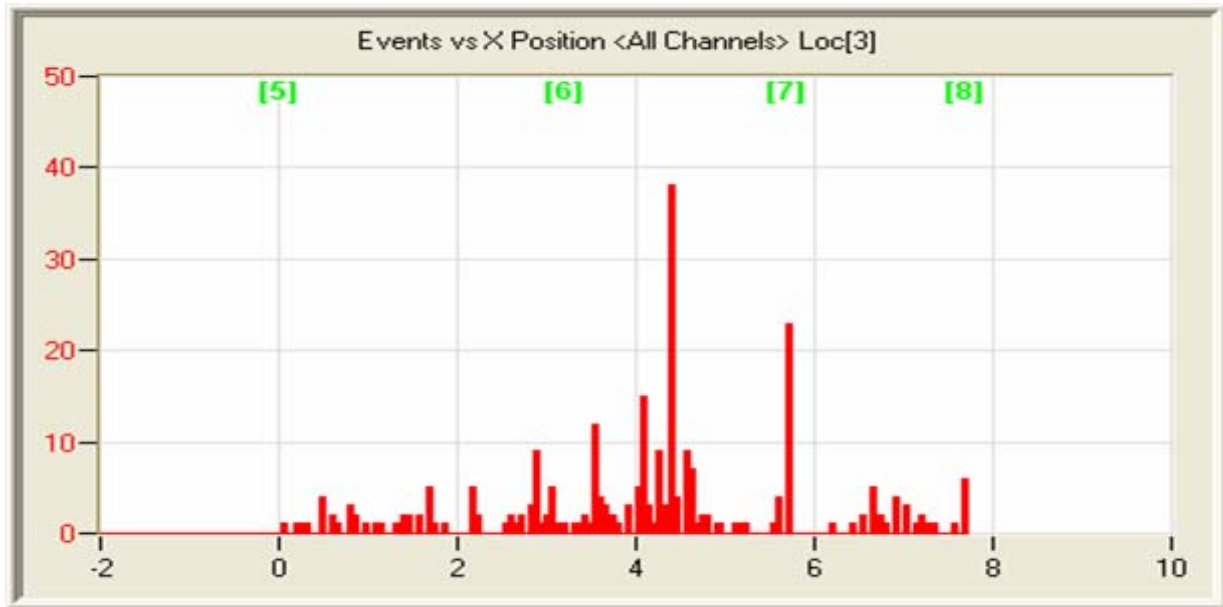
Figure 14. AE events Recorded by Sensors 5-8, October 25-27, 2008

29, 2008, and September 6 through 8, 2008. AE events also occurred October 25 through 27, 2008, as shown in Figures 14 and 15, which show activities in the center and northeast corner of the saddle. From December 11, 2008, to January 29, 2009, there was AE activity in the southwest and northeast corner areas of the saddle, as shown in Figures 16 and 17, respectively.

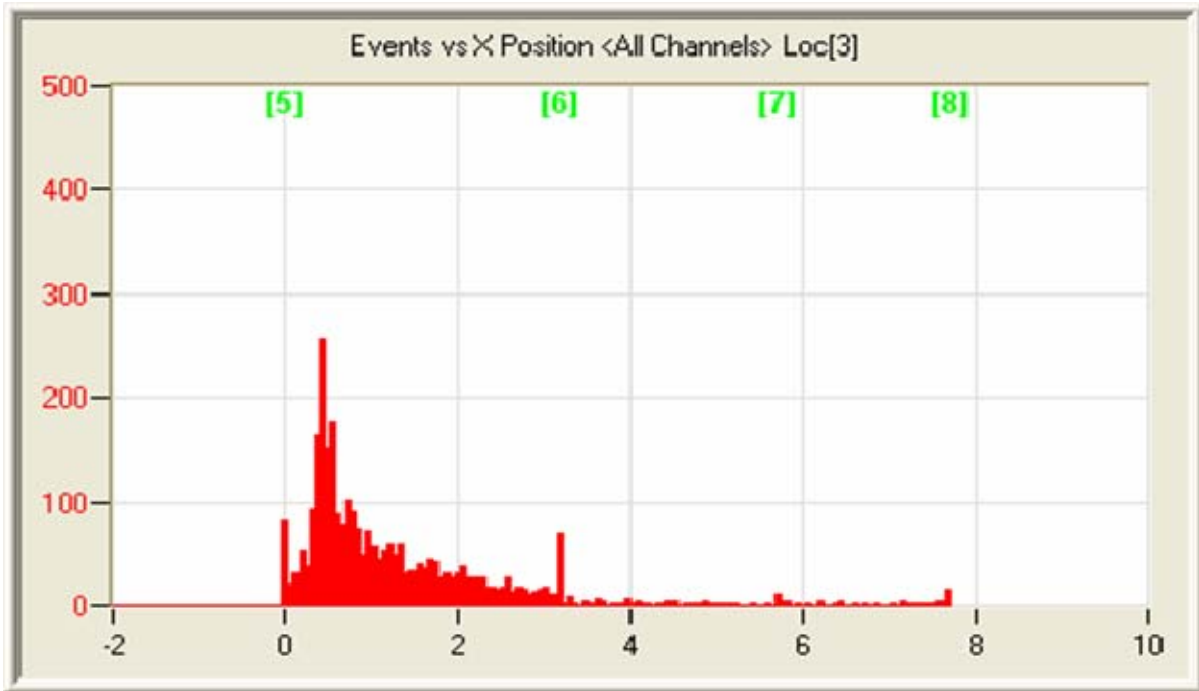
Figure 18. AE Events Recorded by Sensors 5-8, February 26-March 6, 2009 (Extreme Cold)

Figures 18 and 19 represent AE activities that occurred February 26 through March 6, 2009, in the northeast and northwest areas of the saddle, respectively. This was also the period of extreme cold on the bridge. Figures 20 and 21 similarly represent the AE activity that occurred September 28 through 30, 2009, in the center and north areas of the saddle walls, respectively. Data presented in Figures 11 through 21 are only typical examples, although similar AE events
