# A Case Study of the Loop-Welded Eyebars Removed from the Advance Mills Bridge in Albemarle County, Virginia

Final Report VCTIR 11-R13

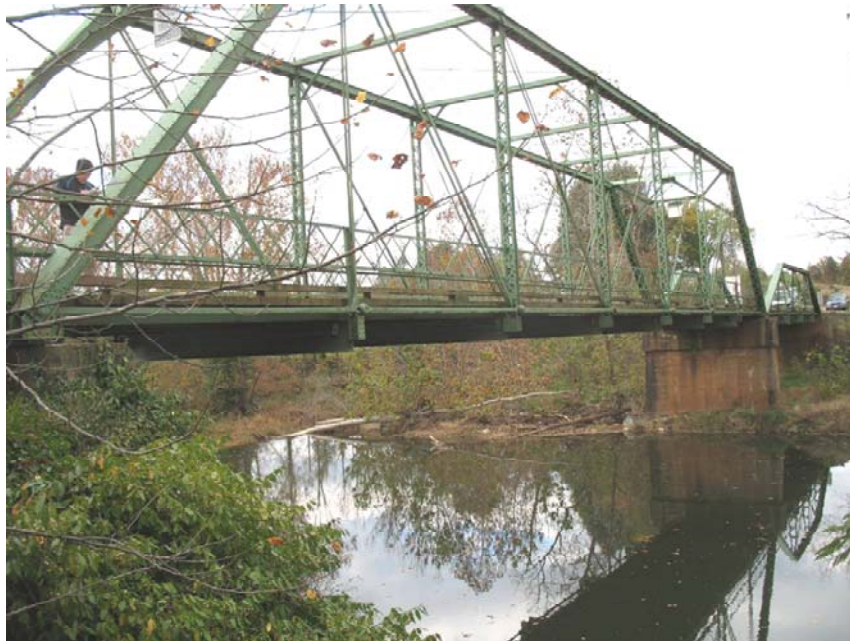
**Figure 1. Advance Mills Bridge at Time of Final Inspection in 2007**

Because of advanced deterioration caused by corrosion and the effects of overloading, the one-lane Advance Mills Bridge was open to traffic with a 3-ton weight limit and was limited to crossing by only one vehicle at a time. Several members in the truss spans had been strengthened by cables since 1994, and the bridge was on a 6-month cycle for safety inspections. However, the findings of the final regularly scheduled safety inspection in April 2007 indicated continued deterioration to such an extent that a decision was made by VDOT and approved by the Albemarle County Board of Supervisors to close the bridge to traffic later that year..

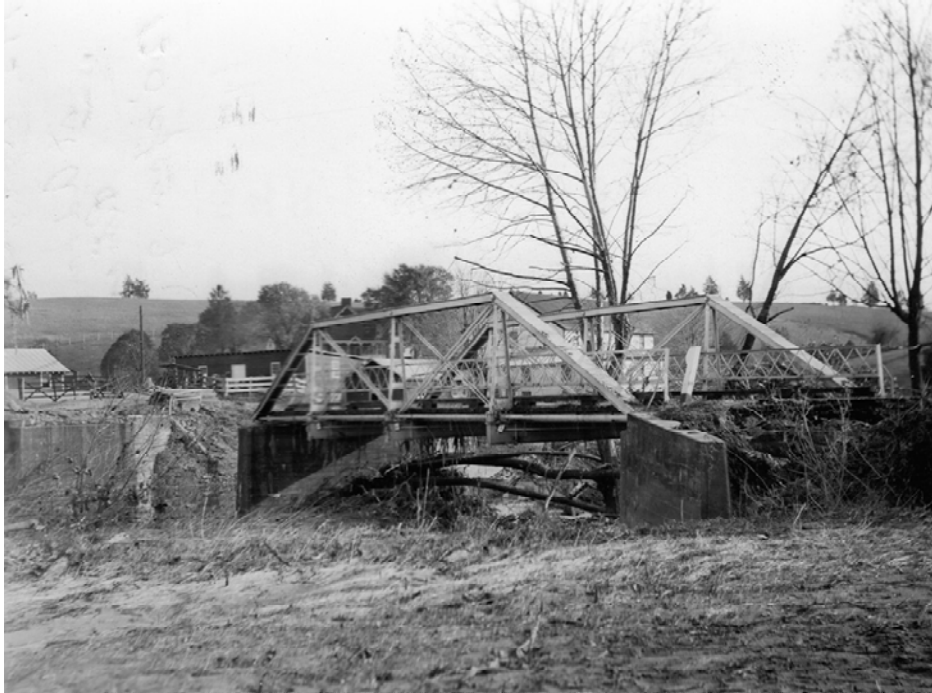
The main through truss span of the early 20th century Advance Mills metal truss bridge was washed out during the widespread flooding that struck Central Virginia, Northern Virginia, and the Shenandoah Valley in October 1942. The pony truss, shown in Figure 5, remained.

**Figure 5. Advance Mills Bridge After Flood of October 1942**

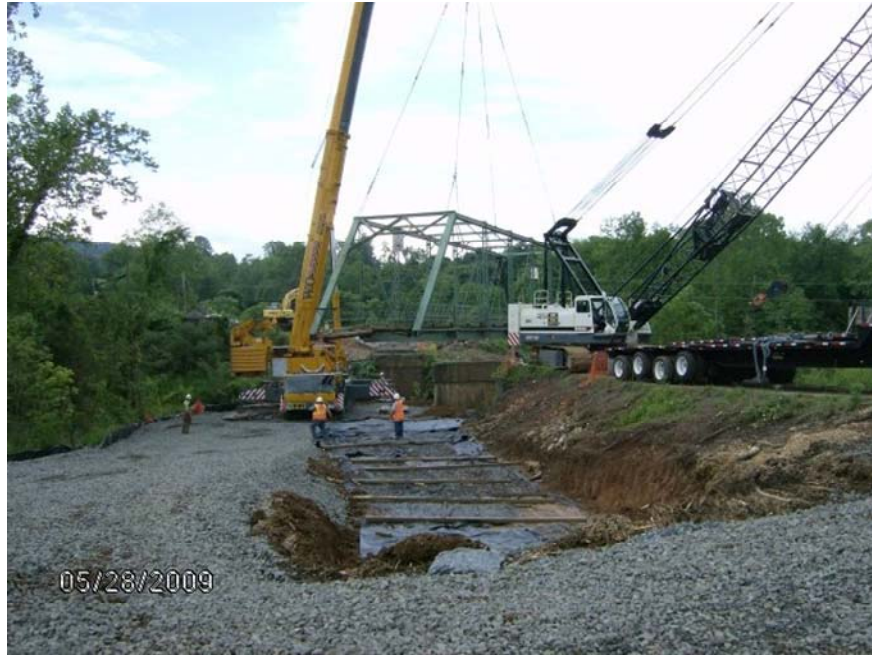
Despite the emphasis placed on the MOA (2008) and its requirement for saving selected loop eyebars for study, the contractor's efforts were more focused on removing and disposing of the trusses as expediently as possible. Unfortunate events, attributable to the contractor's haste and inexperience, significantly affected the scope and course of the research. The contractor decided to remove the longer through truss span as a single unit by removing the deck and joists and lifting the span by cables attached at the hips, as shown in Figure 6.

**Figure 6. Lifting Entire Through Truss From Its Bearings**

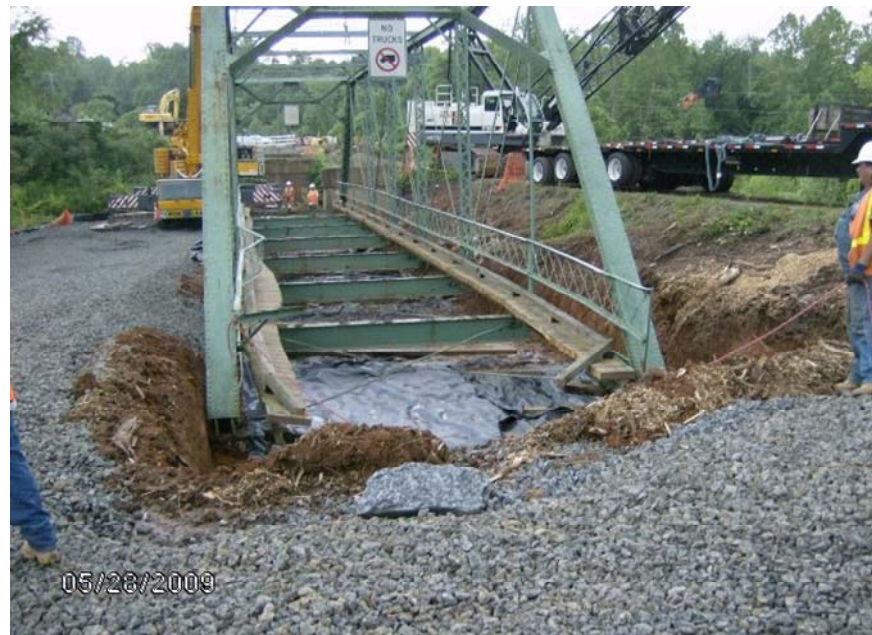
Although portions of the deck were left in place to stiffen the tension members, the bracing proved inadequate to prevent distortion of the rails and bowing of some of the relatively slender diagonals. Nevertheless, the truss was placed on its prepared bed (Figure 7) with only minor damage.

**Figure 7. Through Truss Removed From Bridge, With Only Minor Distortion of Members**

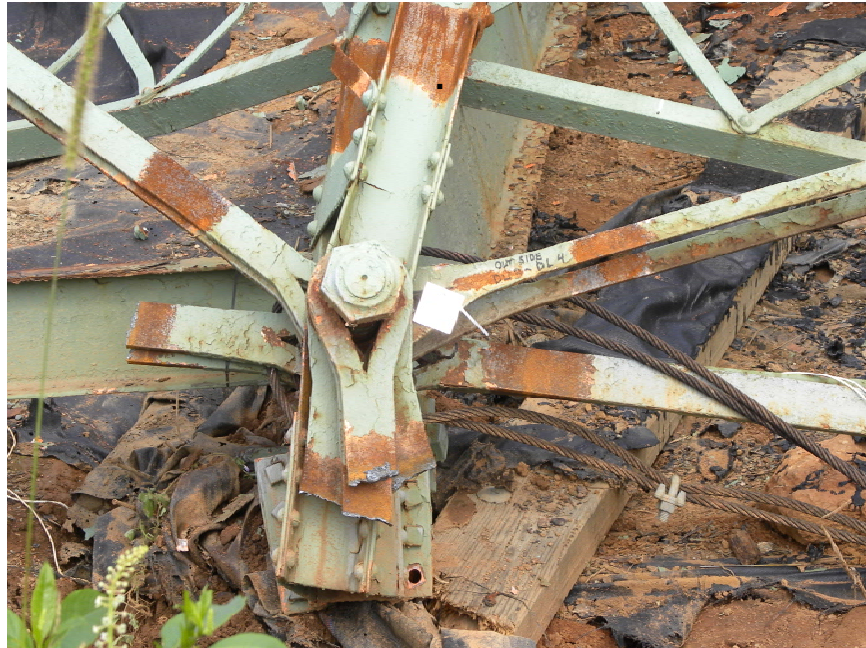
containing those members that had been selected for detailed examination (Figure 10) were cut from the bridge and stored onsite to be picked up and disassembled by the bridge crew at VDOT's Charlottesville Residency. Lead paint on the truss members had to be removed mechanically at points near the joints prior to cutting of the members.

**Figure 10. Panel Point With Member (silver tag) Selected for Study. Lead paint was mechanically removed from members prior to cutting.**
